Providing the Washington State Department of Ecology's views on Hanford tank closure

# Tank Closure Topics

March 2013

#### Update: Leak in double-shell tank AY-102

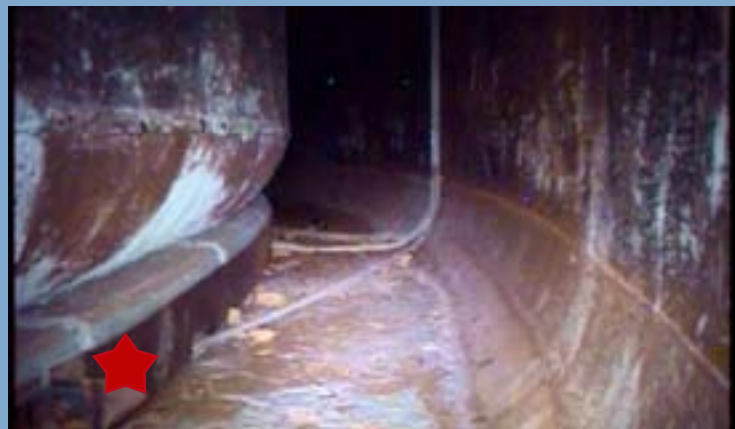
Inside the annulus, or space between the primary and secondary tanks, of tank AY-102, the steel stabilizing ring at the base of the inner tank is 6 1/2 inches tall, 3/8 inches thick, and supports the base of the inner tank.

The red star provides reference for comparison with the close-up photo on page 4.

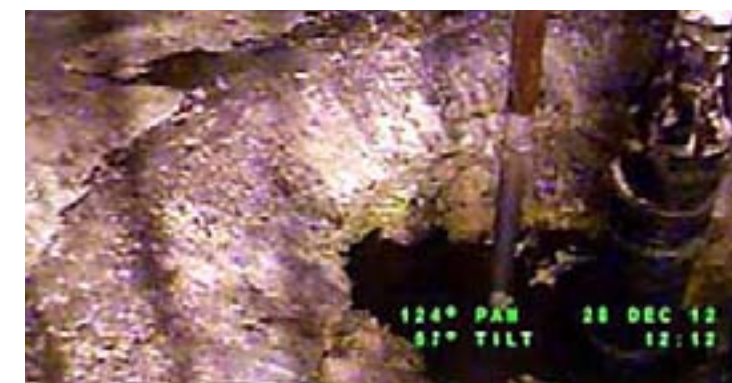
Three in-tank video inspections have been completed on tanks with level increases. Tanks BY-101 and BY-111 were examined, and there was no observable evidence of intrusion nor any structural anomalies noted with the tank dome. Evidence of intrusion was observed from a pit drain leading into tank BY-102. Active dripping was noted. No tank dome structural anomalies were seen.

Probe in tank BY-102 measuring the supernatant (liquid waste) level.
