**CHUMSTICK CREEK SUBWATERSHED  
Hydro-Geologic Monitoring Report**

Chelan County, Washington

June, 2011

This report was prepared by Chelan County Natural Resource Department.

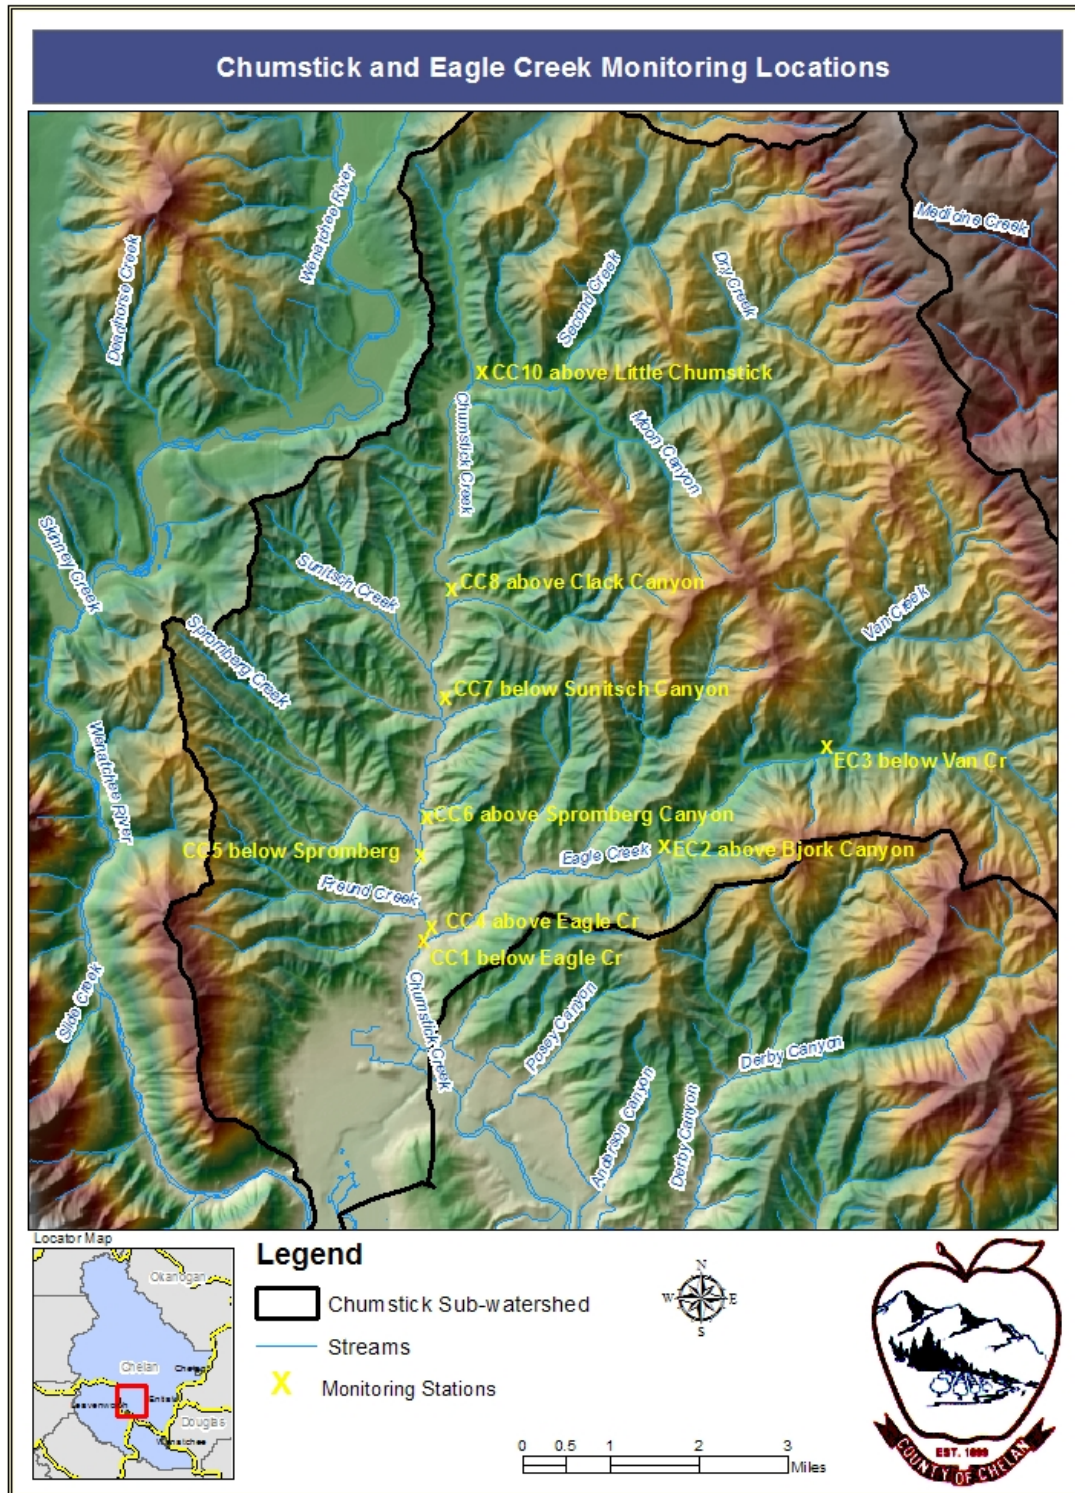
Figure 1

Monitoring stations were established at nine locations in the Chumstick Creek subwatershed (Table 1; Figure 1). At each location, a staff gage, piezometer, and Onset<sup>®</sup> Hobo water level logger were installed. The methods for the Synoptic data are provided in Appendix D. In 2009, due to access issues, station CC5 was eliminated and CC7 experienced equipment malfunction. Due to vandalism the water level loggers at Station EC2 did not record usable data in both 2009 and 2010.

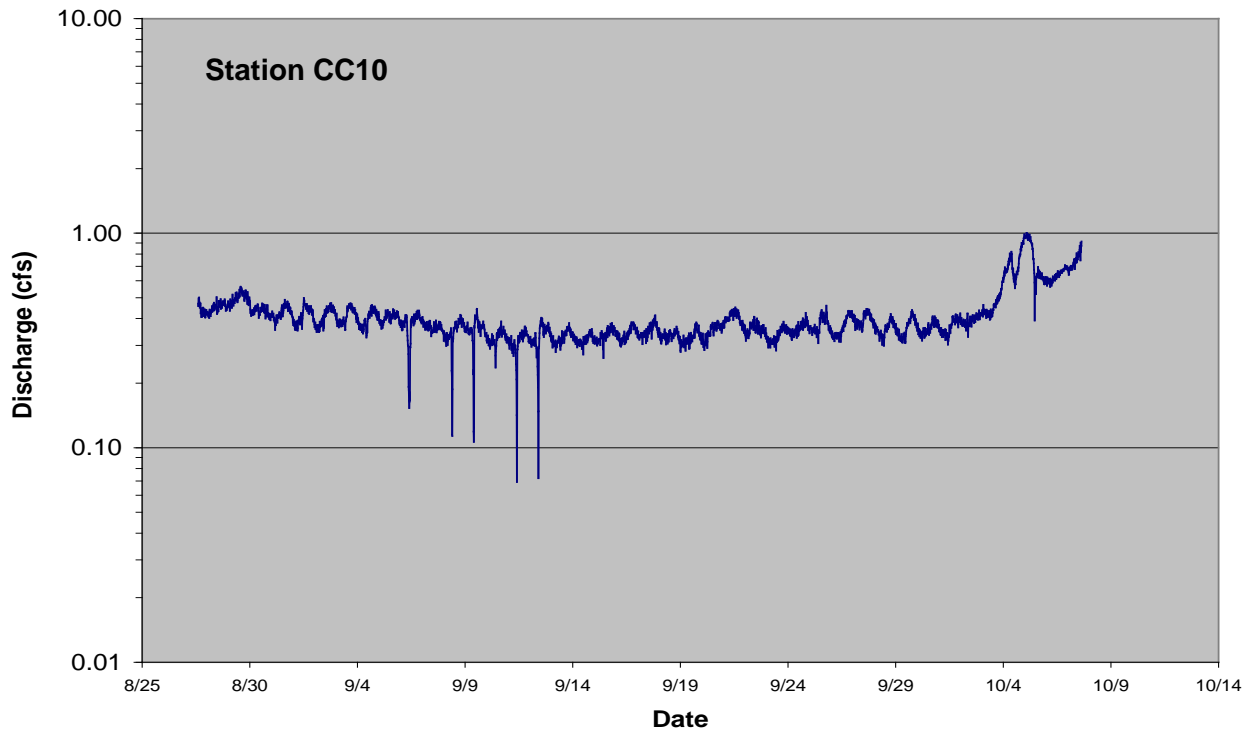
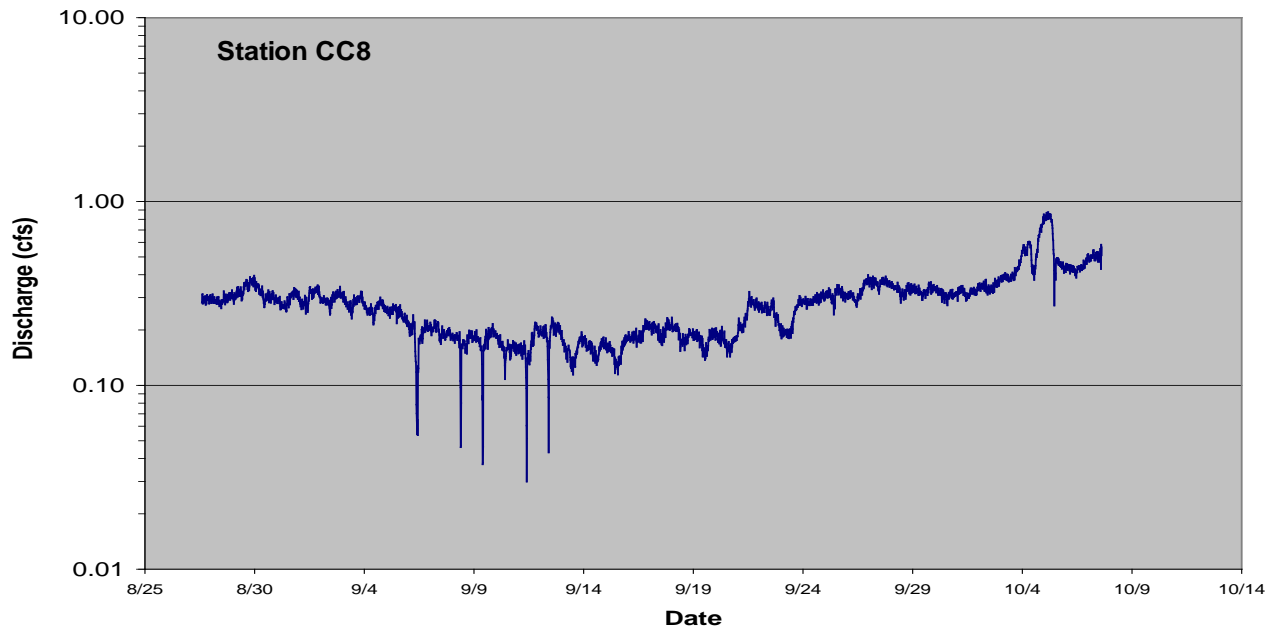
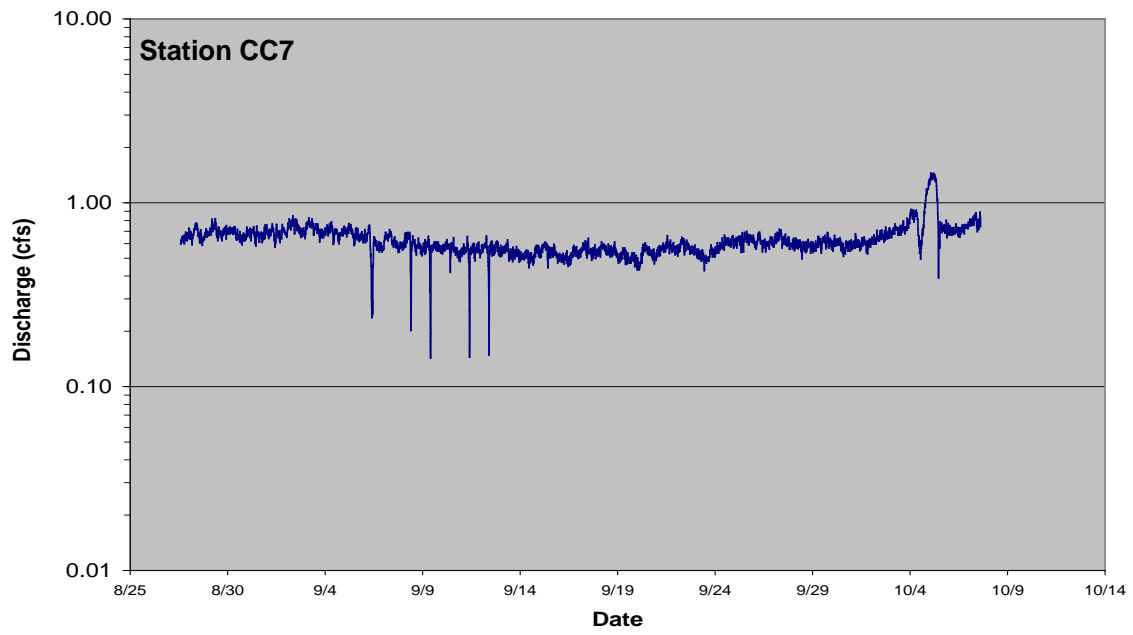
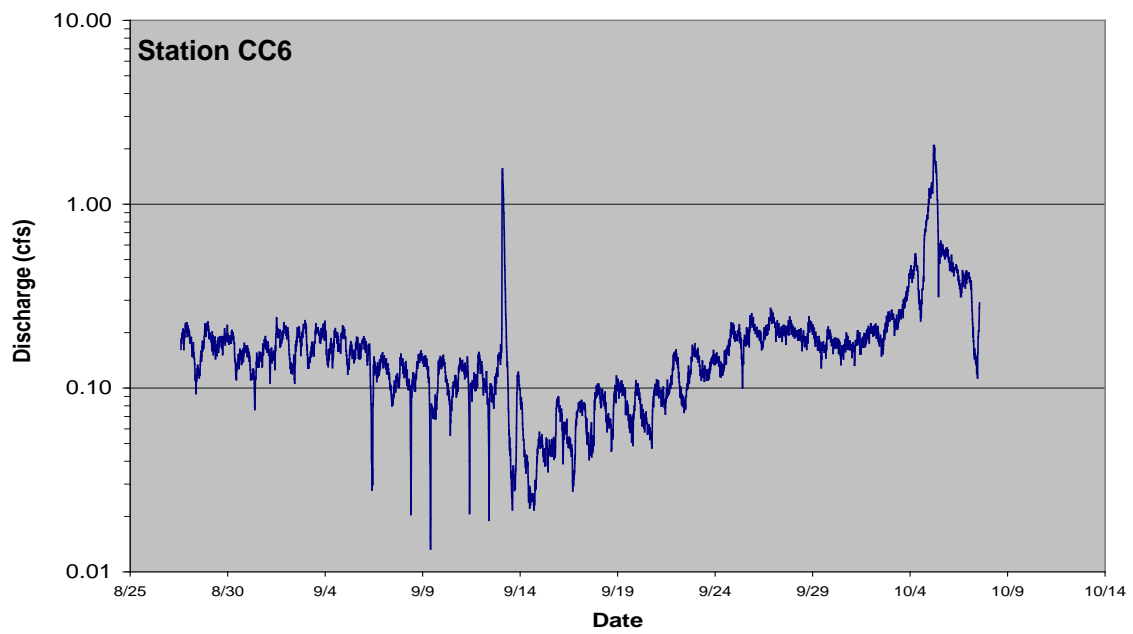
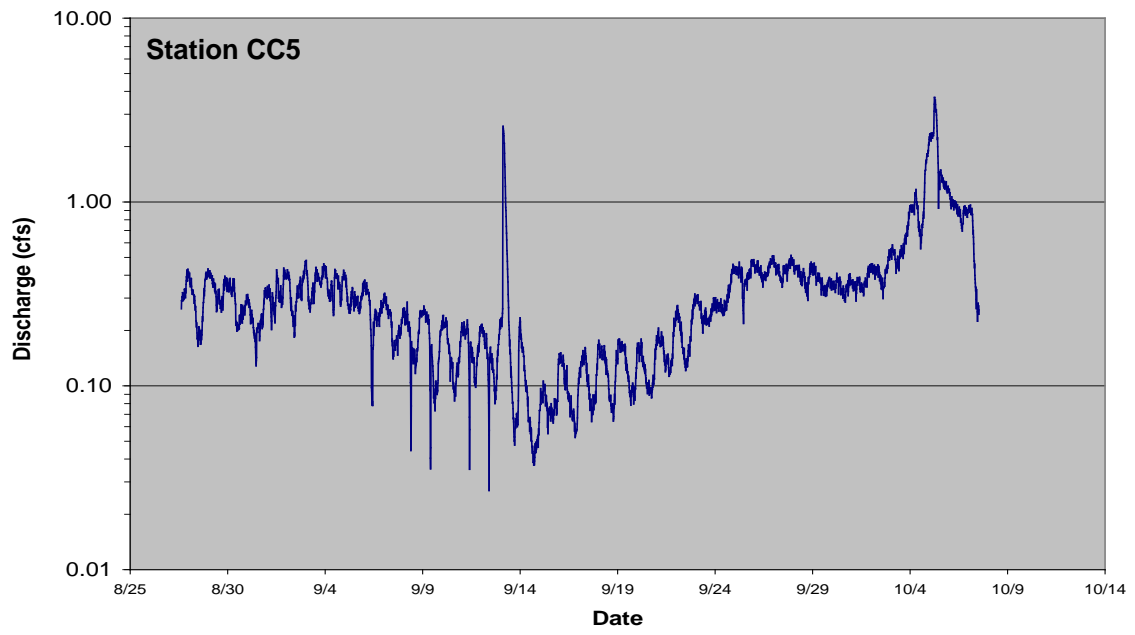
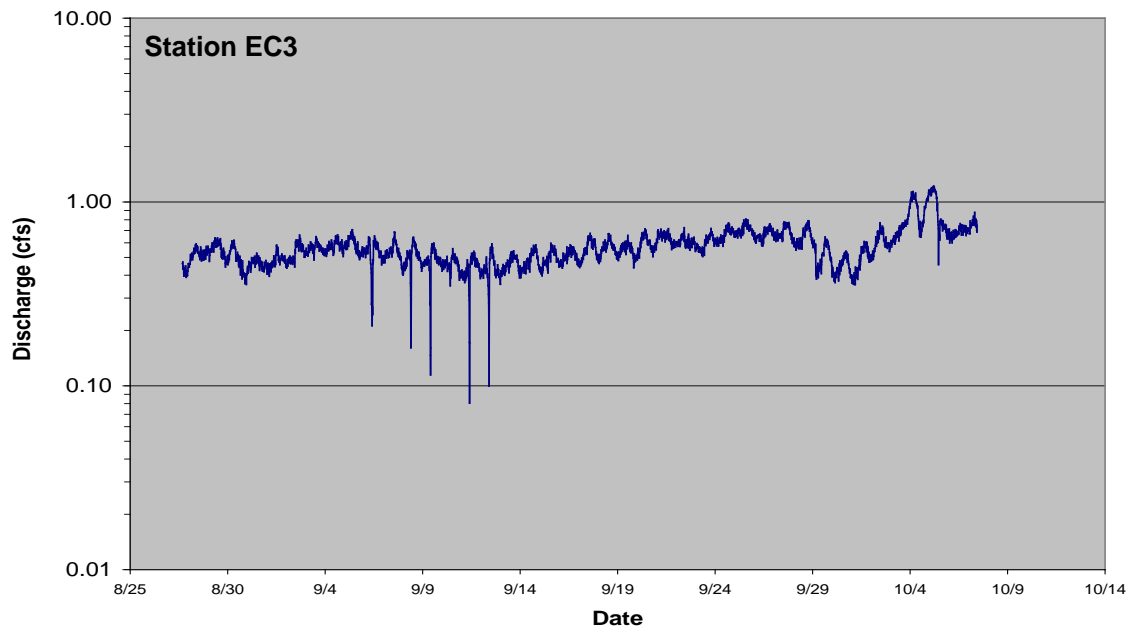
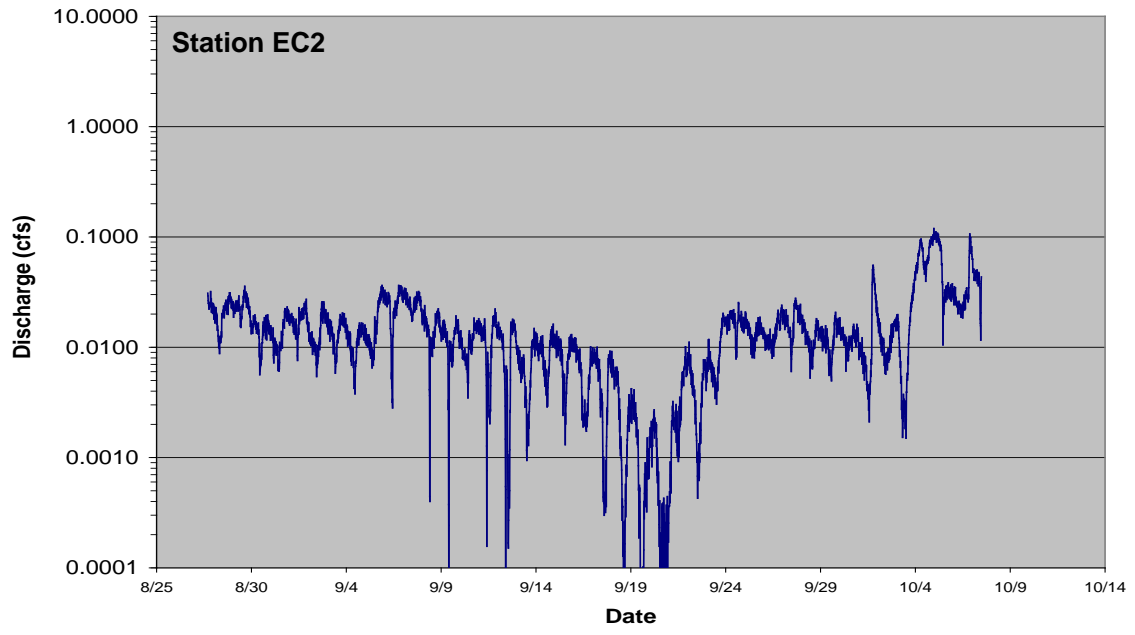
Figure 2 – 2008 Discharge

Discharge at the Chumstick and Eagle Creek monitoring stations for 2008 are shown on Figure 2. Figure 4 represents 2009 data and figure 5 shows 2010. In 2008 no water was present in Chumstick Creek during this study period at the two monitoring locations near the mouth of Eagle Creek (CC1 and CC4). Water was present at all monitoring stations during 2009. In 2010 no water was present at CC1 until early October and CC4 intermittently stopped flowing in August and shortly in early September. CC4 does not usually completely dry up however no flow will be observed i.e. standing water. When CC1 is completely dry Chumstick Creek goes subsurface approximately 15' downstream of CC4.

Figure 2 shows the discharge at the two monitoring stations located in Eagle Creek. No water was present at the mouth of Eagle Creek during late August to early October 2008. In addition, very little water flow occurred at Station EC2 during the month of September 2008.

Synoptic comparison of flows at downstream and upstream monitoring stations provides a measure of whether the reach is gaining or losing water. The change in discharge (upstream station - downstream station) within the reaches established in Chumstick Creek and Eagle Creek are shown on Figures 2, 4, and 5.

In the farthest upstream reach in Chumstick Creek, from above Little Chumstick Creek (CC10) to above Clark Canyon (CC8), discharge declined. The average decline in discharge over this 1.7-mile reach during August through October 2008, 2009 and 2010 was 0.13, 0.18 and 0.16cfs respectively. The 3 year average decline was 0.16cfs.

In the reach from CC8 to below Sunitsch Canyon (CC7), discharge increased during the study period. The average increase over this 2.3-mile reach during August through October was 0.35 cfs in 2008 and 0.52 cfs in 2010. The 2 year average increase was 0.44cfs. Due to equipment failure pressure transducer data was not recorded for CC7, therefore no continuous comparison could be made in 2009. However, using actual discharge measurements (Table 2) an increase in flow from CC8 to CC7 was observed in 2009. The increase in flow between these two stations is from Sunitsch Creek a main tributary to Chumstick Creek.

In the reach from CC7 to above Spromberg Canyon (CC6), discharge declined. The average decline in discharge over this 1.3-mile reach during August to October was 0.45cfs in 2008. In 2009 a decline in discharge was observed using actual discharge measurements. During August to October 2010 an overall slight increase in flow of 0.05cfs was observed in the reach.

In the reach from CC6 to below Spromberg Canyon (CC5), discharge increased. The average increase in stream flow over this 0.4-mile reach during August to October 2008 was 0.17 cfs. The increase in flow between these two stations is from Spromberg Creek a main tributary to Chumstick Creek.

In the reach from CC5 to above Eagle Creek (CC4), discharge decreased from August thru September in 2008. The average decline in stream flow over this 0.9-mile reach during late August to early October was 0.35cfs.

In the farthest upstream reach in Eagle Creek, from below Van Creek (EC3) to above Bjork Canyon (EC2), discharge declined during the study period. The average decline in discharge over this 2.1-mile reach during August to October 2008 was 0.49cfs. Due to vandalism at EC2 there is not a continuous record of discharge for 2009. Using actual discharge measurements there is no considerable increase or decrease in stream flow in 2009 and 2010.

In the reach from EC2 to the mouth of Eagle Creek, discharge decreased and no surface water was observed at the mouth of the Eagle Creek during the 2008 study period. The average decline in discharge over this 3.1-mile reach during August to October was 0.02cfs. In 2009 and 2010 no comparison could be made from EC2 to the mouth due to the elimination of the DOE gauging site on Eagle Creek.

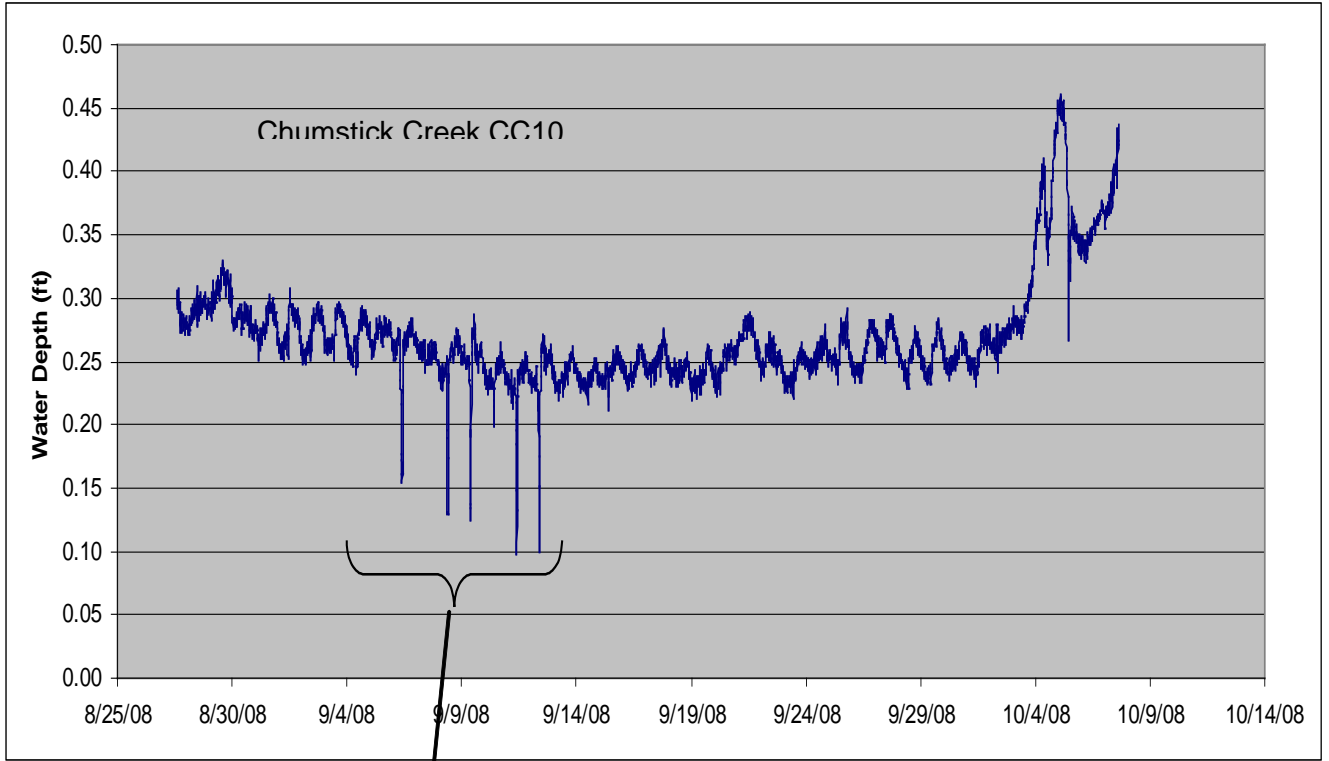
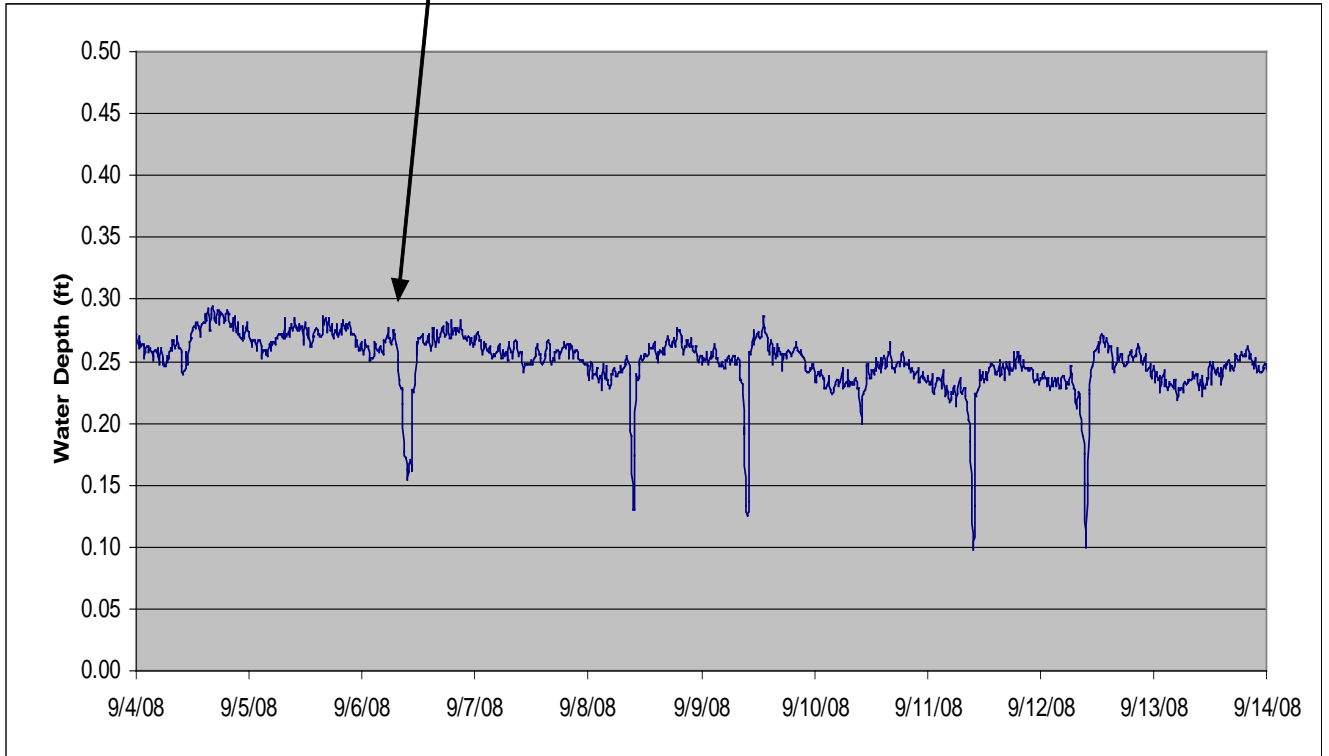
Figure 3 – Example of Anthropogenic Impacts on Creek Flow

One feature that is present for all monitoring sites within both creeks in 2008 are the sharp, regular drops in water level observed during the first half of September (Figure 3). This appears to be clear evidence of anthropogenic impacts to creek flow. At the most upstream monitoring station in Chumstick Creek (CC10), creek flows dropped for about a 2-hour period every morning except Sunday. With one exception, the reduction in creek flow during these periods was quite consistent. This pattern was not observed during the rest of the monitoring record period, which suggests that the observed reductions in creek flow were not due to domestic water use, but may have been associated with agricultural activities. This pattern was not observed during the 2009 and 2010 monitoring periods. However, in 2009 and 2010 irregular increases of discharge were observed only in stations CC7 and CC6 (Figure 4 & 5). These increases are not attributed to precipitation events or tributary contributions. The increase in discharge only lasts for 30-60 minutes and increases discharge by 1.50 to 2.00 times.

The synoptic survey data shows that during low-flow conditions discharge in Chumstick Creek and Eagle Creek can fluctuate markedly within short periods of time. Regular morning declines in discharge observed during early September, 2008 in both creeks provides evidence that water use within the subwatershed can substantially reduce creek discharge.

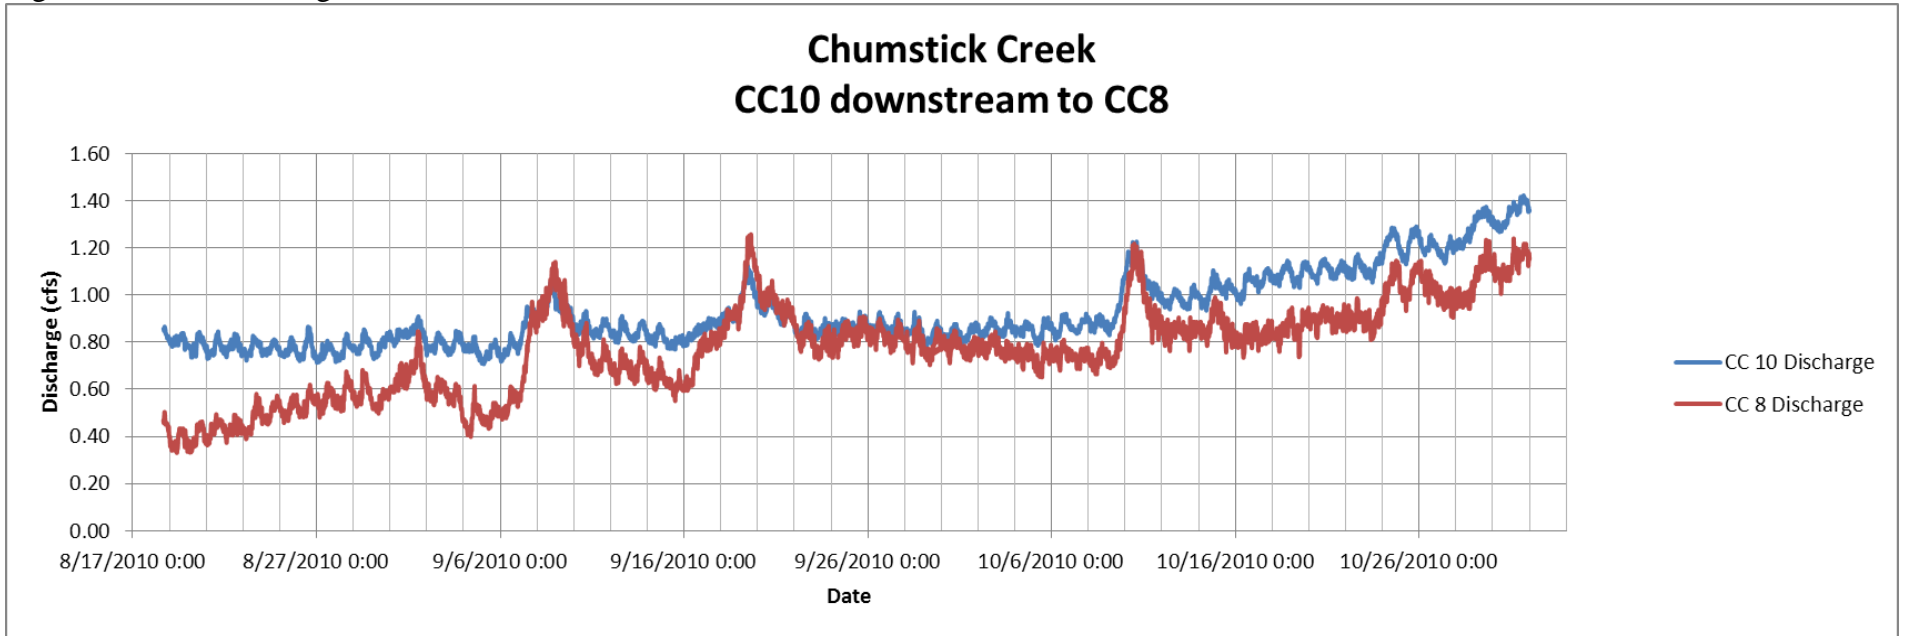
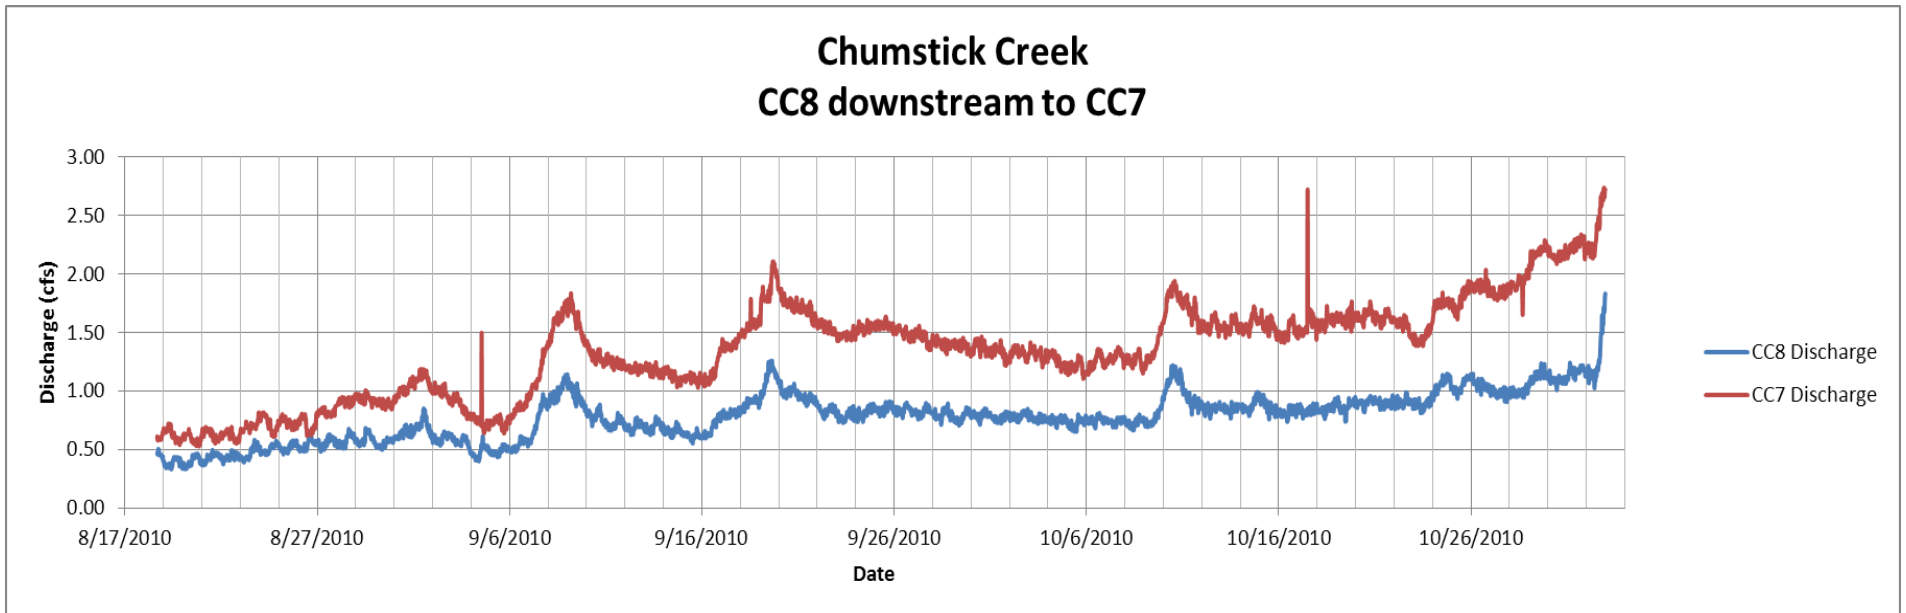
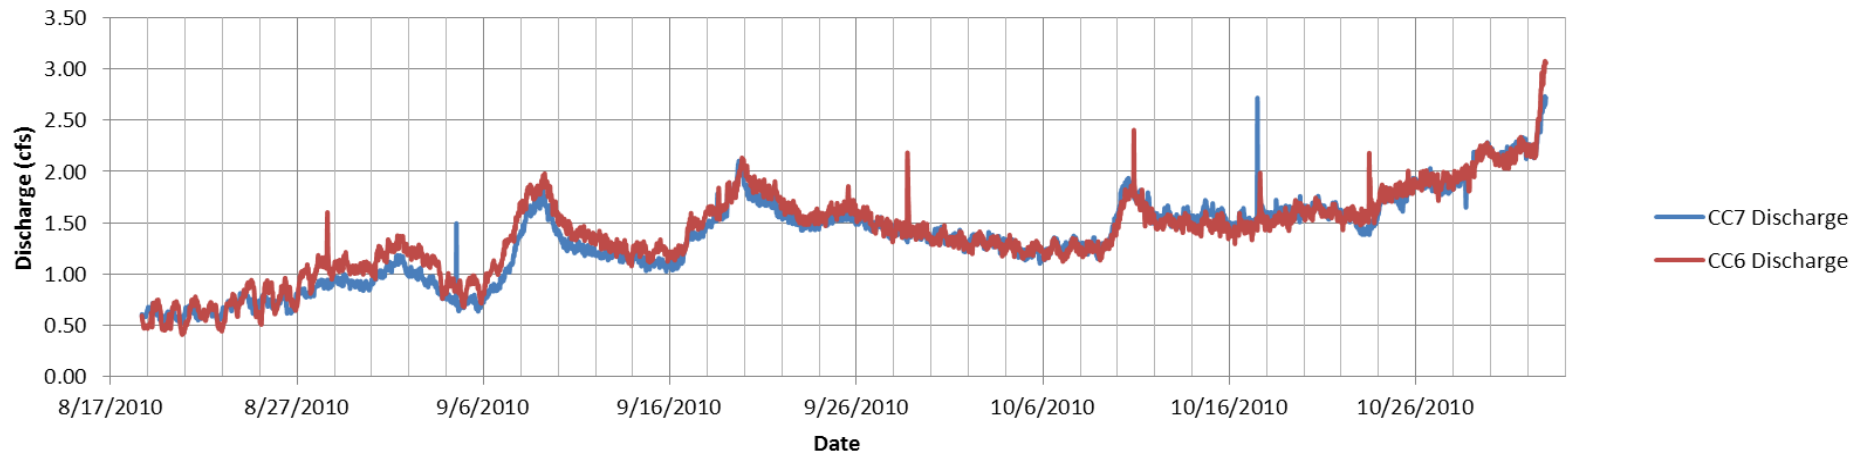
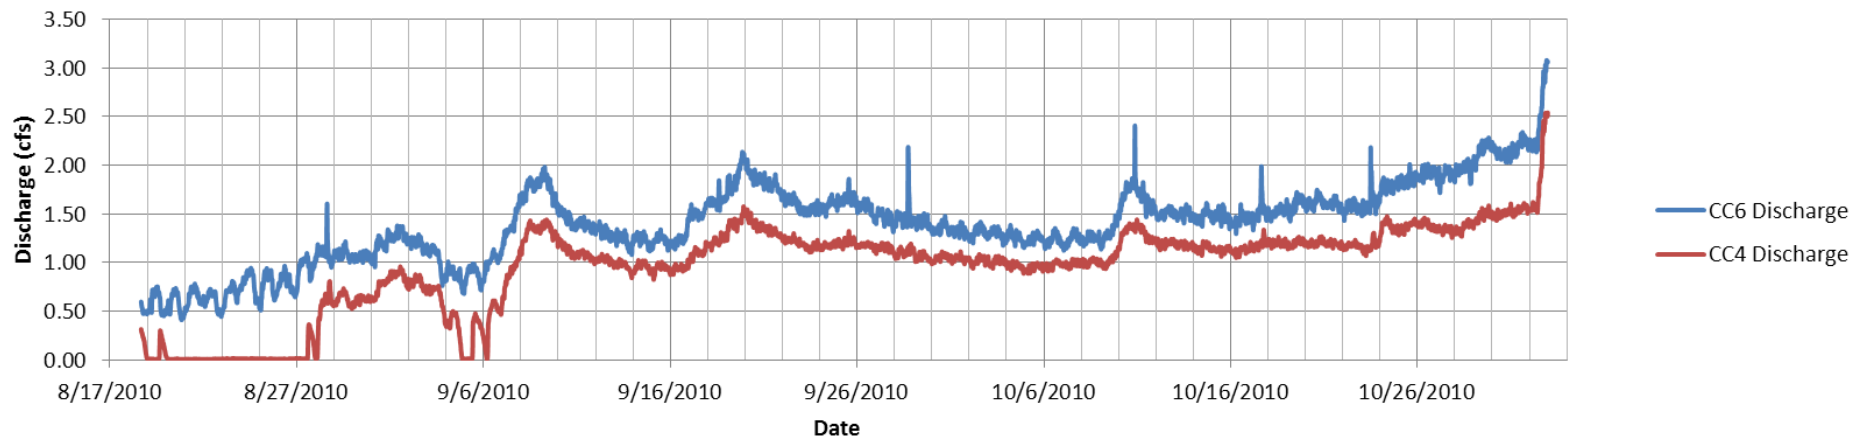
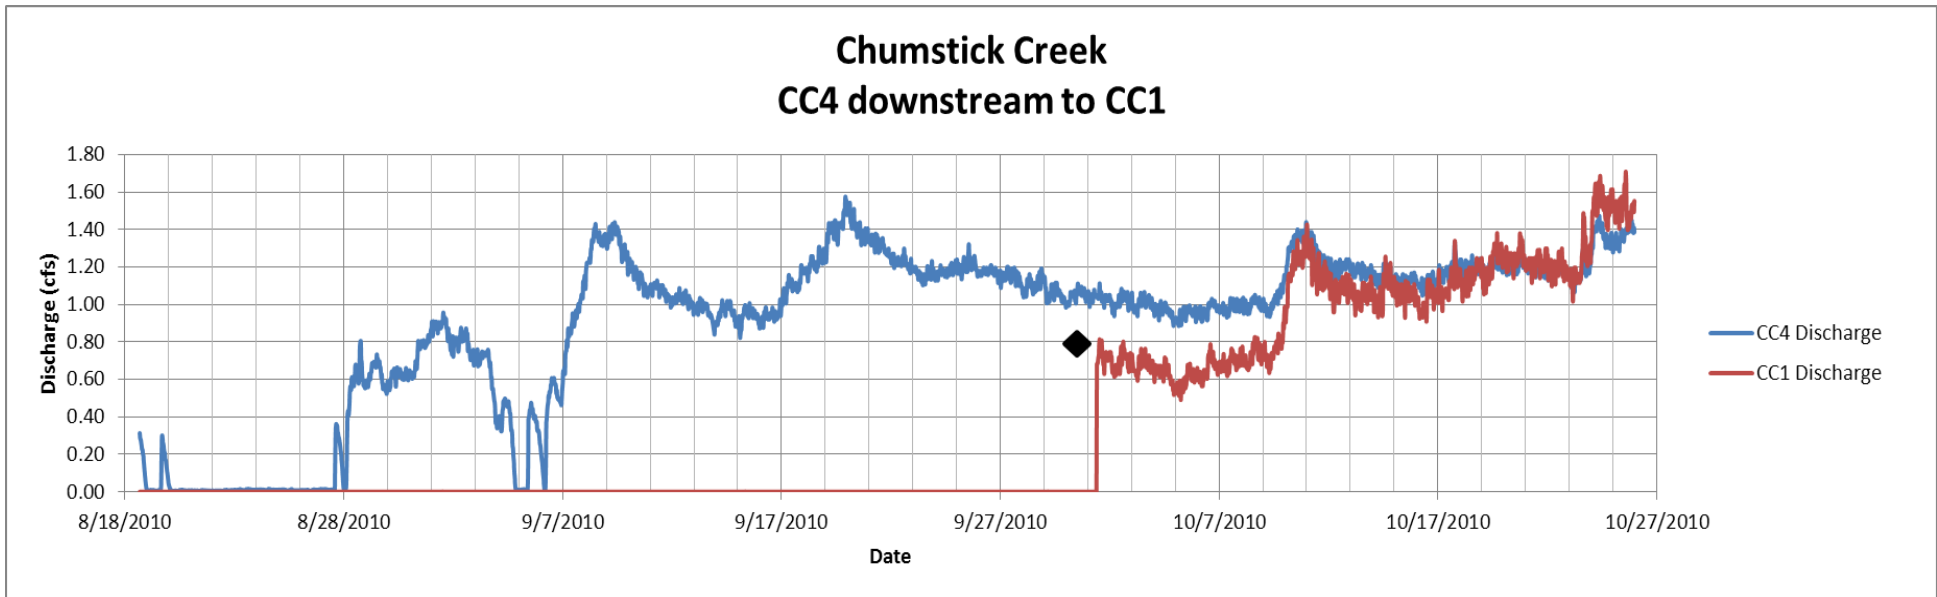
Figure 5 – 2010 Discharge

◆ Pressure transducer re-installed on 10/1 after equipment was not logging correctly. Creek was dry during station visits on 8/18 & 8/24. For the period between 9/7 until just prior to re-installation flows may have been present.

Due to the elimination of Station CC5 only 2008 data could be collected. No comparison could be made for average decline or increase of discharge for CC6 to CC5 and CC5 to CC4 using water level logger data in 2009 and 2010. However comparing data from CC6 and CC4 there was an average increase in discharge of .13cfs in 2009. There were average declines in discharge of 0.18cfs in 2008 and 0.42cfs in 2010.

In the reach from CC4 to below Eagle Creek (CC1), discharge declined during the study period in 2009 and 2010. No flow present at CC1 during the study period in 2008. The average decline in discharge over this 0.25 mile reach during September to October was .26cfs in 2009 and 0.20cfs in 2010.

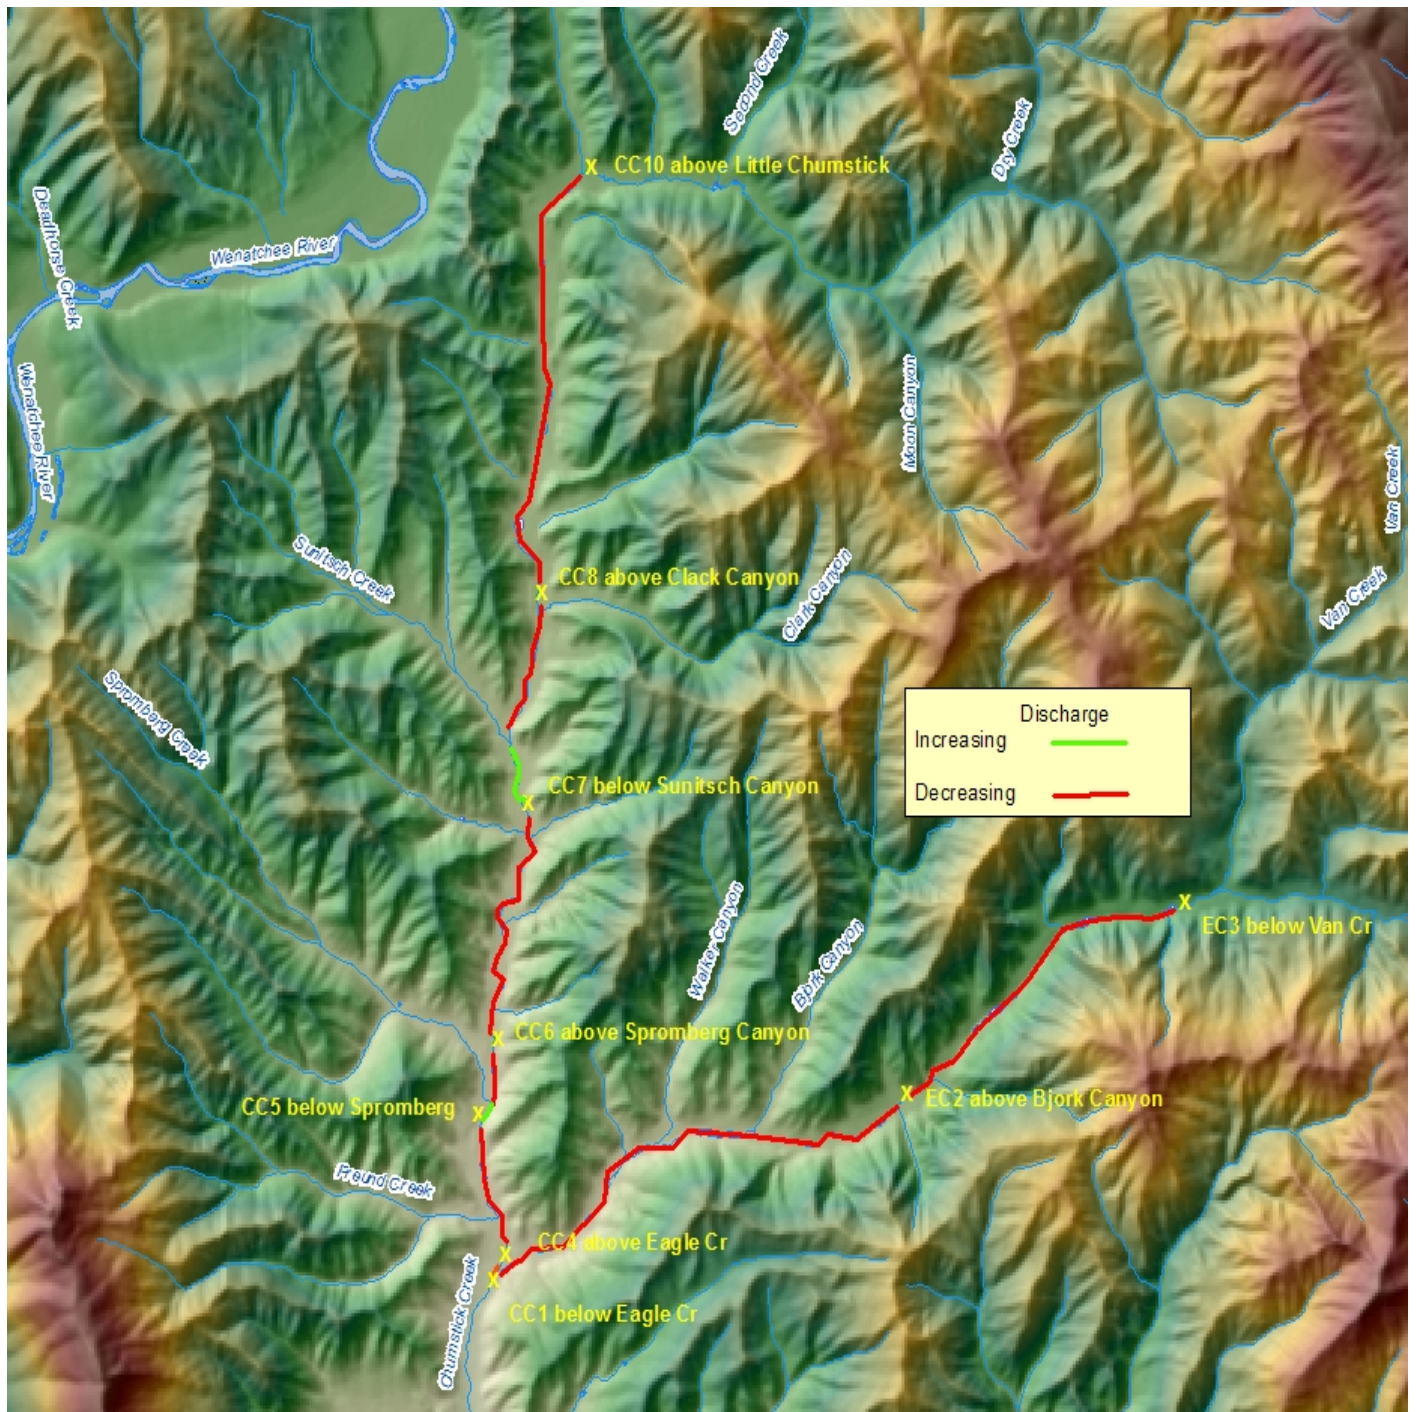
Figure 6 – Comparison of Upstream-Downstream Discharge in Chumstick and Eagle Creeks

Synoptic comparisons of creek discharge at monitoring stations show that stream flow increased in two reaches (CC8 to CC7 and CC6 to CC5) in Chumstick Creek during the study period. Between these stations Sunitsch Creek and Spromberg Creek join Chumstick and contribute to stream flow. Any increase in stream flow by these tributaries is quickly decreased as it moves downstream and has no substantial effect on downstream flow by the time it reaches CC1.

Discharge declined within all other reaches in Chumstick Creek and throughout Eagle Creek. Piezometer monitoring during low-flow conditions in Chumstick Creek showed water moving from the creek to groundwater (losing reach) at monitoring station CC7 downstream to CC6. Groundwater was entering the creek (gaining reach) at the farthest upstream stations CC10 and CC8 and the farthest downstream station with surface flow (CC5) (Appendix B). Piezometer monitoring during low-flow conditions in Eagle Creek, showed water moving from the creek to groundwater at monitoring Station EC3; groundwater was entering the creek at Station EC2 (AMEC, 2009a). It should be noted that a spring is present directly upstream of EC2.

Overall, the study shows that during low-flow conditions in 2008 - 2010 there was a net loss of surface water from upstream to downstream even with tributary contribution. Based on the data collected for this study any water use within the Chumstick subwatershed has the ability to impact surface water during low flow conditions.
