# Eyes Over Puget Sound

[Flight log](#)[Weather](#)[Water column](#)[Aerial photos](#)[Ferry and Satellite](#)[Moorings](#)

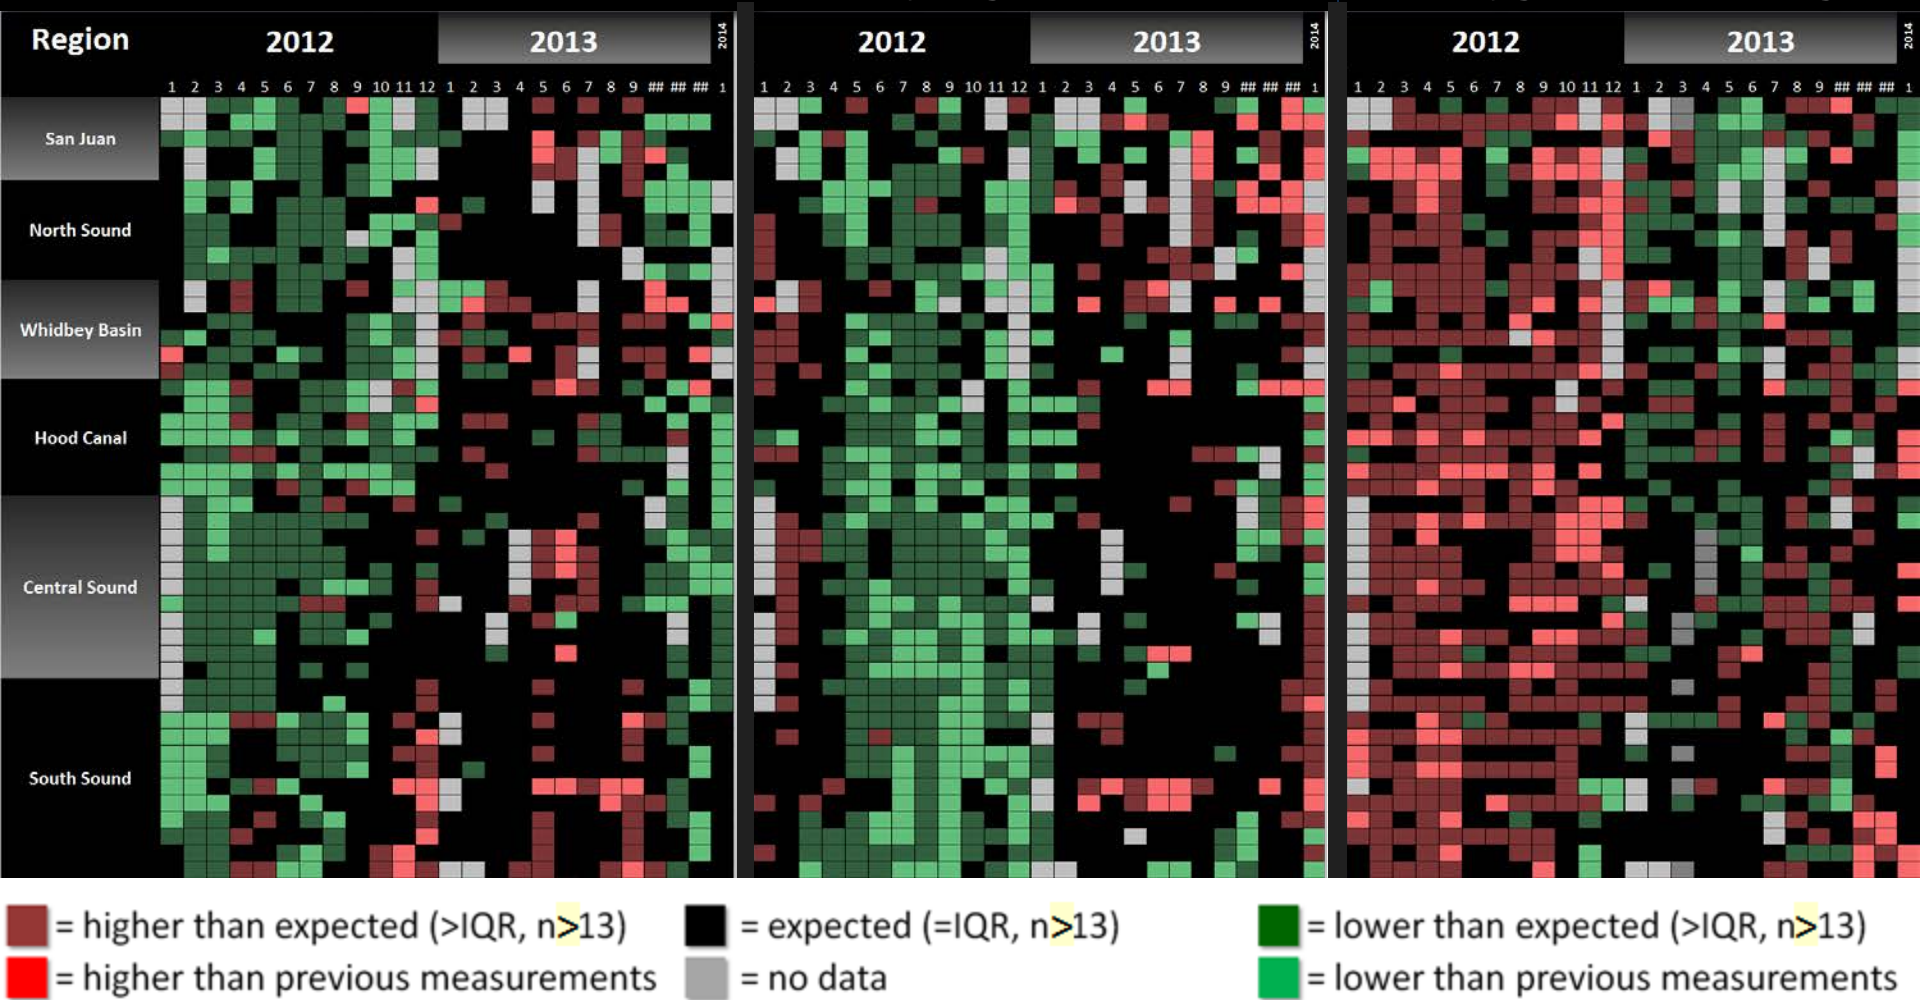
The 2011-2012 colder, fresher, higher oxygen conditions changed. Colder saltier conditions are developing, particularly in the northern regions. Oxygen has stabilized again around expected ranges. The recent fall in temperatures has particularly affected Central Sound and Hood Canal. Starting this year, South Sound is showing high salinities in many places.

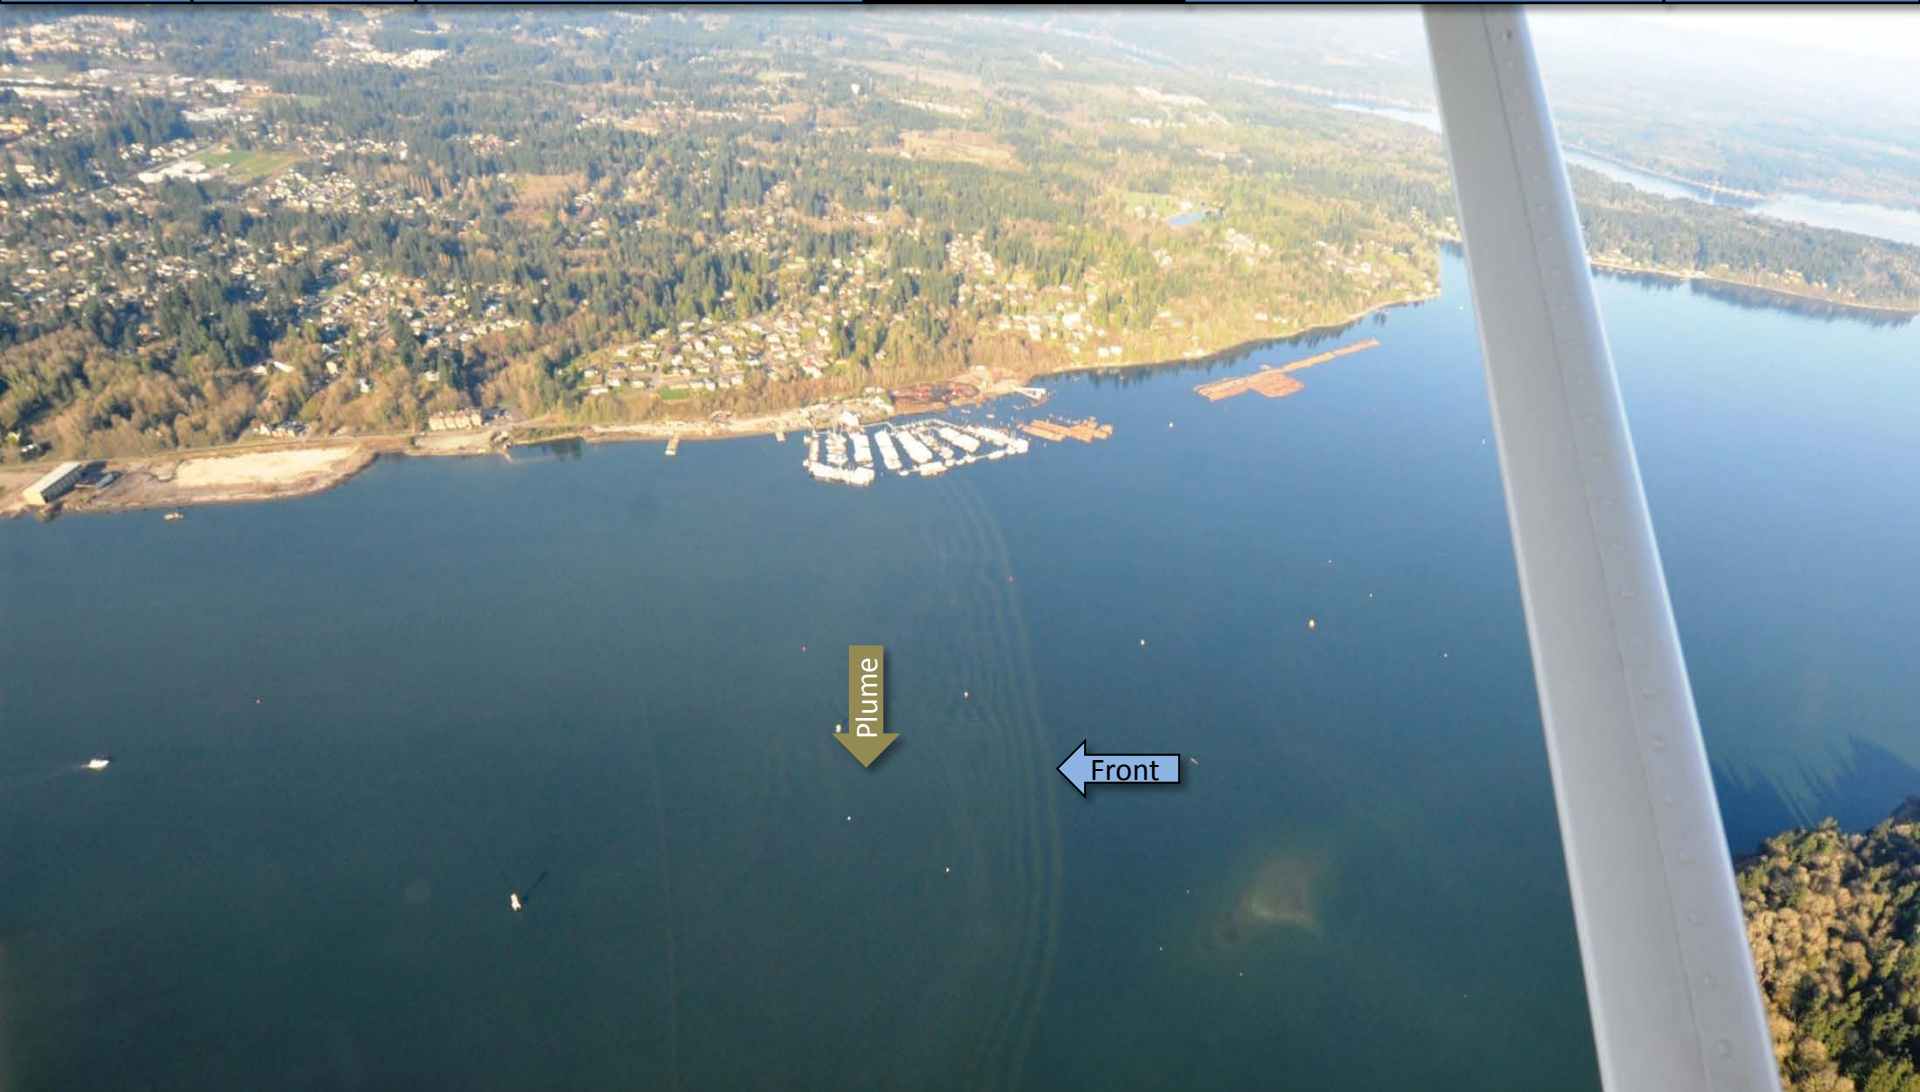
*Edge of sediment-enriched Deschutes River plume with patterns caused by internal waves.*  
Location: Budd Inlet (South Sound), 9:17 AM.
