Eyes Over Puget Sound

Surface Conditions Report

May 12, 2014

Up-to-date observations of visible water quality conditions in Puget Sound and the Strait of Juan de Fuca

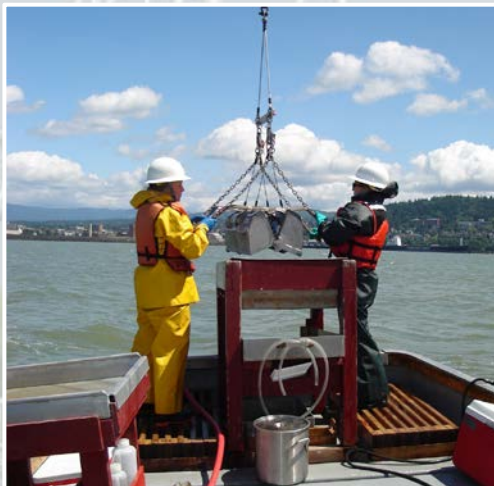
The van Veen grab being deployed

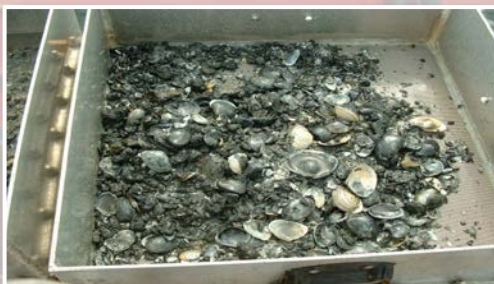
Benthos sieved from the sediment

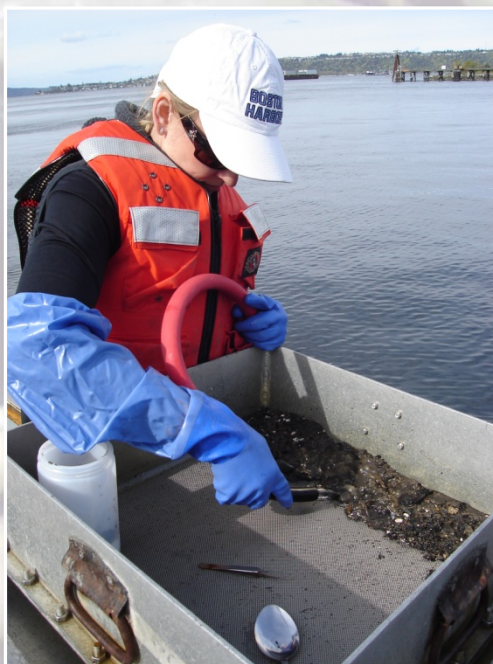
Sieving benthos from sediment in the field

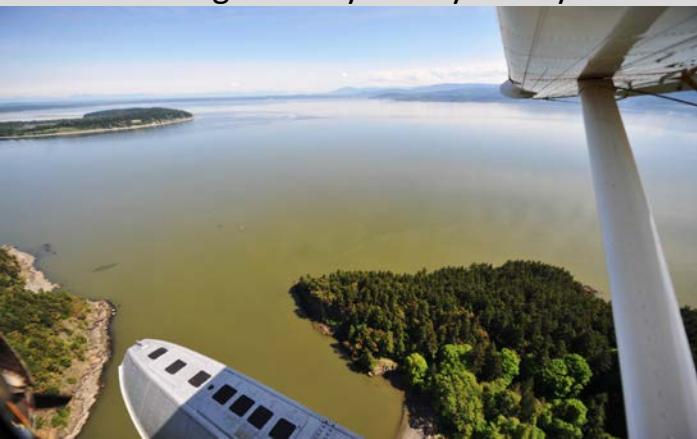
Bellingham Bay is very murky

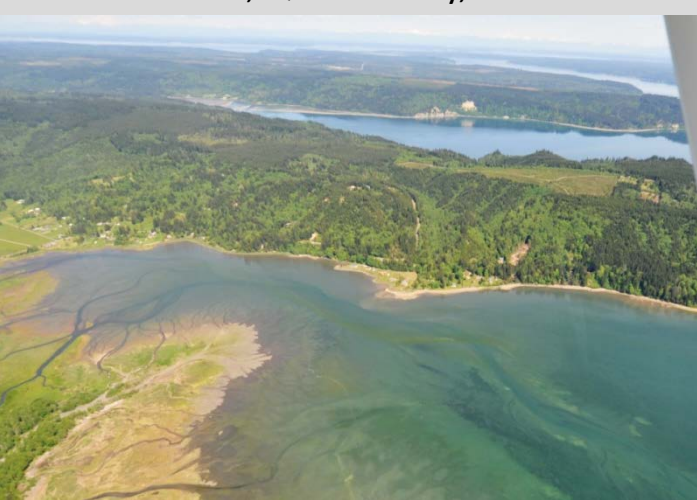
Green bloom, Quilcene Bay, Hood Canal

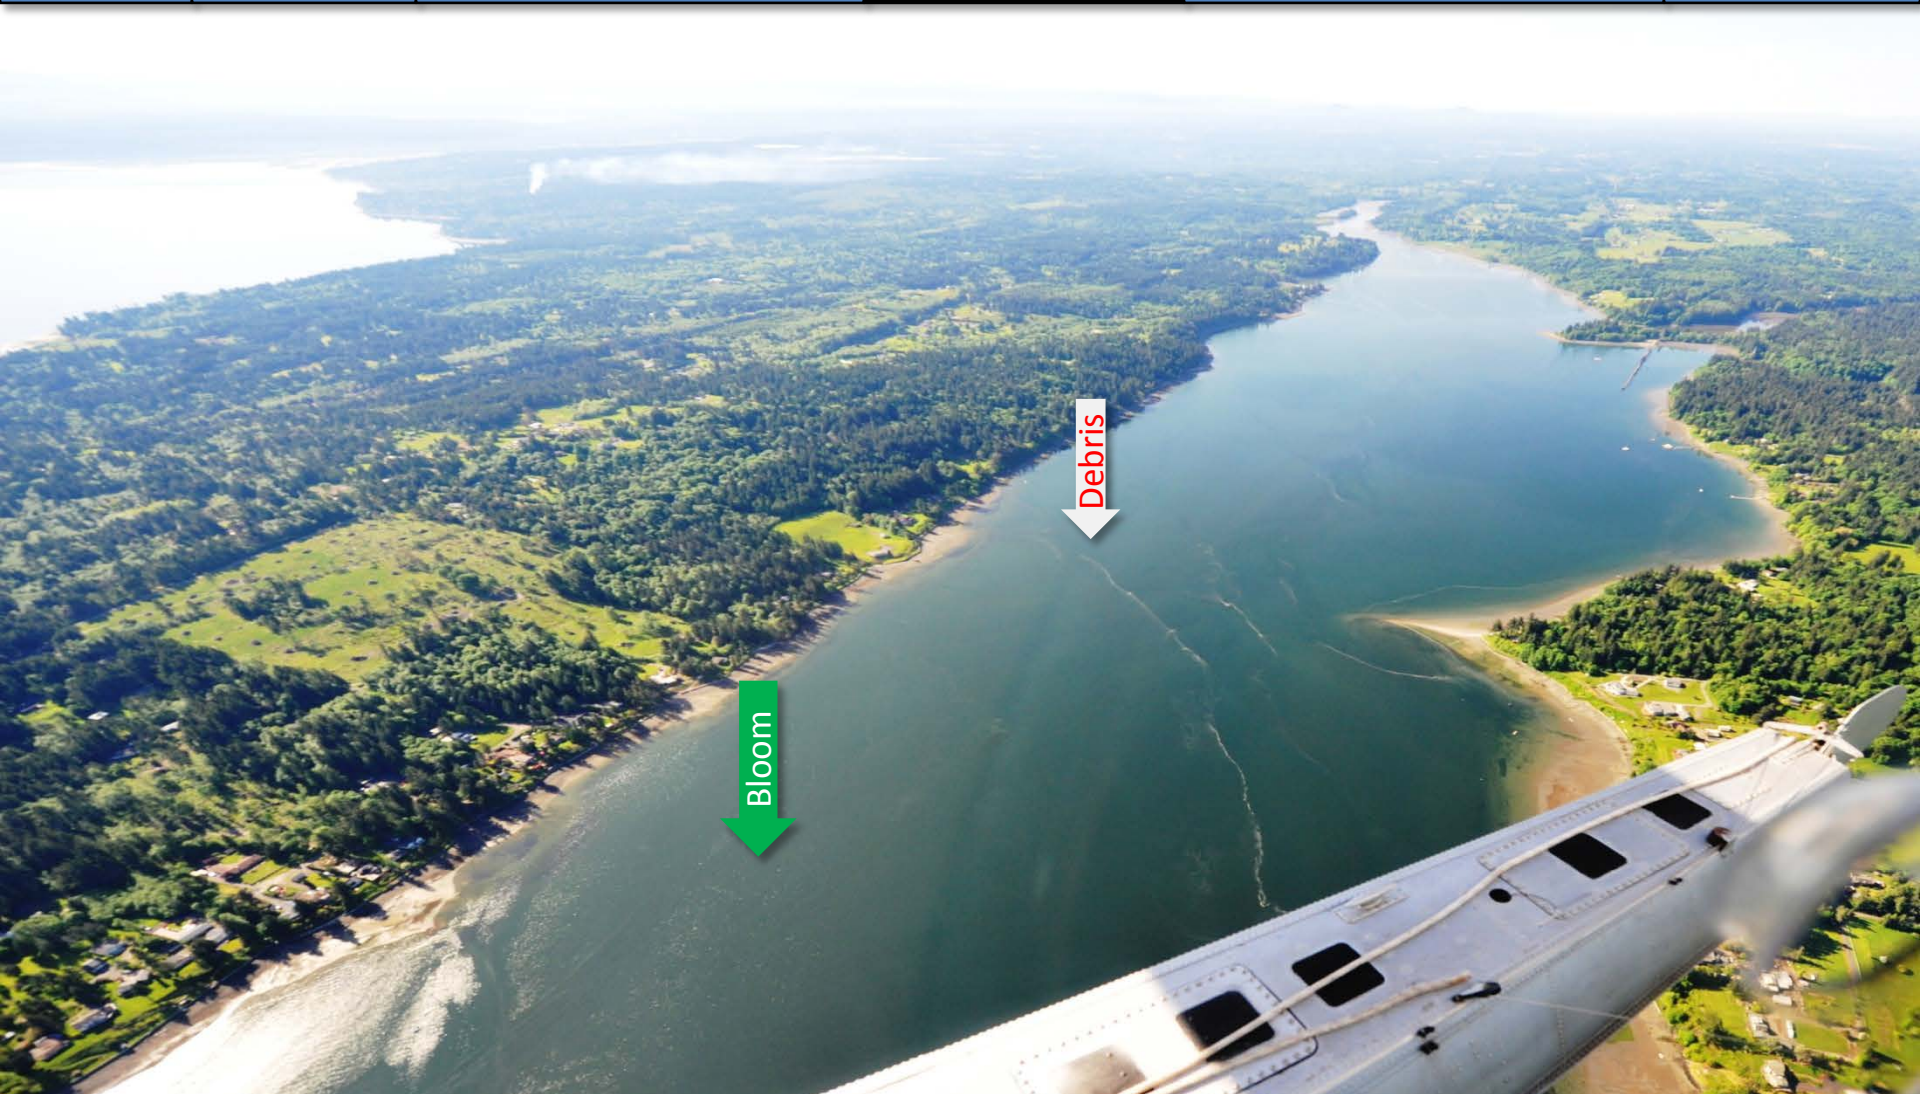
Multiple debris lines and phytoplankton bloom.
Location: Henderson Inlet, 9:35 AM.

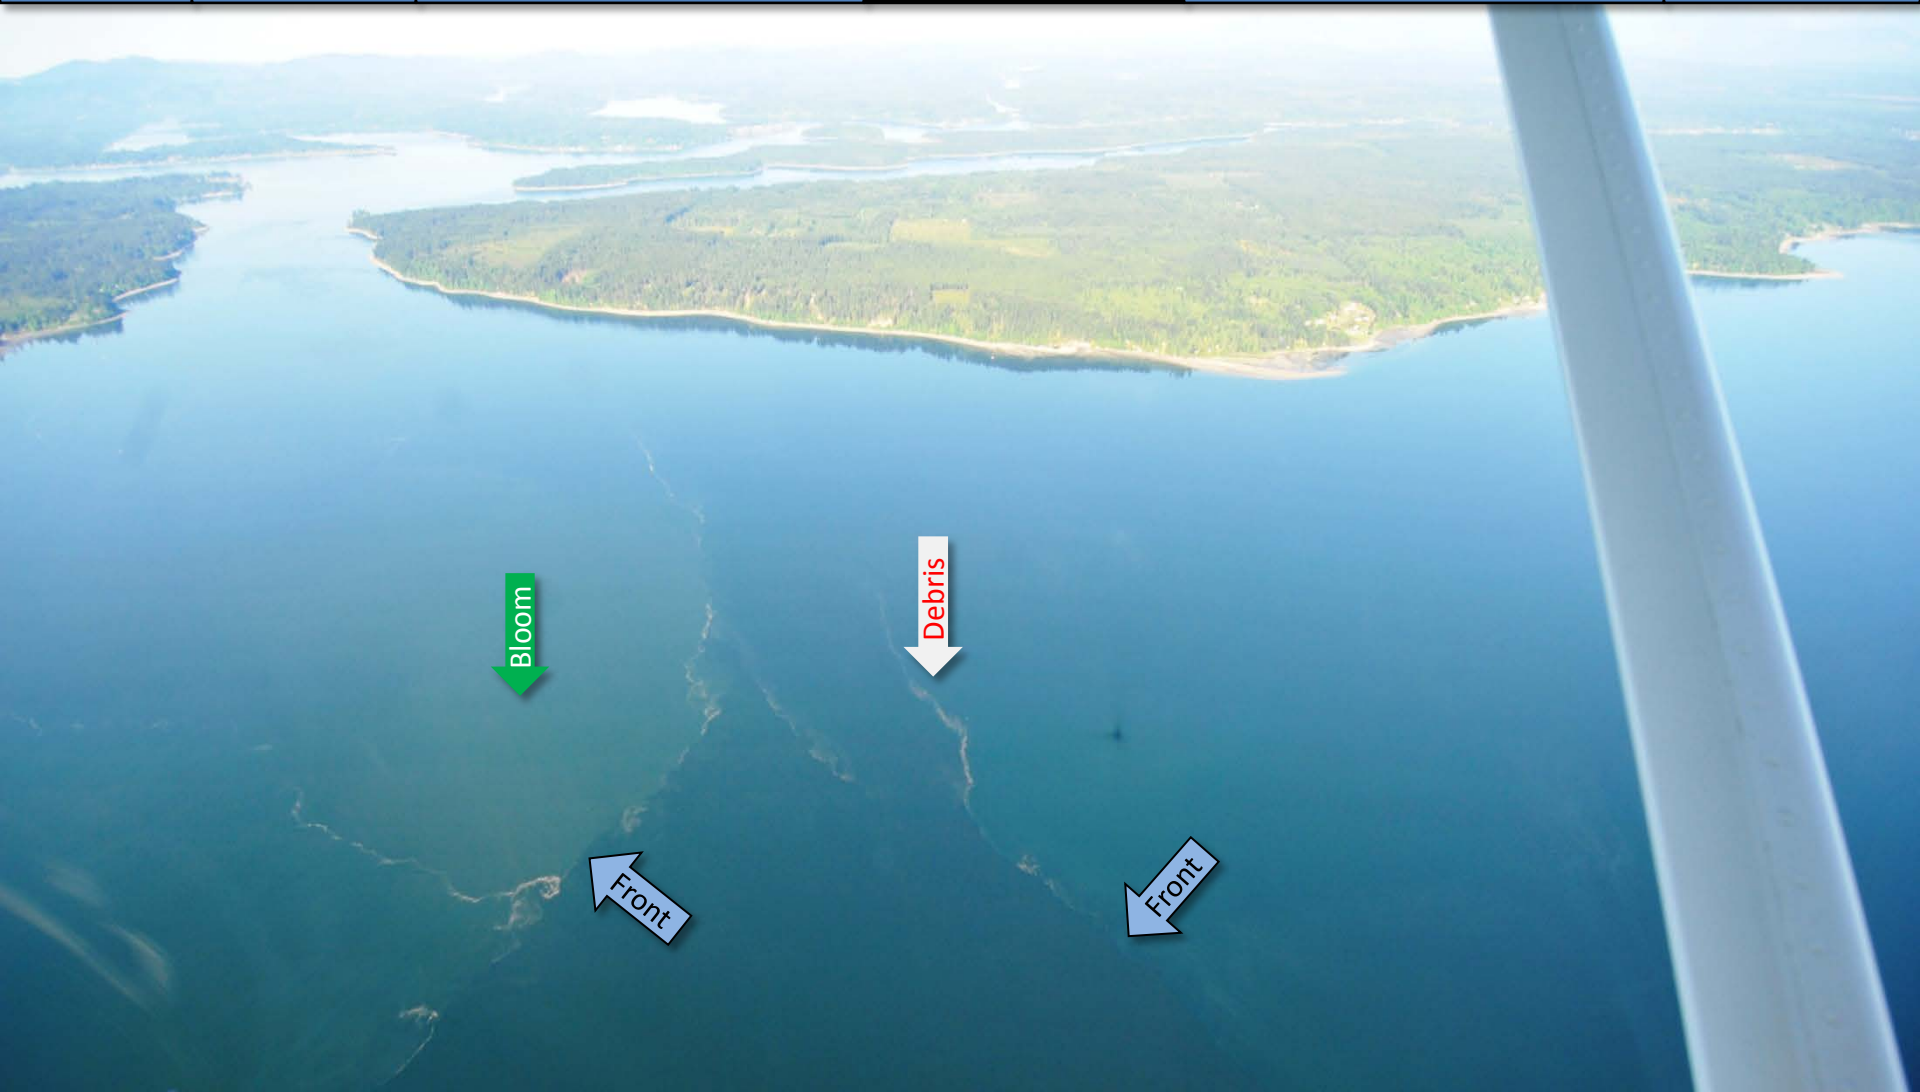
Debris lines of organic material delineating different surface water with different phytoplankton content.
Location: Nisqually Reach, Dana Passage (South Sound), 9:36 AM.

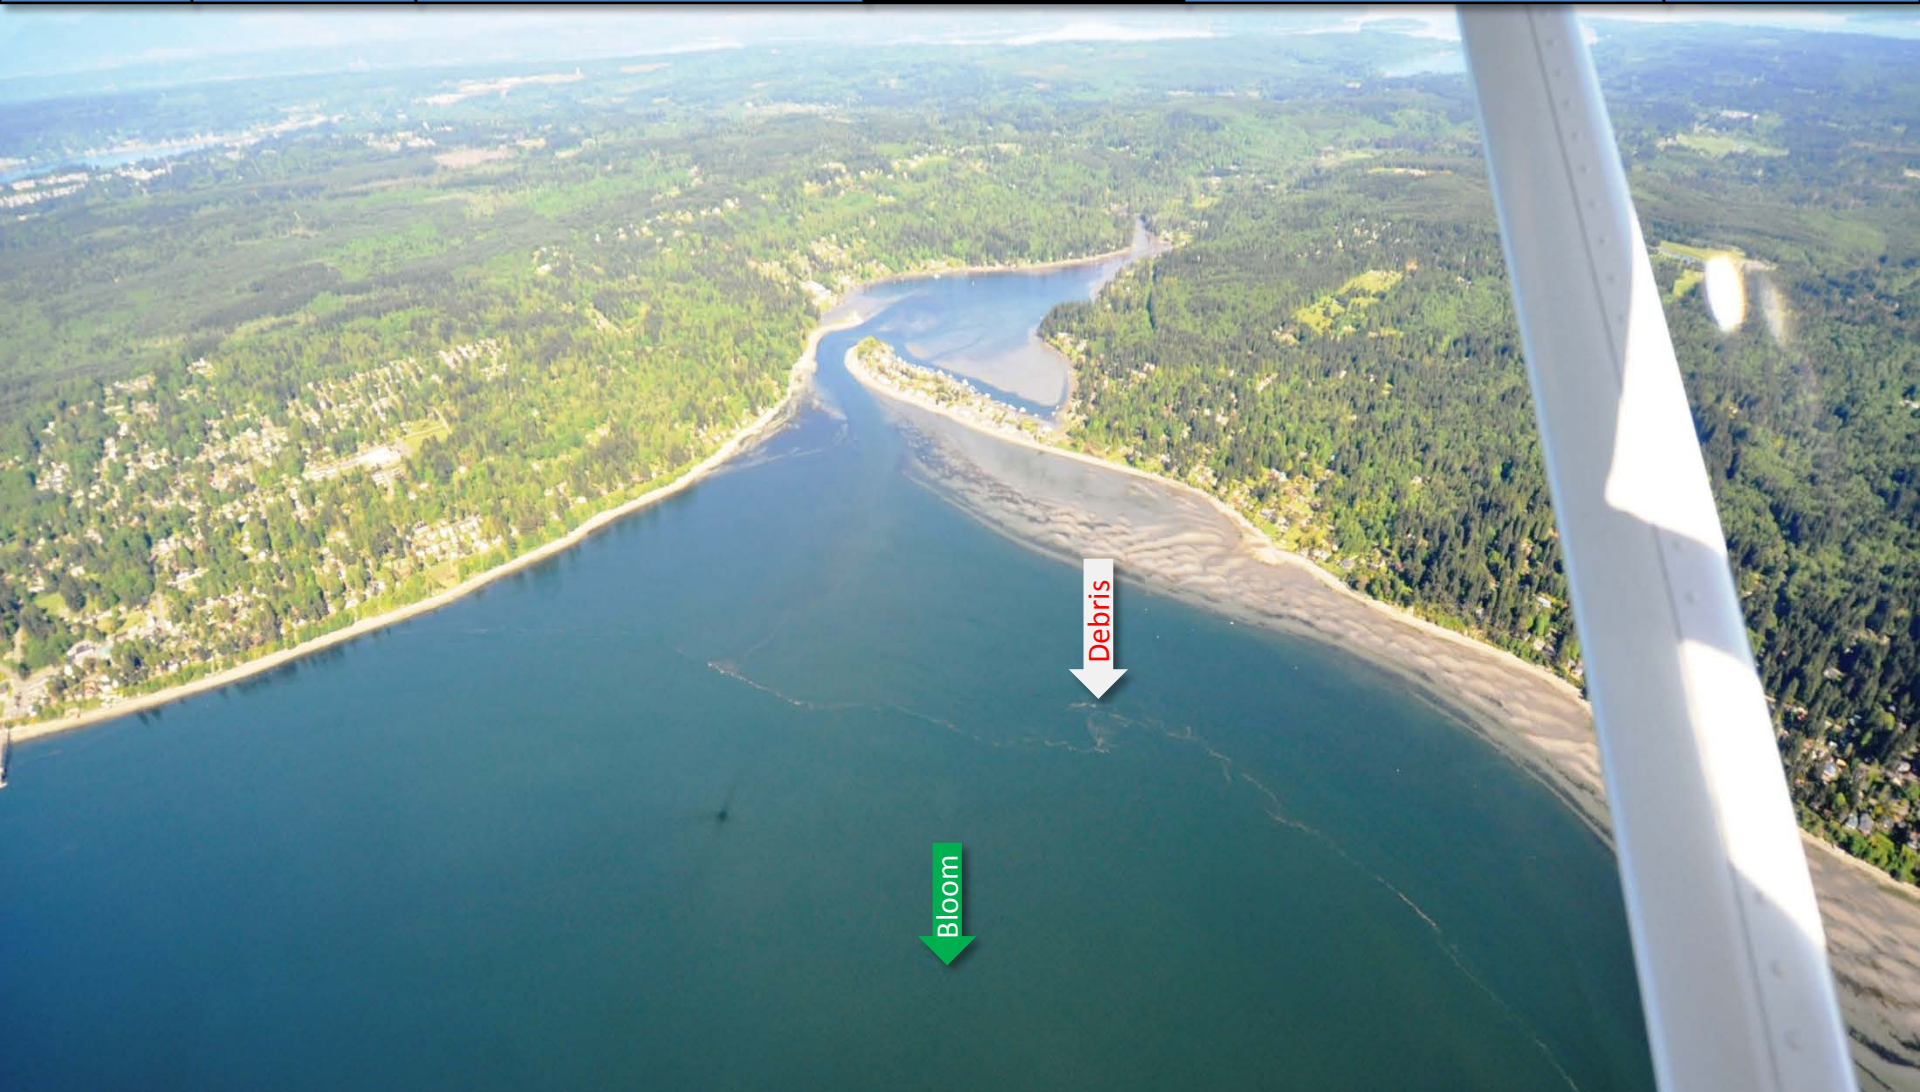
Debris line of organic material and phytoplankton bloom.
Location: Port Madison, (Central Sound), 9:58 AM.

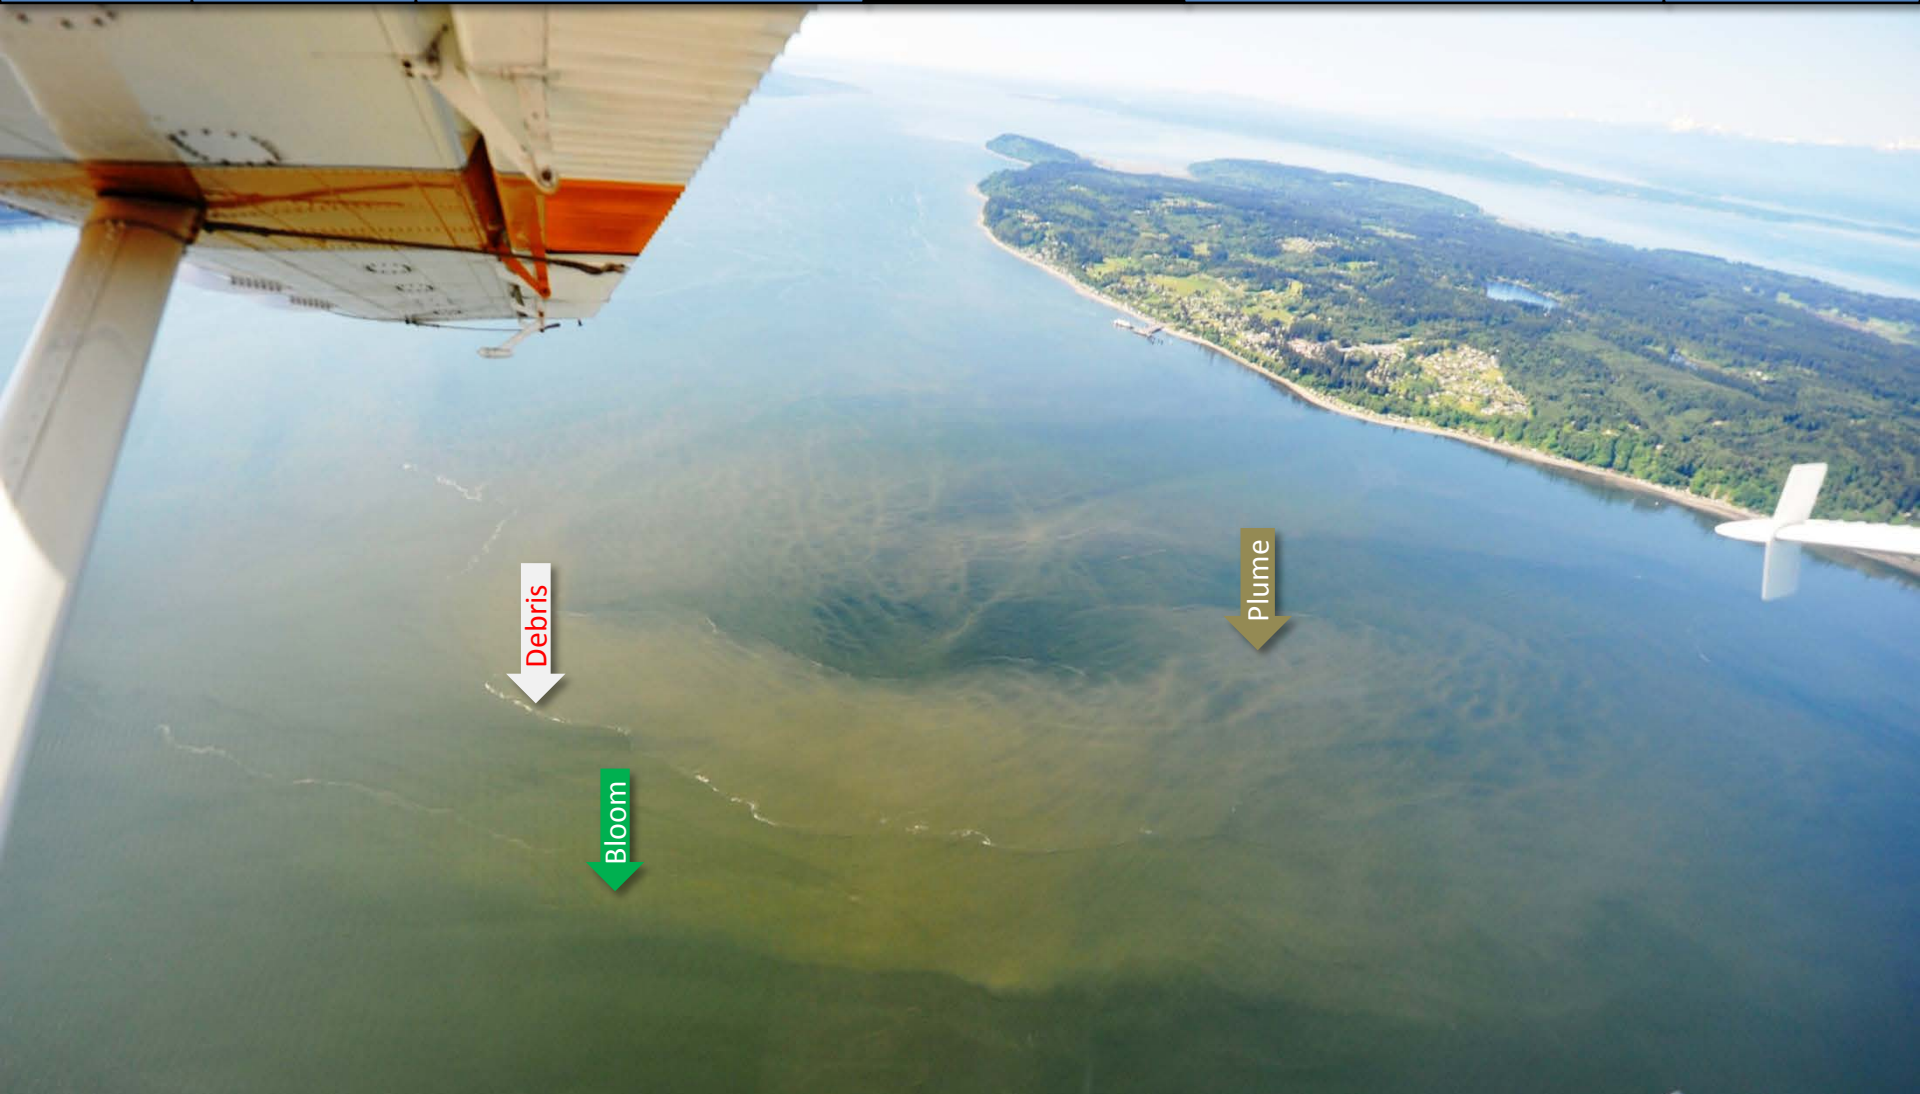
Large eddy of suspended sediment originating from Port Susan and phytoplankton bloom.
Location: Possession Sound (Whidbey Basin), 10:09 AM.

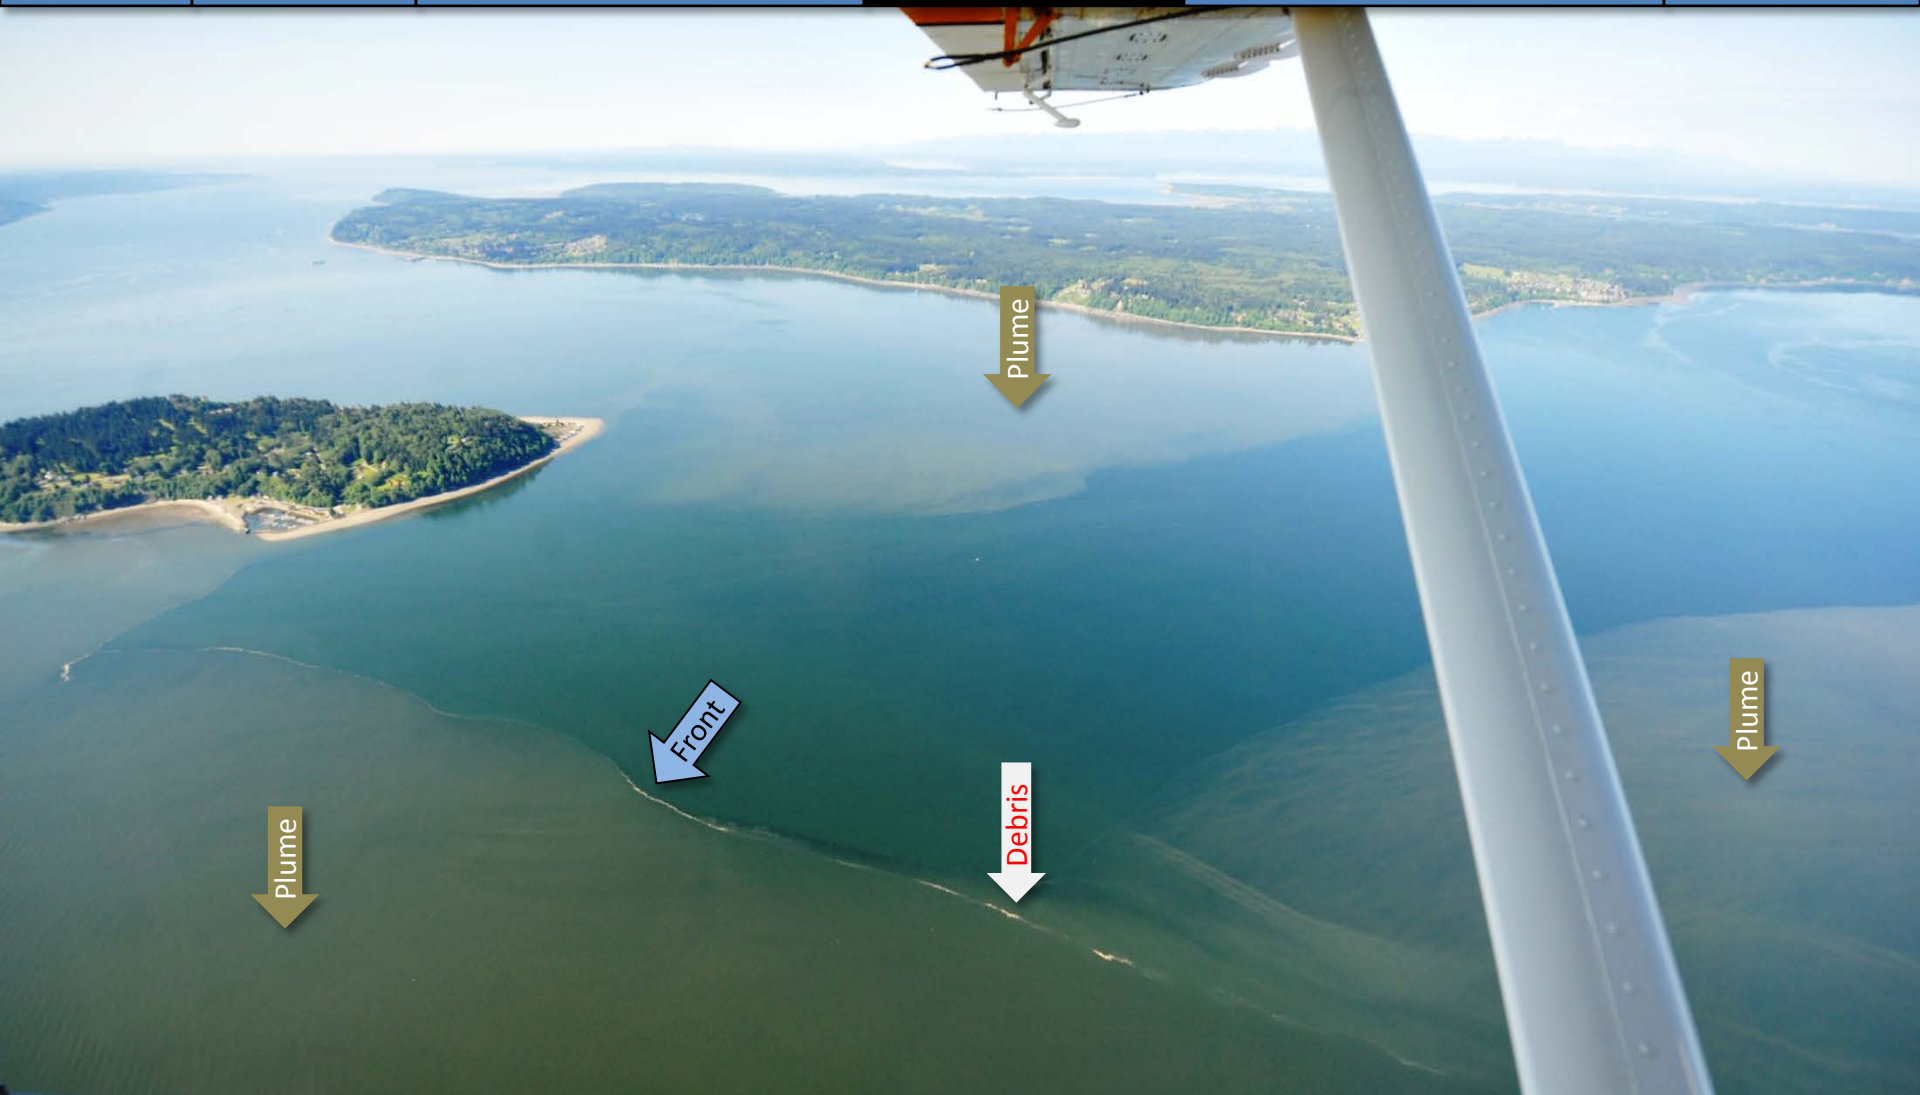
Sediment-laden water from Port Susan and water from Saratoga Passage separated by debris line.
Location: Gedney Island, Possession Sound (Whidbey Basin), 10:11 AM.

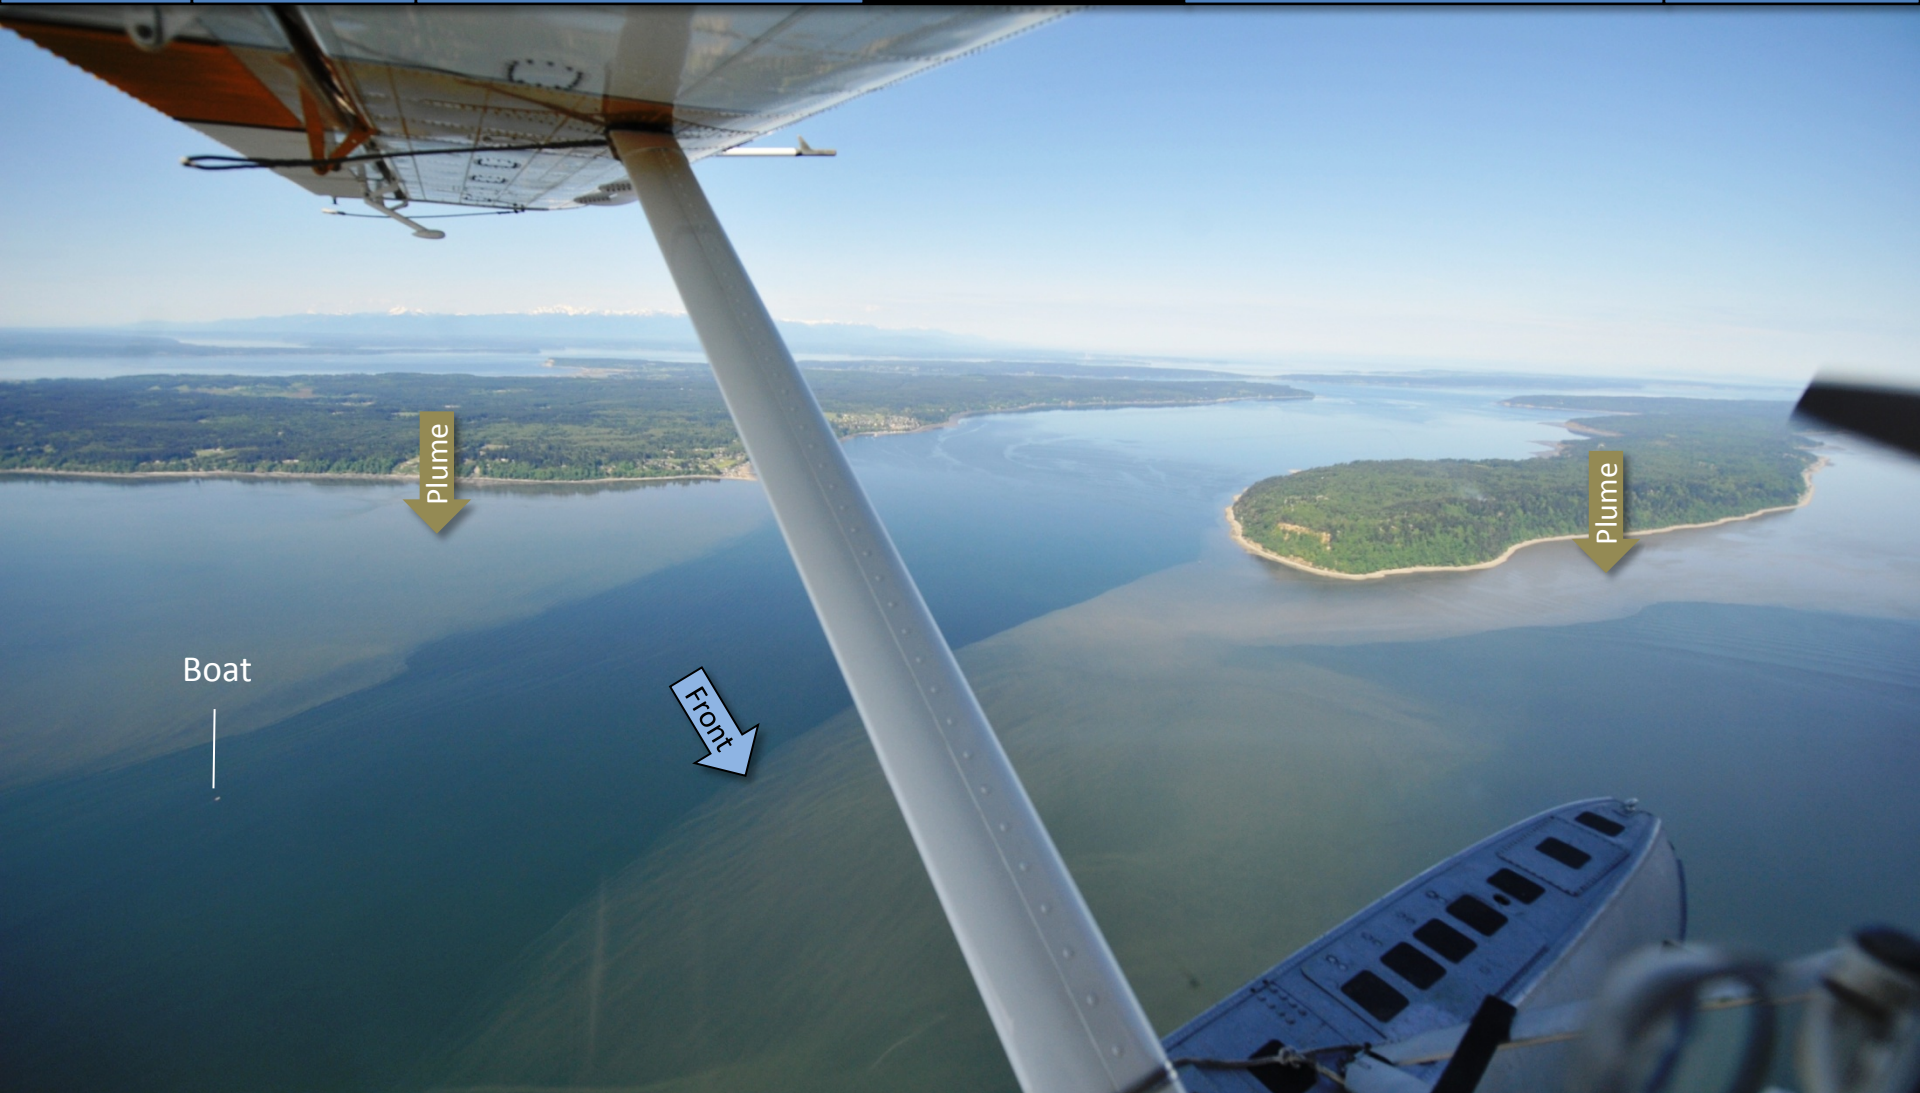
Sediment-rich water from Port Susan meeting water from Saratoga Passage during outgoing tide.
Location: Possession Sound (Whidbey Basin), 10:12 AM.

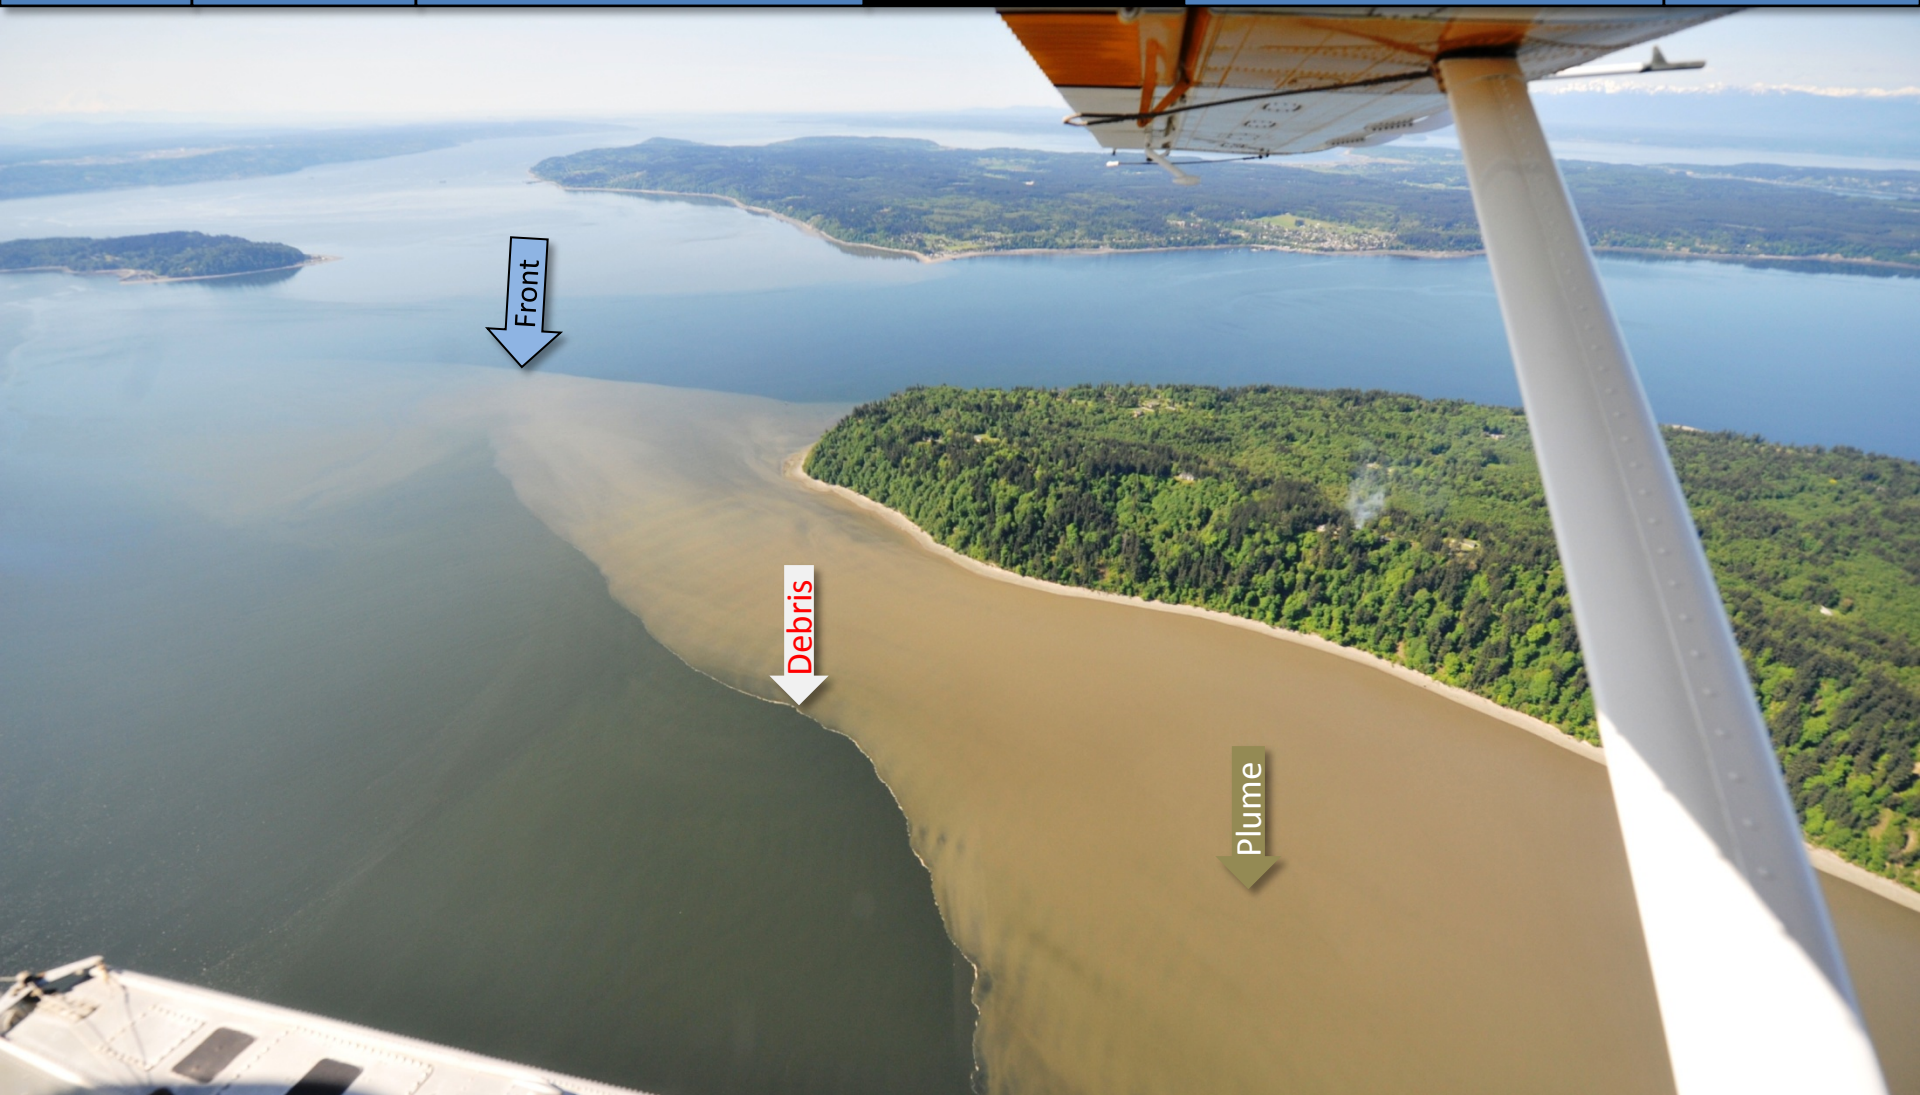
*Sediment-rich water leaving Port Susan at Camano Island during outgoing tide.
Location: Possession Sound (Whidbey Basin), 10:13 AM.*

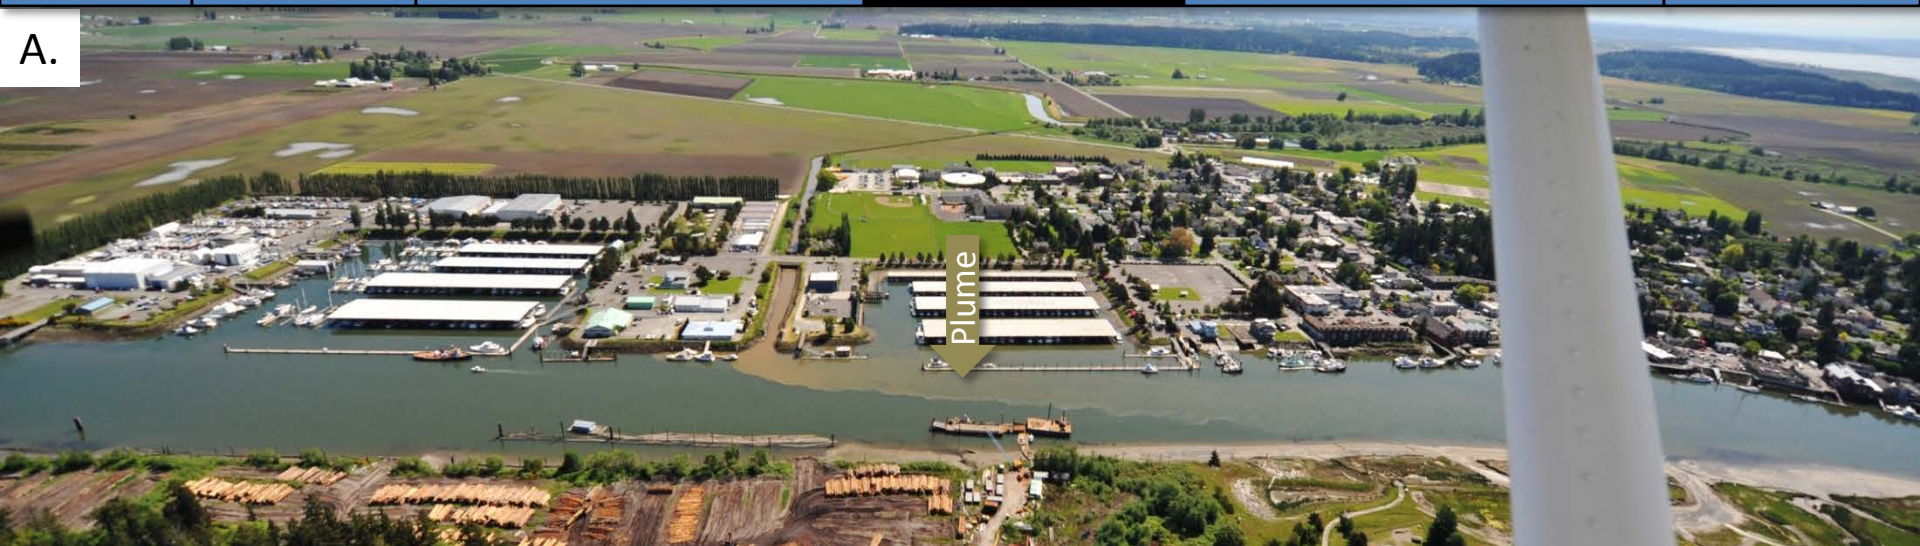
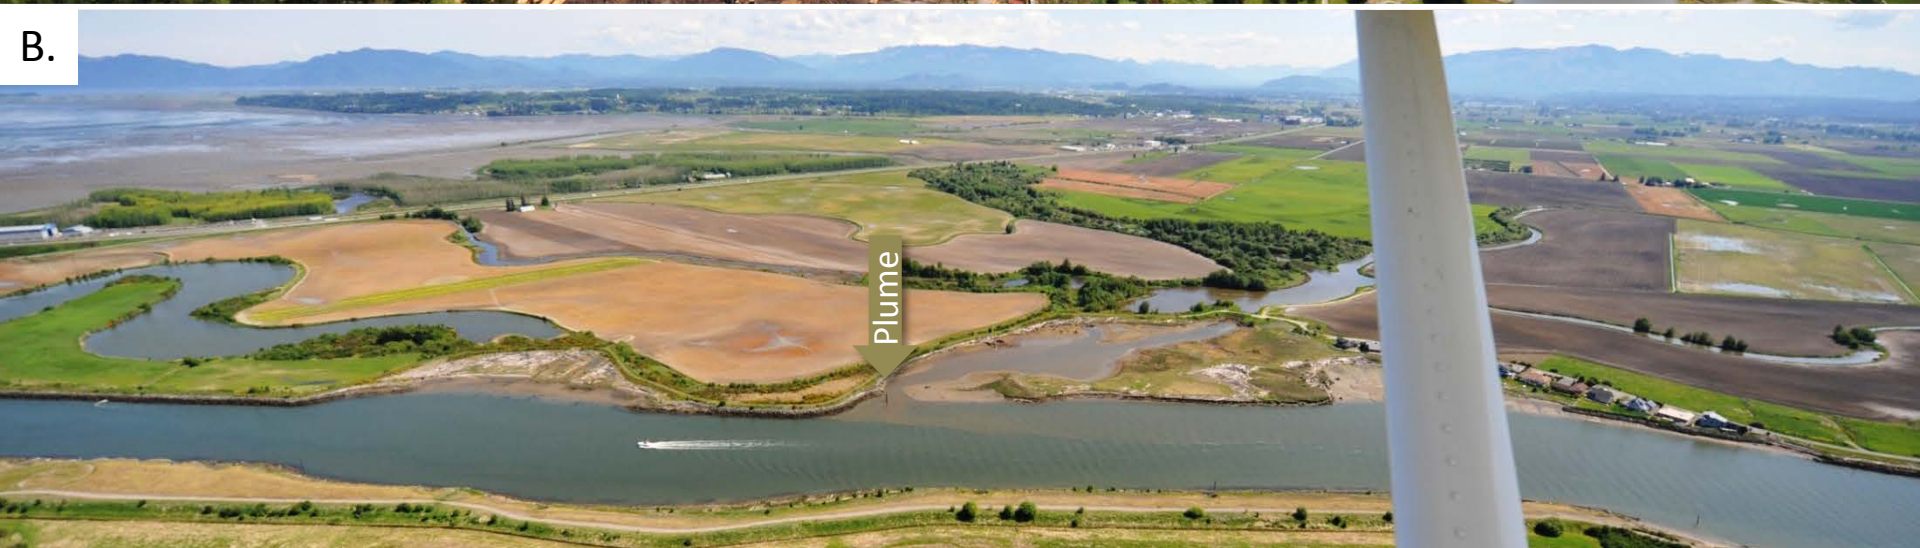
Sediment-rich water entering Swinomish Channel being carried southward.

Location: Swinomish Channel (La Conner), 11:32 AM.

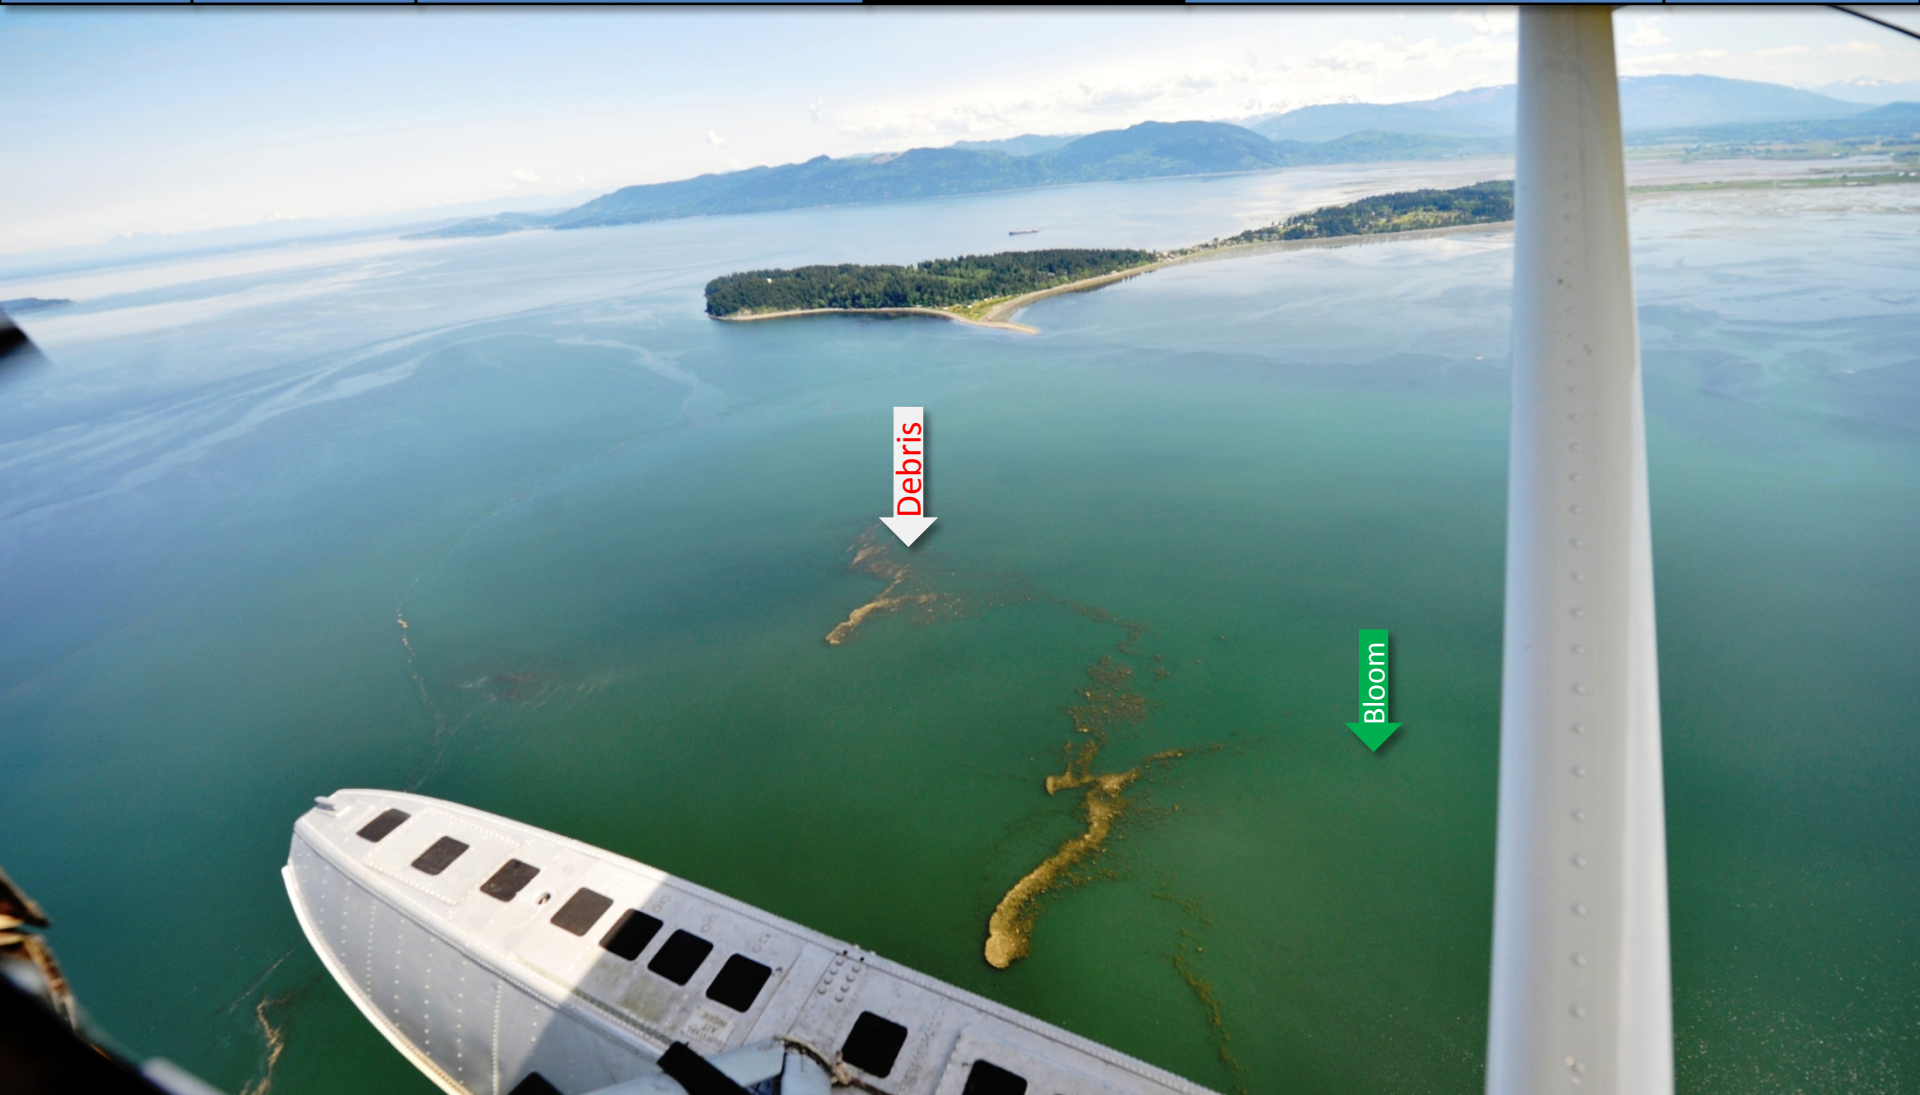
*Large and frequent mats of organic surface debris floating in strong phytoplankton bloom.
Location: Samish Island (Padilla Bay), 11:56 AM.*

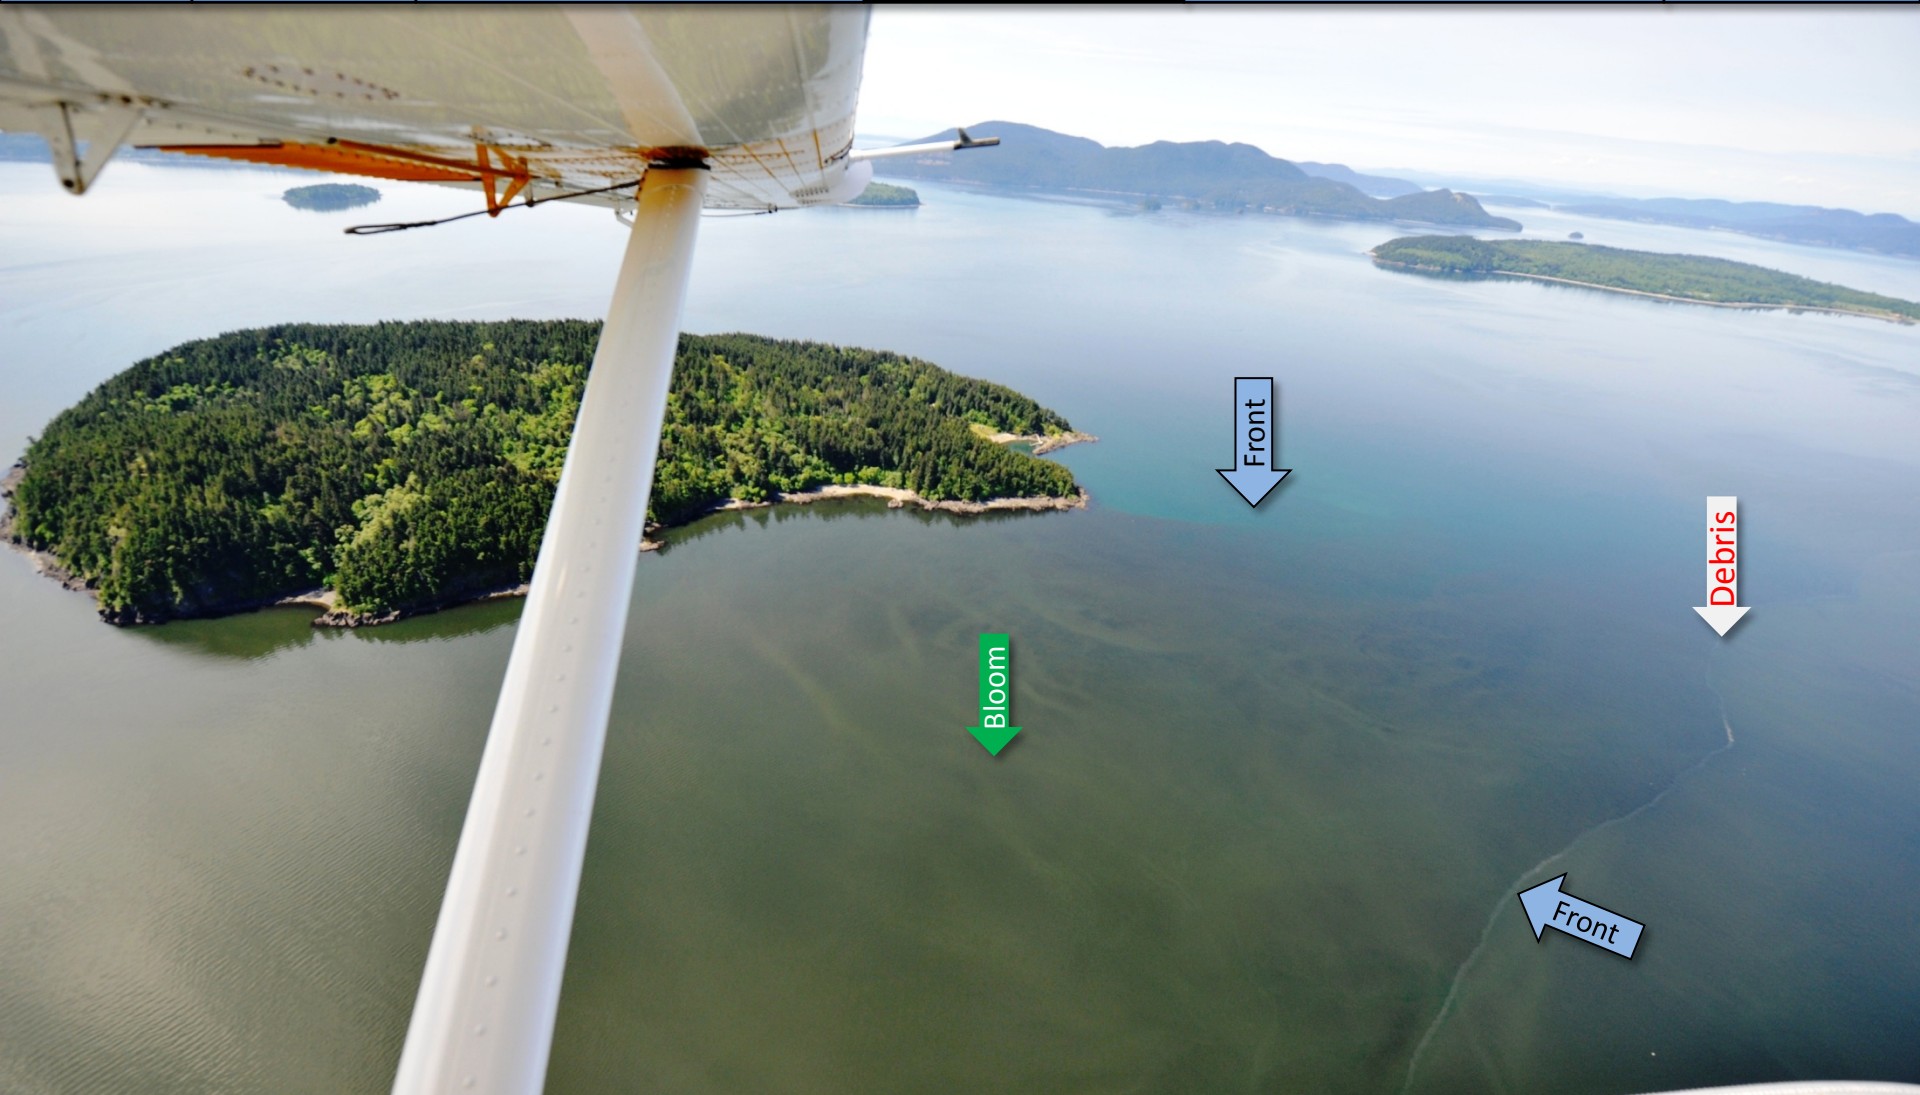
Strong phytoplankton bloom, debris lines bordering clearer water behind island.

Location: Vendovi Island (Samish Bay), 11:58 AM
