Eyes Over Puget Sound

Surface Conditions Report

May 12, 2014

Up-to-date observations of visible water quality conditions in Puget Sound and the Strait of Juan de Fuca

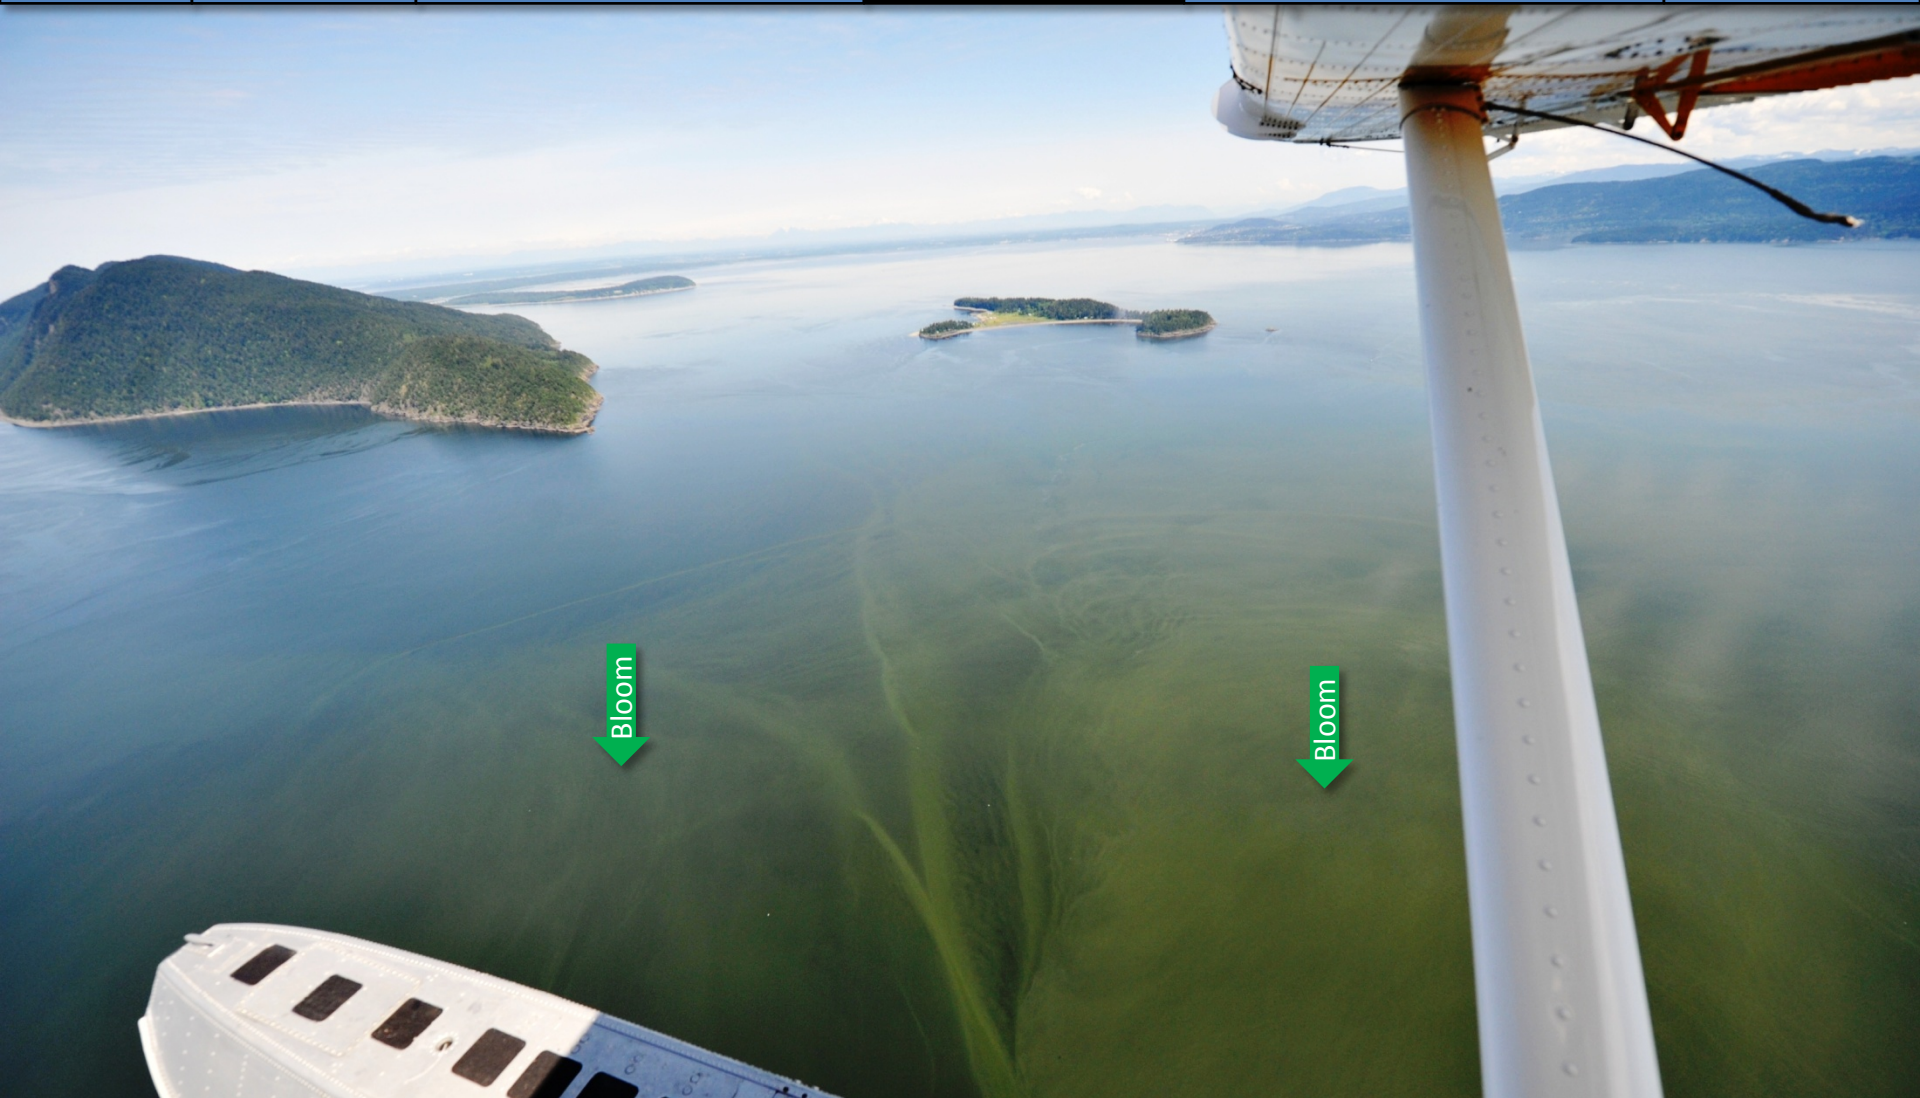
Sediment-rich water and strong phytoplankton bloom drifting out of Bellingham Bay.
Location: Looking onto Lummi Island (Bellingham Bay), 11:58 AM

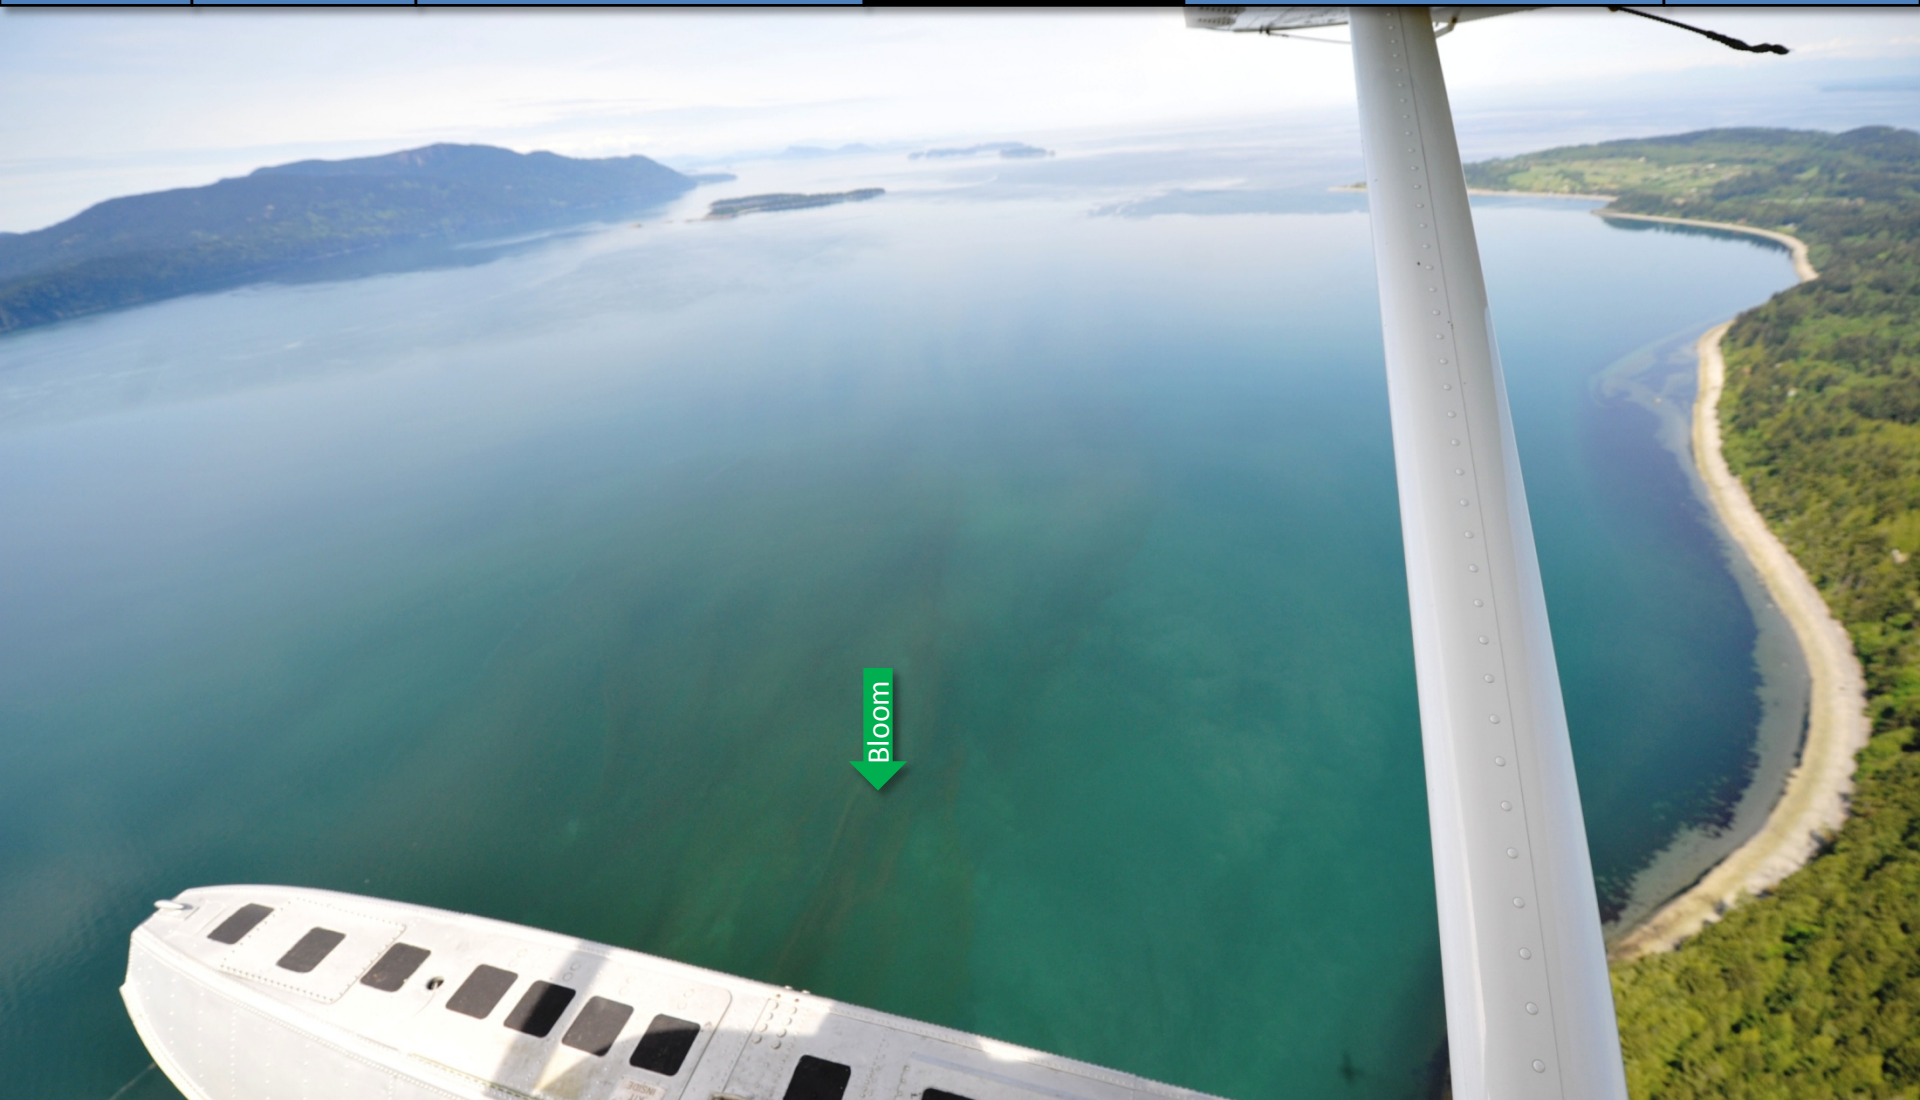
Bellingham Bay water (bloom) mixing into turquoise Rosario Strait water that is rich in silt.
Location: Lummi Island (Rosario Strait), 12:24 PM.

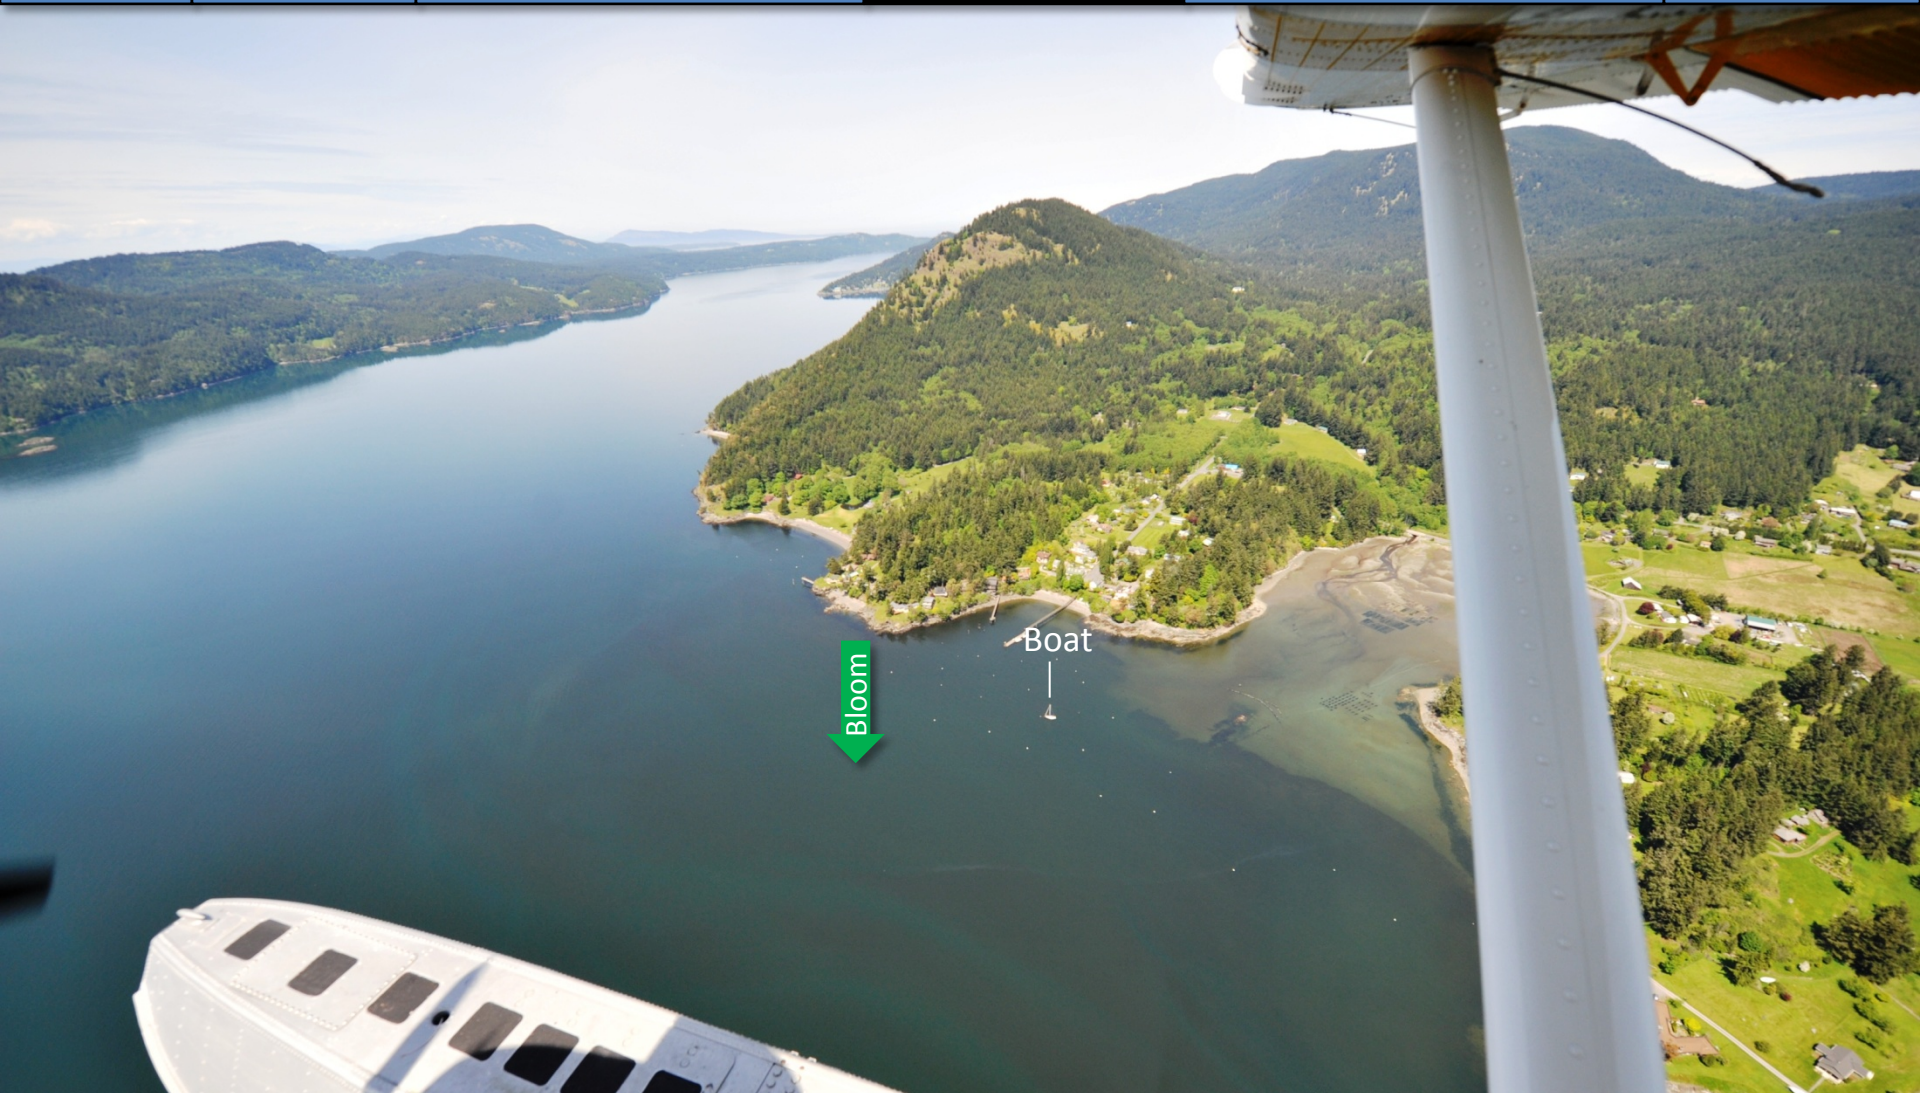
Red-brown phytoplankton bloom and turquoise water.
Location: East Sound, Orcas Island (San Juan Islands), 12:51 PM.

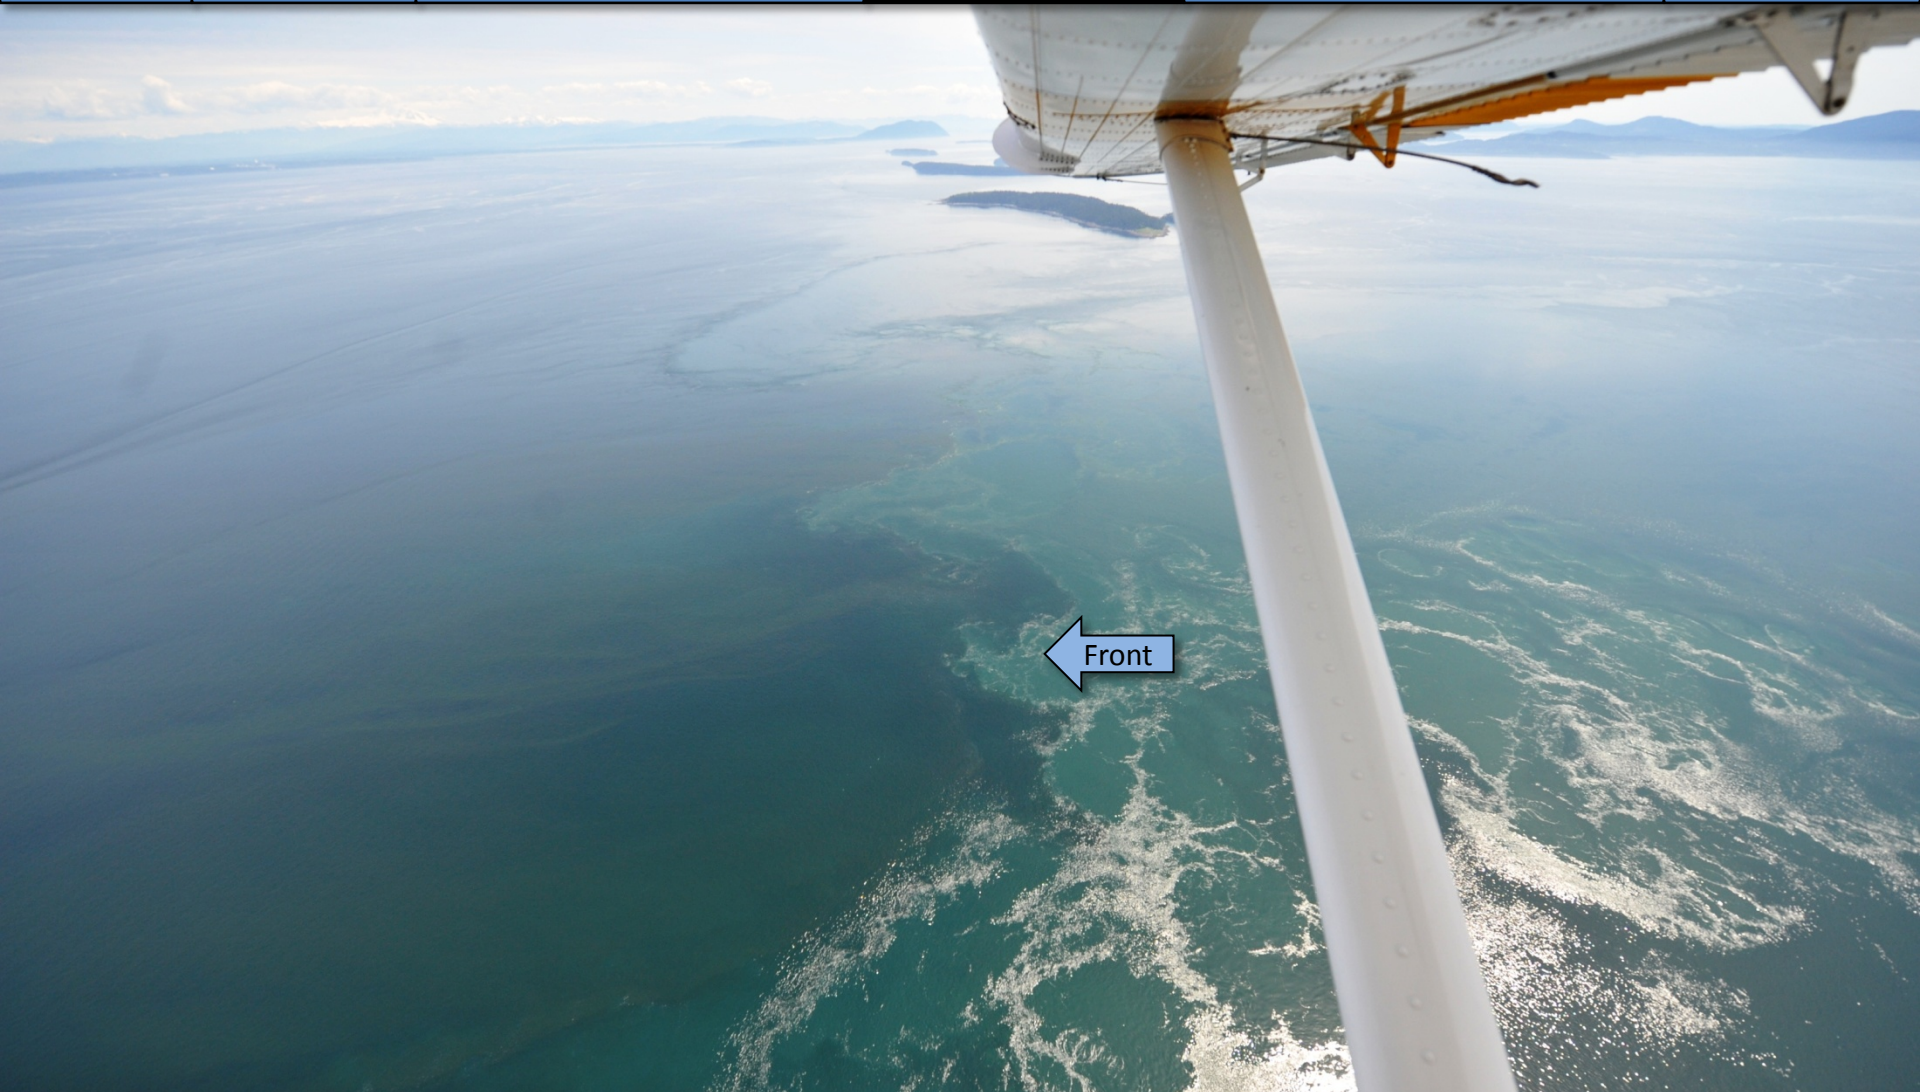
Water rich in phytoplankton meeting a tidal mixing zone bringing turquoise water to the surface.
Location: Off Patos Island, Saturna Island (Georgia Basin), 1:00 PM.

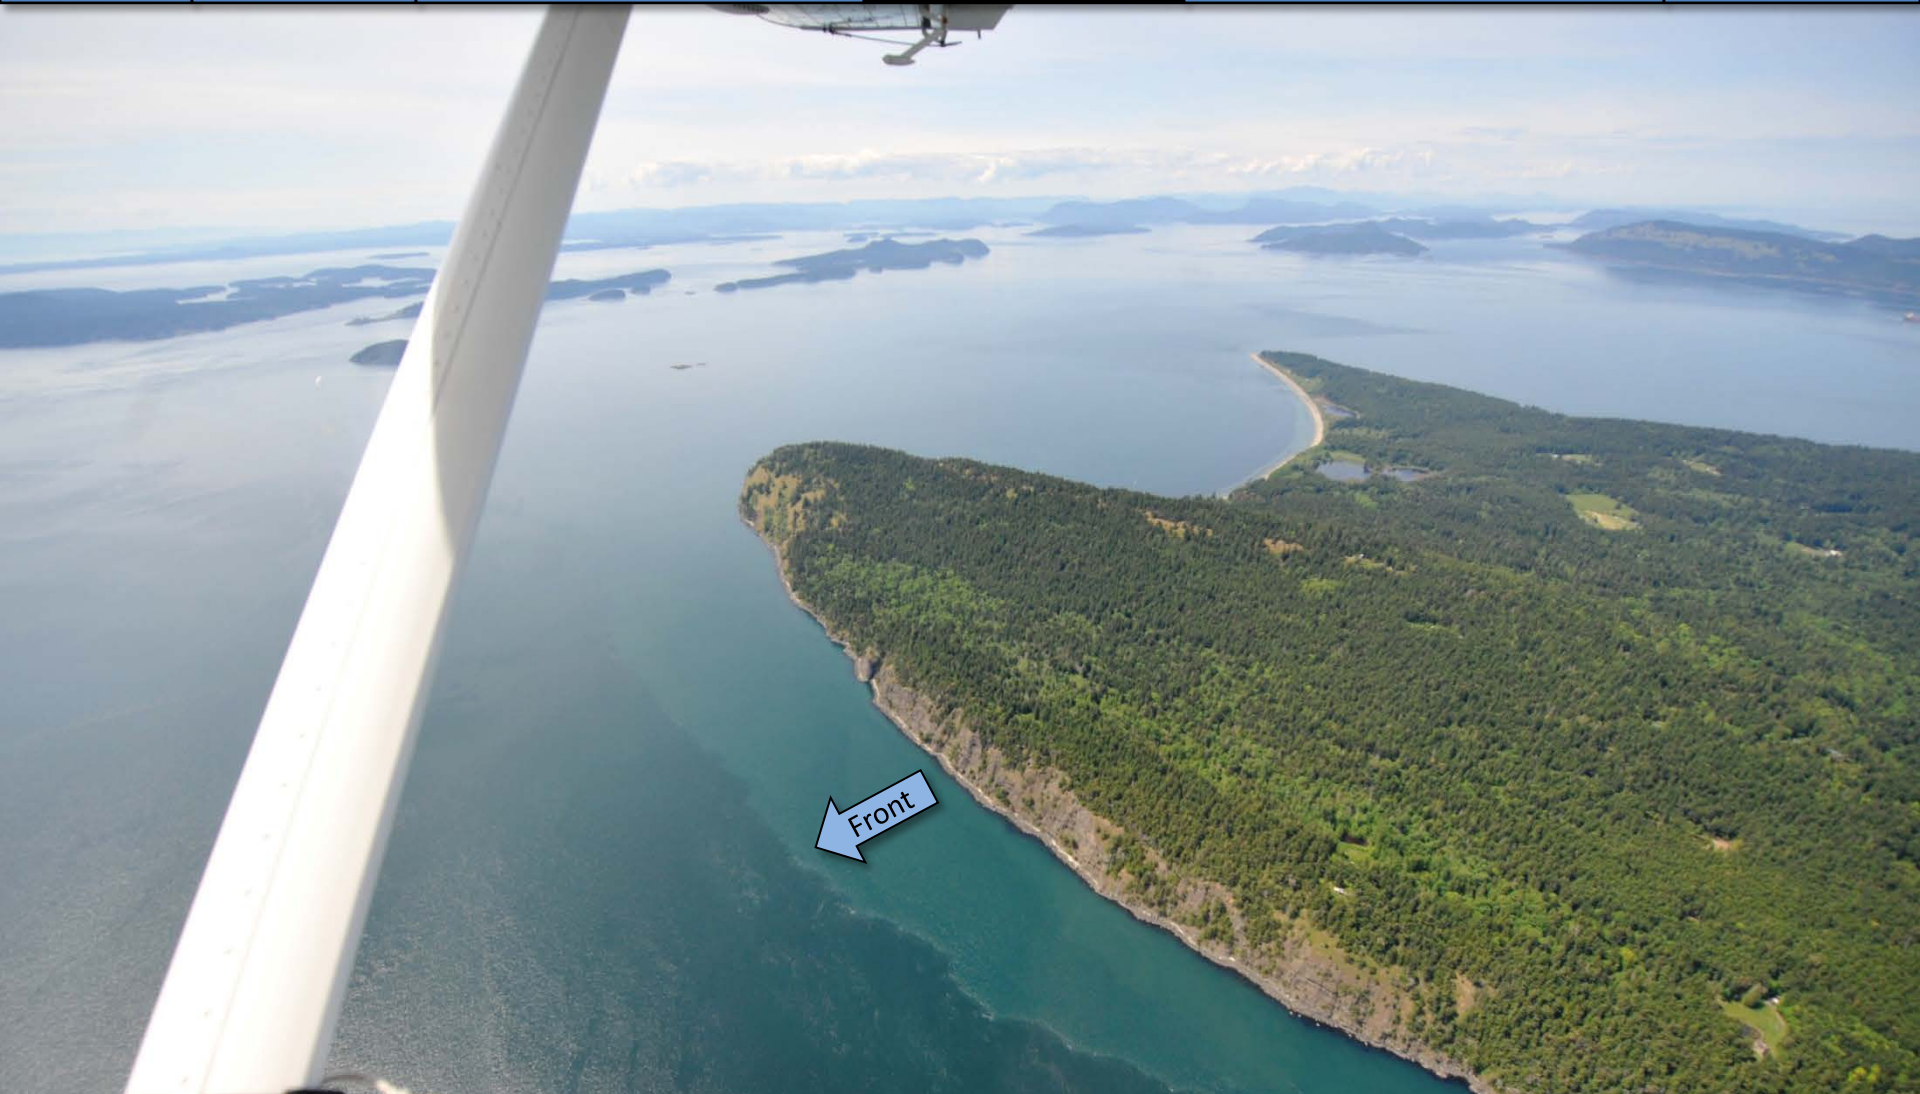
Turquoise water mixing to the surface displacing other water near island.
Location: Waldron Island, President Channel (San Juan Islands), 1:46 PM.

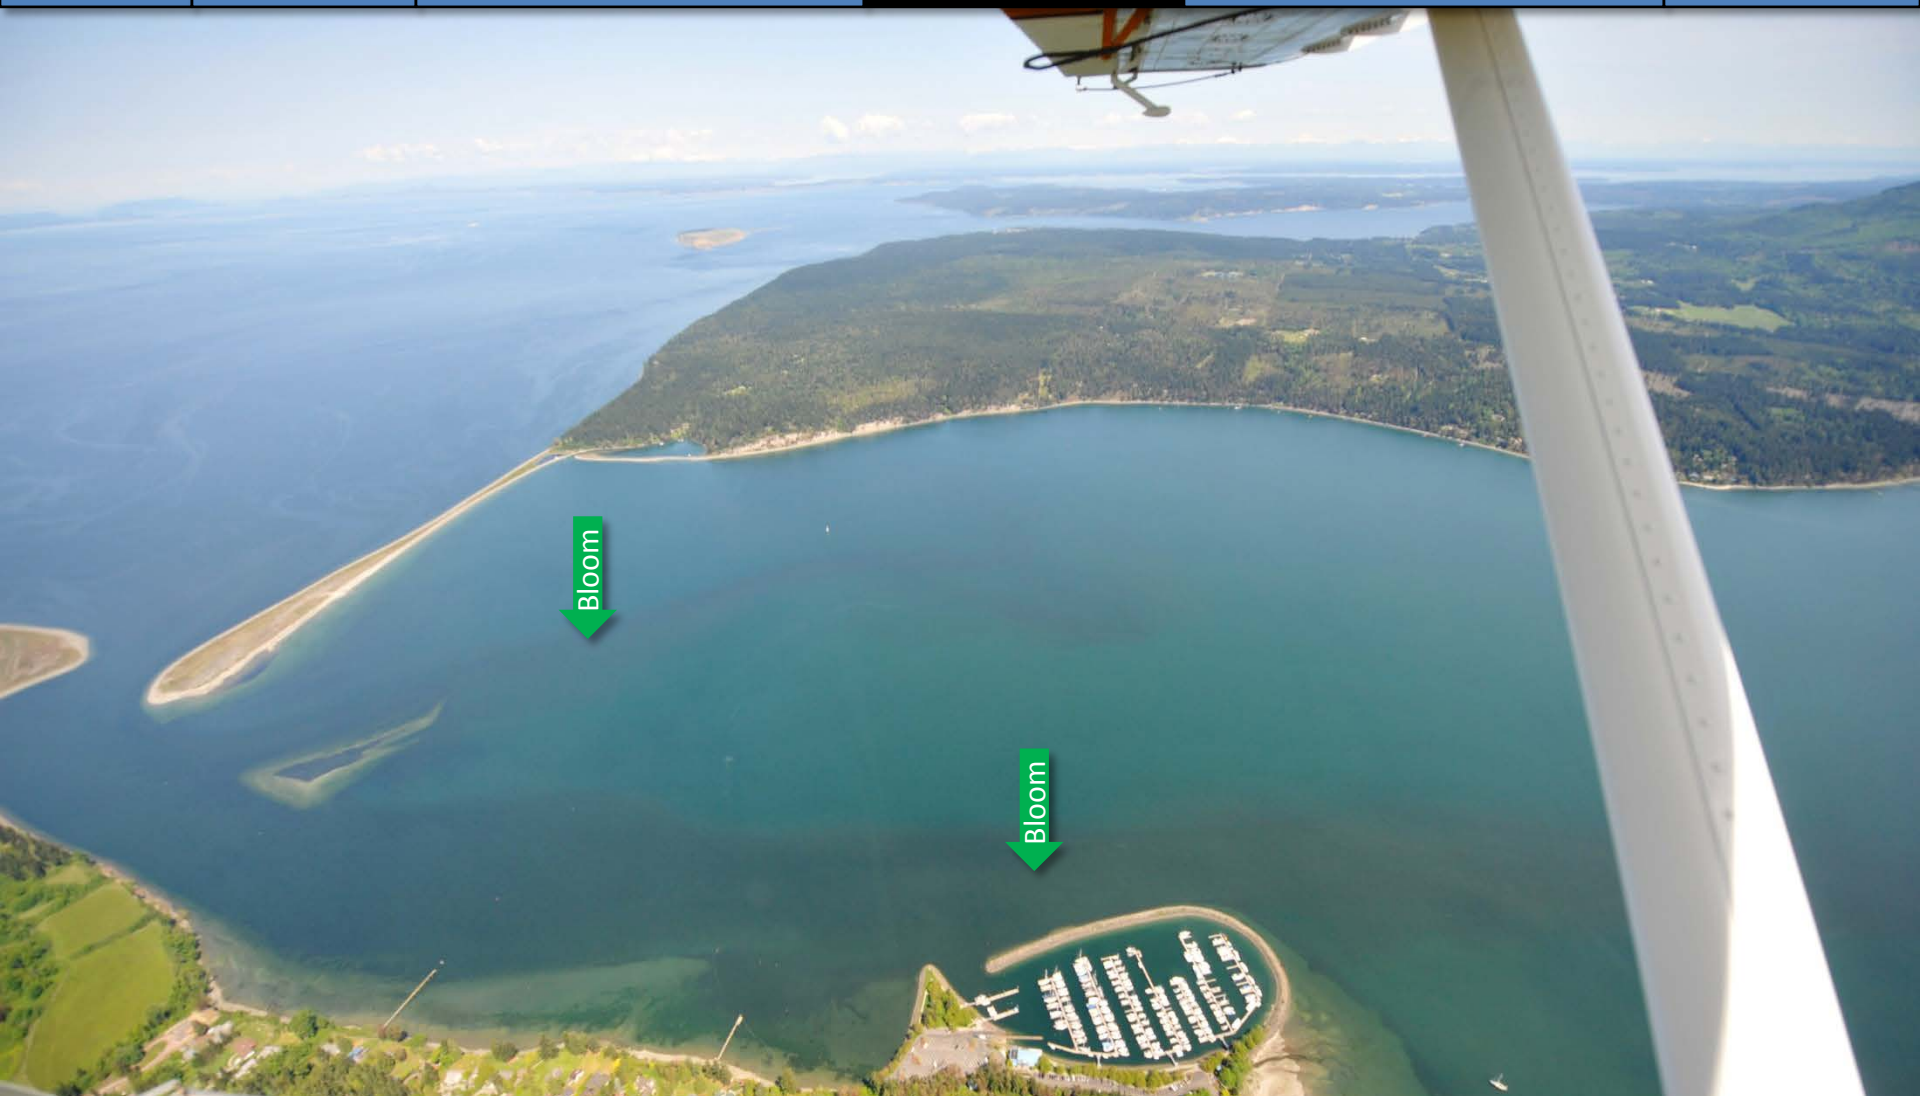
Phytoplankton bloom entering clearer bay water and flowing south along two distinct paths.
Location: Sequim Bay (Olympic Peninsula), 2:11 PM.

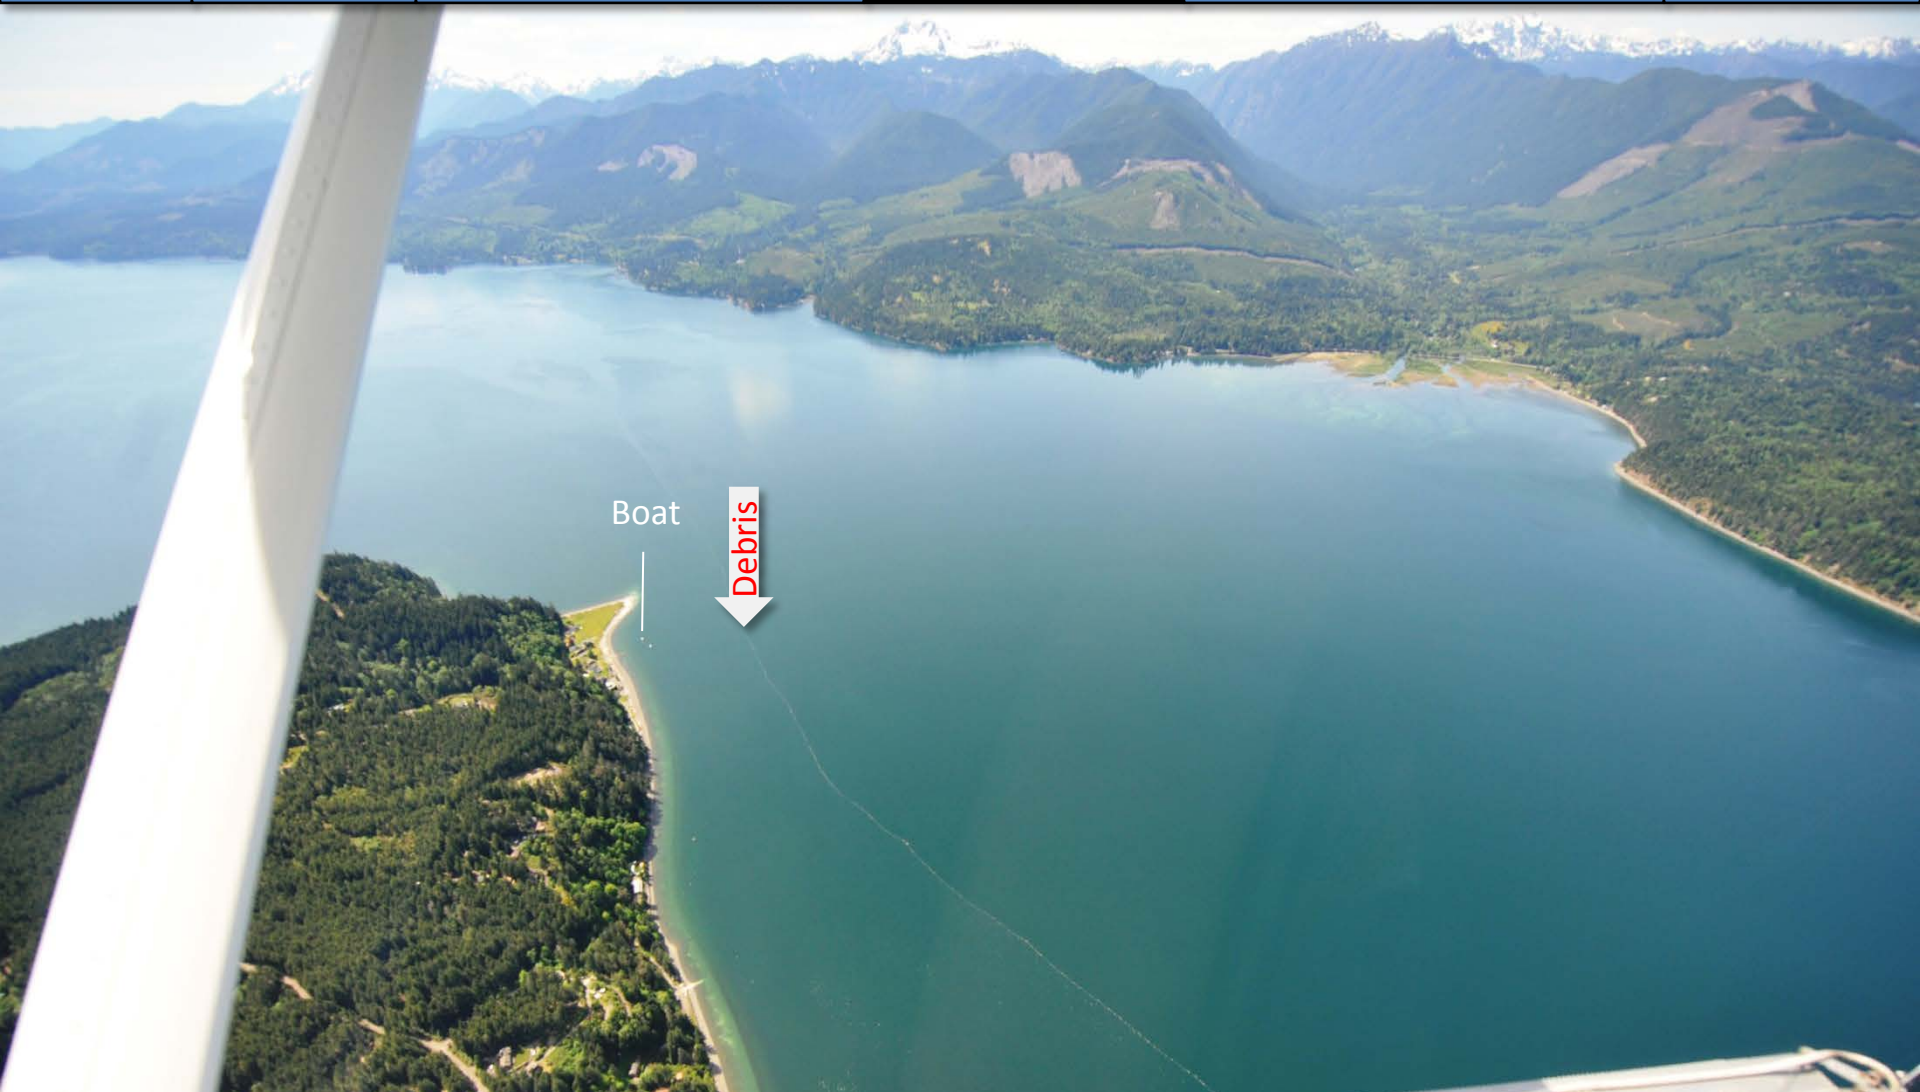
Very long debris line separating phytoplankton-rich and clearer water.
Location: Near Seabeck looking south (Hood Canal), 2:29 PM.

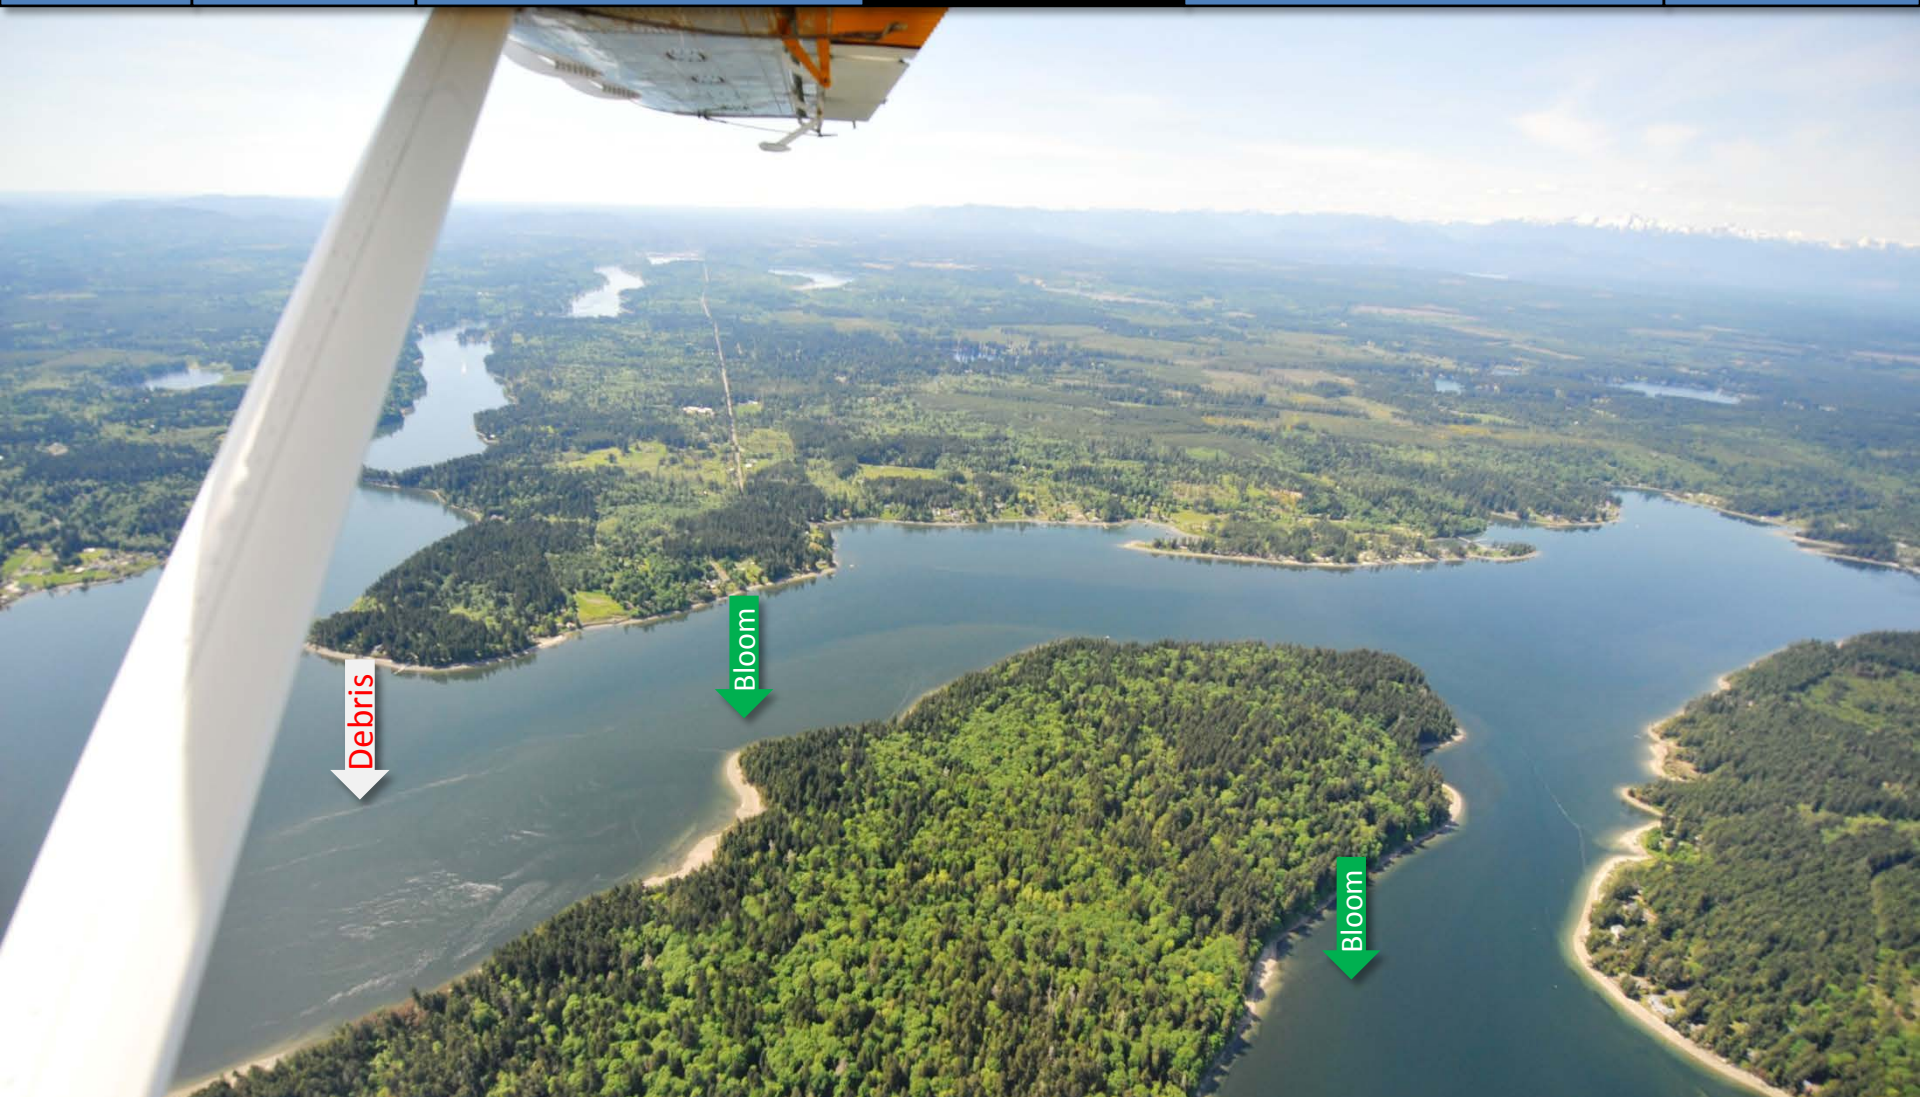
Phytoplankton bloom meeting clearer water in Pickering Passage.

Location: Hope Island (South Sound), 2:44 PM.

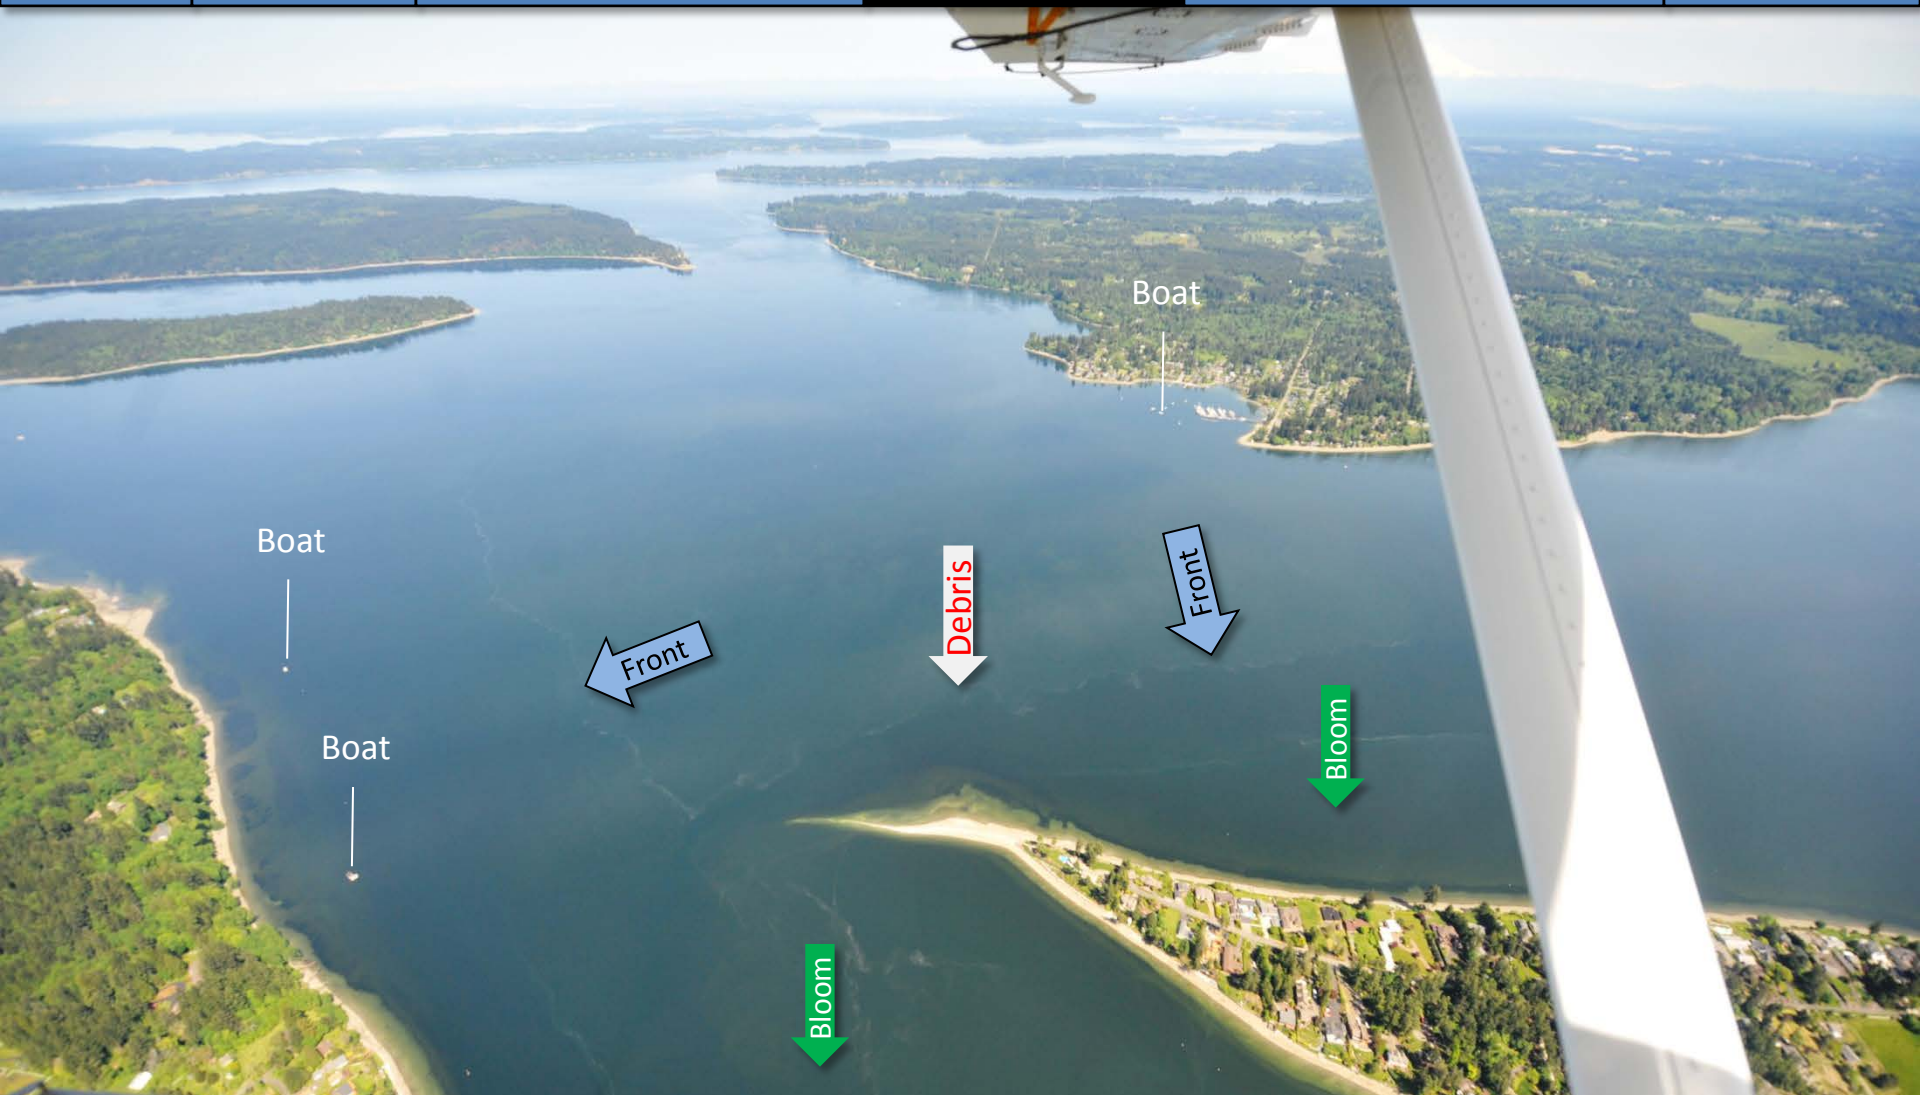
Complex pattern of surface water with different phytoplankton content separated by debris lines.
Location: Entrance to Budd and Eld Inlets (South Sound), 2:46 PM.

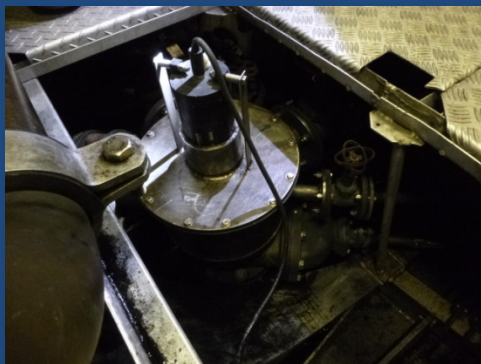
Our fluorometer is inserted through a modified cover over a sea chest strainer.
