Eyes Over Puget Sound

Surface Conditions Report October 29, 2014 Gabriela Hannach Guest: Start here

Marine conditions from 10-29-2014 at a glance

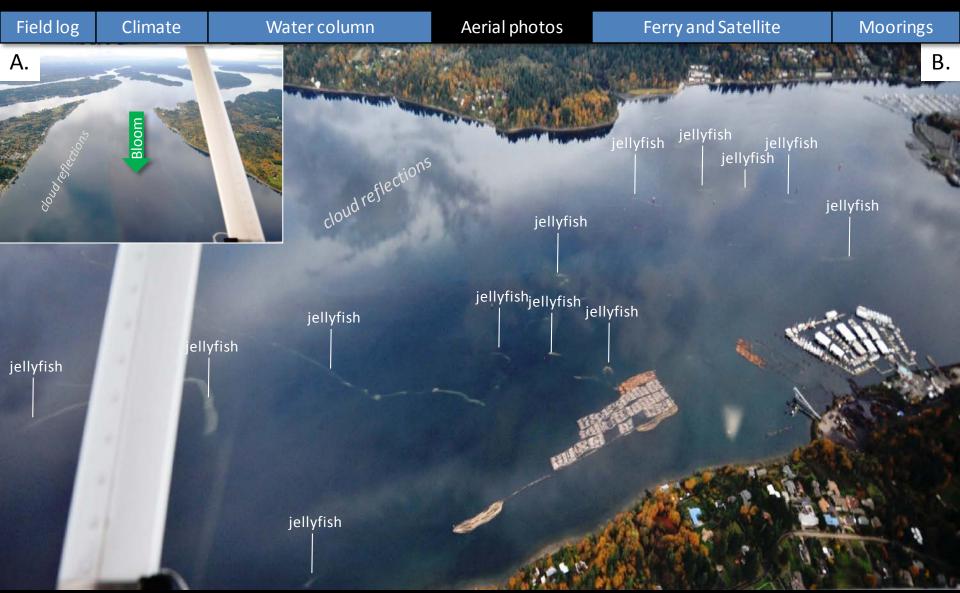
Red-brown bloom and extensive smacks of moon jellies both in size and density. Location: A. Outer bay, B. Inner bay of Budd Inlet (South Sound), 3:50 PM.
