# **Lower Duwamish Waterway Source Control Status Report January through December 2013**

June 2014

Publication No. 14-09-337

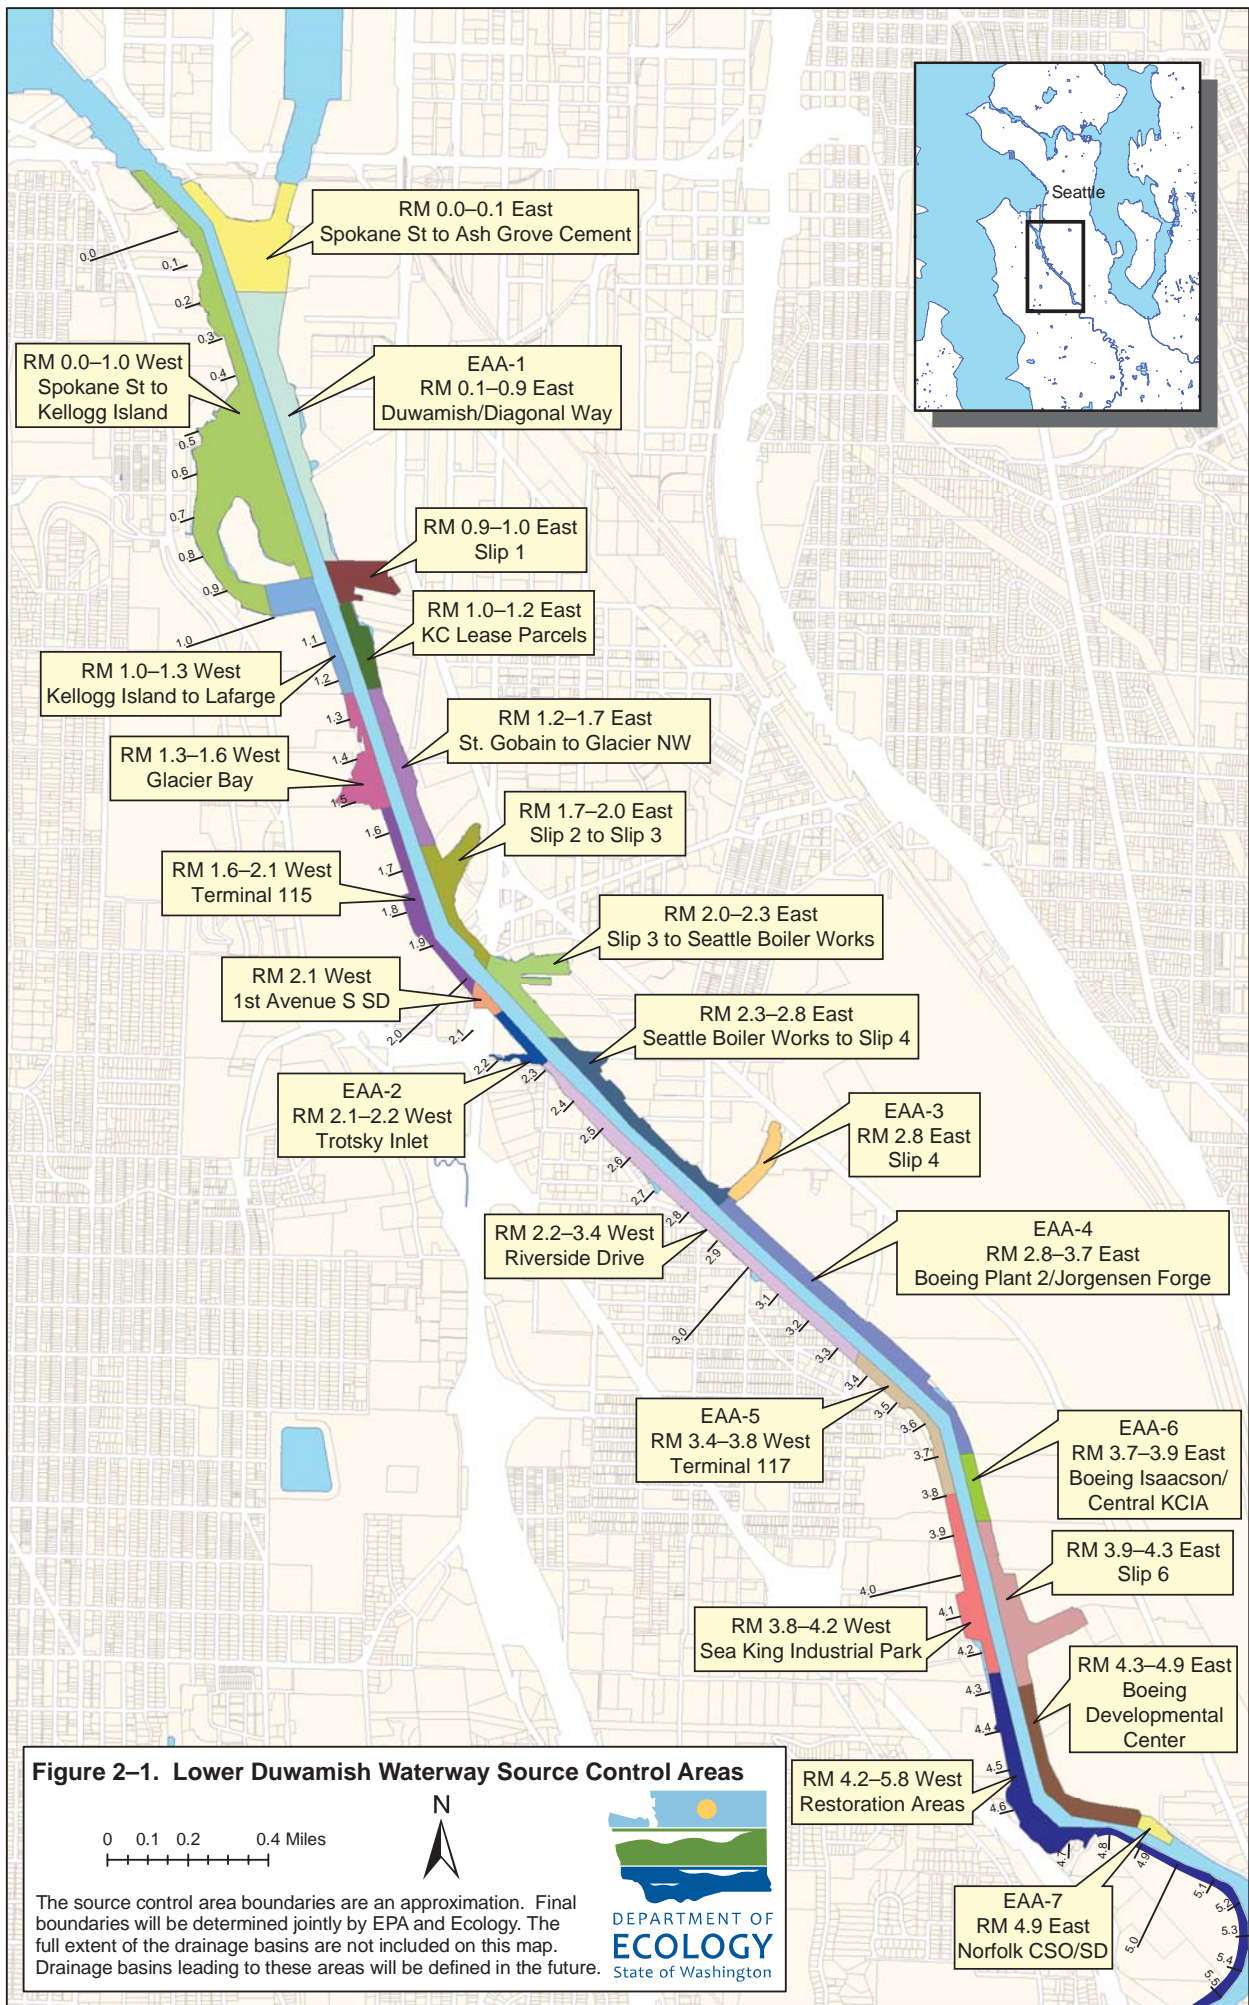
**Figure 2-1. Lower Duwamish Waterway Source Control Areas**

The source control area boundaries are an approximation. Final boundaries will be determined jointly by EPA and Ecology. The full extent of the drainage basins are not included on this map. Drainage basins leading to these areas will be defined in the future.

Ecology conducted source control evaluations for each of the 24 source control areas, including review of existing information, identification of data gaps, and preparation of a SCAP. The 17 Tier 2 and Tier 3 areas and the seven candidate EAAs (a total of 24 source control areas) are shown in Figure 2-1.

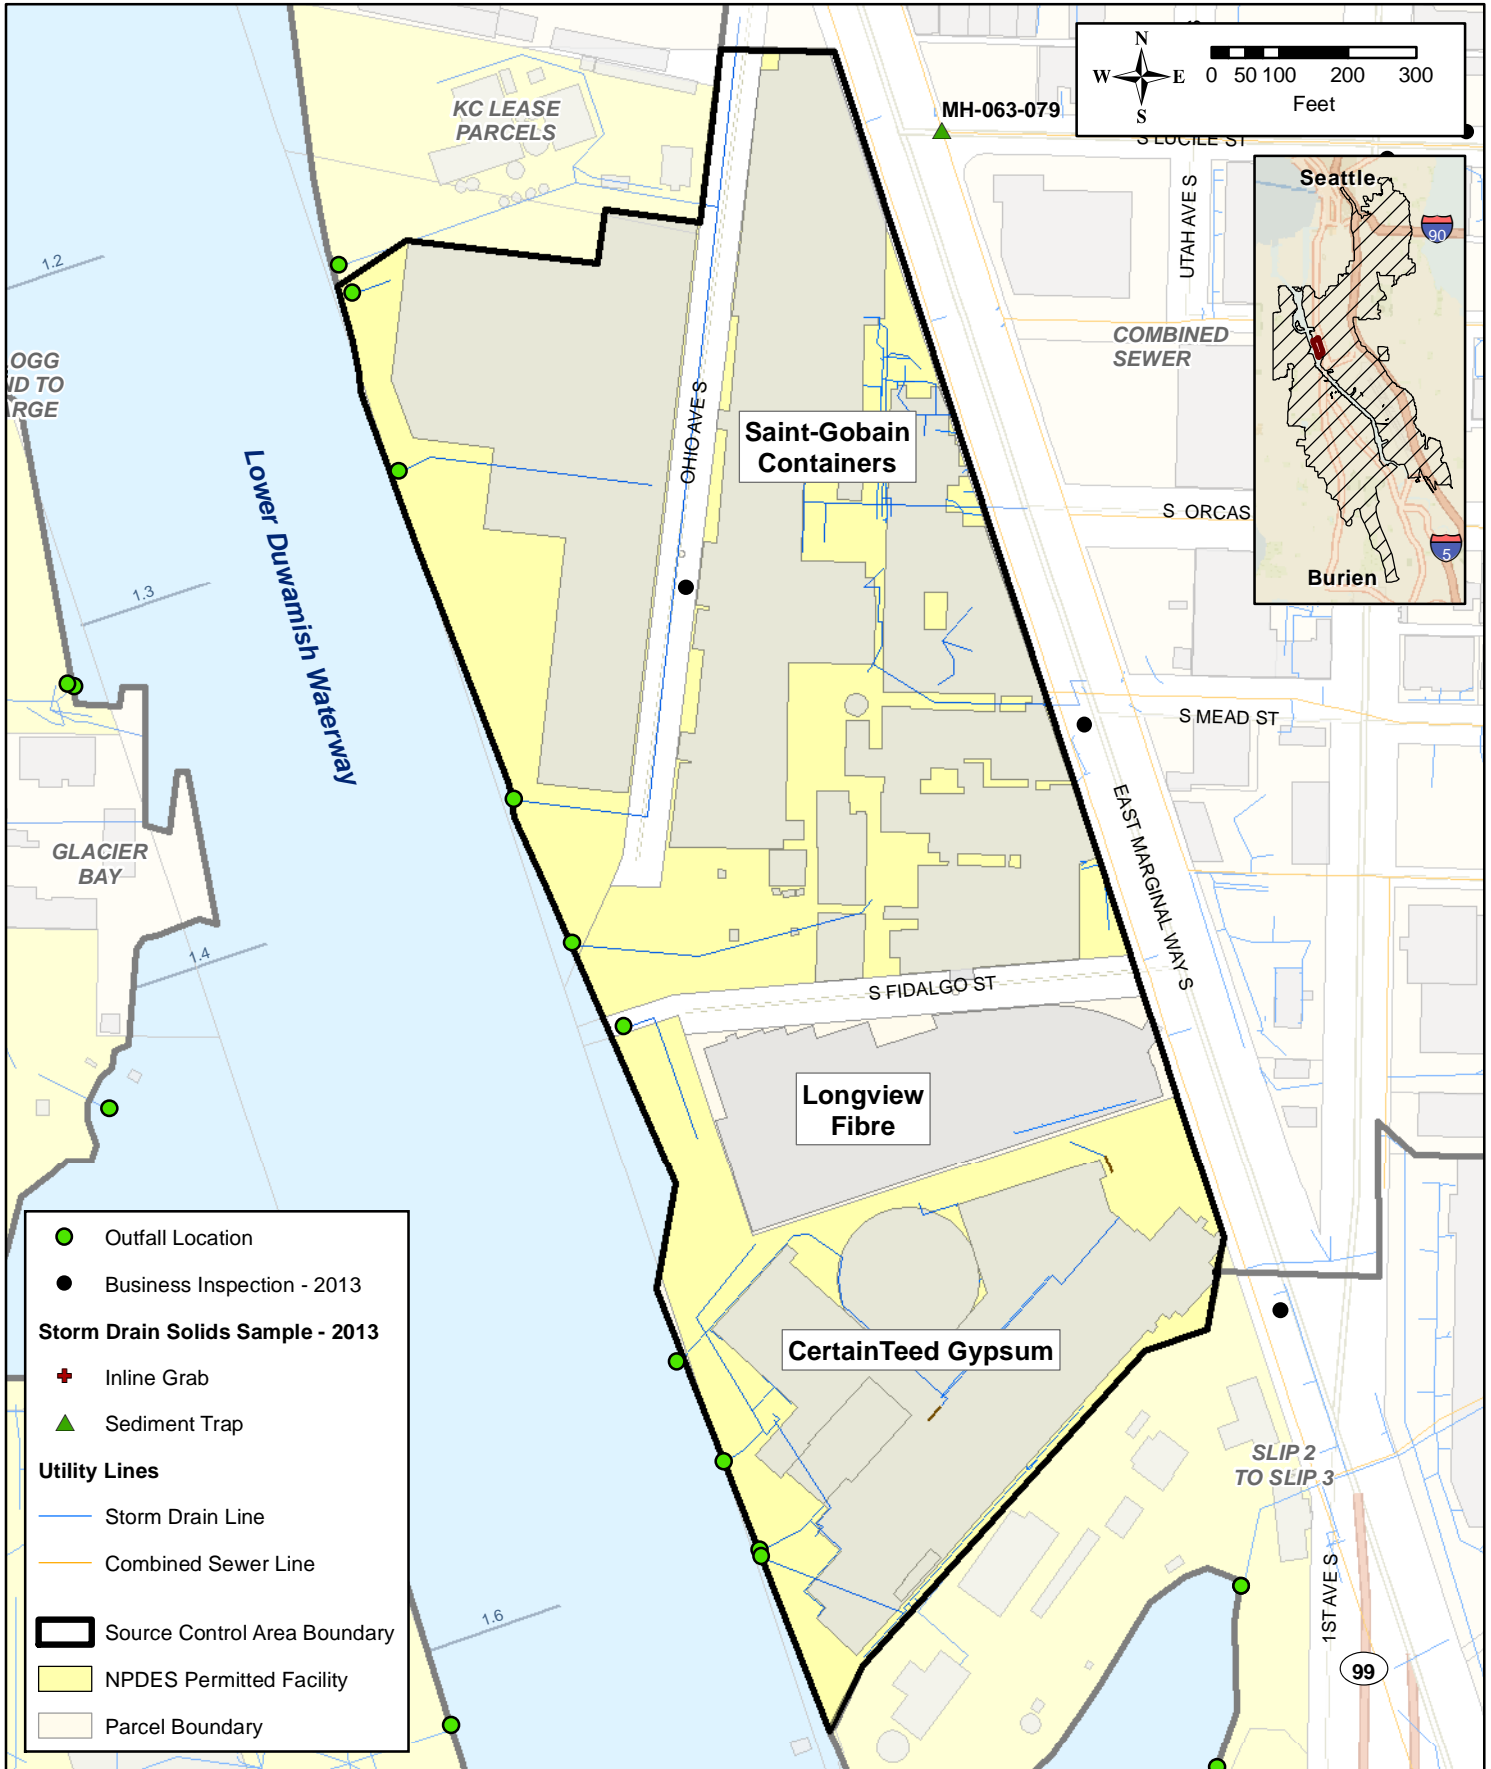
**Figure 8-1. RM 1.2-1.7 East  
(St. Gobain to Glacier Northwest)  
Source Control Area**

- Outfall Location
- Business Inspection - 2013
- Storm Drain Solids Sample - 2013**
- + Inline Grab
- ▲ Sediment Trap
- Utility Lines**
- Storm Drain Line
- Combined Sewer Line
- Source Control Area Boundary
- NPDES Permitted Facility
- Parcel Boundary
