Granger Drain Fecal Coliform Bacteria Total Maximum Daily Load

2013 Adaptive Management Monitoring Report

DEPARTMENT OF
ECOLOGY
State of Washington

July 2014
Publication no. 14-10-036

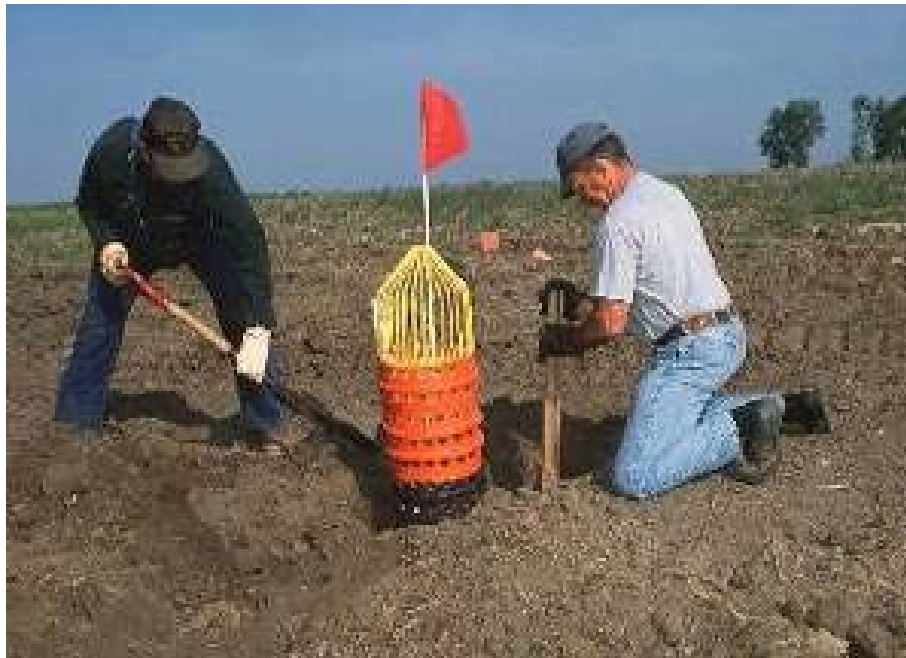
Subsurface drainage systems typically utilize numerous surface inlets (Figure 4, below) that act to equilibrate air pressure for facilitating gravity drainage. However, those same inlets can also allow the entrance of surface runoff which at times is polluted by manure applications (see Figure 5, below). Sylvester and Seabloom (1962) found that subsurface drainage in the Yakima Valley “... at times contains some surface drainage that entered ... directly through vents, holes or other piped connections.”

Figure 4 Surface inlet

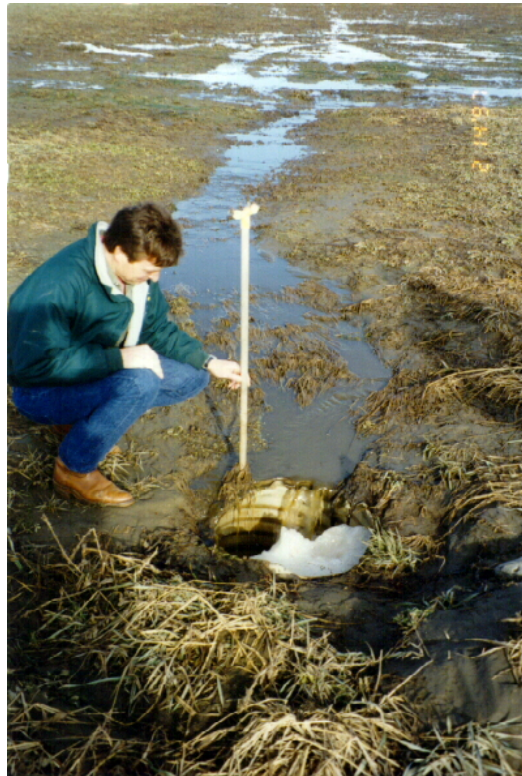
Figure 5 Liquid manure application runoff into surface inlet in Granger Drain watershed

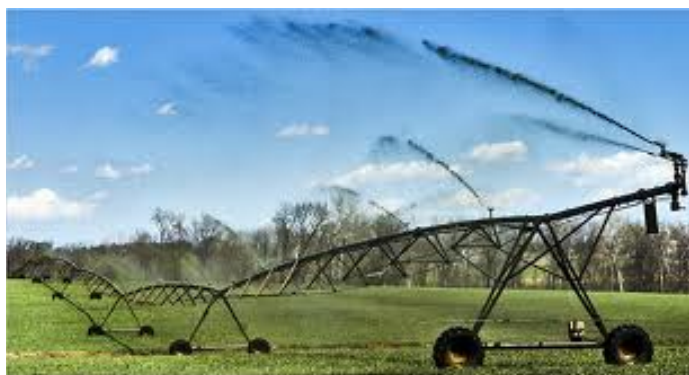
Figure 6 Spraying liquefied manure

Researchers have historically attributed excessive FCB pollution in the Granger Drain and its tributaries to over-application of livestock manure throughout the watershed. In 2009, 53,820 milk cows produced 1.45 million tons of wet manure in the Granger Drain watershed. The majority of the watershed’s dairy manure is spray-applied as a diluted liquid onto dairy-owned land (Figure 6). Solid manure (Figure 7, below) is usually transported to non-adjacent fields.

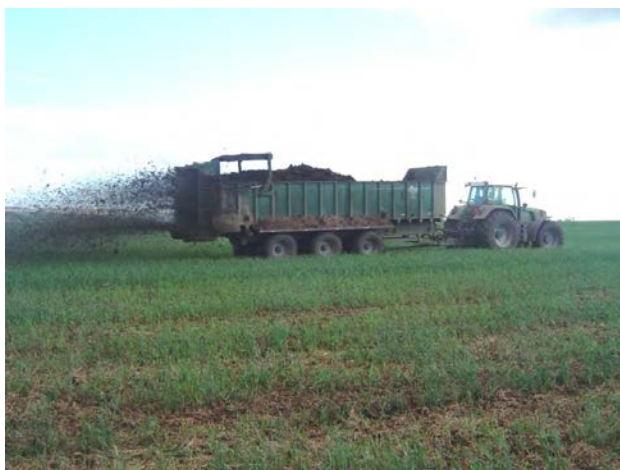
Figure 7 Spreading solid manure

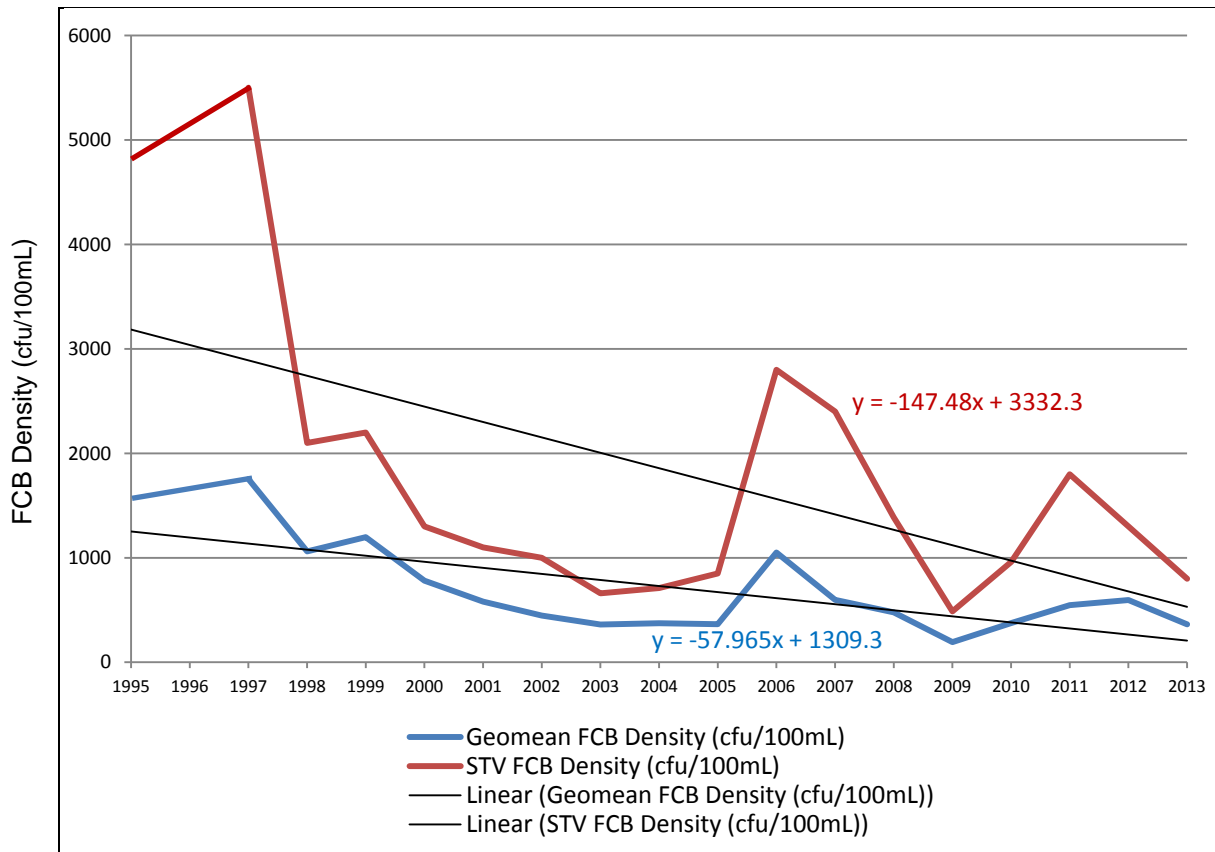
Figure 8 Irrigation season geomean and STV FCB densities: 1995-2013

The 2013 FCB concentrations are significantly ($K-S = 2.34, p < 0.001$) less than those of 1995. Using the linear trend equations given in Figure 8, the geomean (blue) and STV (red) FCB densities have decreased 83.8% and 83.4%, respectively, during the past 19 years. Even with this substantial decrease, the data did not meet the *Granger Drain Fecal Coliform Bacteria TMDL*'s final target of full compliance with the State's WQS in the 2012 irrigation season. That year's actual geomean and STV FCB densities were still 2 and 3 times greater than the State's criteria of 100 and 200 cfu/100mL, respectively. Thus, a new target date for full compliance with State standards is required by the "adaptive management" section of the TMDL.

According to the linear trend equations given in Figure 8, the State water quality geomean FCB criterion (100 cfu/100mL) is projected to be met in the 2014 irrigation season. However, the STV FCB criterion (200 cfu/100mL) is projected to be met in the 2016 irrigation season. Consequently, the TMDL's new target date for full compliance with State WQS for bacteria is the 2016 irrigation season. This is 4 years later than the original target.
