# Eyes Over Puget Sound

## Surface Conditions Report

January 28, 2015

*Up-to-date observations of visible water quality conditions in Puget Sound and the Strait of Juan de Fuca*

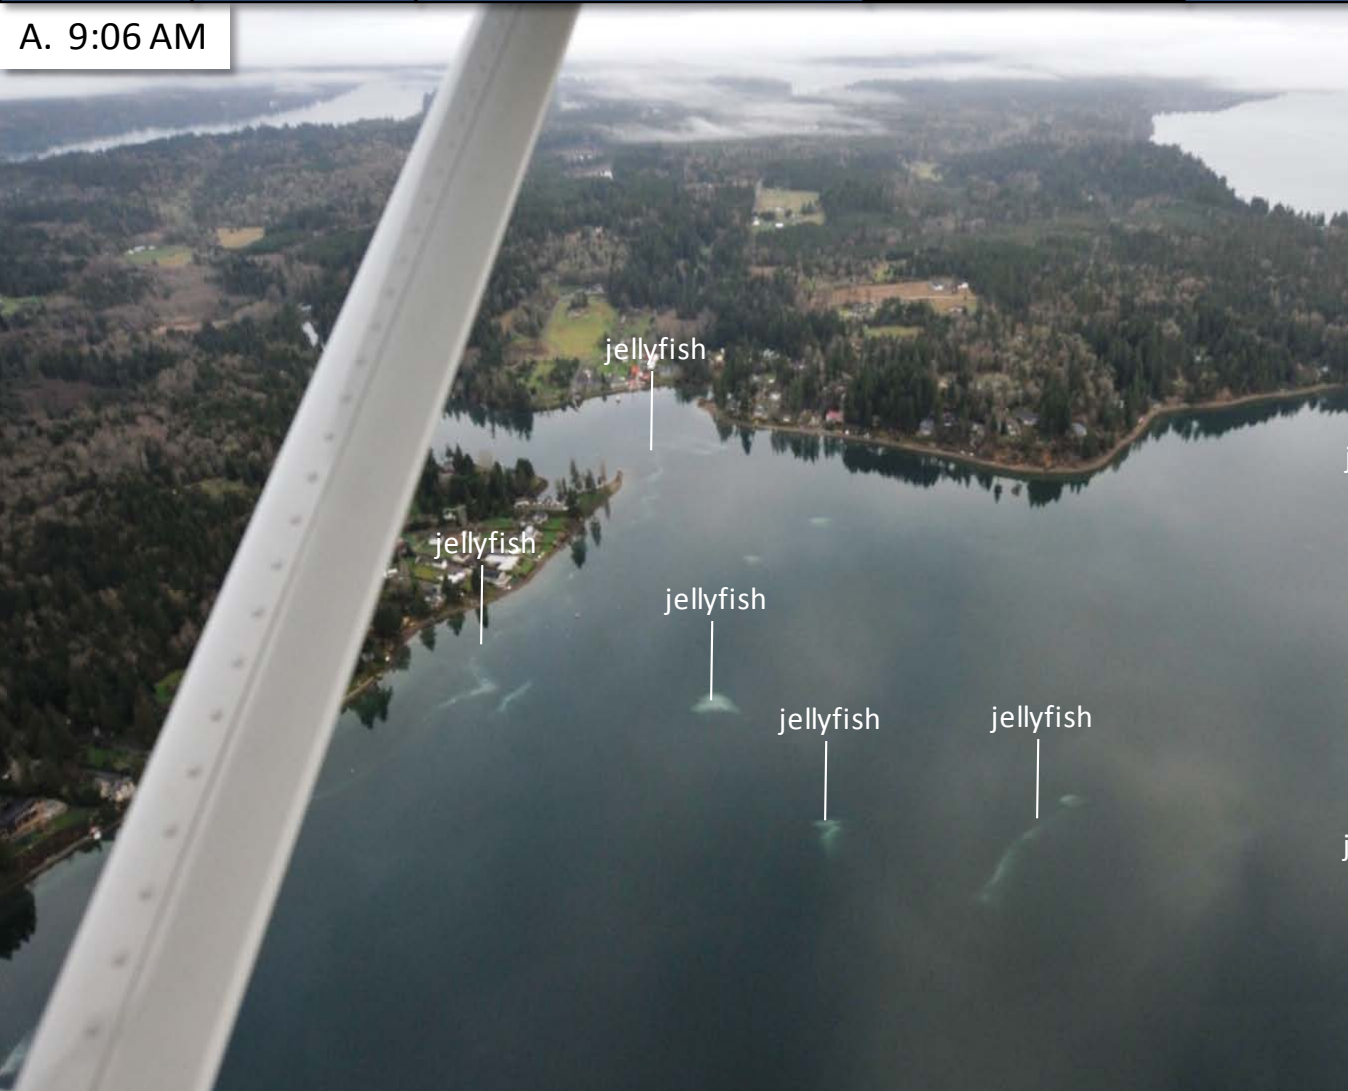
*Numerous jellyfish patches in otherwise clear blue green water.*  
Location: A. Off Young Cove, Eld Inlet, B. , Budd Inlet (South Sound).

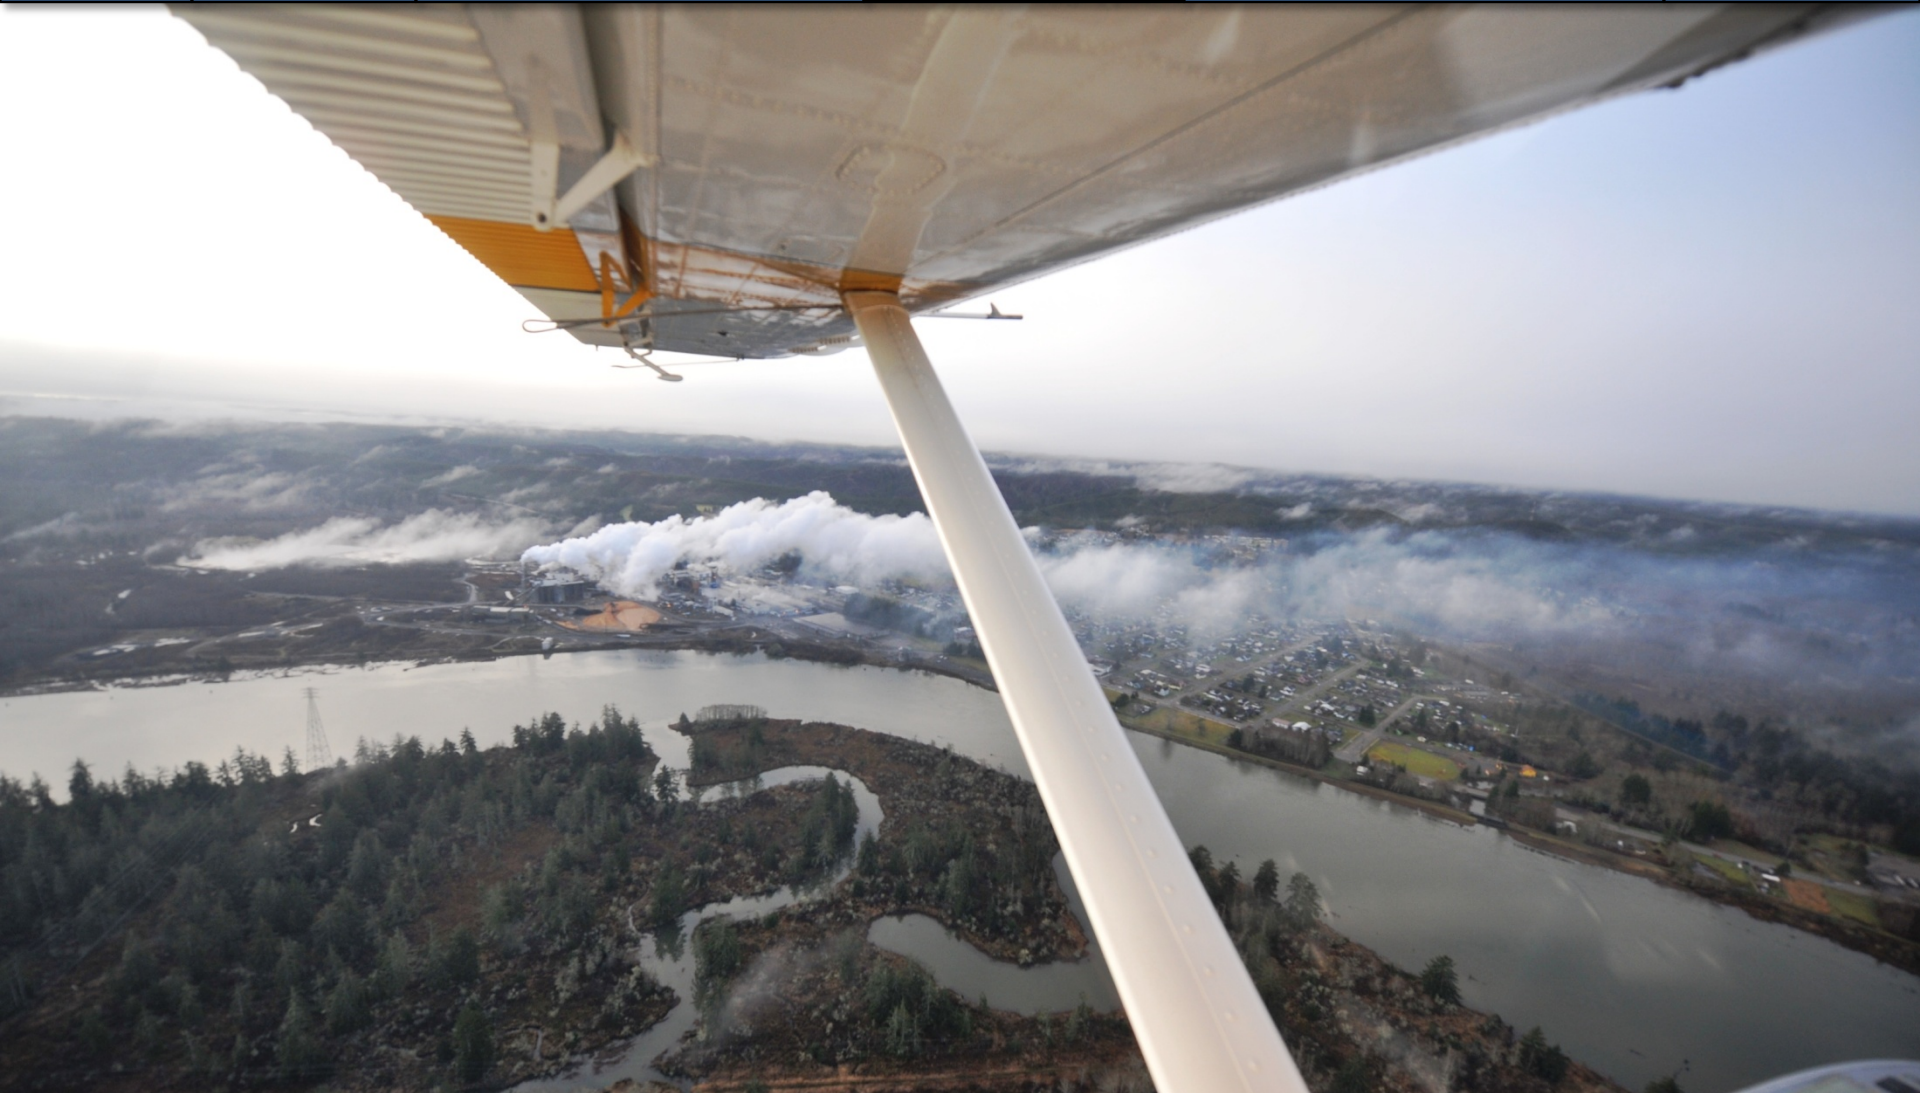
*Industrial complex next to Chehalis River with billowing emissions traveling at low altitude.  
Location: Cosmopolis, Aberdeen (Gray Harbor) 9:25 AM.*

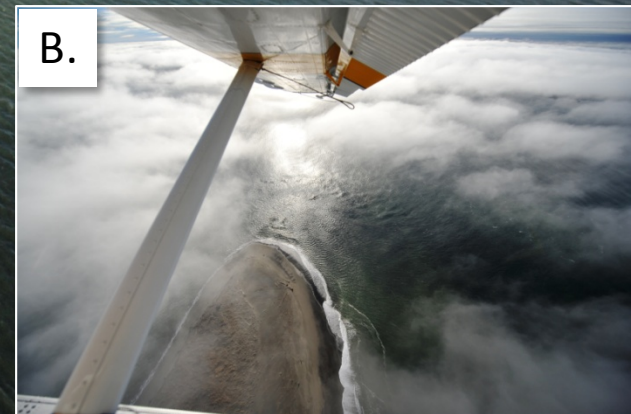
A. Offshore wind pushing sediment rich Chehalis River plume into the ocean below. B. Low lying clouds.  
Location: Off Damon Point (Grays Harbor), 10:19 AM.

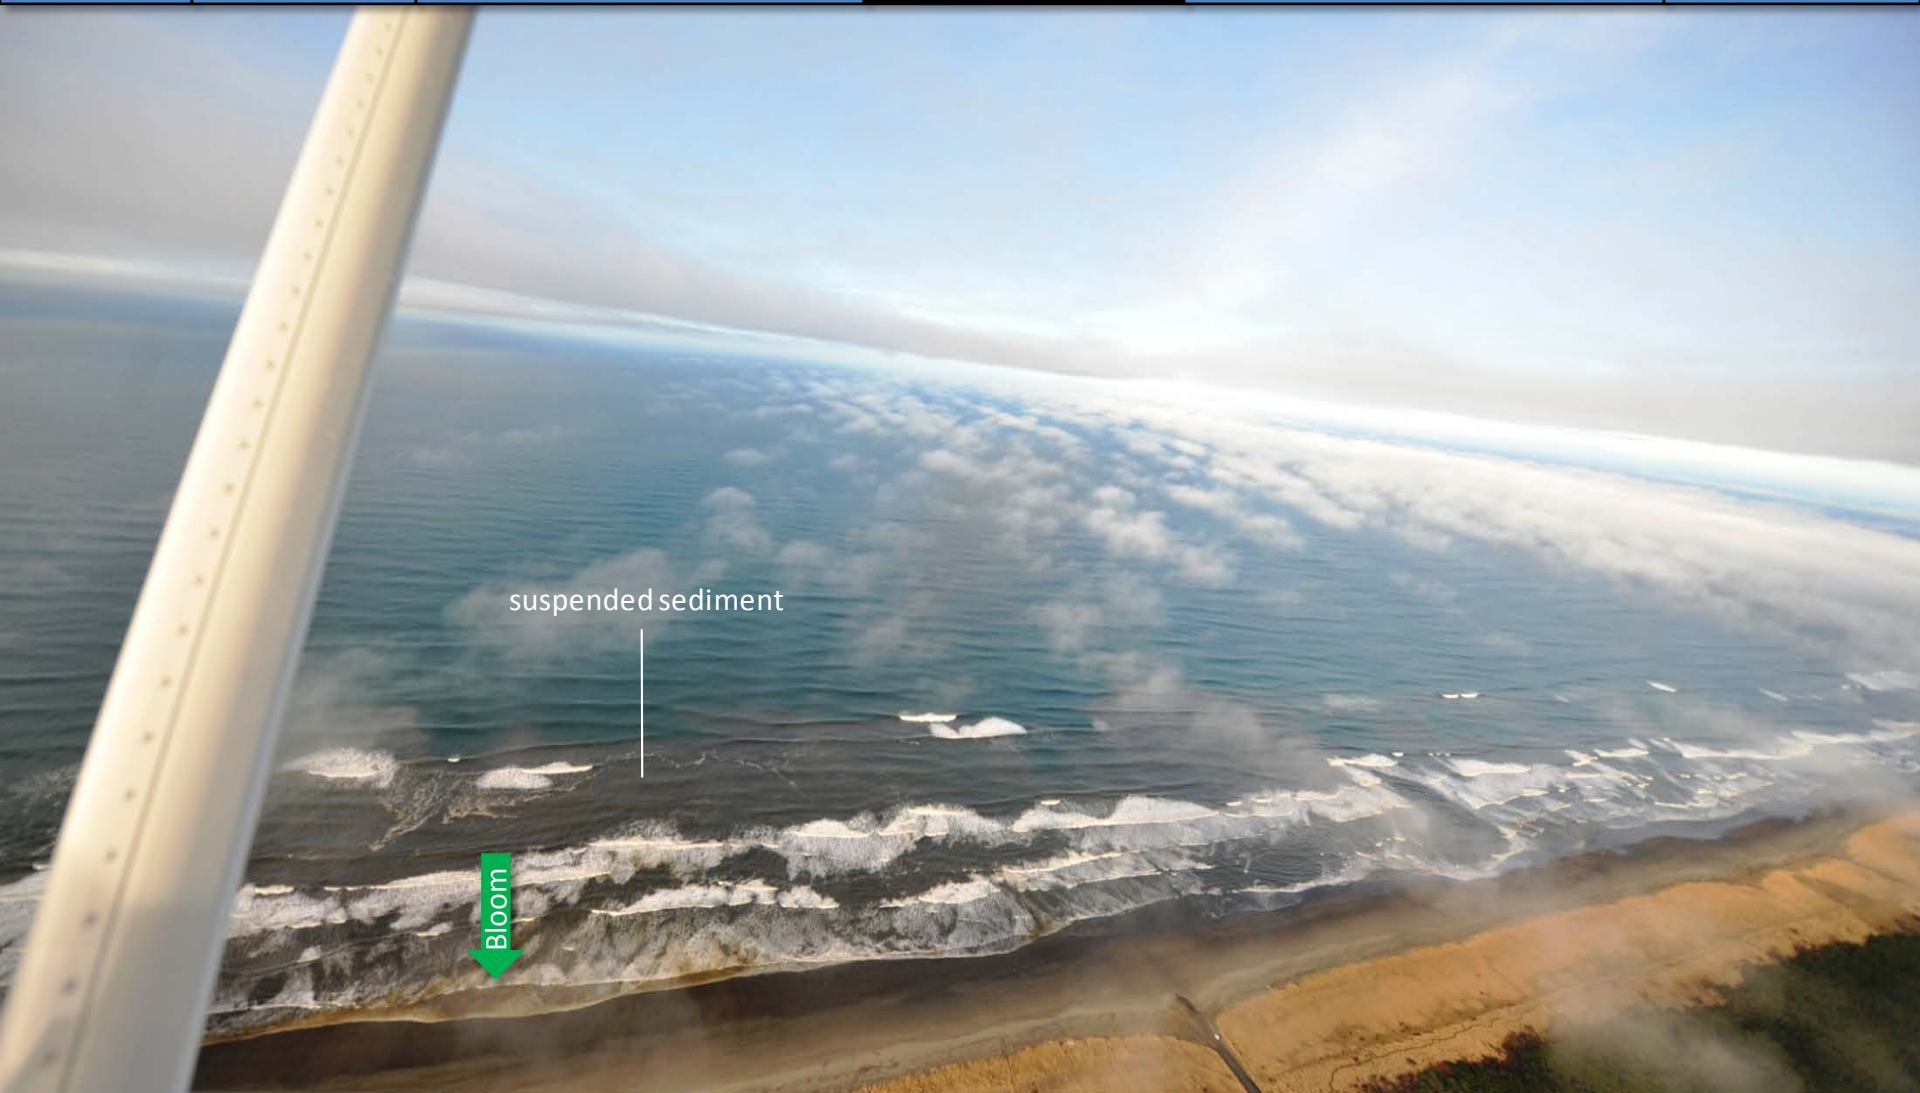
*Diatom bloom in surf zone, suspended sediment from waves and low lying clouds.*  
Location: Off Twin Harbor State Park, Cohasset Beach (Coast), 10:25 AM.

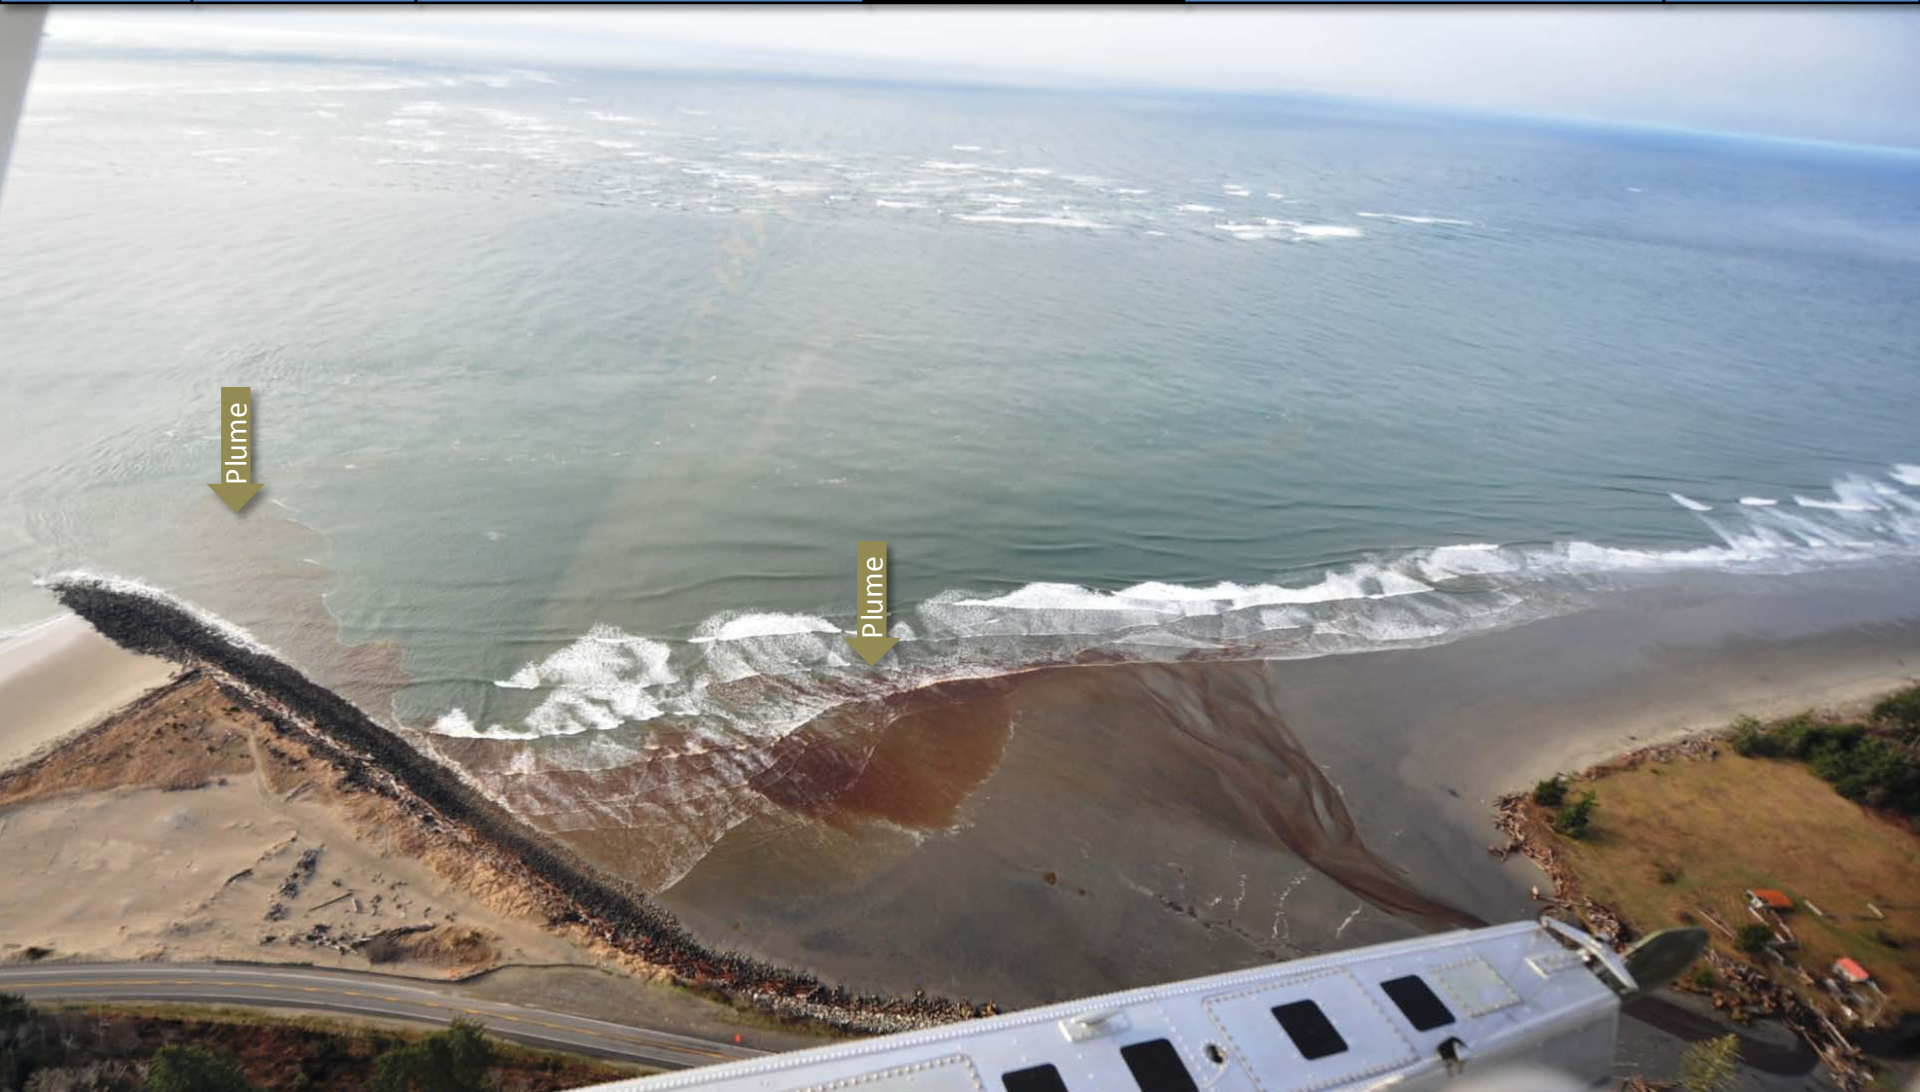
*Boggy water entering from Drainage Ditch number 1 into Willapa Bay.*  
Location: Entrance to Willapa Bay (Willapa Bay), 10:32 AM.

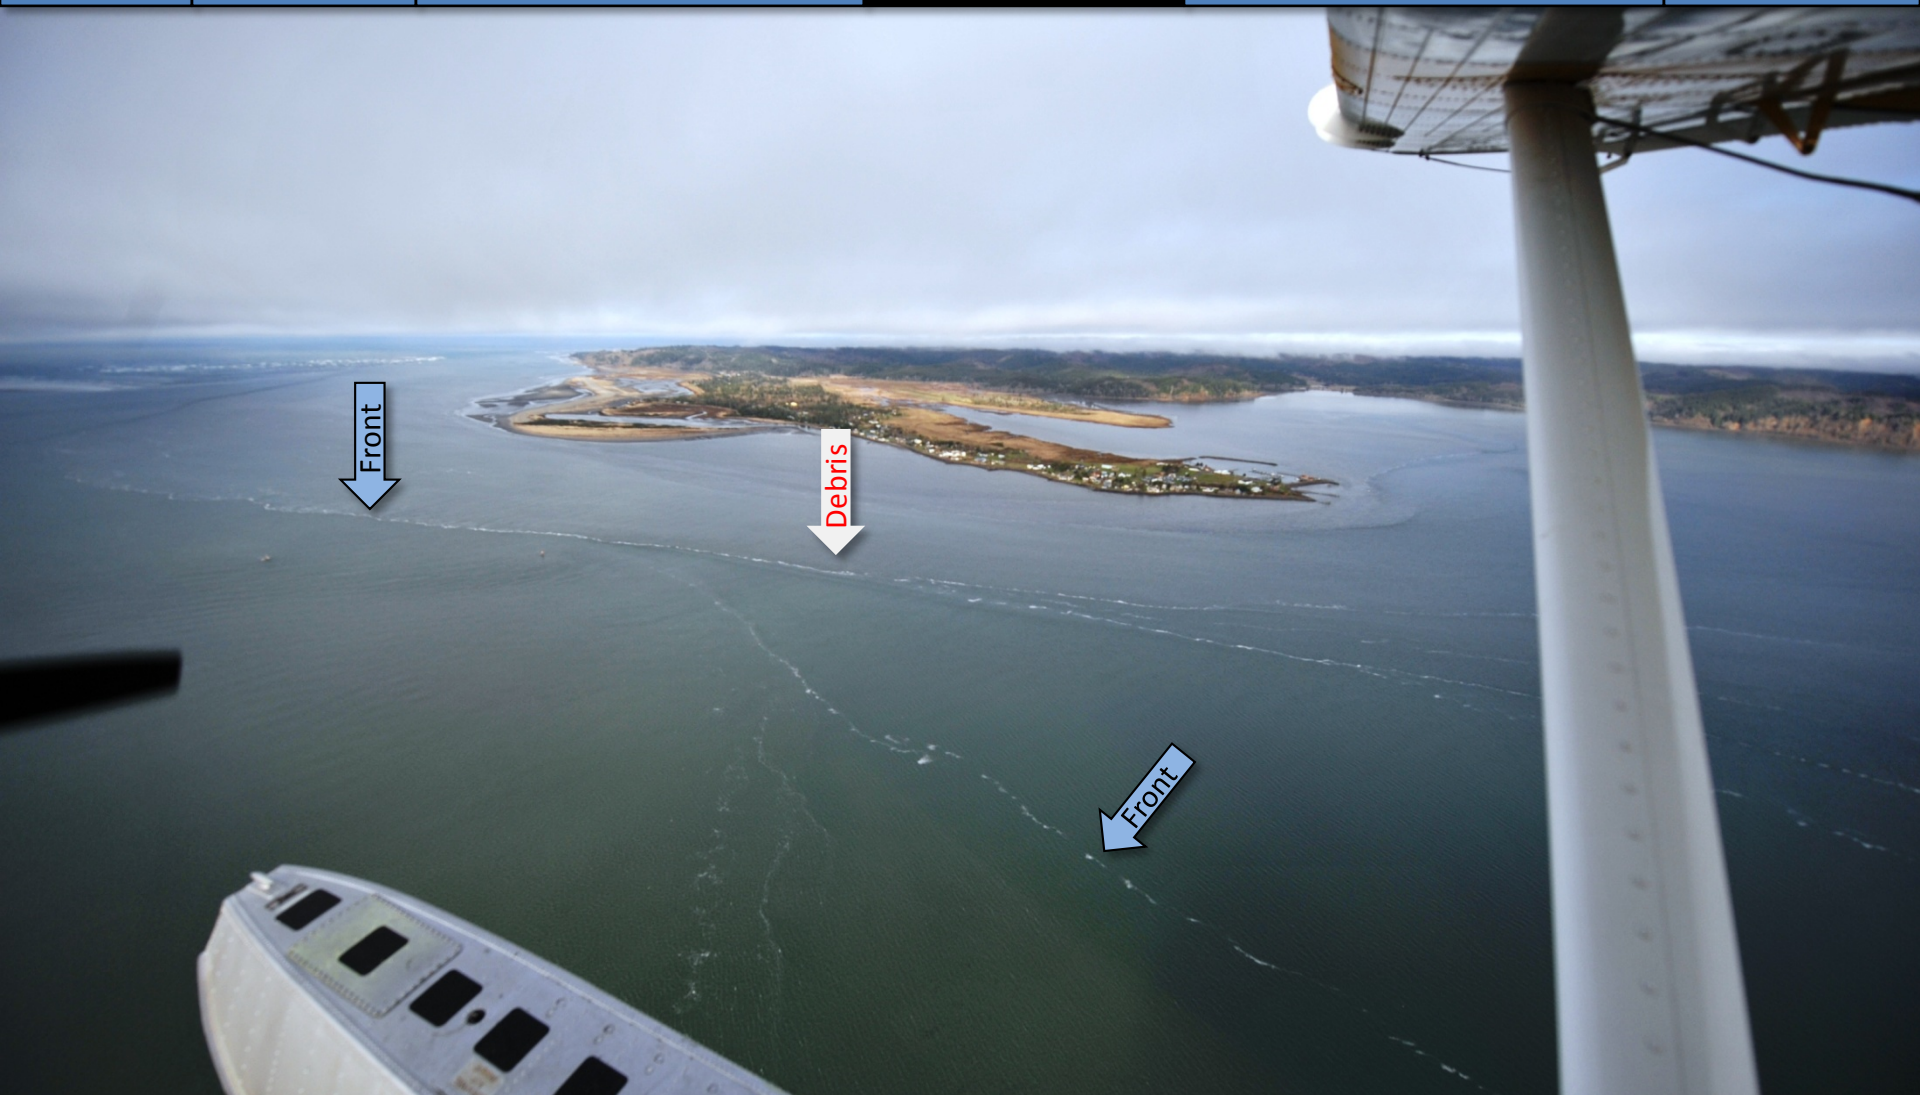
*Numerous large fronts lined by organic debris and foam show surface water flow during ebbing tide.*  
Location: Off Kindred Island (Willapa Bay), 11:00 AM.

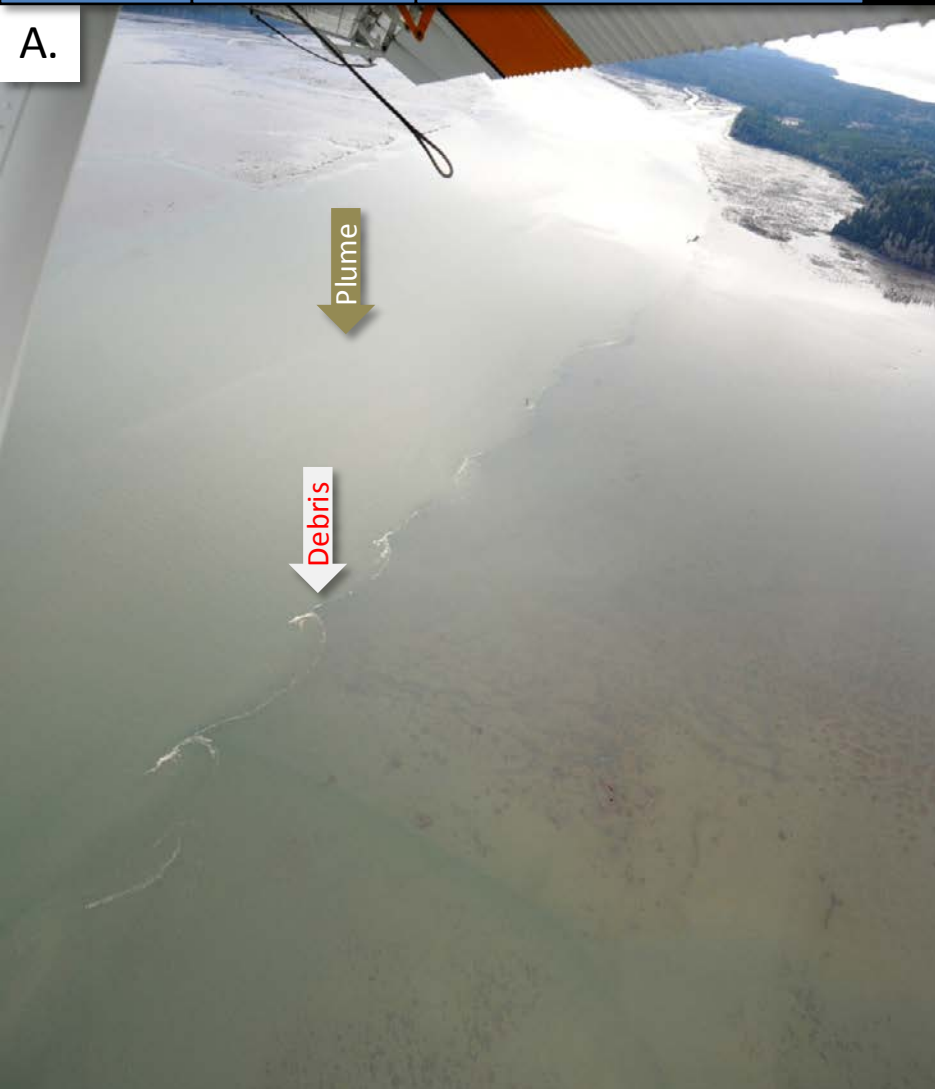
*Regular convection cells at the transition to deeper water as ebbing water moves into channels.*  
Location: A. Off Diamond Point on Long Island, B. Stanley Channel (Willapa Bay), 12:00 PM.

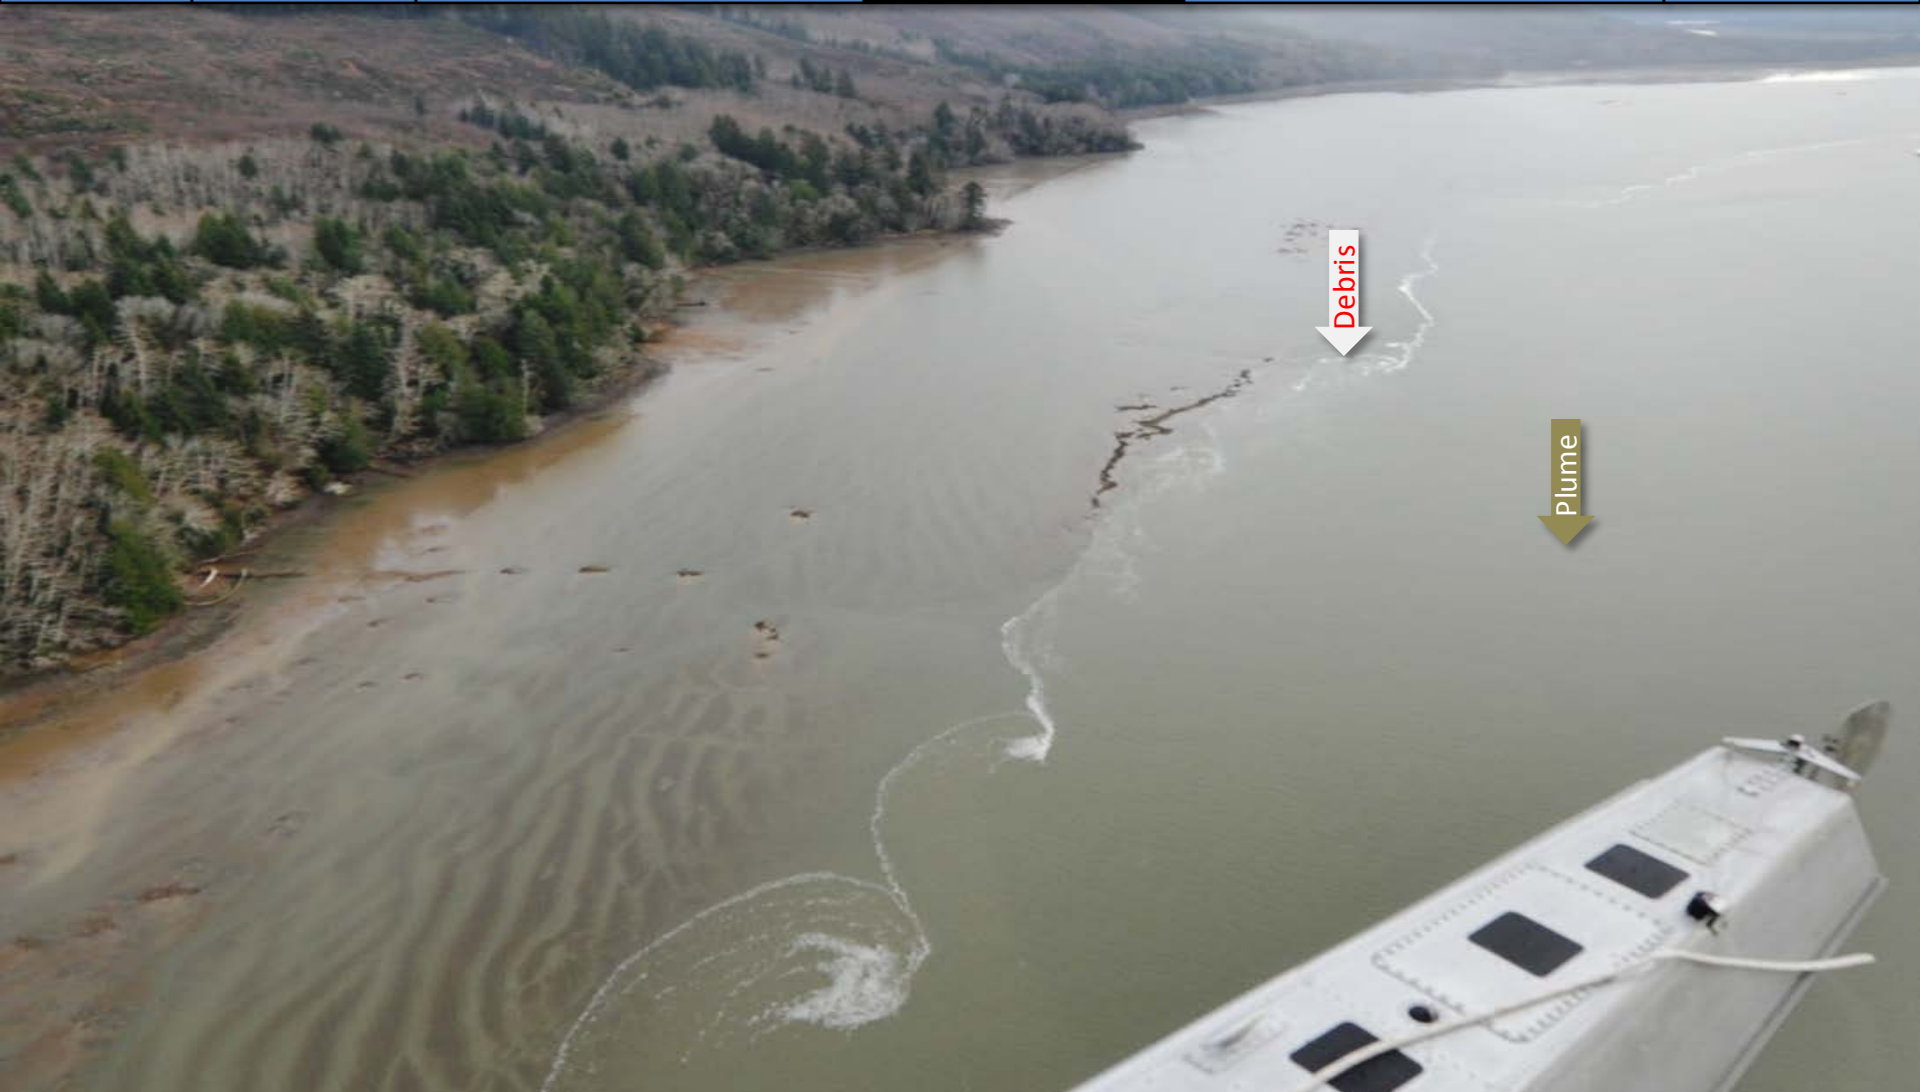
*Surface water of different origins (South and North Bay) meeting at the entrance to Grays Harbor.*  
Location: Off Sunshine Point, Naselle River (Willapa Bay), 12:24 PM.

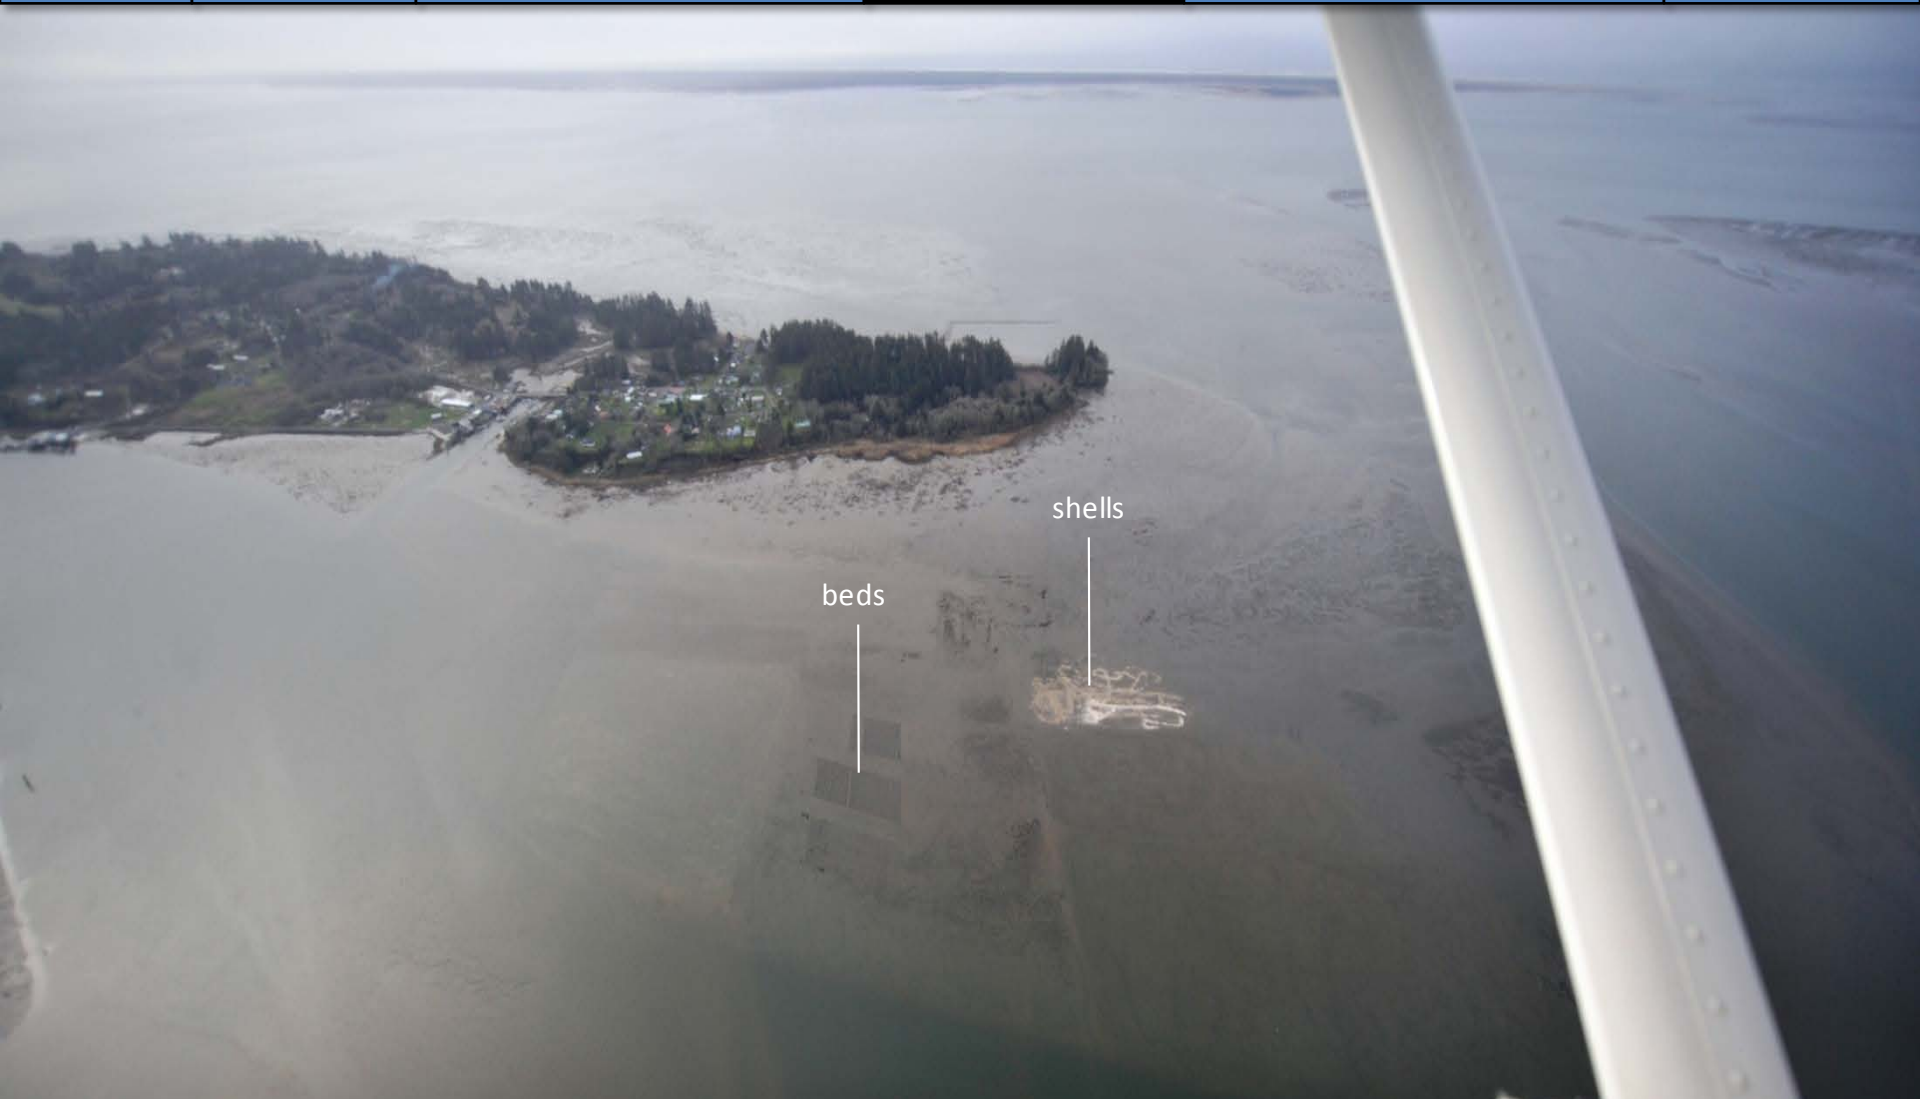
*Crushed shells distributed on mud flats highlight the large-scale underwater management of the bay.*

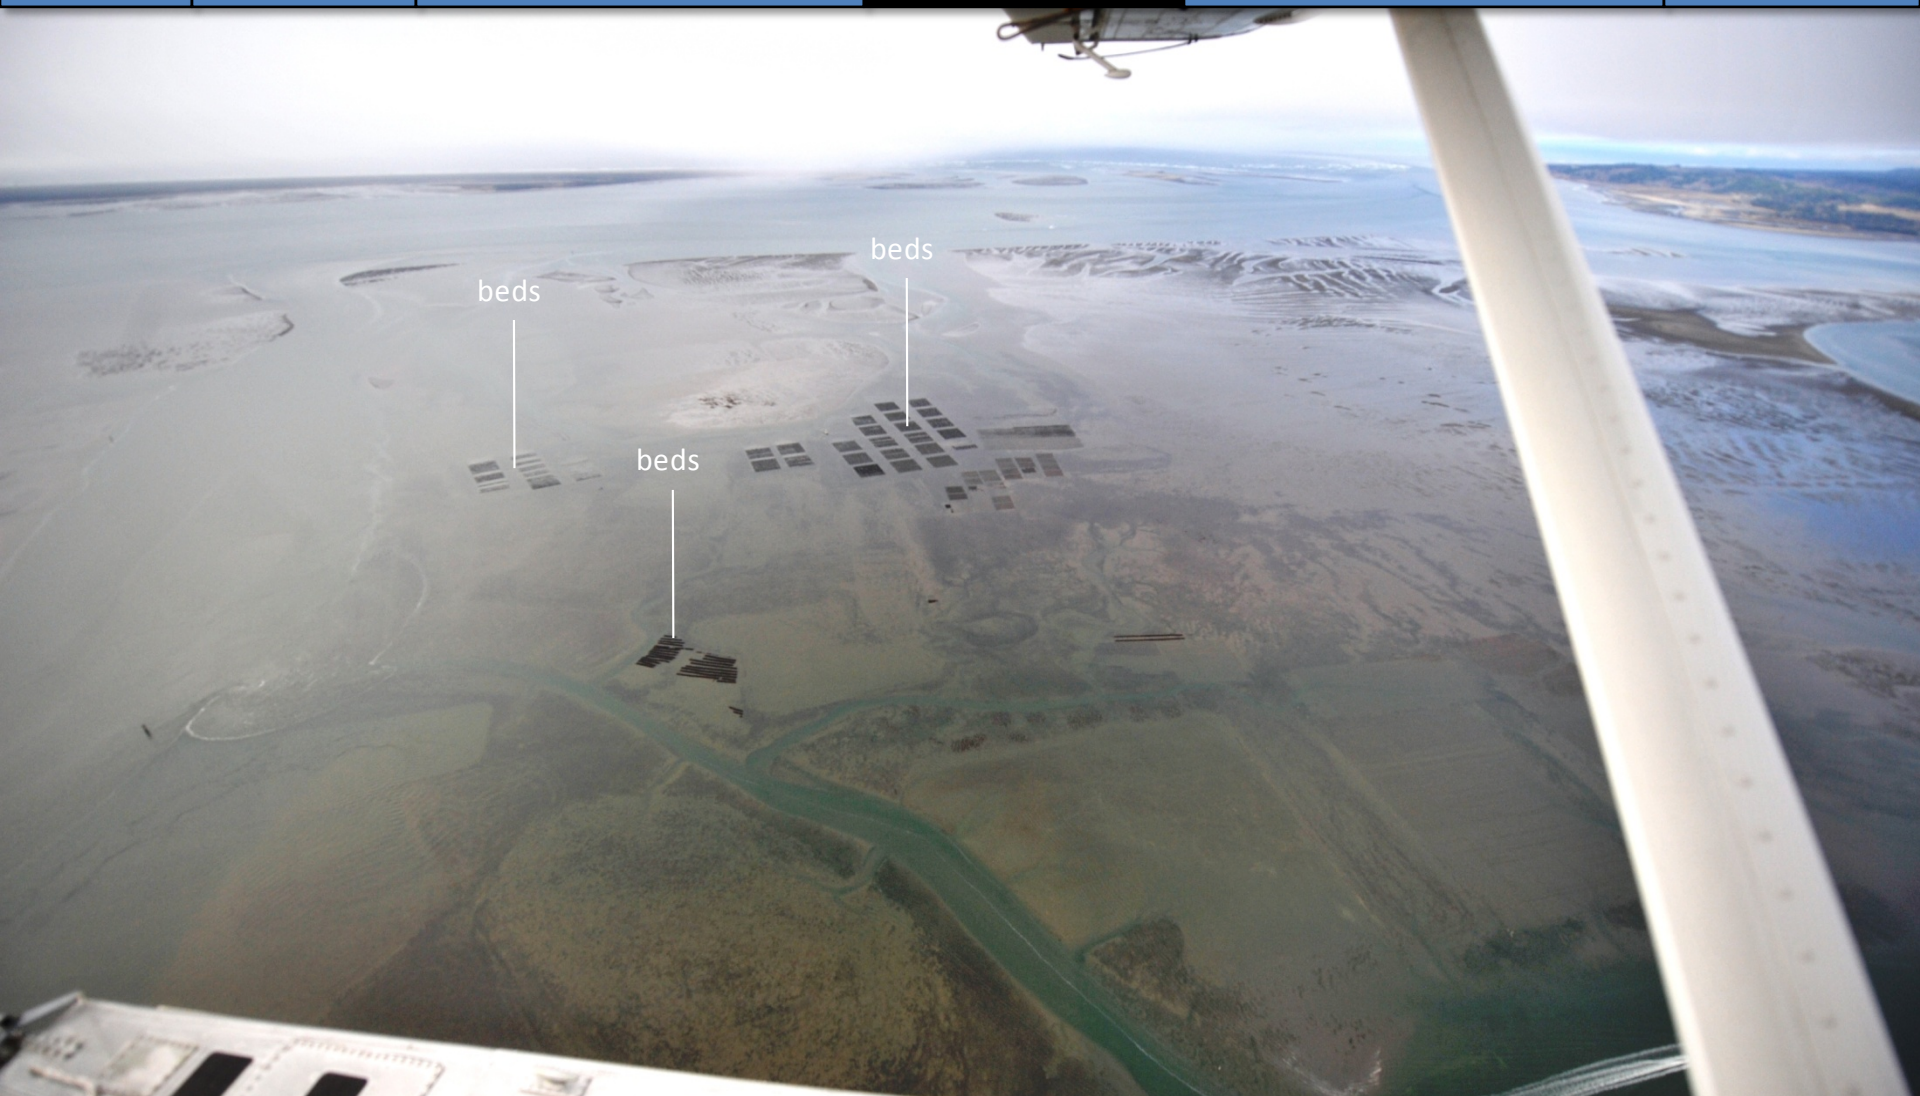
*Patterns on mud flats, resembling fields, highlight the large-scale underwater management of the bay.*

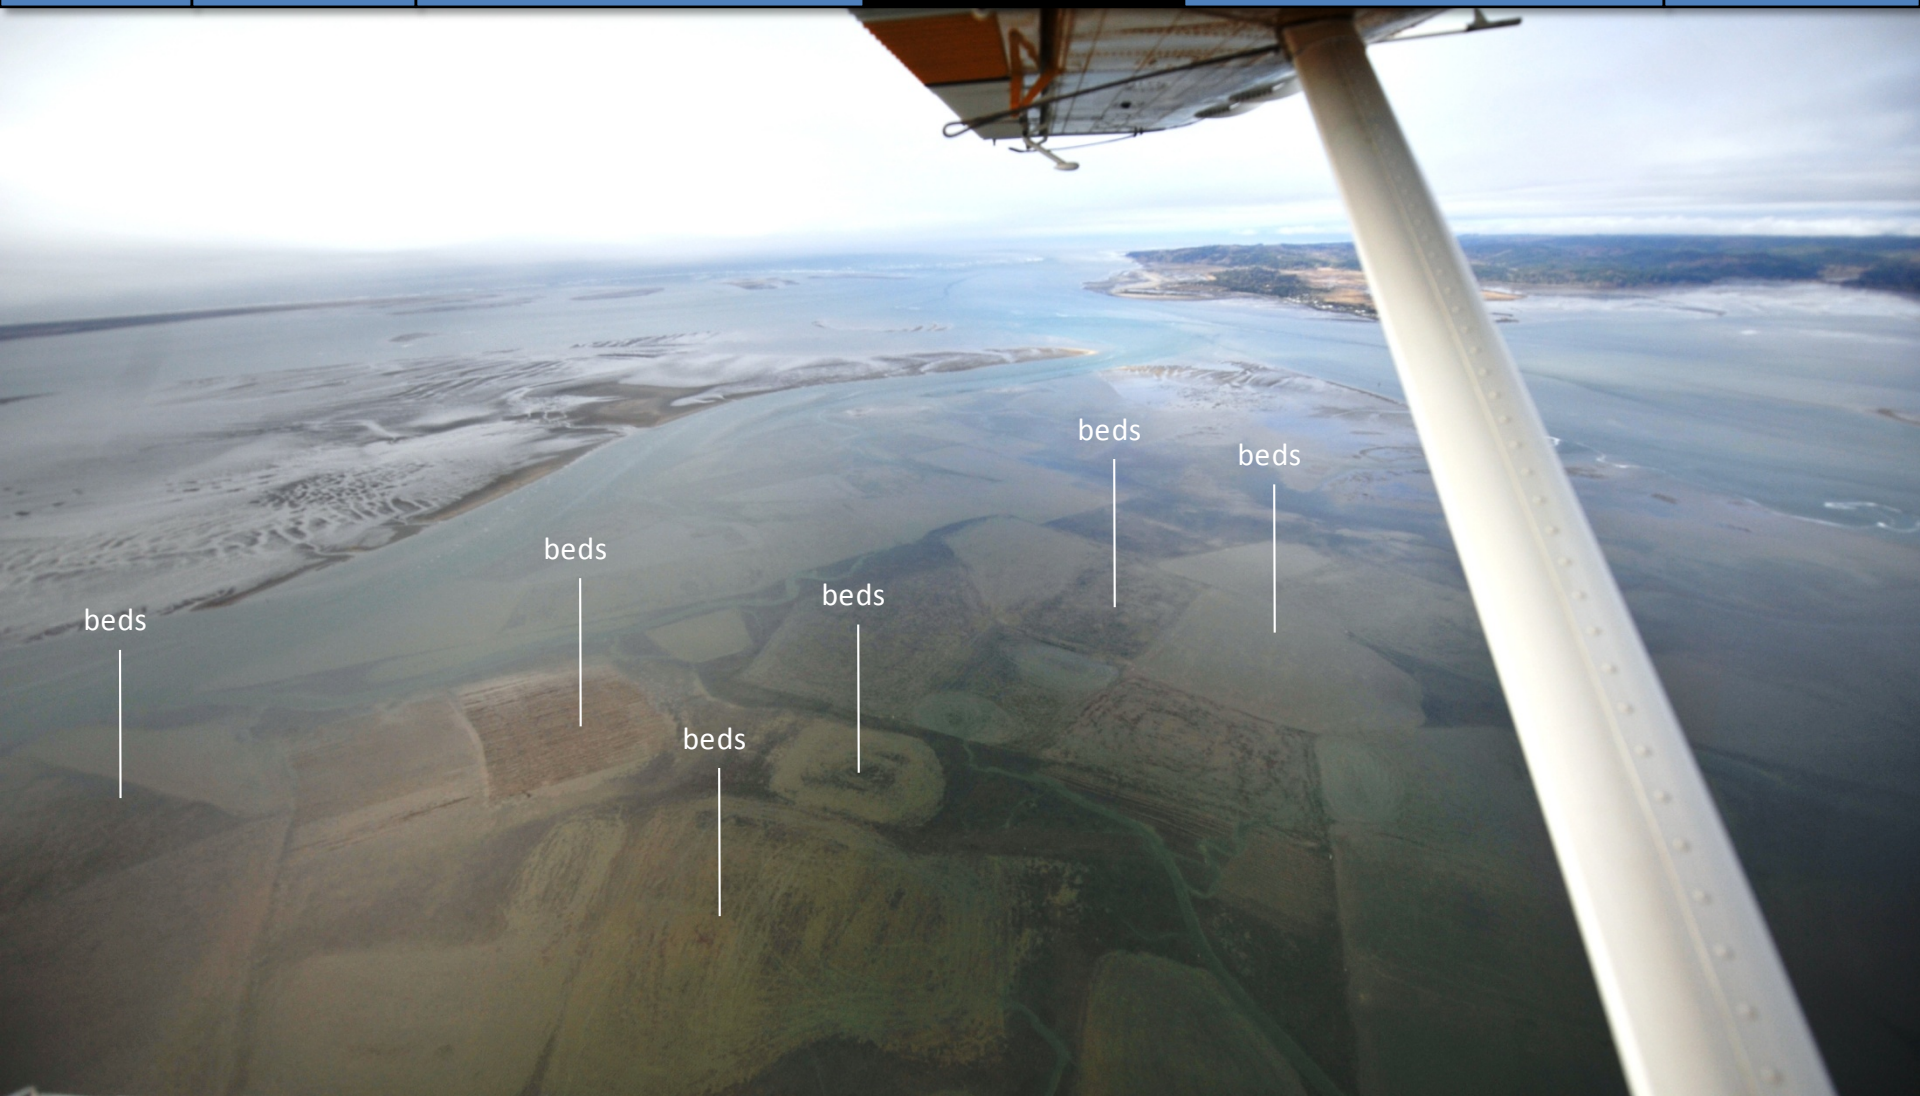
*Patterns on mud flats, resembling fields, highlight the large-scale underwater management of the bay.*

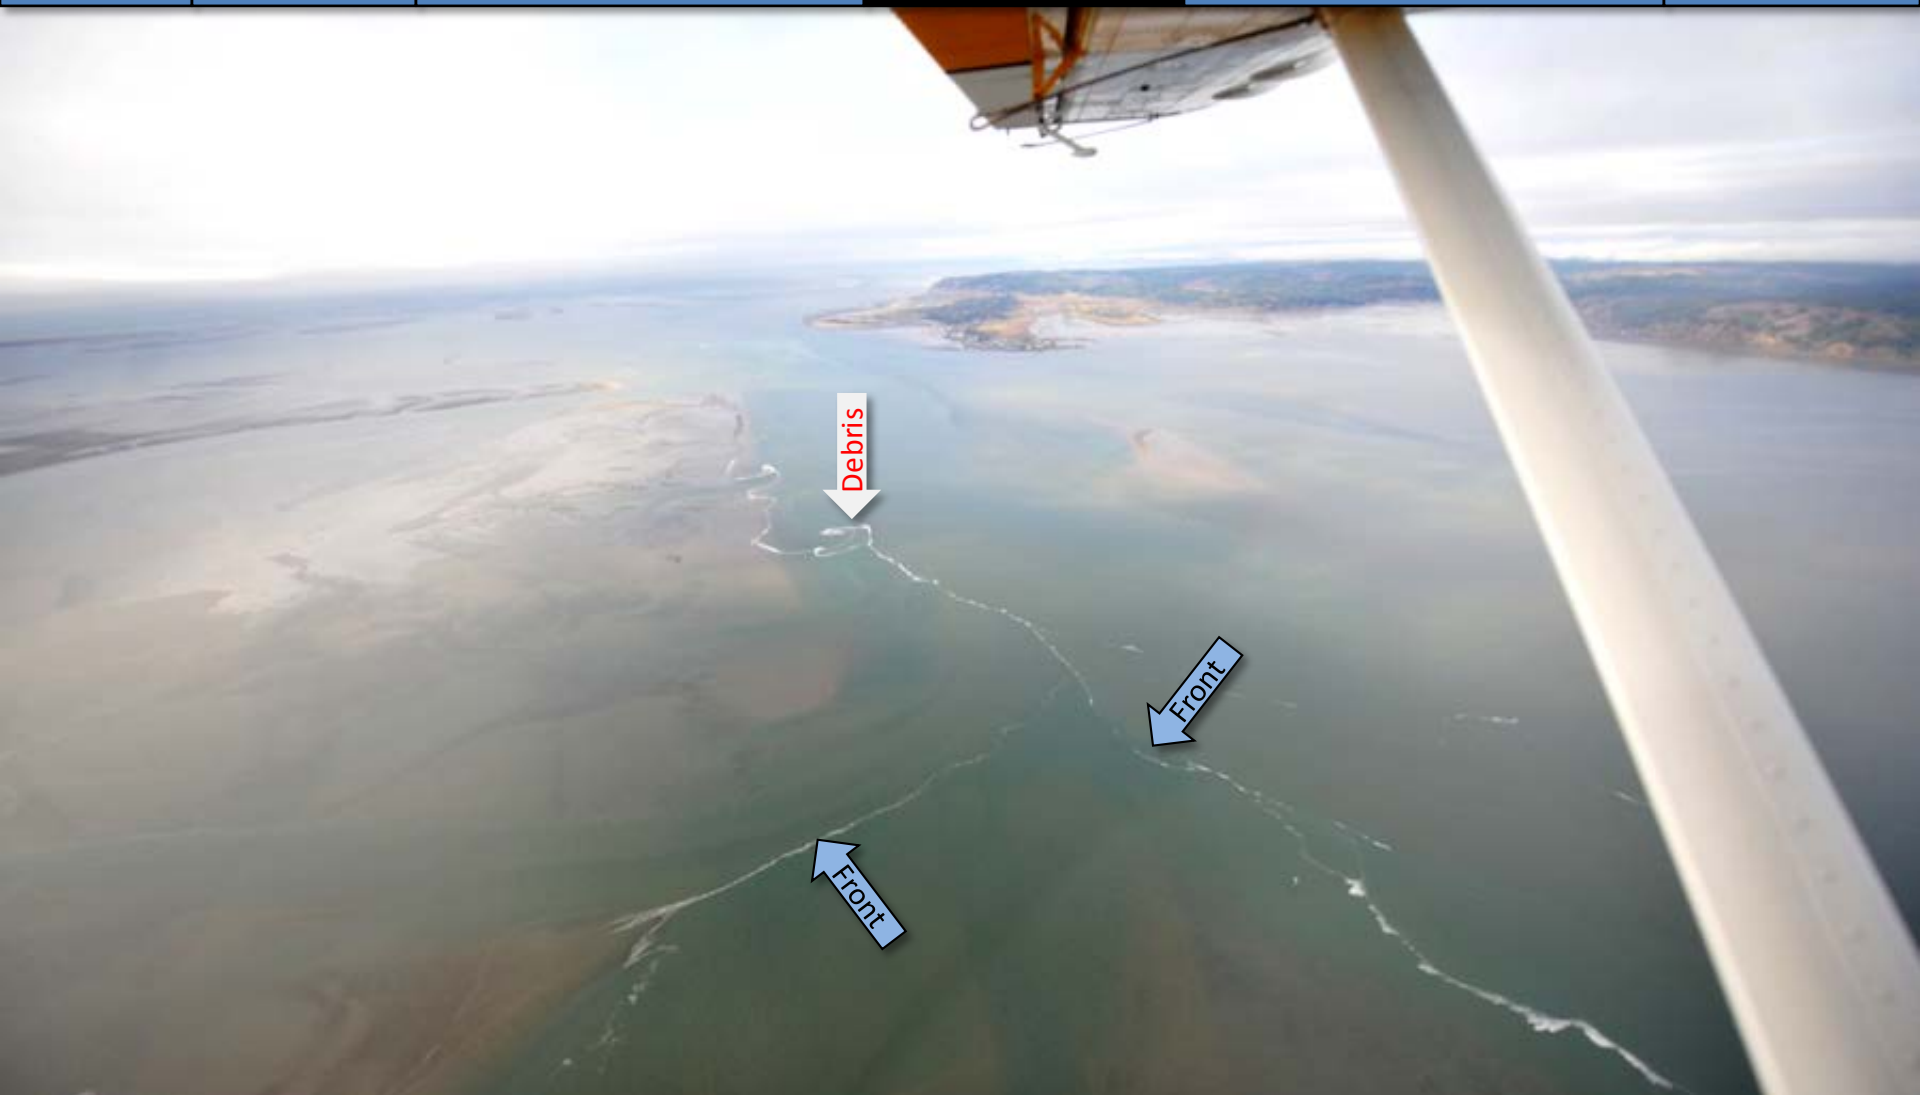
*Long foamy debris lines form along convergences of surface water leaving the bay.*  
Location: Russell Channel (Willapa Bay), 12:51 PM.
