# Eyes Over Puget Sound

## Surface Conditions Report

January 28, 2015

*Up-to-date observations of visible water quality conditions in Puget Sound and the Strait of Juan de Fuca*

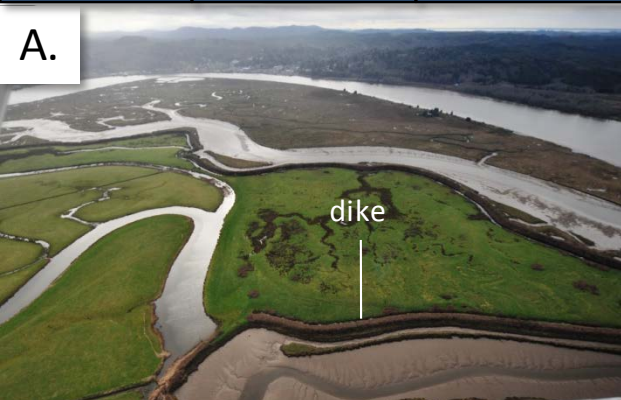
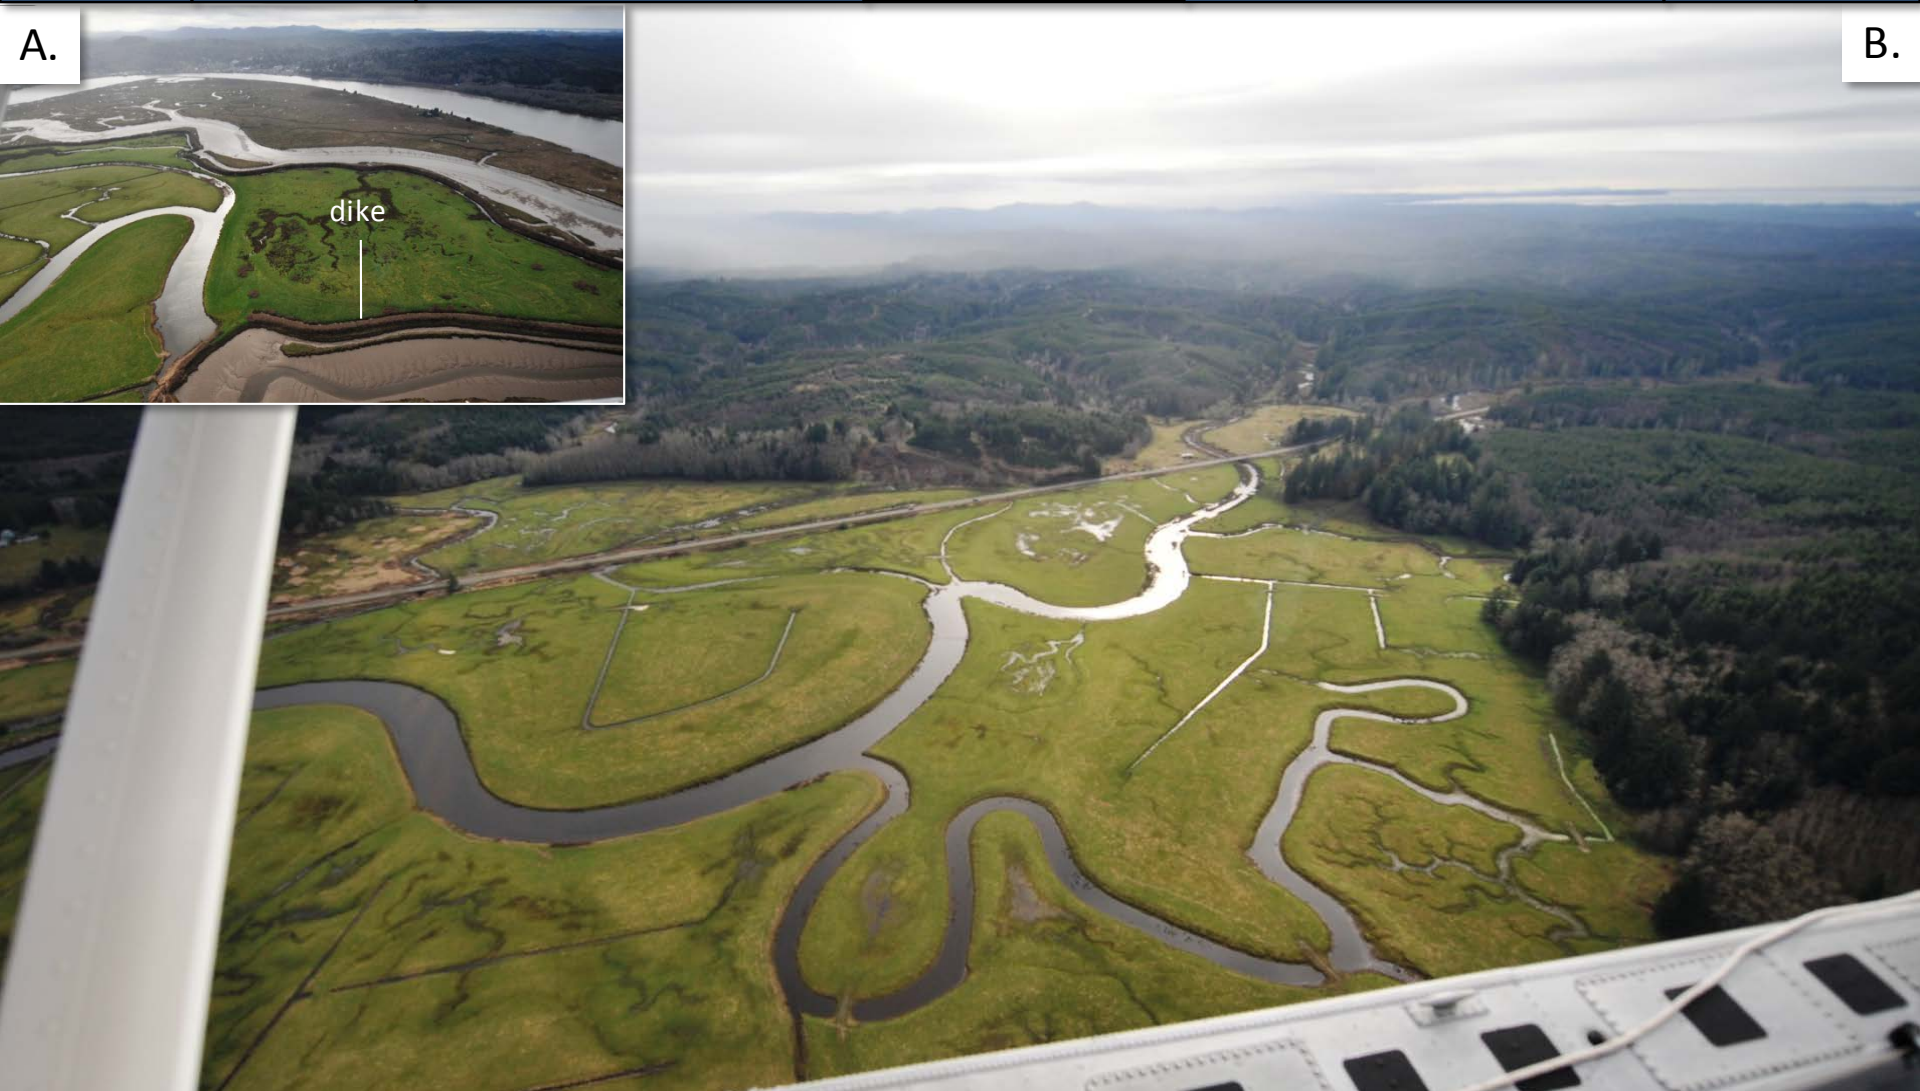
*Tidally regulated regions at the Willapa Bay estuary garner productive grasslands.*  
Location: A. Mailboat Slough, B. Stuart Slough (Willapa Bay), 12:53 PM.

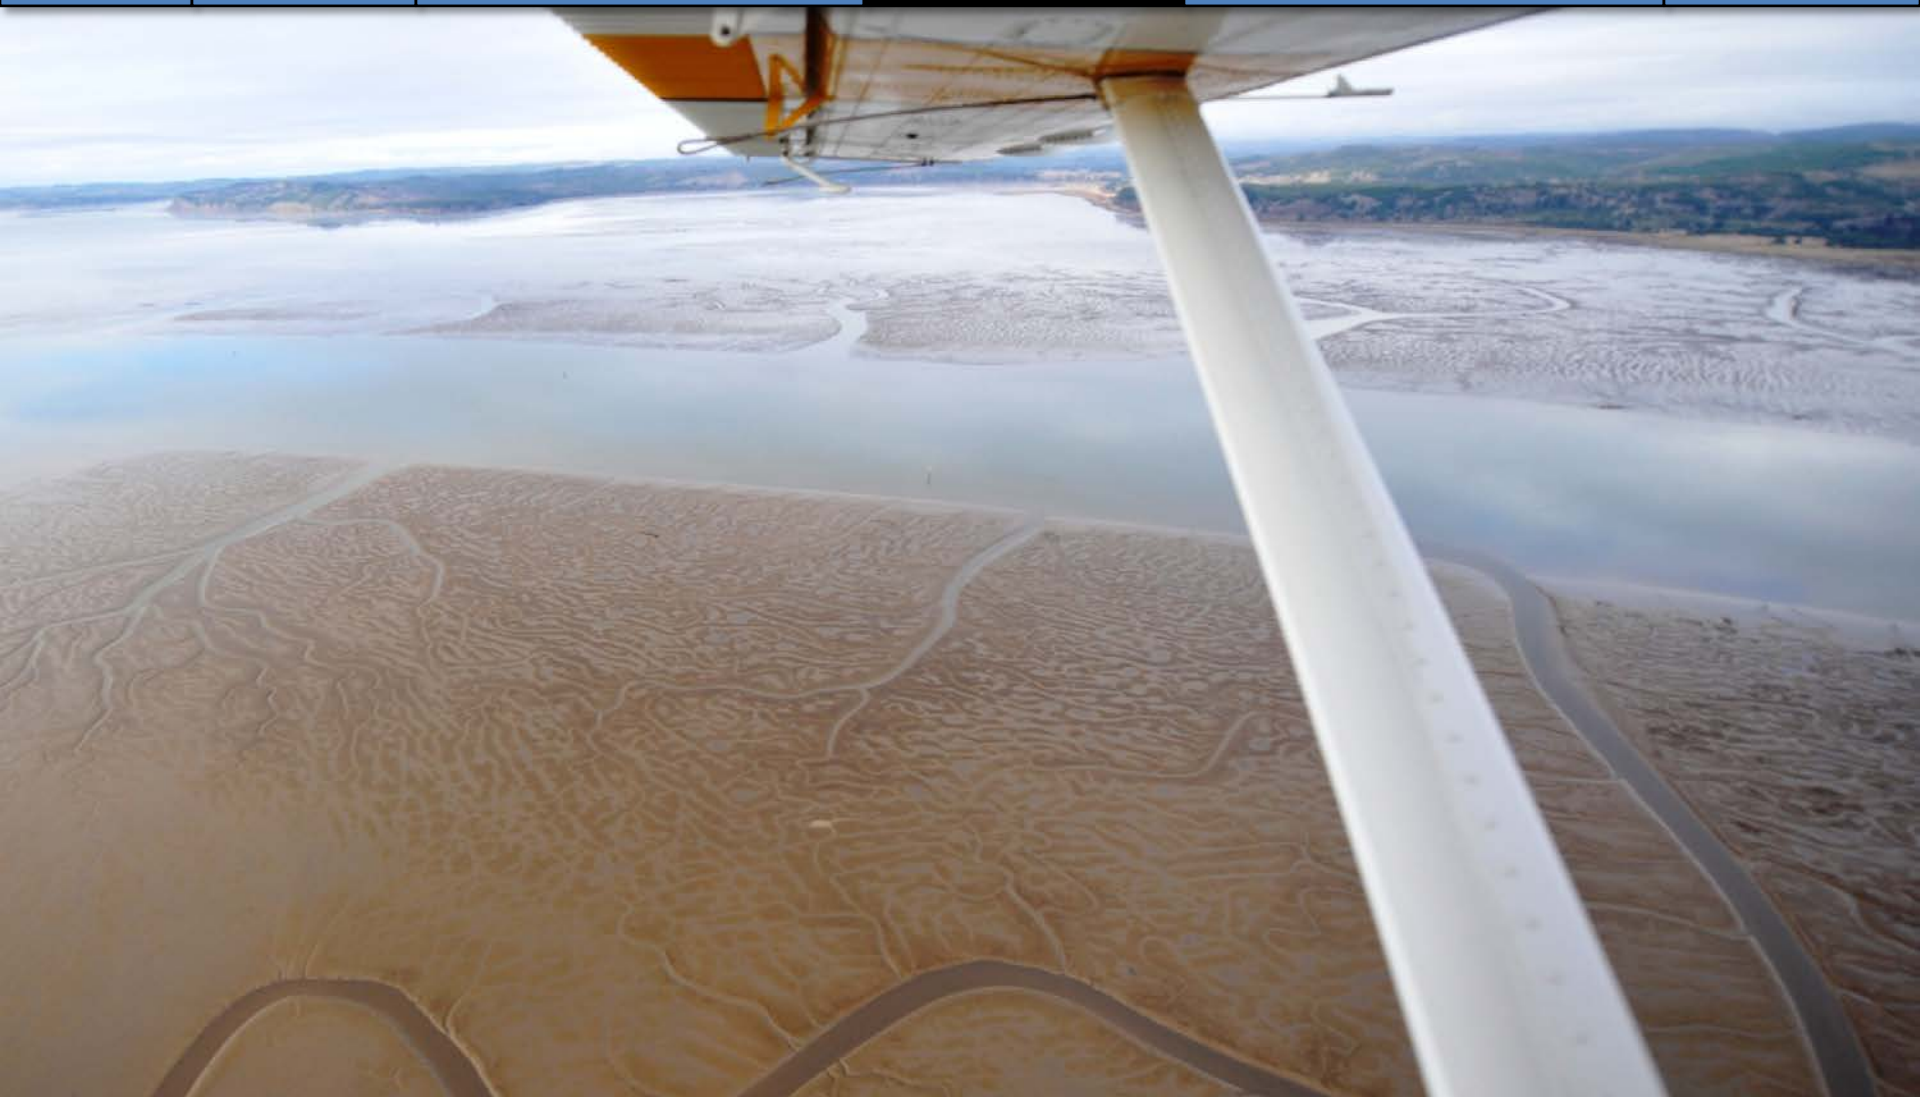
*The artistic patterns of mud flats and tidal gullies.*  
Location: Across Kellogg Slough (Willapa Bay), 12:53 PM.

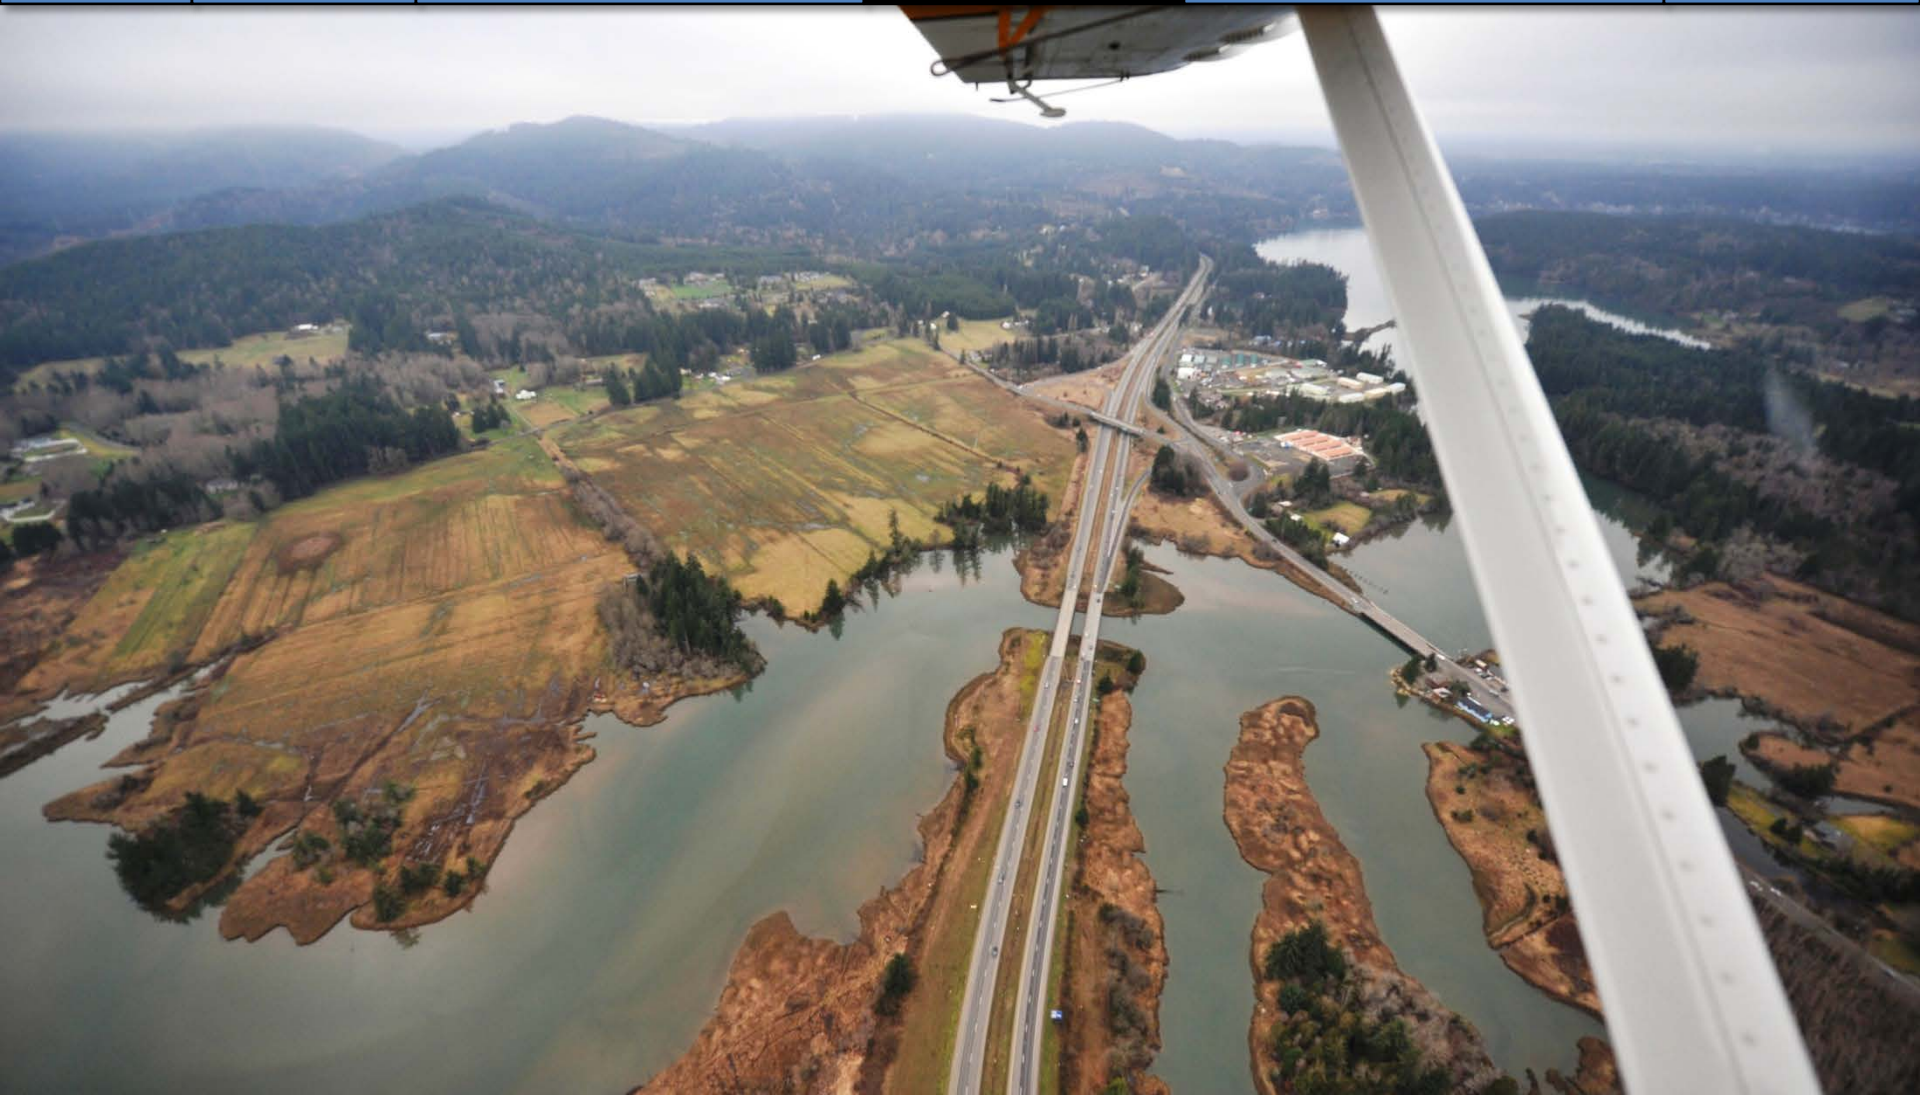
*Interstate crossing southern reaches of Eld Inlet during high tide.*

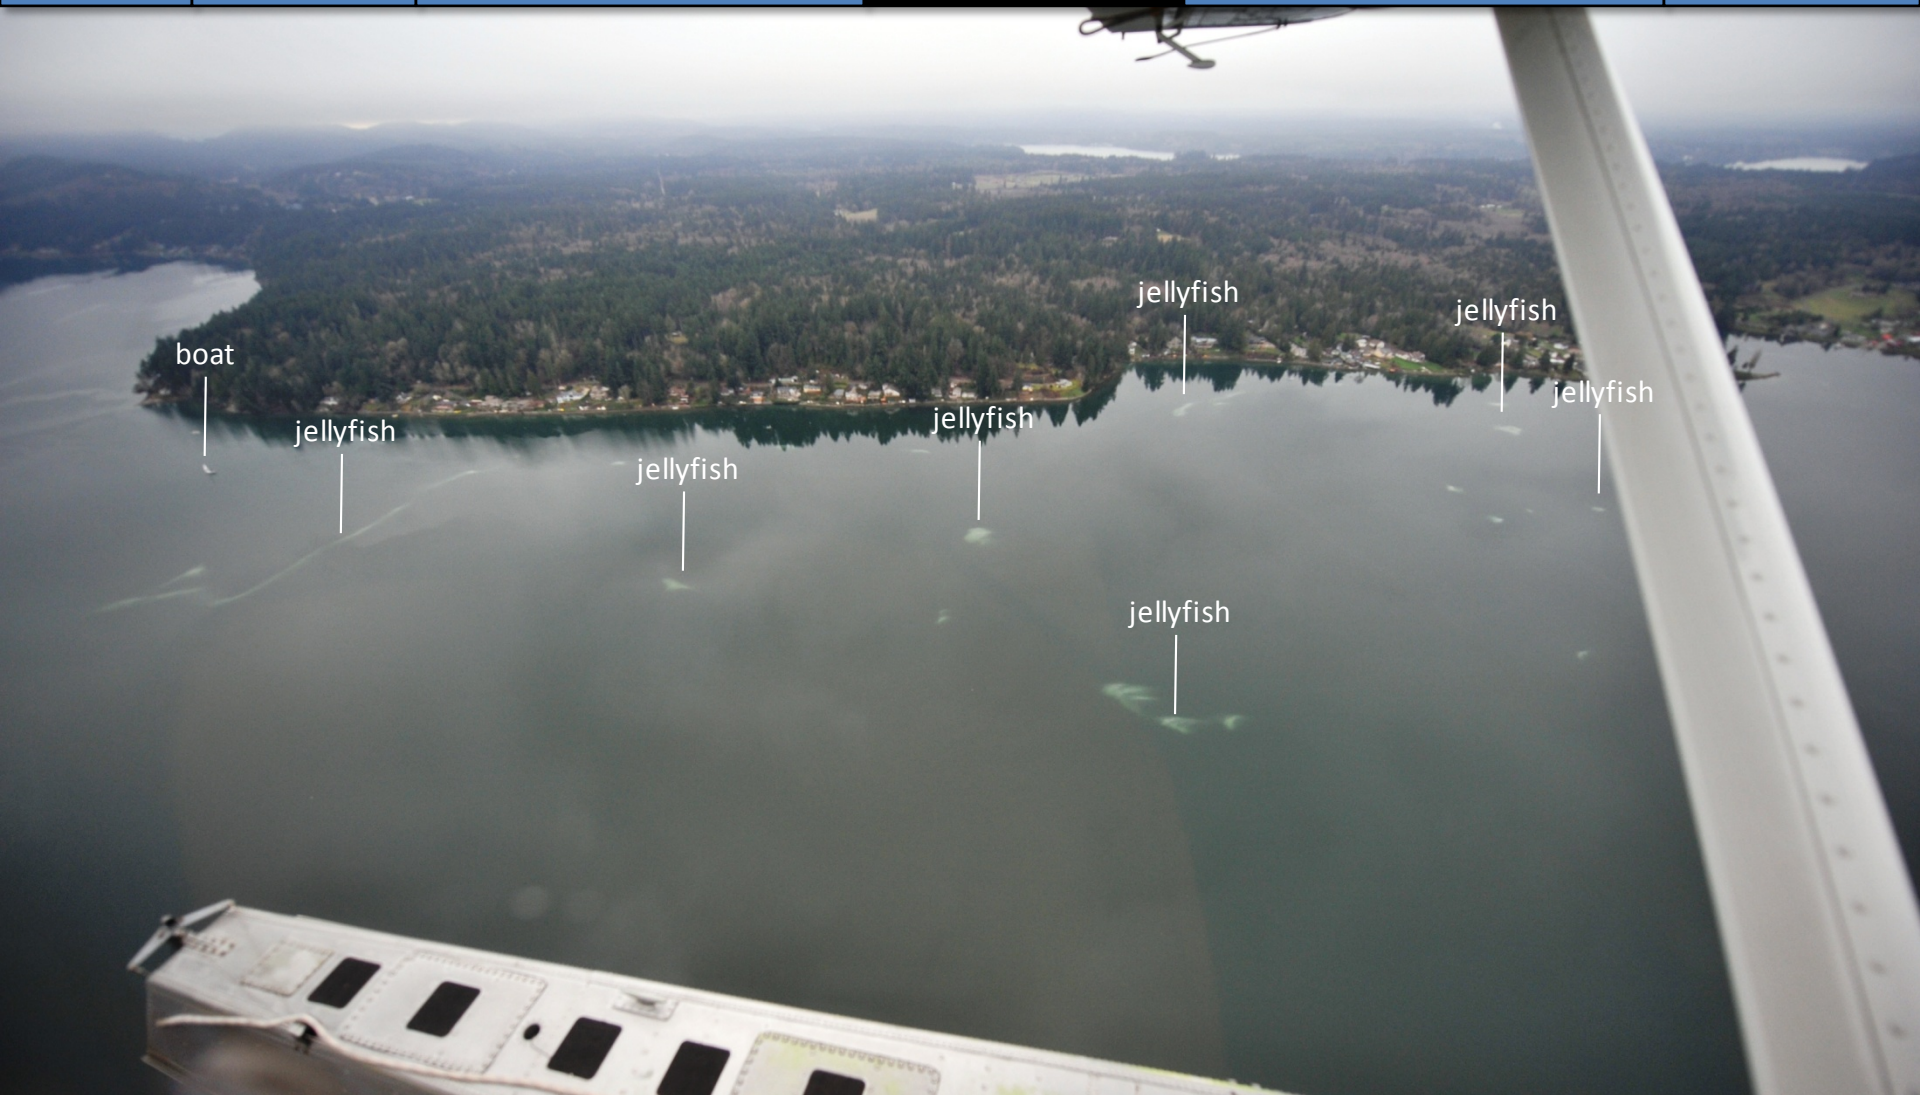
*Numerous jellyfish patches in otherwise clear bluegreen water.*  
Location: Across Snyder Cover, Eld Inlet, (South Sound) 1:55 PM.
