Eyes Over Puget Sound

Surface Conditions Report, February 17, 2015

Up-to-date observations of visible water quality conditions in Puget Sound and the Strait of Juan de Fuca

LONG-TERM MARINE MONITORING UNIT

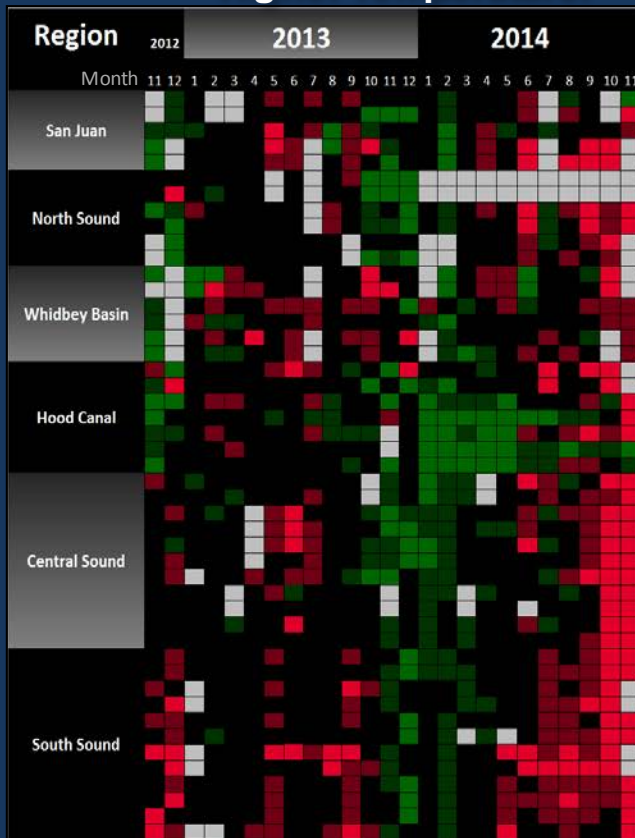
In 2014, conditions were dominated by warm water during summer and fall, associated with the NE Pacific Ocean warm surface anomaly. In October and November, temperatures were the highest on our record since 1989. In 2014, salinity was higher and later, waters south of Admiralty Reach became fresher. Oxygen was mostly lower except in Hood Canal where a high anomaly persisted into the fall.

Red boxes show that the water measured in fall 2014 is warmer than any of our measurements since 1999

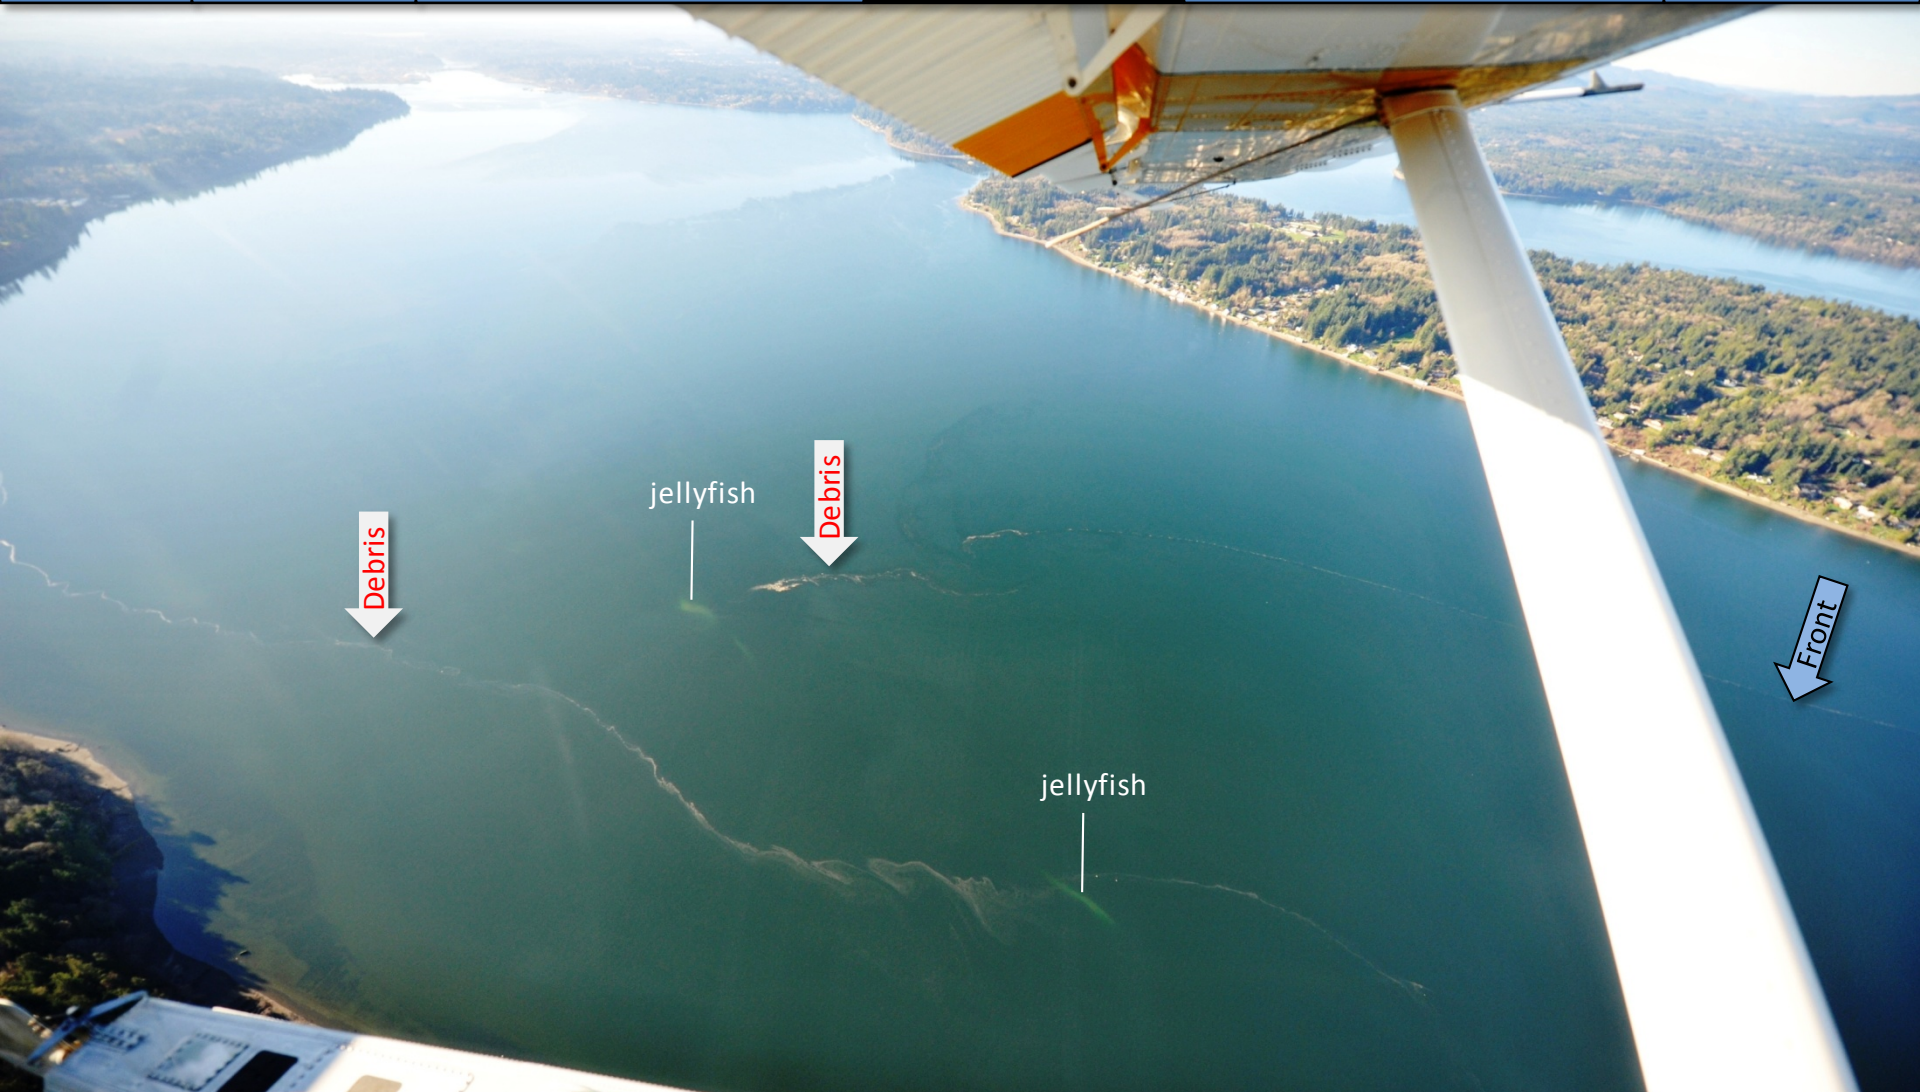
Location: Off Burfoot Park, Budd Inlet (South Sound), 9:32 AM.

Jellyfish patches and strong organic debris lines.

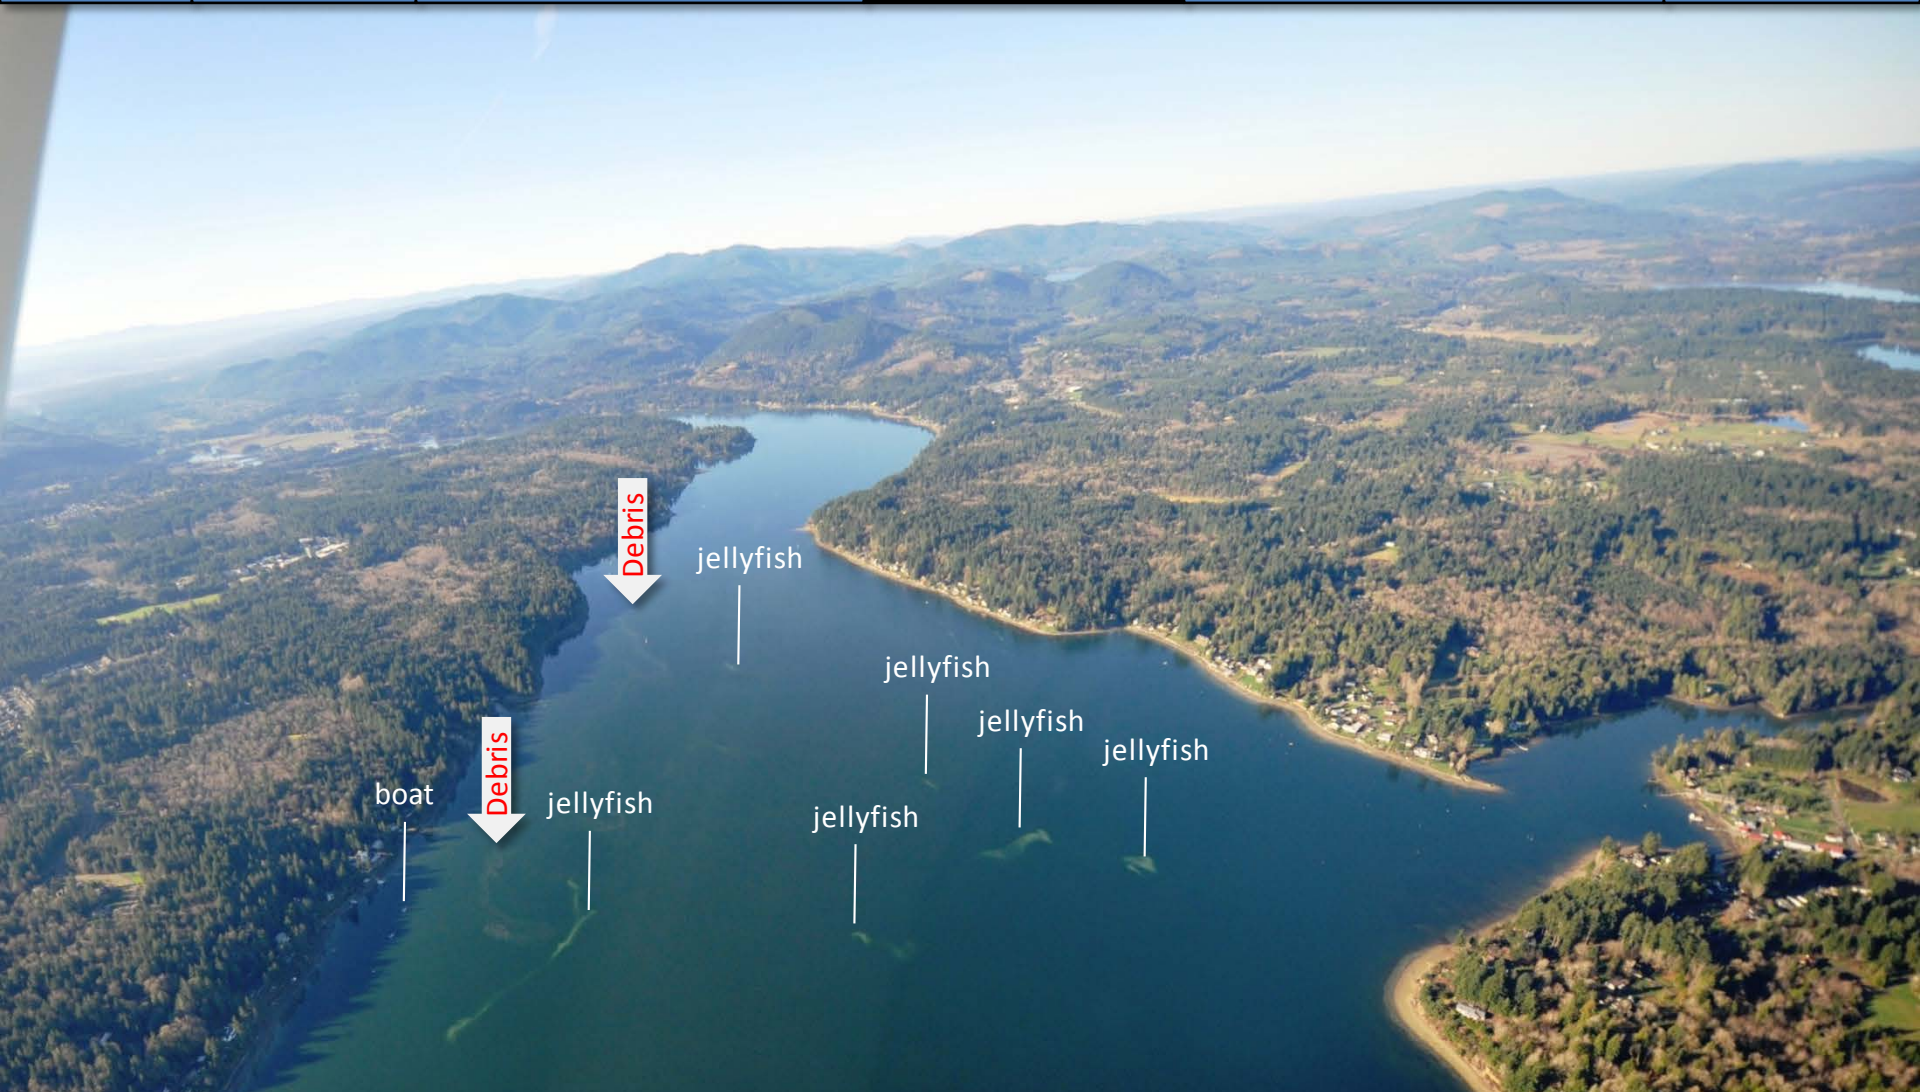
Numerous jellyfish patches lasting through the warm winter.
Location: Near Young Cove, Budd Inlet (South Sound), 9:34 AM.

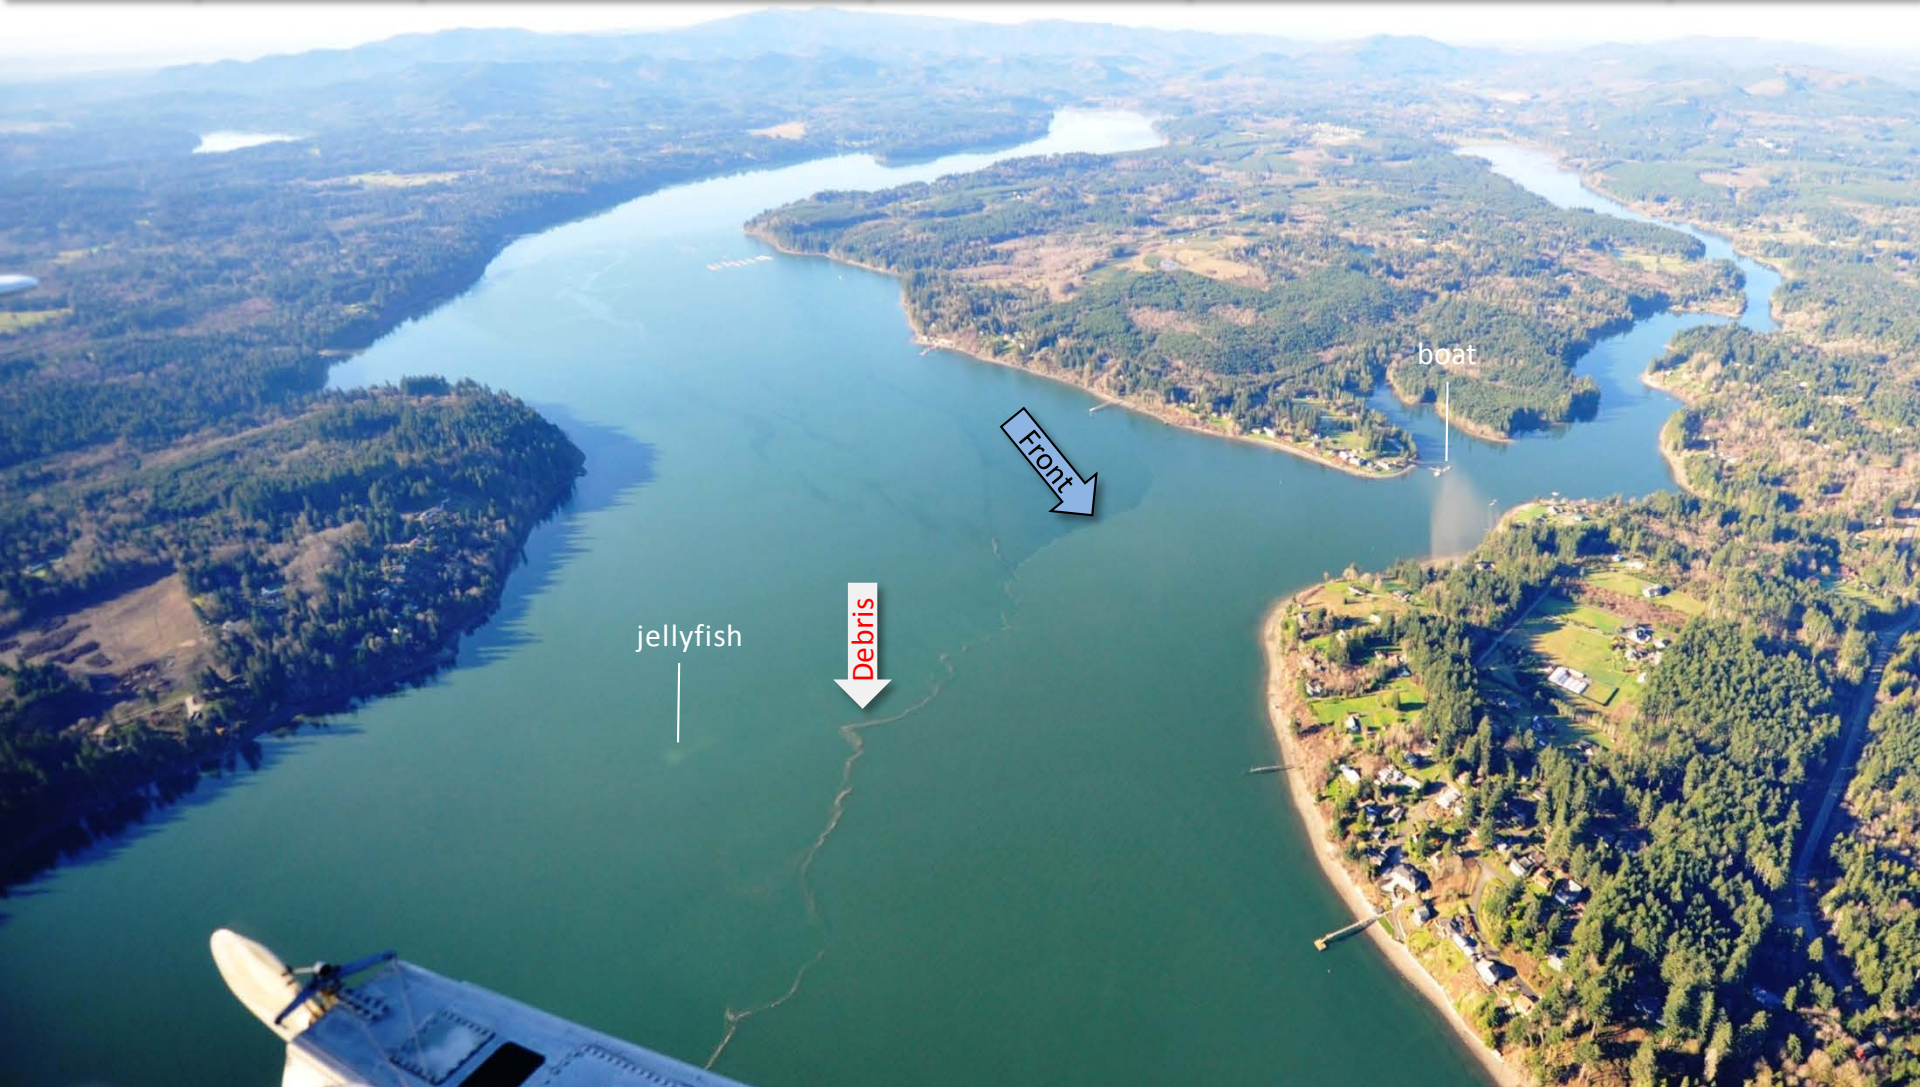
Location: Off Baron Point, Totten Inlet (South Sound), 9:51 AM.

Long organic debris line along front.

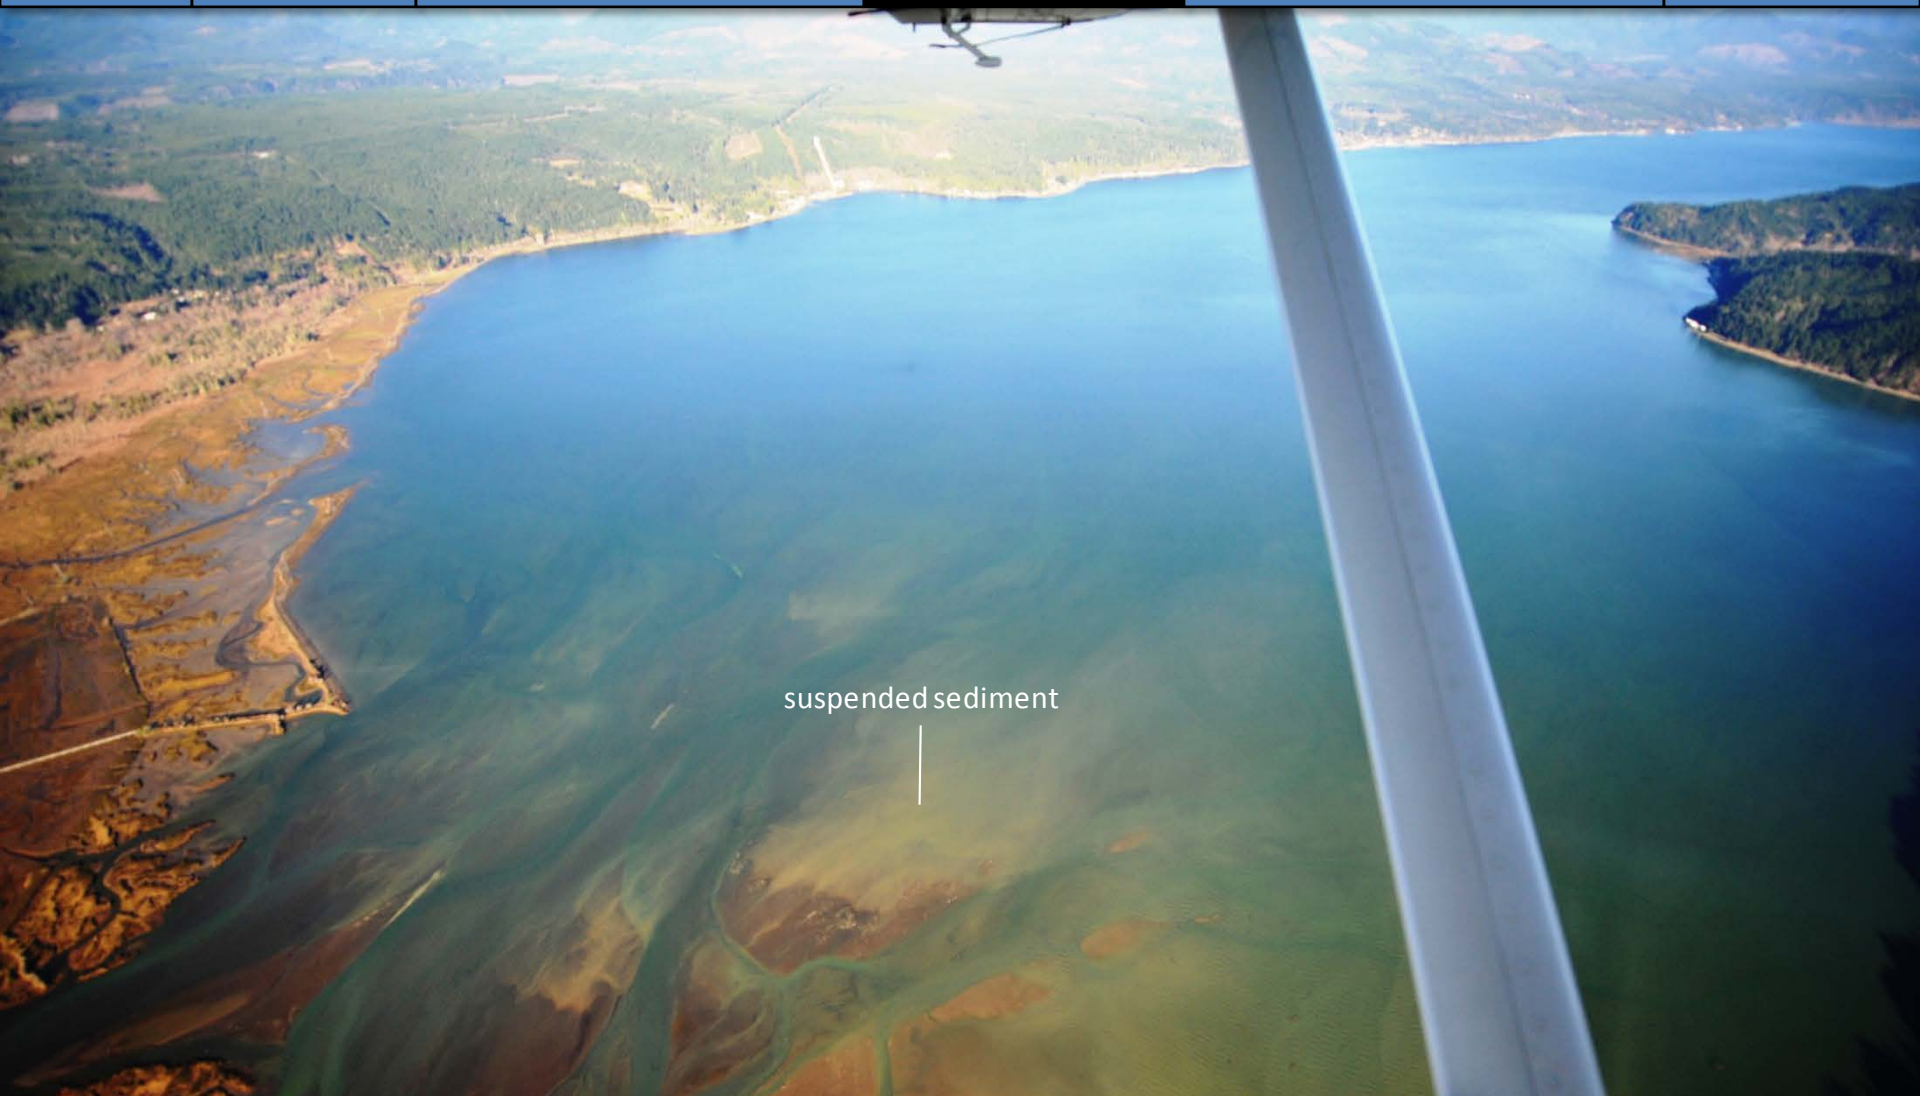
Location: Off Union (Hood Canal), 11:18 AM.

Skokomish River plume entering Hood Canal between tidally submerged flats.

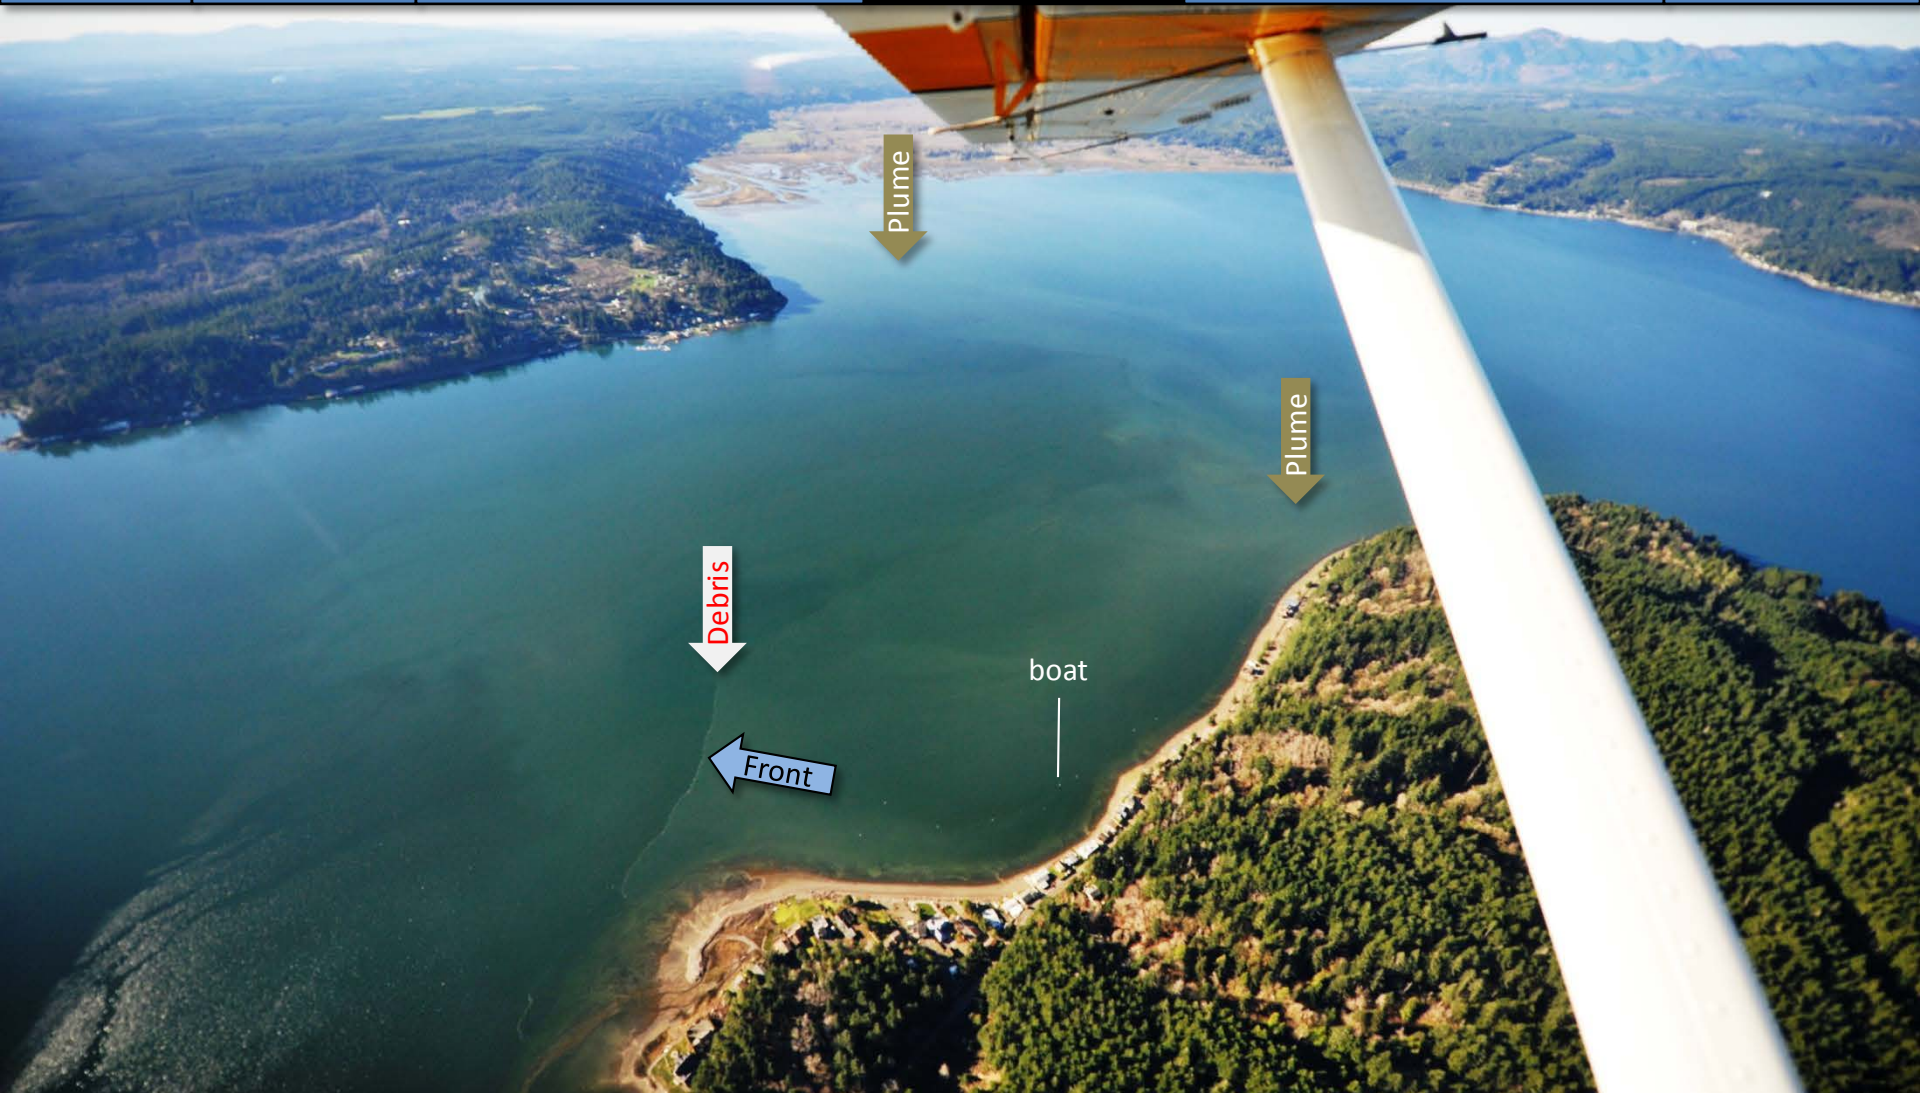
Fronts delineating the flow of Skokomish River water.
Location: Across from Union, Great Bend (Hood Canal), 9:48 AM.

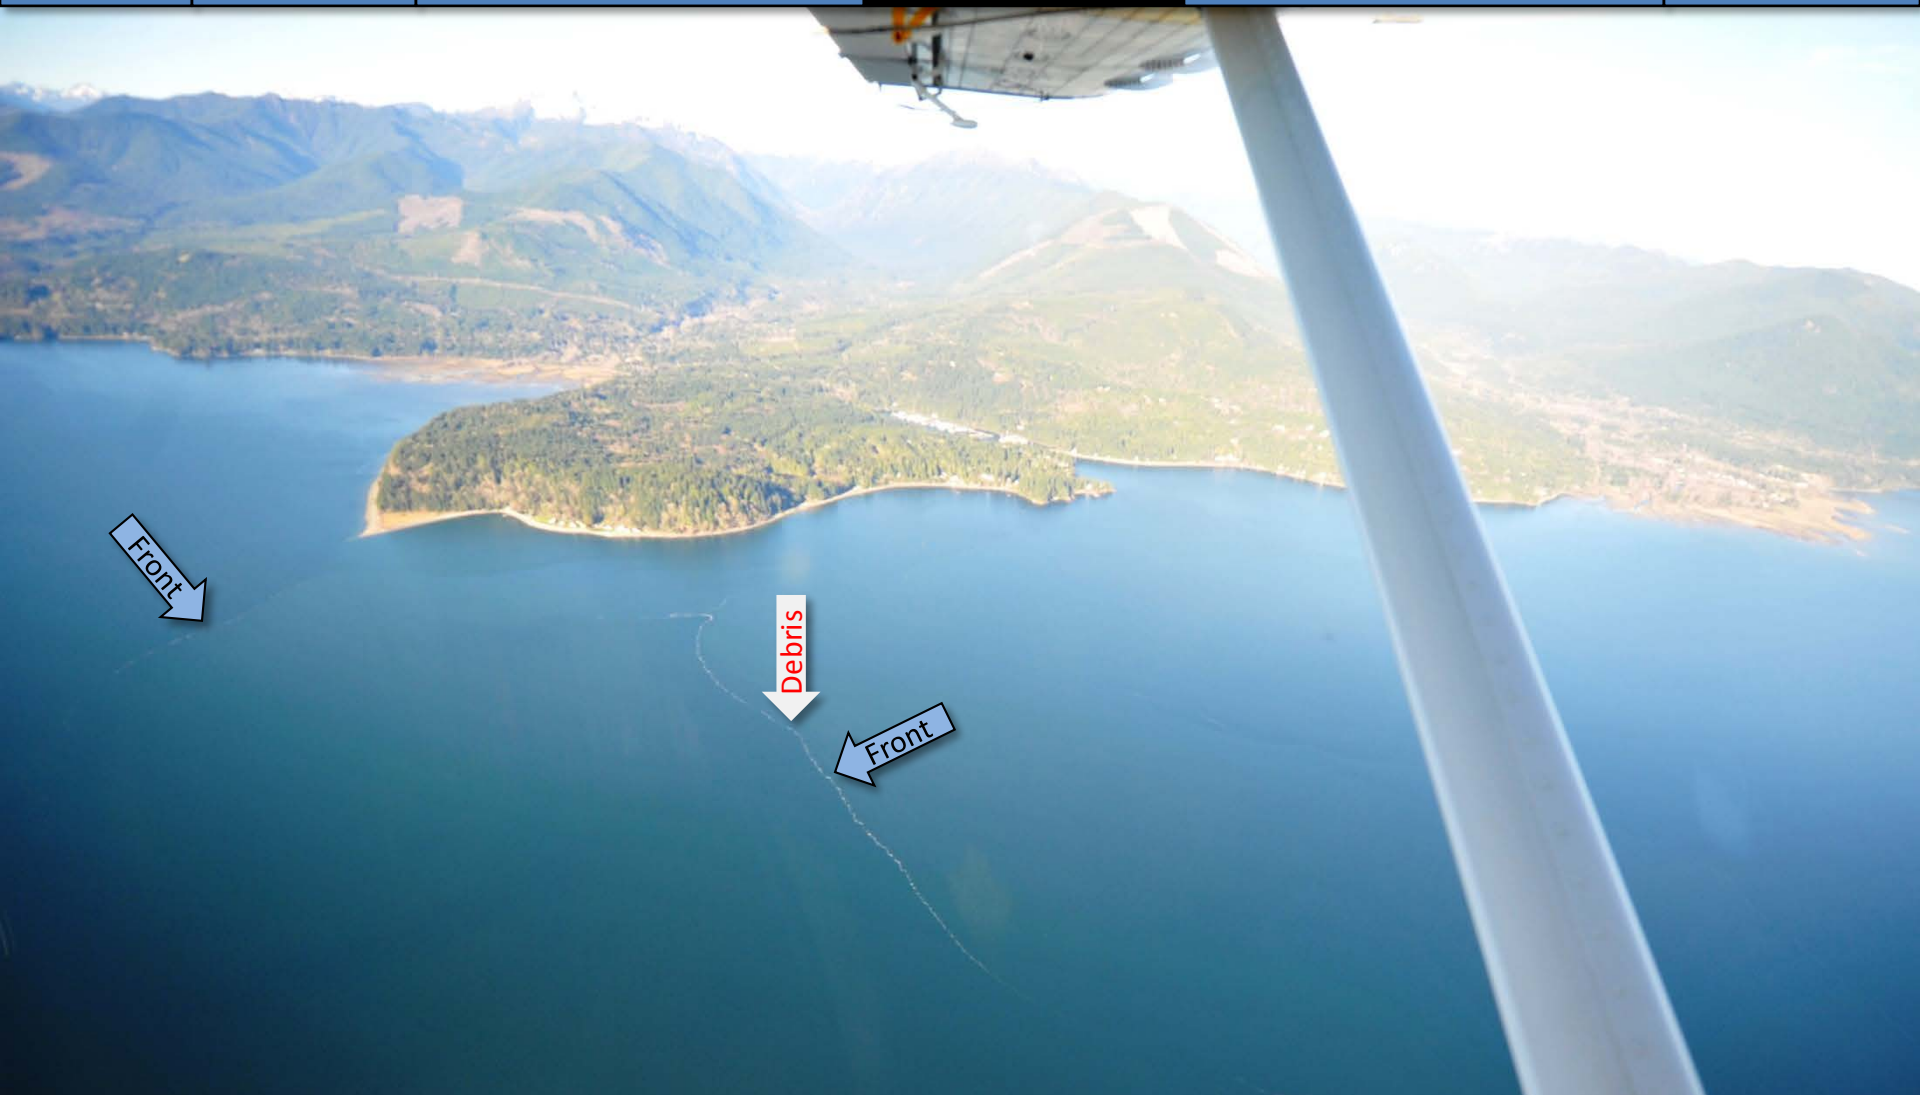
*Long front and organic debris line at entrance to Dabob Bay.
Location: Across from Seabeck (Hood Canal), 10:03 AM.*

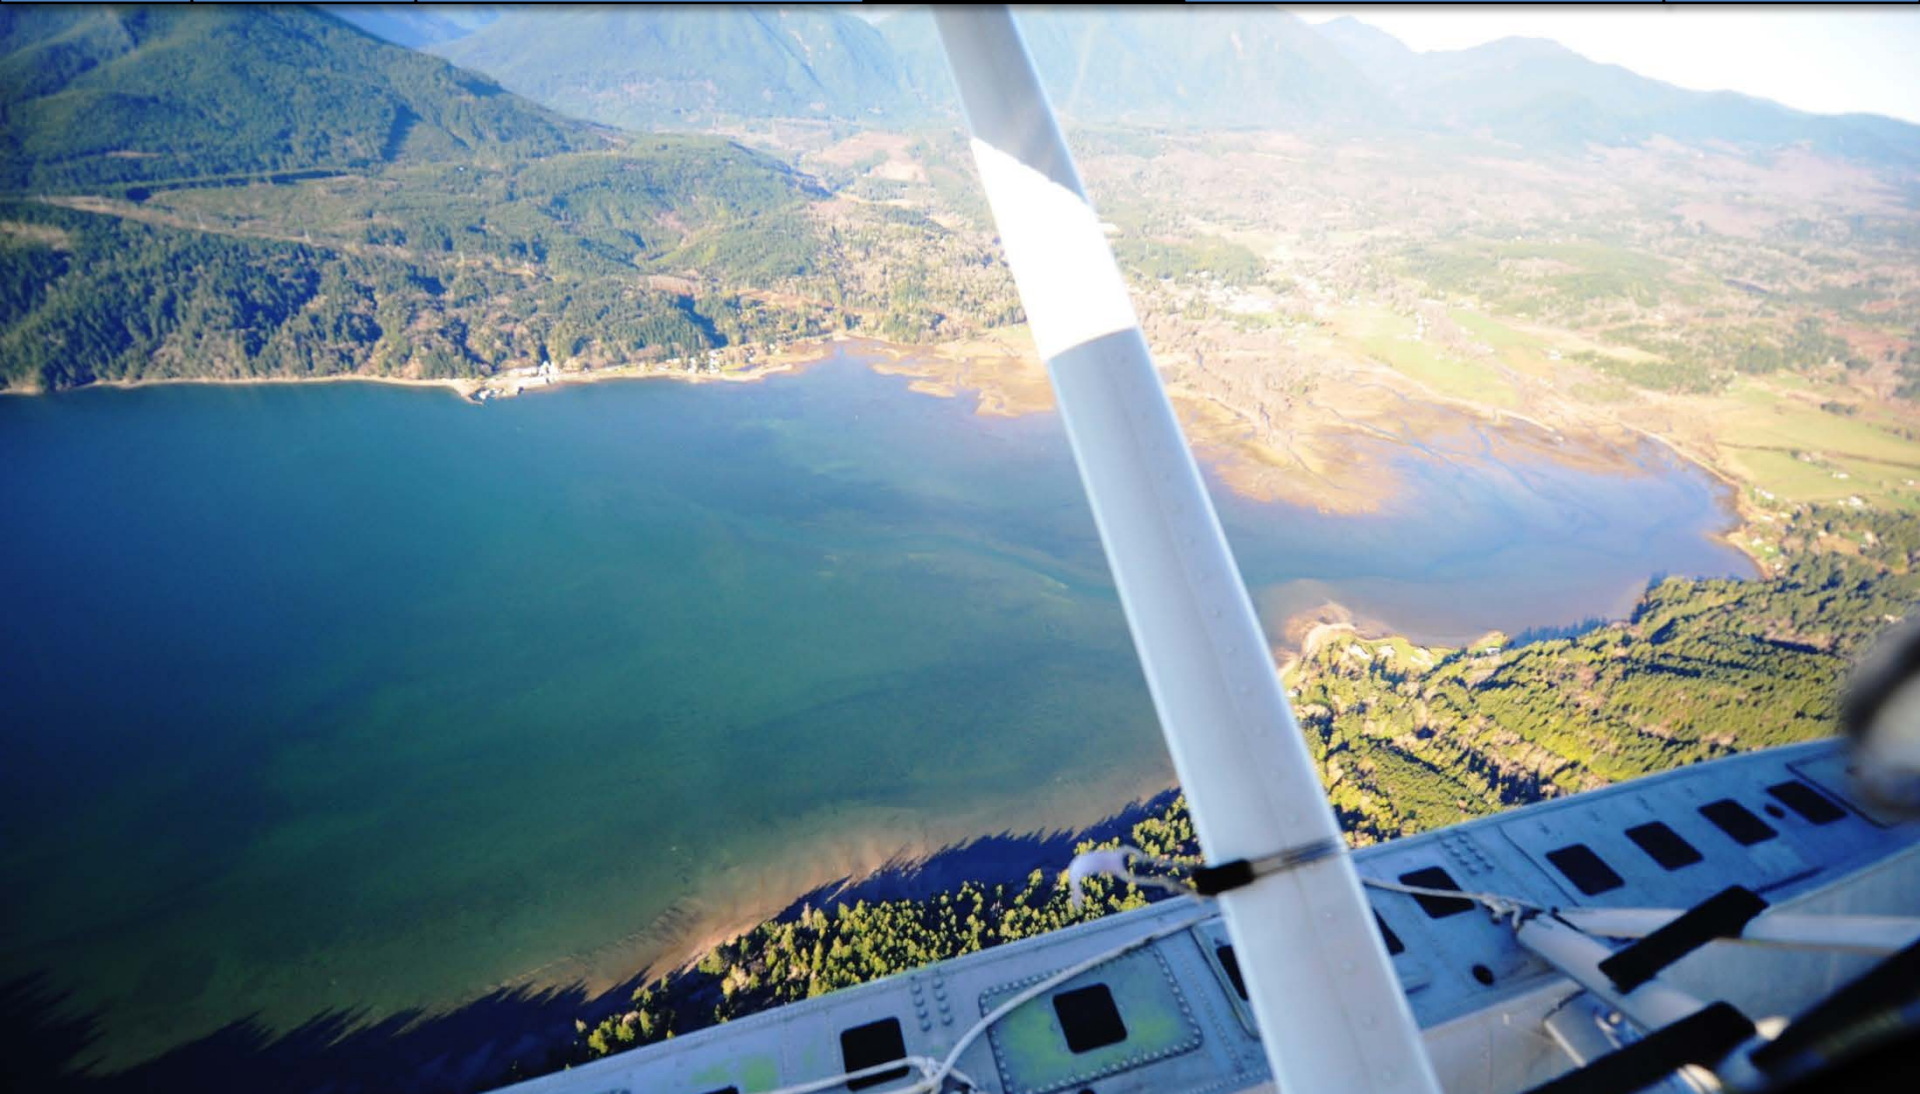
Location: Dabob Bay (Hood Canal), 10:10 AM.

Quilcene Bay appears to be clear of algal blooms

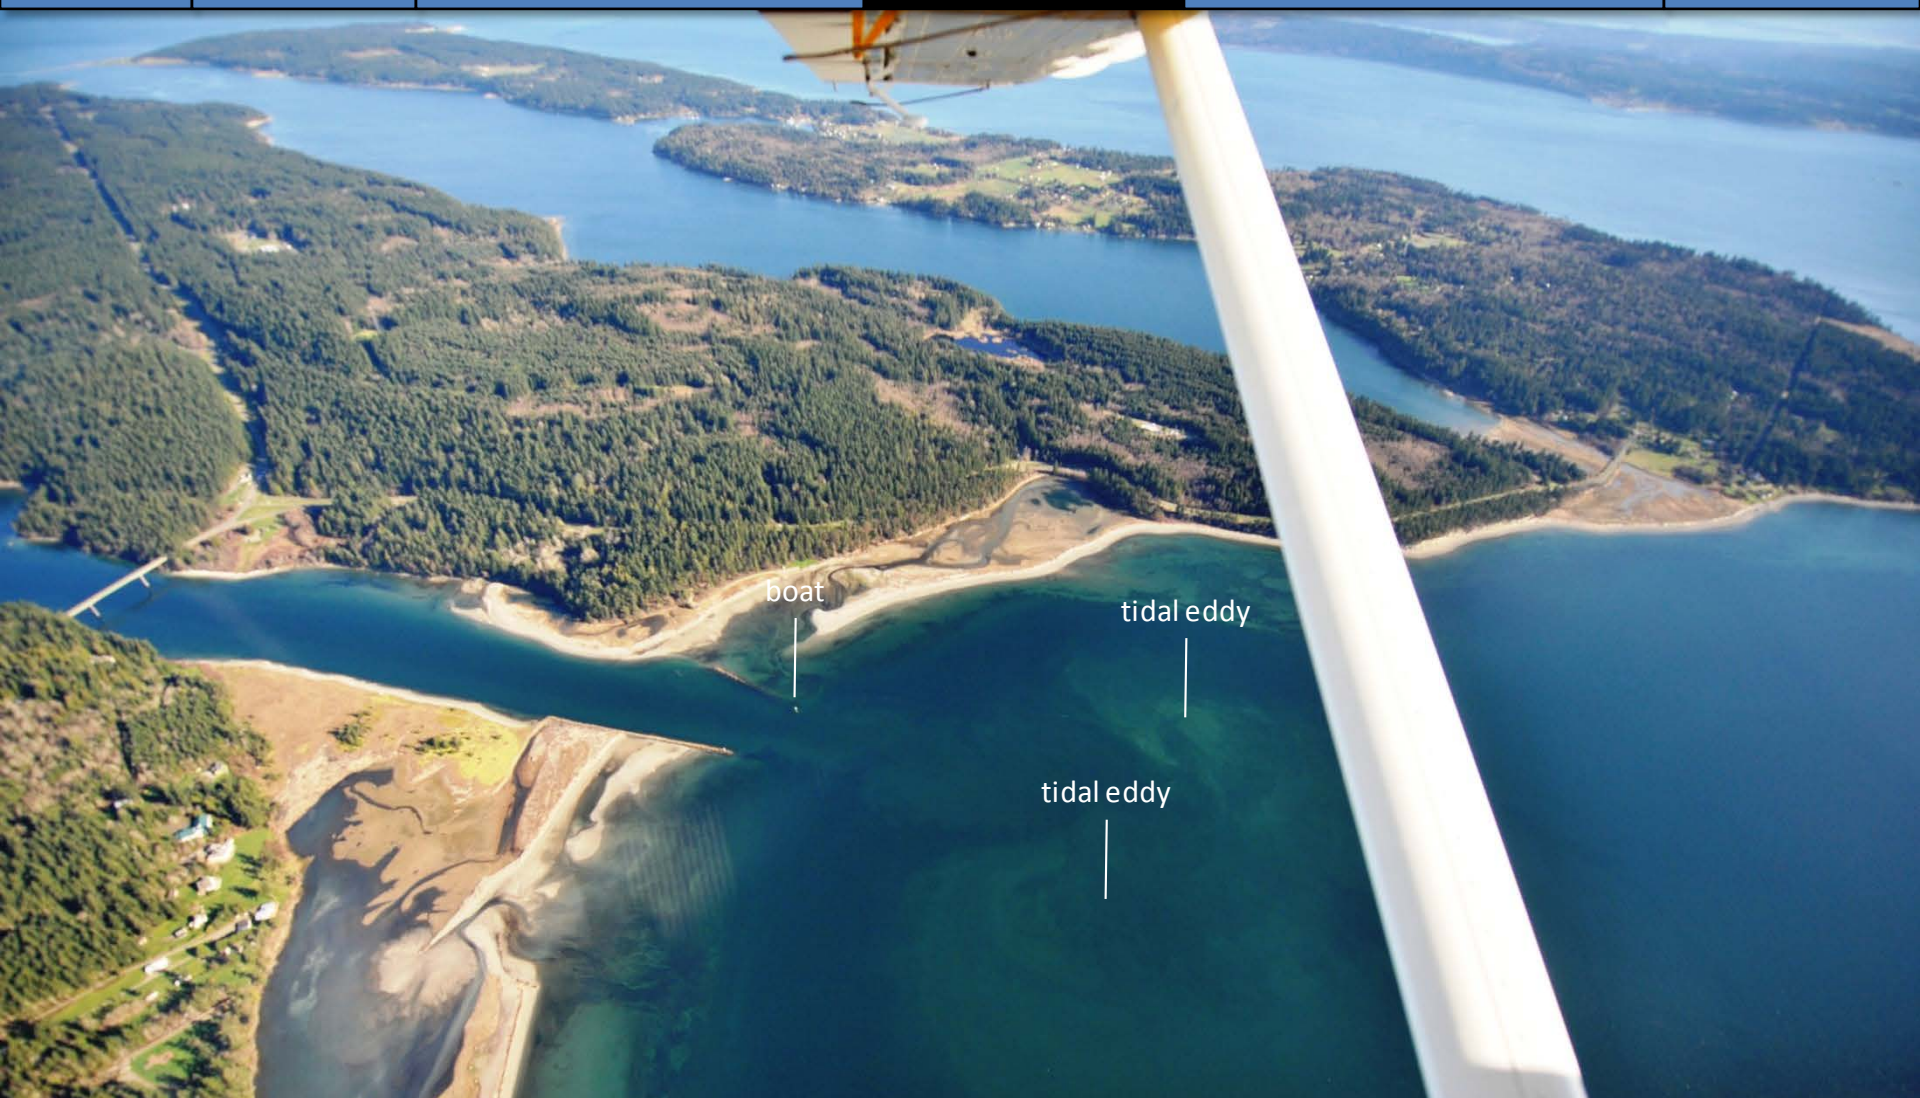
Location: Indian Island (North Sound), 10:22 AM.

Tidal eddies form as water flows southward through Portage Canal.

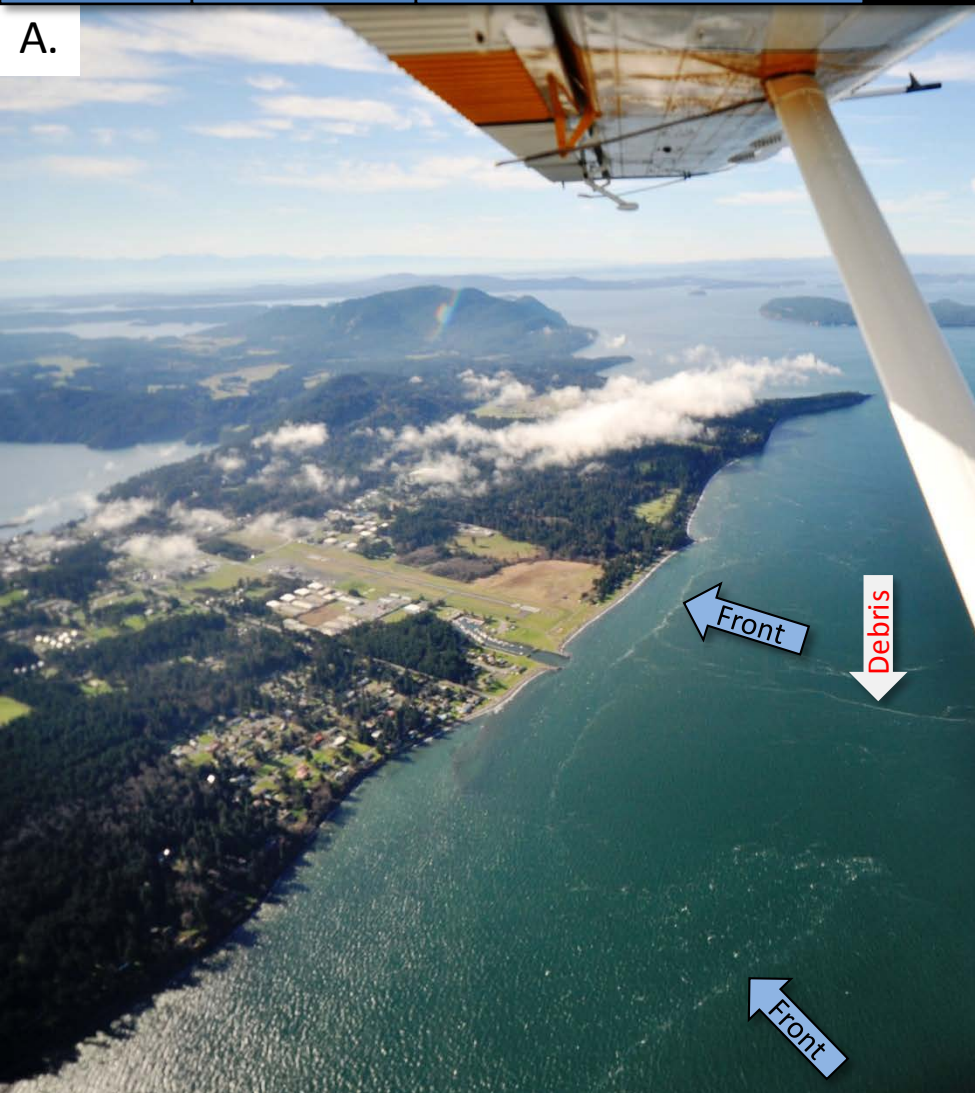
Location: A. Eastsound, B. San Juan Islands National Wildlife Refuge (Orcas Island), 12:04 PM.

Very structured surface water with fronts and debris lines.

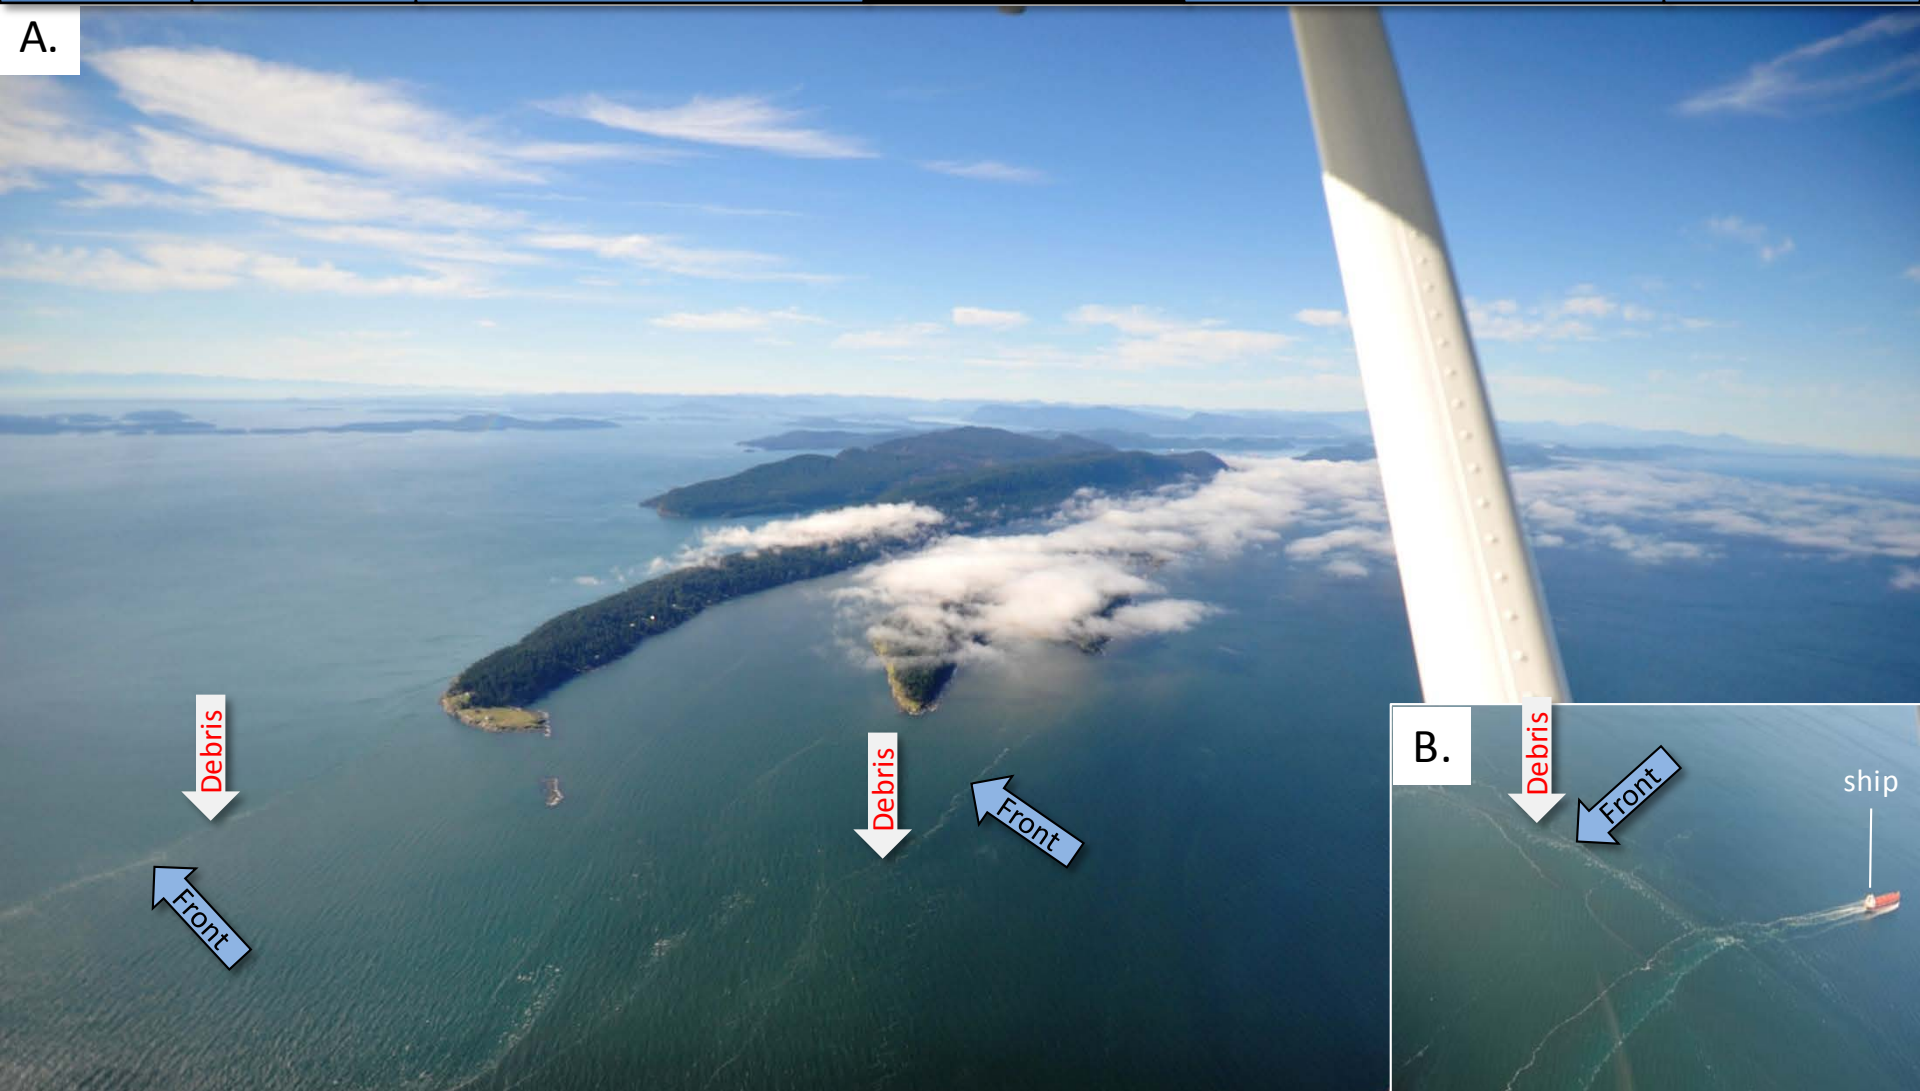
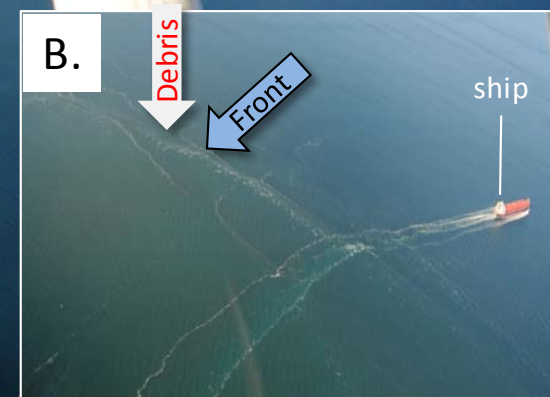
Location: A. Tumbo Island looking across US-Canada border, B. Ship wake (Georgia Basin), 12:08 PM.

Front with near-surface phytoplankton-rich layer and debris lines.

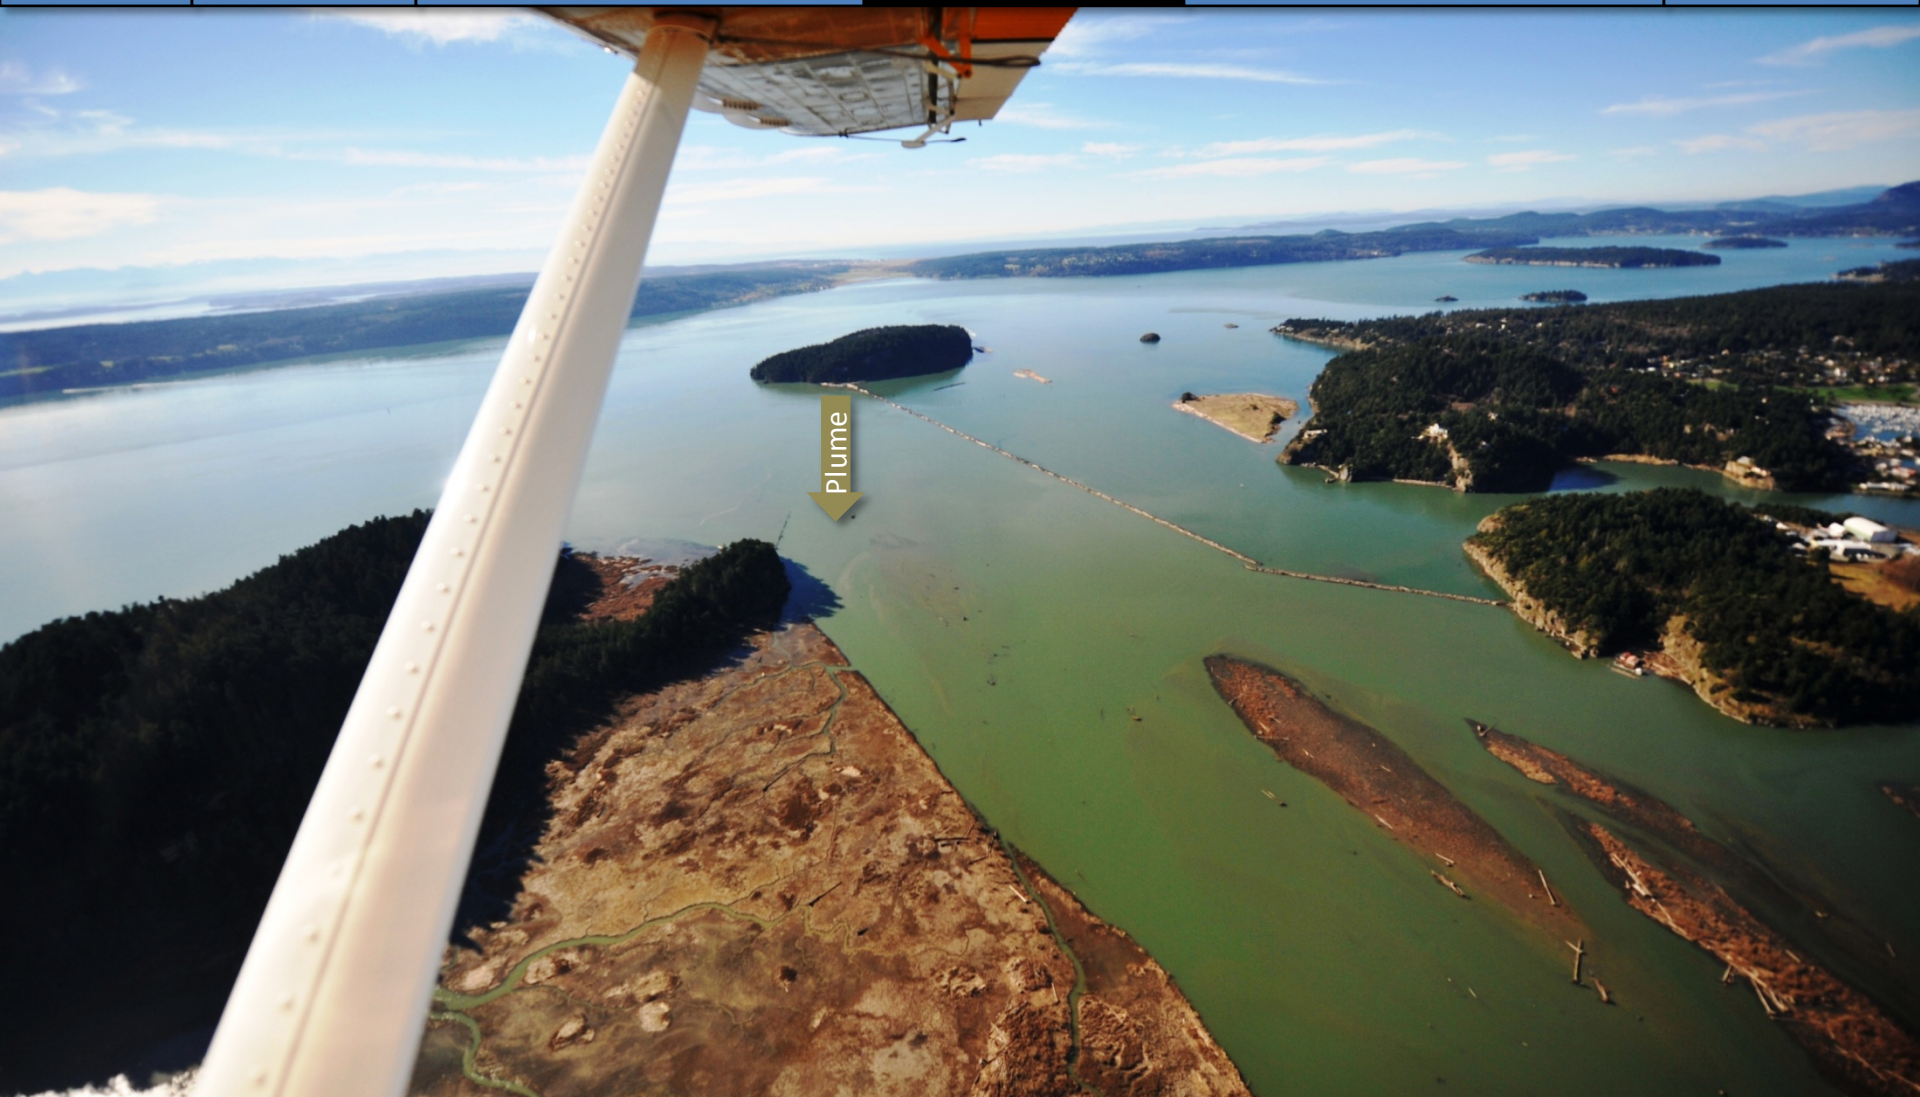
Suspended sediment of the Skagit River carrying woody debris into Skagit Bay.
Location: Near La Conner, Skagit Bay (Whidbey Basin), 1:50 PM.
