Eyes Over Puget Sound

Surface Conditions Report, February 17, 2015

Up-to-date observations of visible water quality conditions in Puget Sound and the Strait of Juan de Fuca

LONG-TERM MARINE MONITORING UNIT

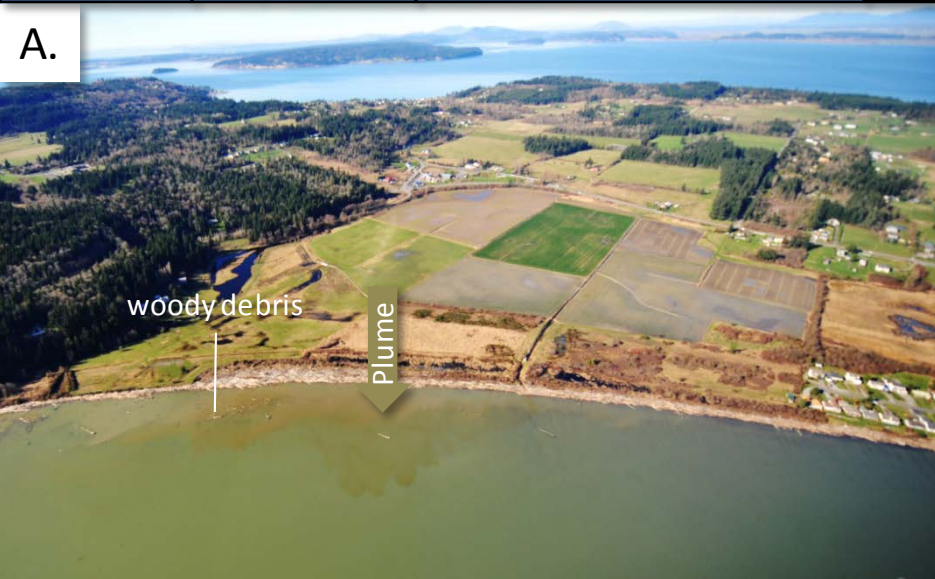
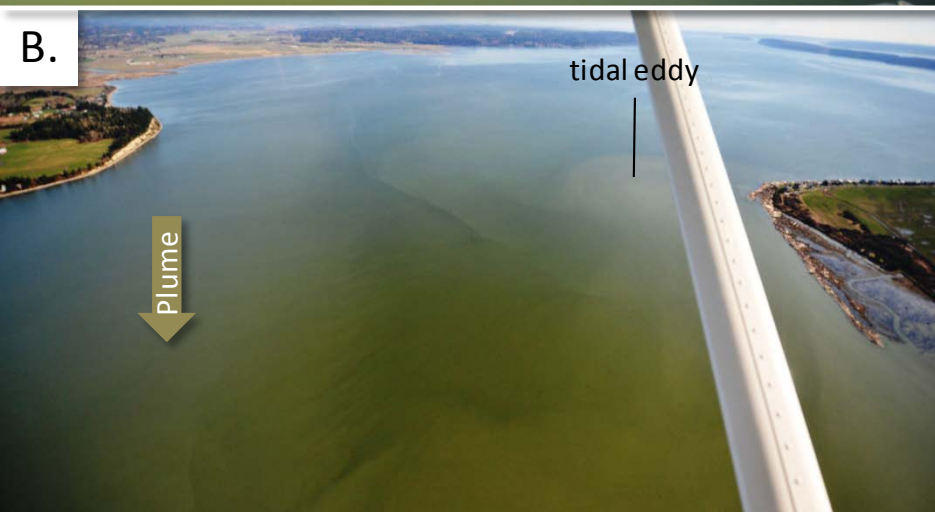
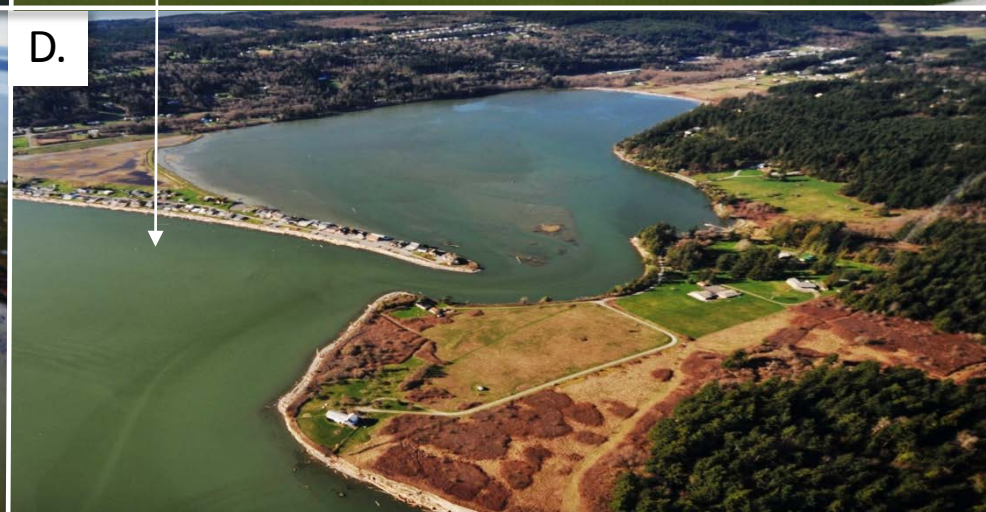
Plumes of a murky creek (A), turbid and green water (B), patches of organic debris and driftwood (C, D)
Location: A-B. Livingston Bay, C-D. Outside Triangle Cove, Port Susan (Whidbey Basin), 2:27 PM.

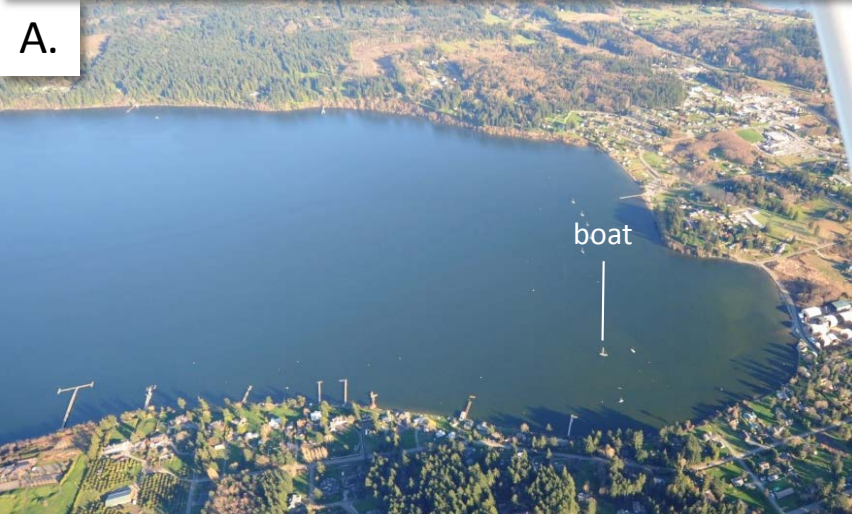
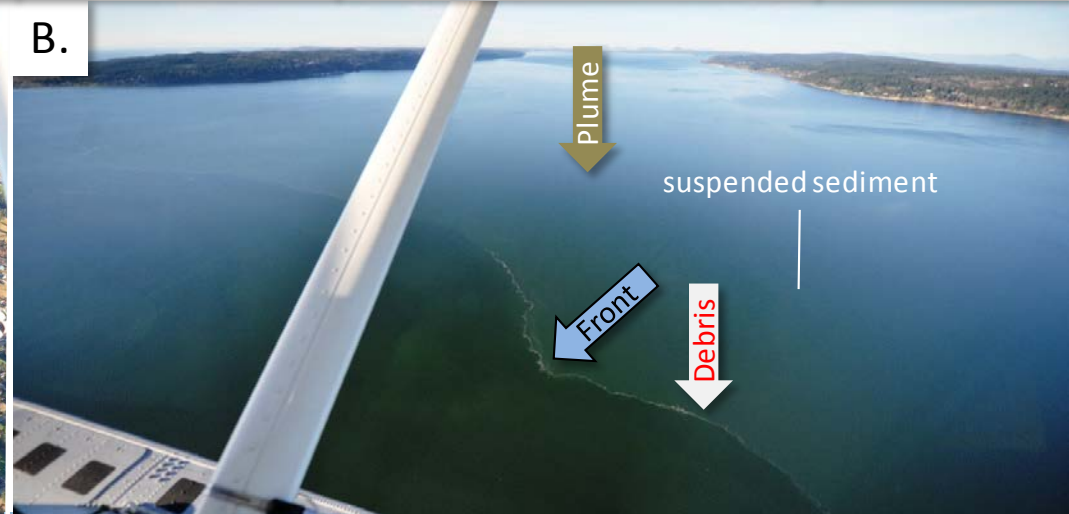
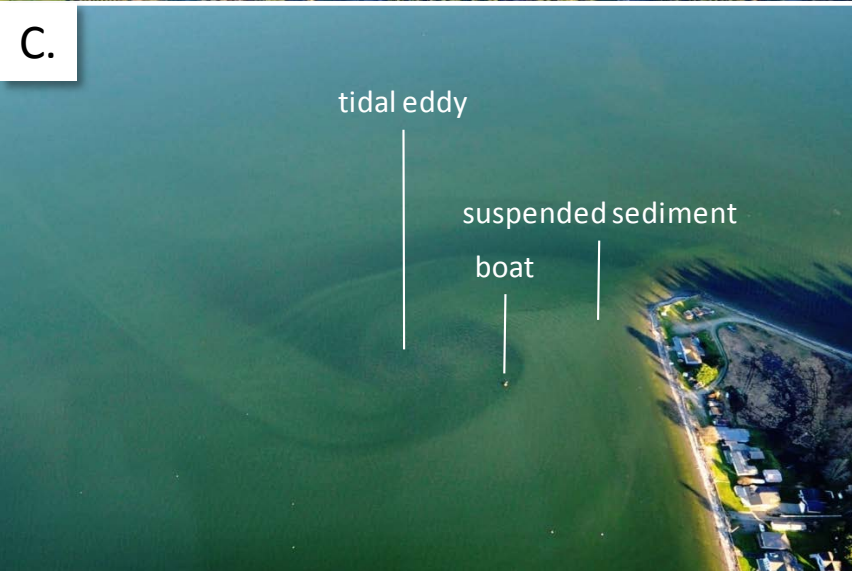
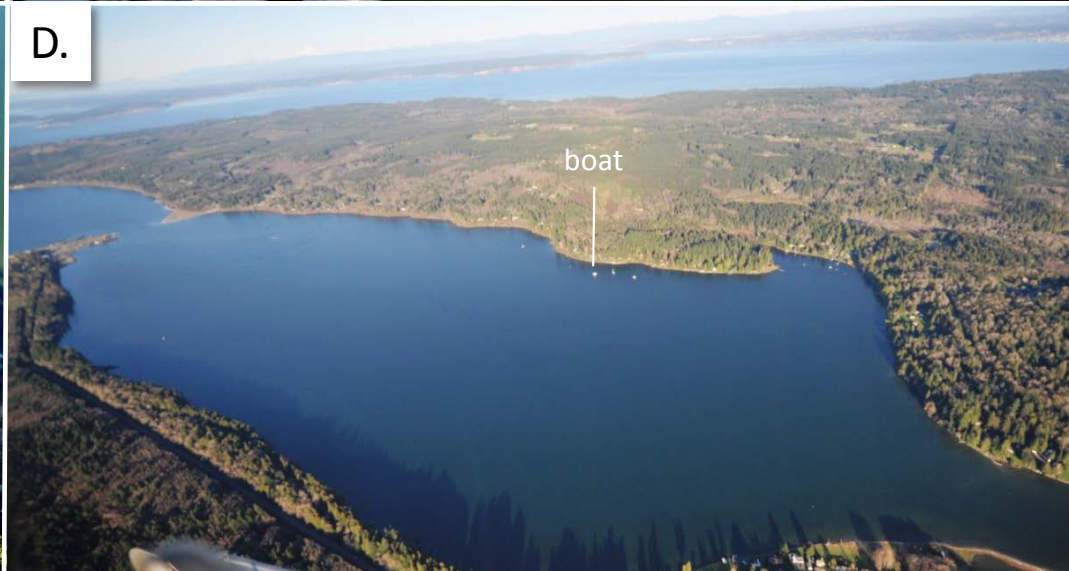
Smaller bays prone to water quality issues are appearing relatively clear (A-B, D). Small eddy (C). Location: A-C. Holmes Harbor (Whidbey Basin), D. Port Gamble (Hood Canal), 3:50 PM.

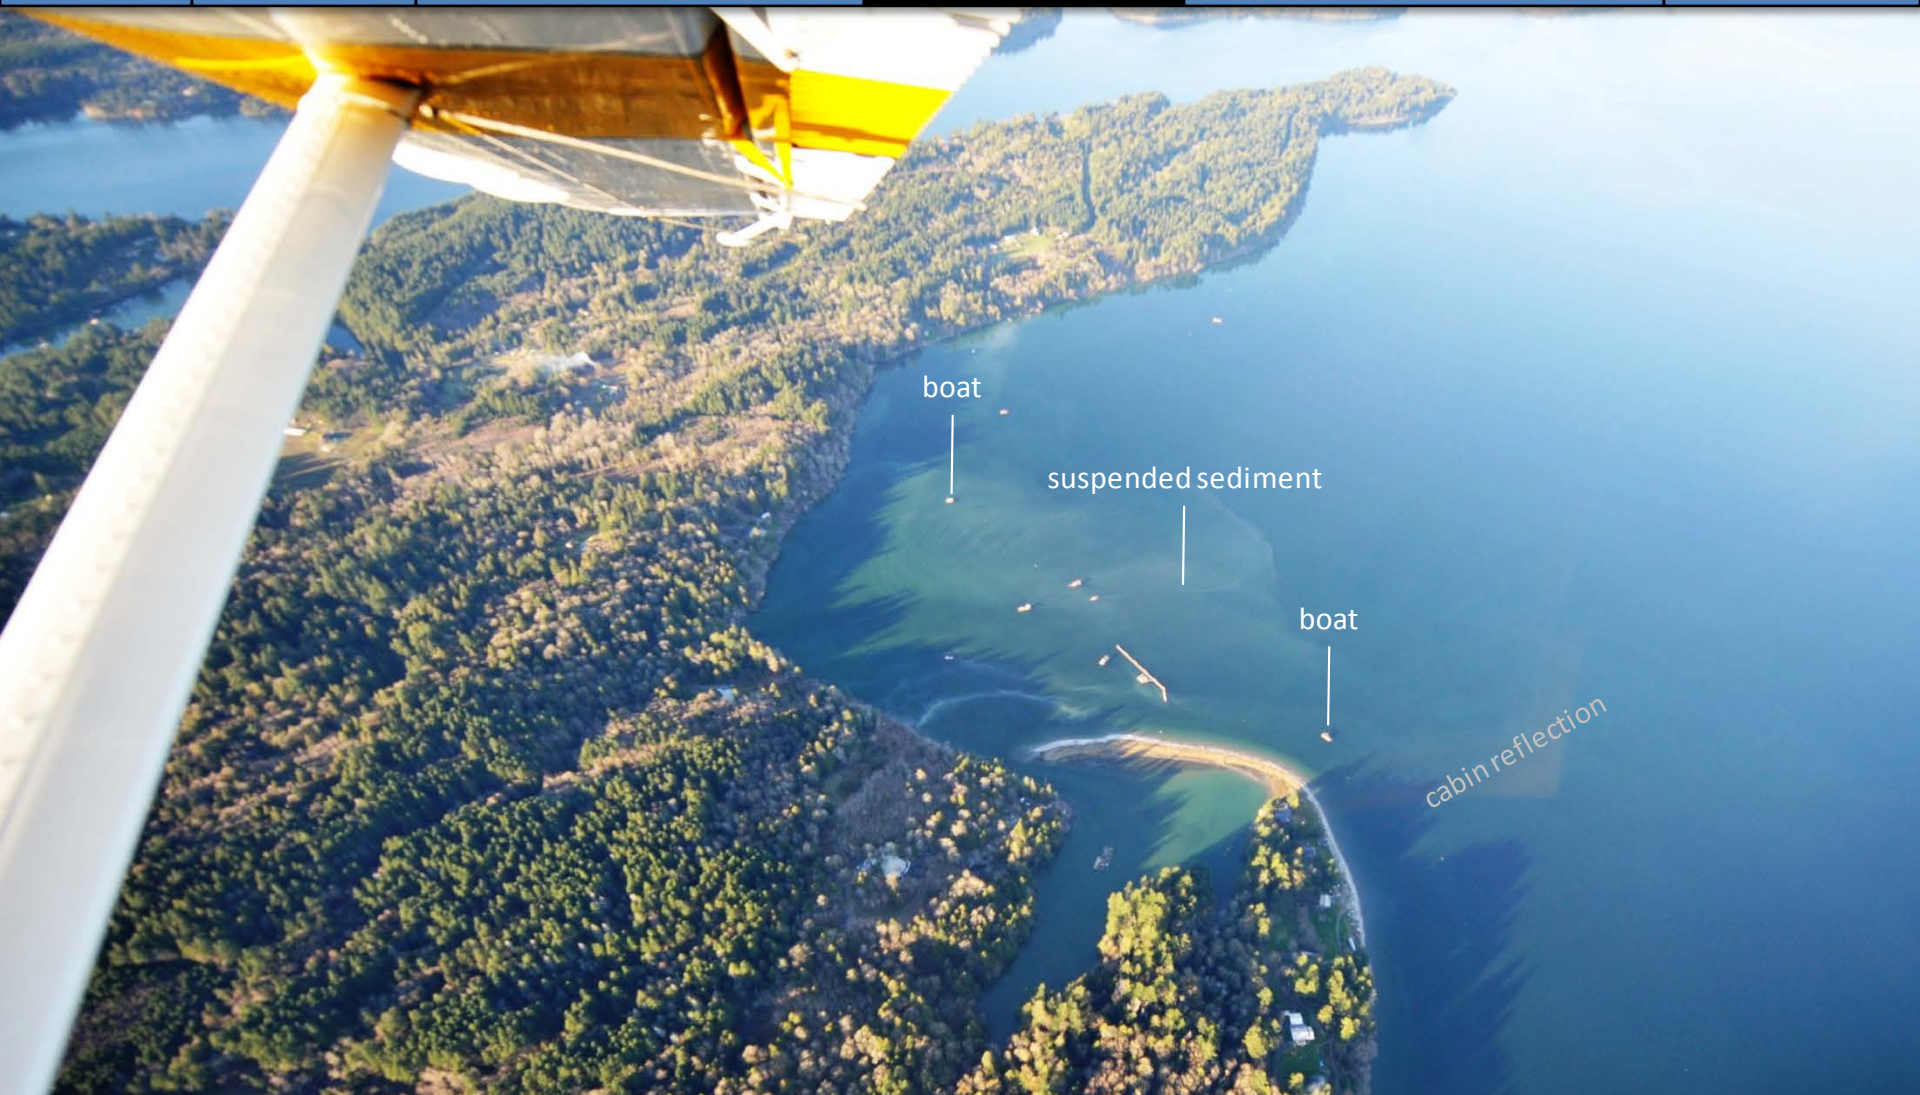
Location: Northeastern bay of Harstine Island, Case Inlet (South Sound), 4:27 PM.

Ongoing suspended sediment from human activity.
