# Eyes Over Puget Sound

## Surface Conditions Report June 8, 2015

Up-to-date observations of visible water quality conditions in Puget Sound and the Strait of Juan de Fuca

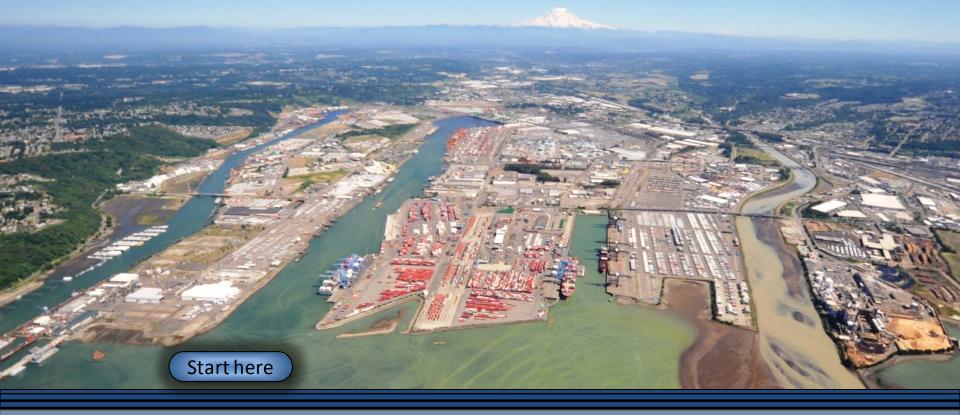
Puyallup River at a record low flow

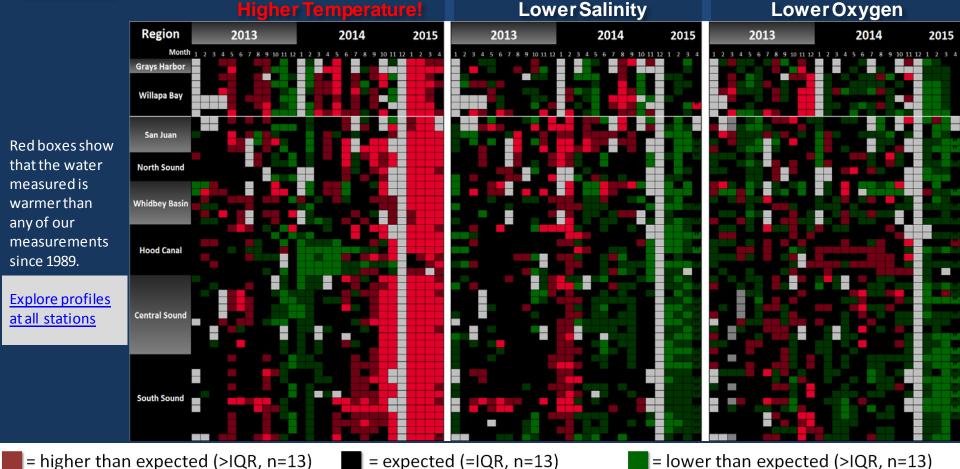
Conditions were dominated by <u>warm water</u> associated with the warm NE Pacific Ocean surface anomaly ("The Blob"). Starting in October, temperatures are the highest on record since 1989. Salinities and oxygen are lower in Puget Sound. Hood Canal has also reached new temperatures maxima.

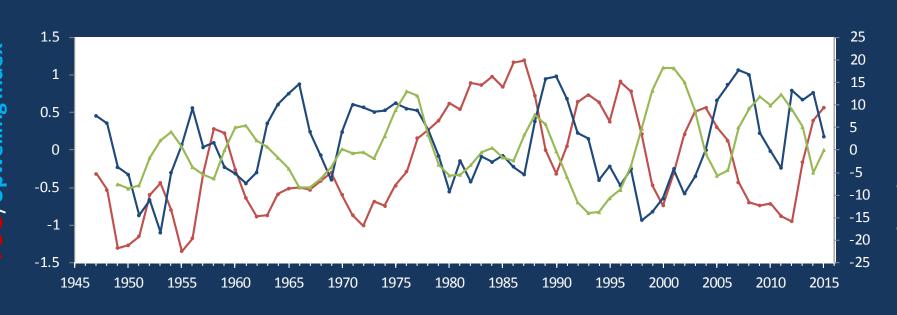
Three-year running average of PDO, Upwelling, and NPGO indices scores

Ocean boundary conditions are no longer favorable for water quality in Puget Sound: (a) water is warming (PDO), (b) upwelling of low oxygen and high nutrient ocean water is again increasing (Upwelling Index), and (c) higher surface productivity along the coast (NPGO) is falling. Where are we heading next?

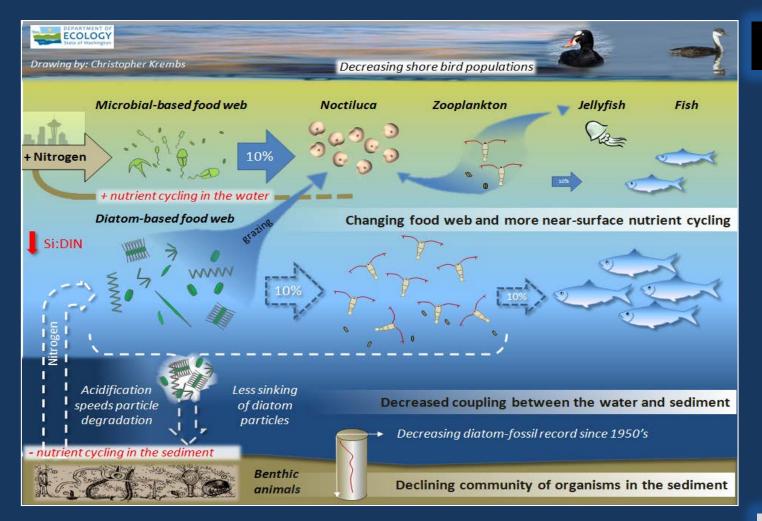
#### Hypothesis!

Increases in nitrate concentrations could be caused by a top-down control on phytoplankton biomass.

Is Noctiluca
a visible
harbinger of a
food web
change?

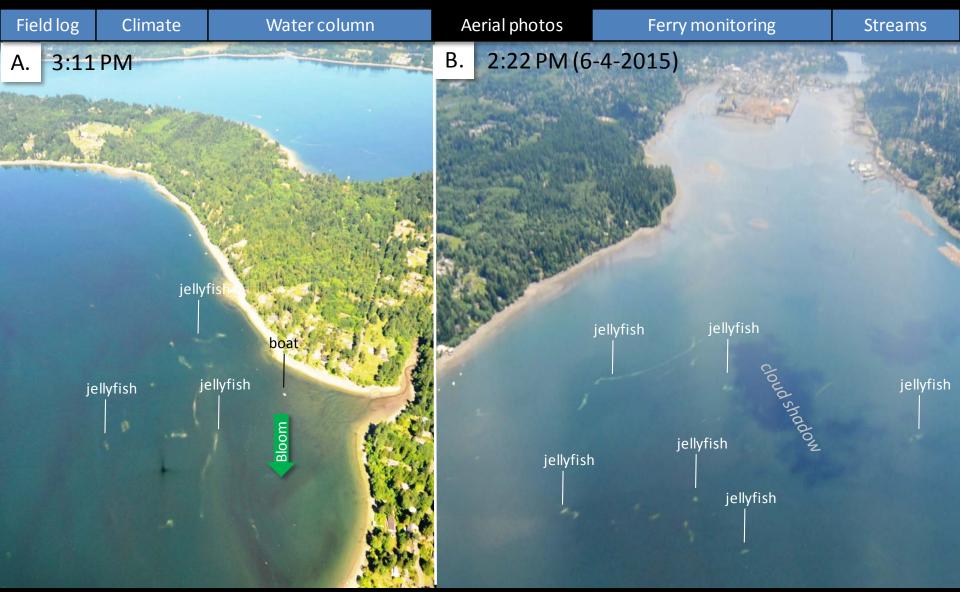
Large patches of jellyfish forming in finger inlets of South Sound. Location: A. Eld Inlet; B. Budd Inlet on 6-4-2015 (South Sound).

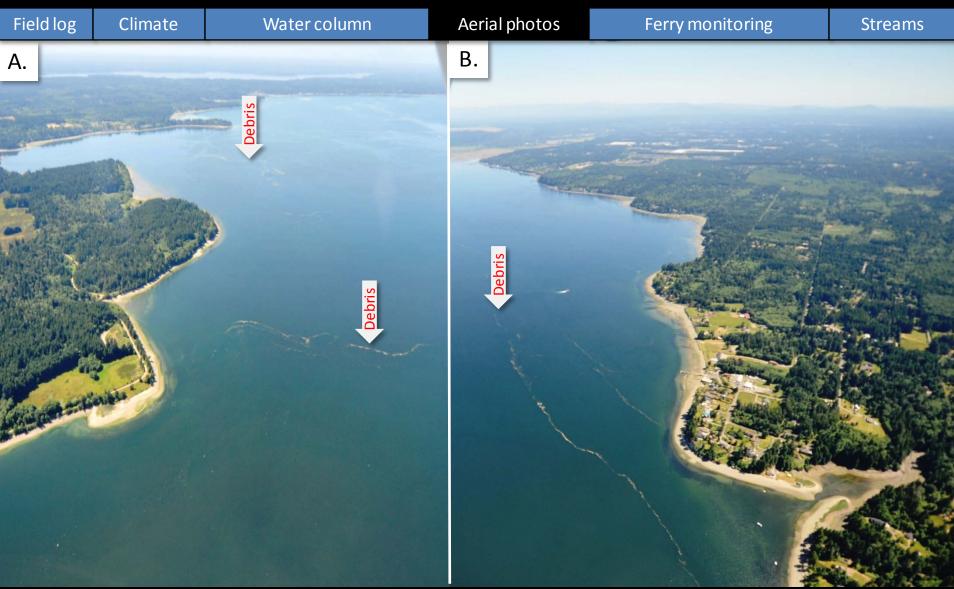
Large ribbons and patches of organic debris in many places of South Sound. Location: A. North of McNeil Island, B. Nisqually Reach (South Sound), 3:16 PM.

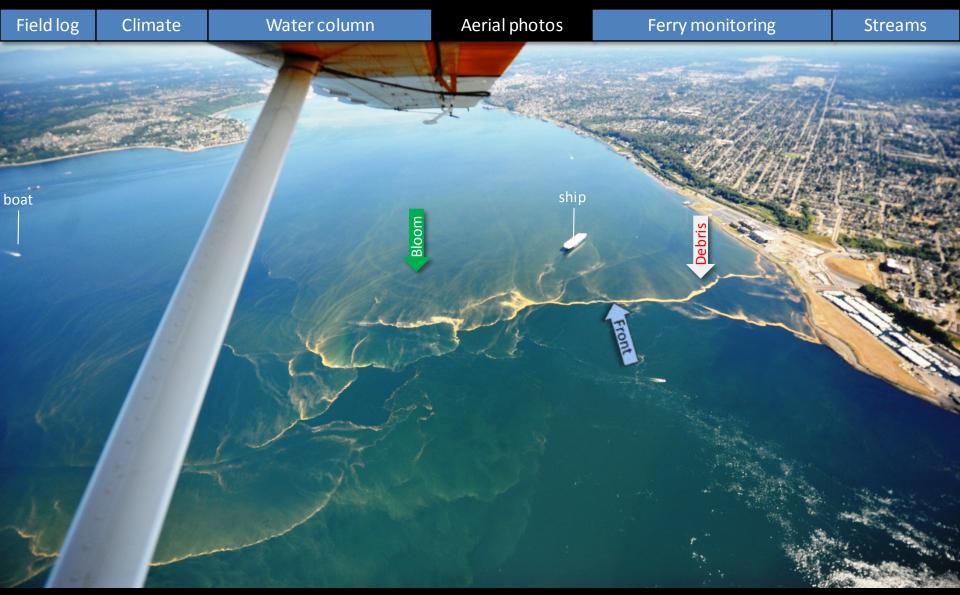
Large Noctiluca bloom surfacing and gathering in large quantities at tidal front.

Location: Commencement Bay (Central Sound), 3:32 PM.

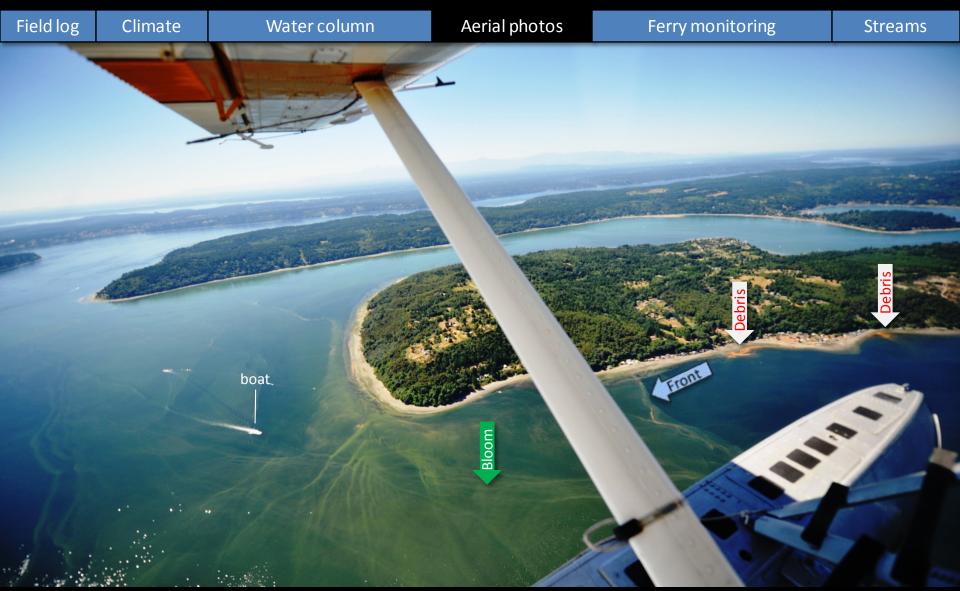
Large Noctiluca bloom surfacing and being washed on beaches near Piner Point.

Location: Vashon Island (Central Sound), 3:32 PM.

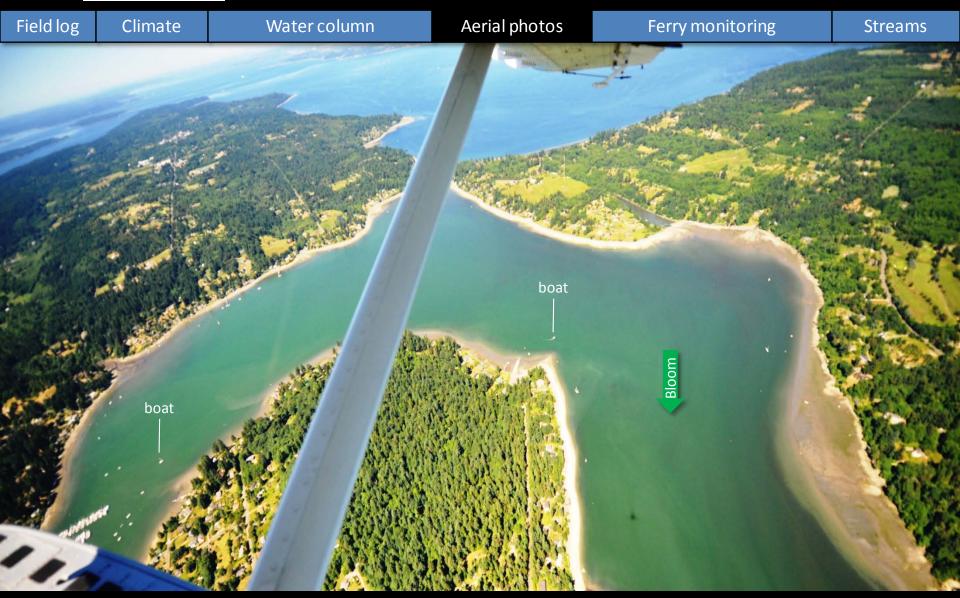
Algae bloom in Quartermaster Harbor. Location: Quartermaster Harbor, Vashon Island (Central Sound), 3:33 PM.

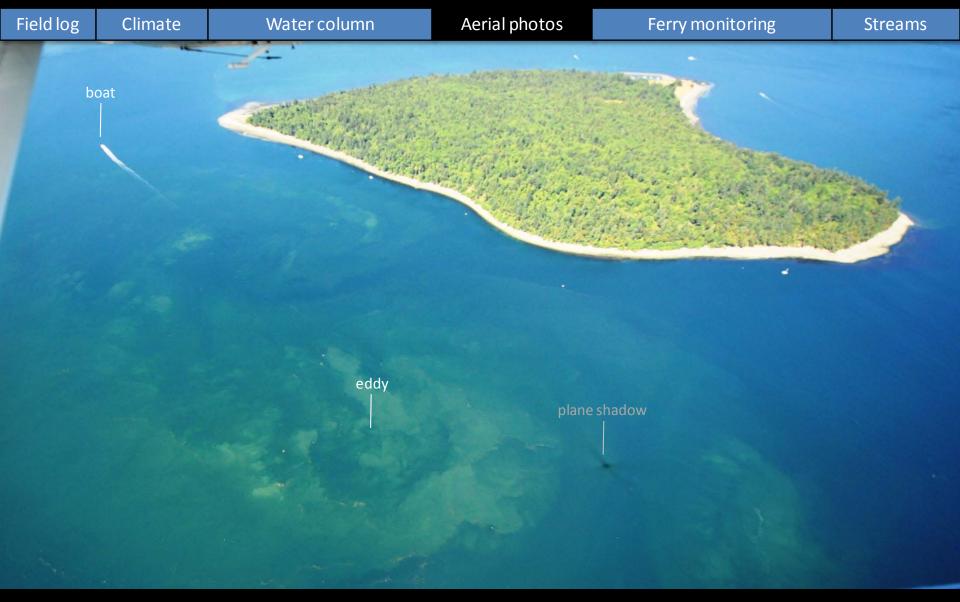
Large tidal eddy off Blake Island visible by bloom that mixes into the eddy.

Location: Blake Island, (Central Sound), 3:39 PM.

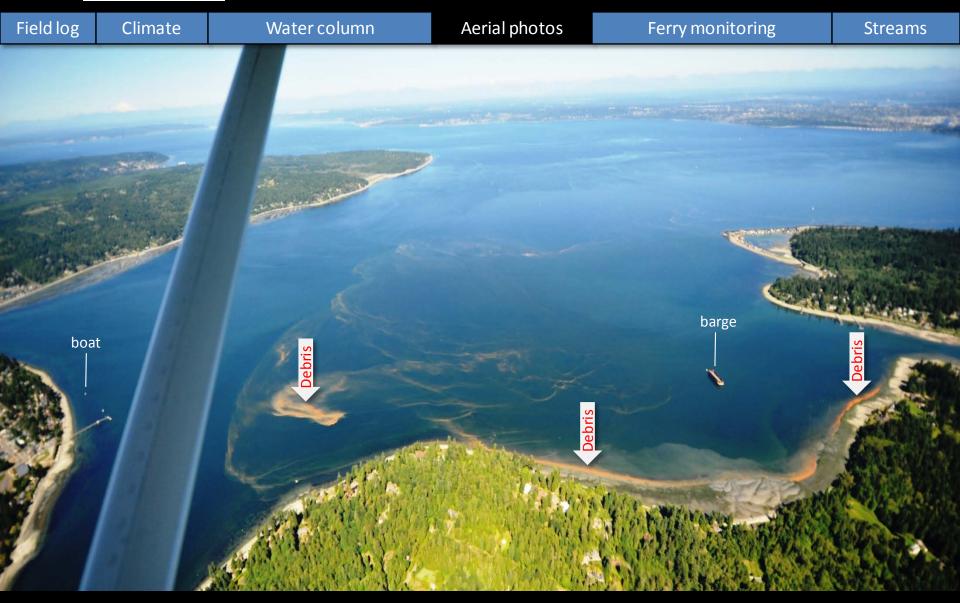
Noctiluca bloom starting to surface and getting washed onto beaches. Location: Port Madison (Central Sound), 3:47 PM.

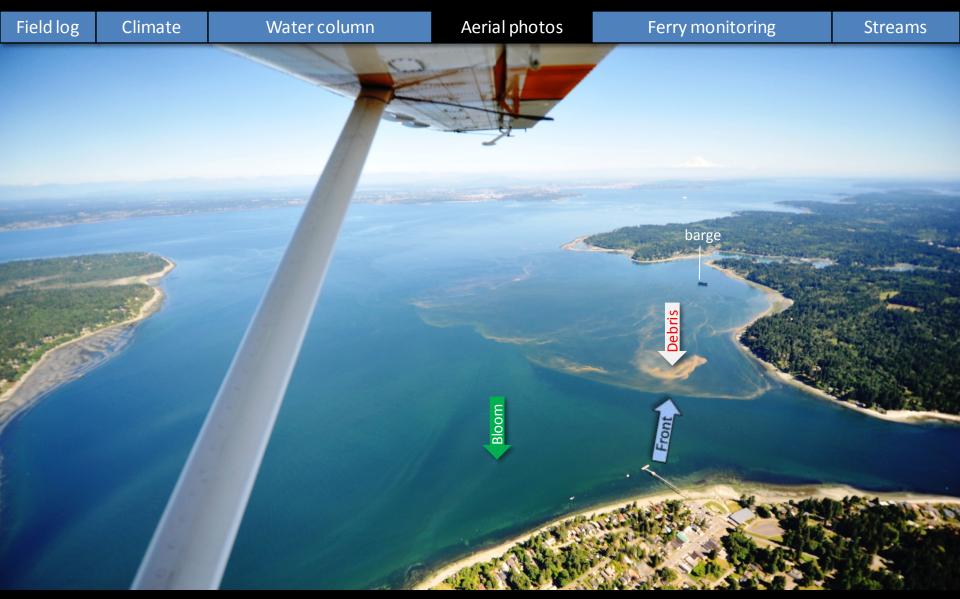
Much of the Noctiluca bloom is still under the surface. Location: Port Madison (Central Sound), 3:47 PM.

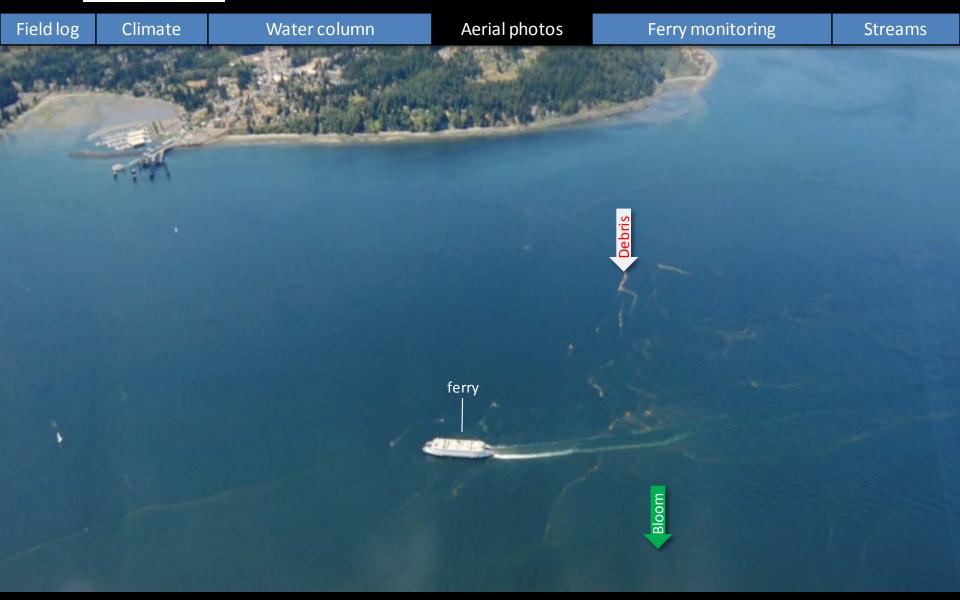
Noctiluca first emerges in red ribbons at surface on near Kingston on 6-4-2015. Location: Kingston (South Sound), 2:30 PM.

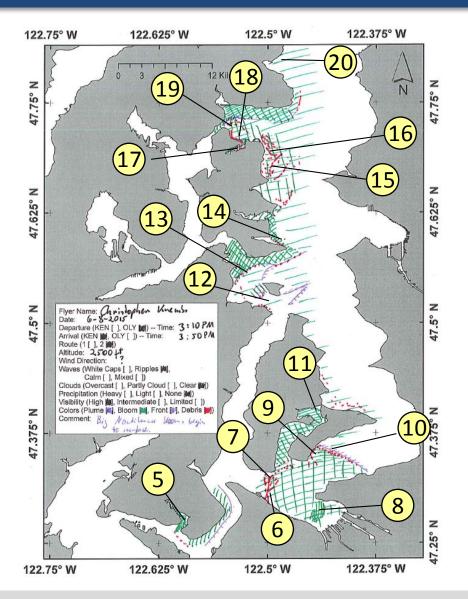
**Central Sound Date: 6-8-2015**

Maps are produced by observers during and after flights. They are intended to give an approximate reconstruction of the surface conditions on scales that connect to and overlap with satellite images in the section that follows.

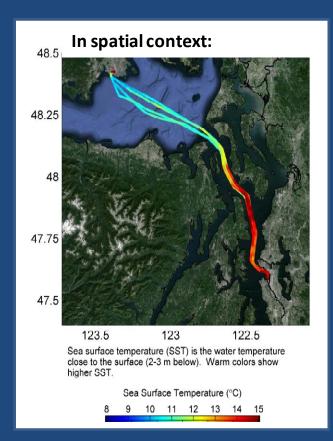
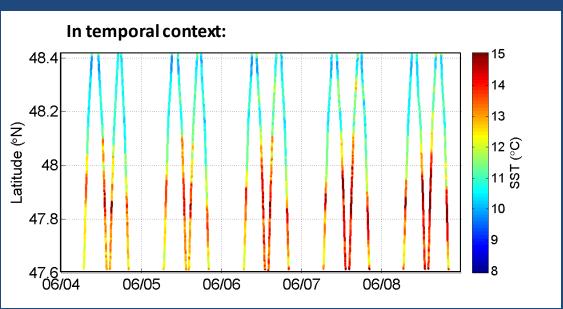
Pockets of sea surface temperatures are now reaching >15°C near Kingston around the "Triple Junction" (Admiralty Reach, Whidbey Basin and Central Sound). Temperature are favorable for harmful algae species to bloom.

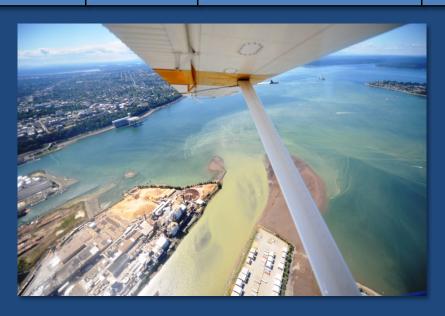
Left: Aerial photo of the Puyallup River flowing into Commencement Bay on the record day of 6-4-2015

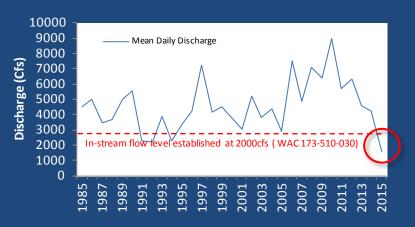
USGS Flow Gage 12101500 Puyallup River @ Puyallup, WA Mean Daily Discharge recorded for June 4th (30 year Period of Record)

The plot on the left indicates the observed mean daily discharge recorded since 1985 for the day of June 4<sup>th</sup>.

According to USGS historical flow data, this is the lowest discharge value recorded for the day of June 4<sup>th</sup> for the entire period of record (1914-2015).

Furthermore, the observed flow on 6/4/2015 (1600 cfs) is below the minimum mean flow observed for the months of May and June during the entire historical record as well.
