Eyes Over Puget Sound

Water column

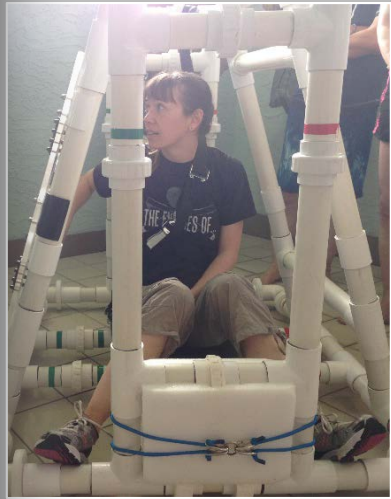
Mya practicing 1,2,3,4 out the door on dry land.

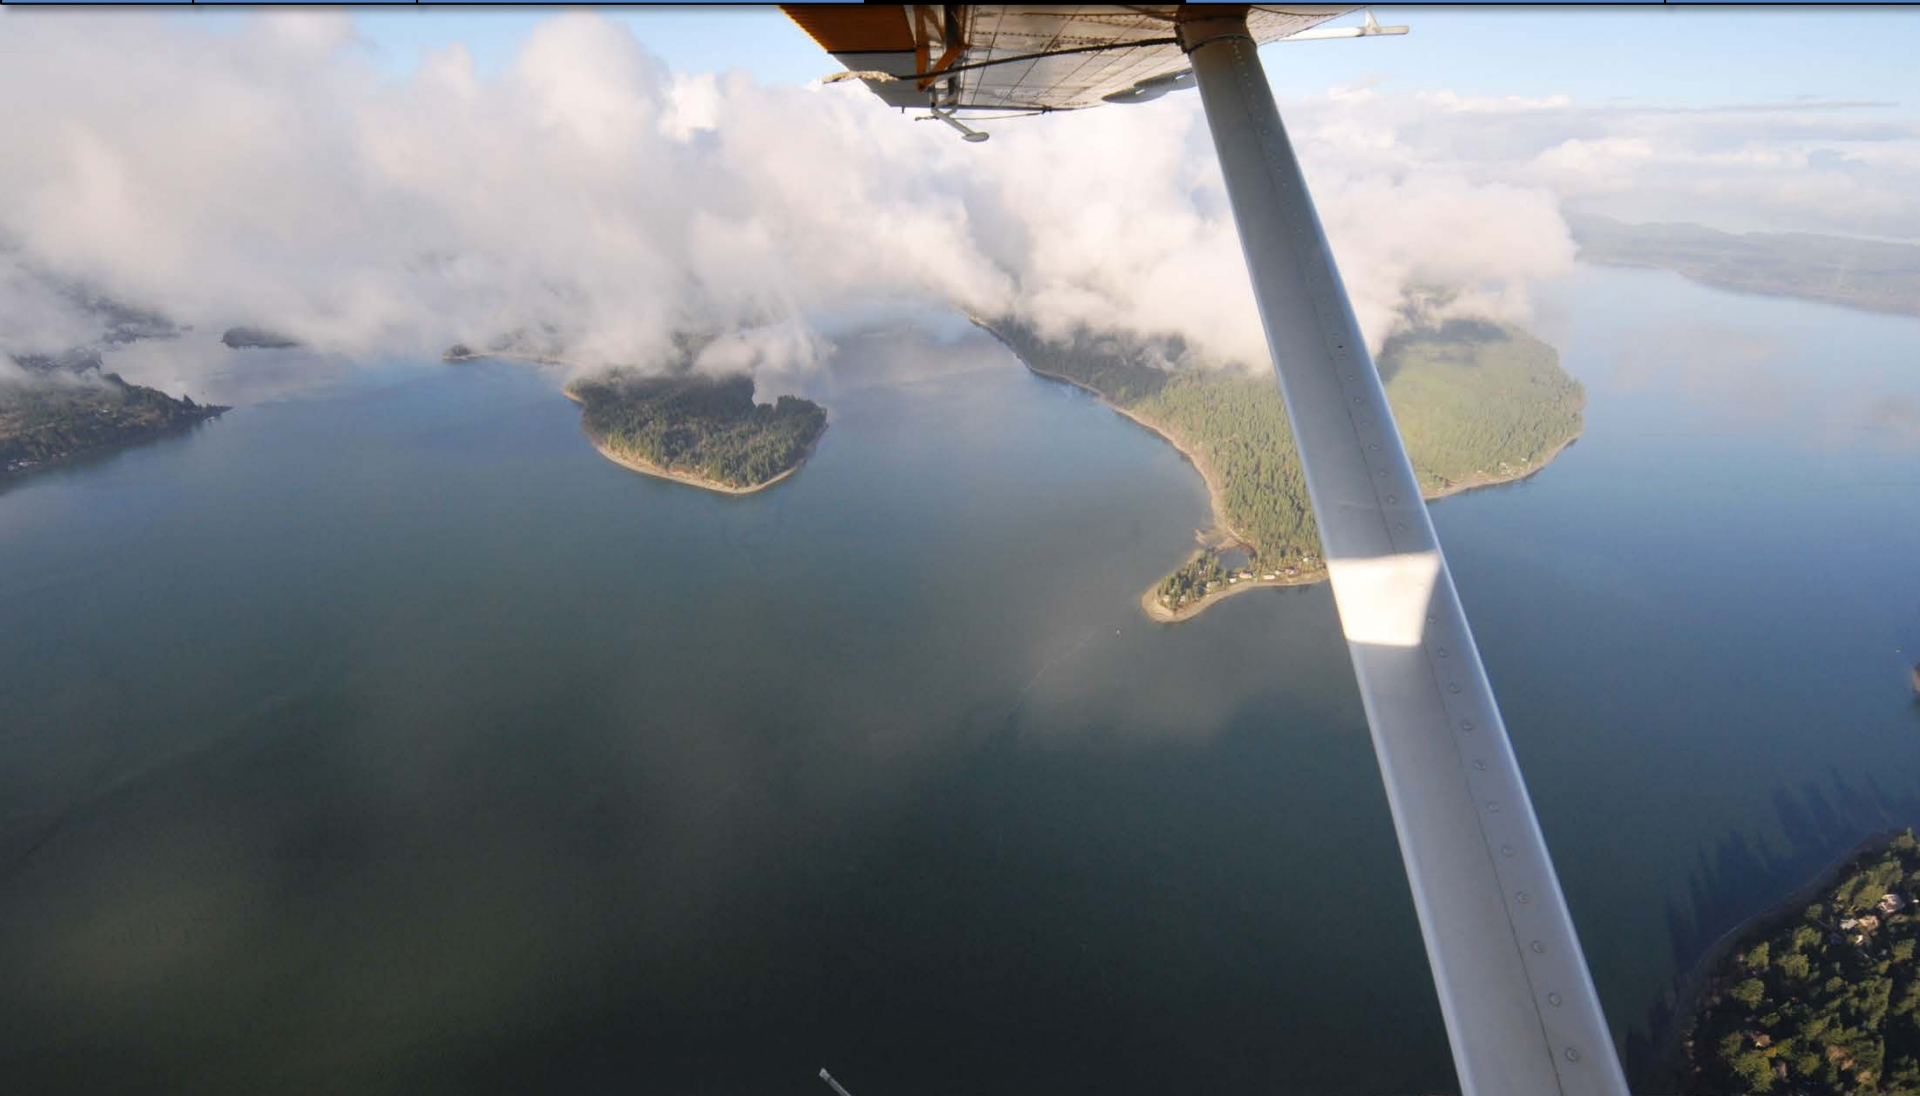
Calm conditions in Dana Passage showing no signs of phytoplankton bloom.

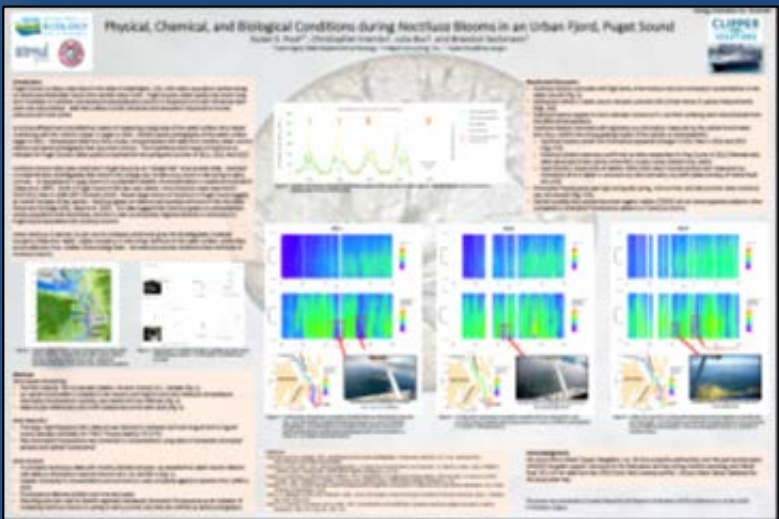
Pool, S.S., C. Krembs, J. Bos, and B. Sackmann. 2015. **Physical, Chemical, and Biological Conditions during Noctiluca Blooms in an Urban Fjord, Puget Sound**. Poster presented at Coastal Estuarine and Research Federation 2015 Conference, Portland, Oregon. Washington State Department of Ecology Publication No. 15-03-040. <https://fortress.wa.gov/ecy/publications/documents/1503040.pdf>
