Eyes Over Puget Sound

Surface Conditions Report, March 16, 2016

Up-to-date observations of visible water quality conditions in Puget Sound and the Strait of Juan de Fuca

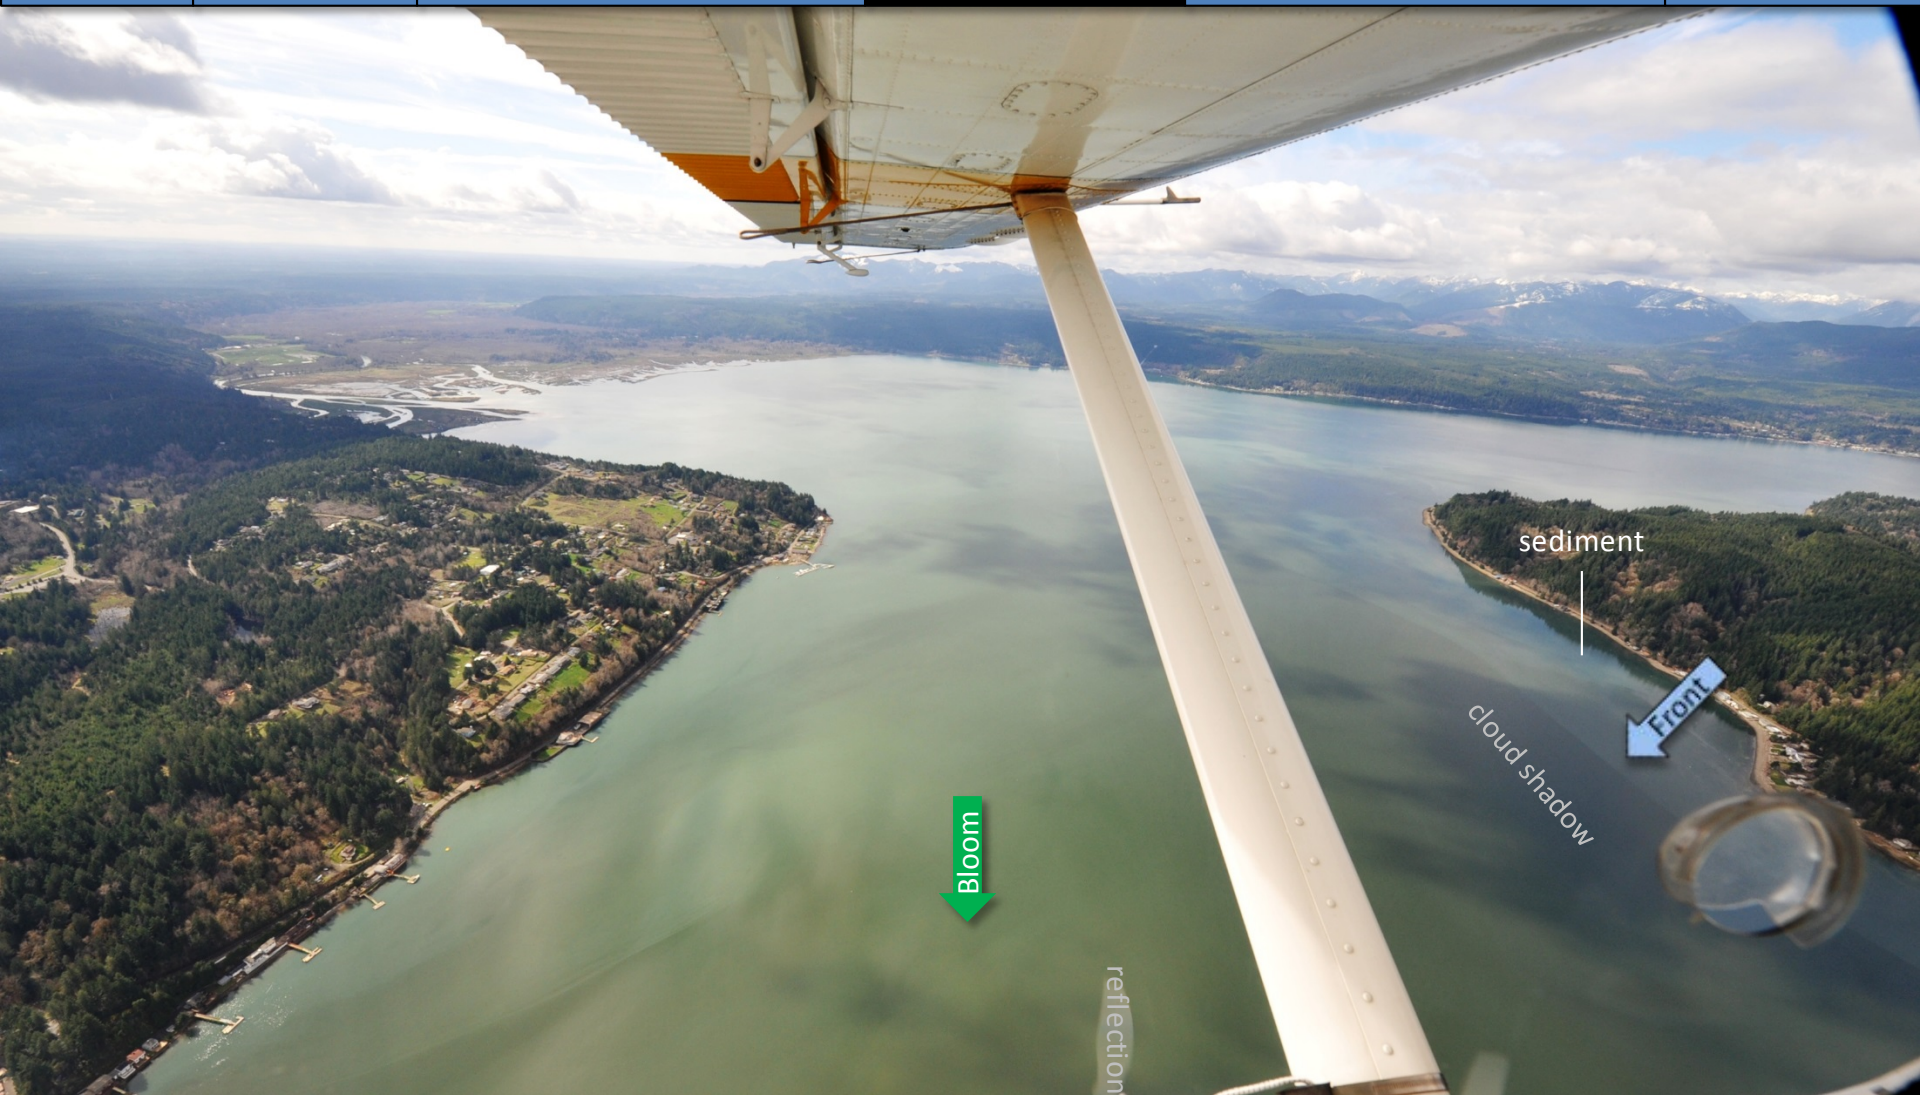
*Phytoplankton bloom in green and red-brown colors and in full swing.
Location: Hood Canal near Union (South Sound), 2:21 PM.*

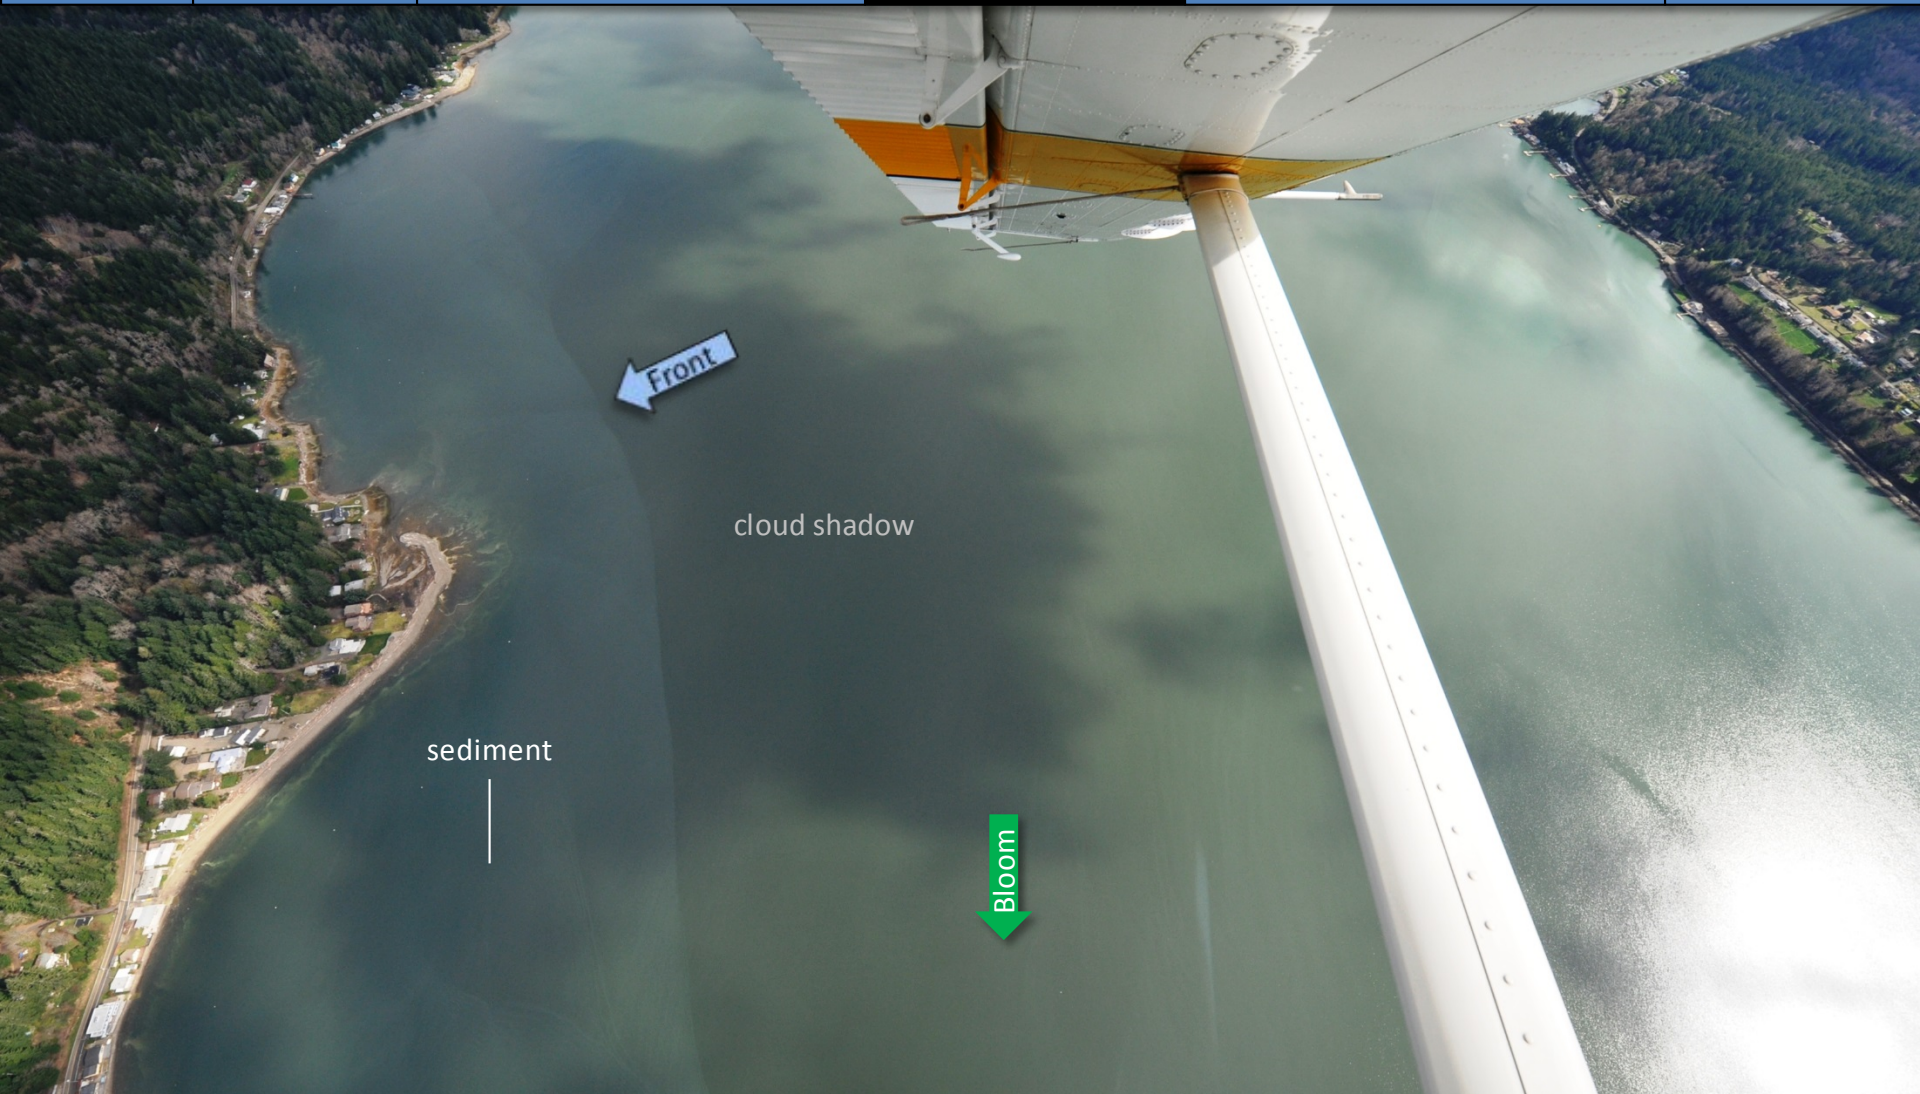
Phytoplankton bloom in full swing next to water from the Skokomish River. Shadow of cloud dark.
Location: Hood Canal near Union (South Sound), 2:21 PM.

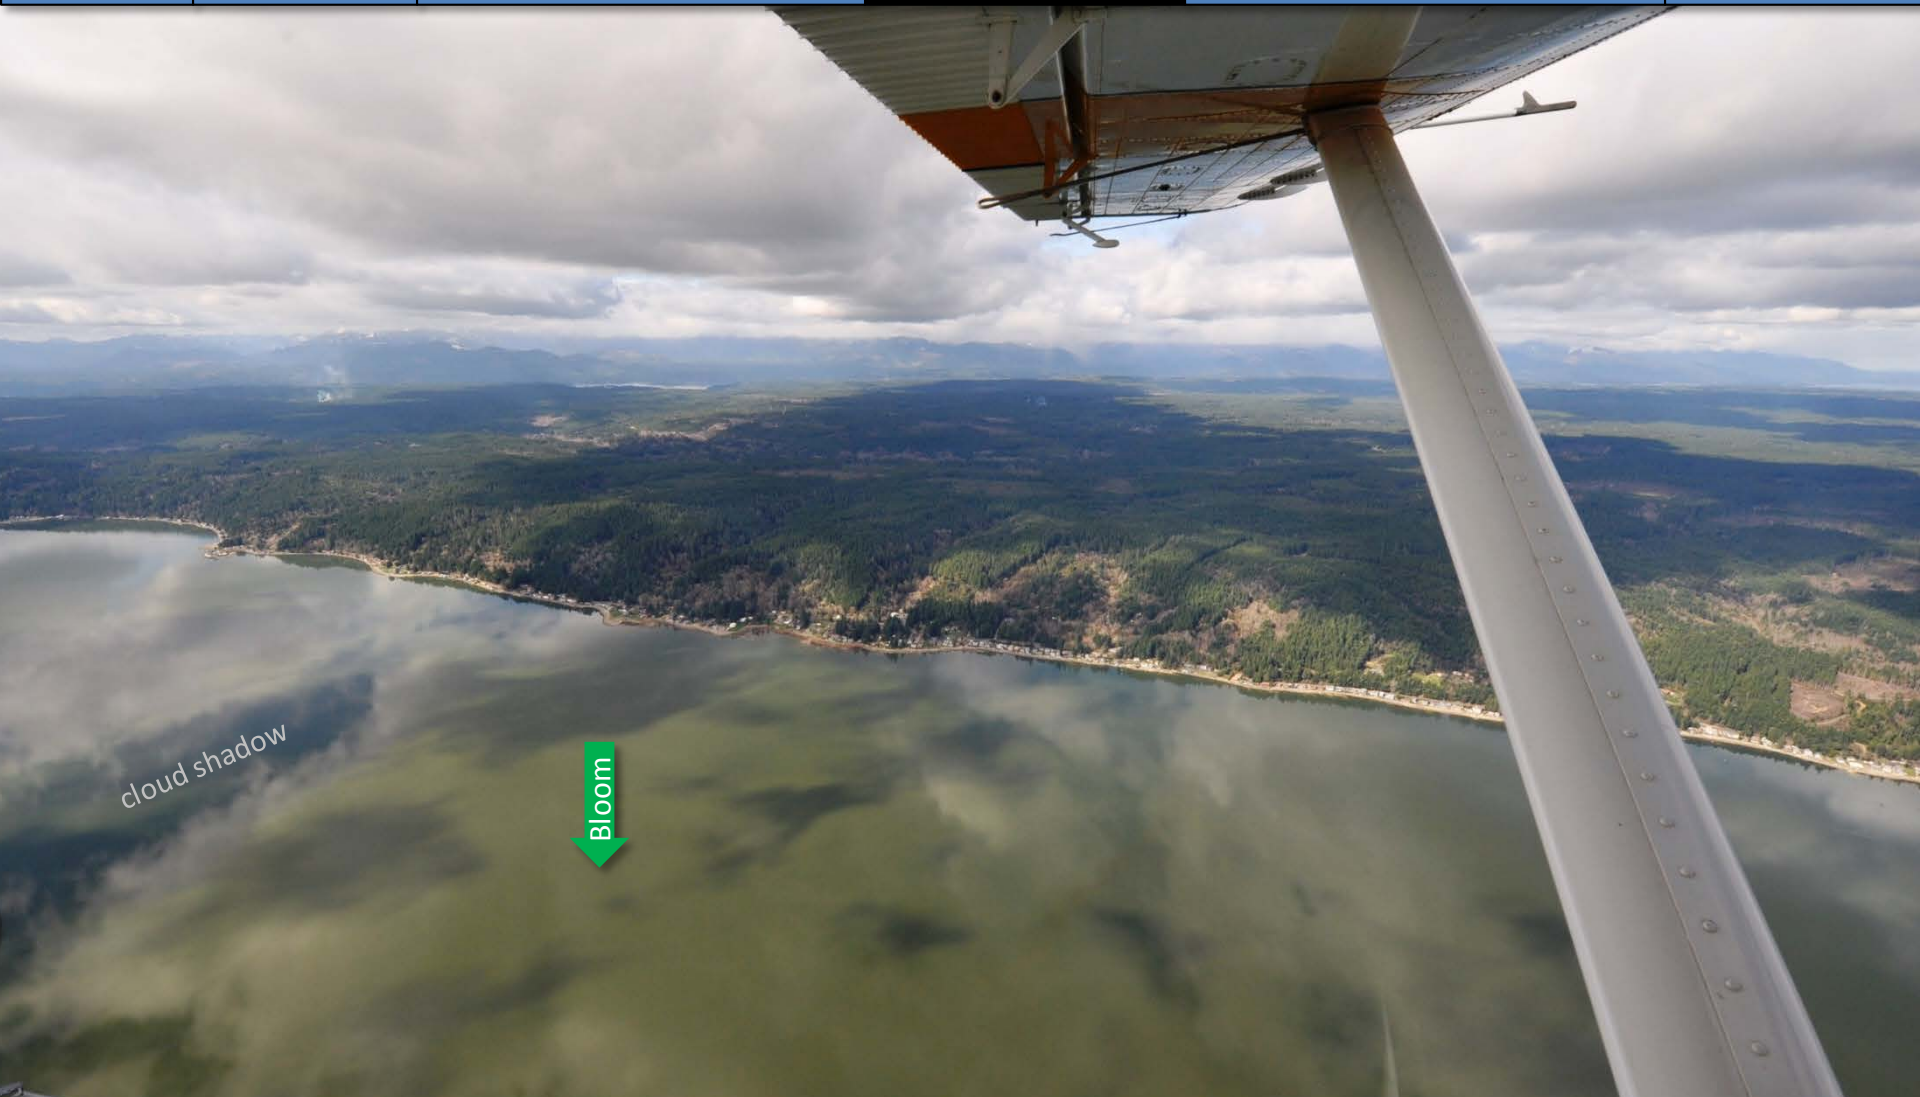
Phytoplankton bloom in green-brown color with clouds and their reflections.
Location: Hood Canal near Union (South Sound), 2:26 PM.

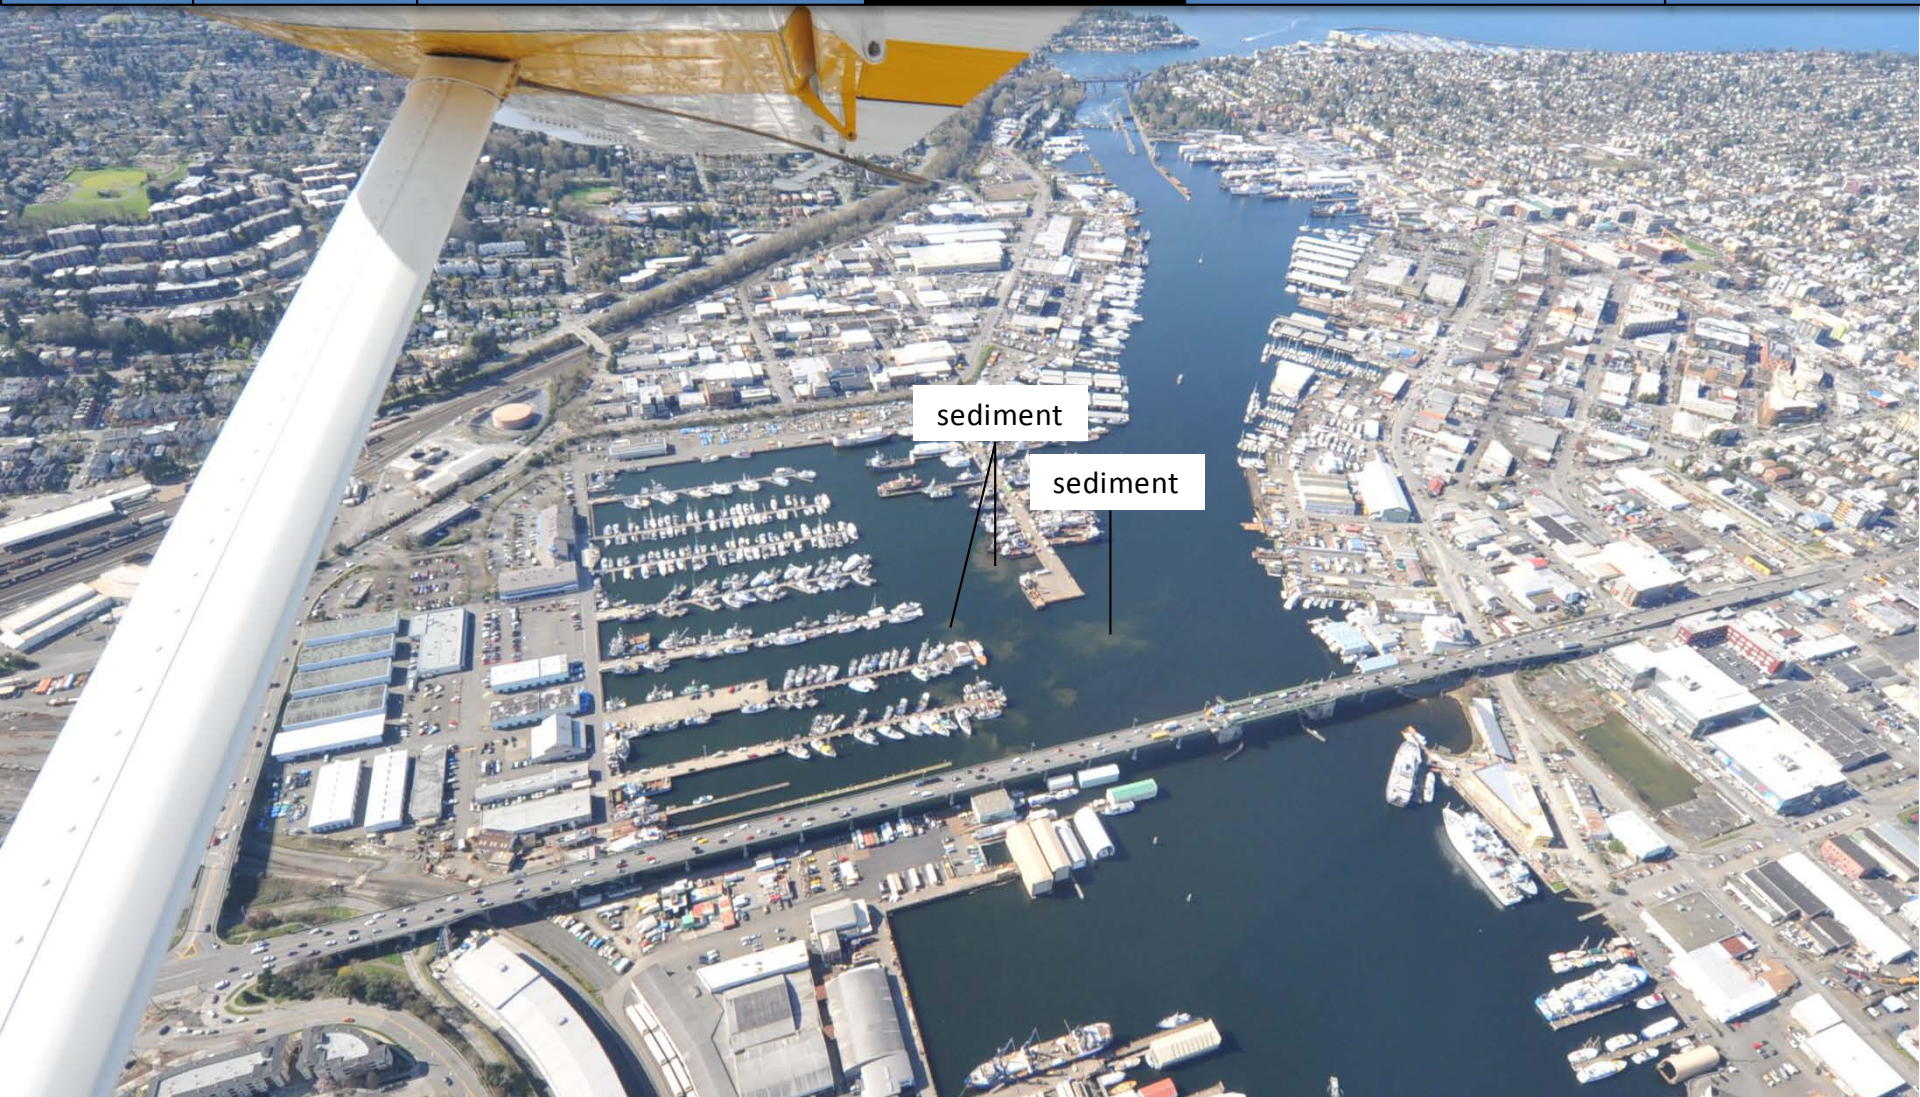
Multiple isolated plumes of suspended sediment near NW Dock and Dock 3 & 4.
Location: Salmon Bay (Seattle), 2:44 PM.

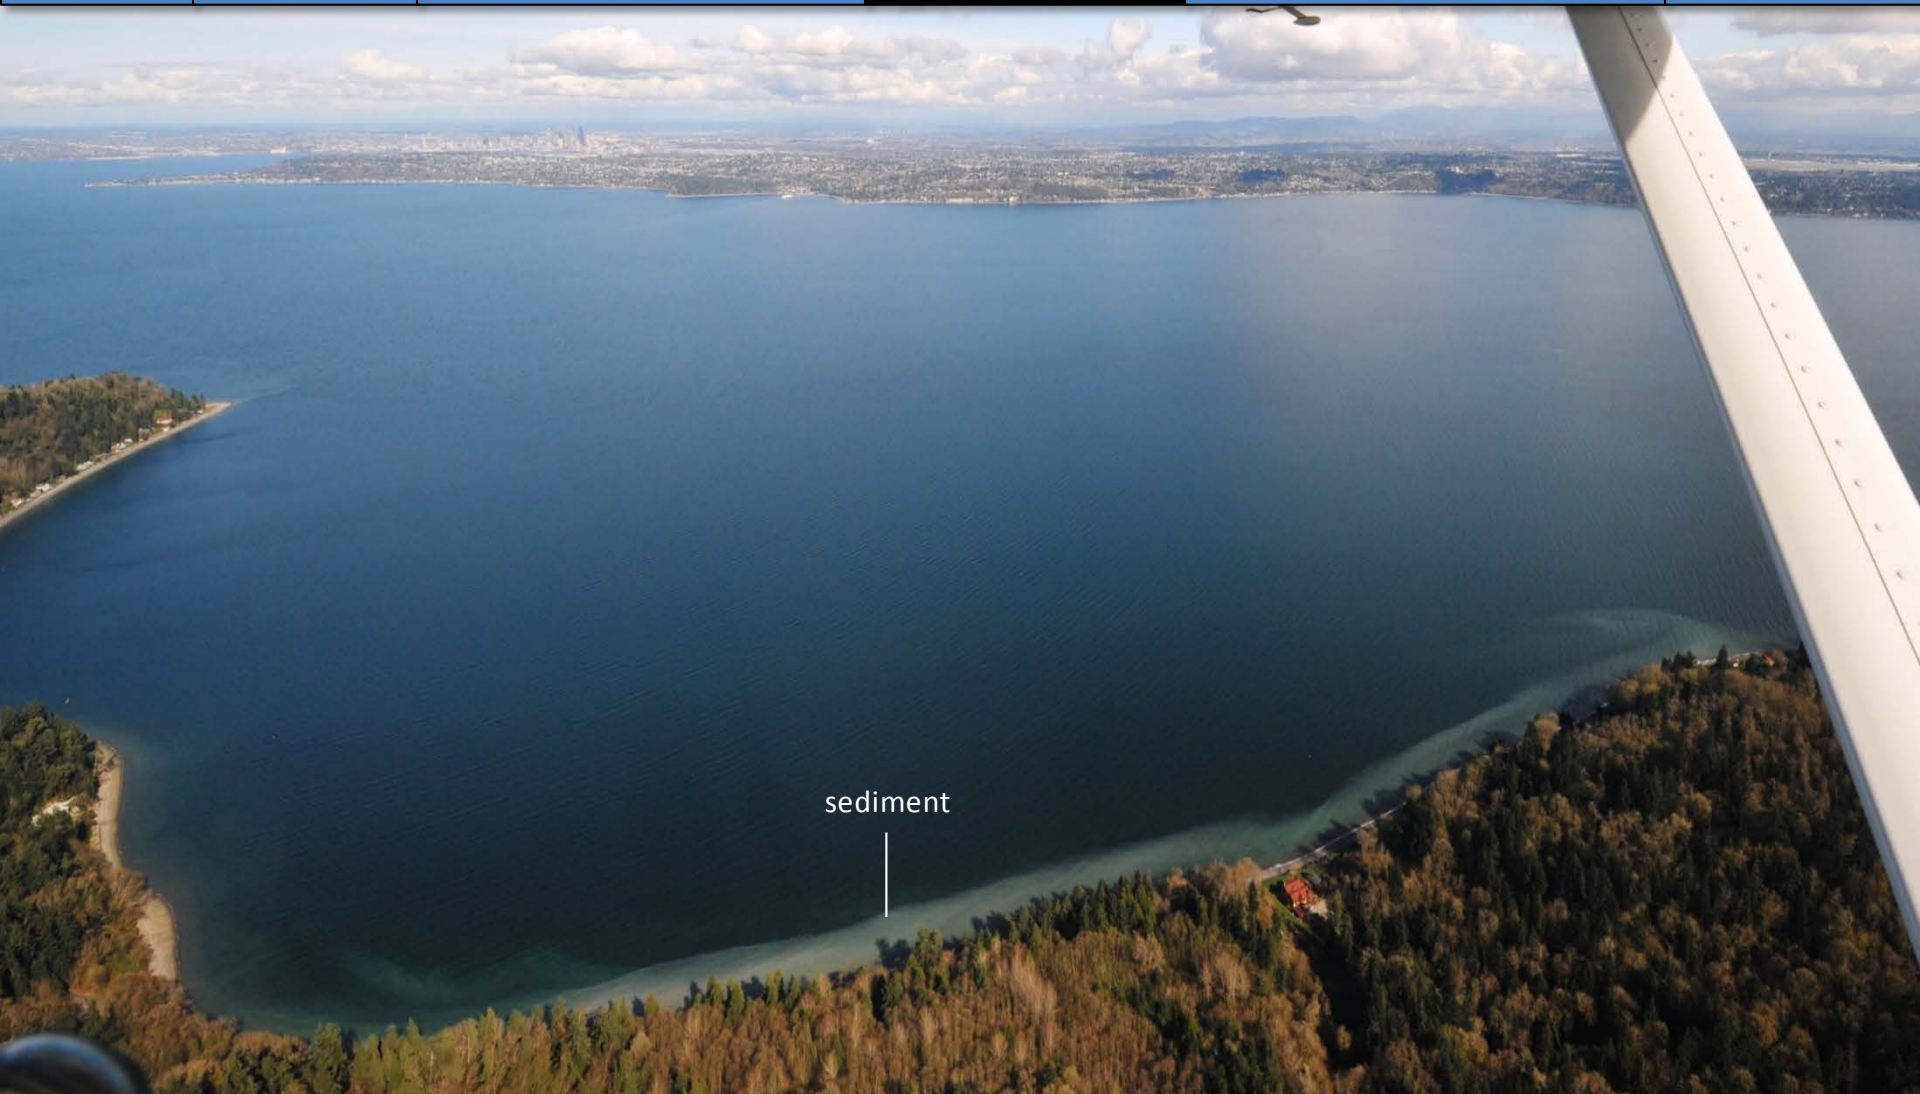
Large ribbon of suspended sediments along eastern Vashon Island beaches.

Location: Chautauqua, Vashon Island (Central Sound), 2:51 PM.

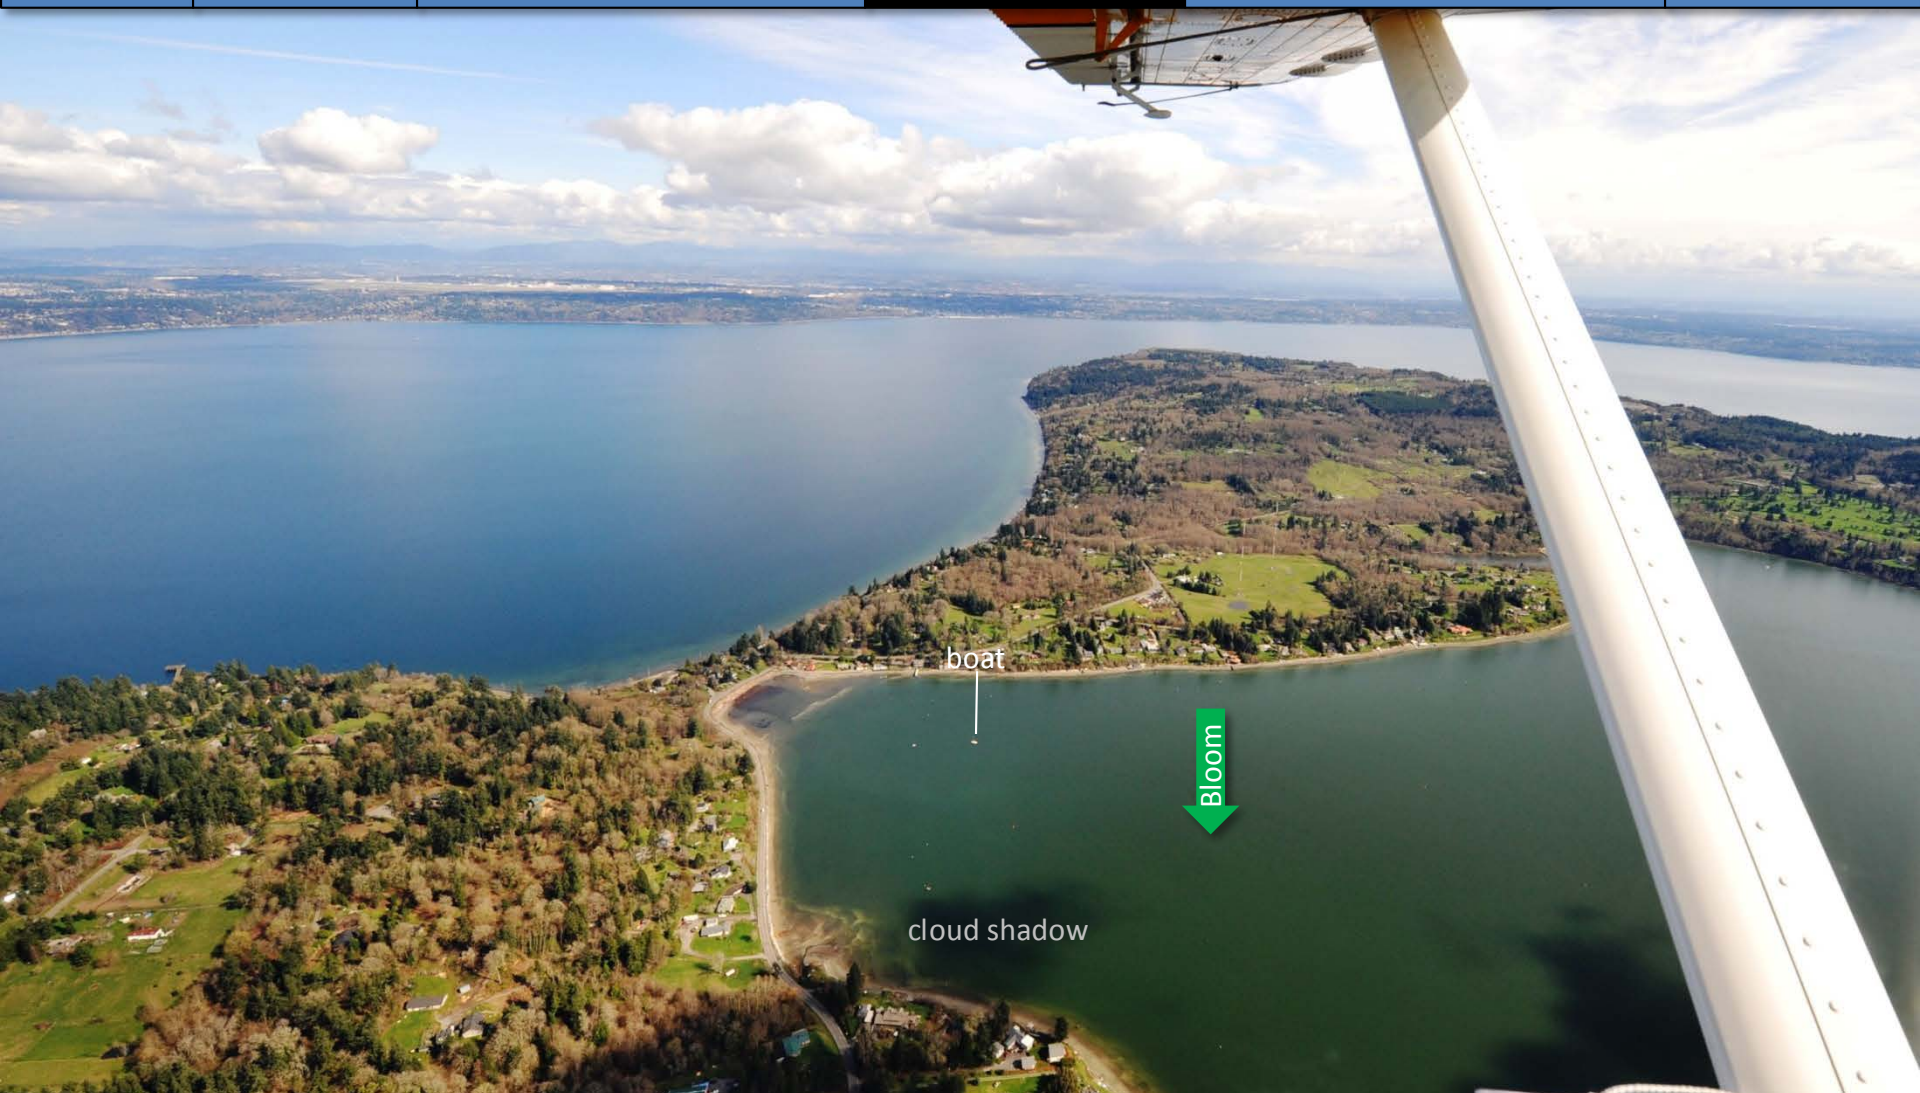
Phytoplankton staining water greenish and shades from clouds.

Location: Portage, Vashon Island (Central Sound), 2:54 PM.

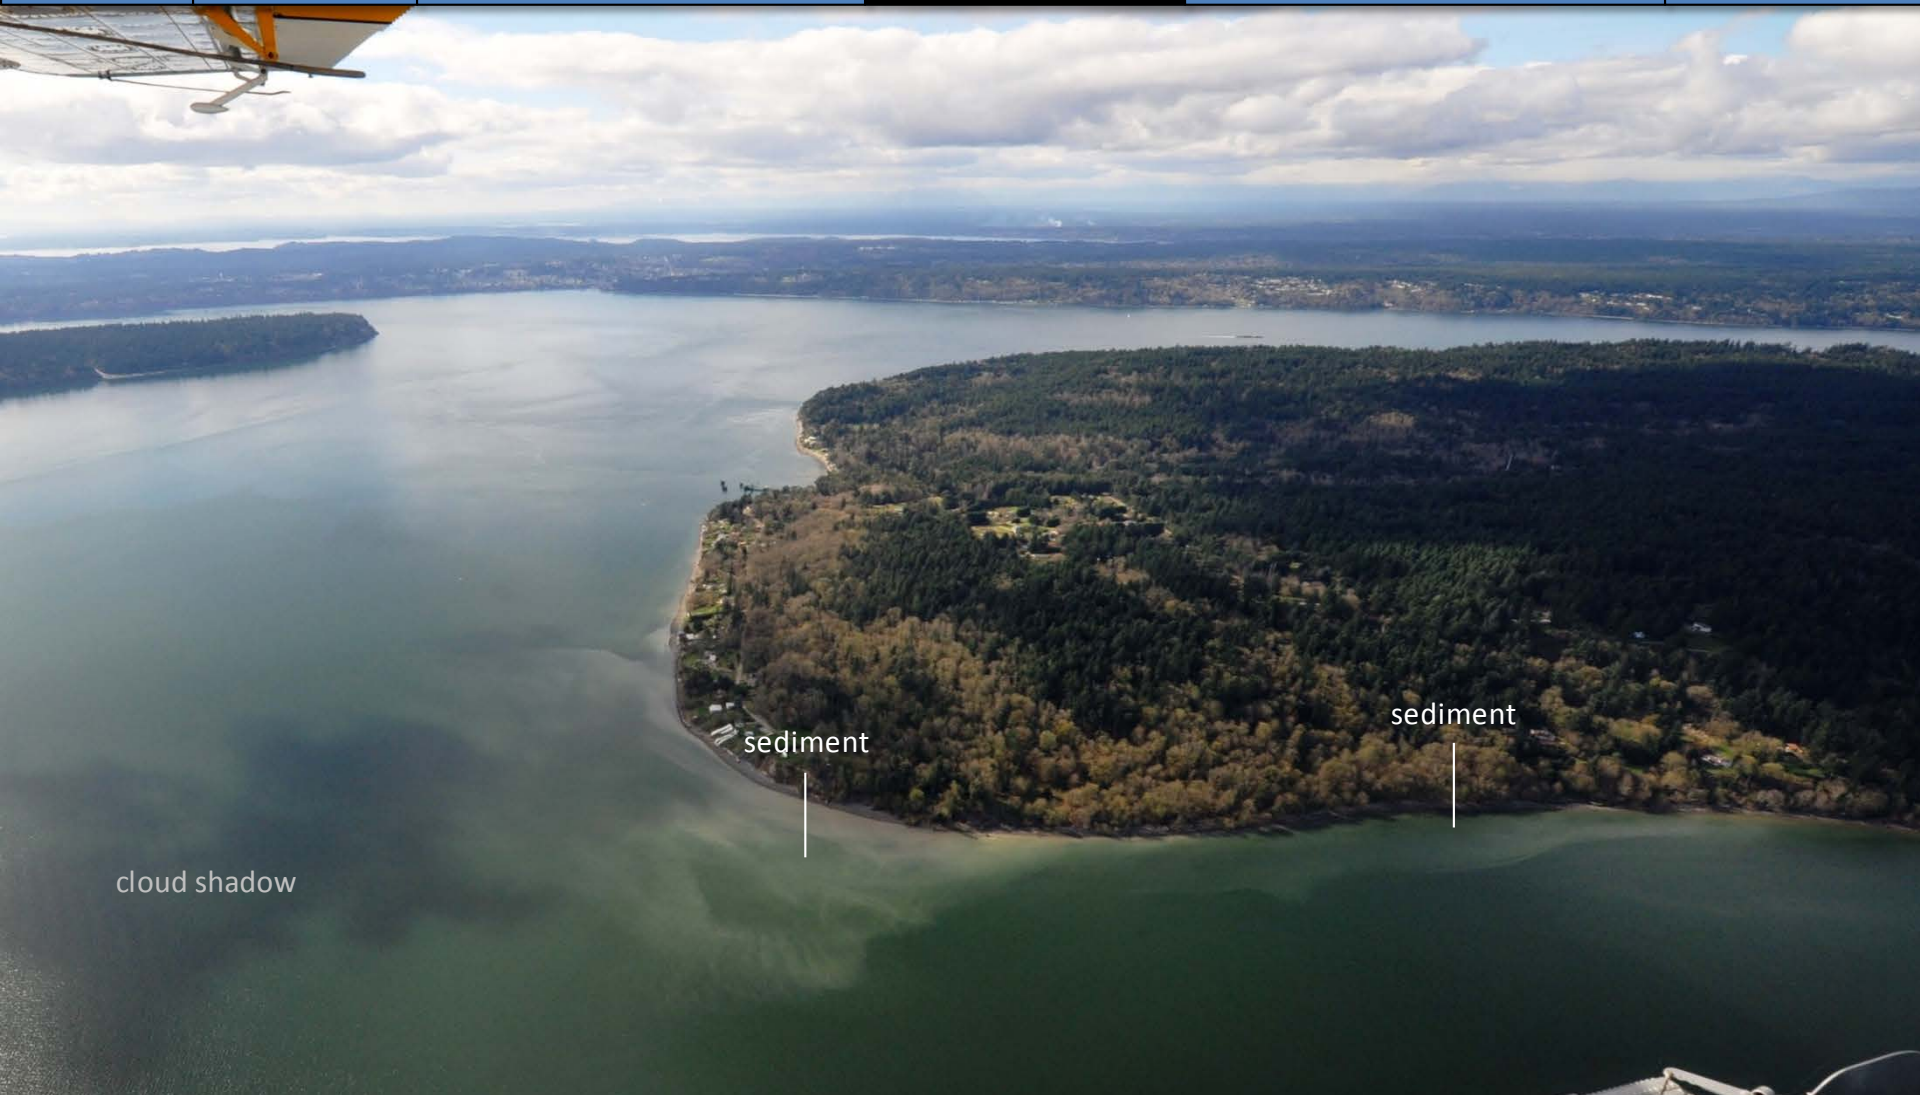
Large patch of suspended sediments along eastern Vashon Island beaches.
Location: Neill Point, Vashon Island (Central Sound), 2:57 PM.

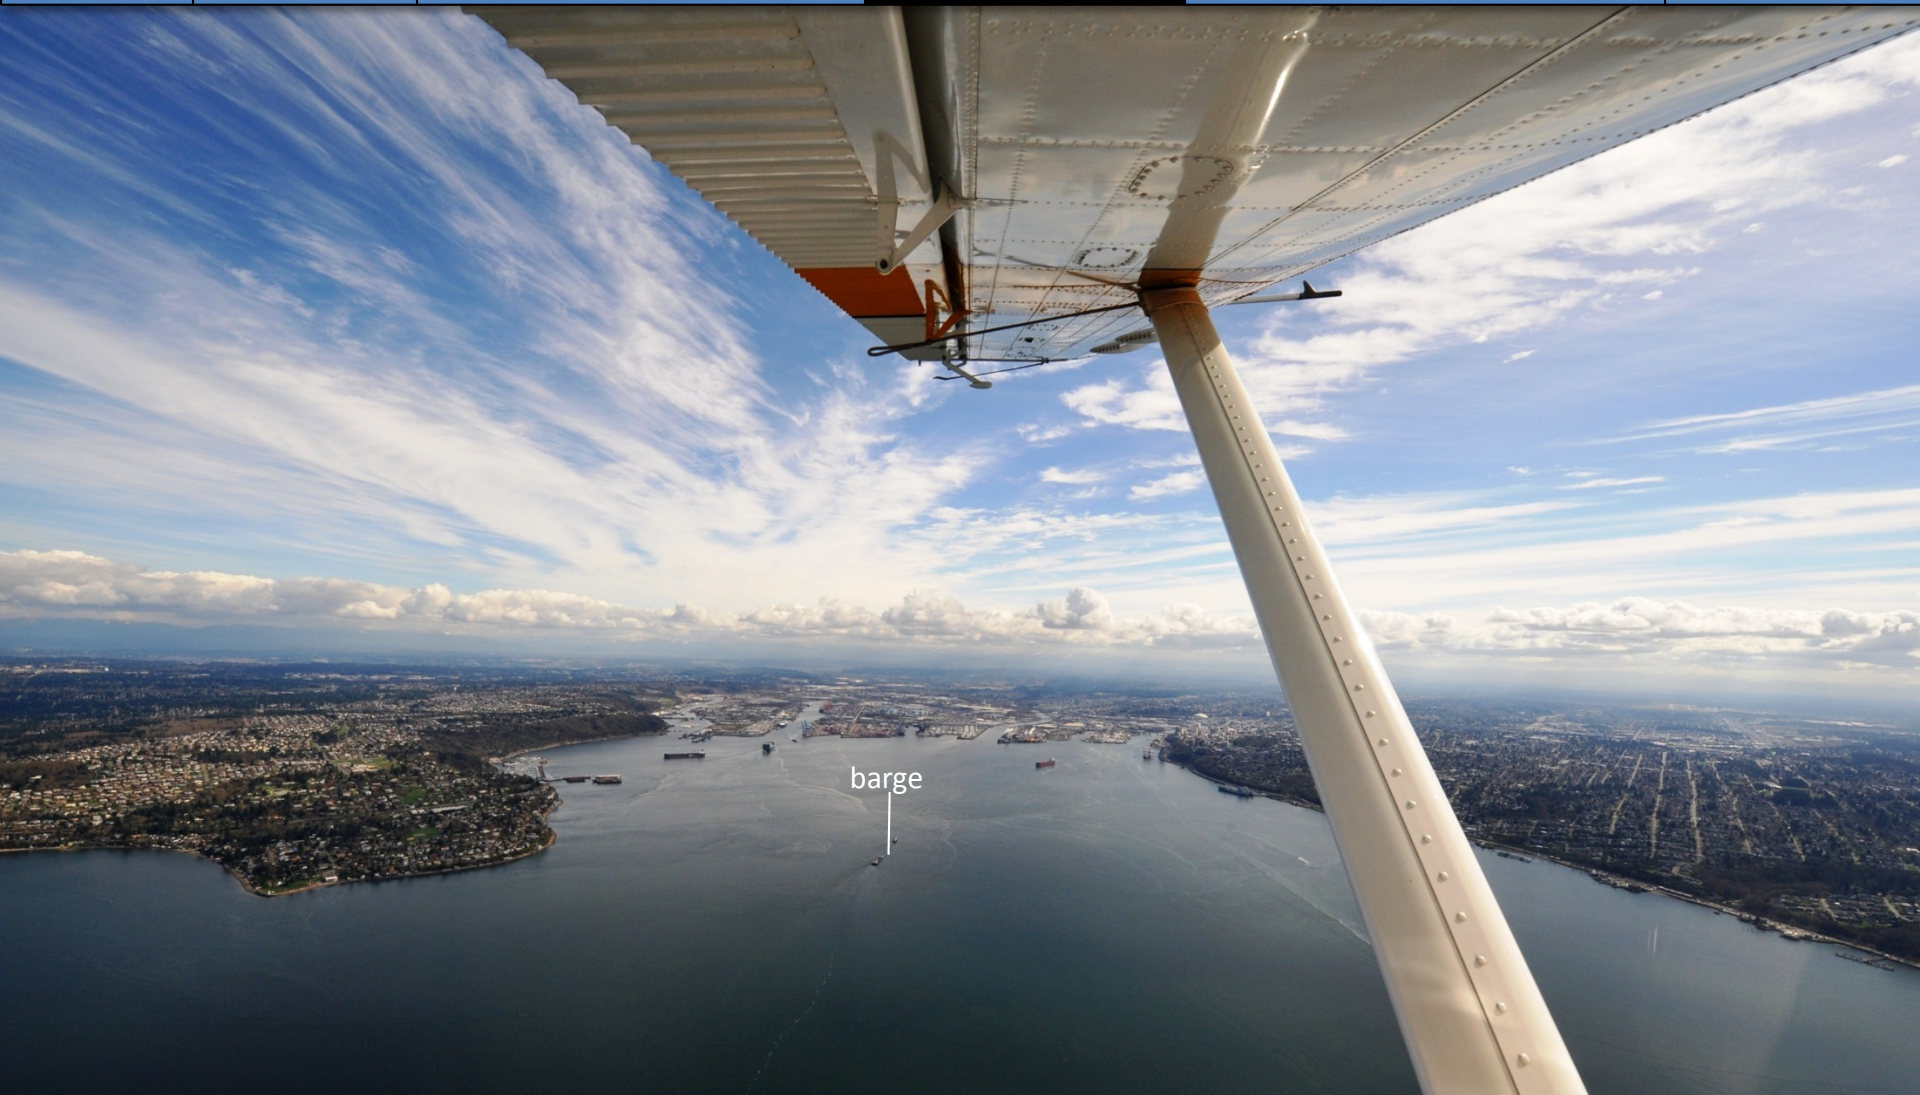
Commencement Bay in dramatic cloud setting. Puyallup River plume barely visible despite recent heavy rain.
Location: Commencement Bay, Tacoma (Central Sound), 2:57 PM.

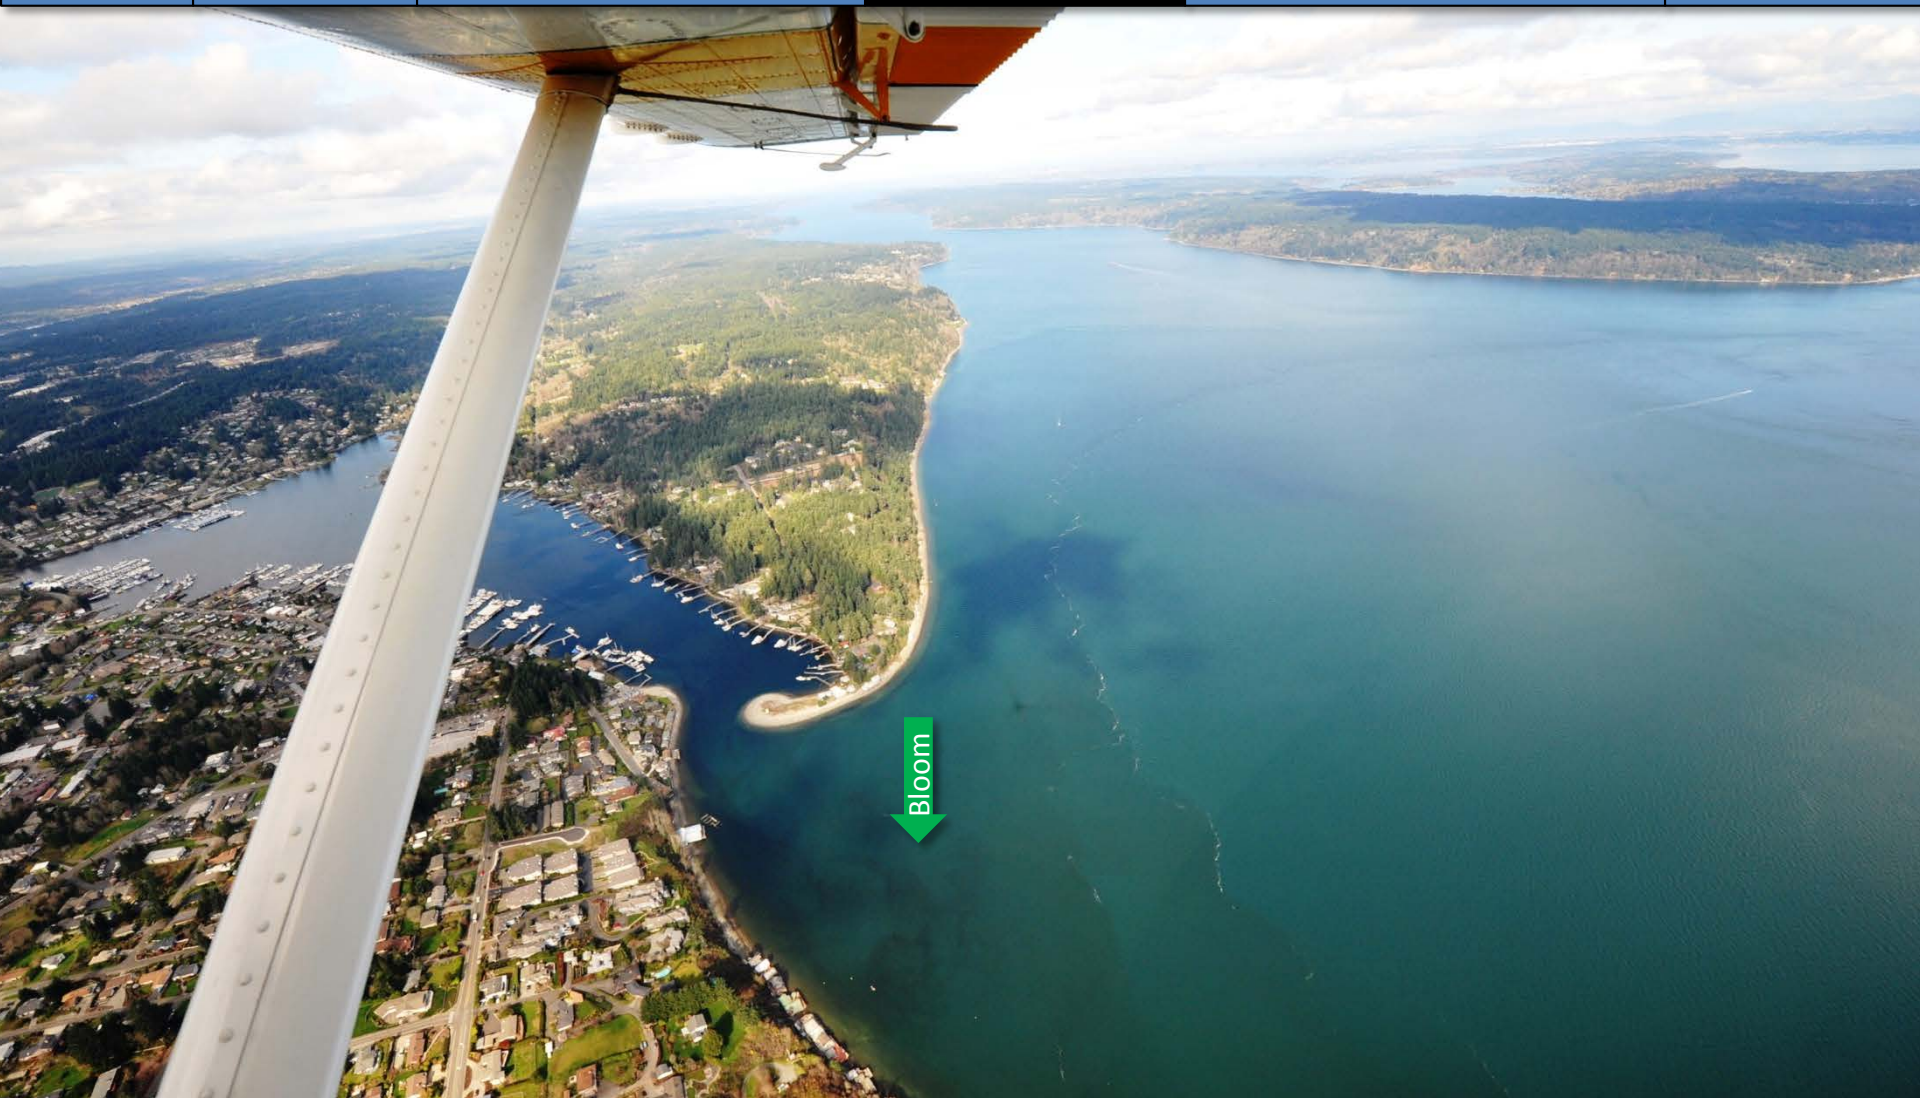
*Red-brown bloom originating from Gig Harbor flowing into the Tacoma Narrows.
Location: Gig Harbor (Central Sound), 3:00 PM.*

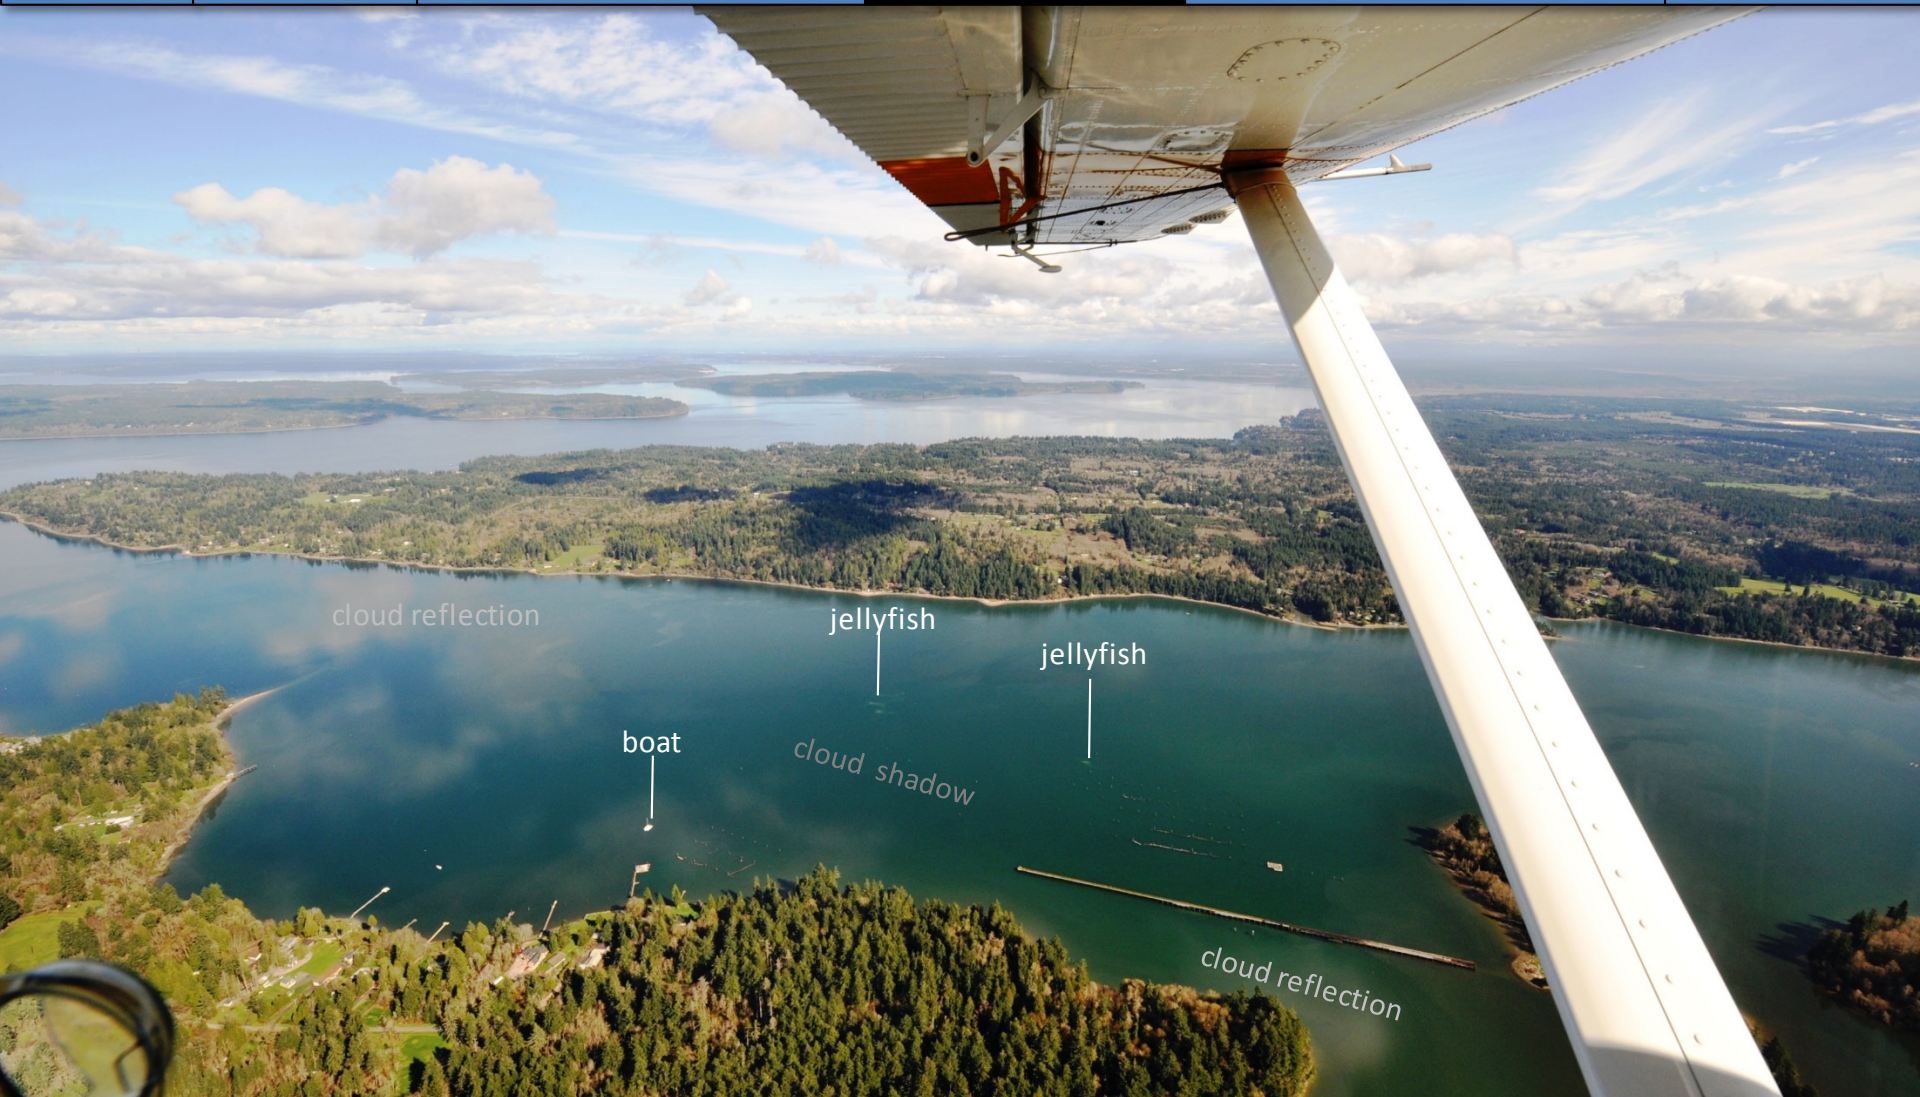
Jellyfish patches and green water stained by phytoplankton bloom.
Location: Henderson Inlet (South Sound), 3:12 PM.
