Eyes Over Puget Sound

Surface Conditions Report, March 16, 2016

Up-to-date observations of visible water quality conditions in Puget Sound and the Strait of Juan de Fuca

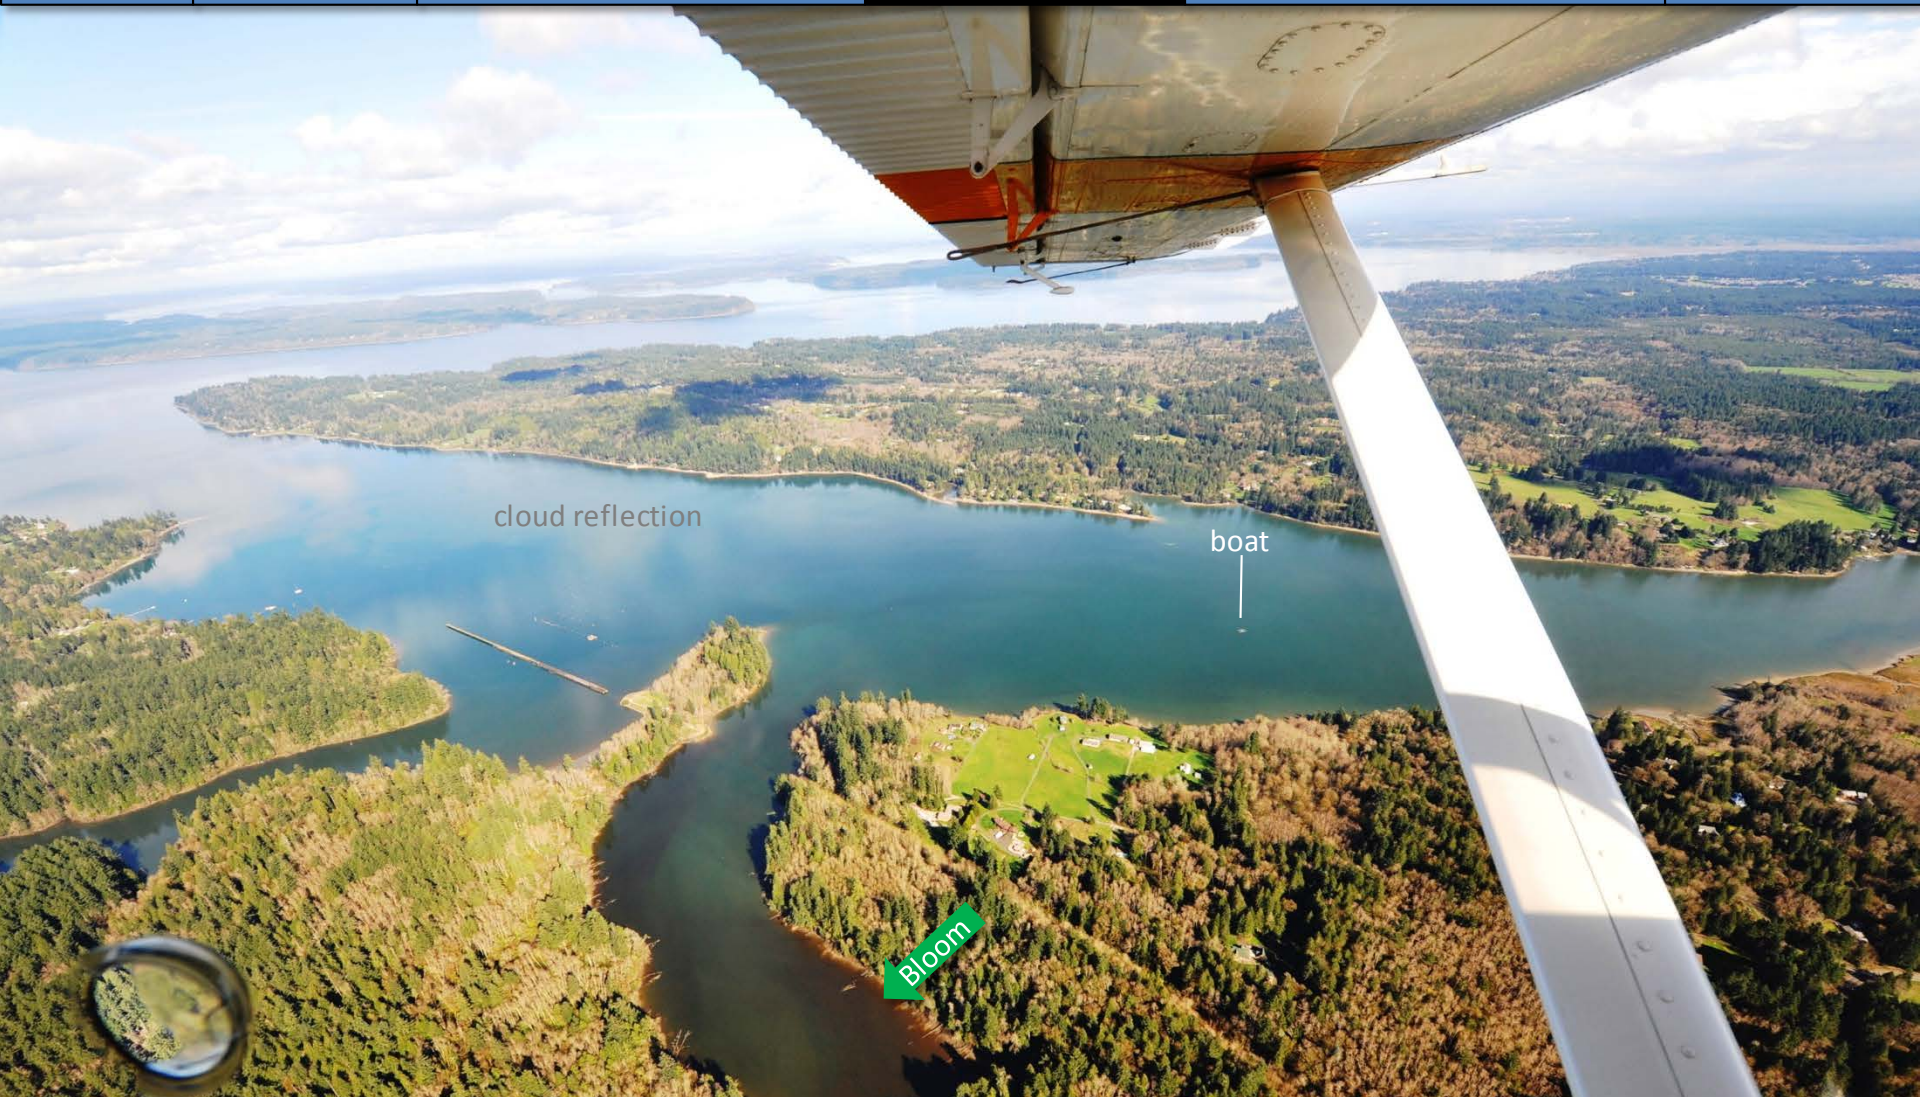
Red-brown bloom confined to Woodard Bay.
Location: Henderson Inlet (South Sound), 3:12 PM.

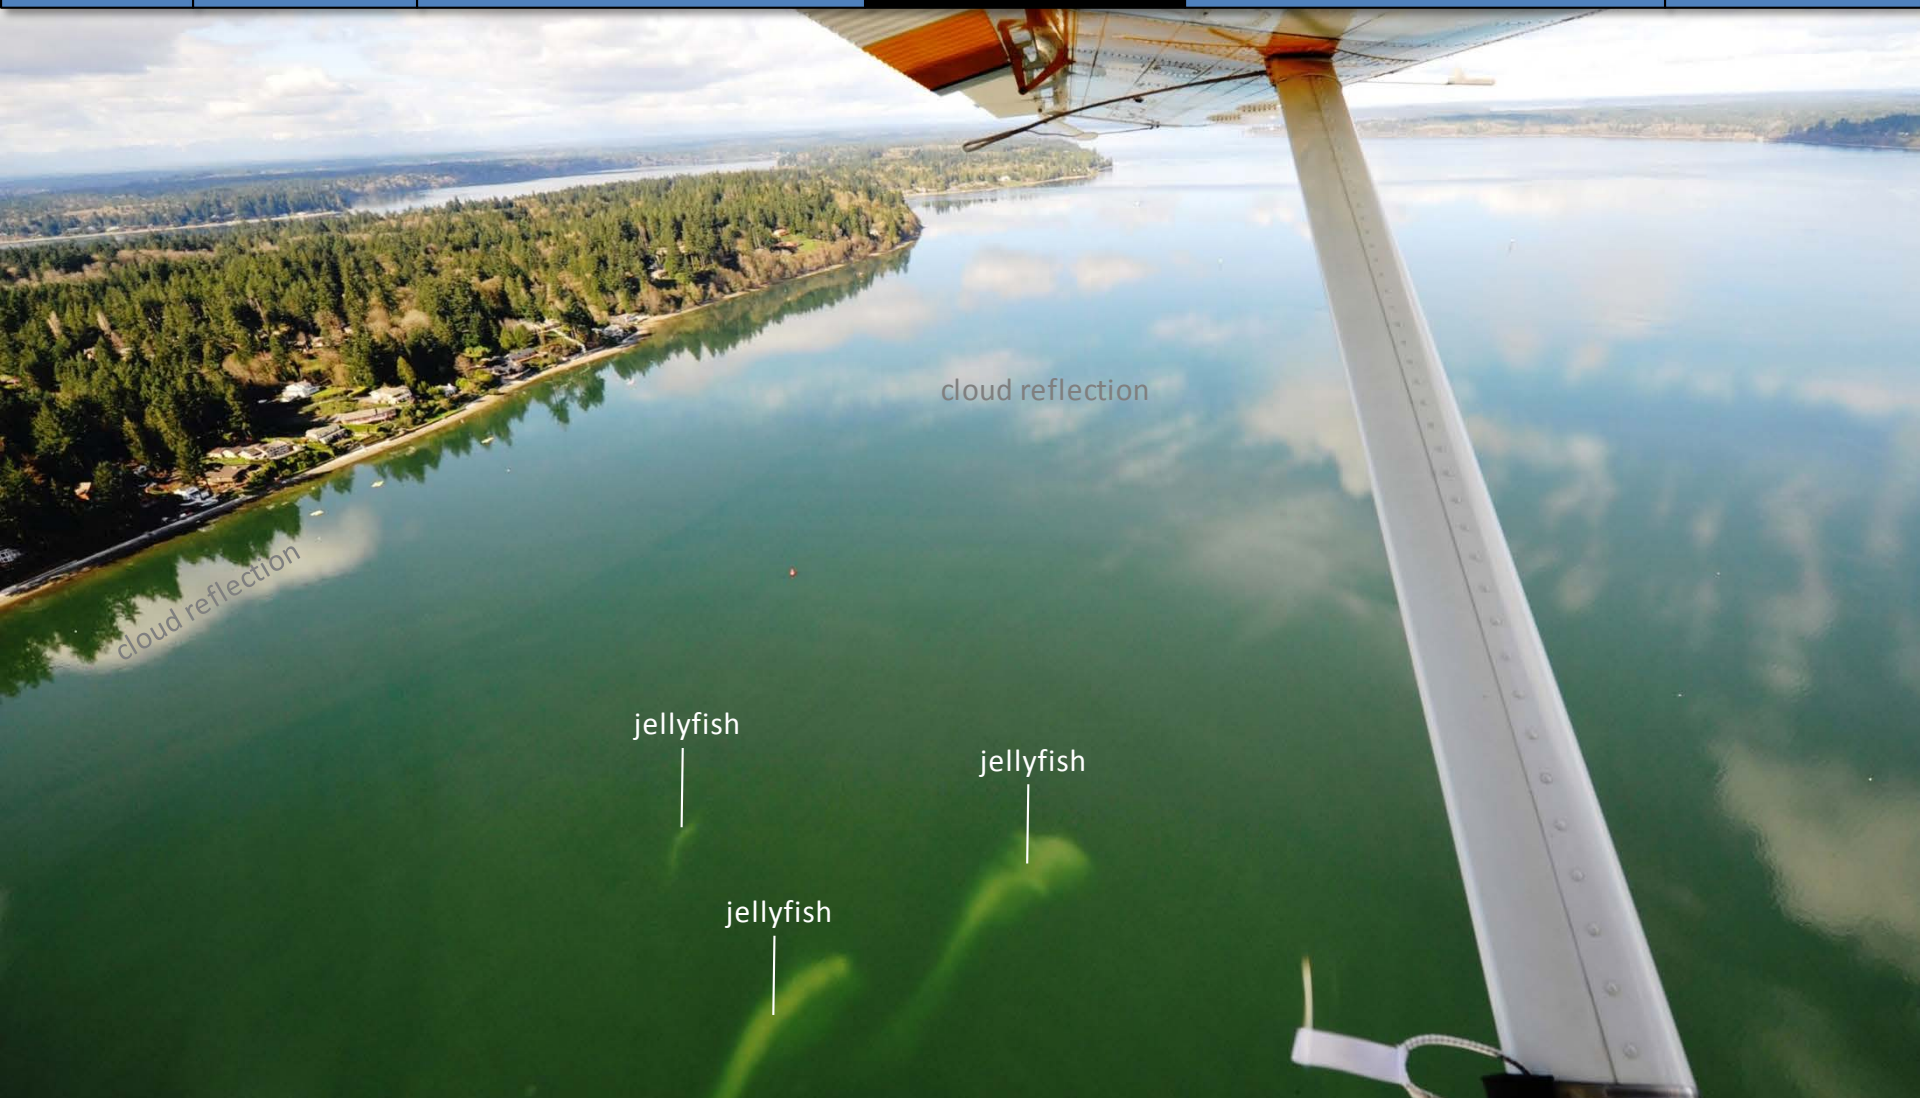
Jellyfish patches in green water discolored by a spring bloom.
Location: Budd Inlet (South Sound), 3:16 PM.

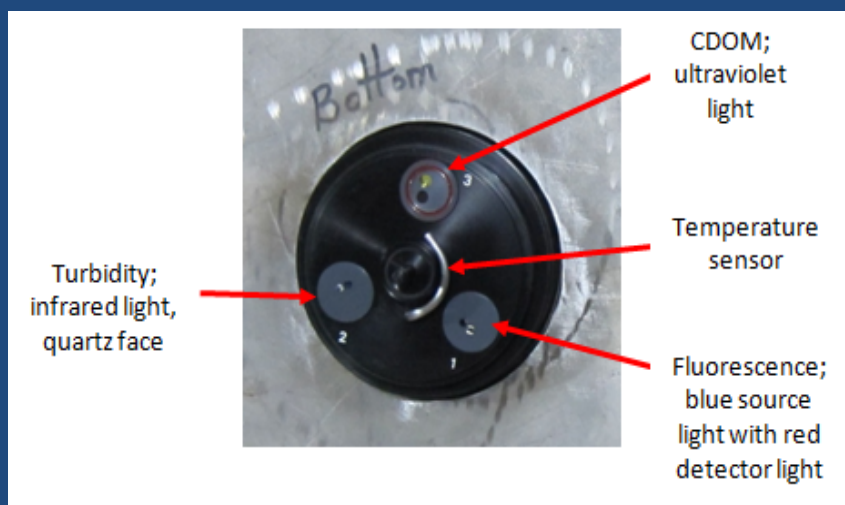
The fluorometer sensor package has three optical lenses that emit light to measure seawater properties (turbidity, colored dissolved material (CDOM) and phytoplankton pigments).

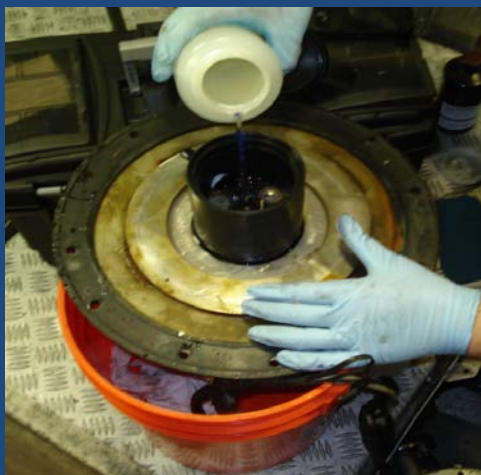
The sensor is inverted over a bucket. We use several test liquids to check that our sensor is operating properly. These include deionized water, ambient seawater, and liquid standards.

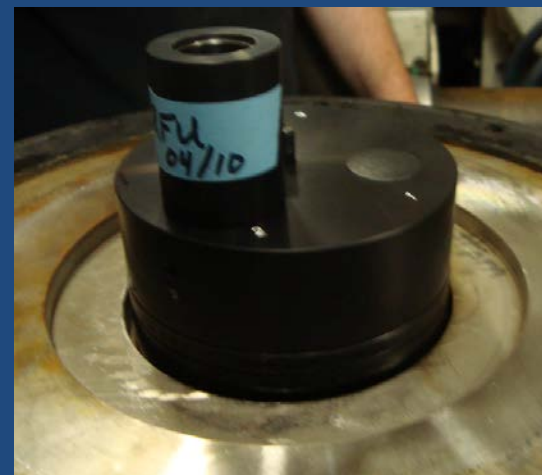
We also check measurements of solid secondary standards. When our servicing is complete, we reinstall the instrument in the sea chest.
