Eyes Over Puget Sound

Surface Conditions Report

July 20, 2016

Up-to-date observations of water quality conditions in Puget Sound and coastal bays

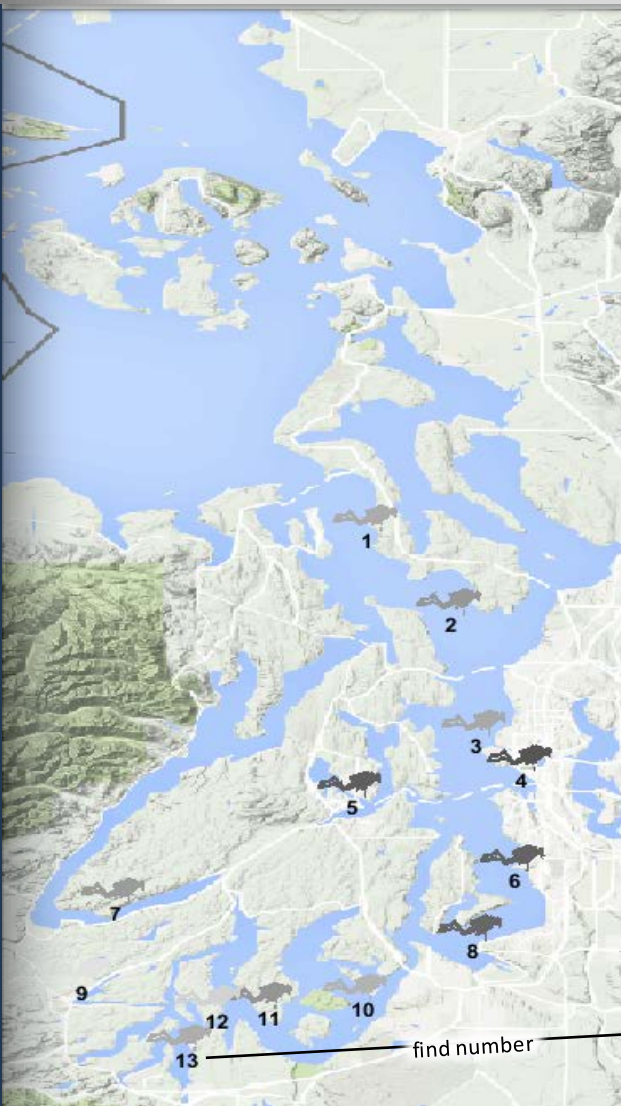
Best /Depth		Least /Depth
	(Depth is in feet)		
1)	19 / 79	 	6 / 5
2)	23 / 98

7 / 8
3)	19 / 49	 	11 / 7
4)	39 / 77	 	13 / 18
5)	37 / 5	 	8 / 38
6)	36 / 80	 	23 / 10
7)	23 / 61	 	4 / 23
8)	35 / 89	 	3 / 3
9)	6 / 16	 	5 / 3
10)	17 / 98	 	13 / 16
11)	24 / 95	 	11 / 10
12)	9 / 97	 	7 / 3
13)	18 / 25	 	4 / 5

- **Best visibility** was around 35 feet or more.
- **Poor visibility** occurred in many places of Puget Sound in the first 10 feet of the surface.
- In June, compared to May, visibility improved in Central Basin to the south of Seattle.
- Elliott Bay visibility improved from 22 feet to 39 feet.
- We use transmissometer readings from our CTD package and convert them into horizontal visibility.

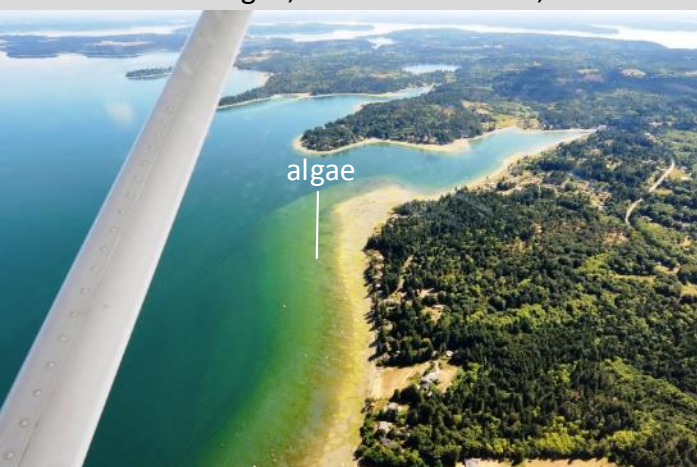
Mats of macro-algae, Von Geldern Cove, Carr Inlet

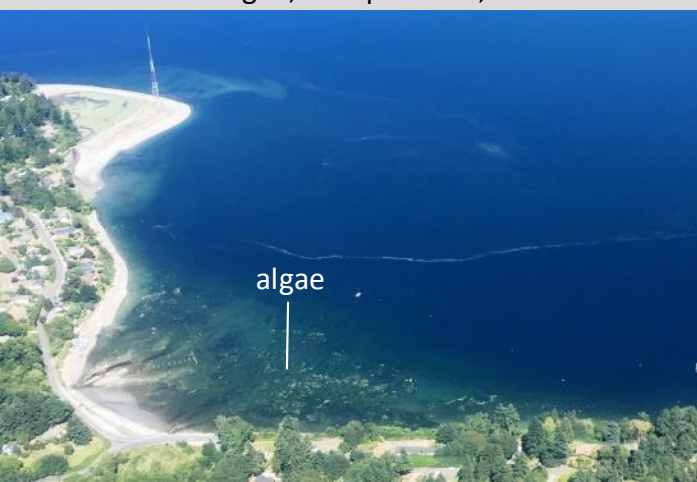
Mats of macro-algae, Tramp Harbor, Vashon Island

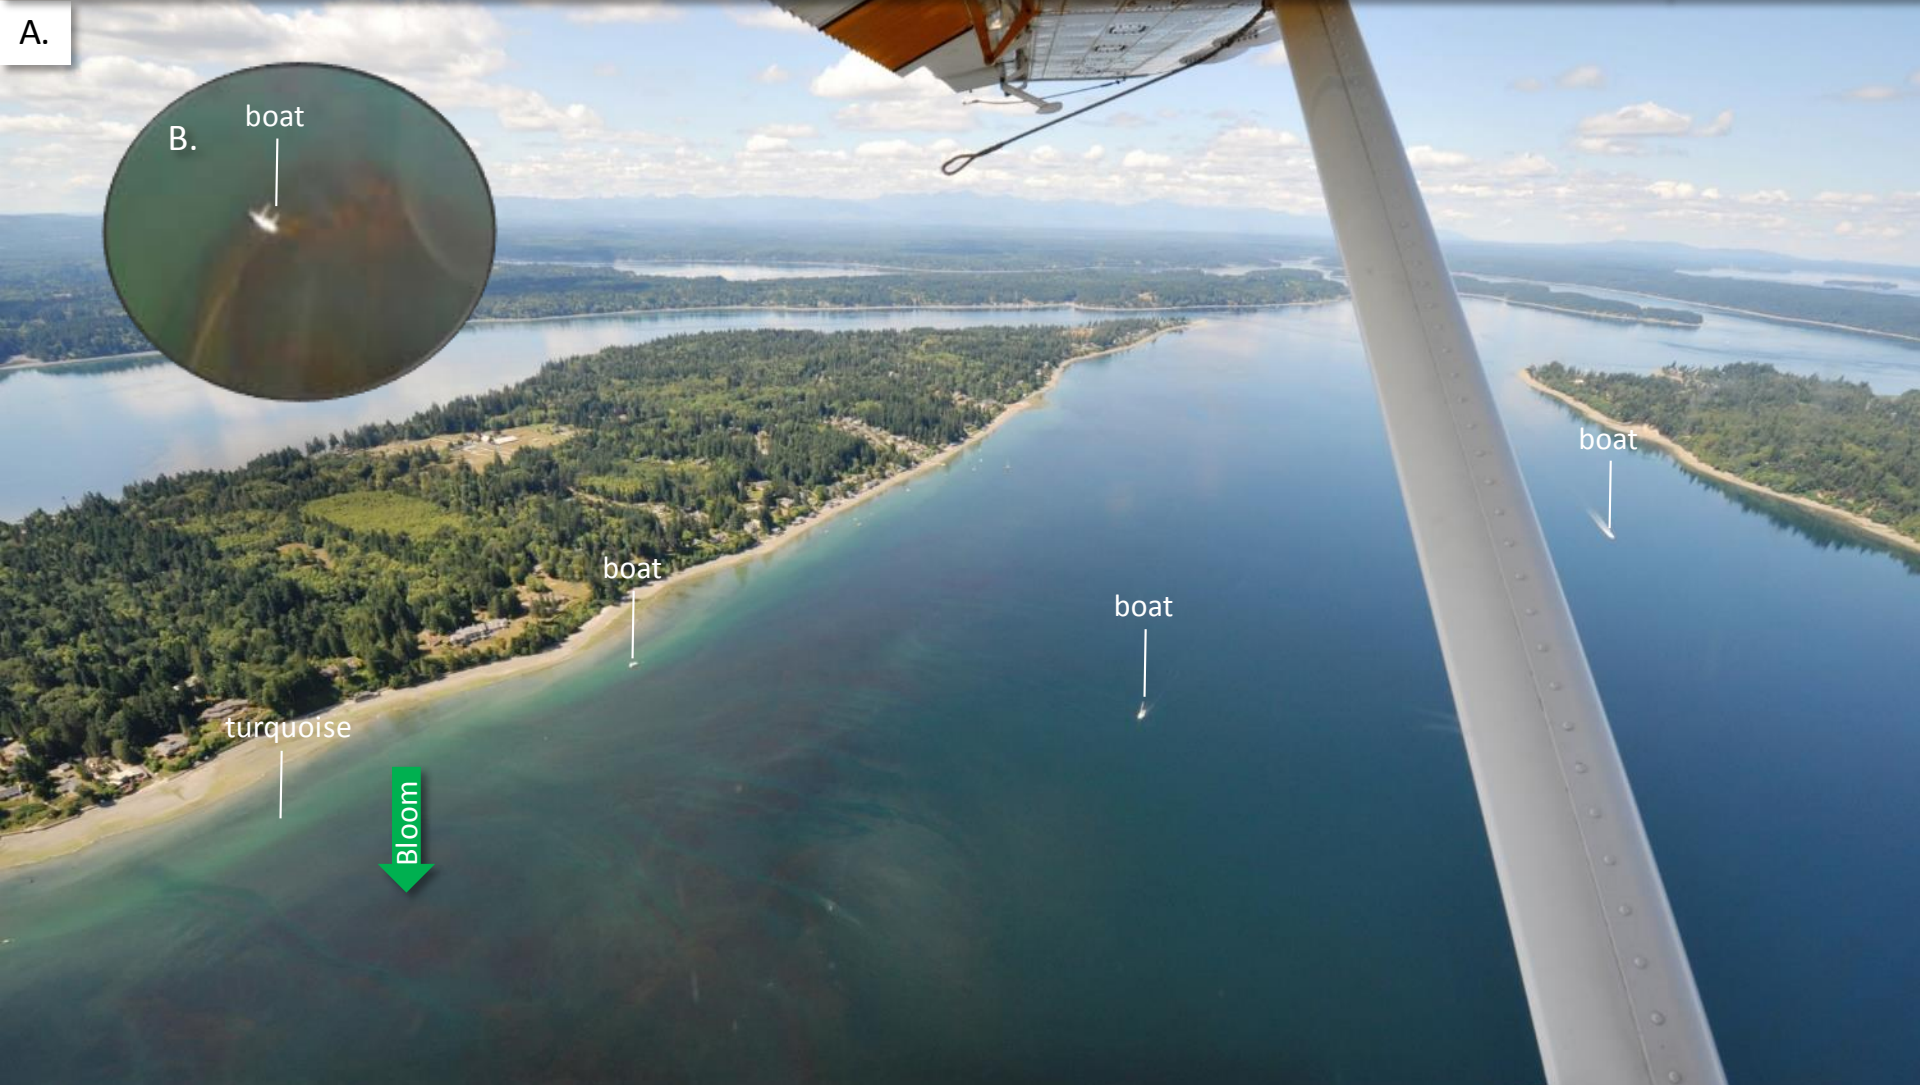
A. Red-brown bloom and turquoise water in western Budd Inlet. B. Sailboat in an intense patch of the bloom. Location: A. North of Big Tykle Cove. B. Butler Cove, Budd Inlet (South Sound), 3:00 PM.

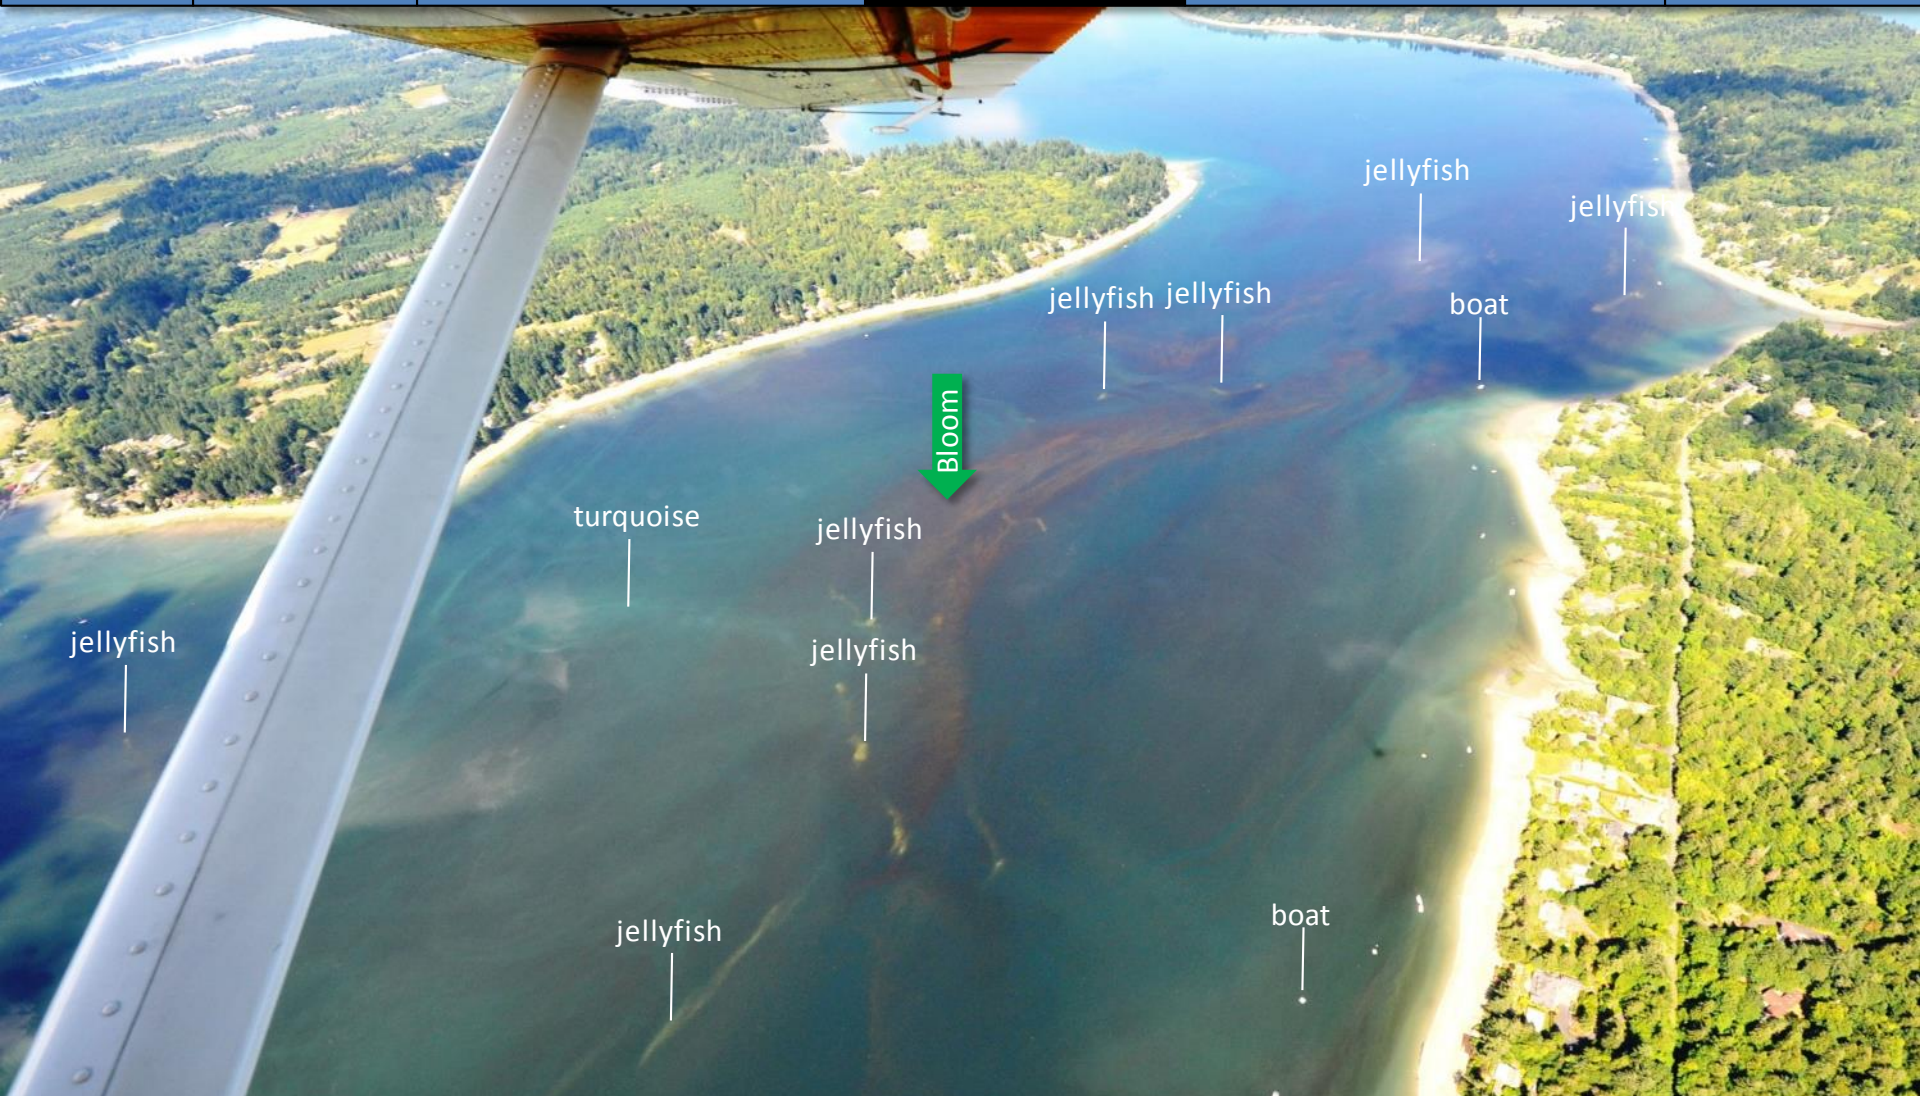
Red-brown bloom and large patches of jellyfish. Turquoise water is likely freshwater.
Location: Across from Young Cove, Eld Inlet (South Sound), 3:08 PM.

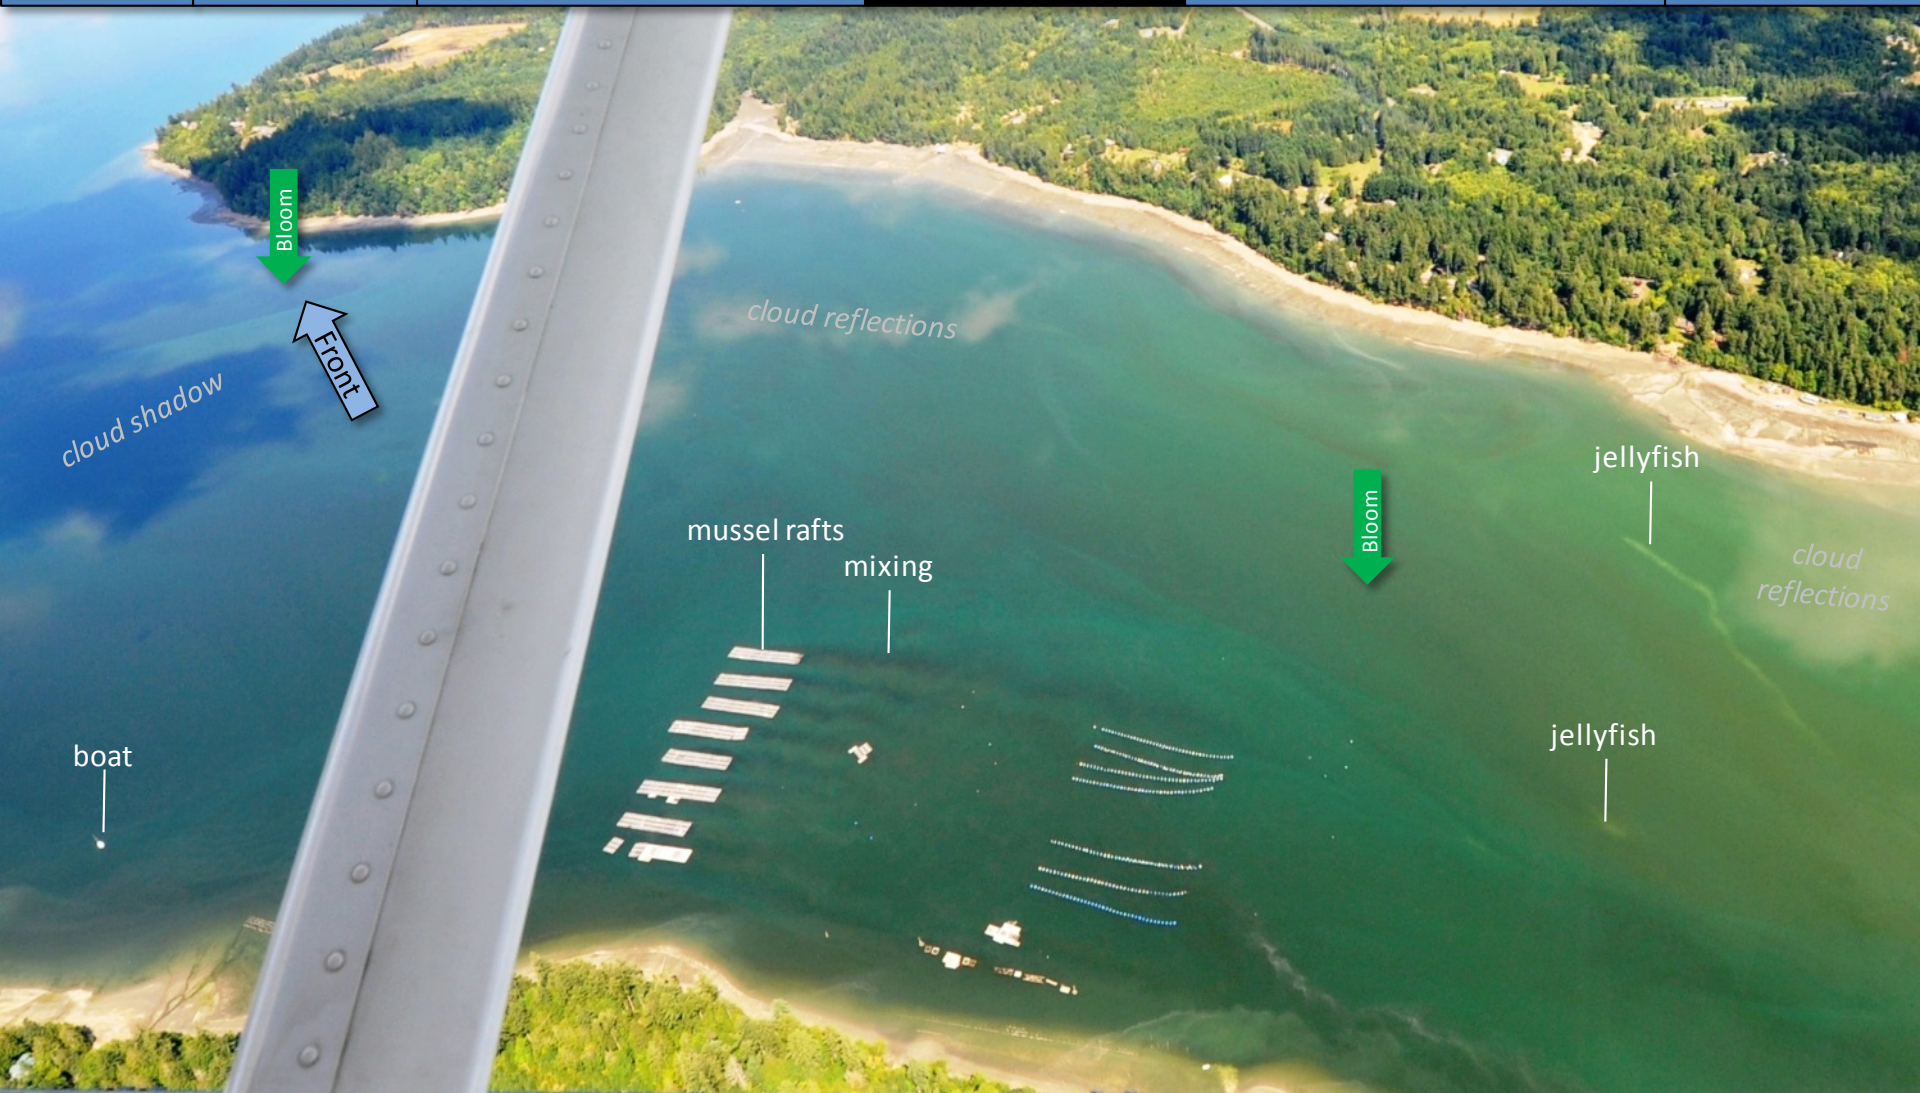
*Mixing of water behind aquaculture structures in stratified water containing a bloom (incoming tide).
Location: South of Big Cove, Totten Inlet (South Sound), 3:11 PM.*

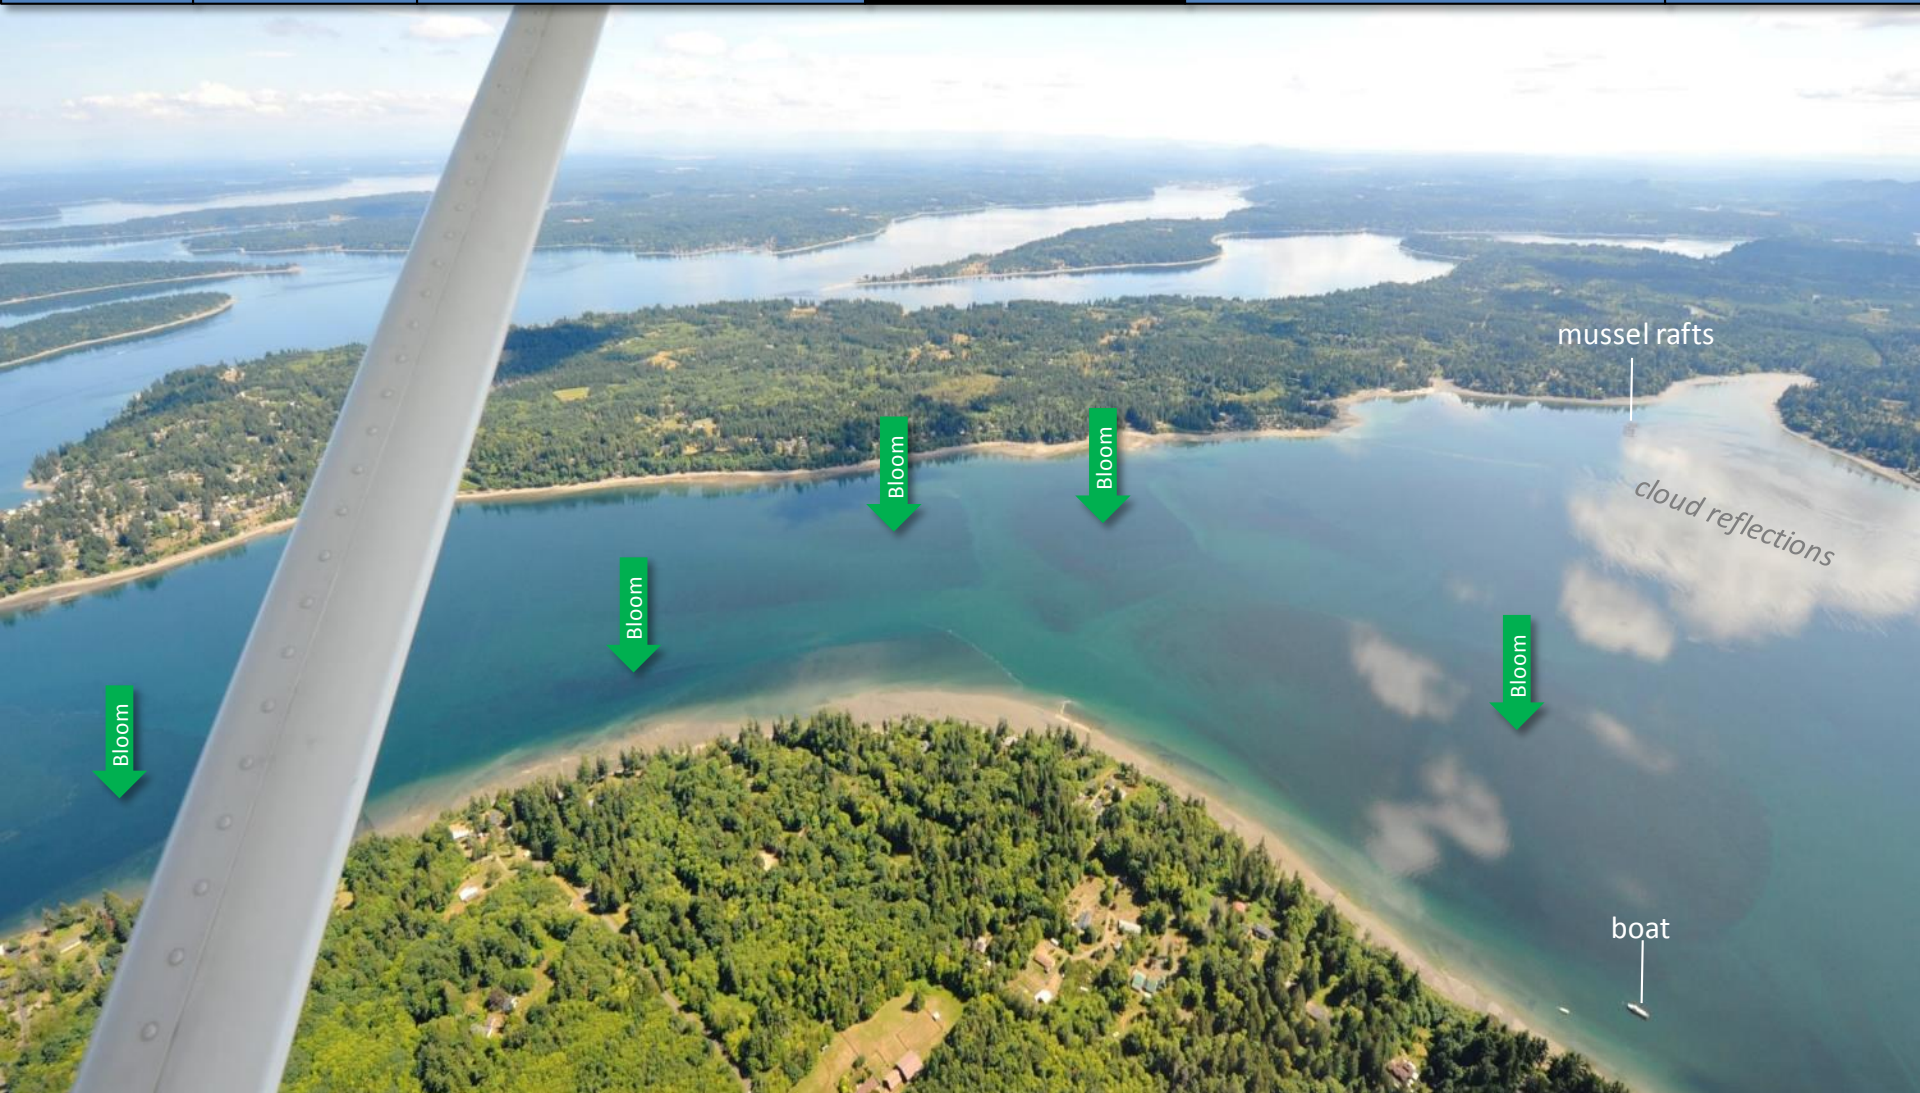
Location: Totten Inlet (South Sound), 3:13 PM.

Phytoplankton blooms tend to be patchy, as seen nicely in this image.

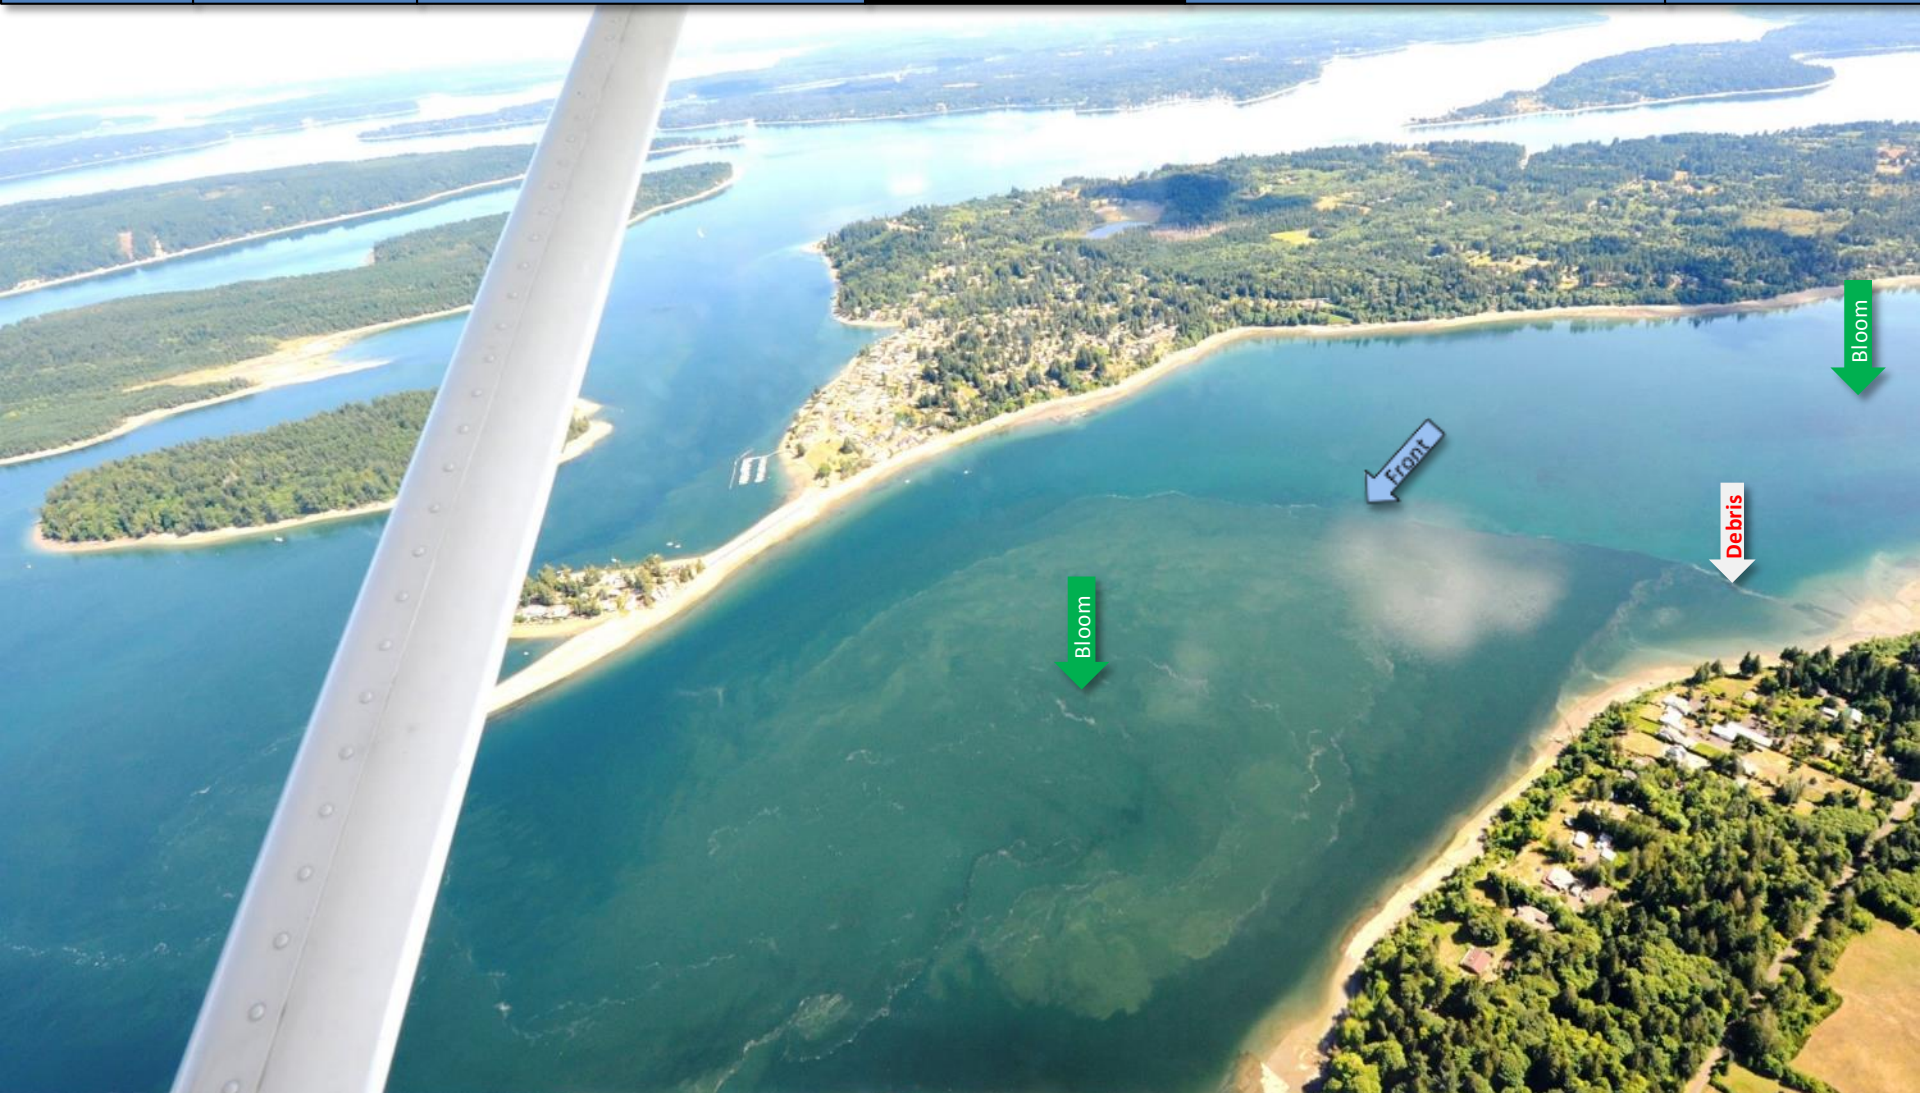
Mixing of water rich in phytoplankton and suspended sediment, during incoming tide.
Location: Steamboat Island, Totten Inlet (South Sound), 3:13 PM.

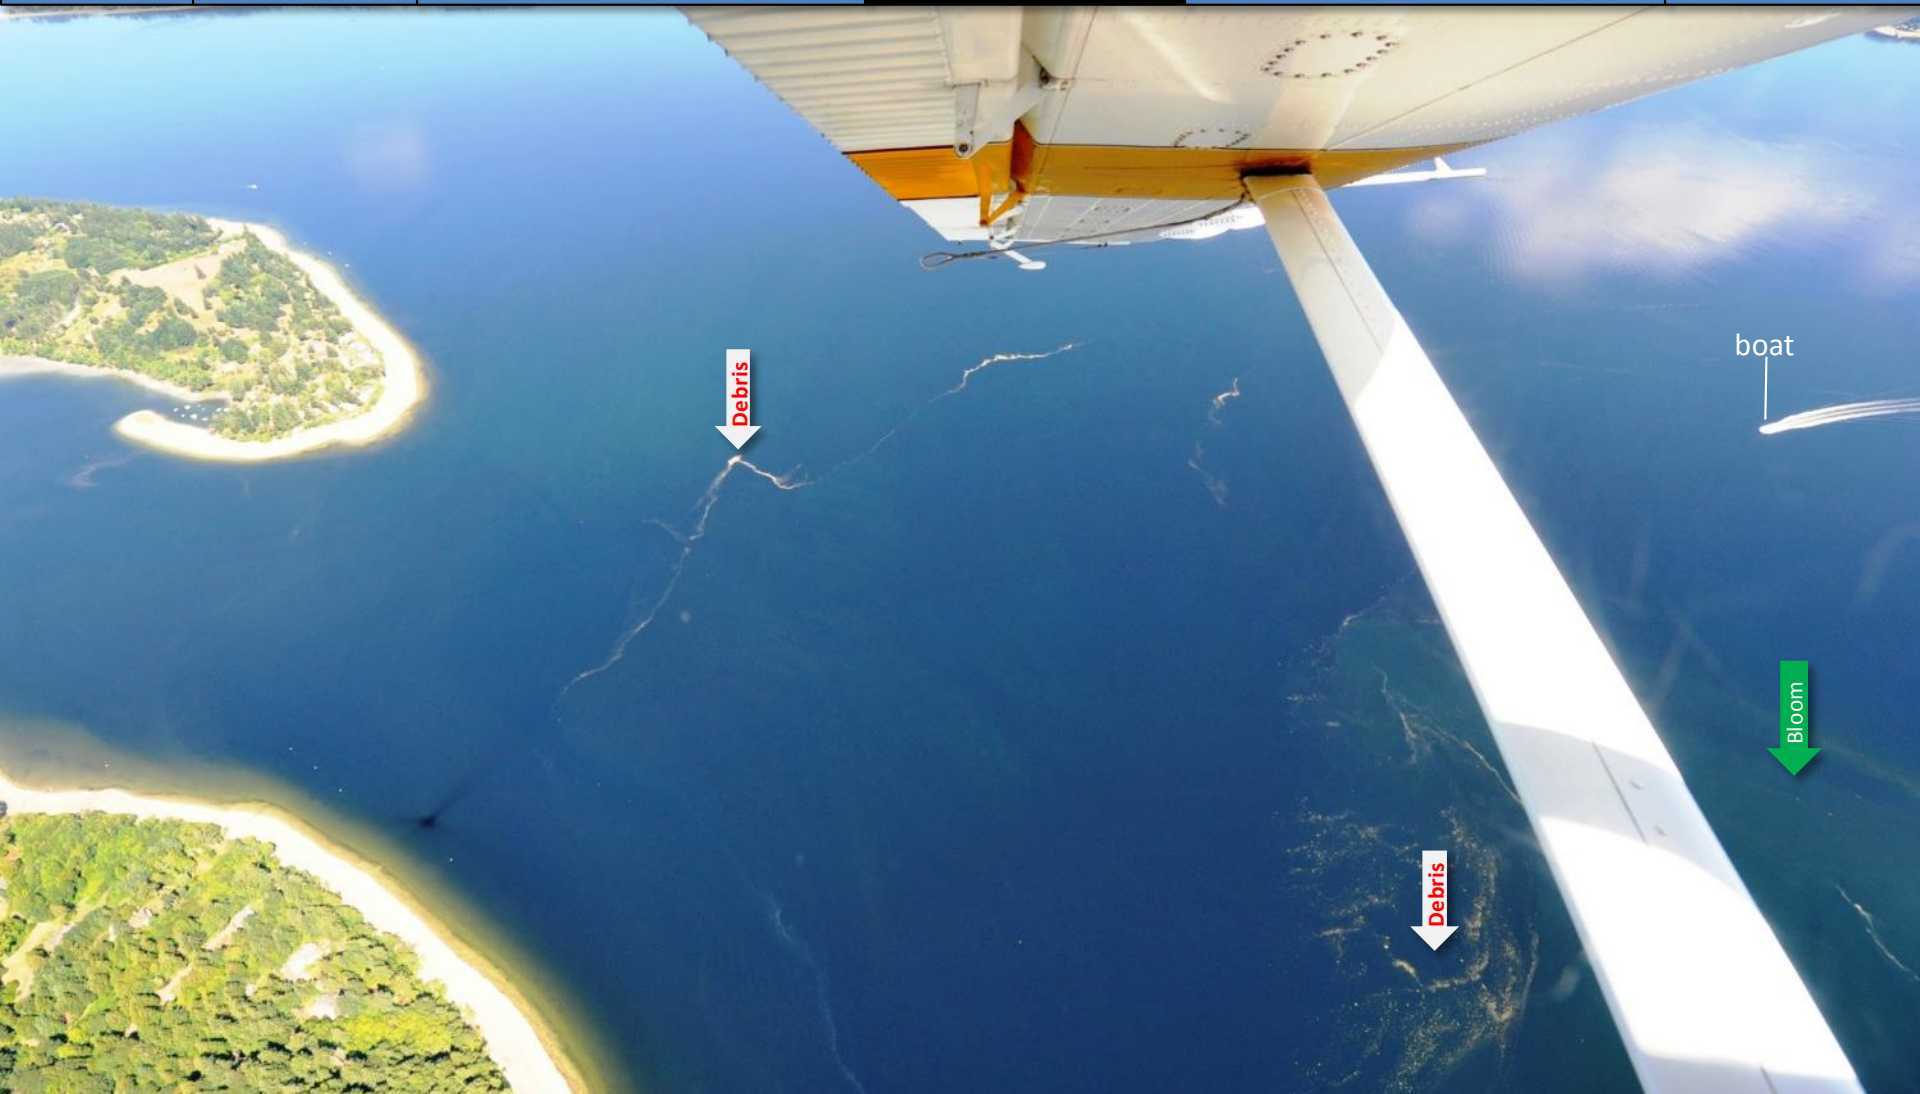
*Large accumulation of floating organic debris at the surface of dark water.
Location: Off Dougall Point, Case Inlet (South Sound), 3:21 PM.*

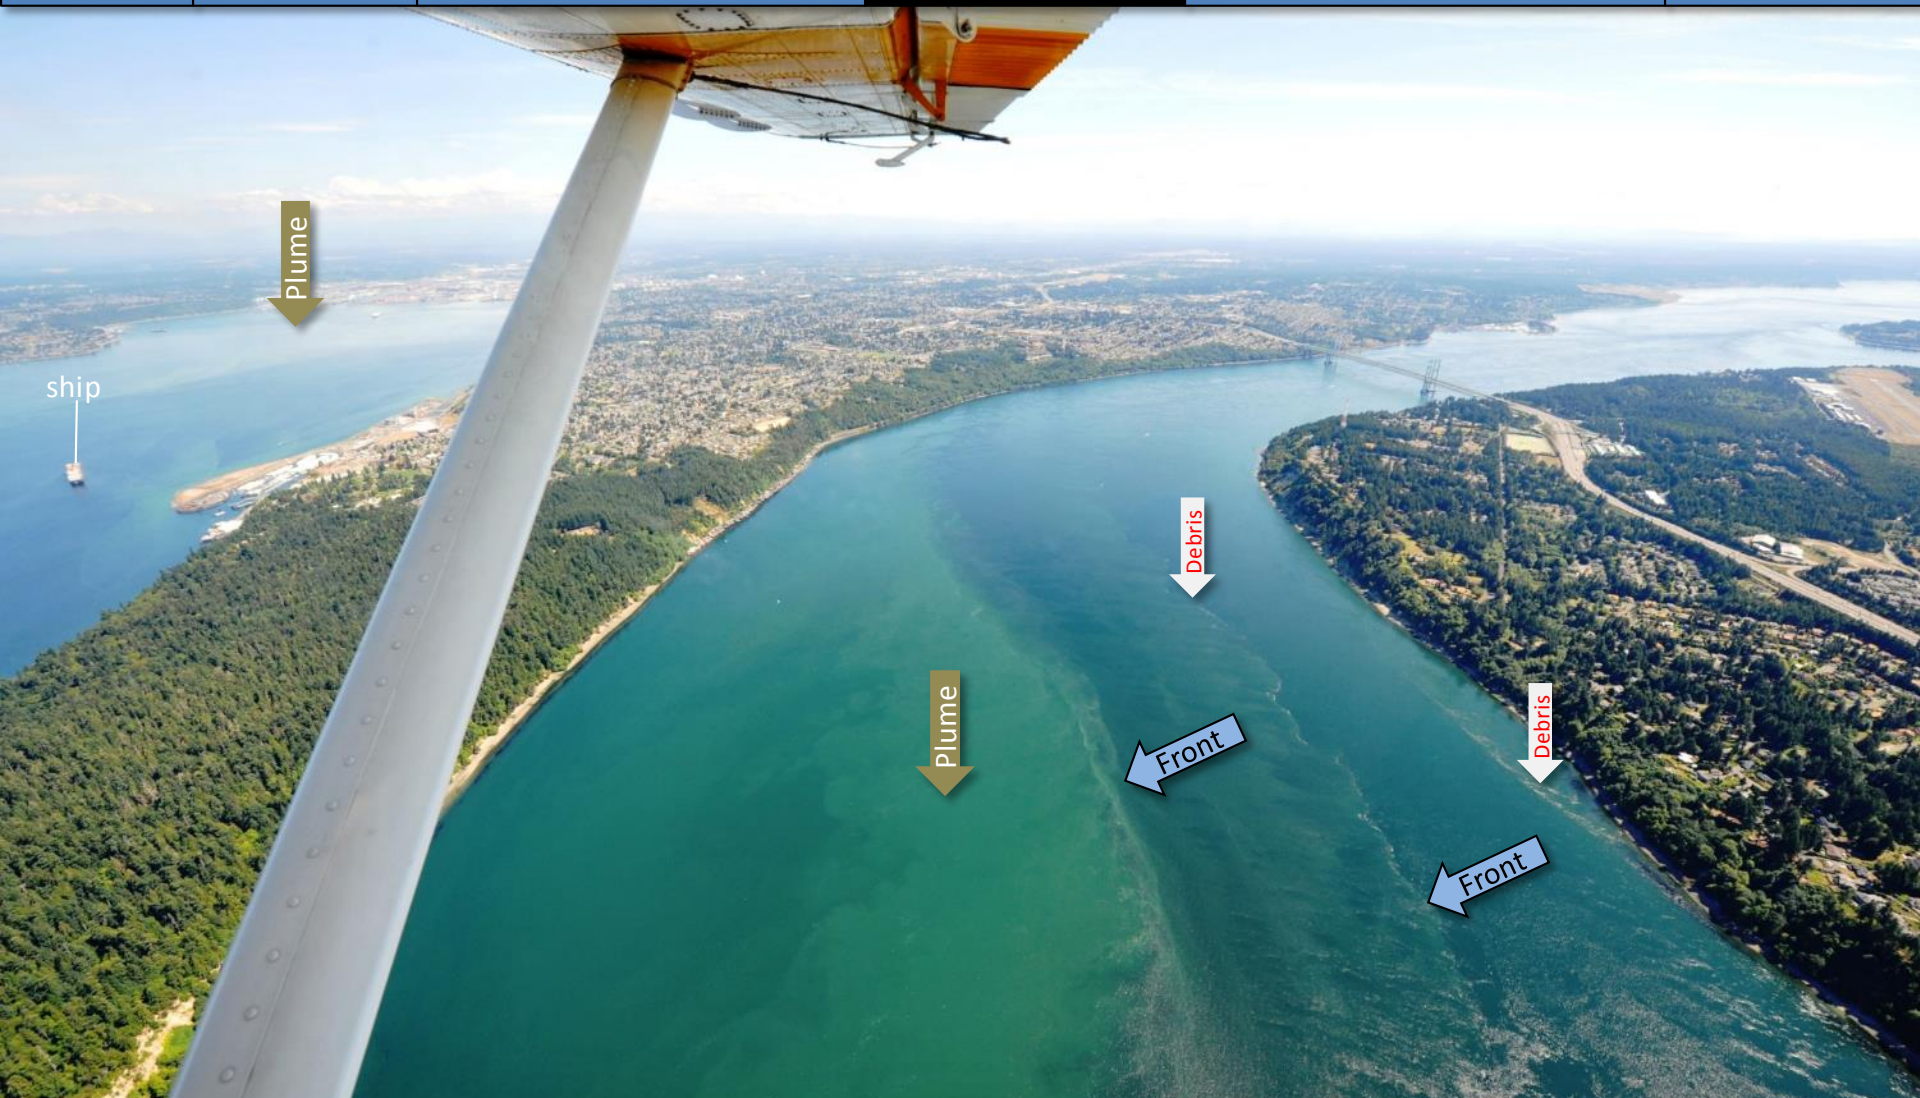
The Puyallup River plume, stained by glacial flour, is entrained into the Tacoma Narrows during flooding tide.
Location: Point Defiance, Tacoma Narrows (Central Sound), 3:31 PM.

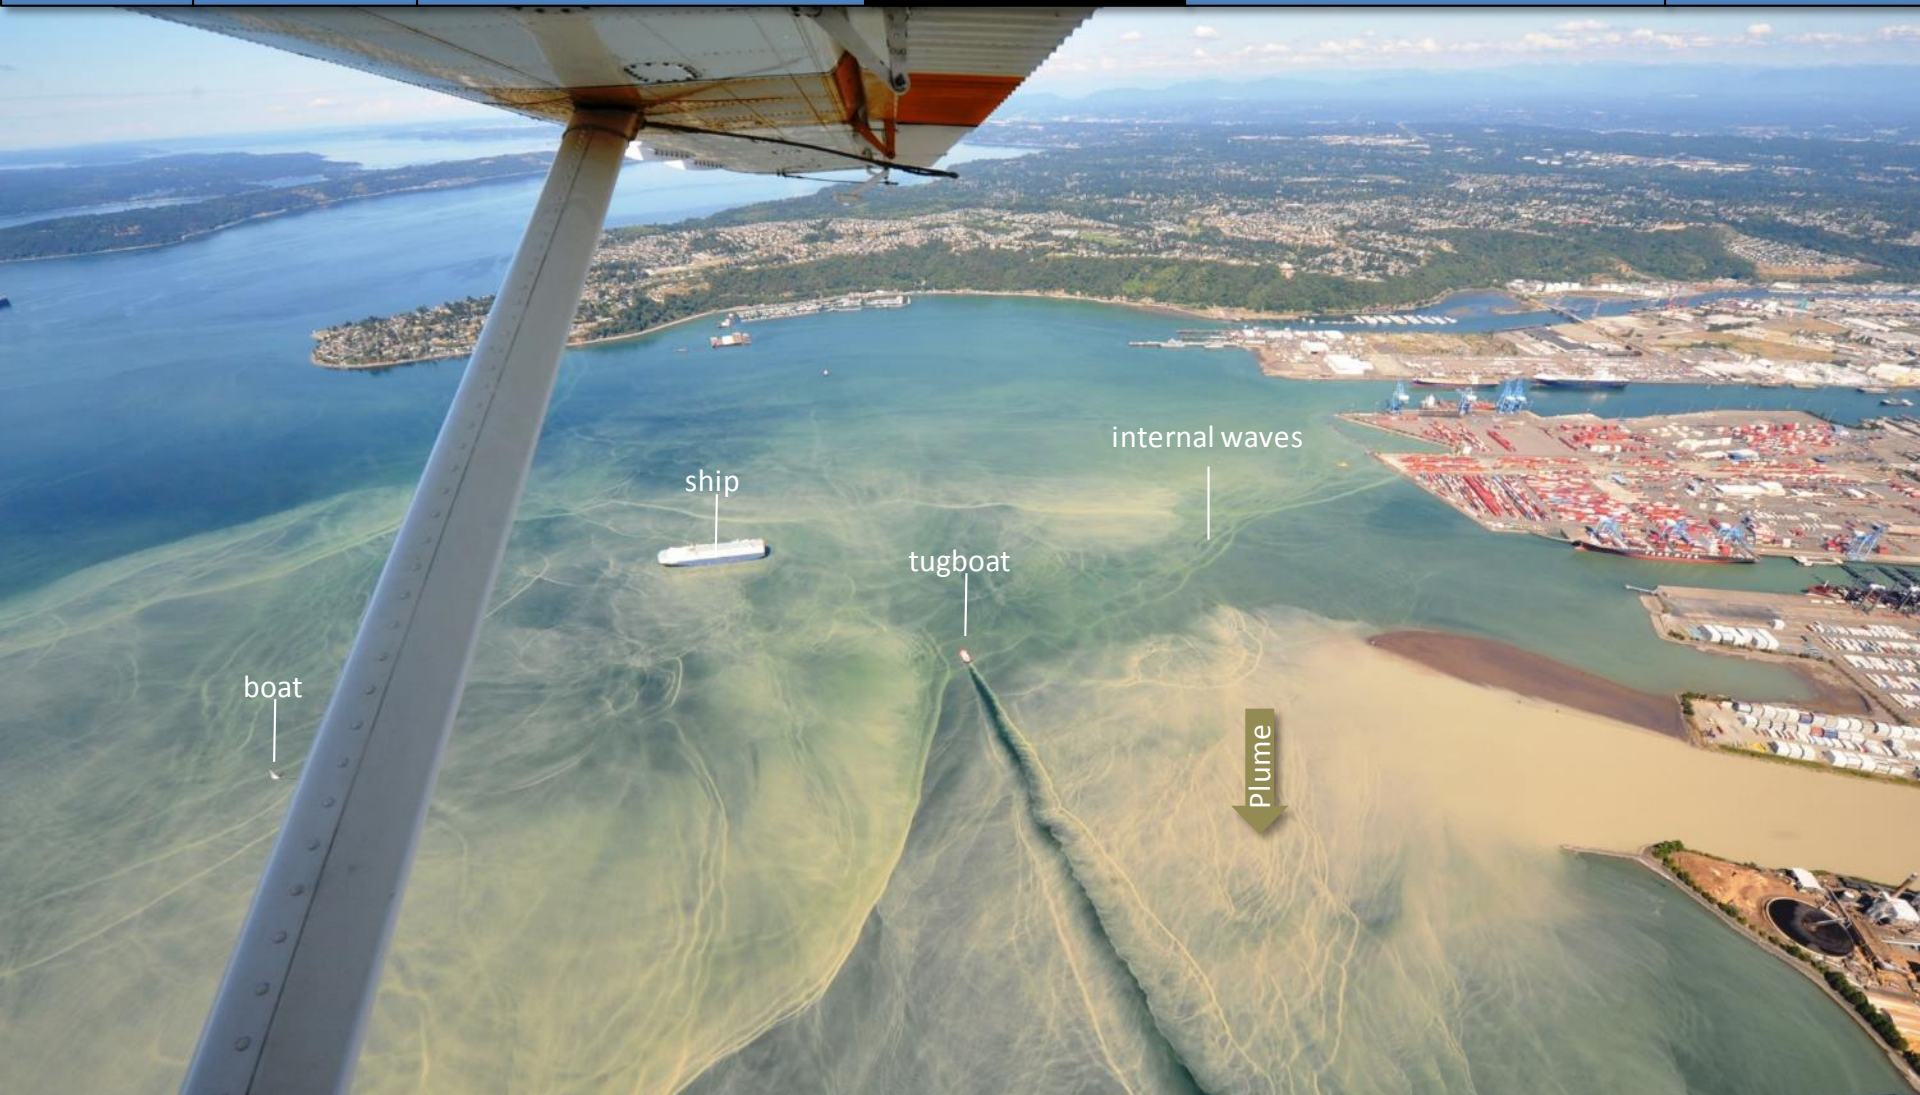
The wake of a tugboat reveals that the Puyallup River plume is only a thin layer at the surface.
Location: Commencement Bay (Central Sound), 3:36 PM.

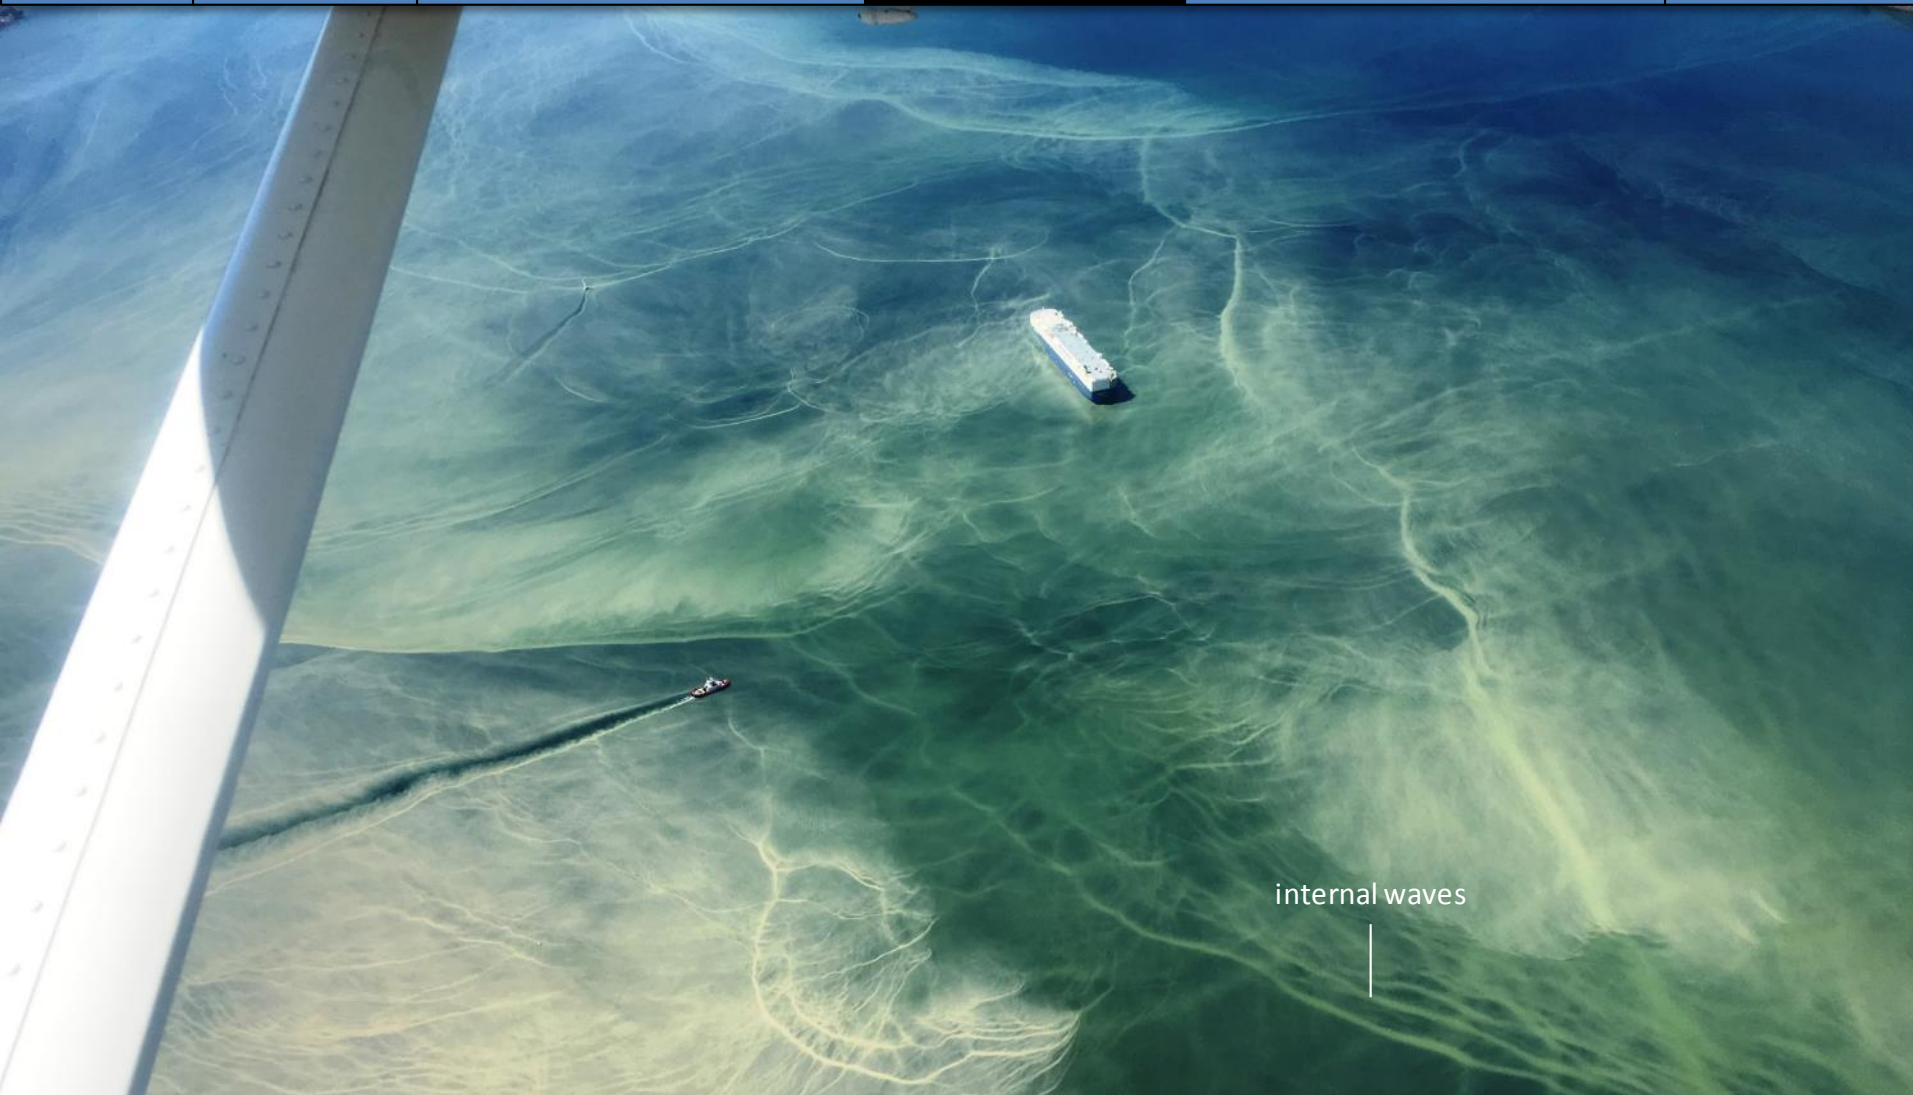
Water rich in glacial flour allows us to see how thin, complex, and far-reaching river plumes can be.
Location: Puyallup River plume in Commencement Bay (Central Sound), 3:36 PM.

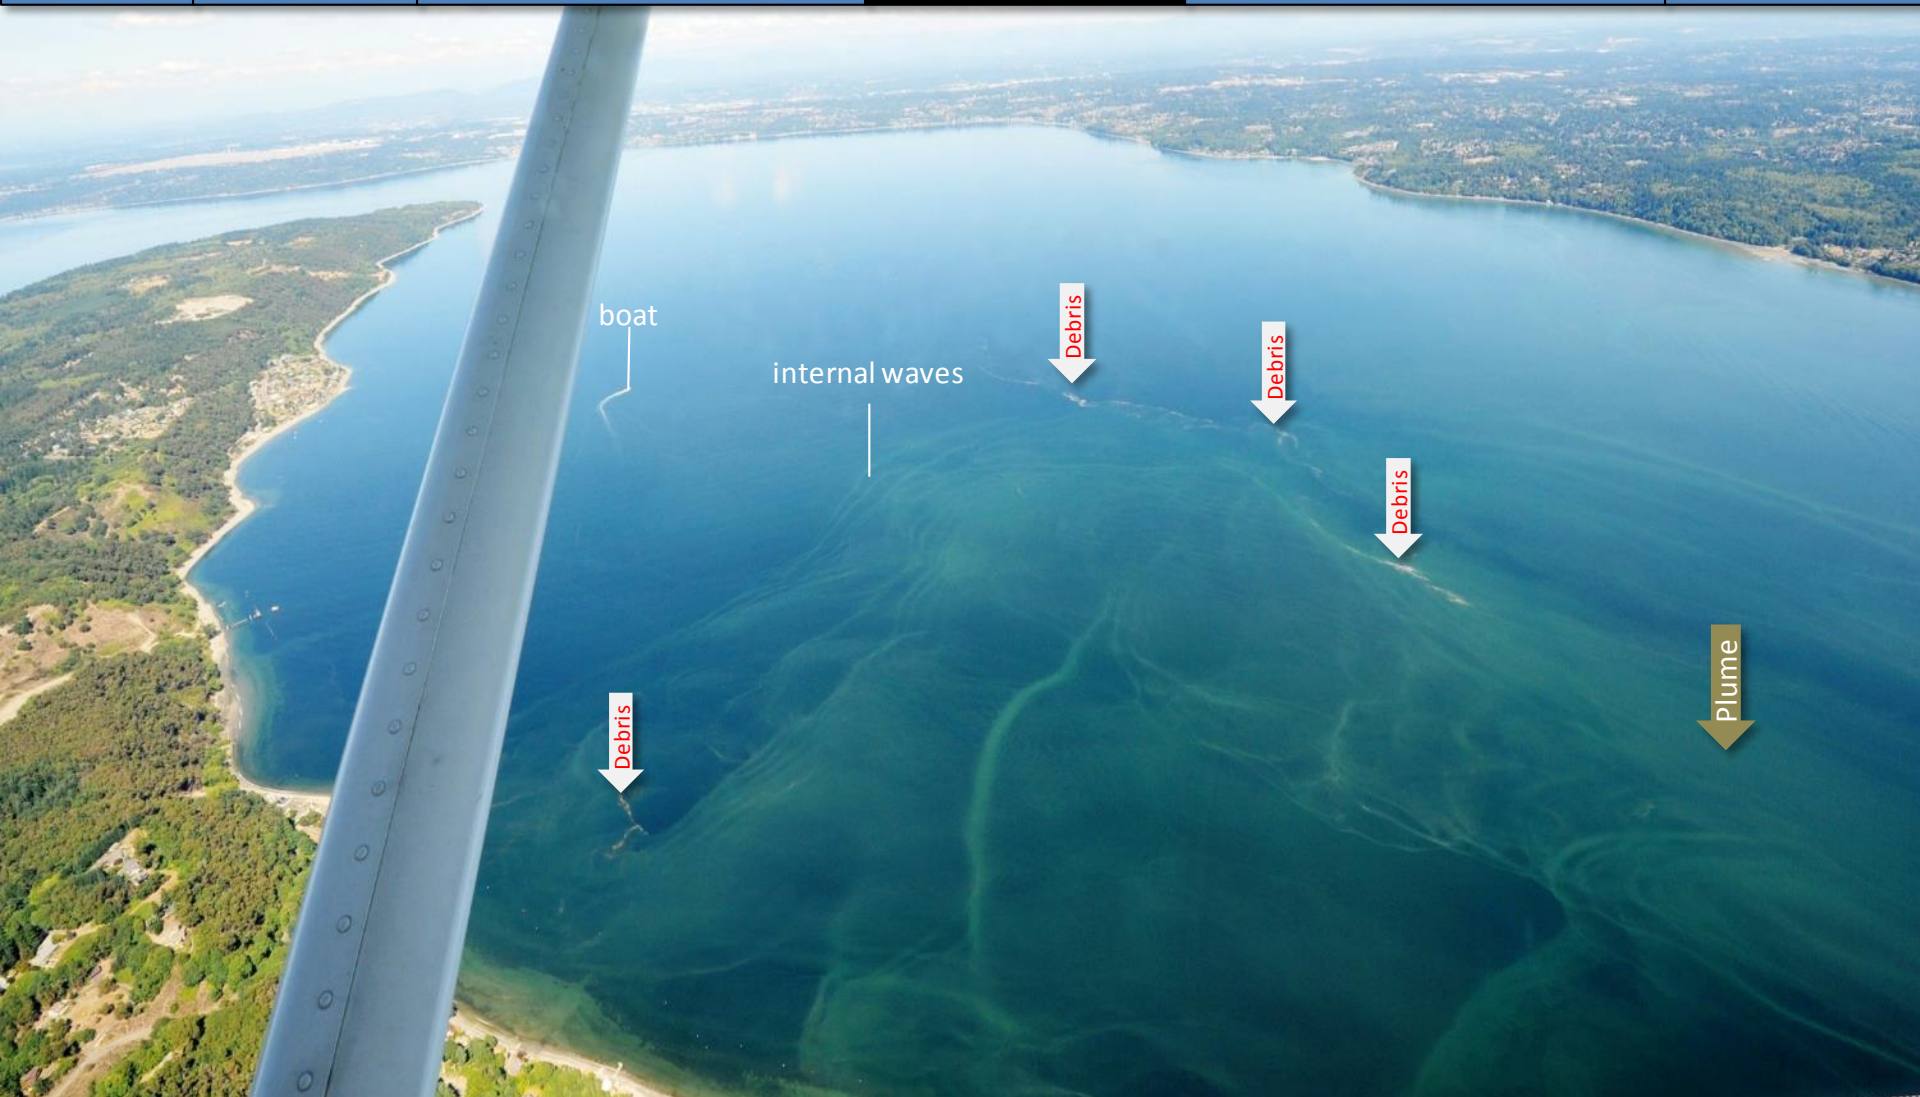
Organic debris and the far-reaching influence of the Puyallup River plume.
Location: Off Shore Acres, Vashon Island (Central Sound), 3:33 PM.
