Eyes Over Puget Sound

Surface Conditions Report

July 20, 2016

Up-to-date observations of water quality conditions in Puget Sound and coastal bays

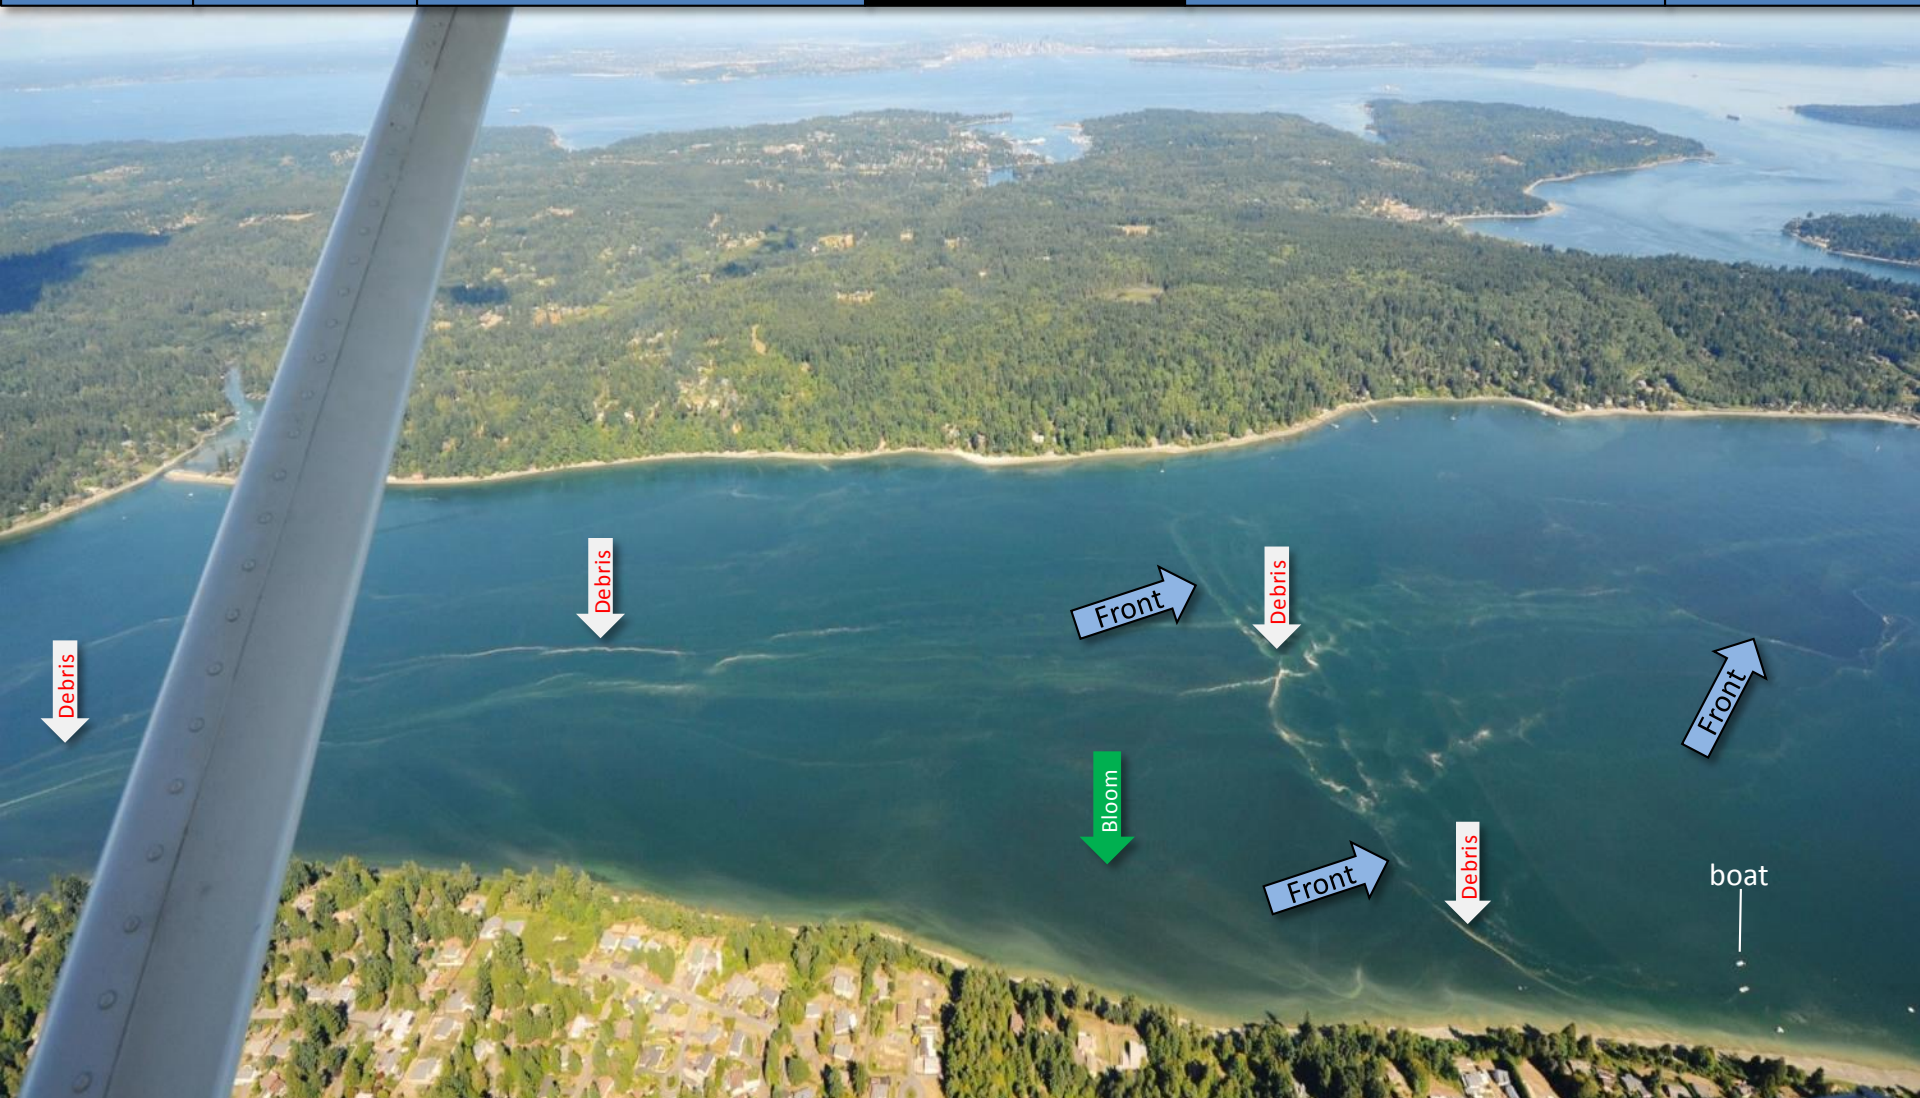
Large accumulations of reddish-white organic material, which could be a spent Noctiluca bloom.
Location: South of Fletcher Bay, Bainbridge Island (Central Sound), 3:53 PM.

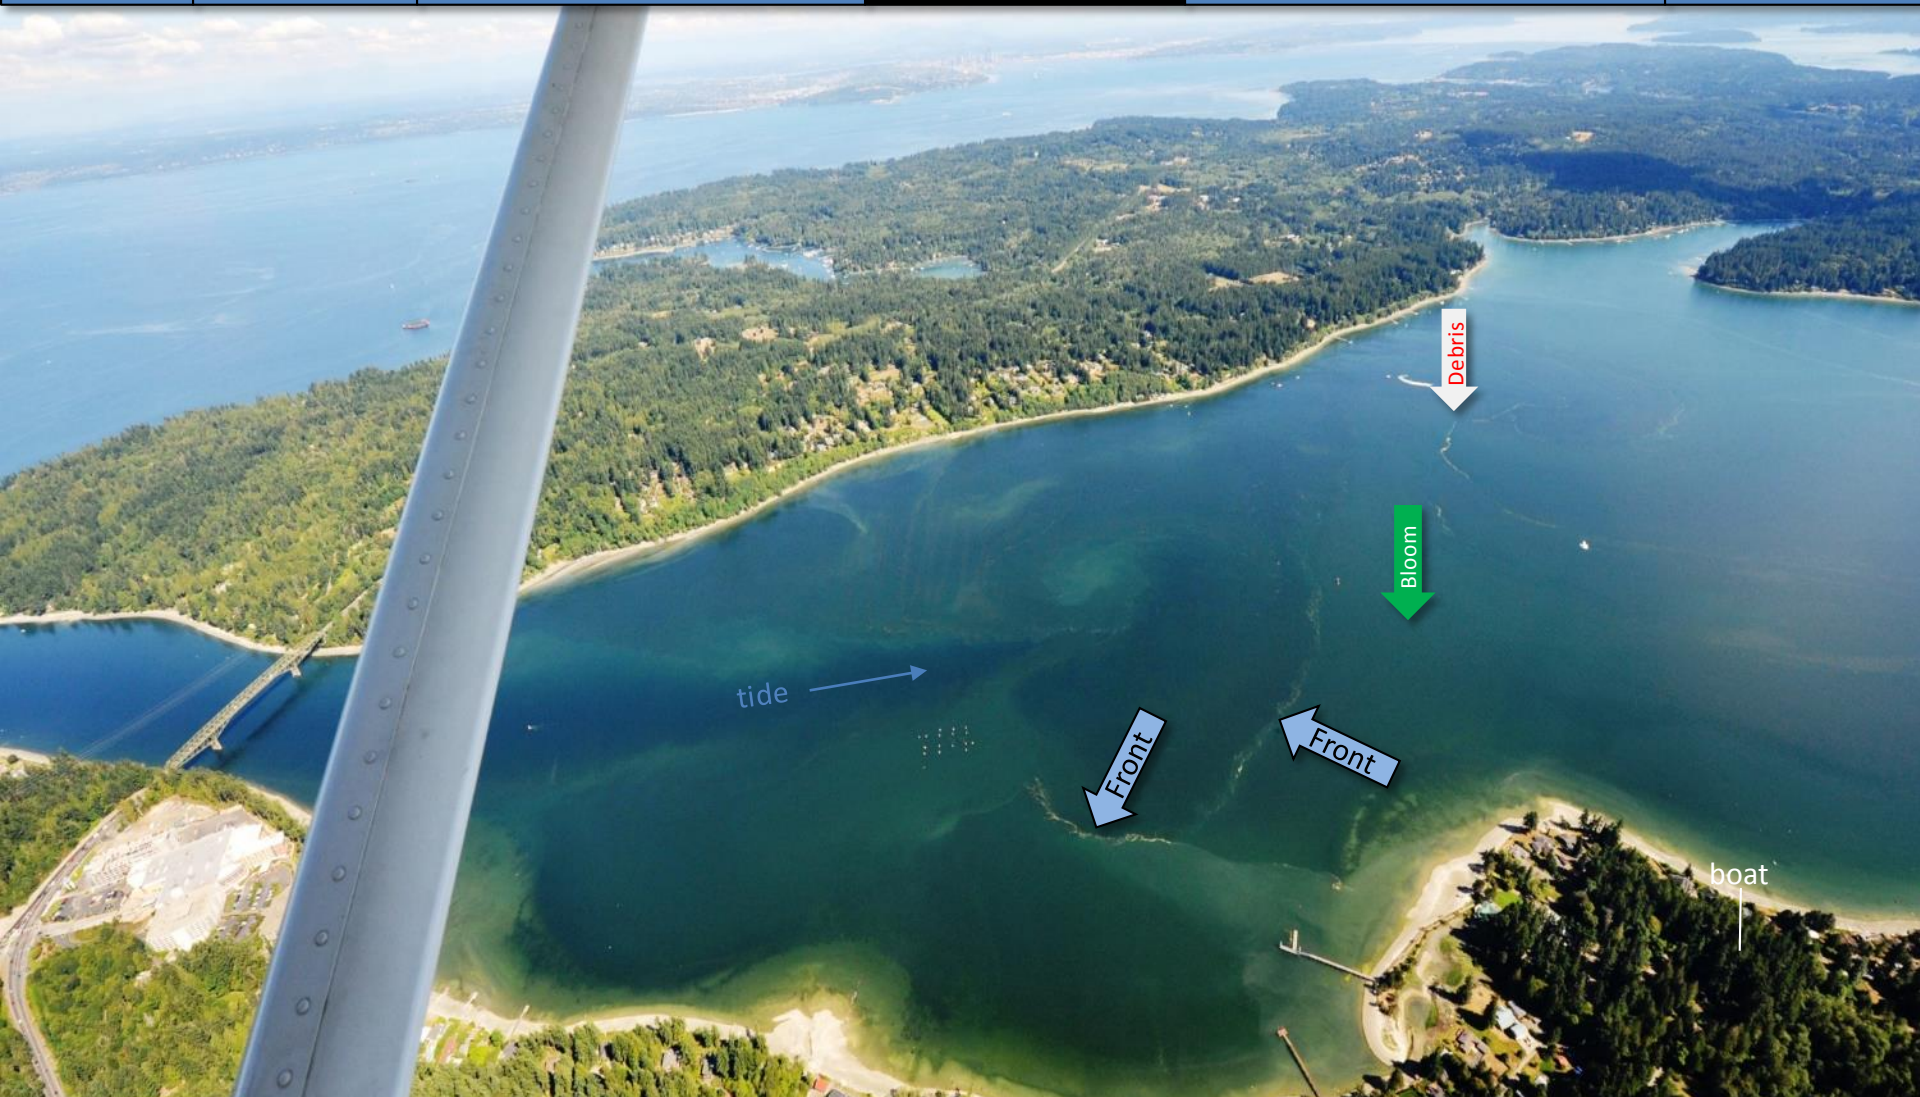
Tide moving into water that has an algal bloom and floating organic debris. Bloom reveals flow patterns.
Location: Agate Passage, Bainbridge Island (Central Sound), 3:56 PM.

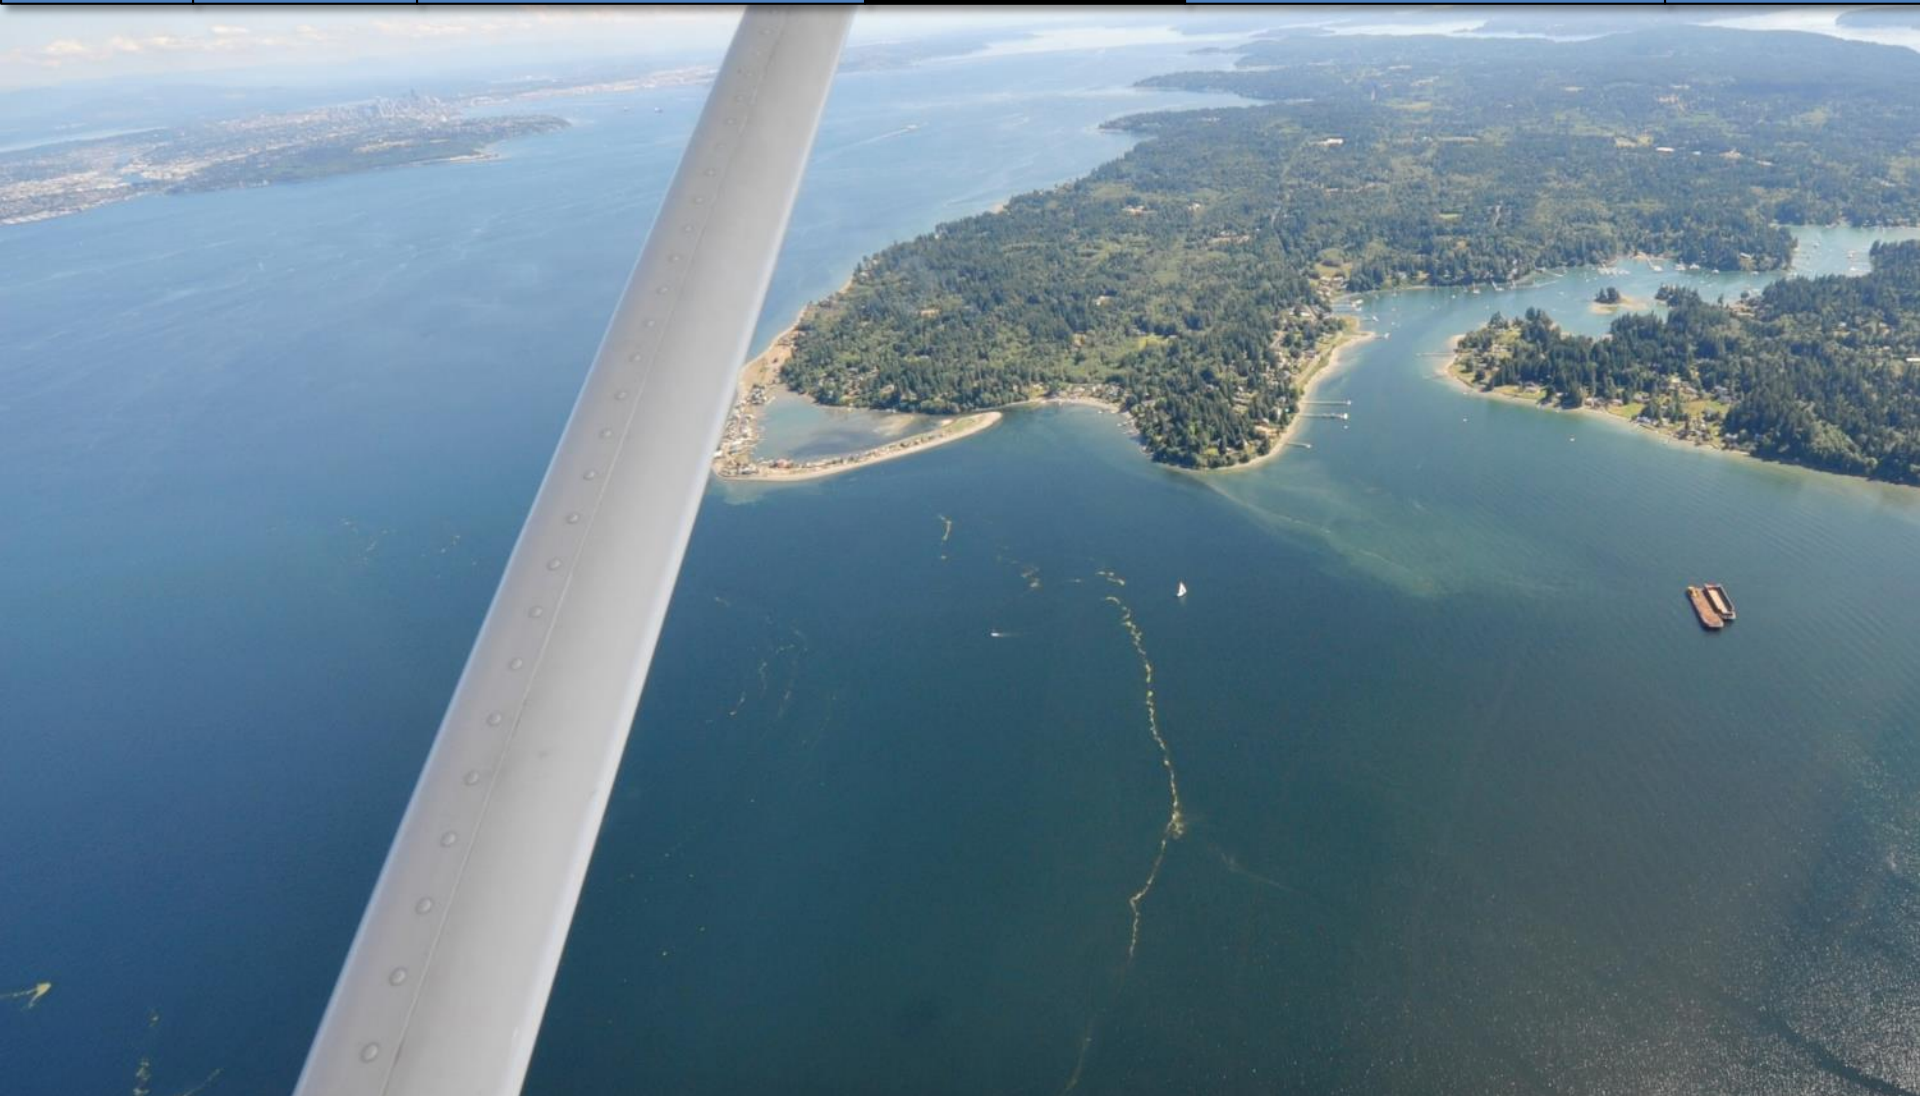
*Very large mats of organic material drifting in Port Madison and adjacent parts of Central Basin.
Location: Point Monroe, Bainbridge Island (Central Sound), 3:58 PM.*
