Eyes Over Puget Sound

2016 Review

Up-to-date observations of visible water quality conditions in Puget Sound and the Strait of Juan de Fuca

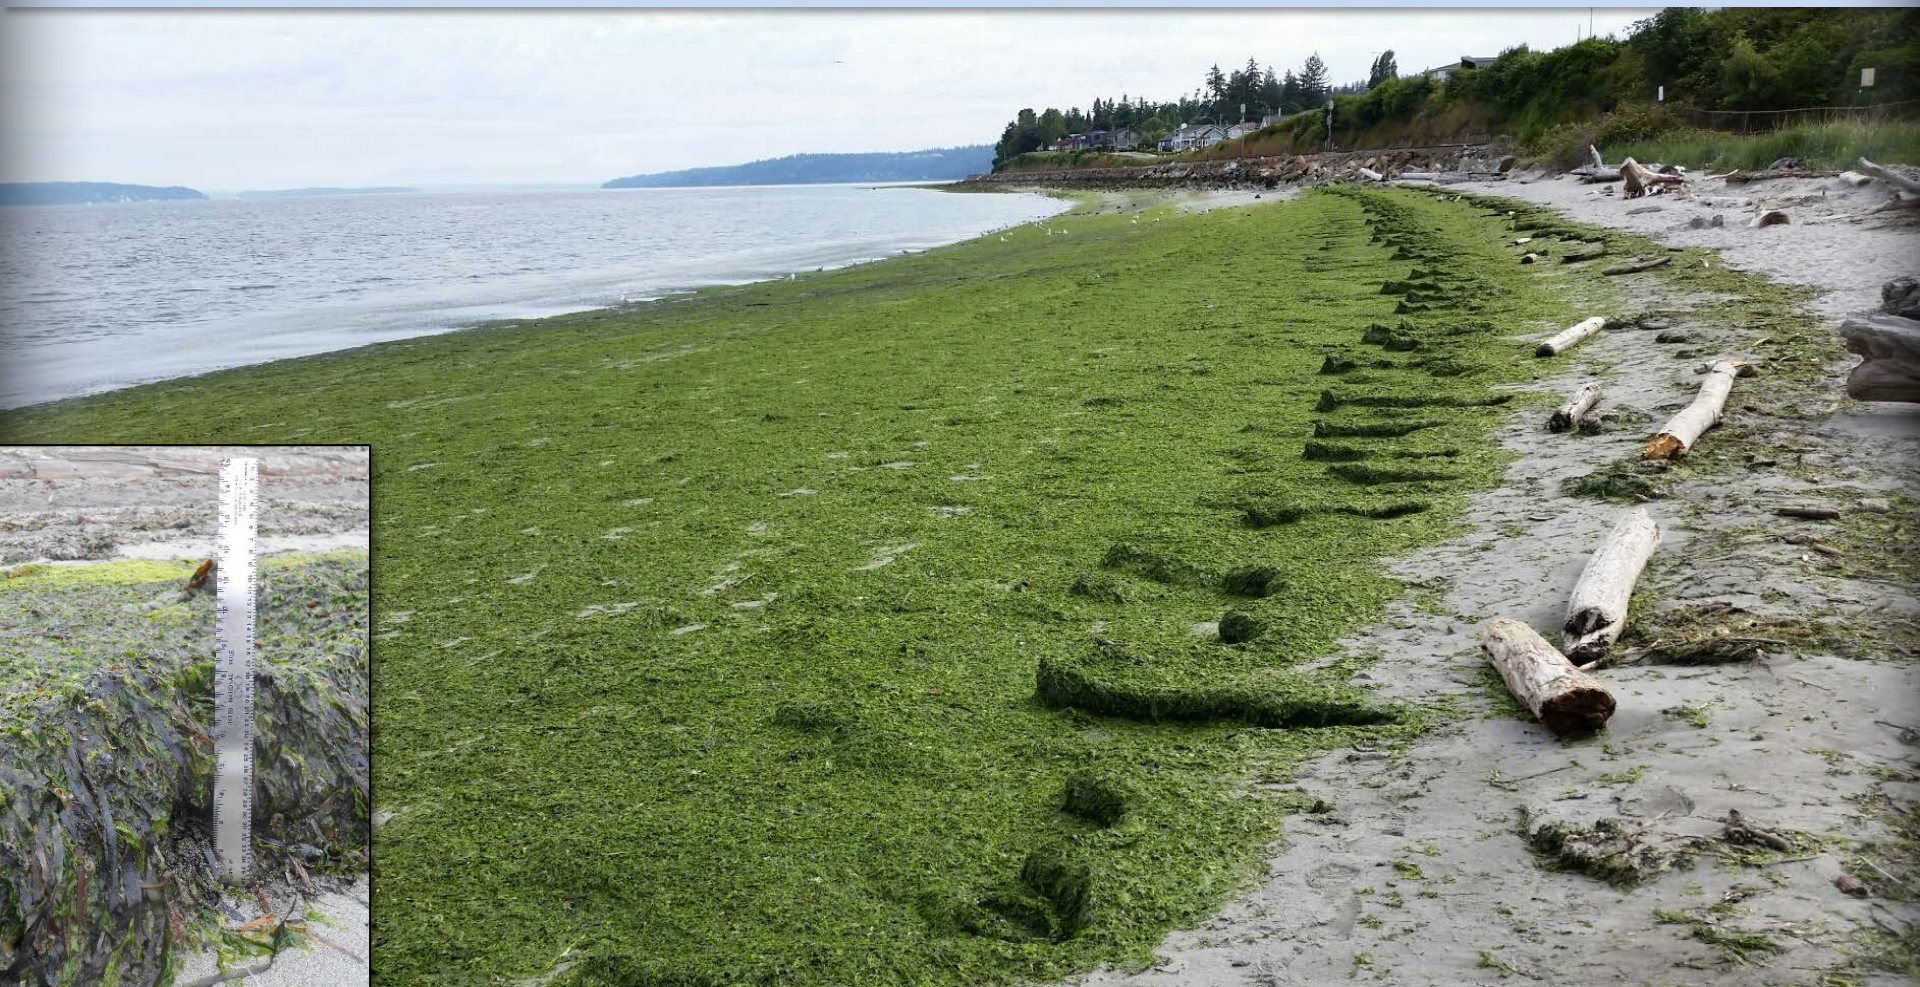
Algae washed up on beaches in thick layers and rotting.
Location: Edmonds Underwater Park, Snohomish County, July 2016.

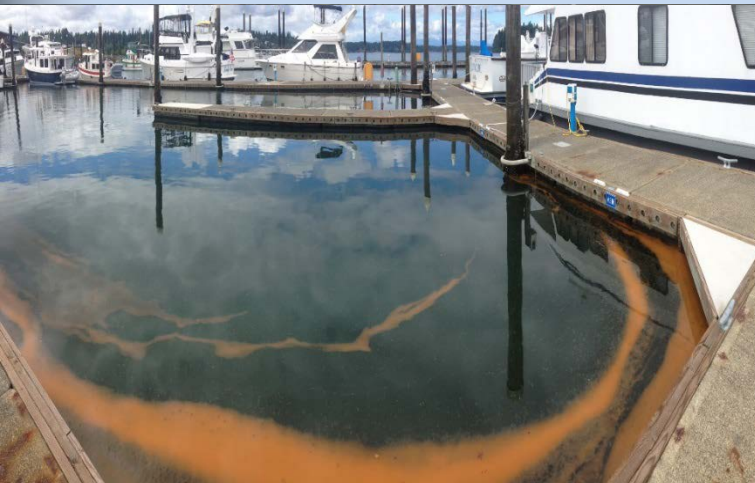
Noctiluca bloom, marine in Budd Inlet

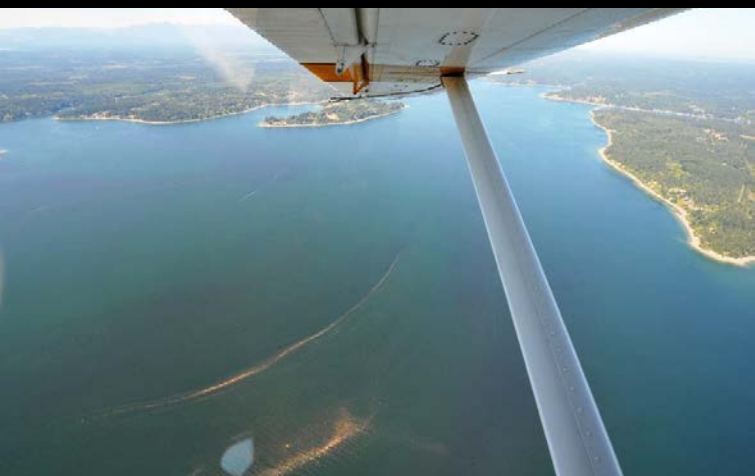
Noctiluca bloom Pickering Passage, Case Inlet

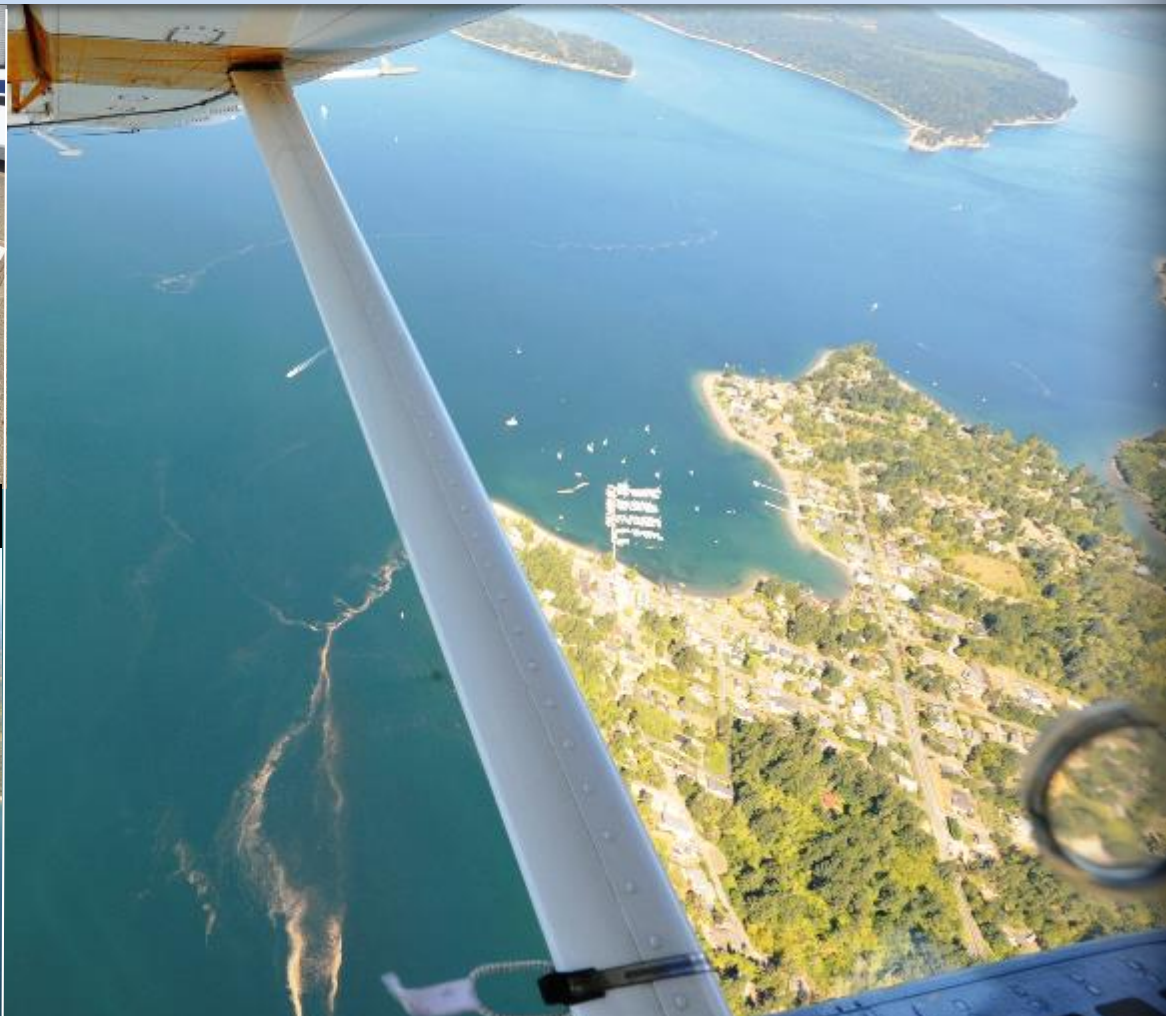
*Noctiluca and organic material accumulating near Boston Harbor
Entrance to Budd Inlet (South Sound),.*

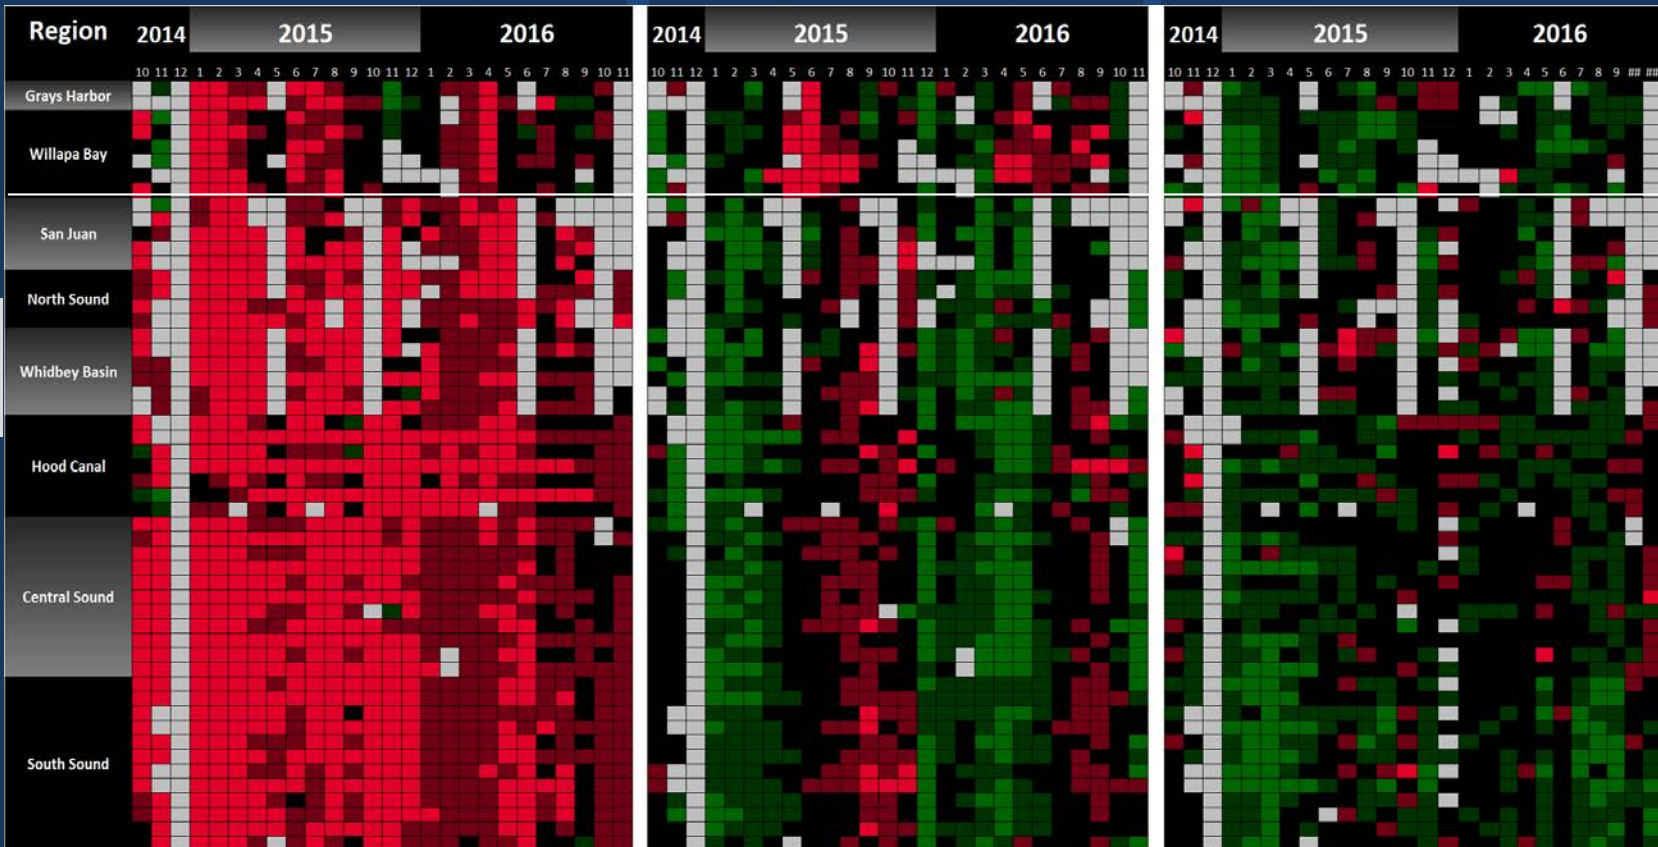
In 2016 **temperatures** were **still remarkably high** in Puget Sound due to El Niño conditions following **effects of the 2015 Blob event**. Warmer temperatures both years forced shifts in hydrology with more winter rainfall creating fresher conditions while drought effects in summer led to higher than normal salinity levels. In 2016, oxygen levels were lower than normal, particularly in South Sound.

Blob and El Niño affect Temperature

Salinity follows rivers & rainfall

Oxygen lower in summer

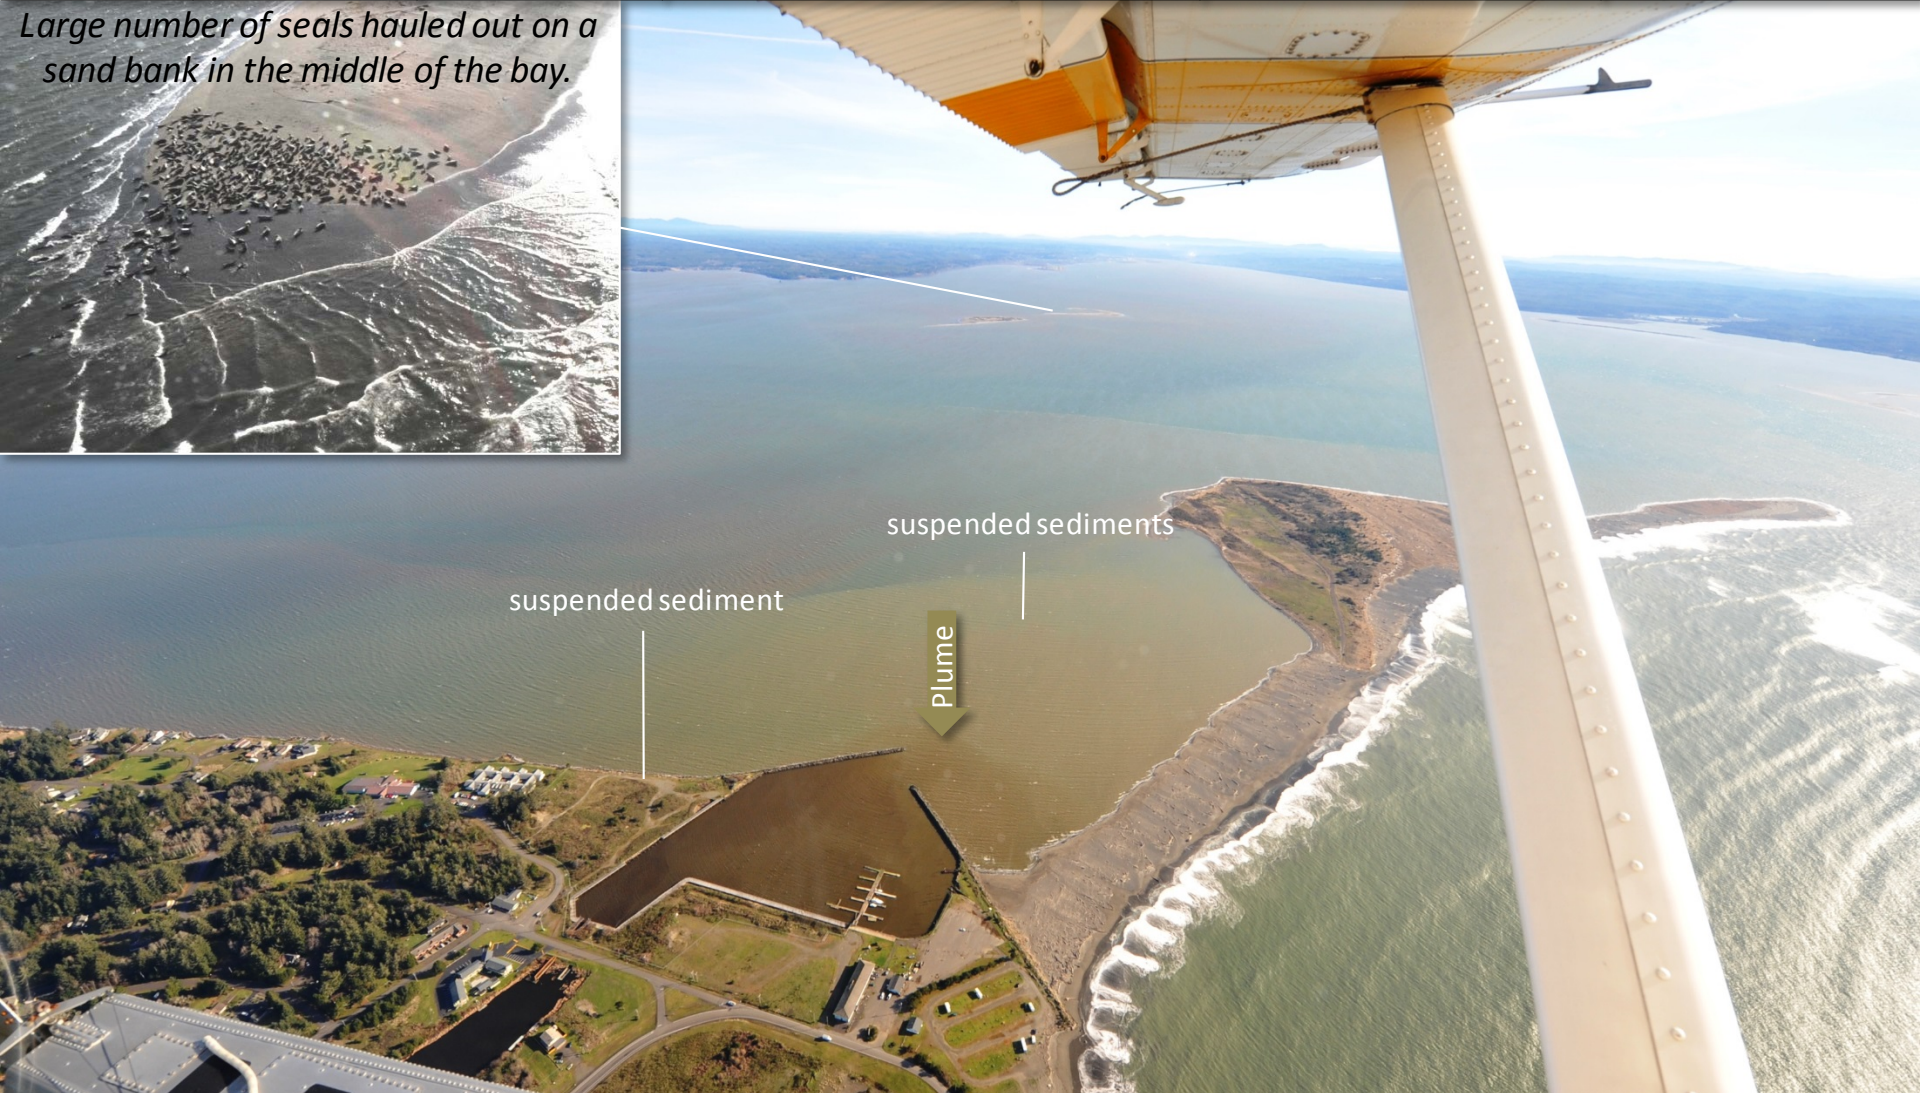
*Brown-colored water of Duck Lake stained by humus (soil/organic material) flowing into coastal bays.
Location: Ocean Shores (Grays Harbor), 10:46 AM.*

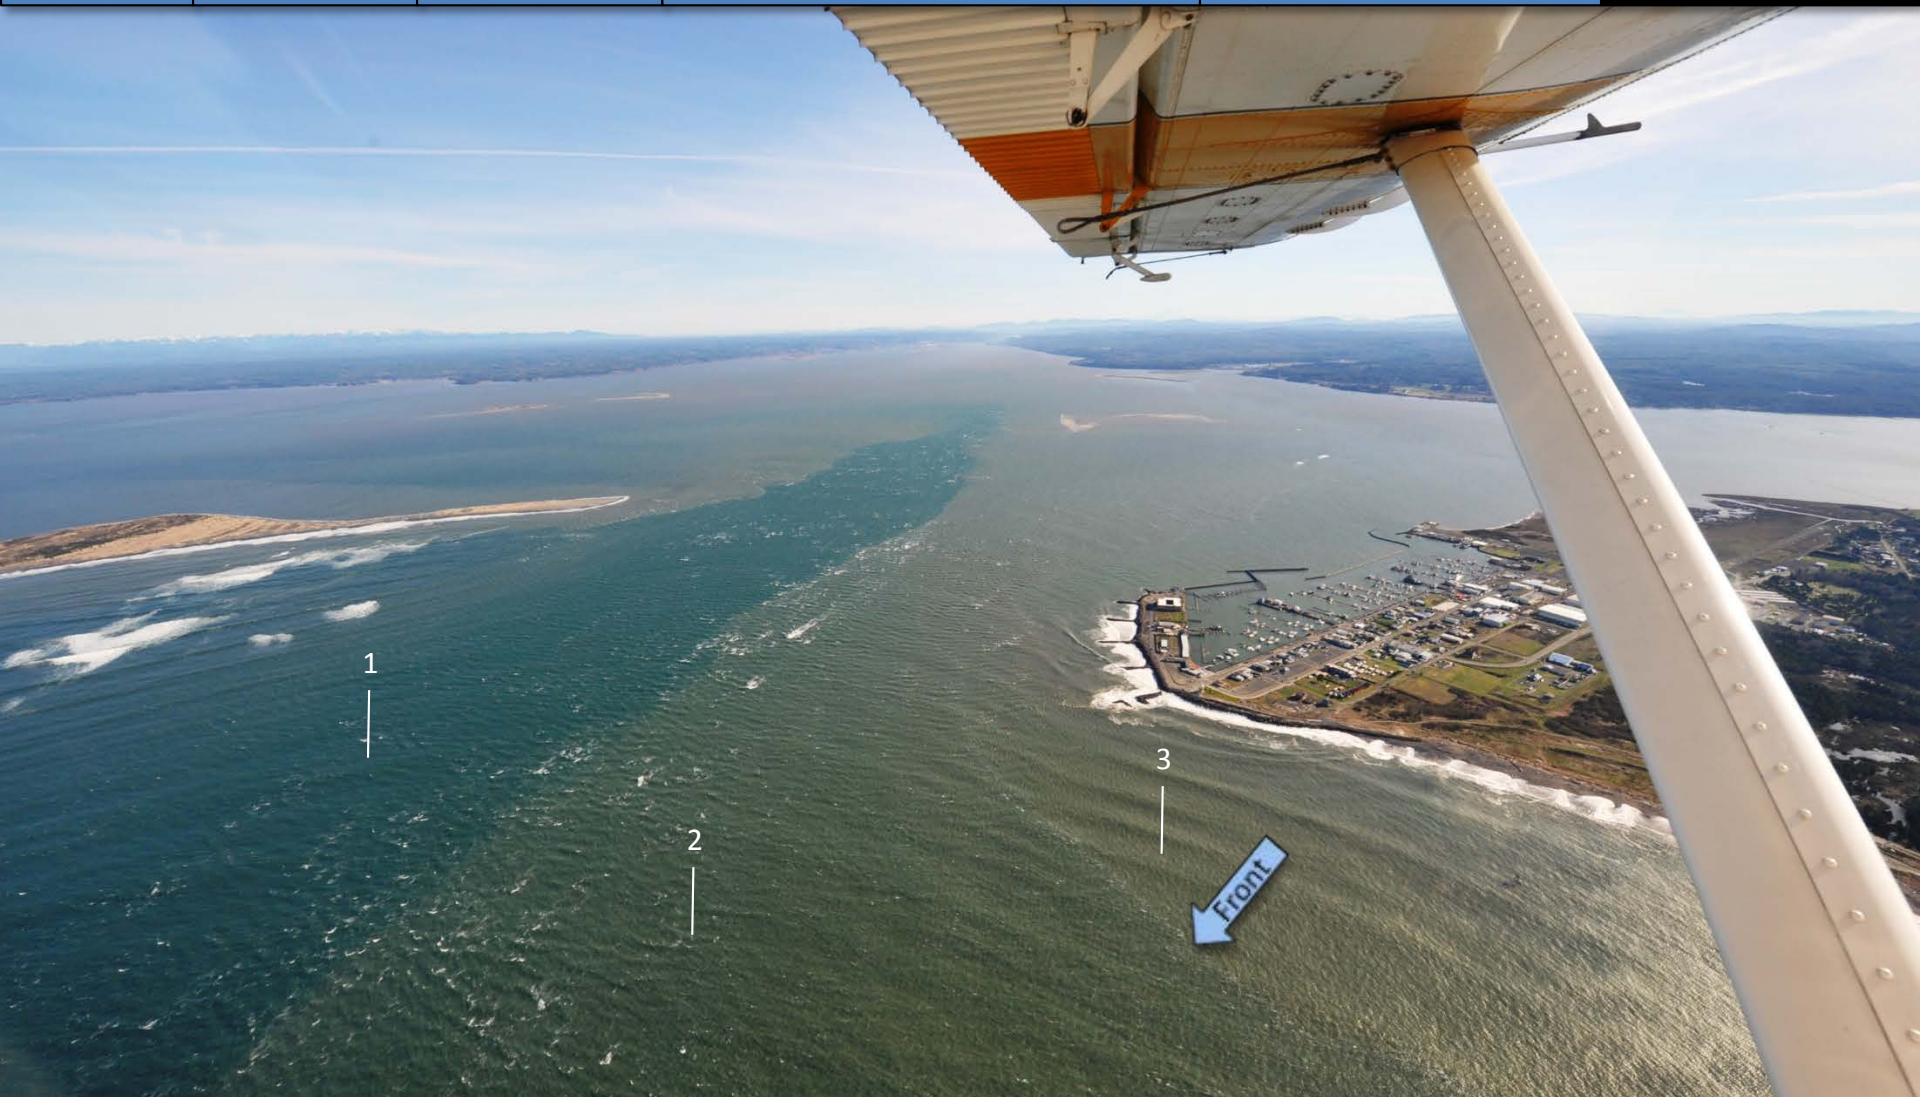
Incoming tide at the entrance to Grays Harbor. Colors indicate three different water masses.
Location: Westhaven State Park (Westport), 10:48 AM.

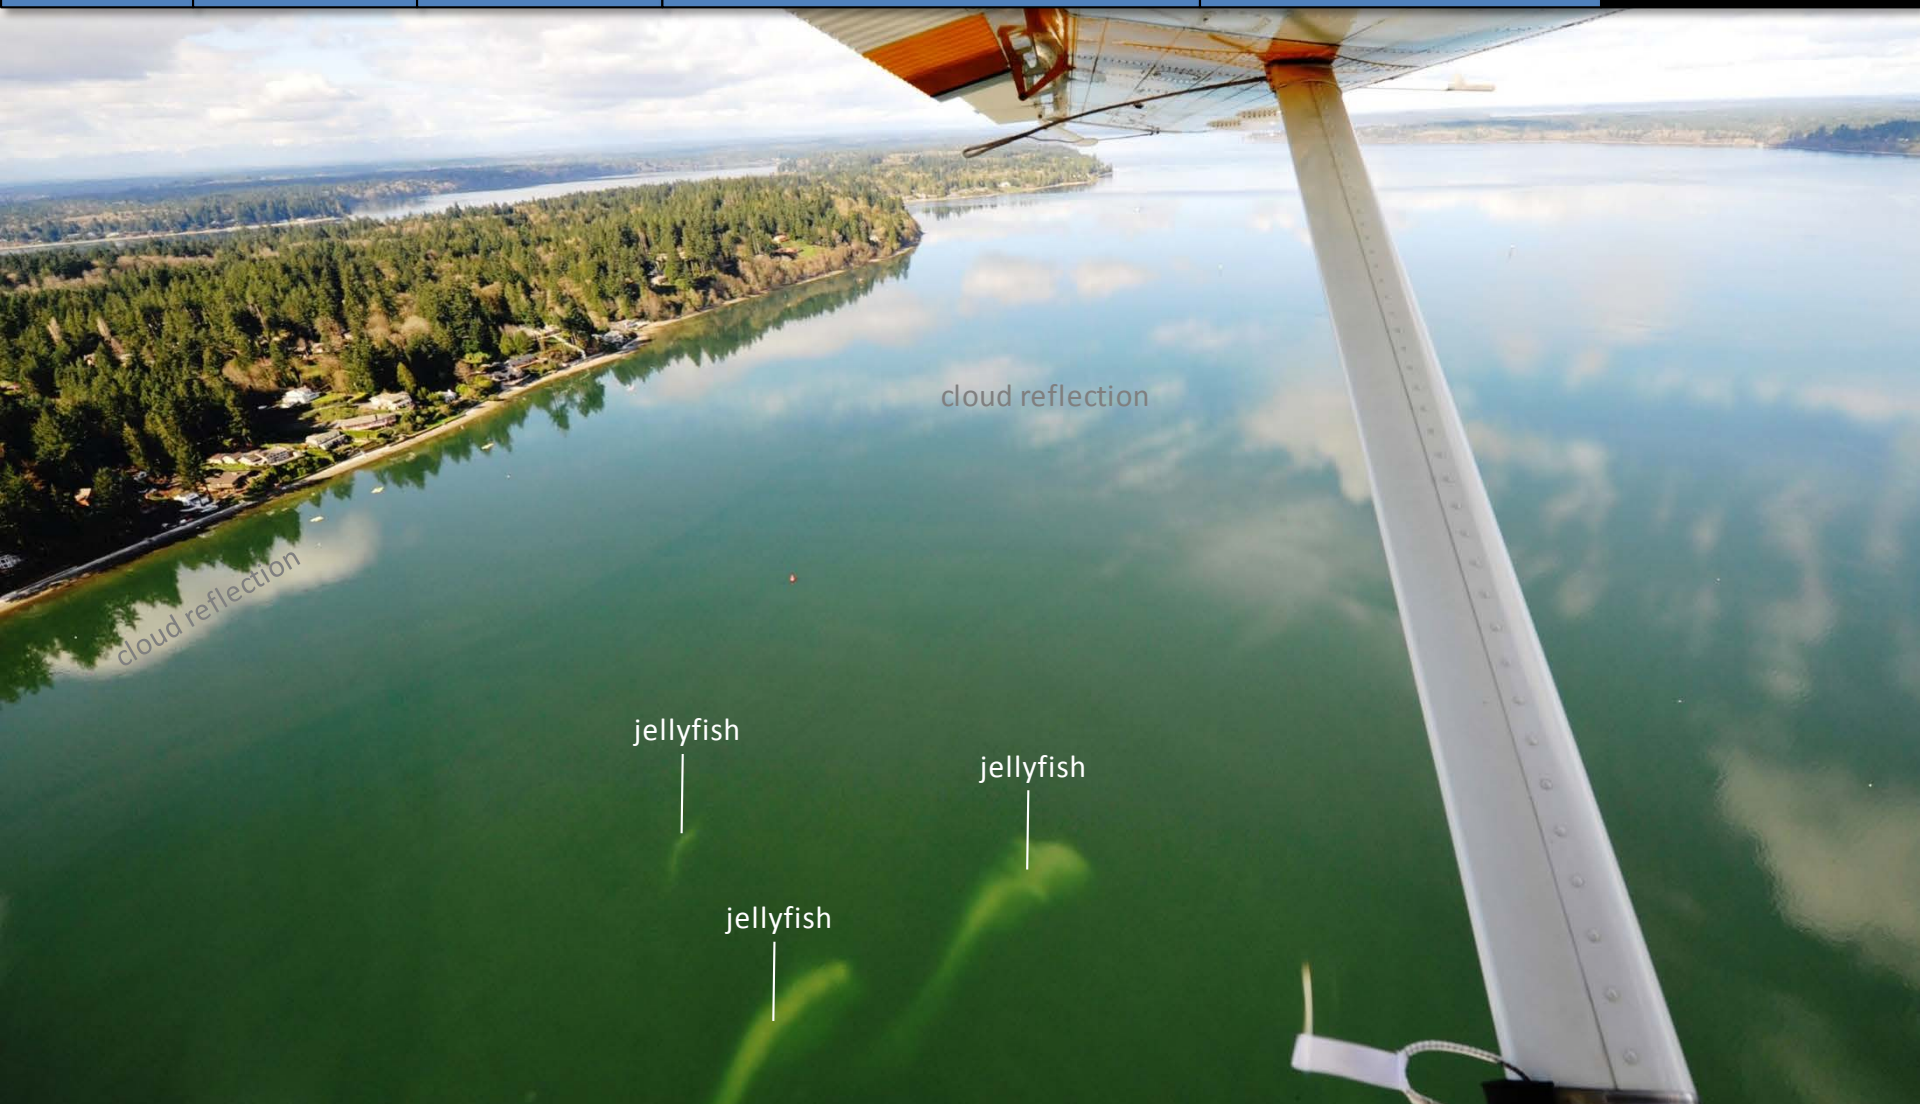
Jellyfish patches in green water, colored by a spring bloom.
Location: Budd Inlet (South Sound), 3:16 PM.

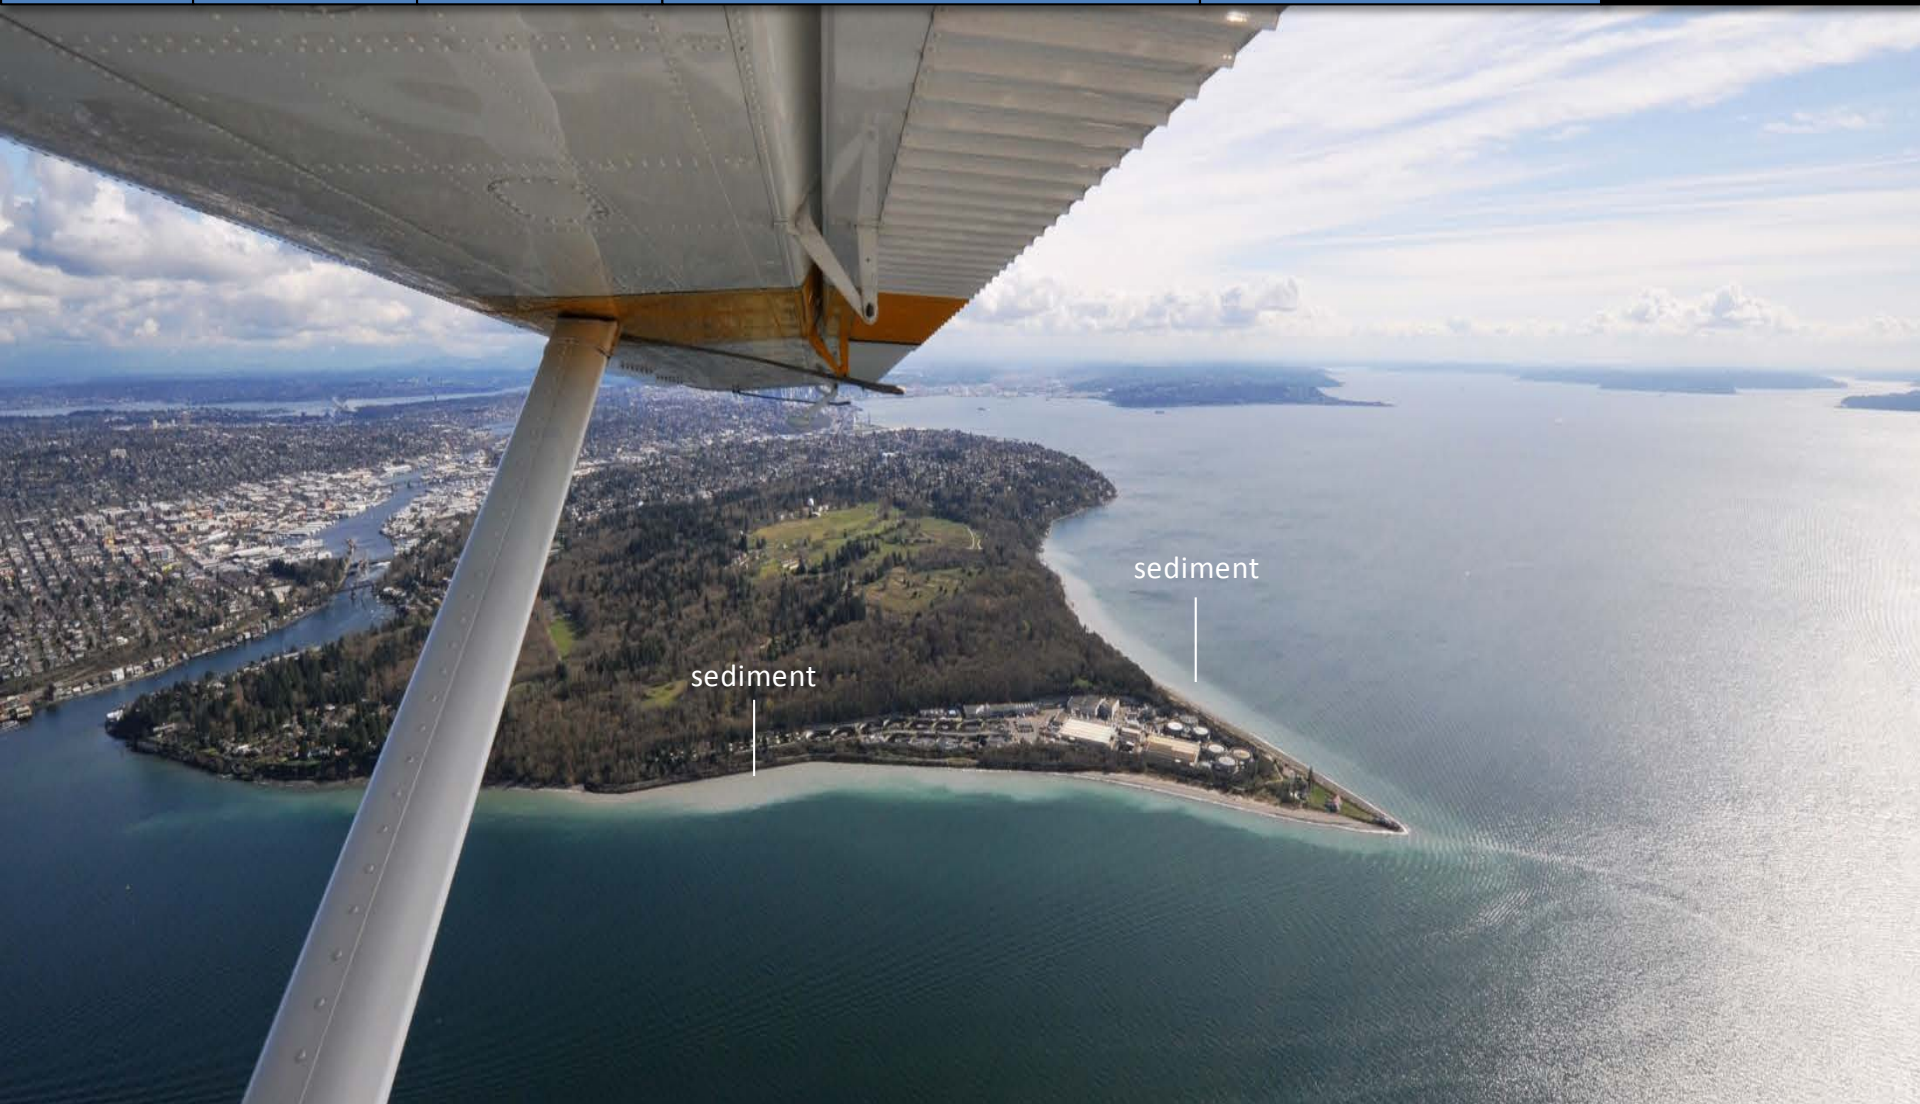
Suspended fine sediments lining all beaches around Discovery Park.

Location: Seattle (Central Sound), 2:42 PM.

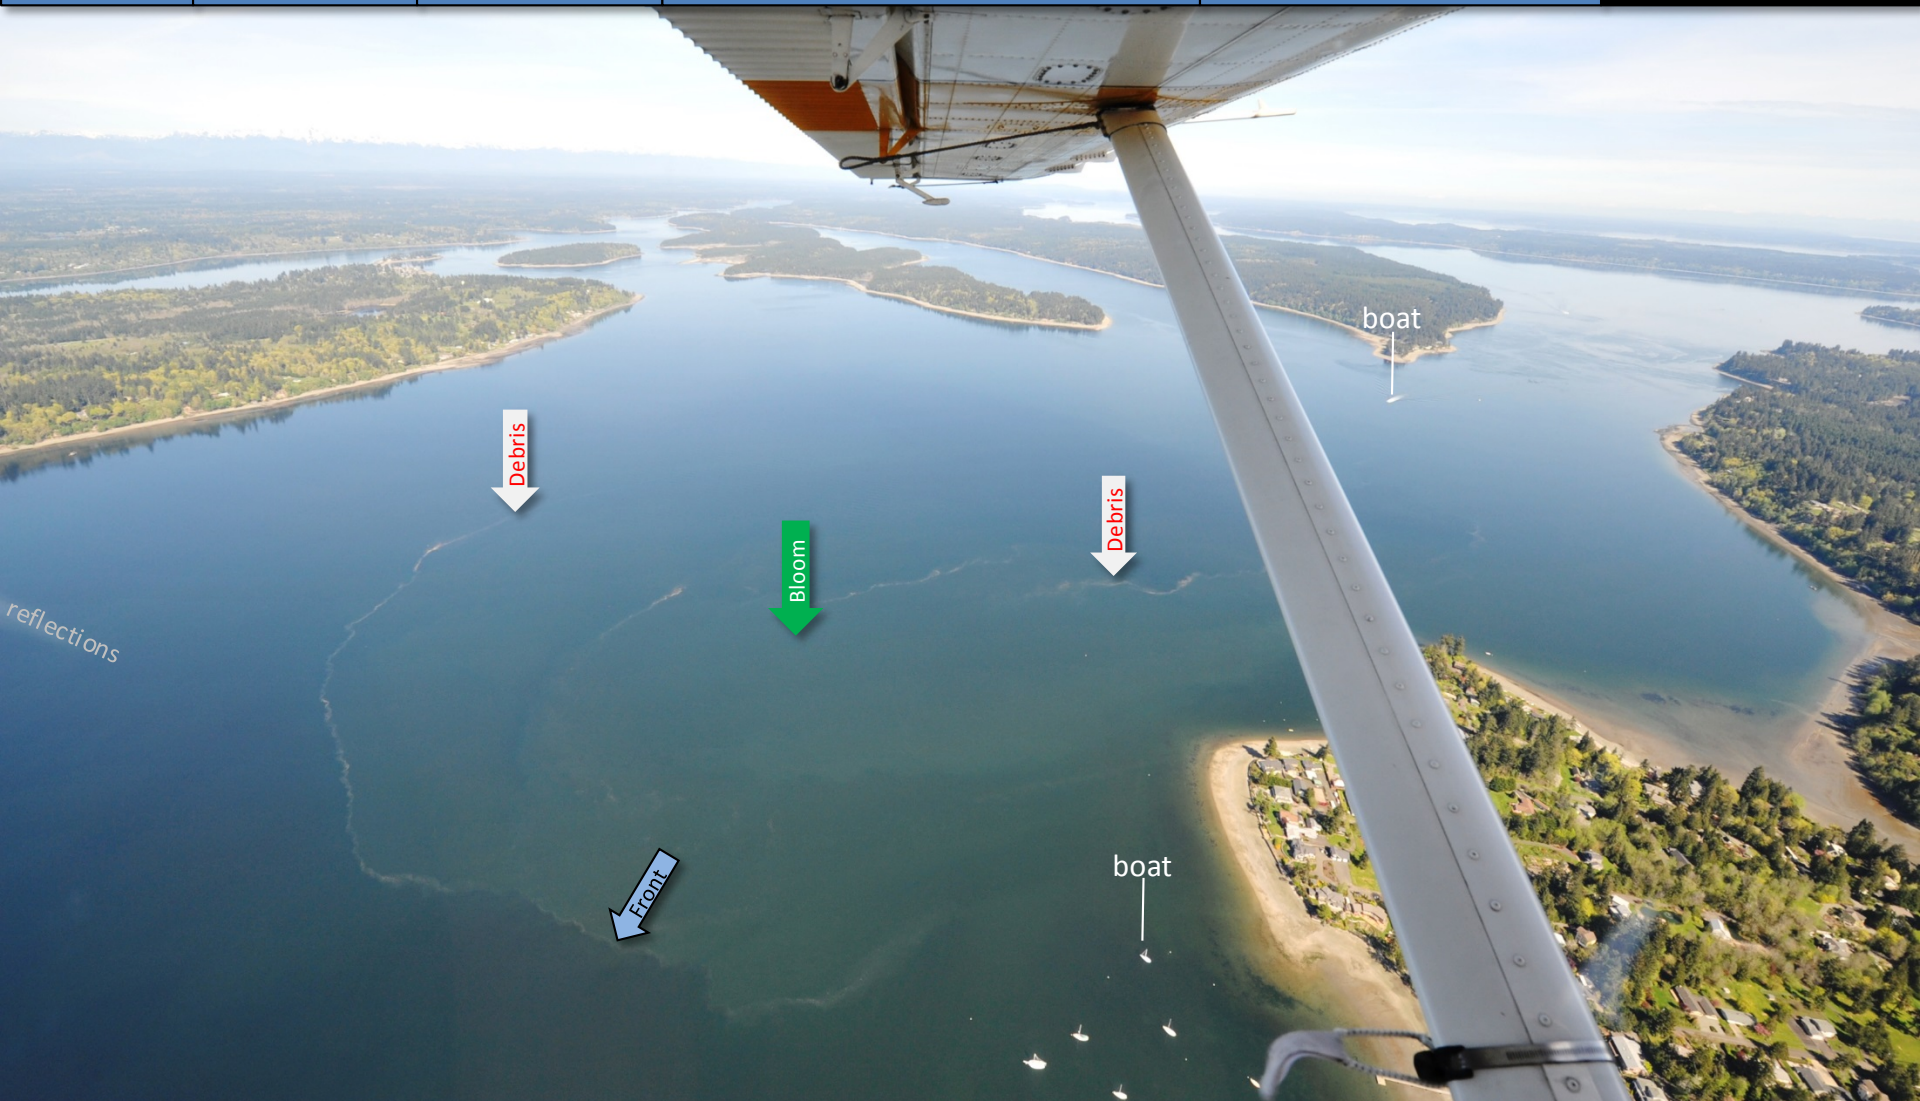
*Water rich in phytoplankton from Peale Passage flowing past Boston Harbor.
Location: Off Dover Point, near Dana Passage (South Sound), 12:33 PM.*

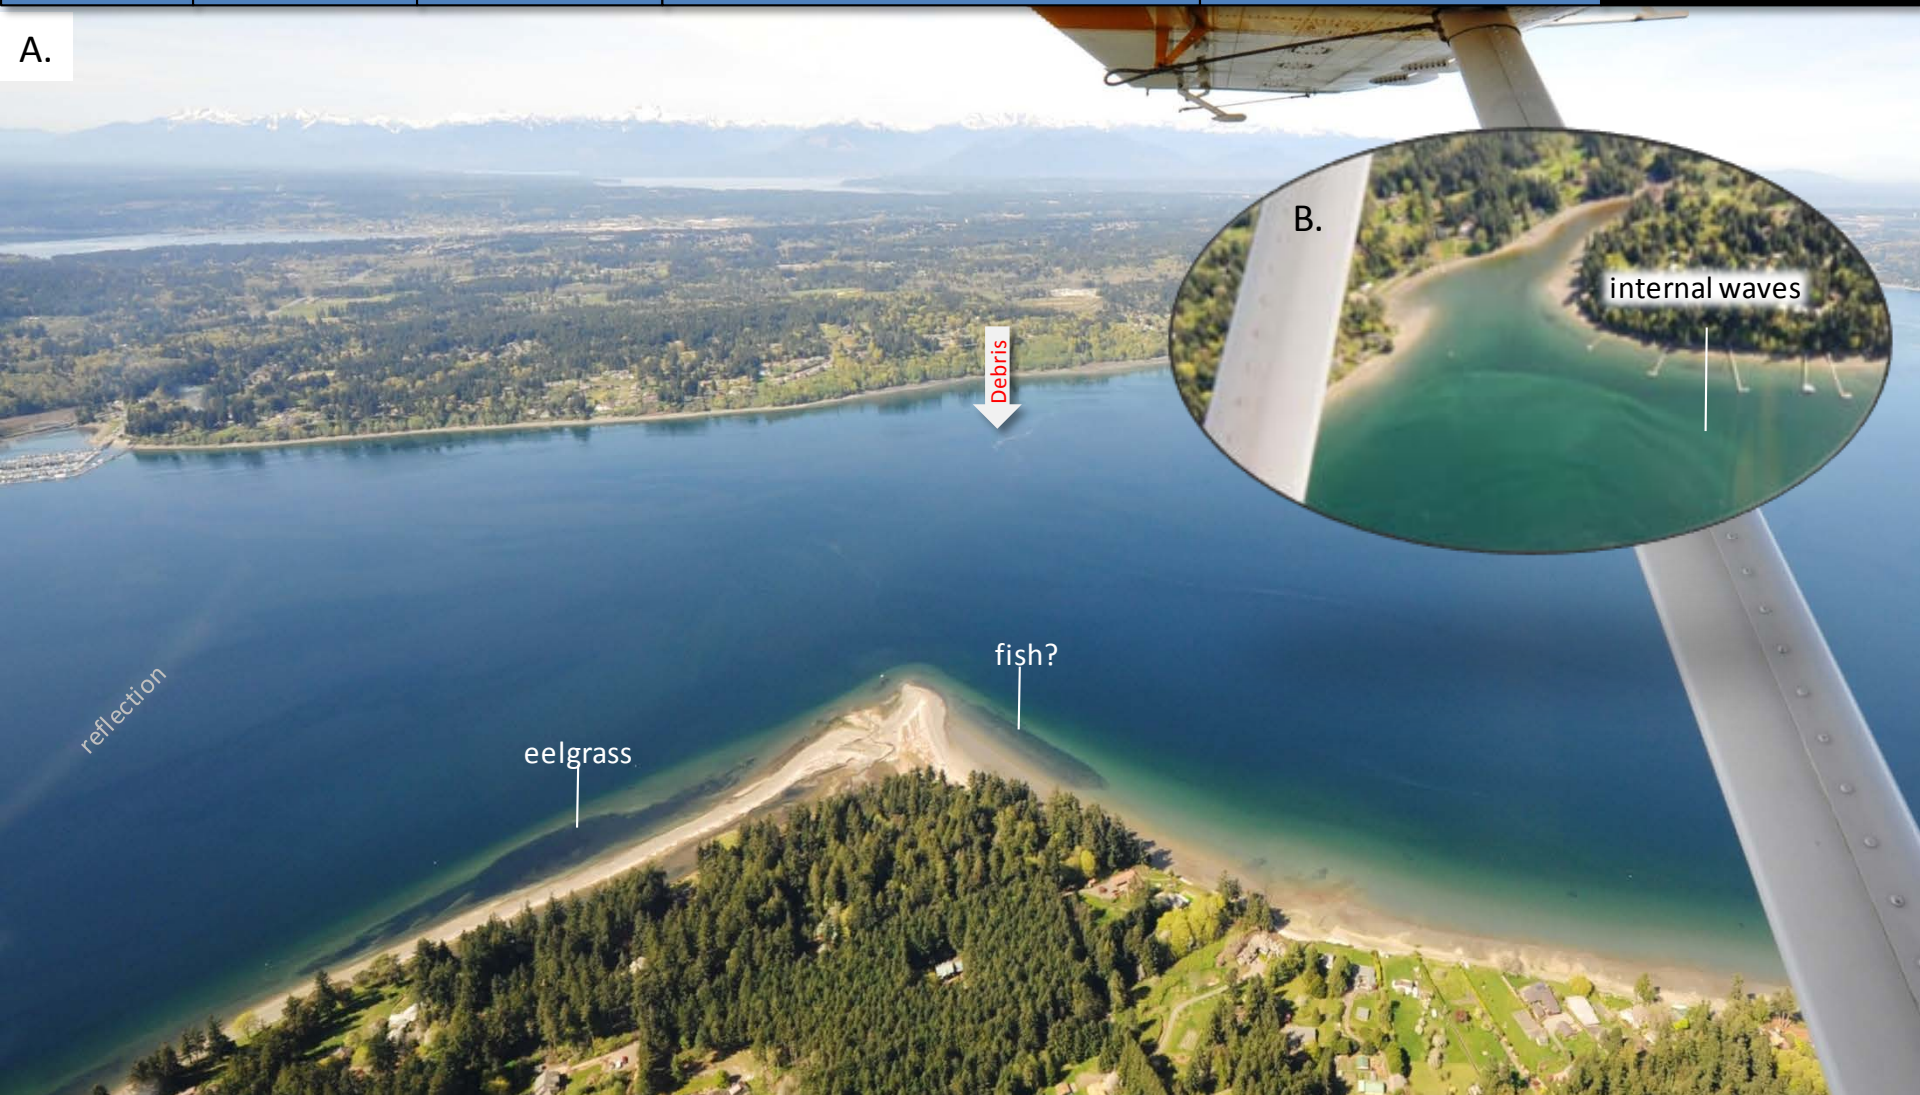
A. Schooling fish or eelgrass, keeping them apart remains a guessing game! B. Internal waves in bay.
Location: A. Battle Point, B. Manzanita Bay, Bainbridge Island (Central Sound), 1:01 PM.

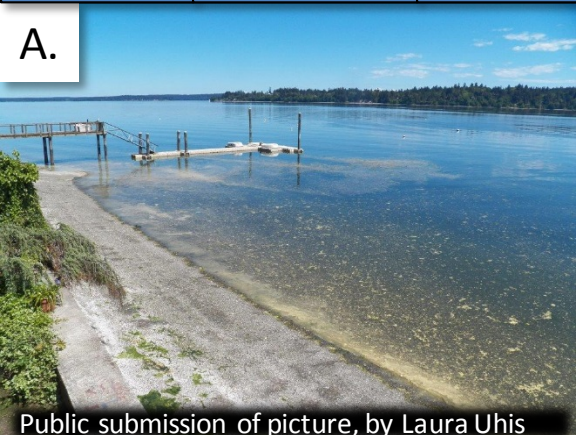
A. Organic material washing onto beaches and decaying. B. Very strong spring bloom conditions.
Location: West side of Budd Inlet (South Sound), 4:44 PM.

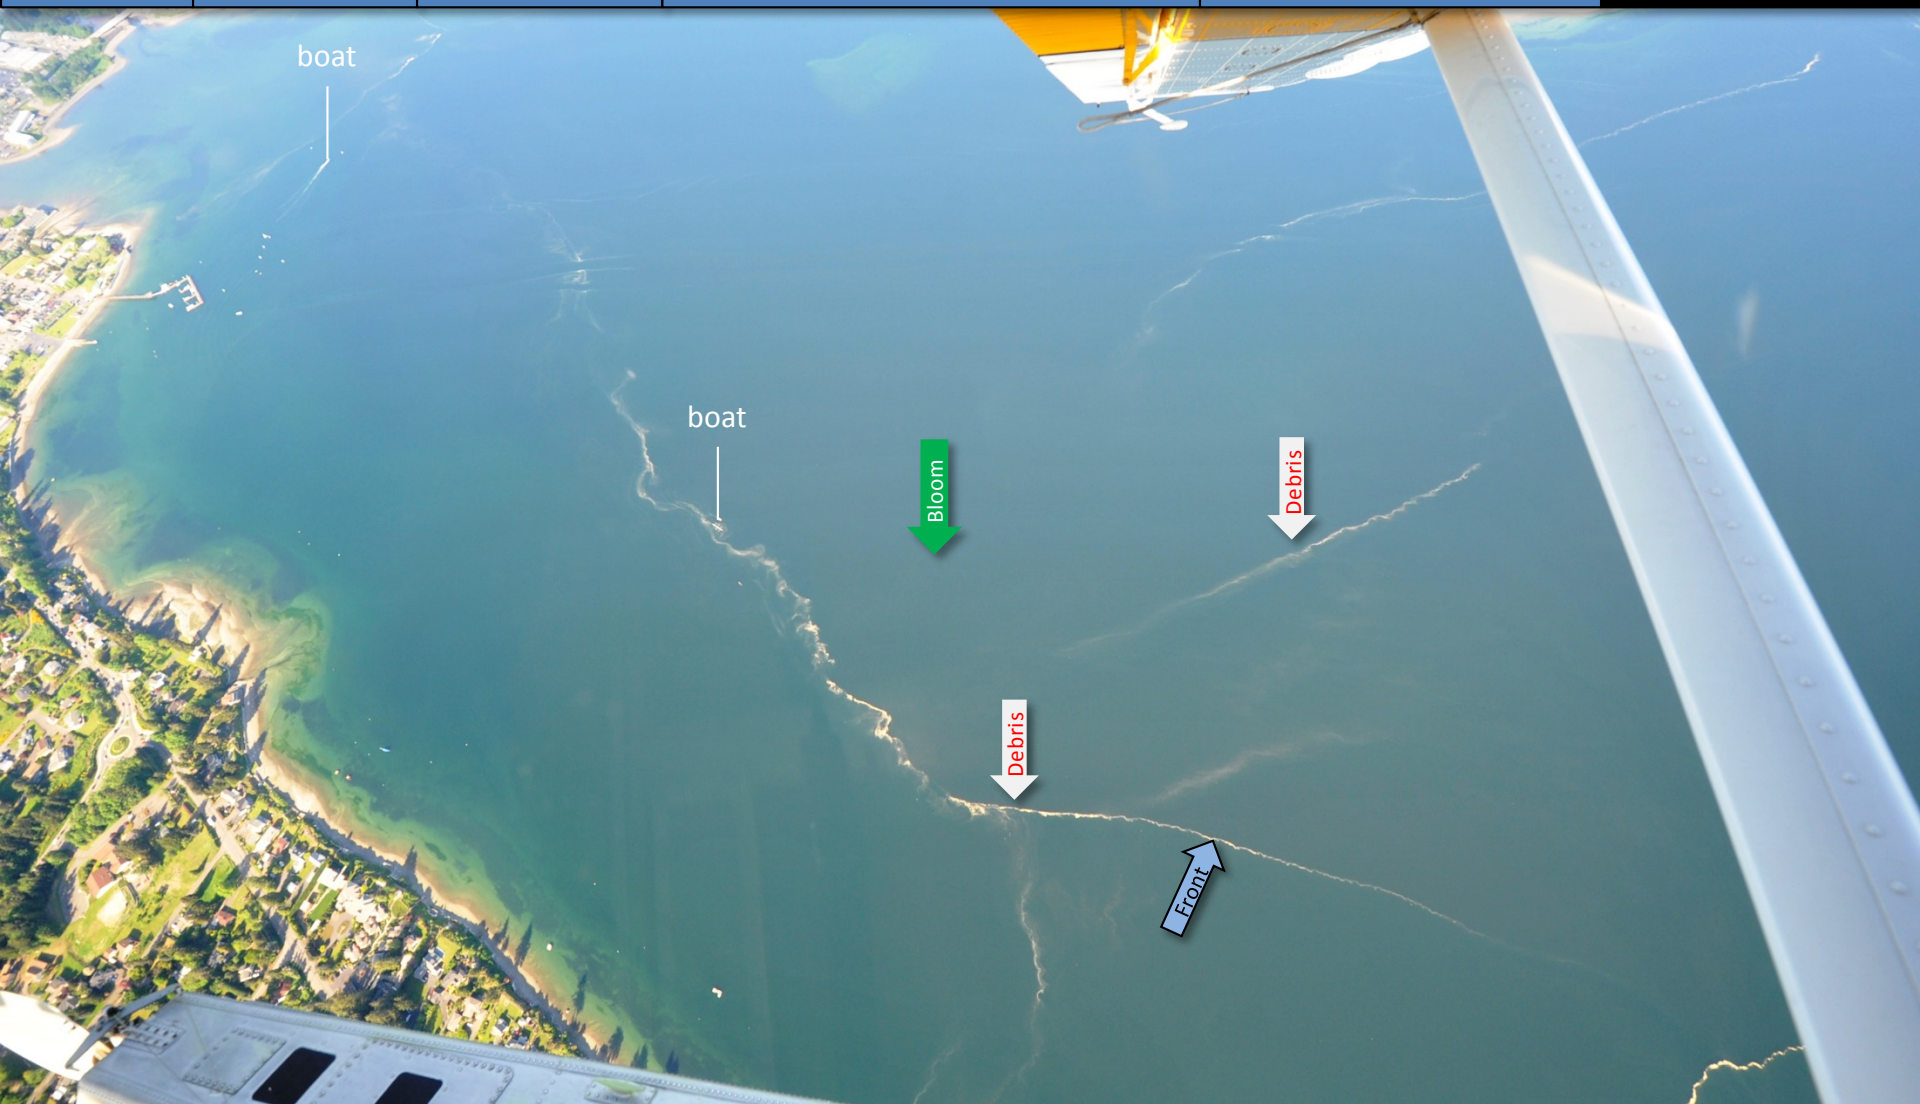
Large and numerous accumulations of organic material at the surface. Phytoplankton bloom.
Location: Dyes Inlet (Central Sound), 5:19 PM.

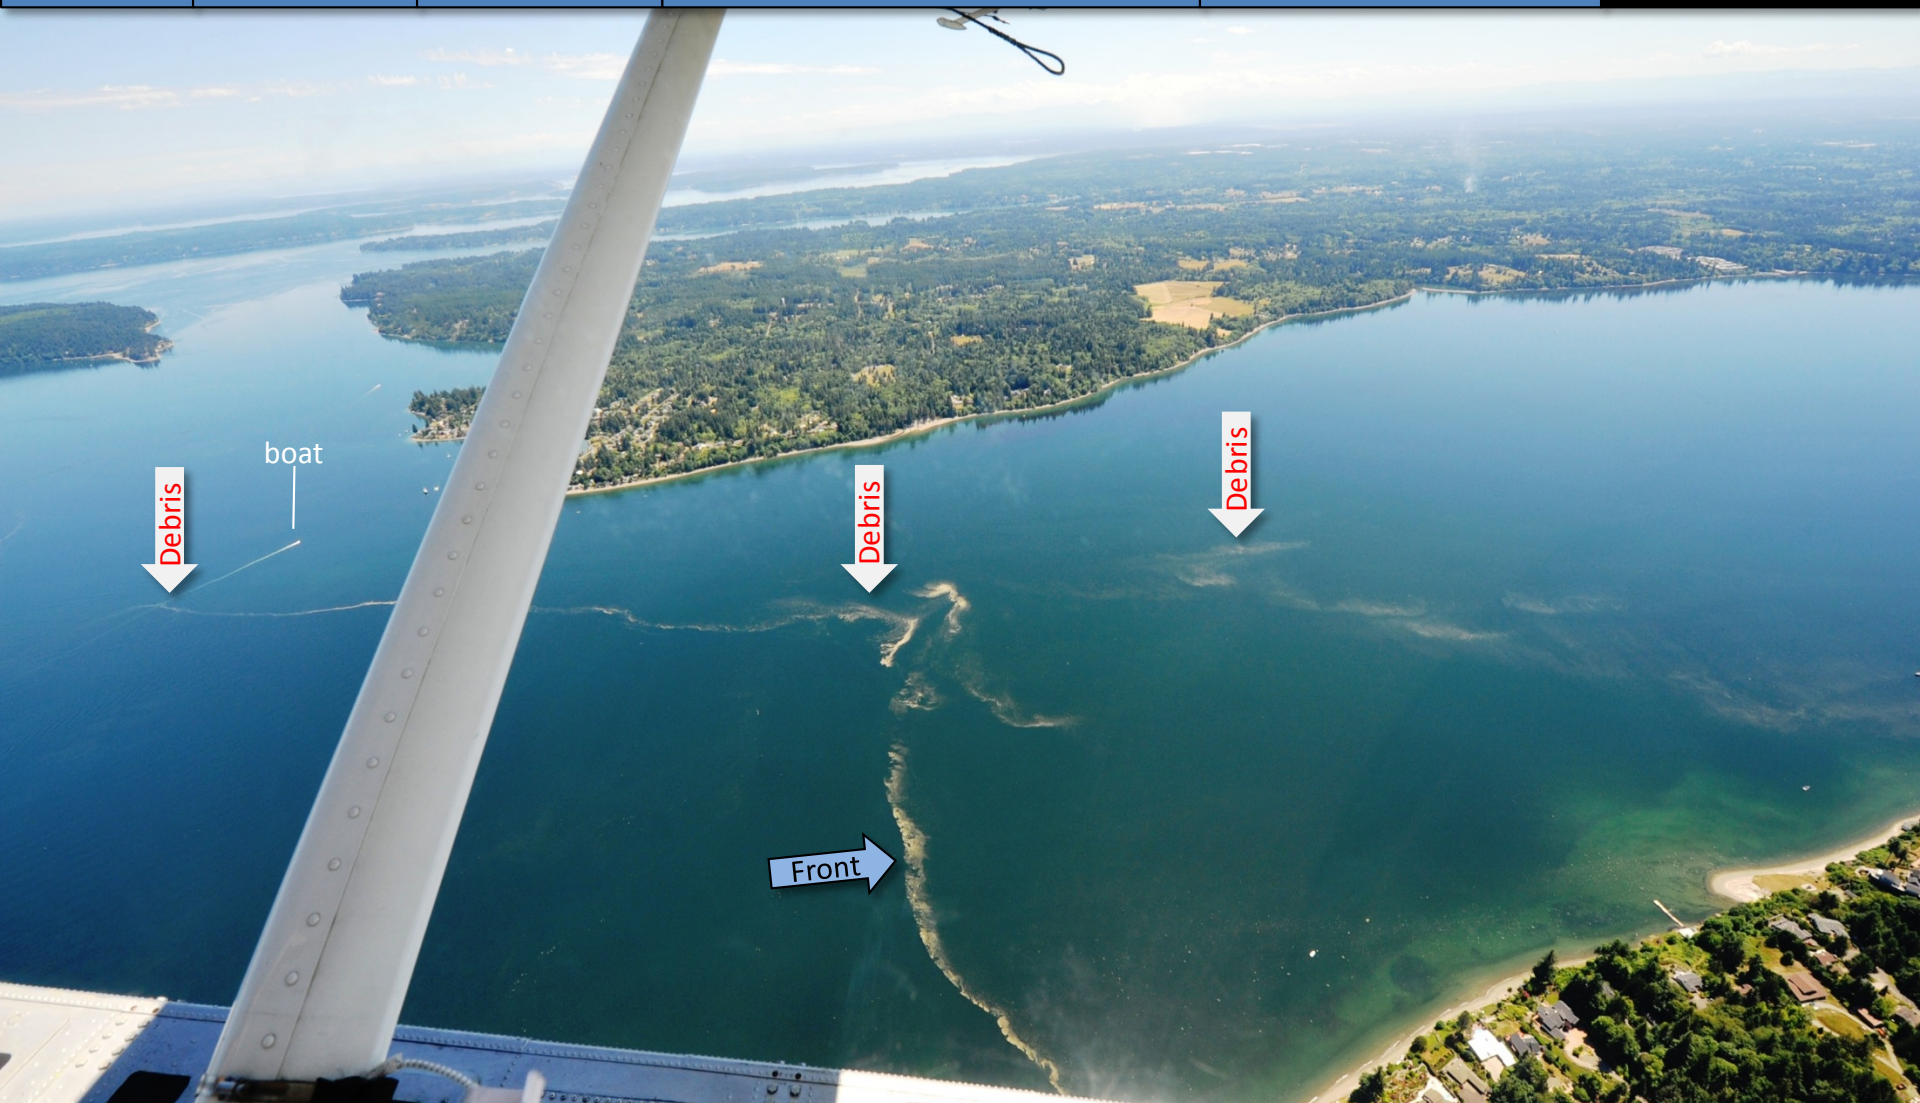
Organic material accumulating in large ribbons along tidal front at the entrance to Budd Inlet.
Location: Across from Boston Harbor, Budd Inlet (South Sound), 12:51 PM.
