Eyes Over Puget Sound

2016 Review

Up-to-date observations of visible water quality conditions in Puget Sound and the Strait of Juan de Fuca

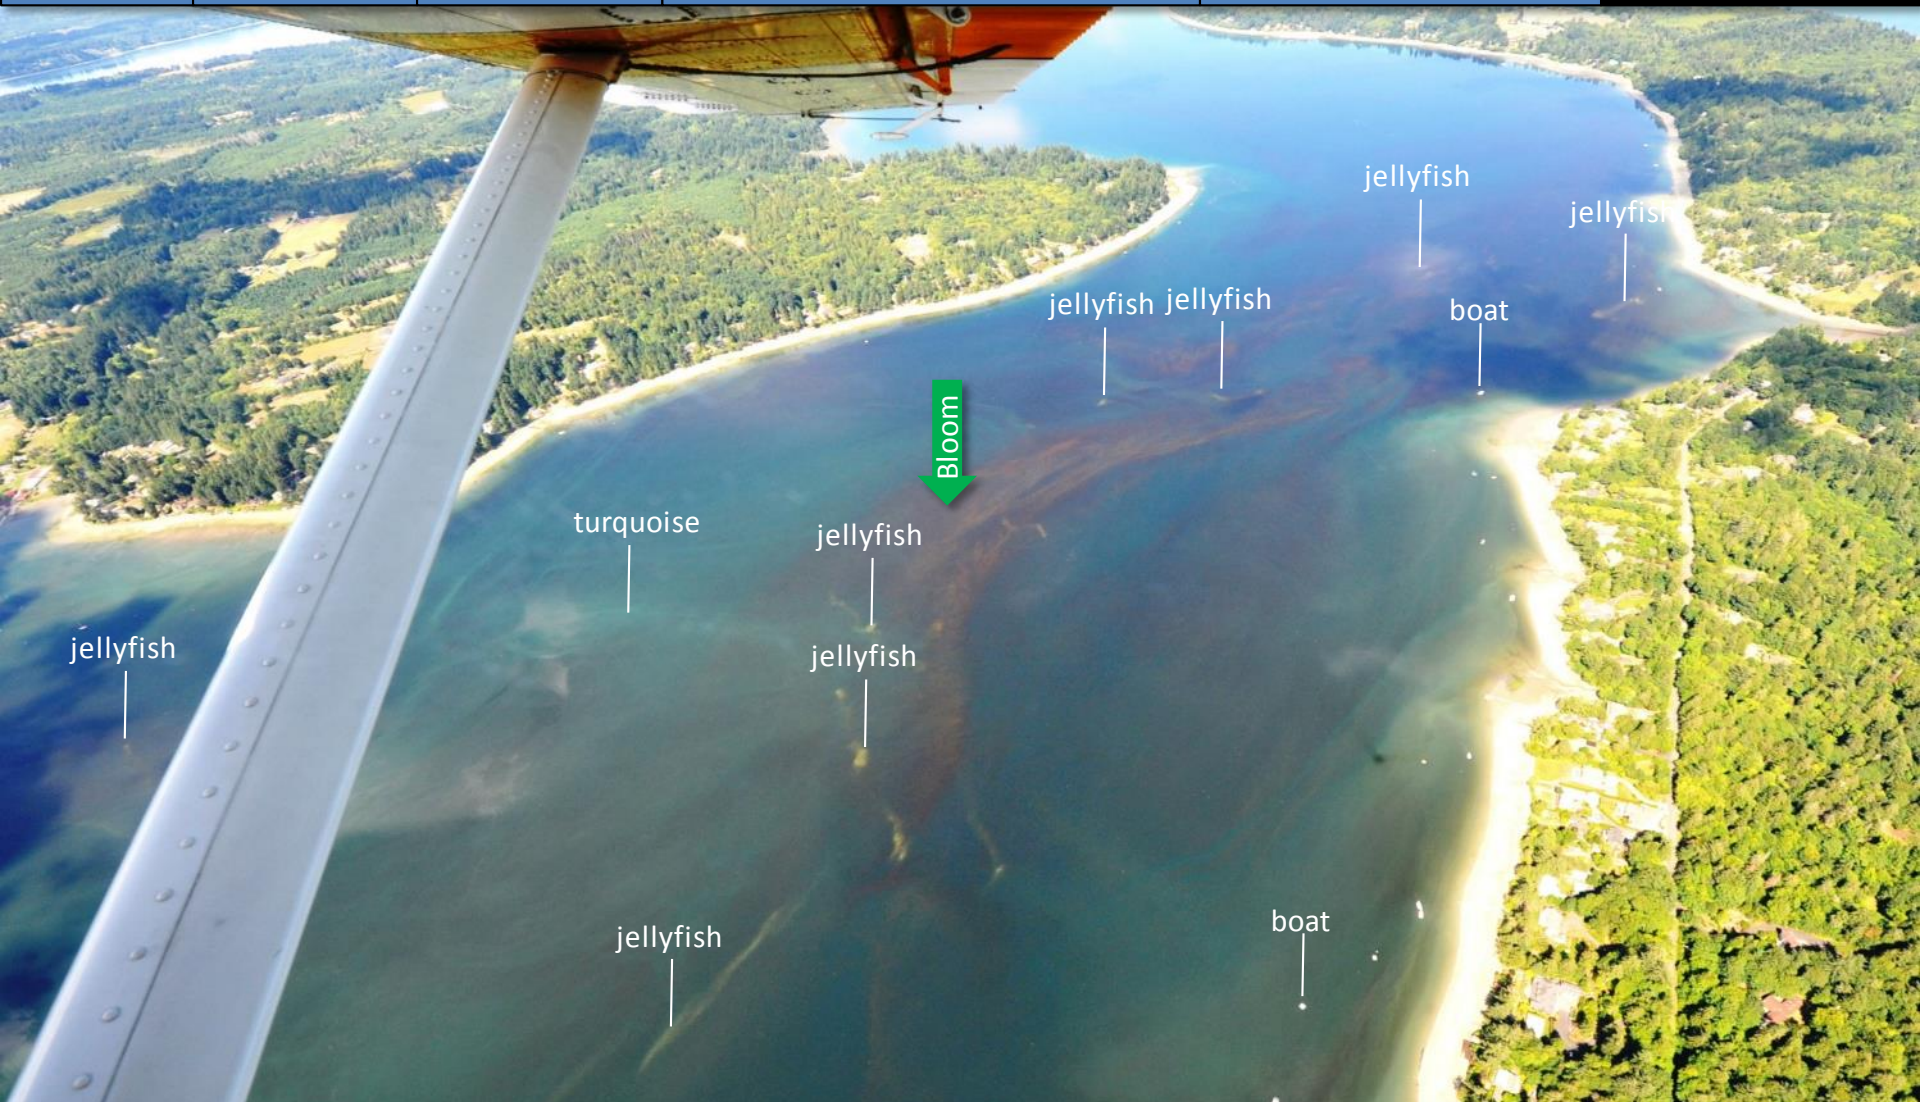
Red-brown bloom and large patches of jellyfish. Turquoise water is likely freshwater.
Location: Across from Young Cove, Eld Inlet (South Sound), 3:08 PM.

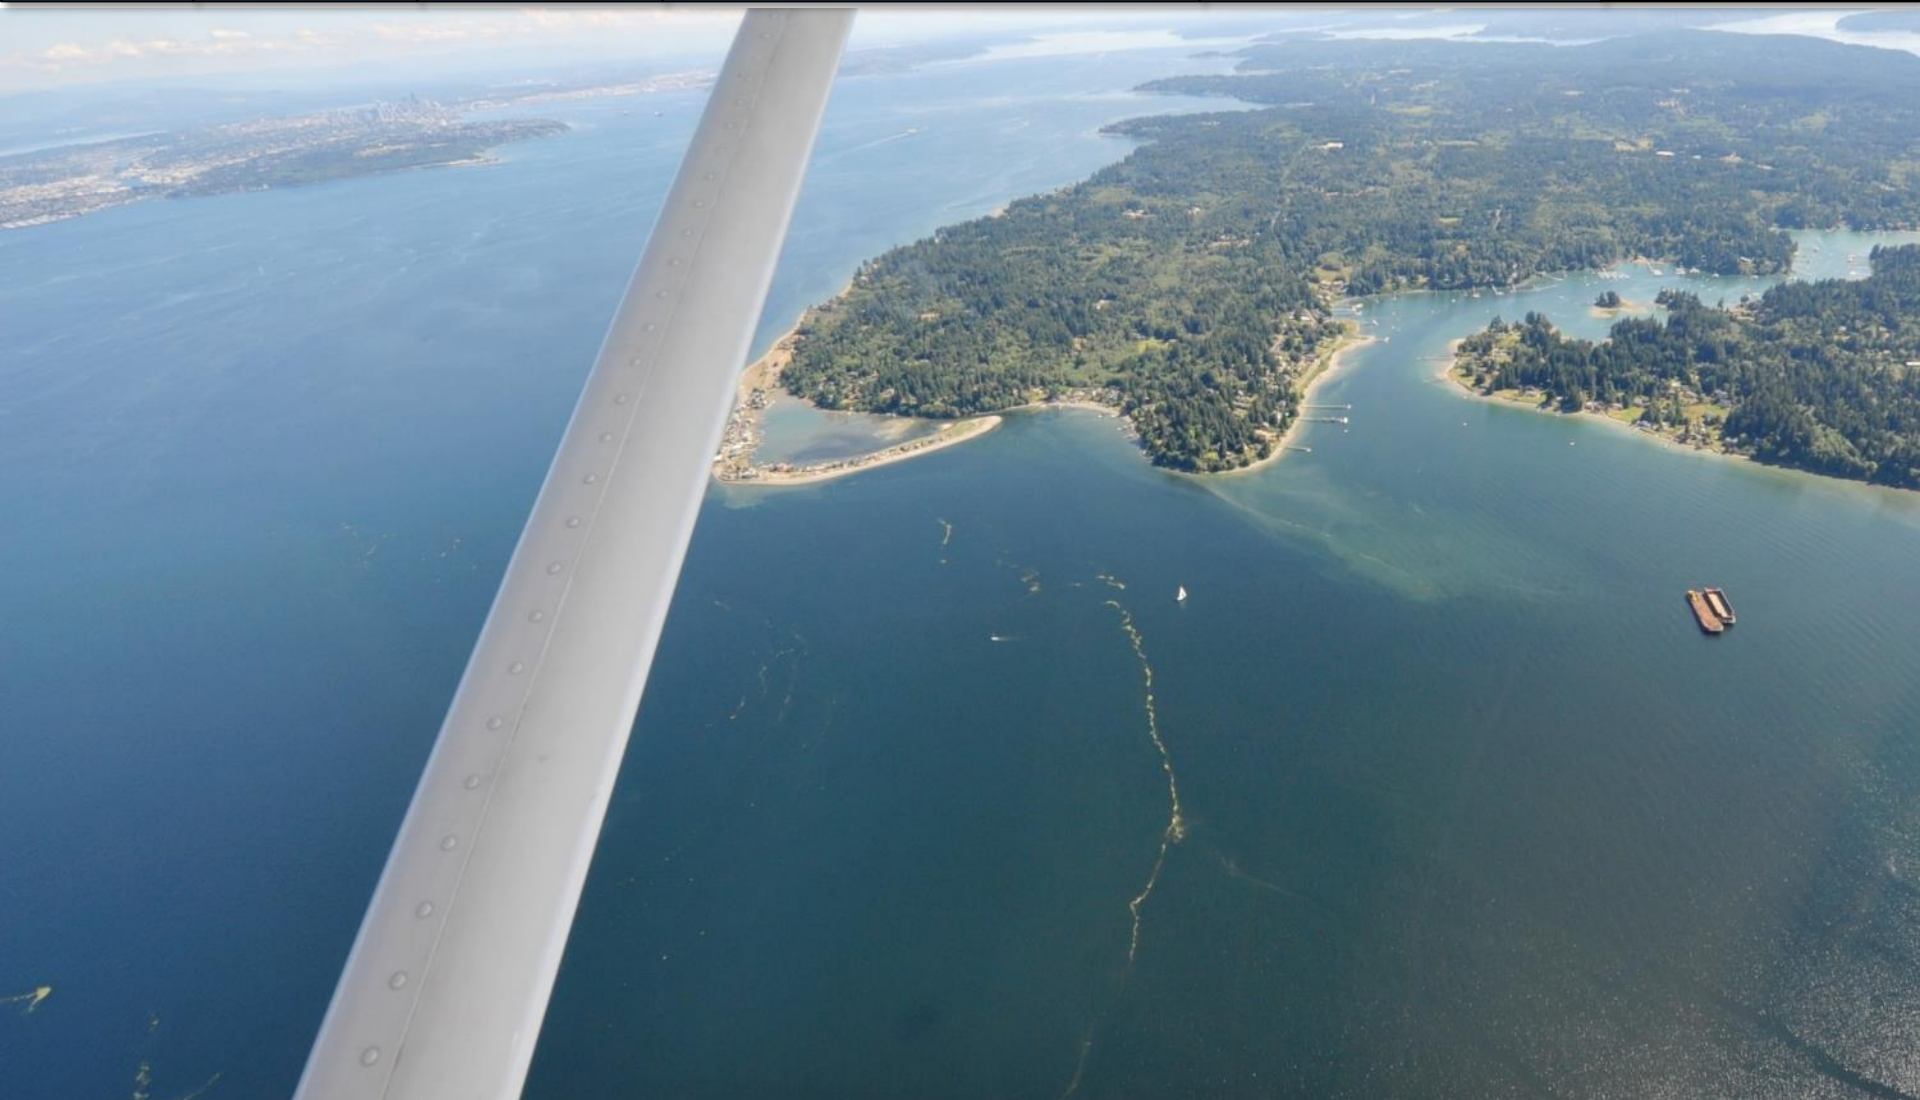
*Very large mats of organic material drifting in Port Madison and adjacent parts of Central Basin.
Location: Point Monroe, Bainbridge Island (Central Sound), 3:58 PM.*

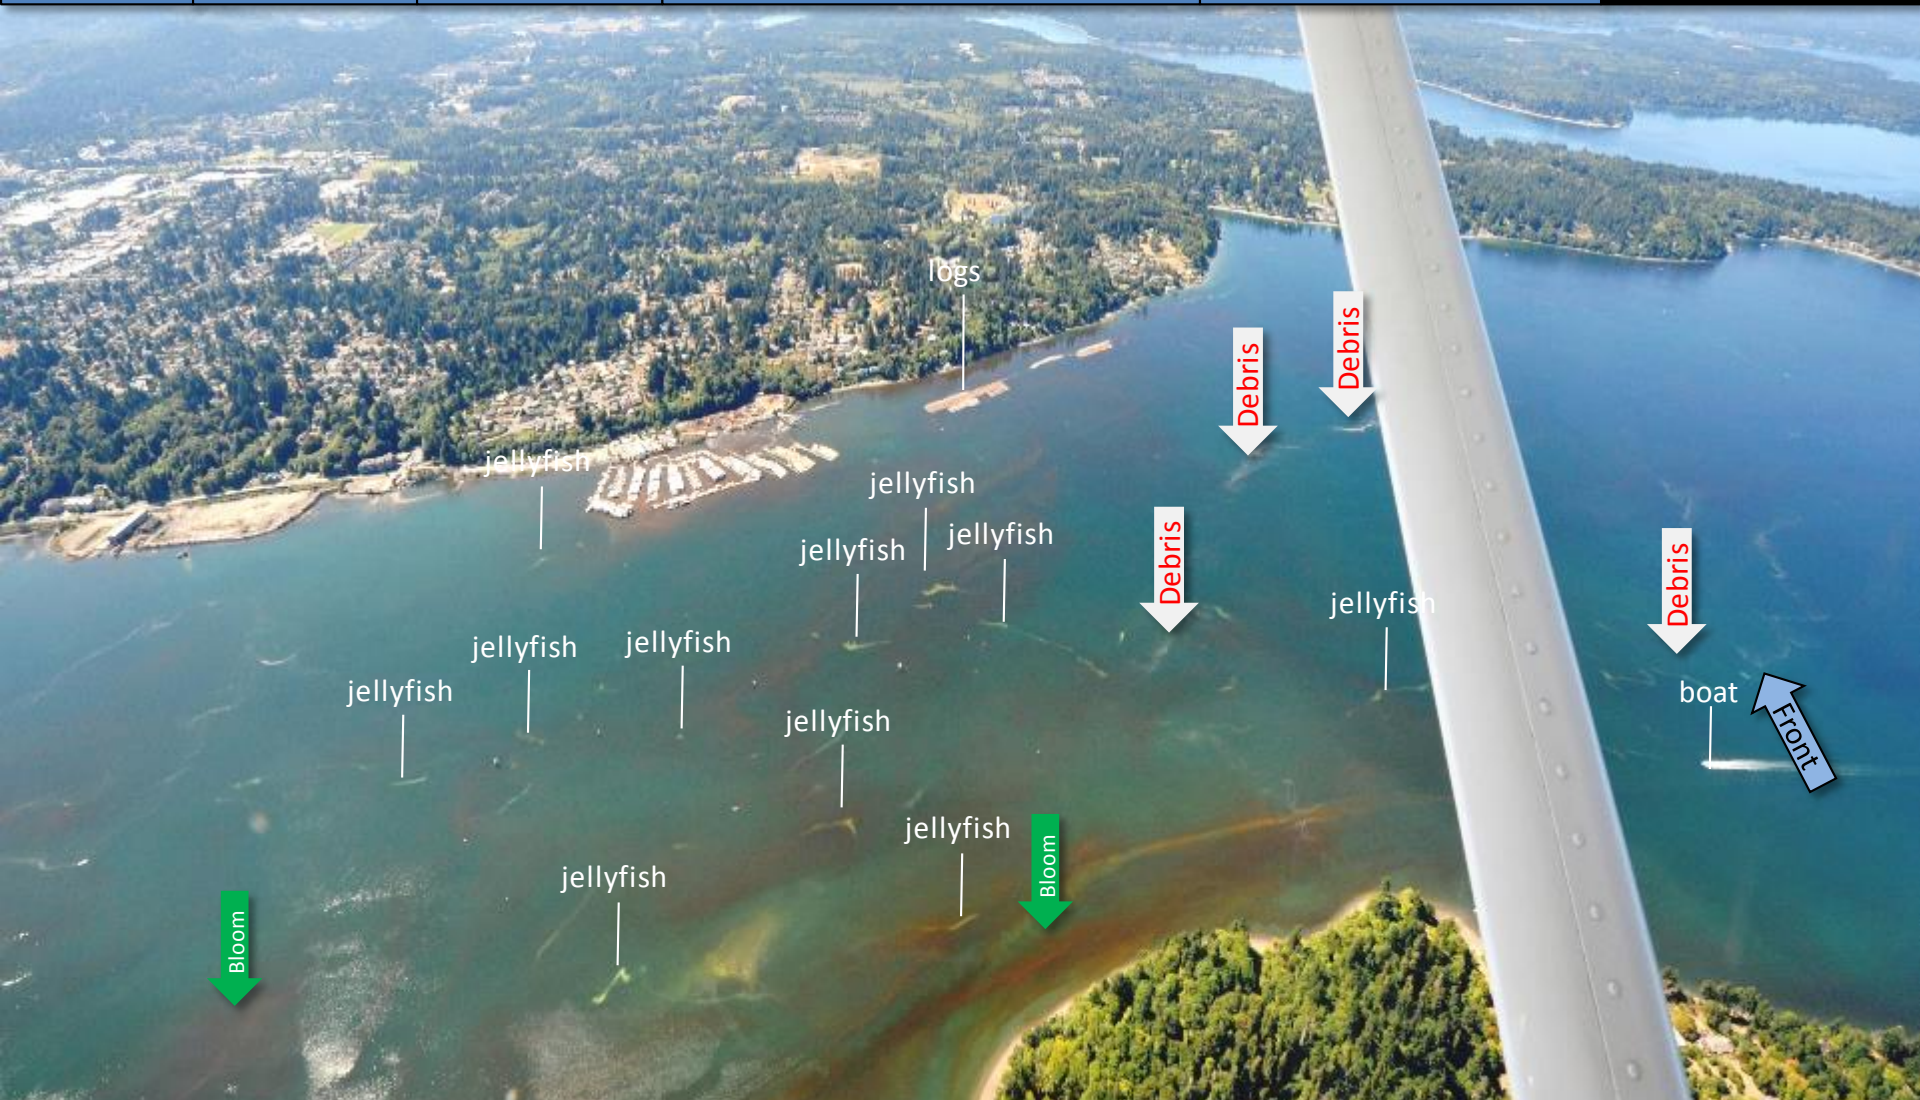
Strong red-brown bloom, abundant jellyfish patches and organic debris at surface.
Location: Budd Inlet (South Sound), 2:25 PM.

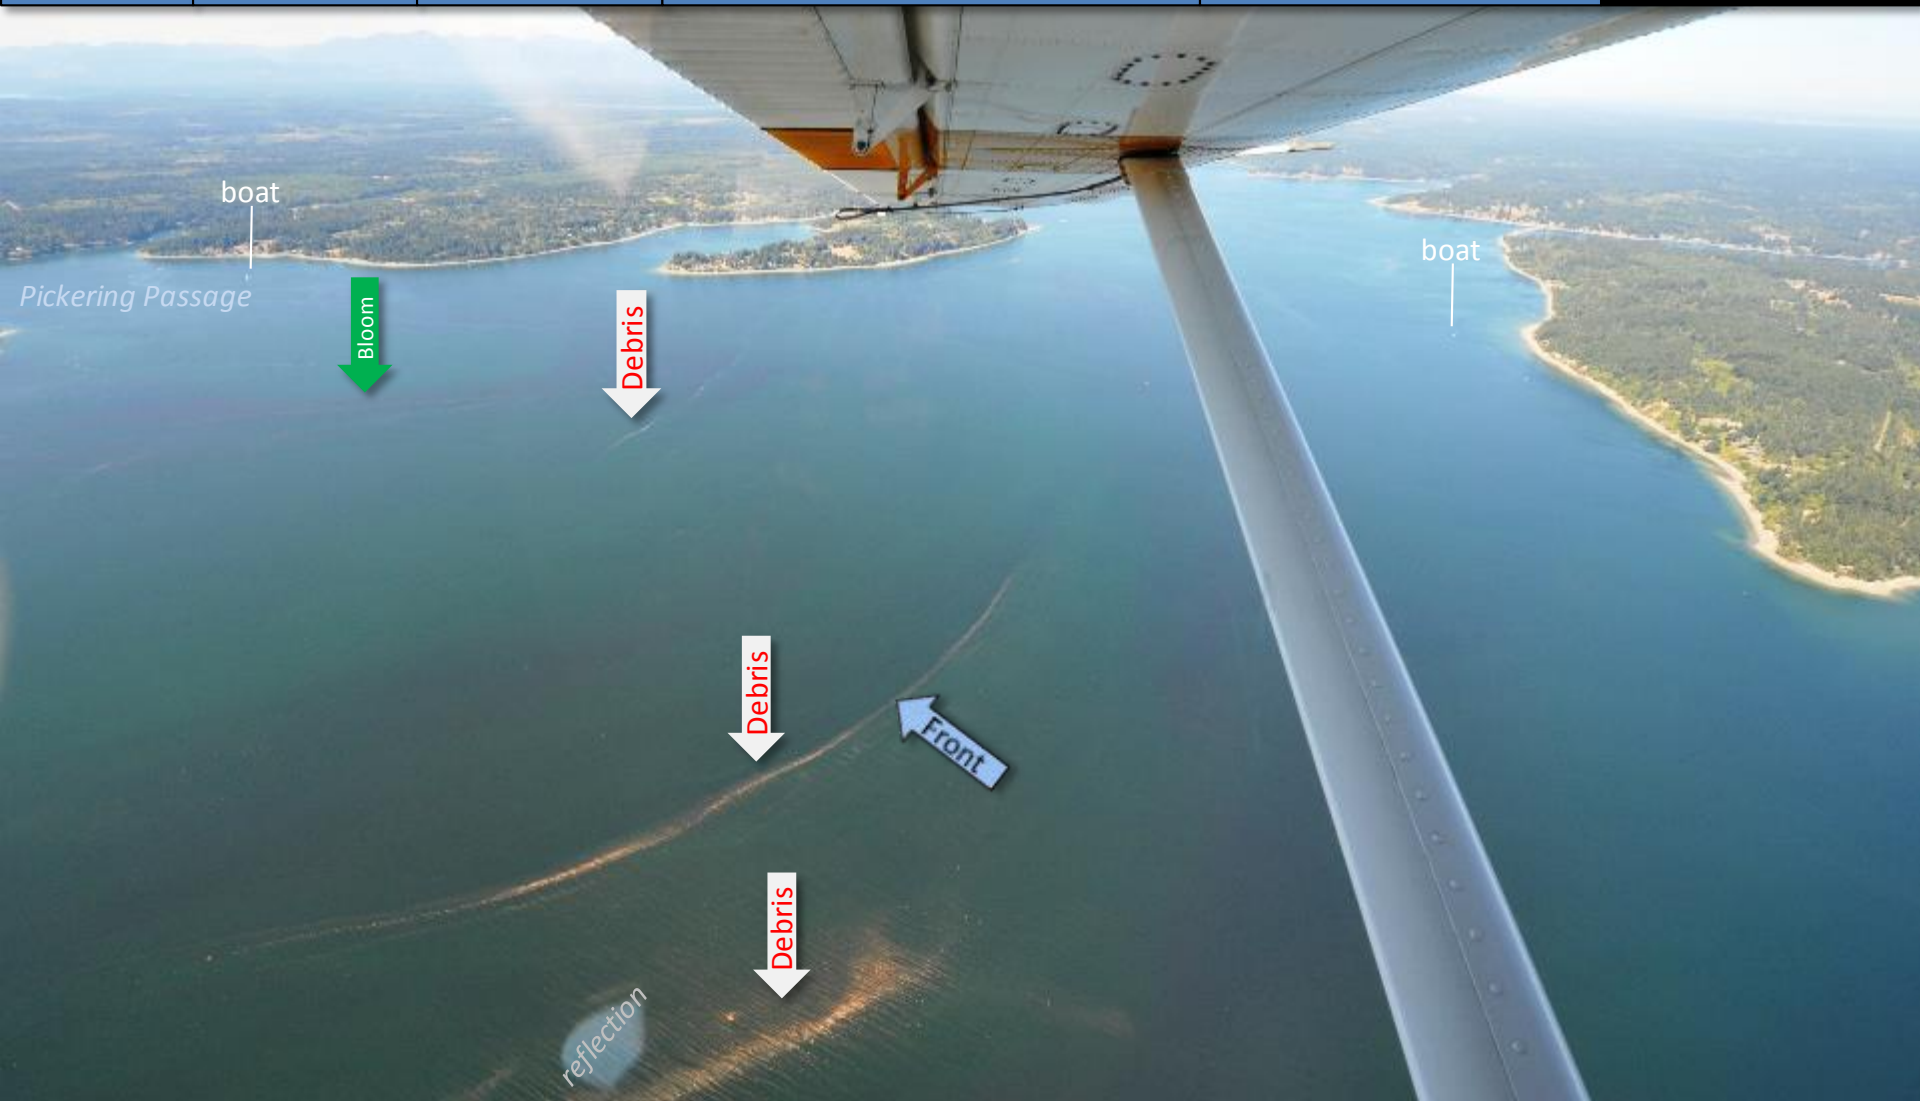
Large accumulations of a Noctiluca bloom at an unusual time of the year.
Location: Entrance to Pickering Passage, Case Inlet (South Sound), 2:48 PM.

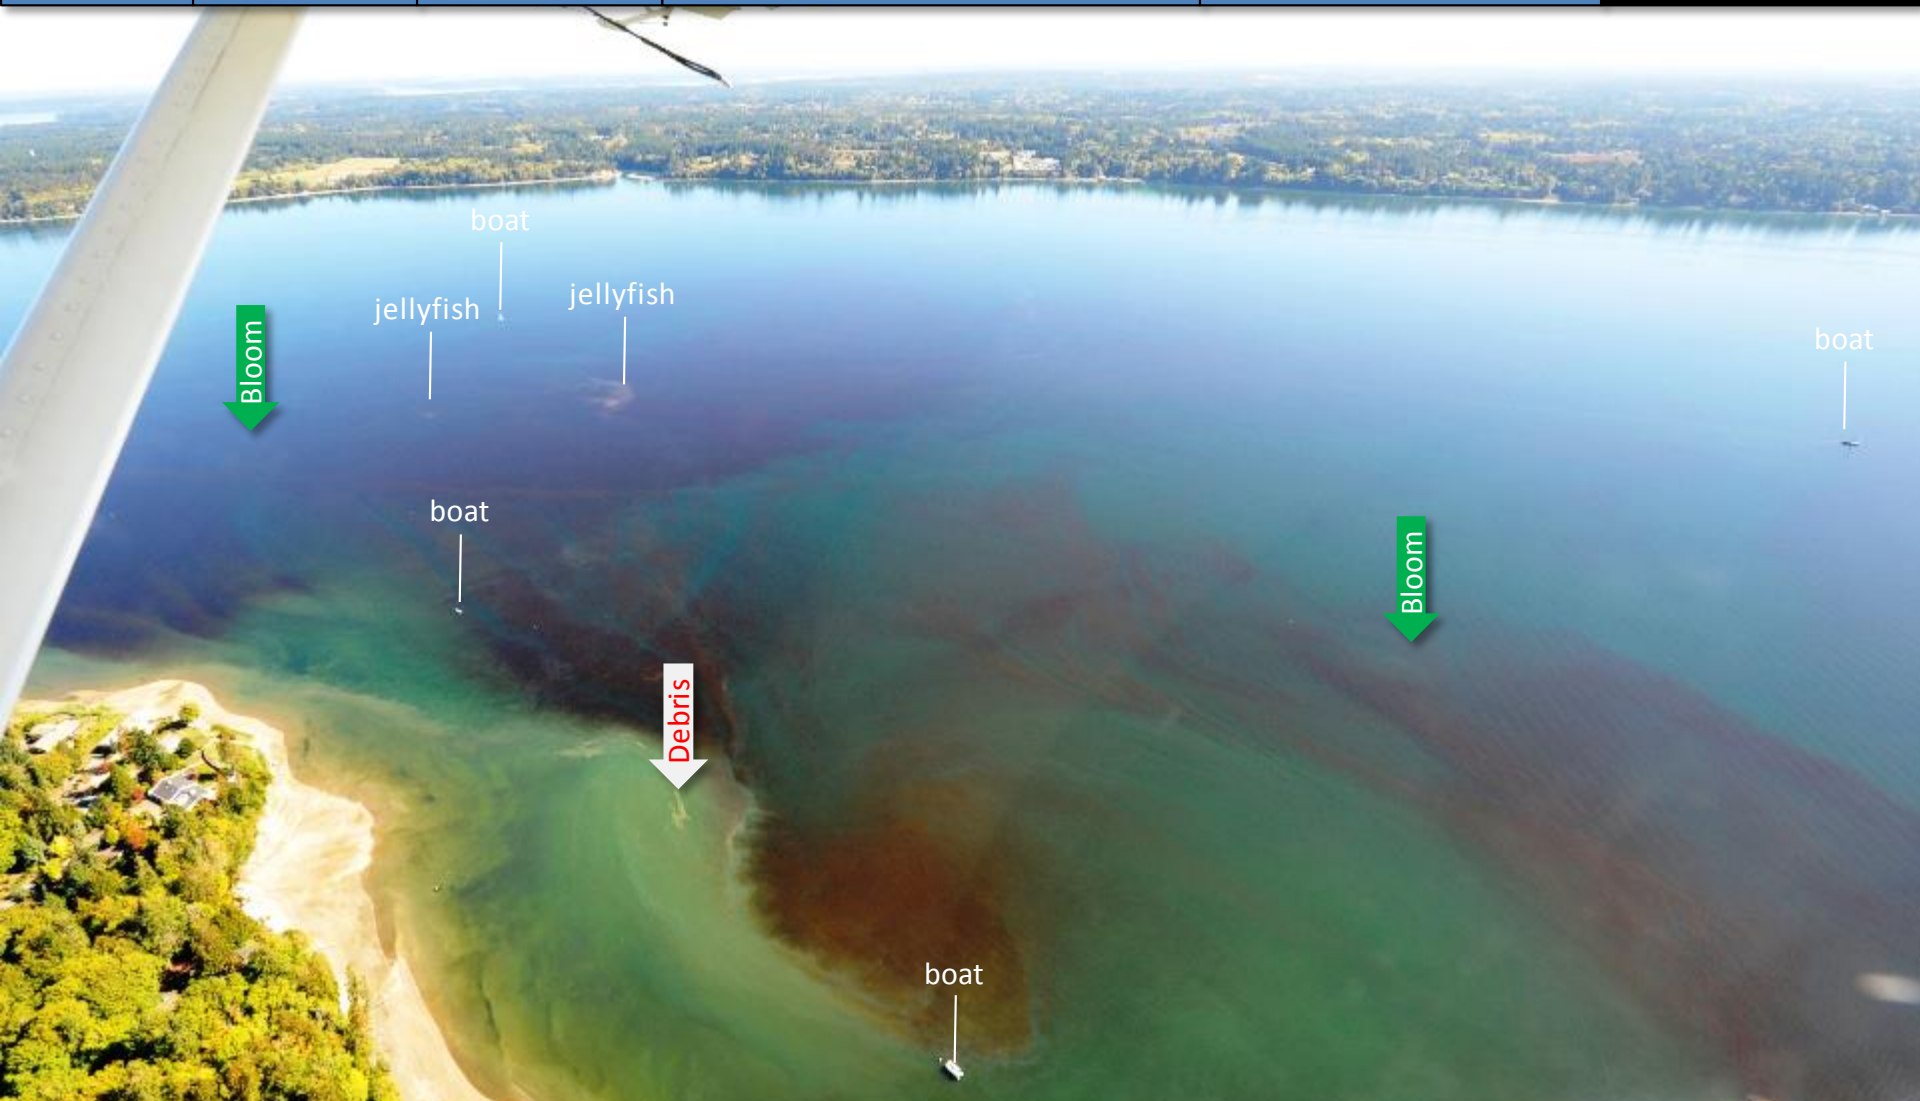
Strong red-brown bloom, jellyfish patches, and organic debris at surface.
Location: Near Big Tykel Cove, Budd Inlet (South Sound), 12:28 PM.

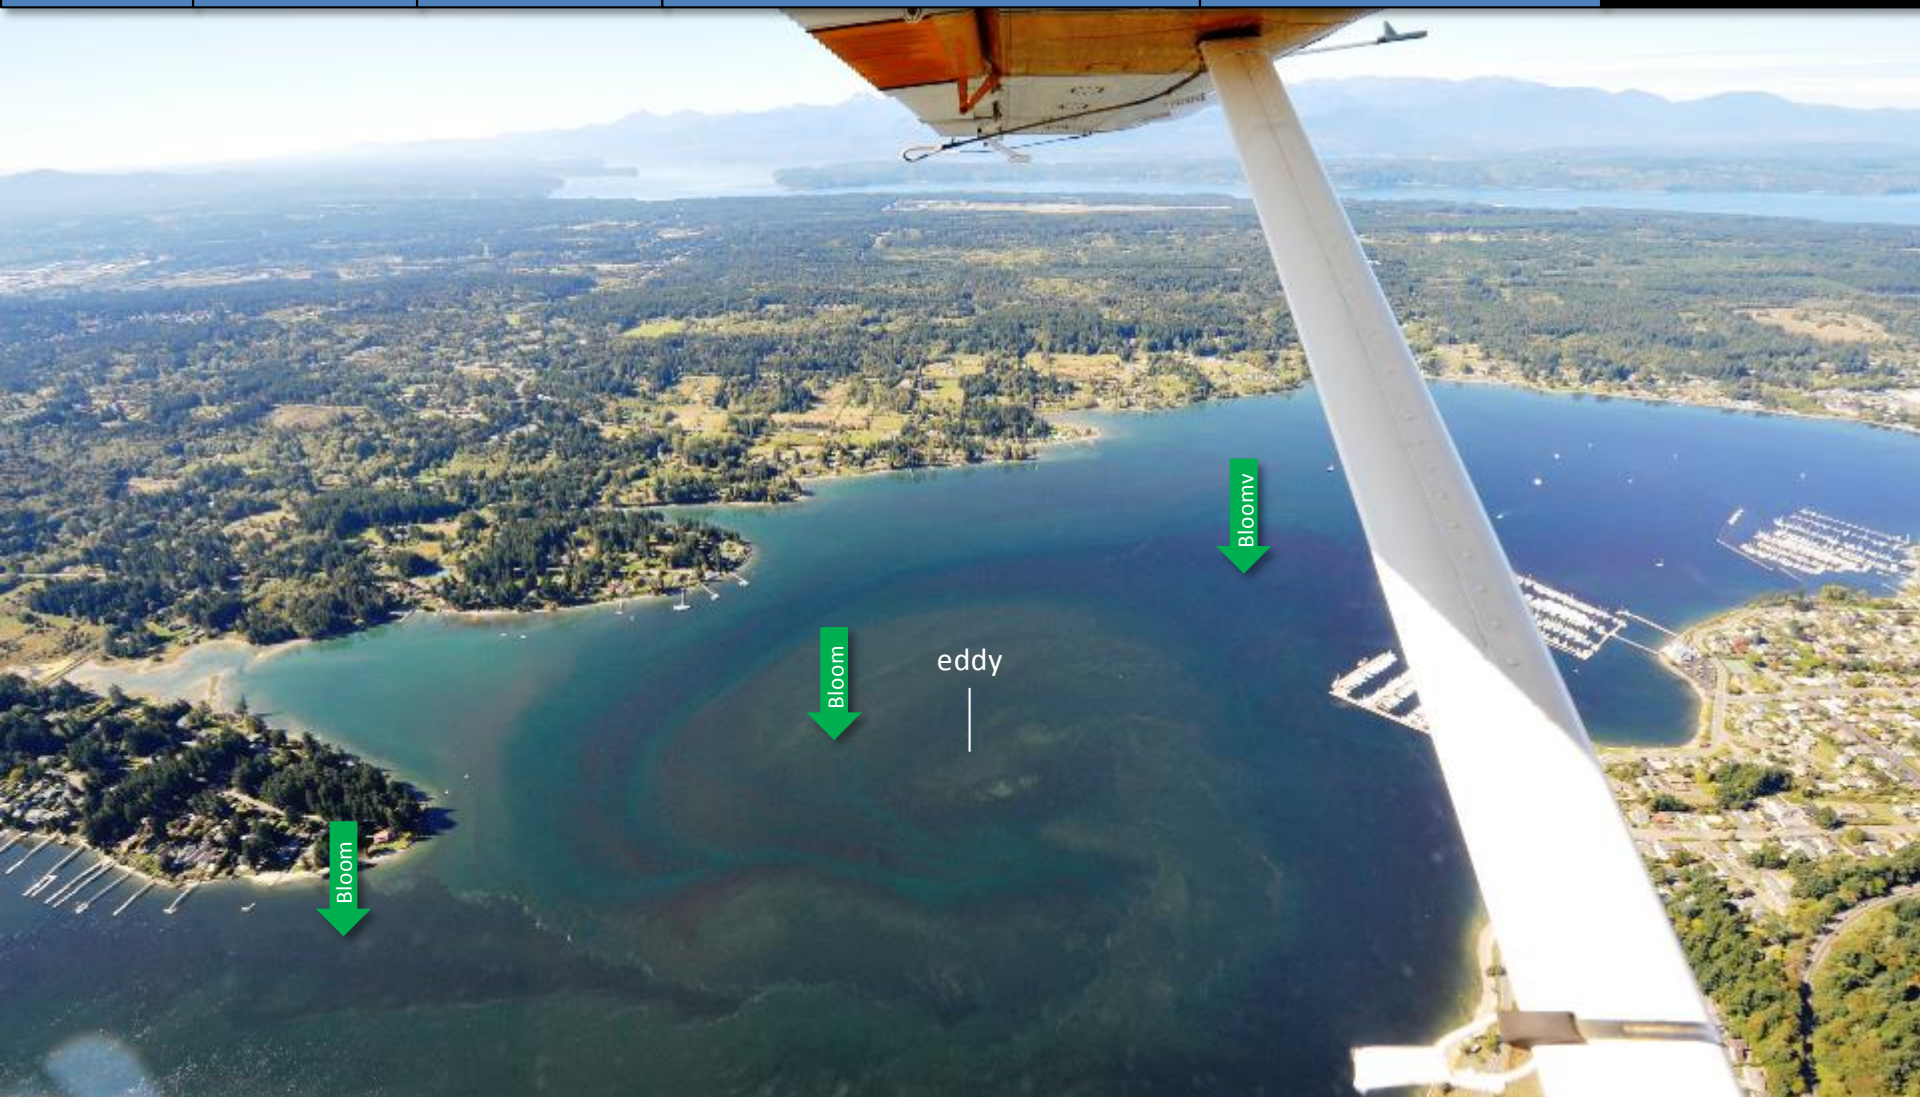
Large tidal eddy and water with different colored blooms.
Location: Liberty Bay (Central Sound), 1:01 PM.

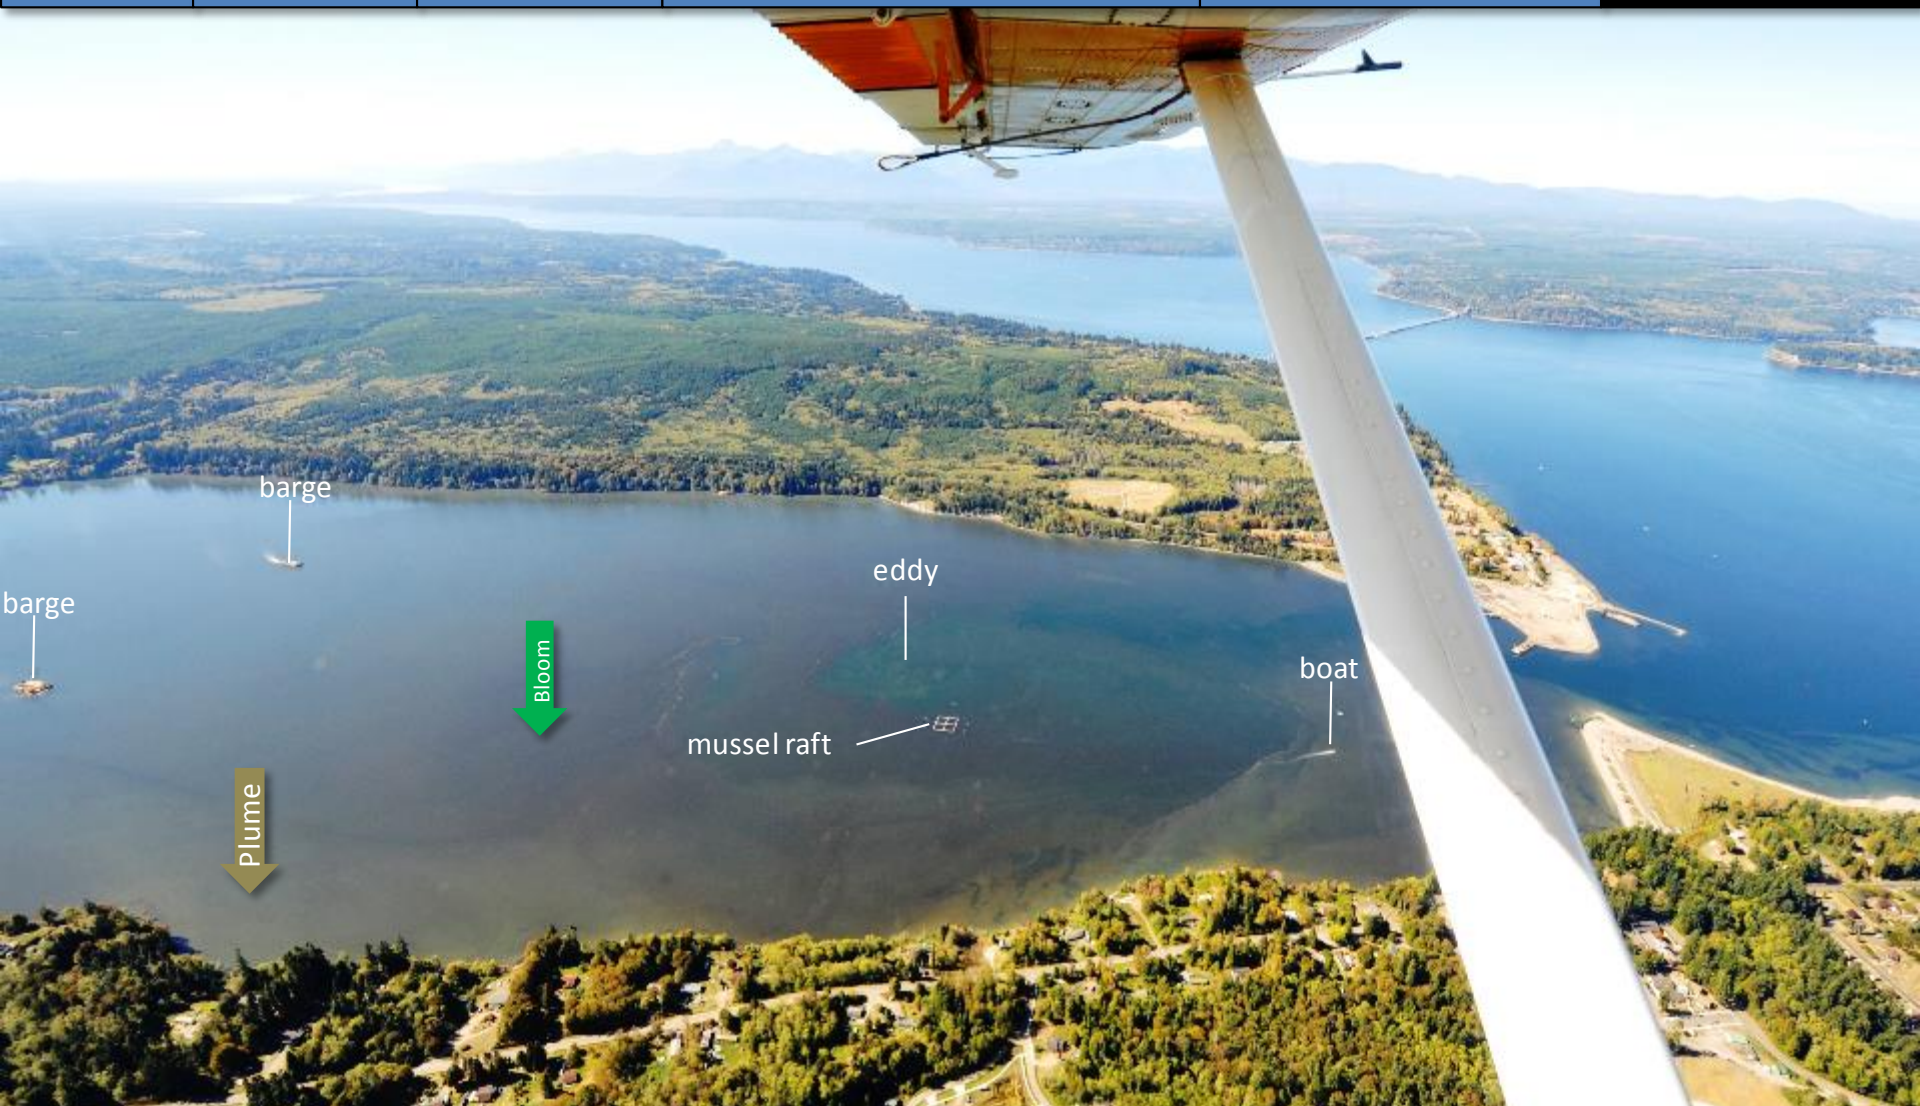
*Red-brown bloom and flood tide setting off eddy. River plume with suspended sediment on eastern shore.
Location: Port Gamble (Hood Canal), 1:06 PM.*

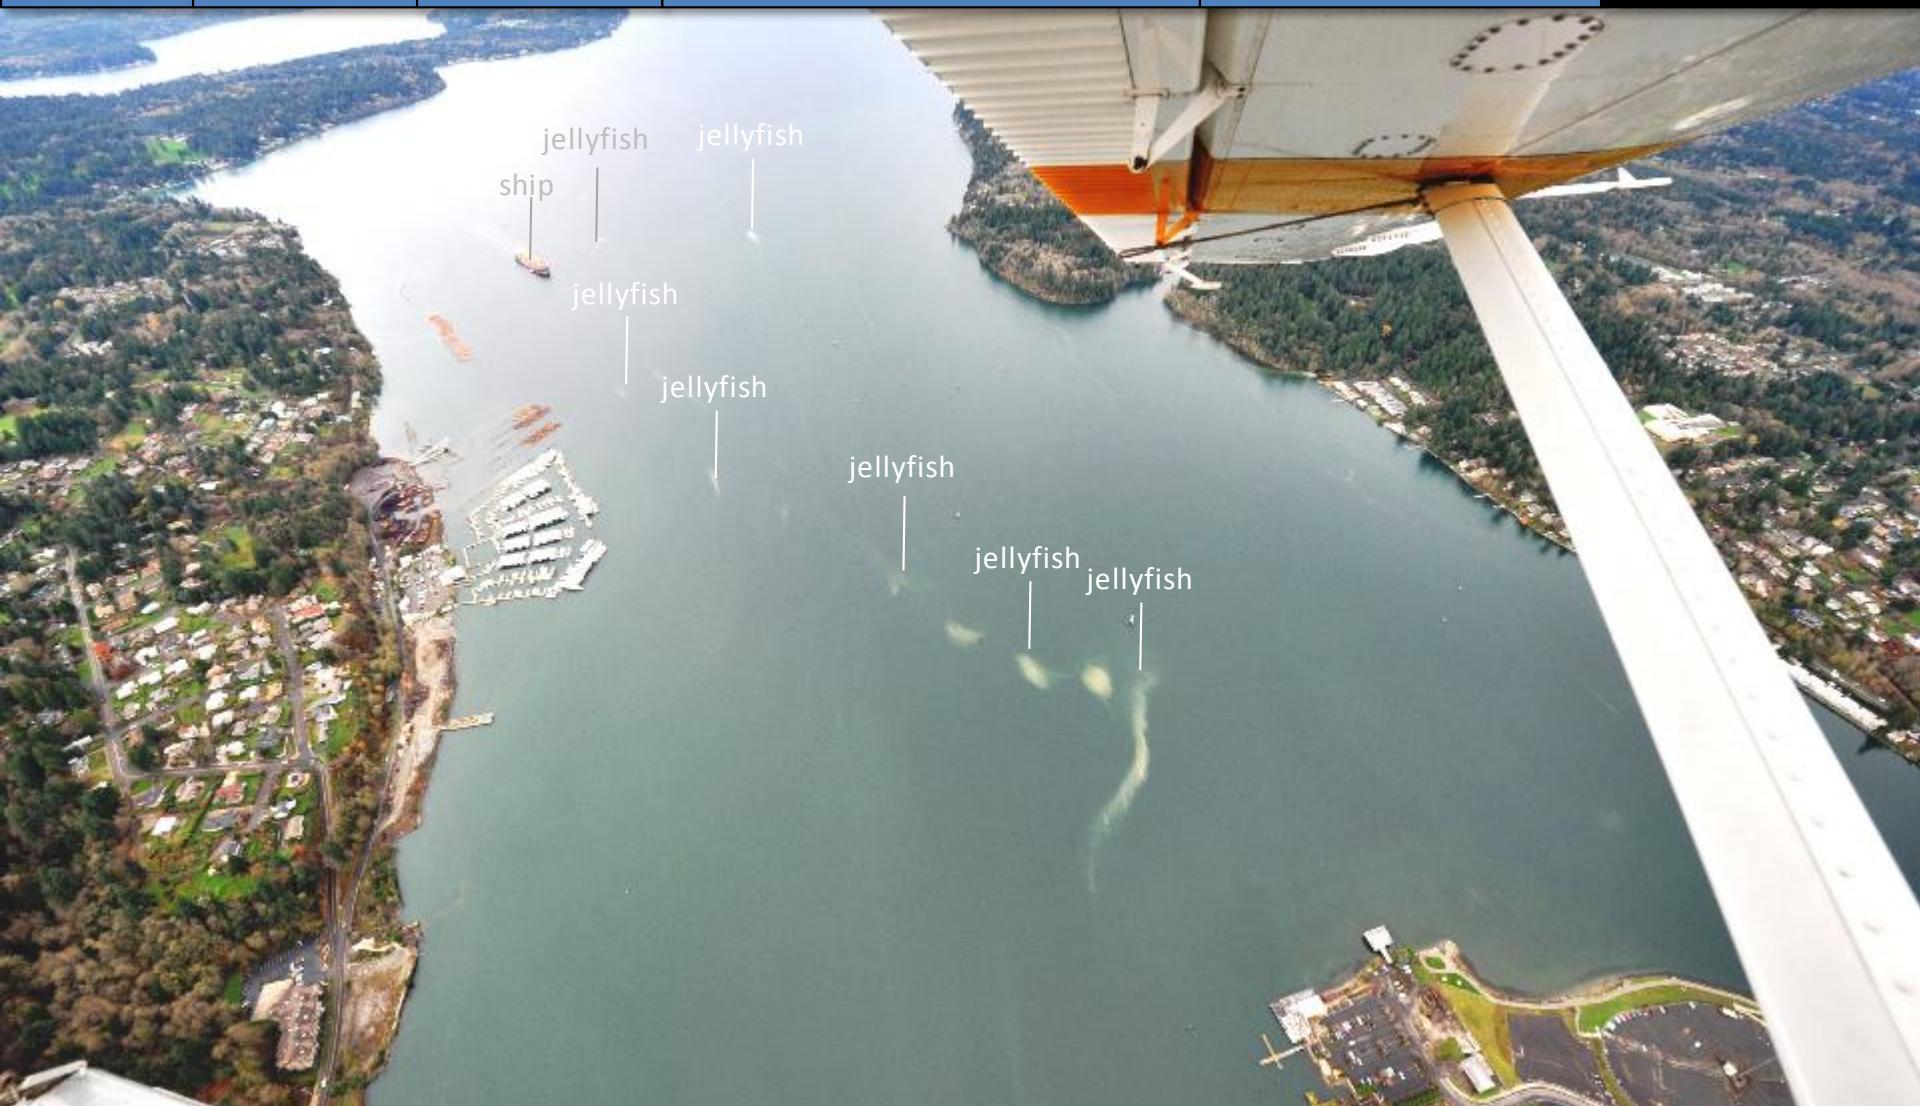
Abundant jellyfish patches.

Location: Budd Inlet (South Sound), 12:18 PM.

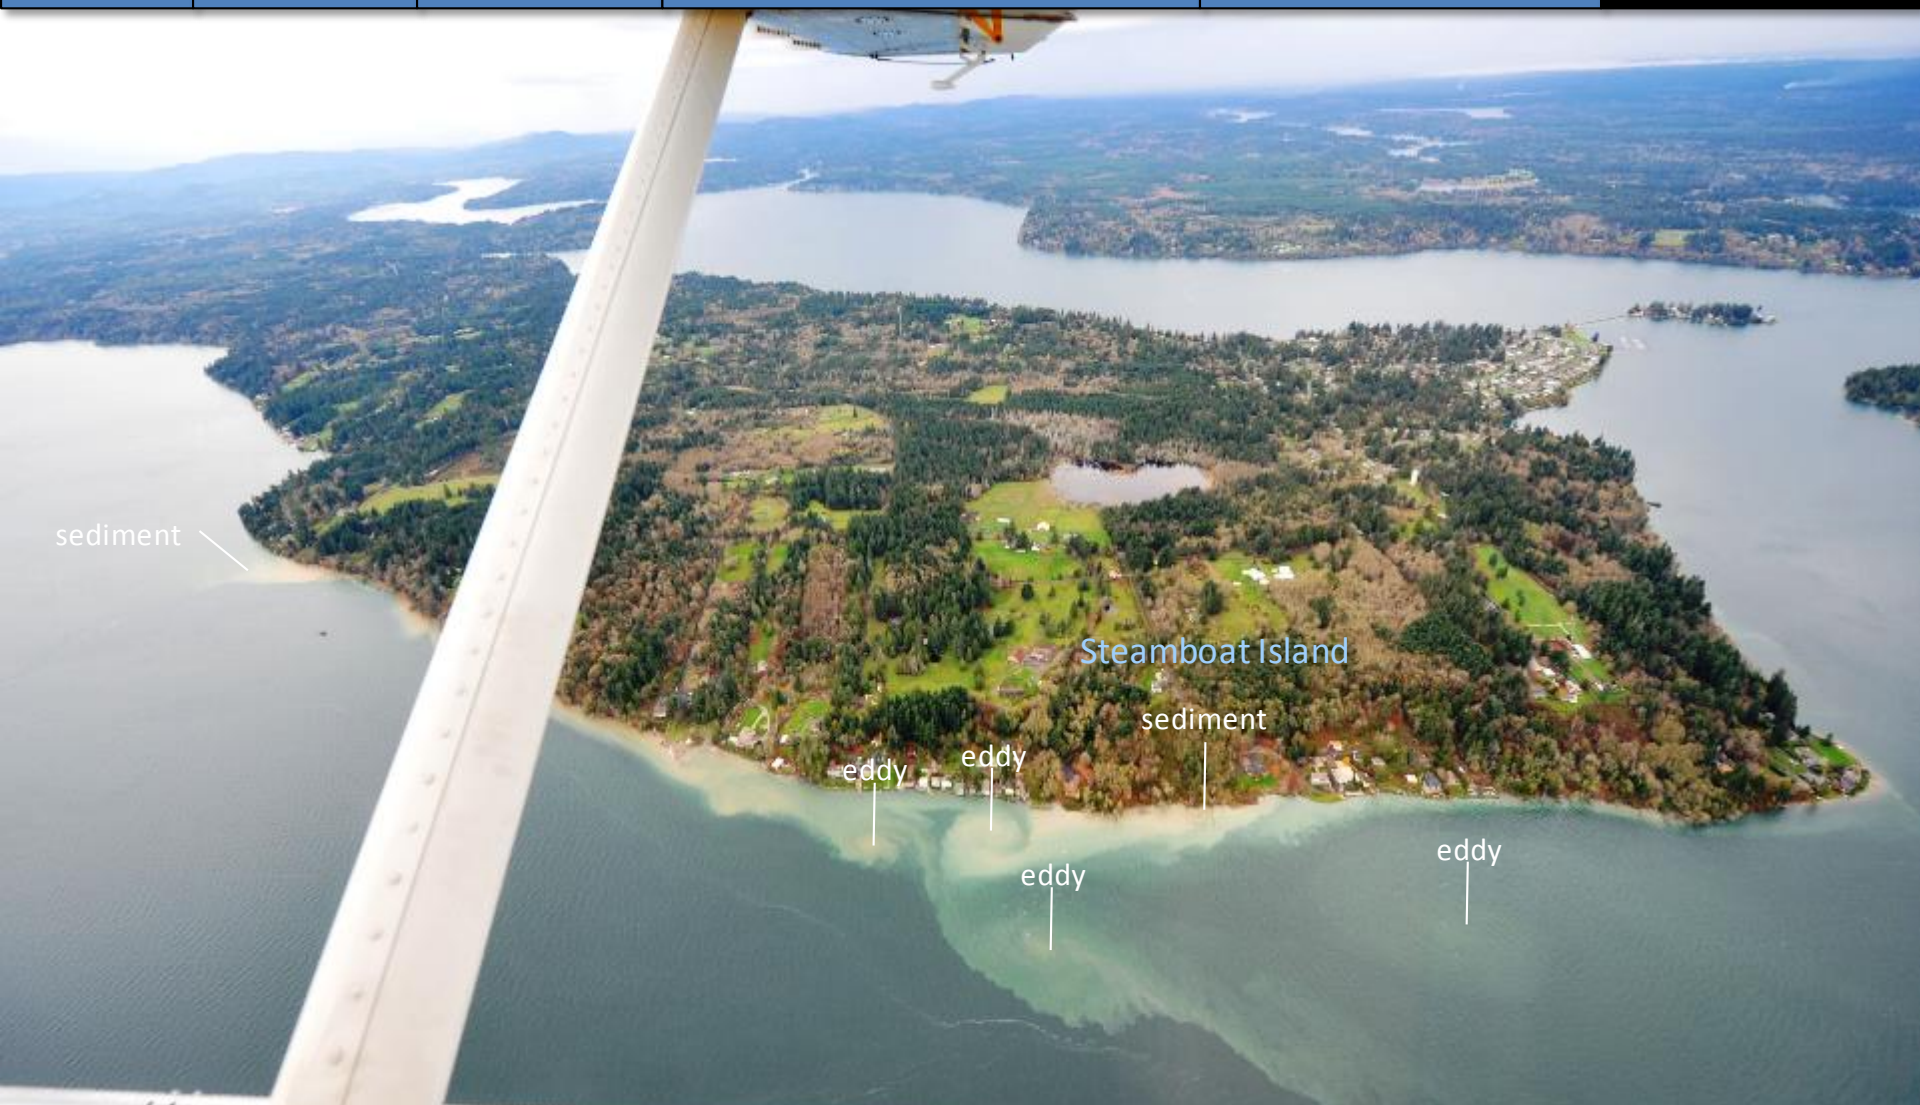
Large quantities of suspended sediment and eddies off eastern shores of Steamboat Island.
Location: Squaxin Passage (South Sound), 12:31 PM.
