# Eyes Over Puget Sound

## Surface Conditions Report, *June 6, 2017*

*Up-to-date observations of water quality conditions in Puget Sound and coastal bays*

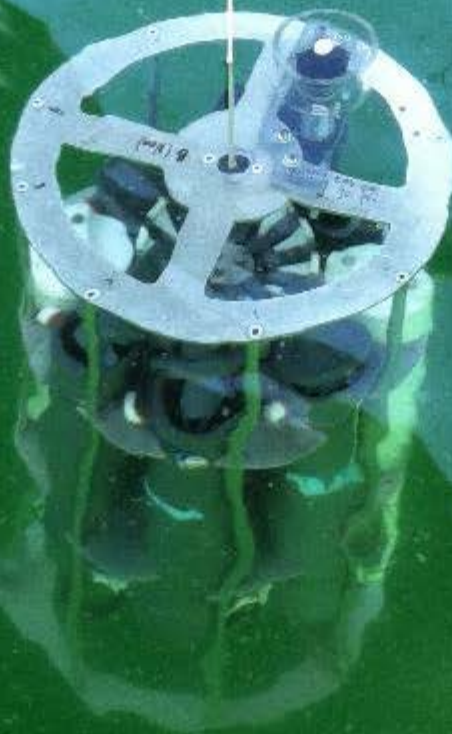
We use a SeaBird CTD (Conductivity, Temperature, Depth) profiler with added sensors to measure a suite of water column parameters:

- Temperature
- Salinity/Conductivity
- Dissolved oxygen
- PAR (Light)
- Transmissivity
- Fluorometry
- Turbidity
- pH

Surrounding the sensors are water-sampling Niskin bottles that we can program to collect water samples at discrete depths. We analyze:

- Nutrients
- Chlorophyll *a*
- TN (Total nitrogen)
- TOC (Total organic carbon)
- POC (Particulate organic carbon)
- PN (Particulate organic nitrogen)
- Dissolved oxygen
- Salinity

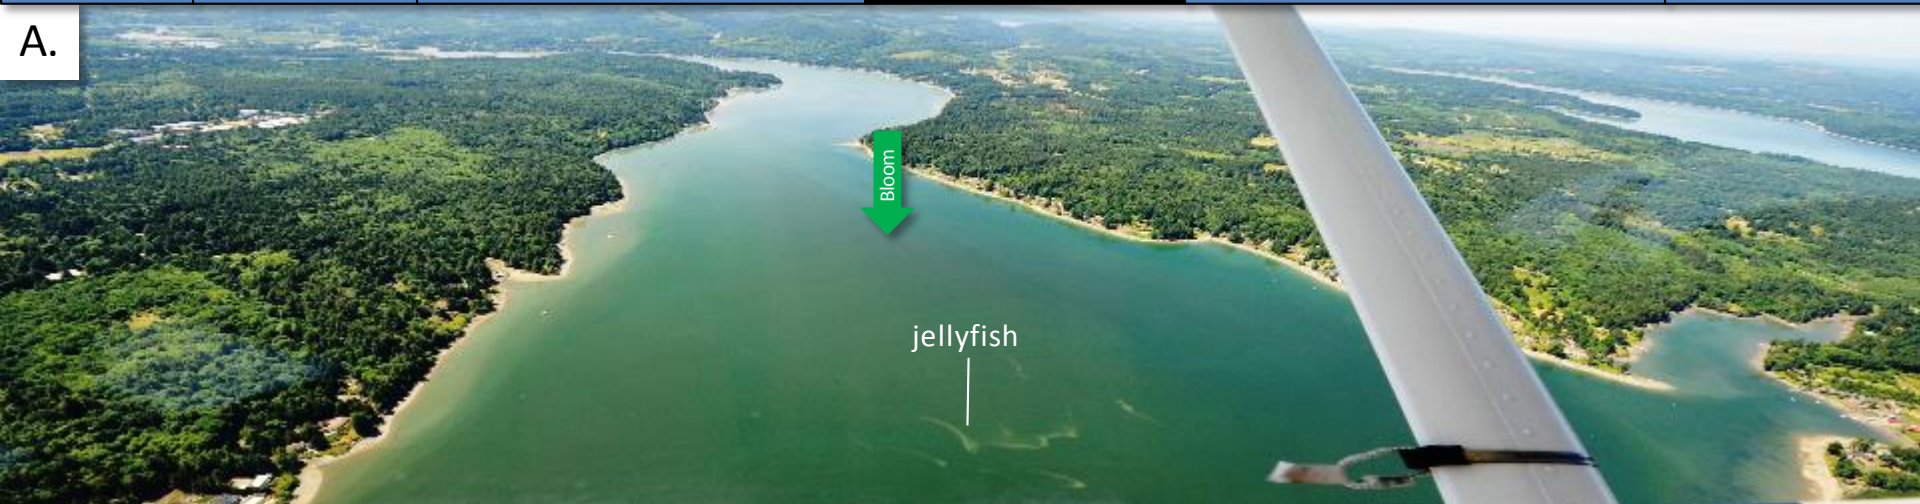
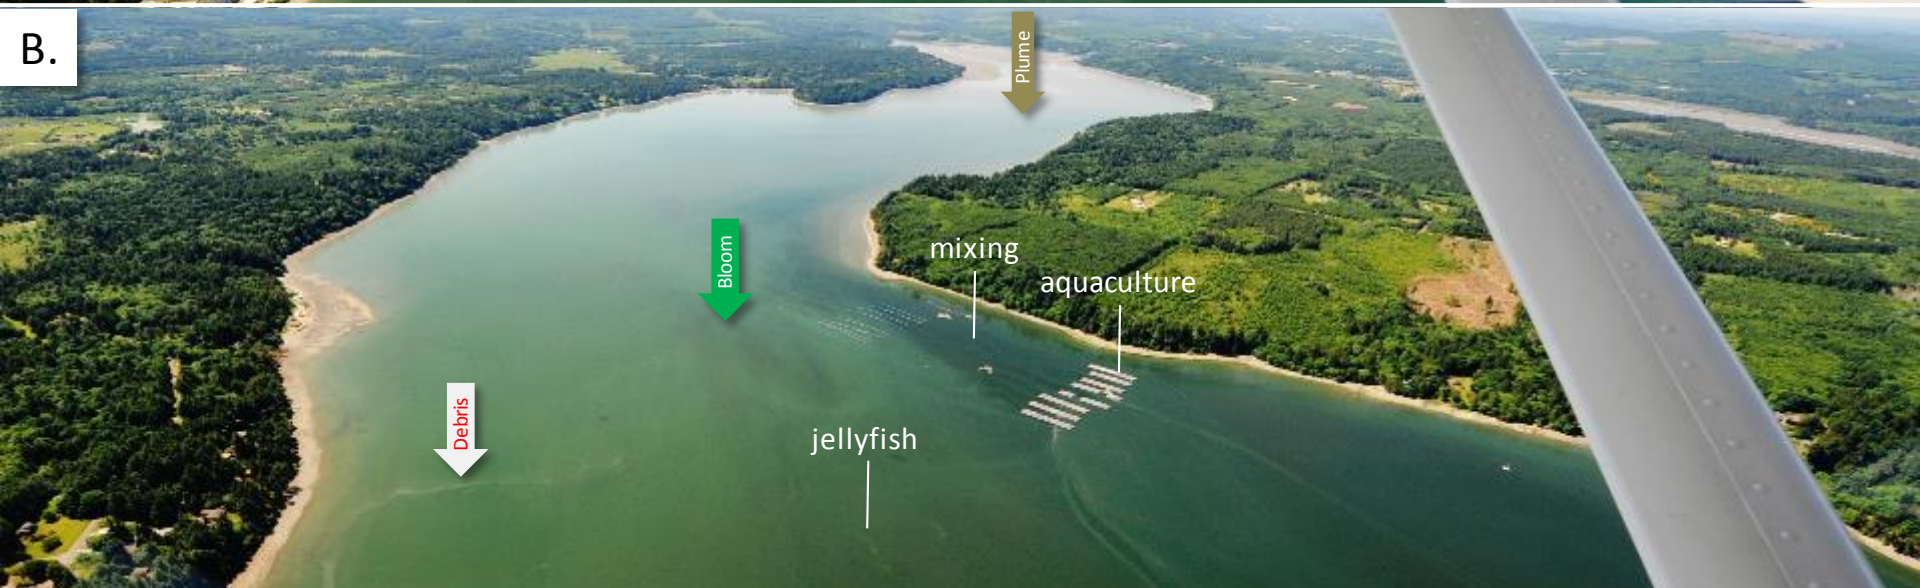
*A. Jellyfish patches and small bloom. B. Aquaculture and effects on surface layer during incoming tide.*  
Location: A. Eld Inlet, B. Totten Inlet (South Sound), 1:02 PM.

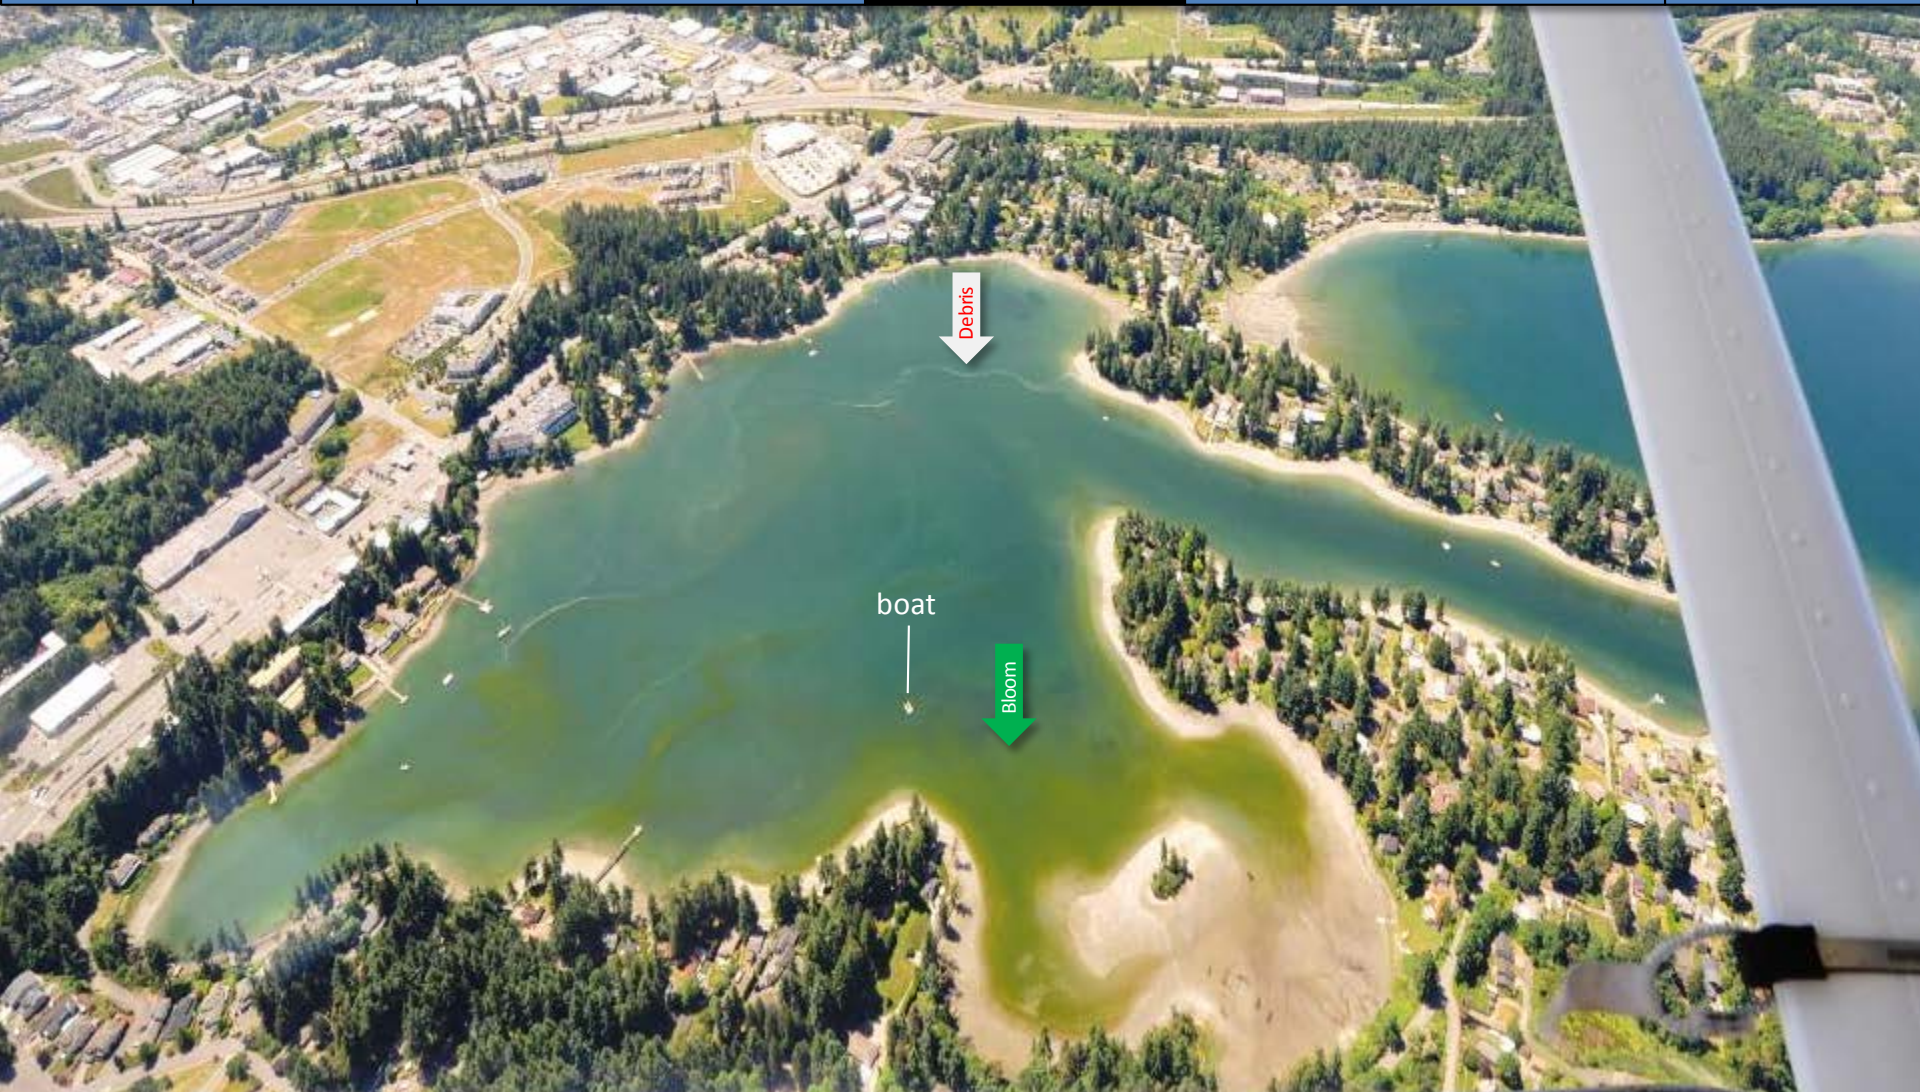
*Bright yellow-green bloom.*

Location: Oyster Bay/Dyes Inlet (Central Sound), 1:27 PM.

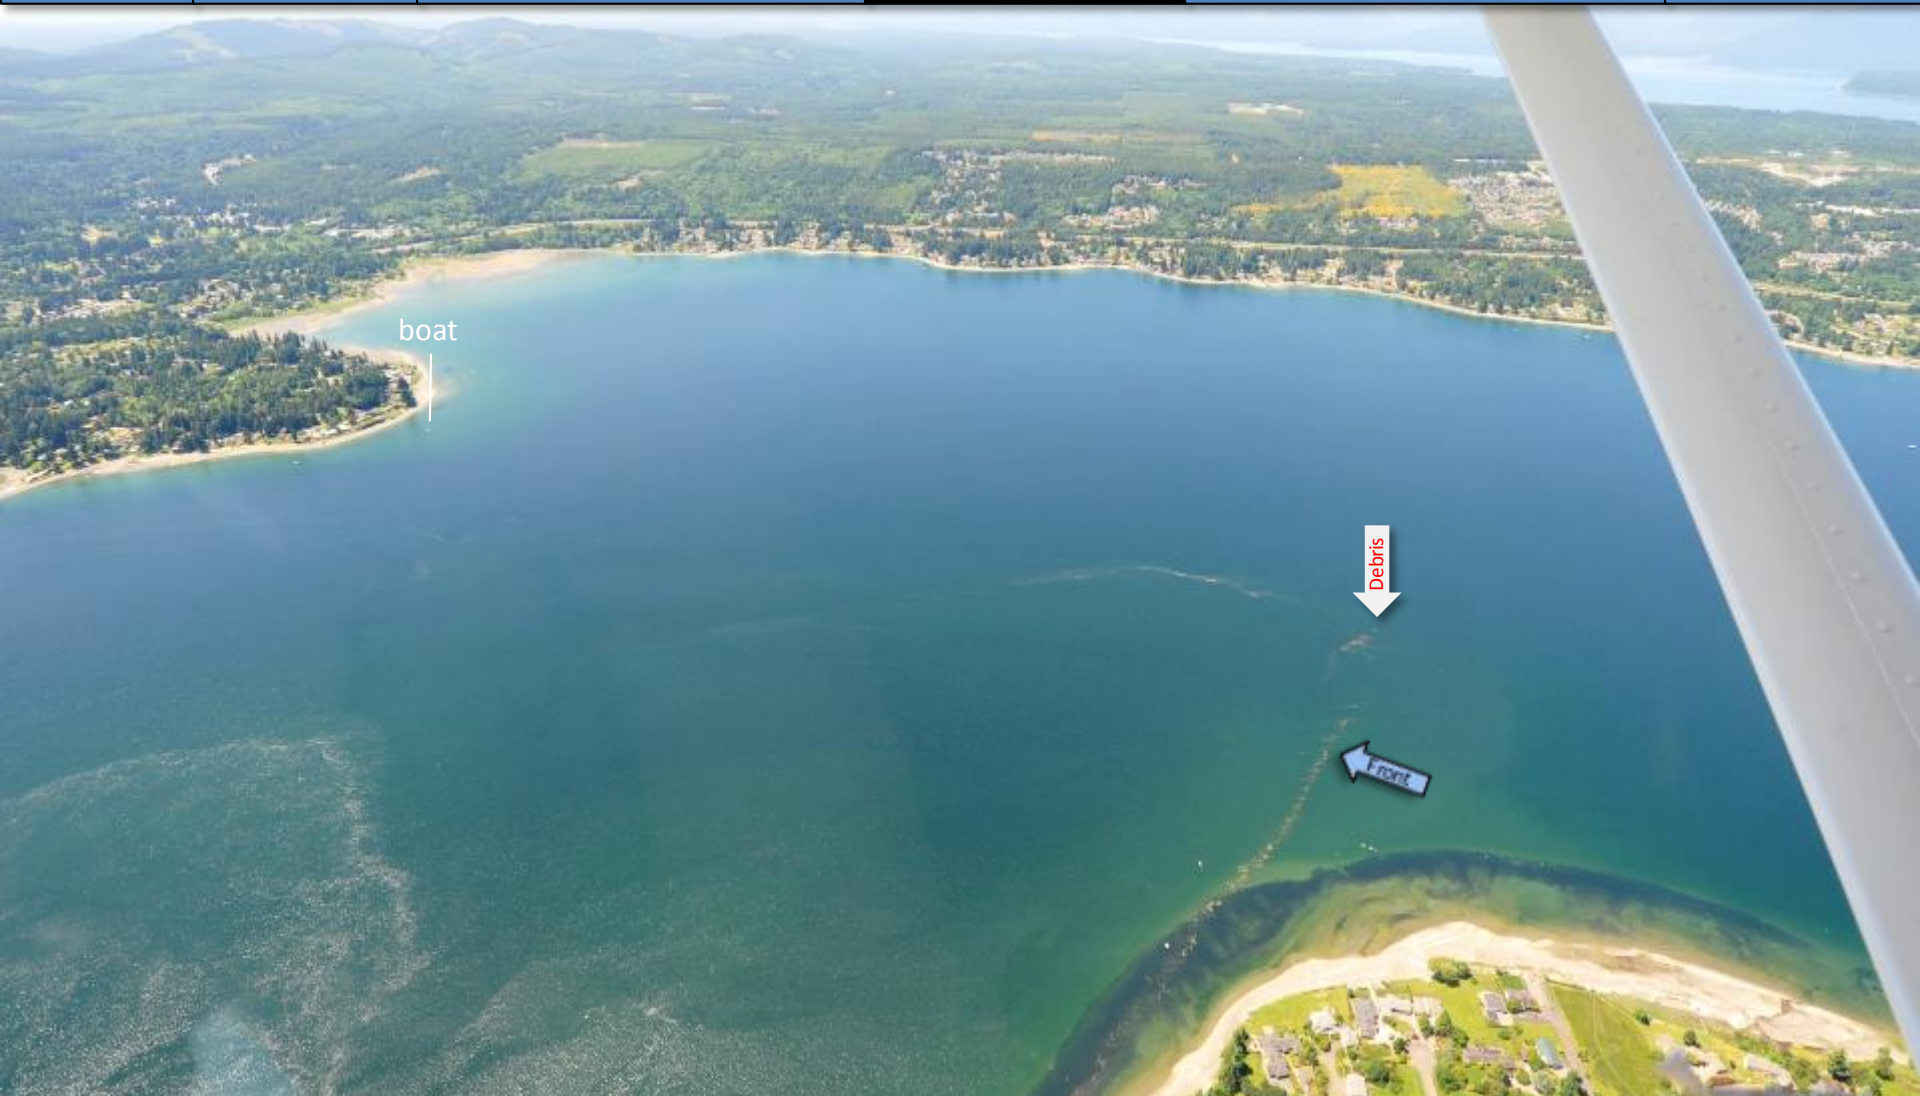
*Macro algae accumulating along tidal frontline.*  
Location: Off Windy Point/Dyes Inlet (Central Sound), 1:29 PM.

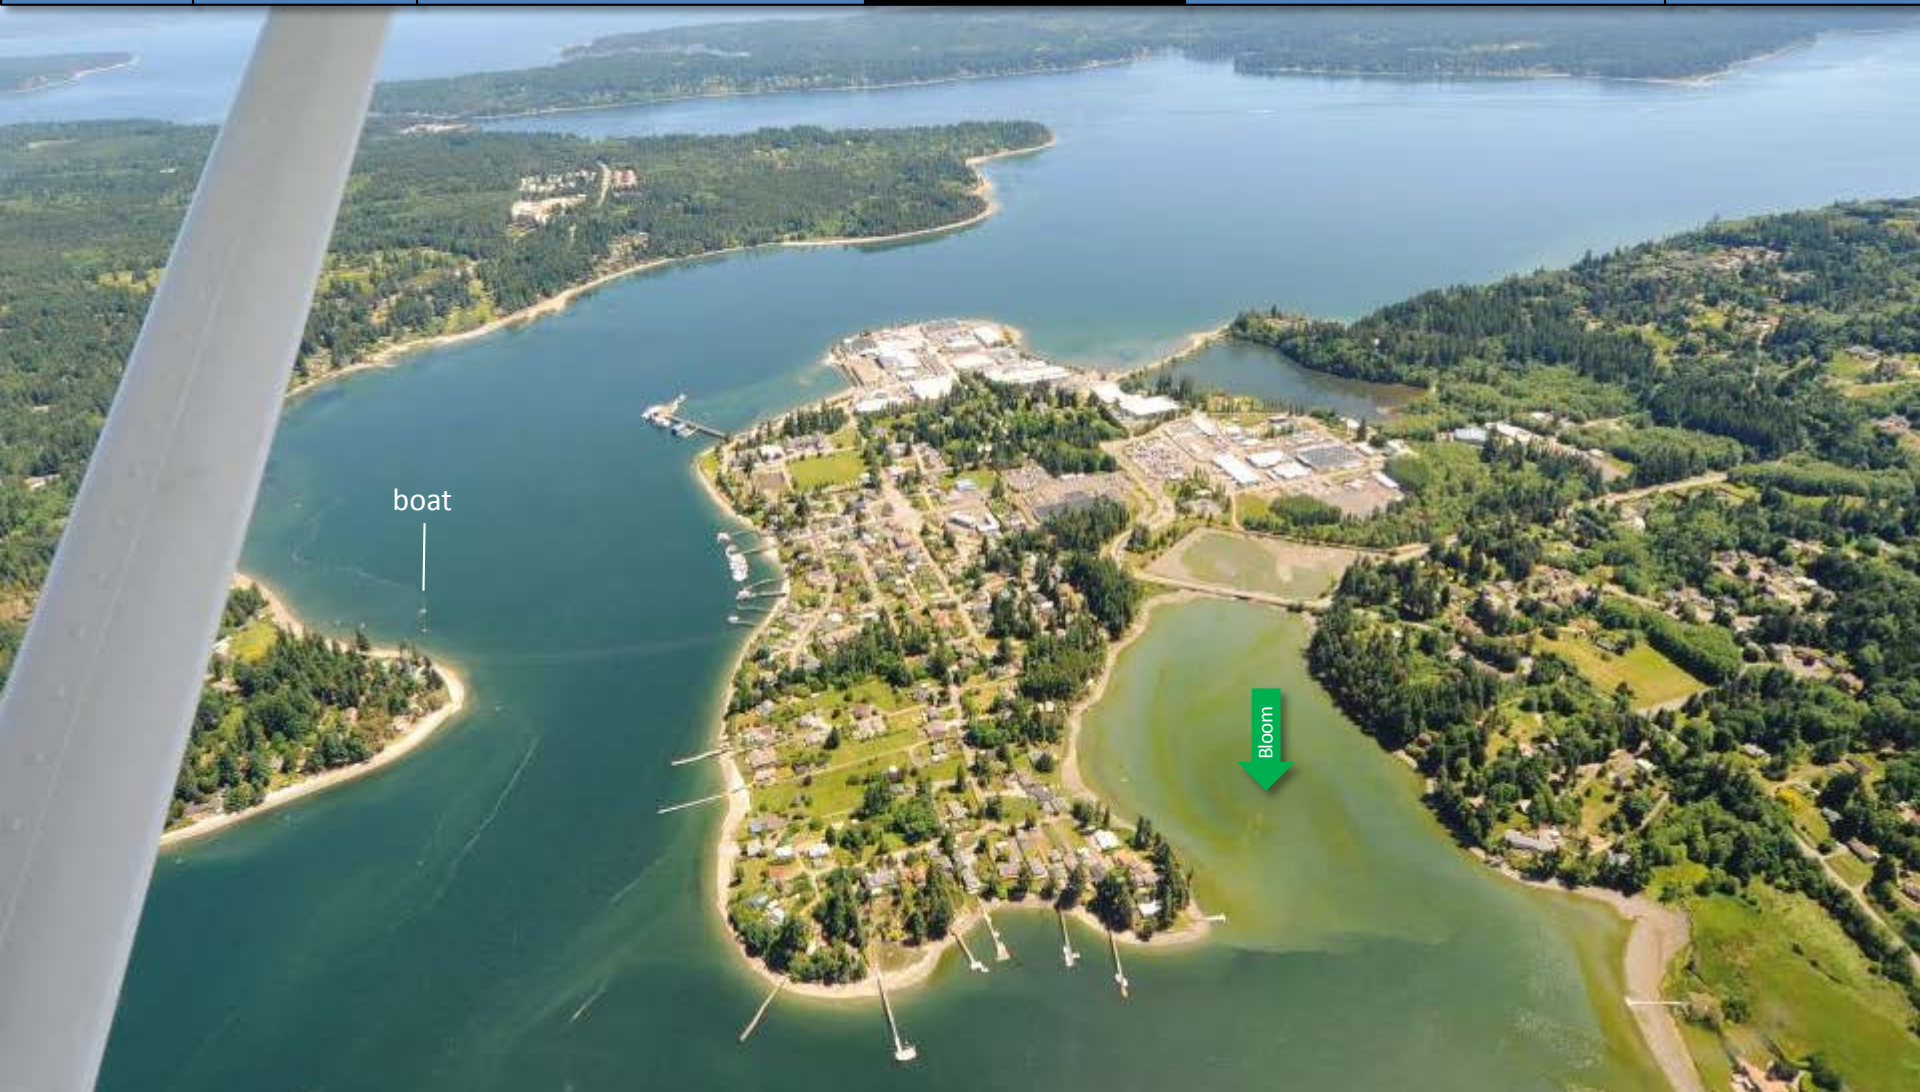
*Bright yellow-green bloom.*

Location: Off Keyport Saltwater Park, Liberty Bay (Central Sound), 1:32 PM.

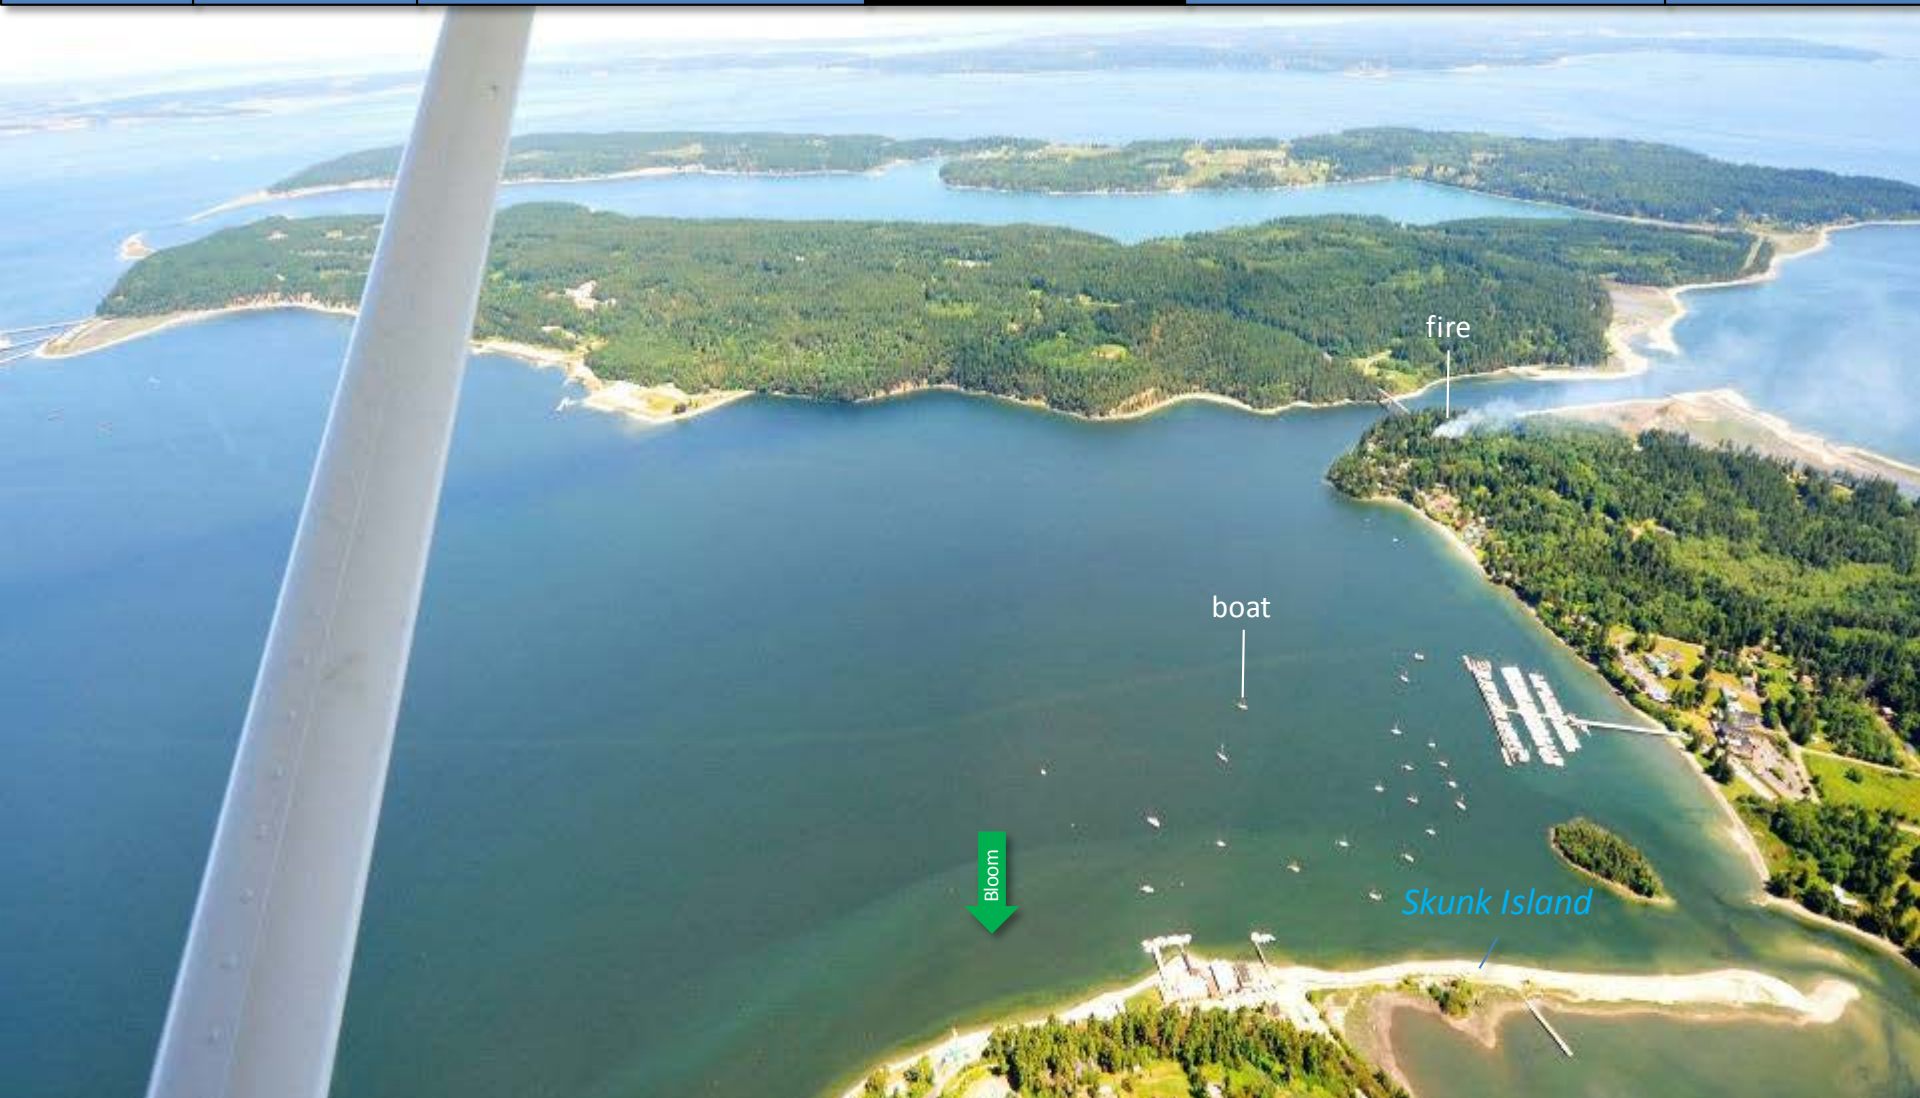
*Bloom and freshwater plume near Skunk Island.*

Location: *Port Hadlock, Port Townsend Bay (Central Sound), 1:46 PM.*

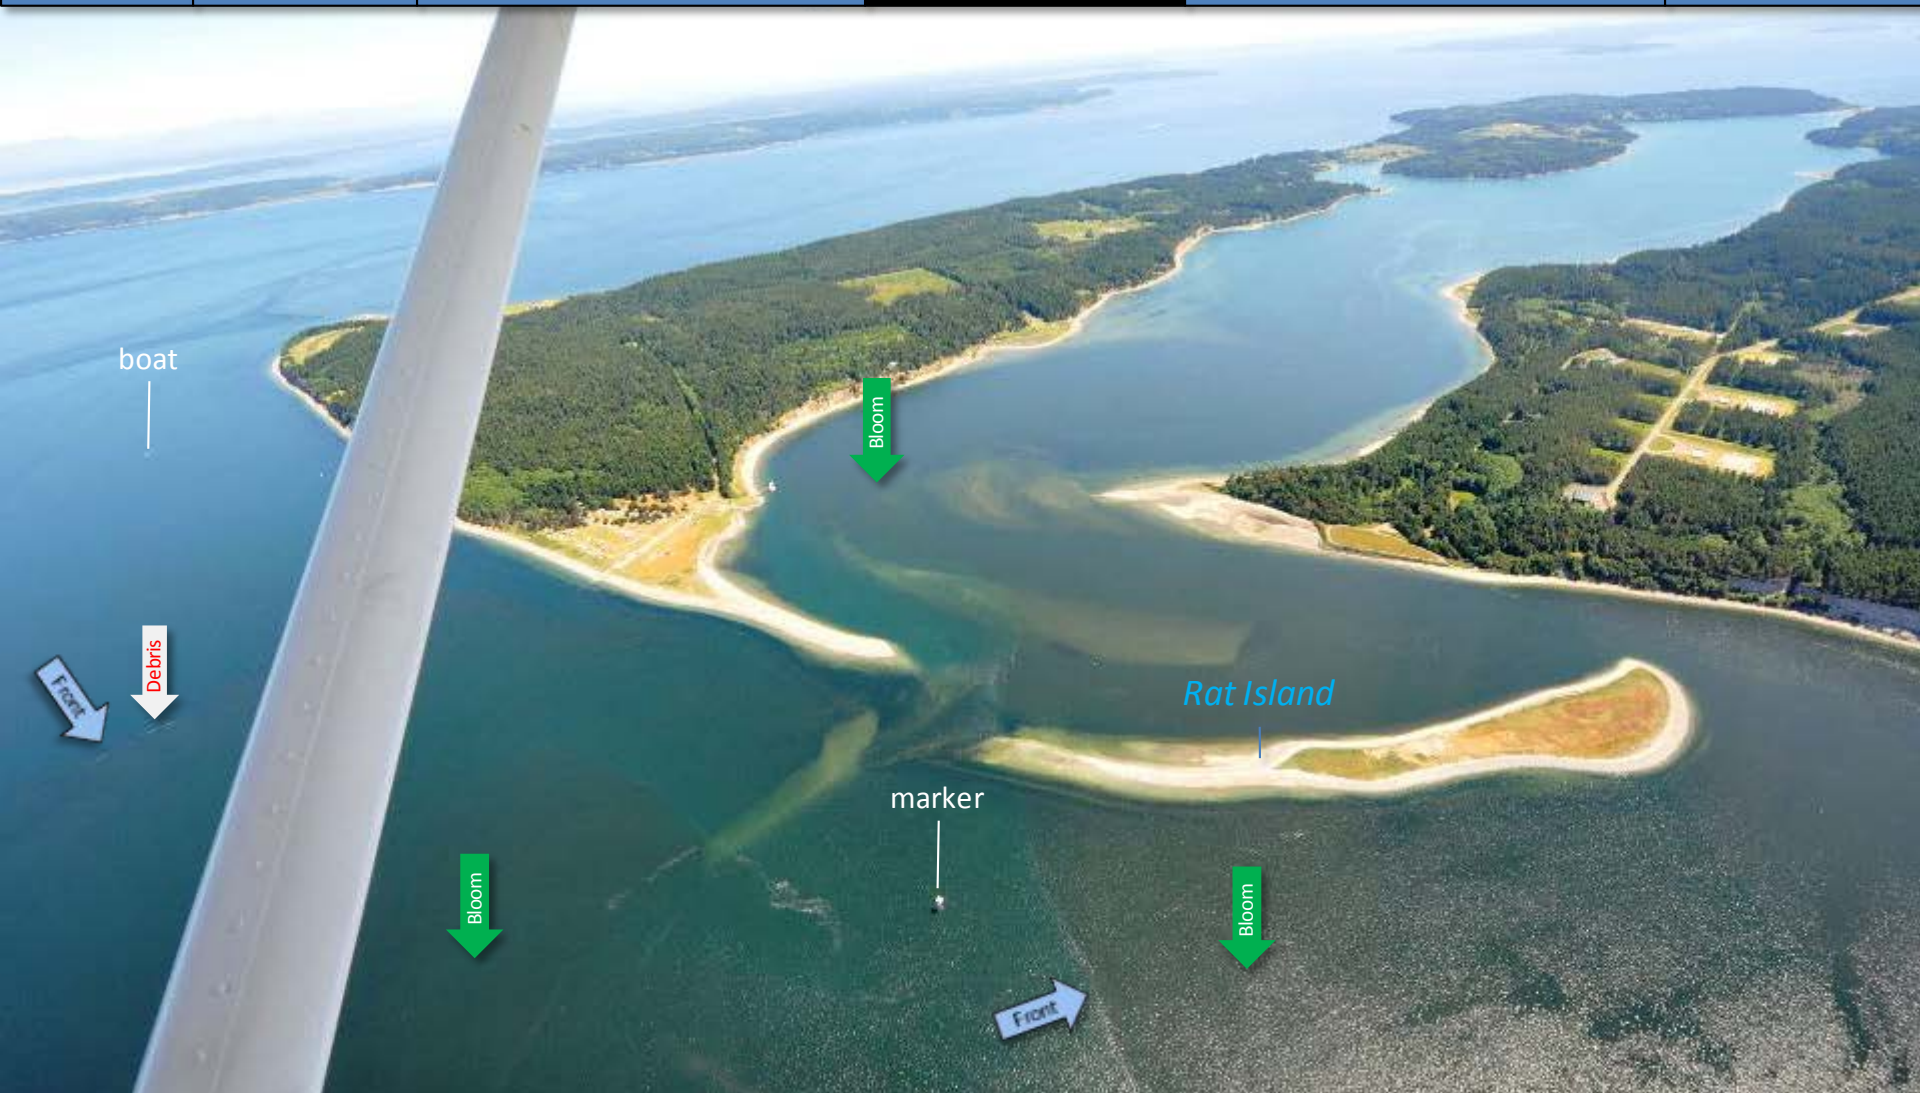
*Bloom extending into Kilisut Harbor.*

Location: Port Townsend Bay (Central Sound), 1:49 PM.

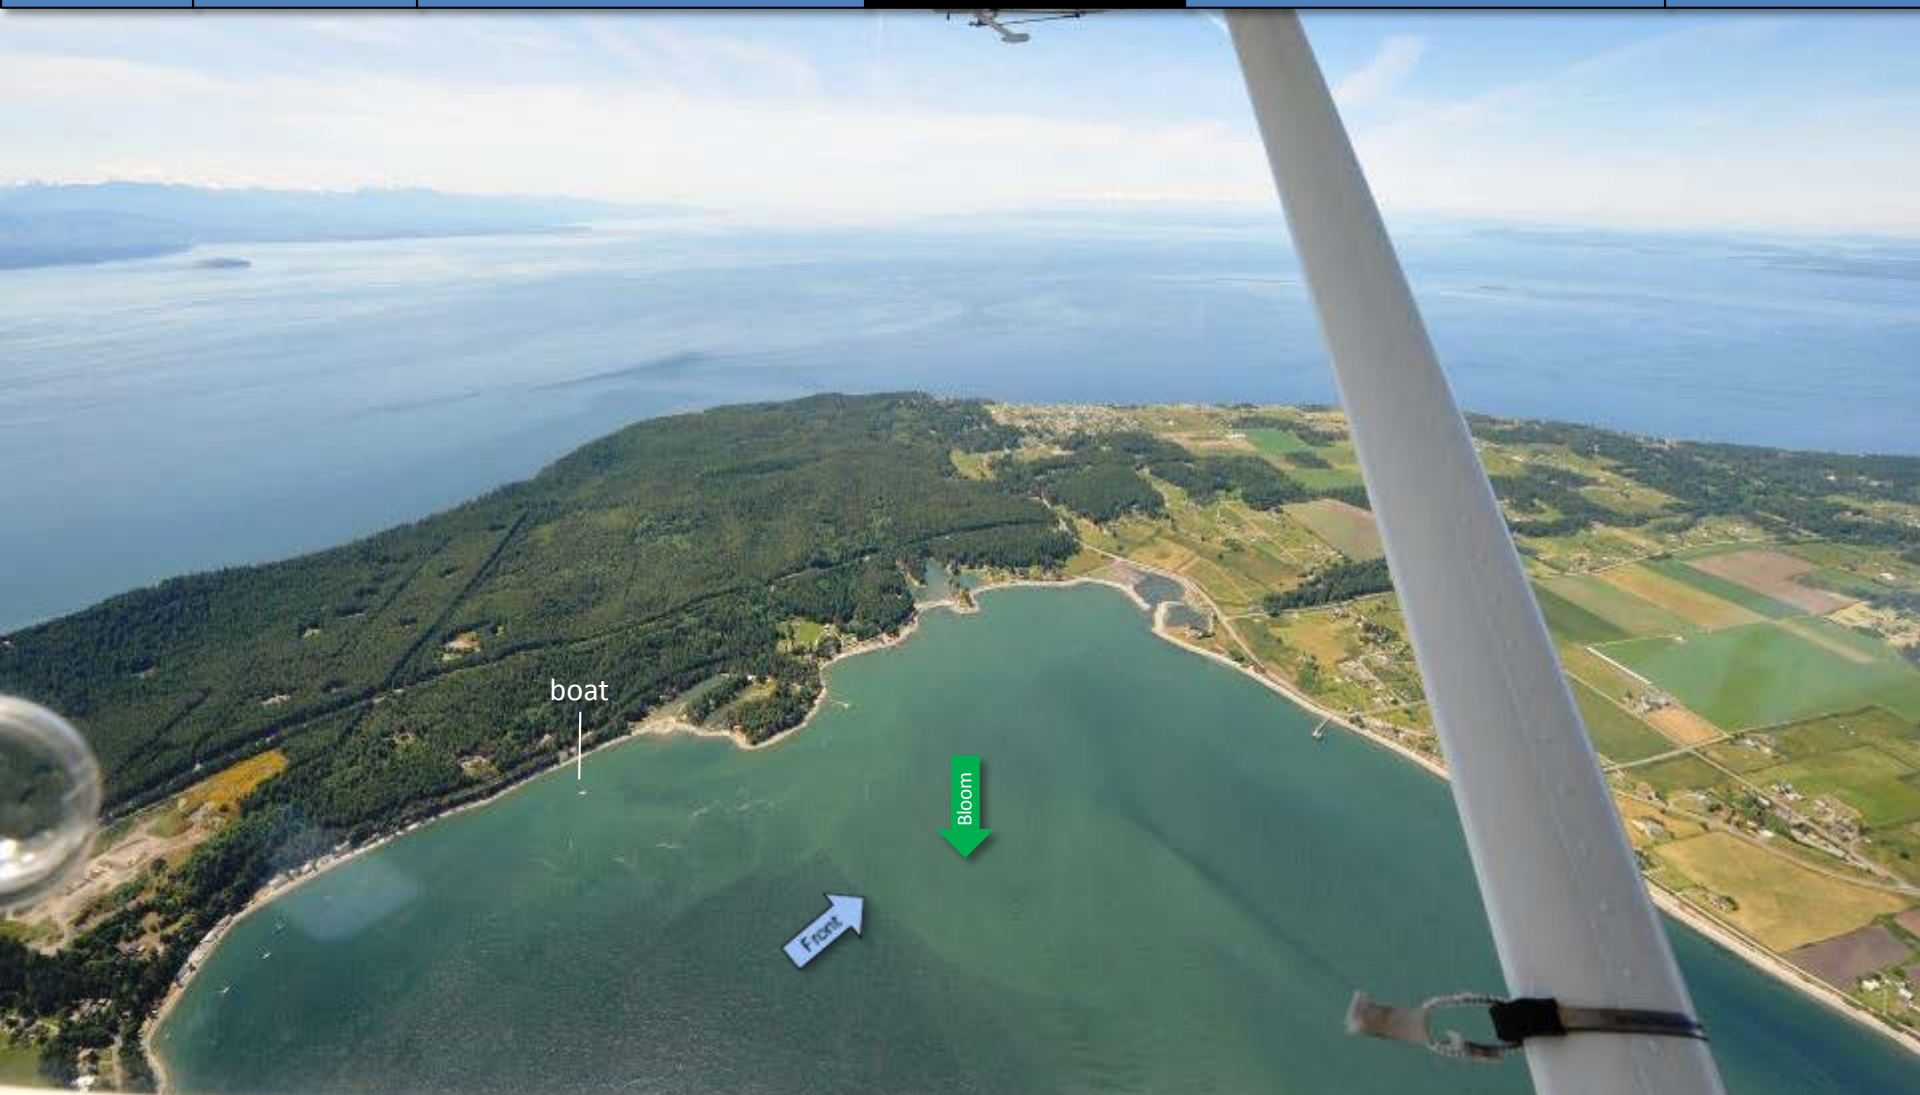
*Skagit Sediment plume extending into Penn Cove.*  
Location: Penn Cove (Whidbey Basin), 1:54 PM.

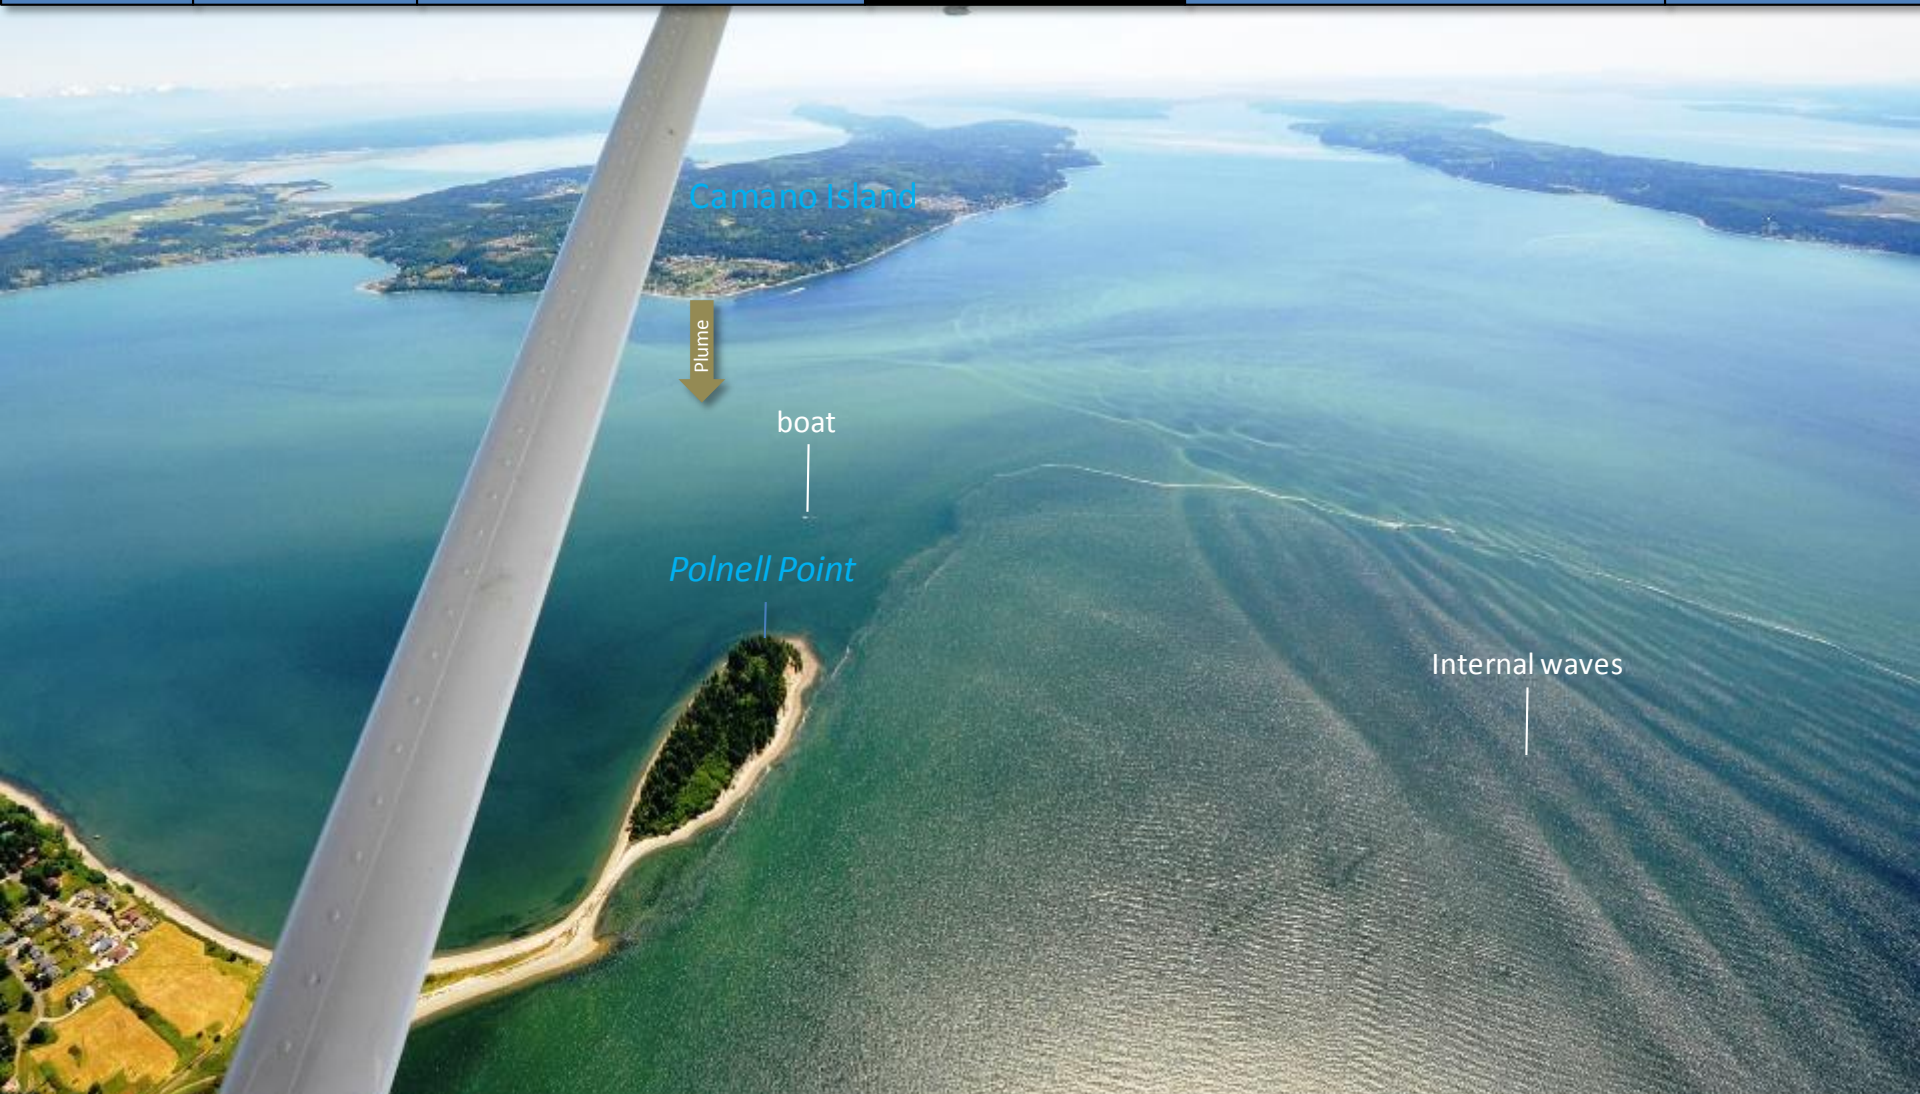
*A train of internal wave traveling towards Skagit Bay.*  
Location: Entrance to Skagit Bay (Whidbey Basin), 1:59 PM.

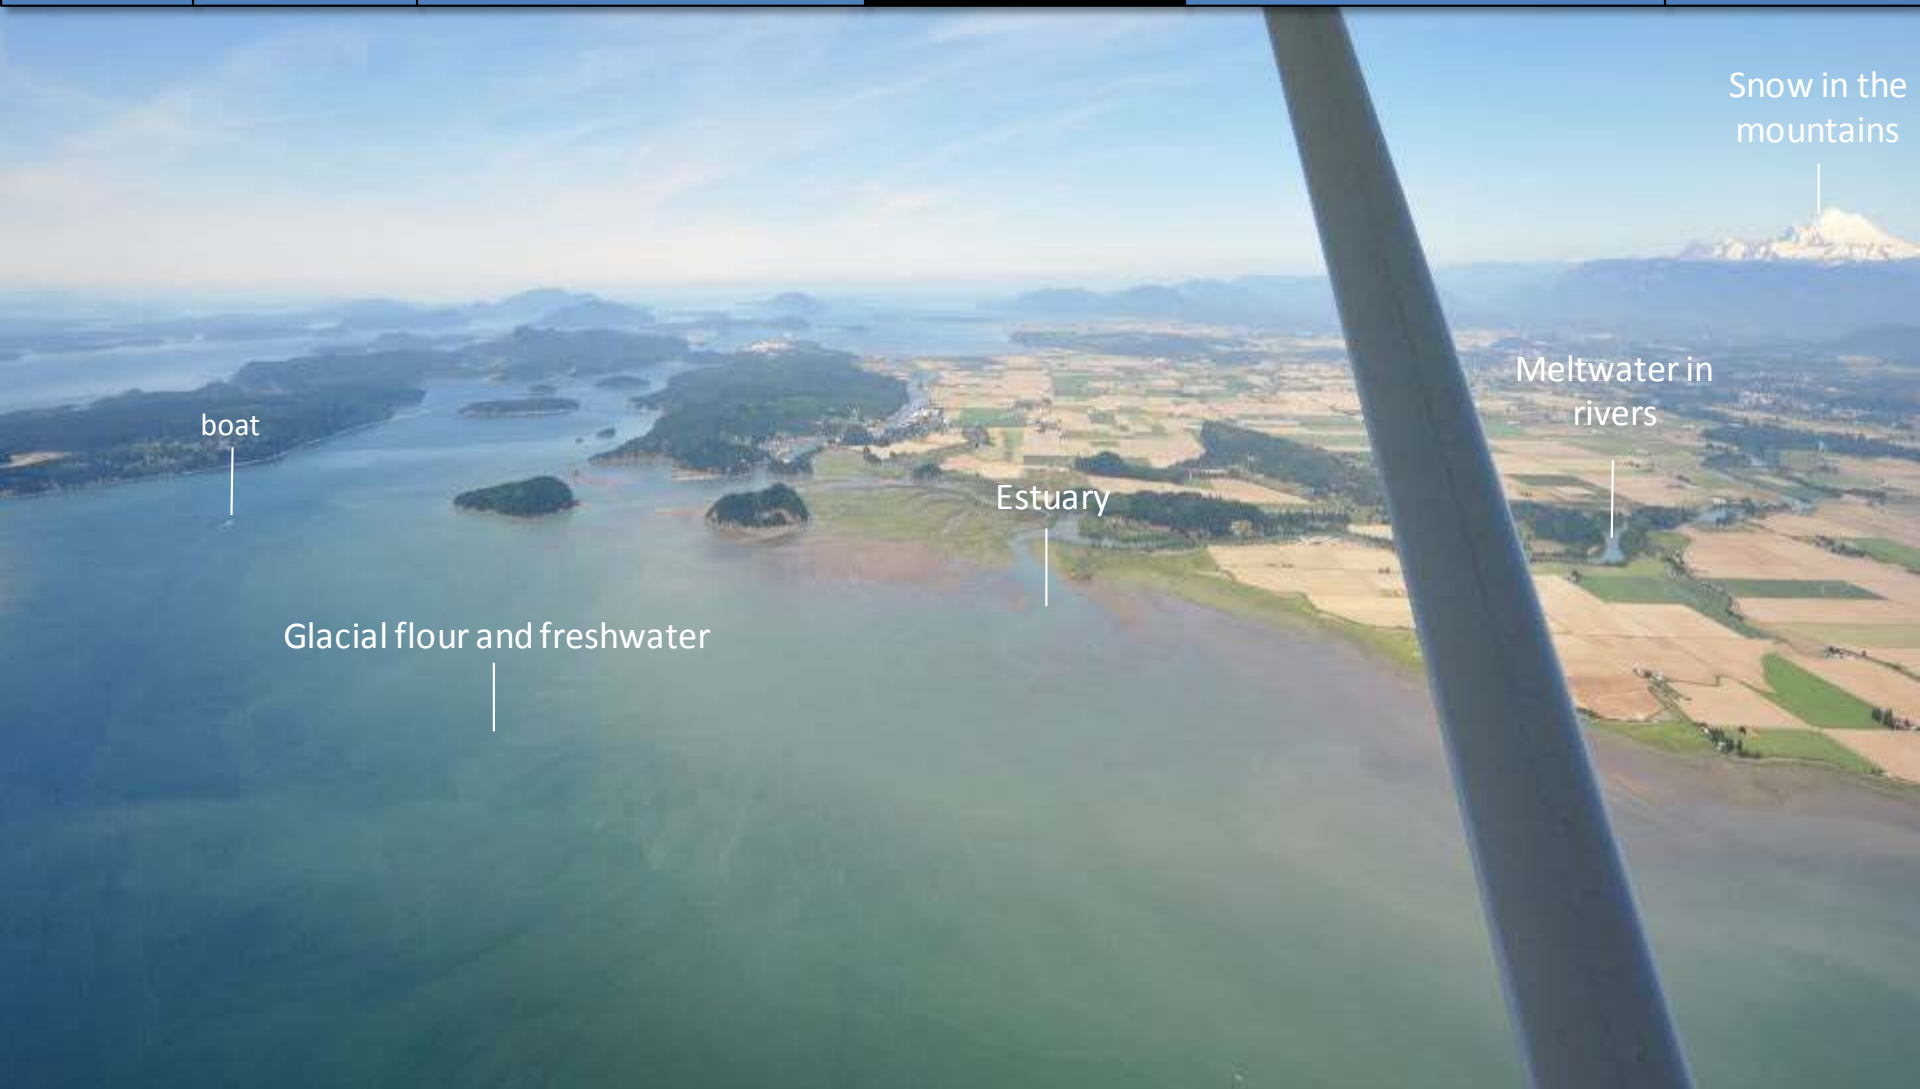
*Fed by meltwater in the mountains, the Skagit River is the largest freshwater contributor to Puget Sound.*

Location: North Fork Skagit River, Skagit Bay (Whidbey Basin), 2:01 PM.

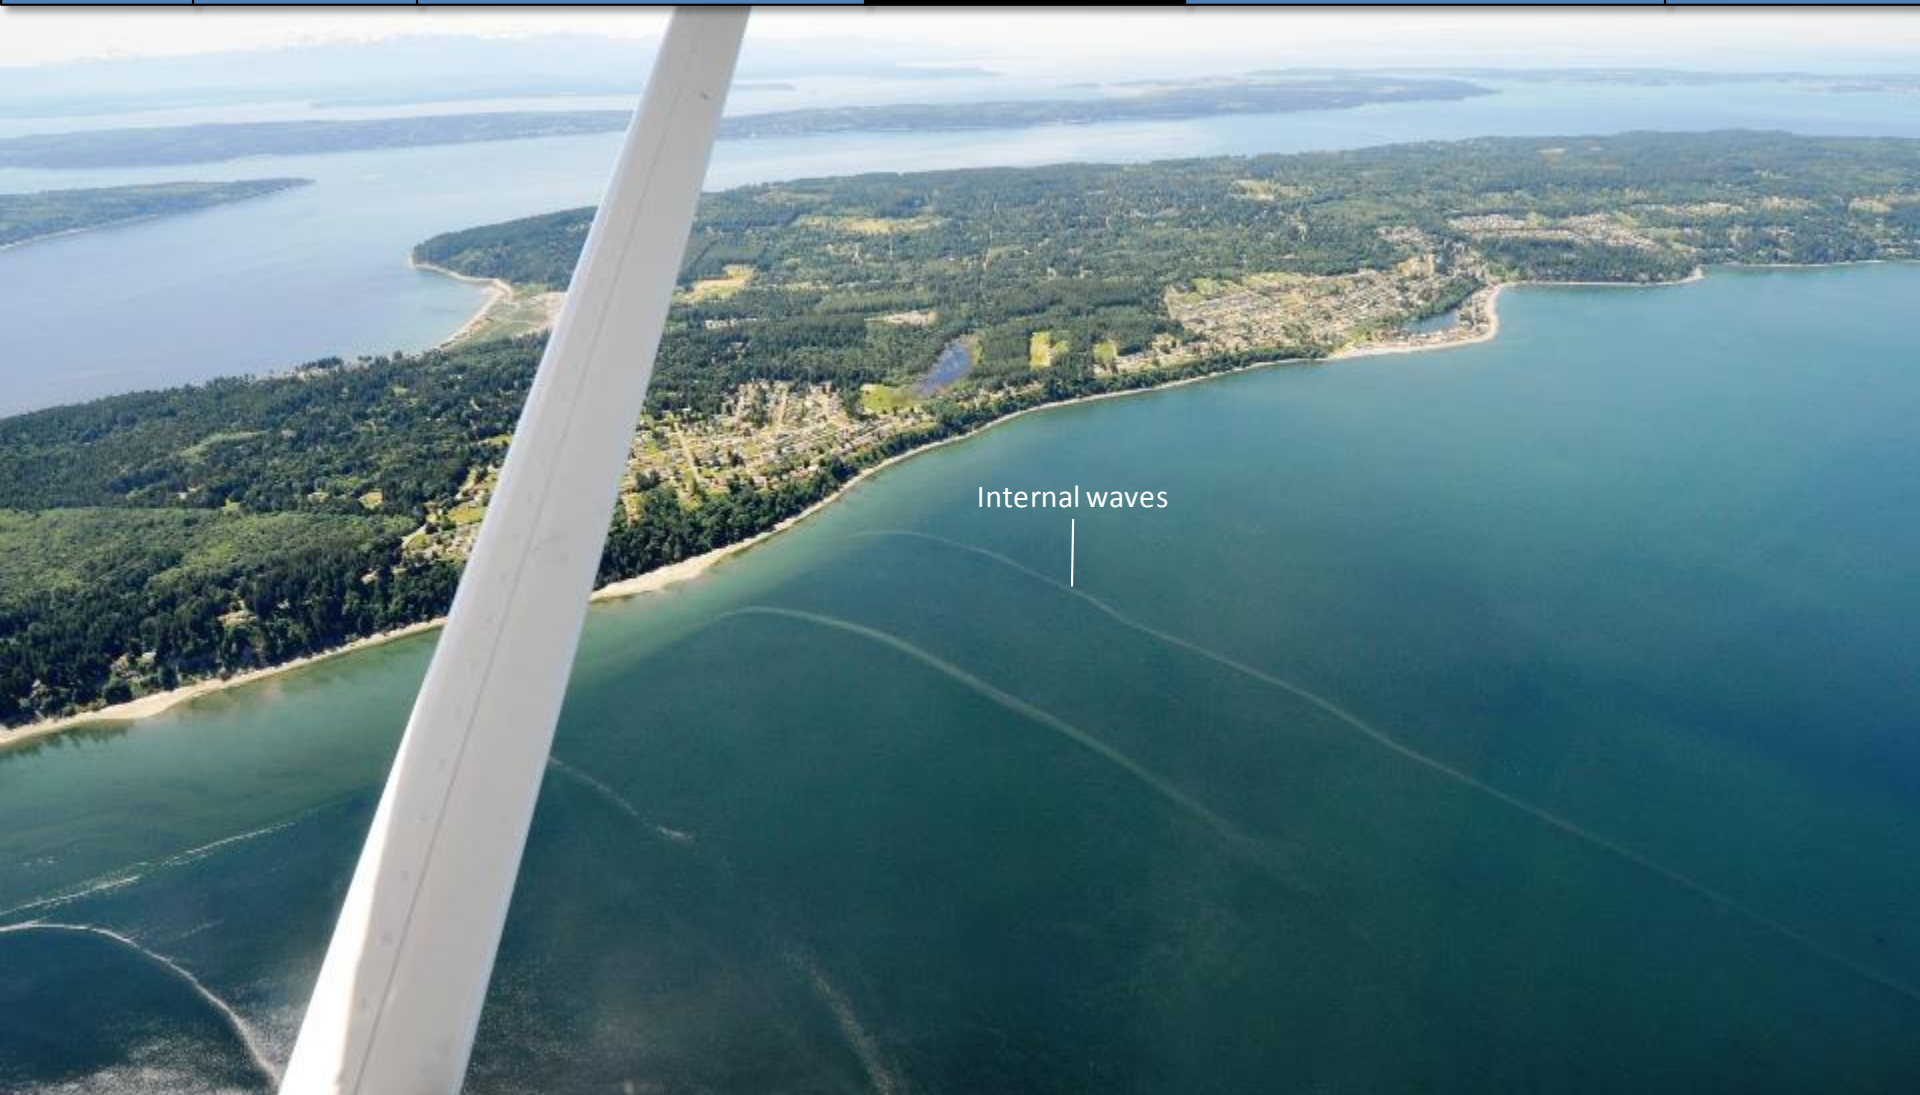
*Internal waves running northward curving in shallow water of Camano Island.  
Location: Port Suzan (Whidbey Basin), 2:08 PM.*
