# Eyes Over Puget Sound

## Surface Conditions Report, *June 6, 2017*

*Up-to-date observations of water quality conditions in Puget Sound and coastal bays*

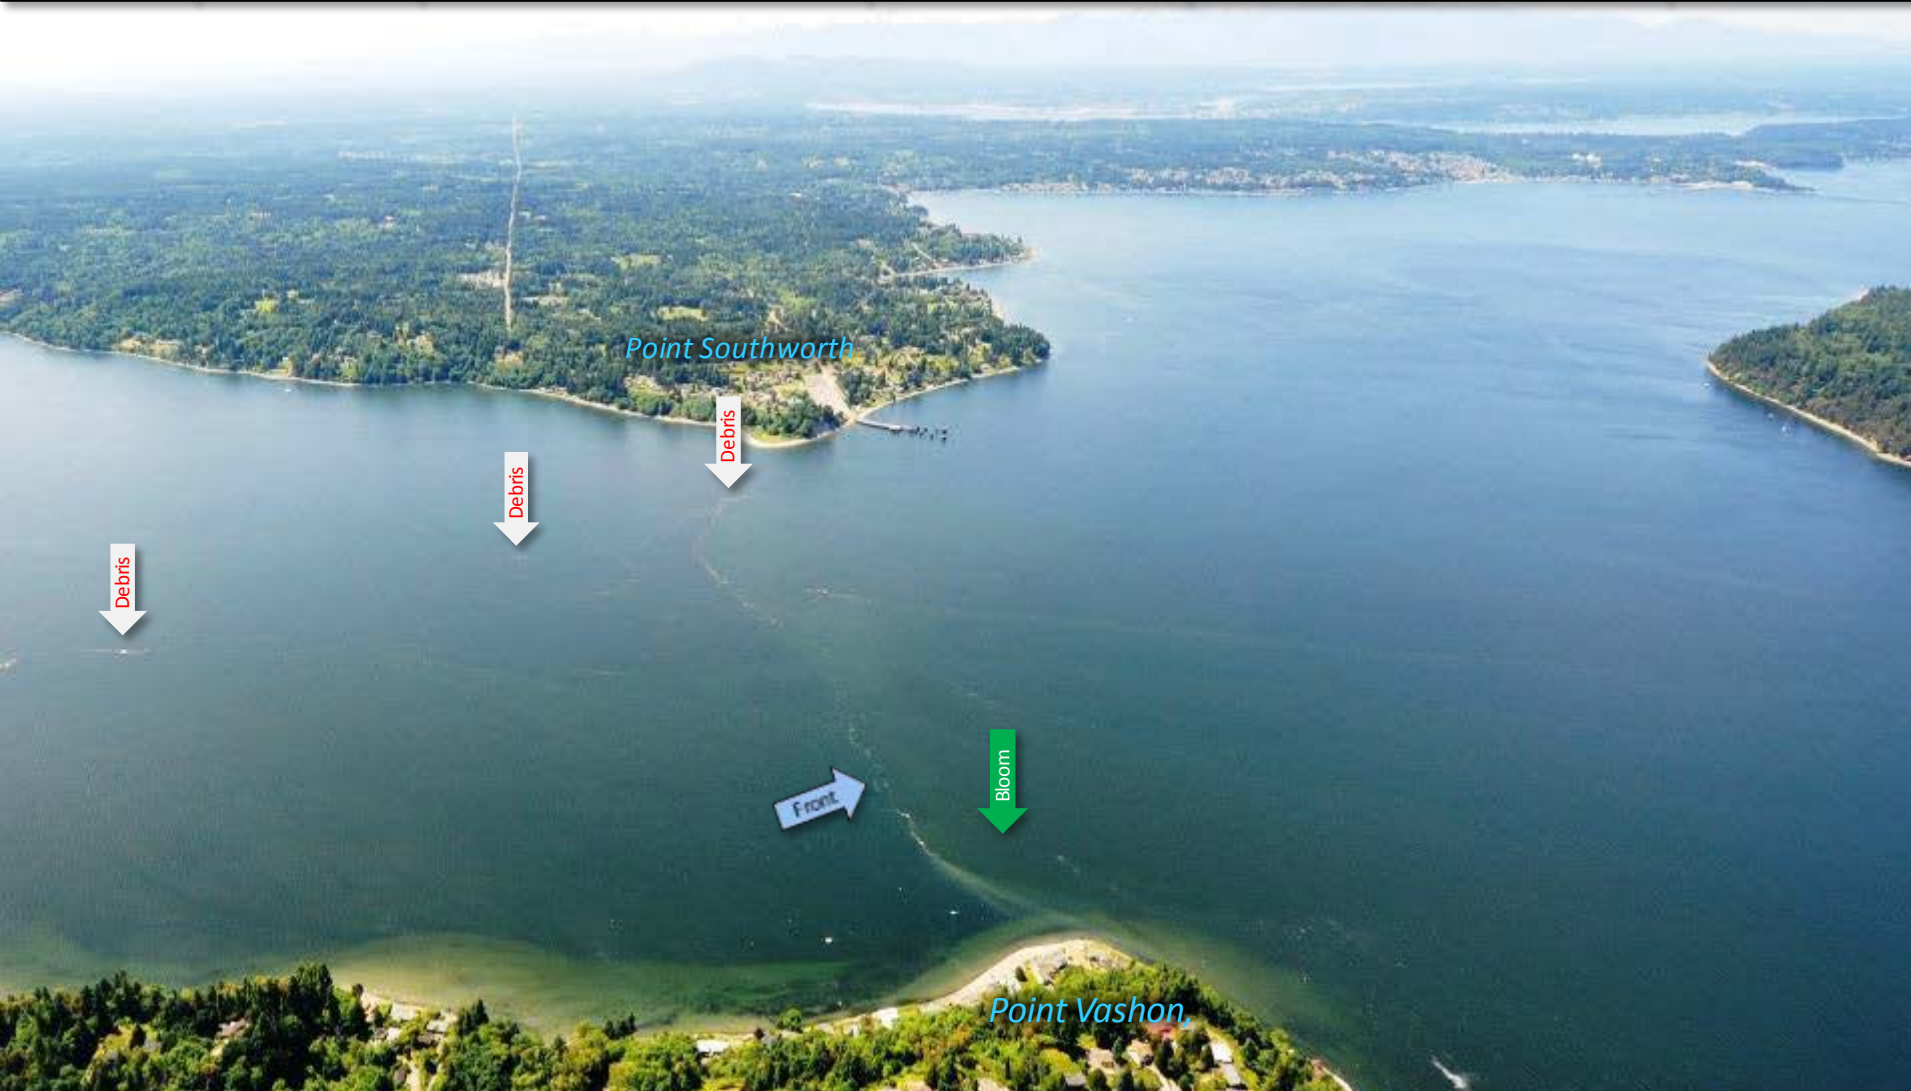
*Tidal front and macro-algae at the entrance and inside Colvos Passage.*  
Location: Point Vashon, Point Southworth, Colvos Passage (Central Sound), 2:30 PM.

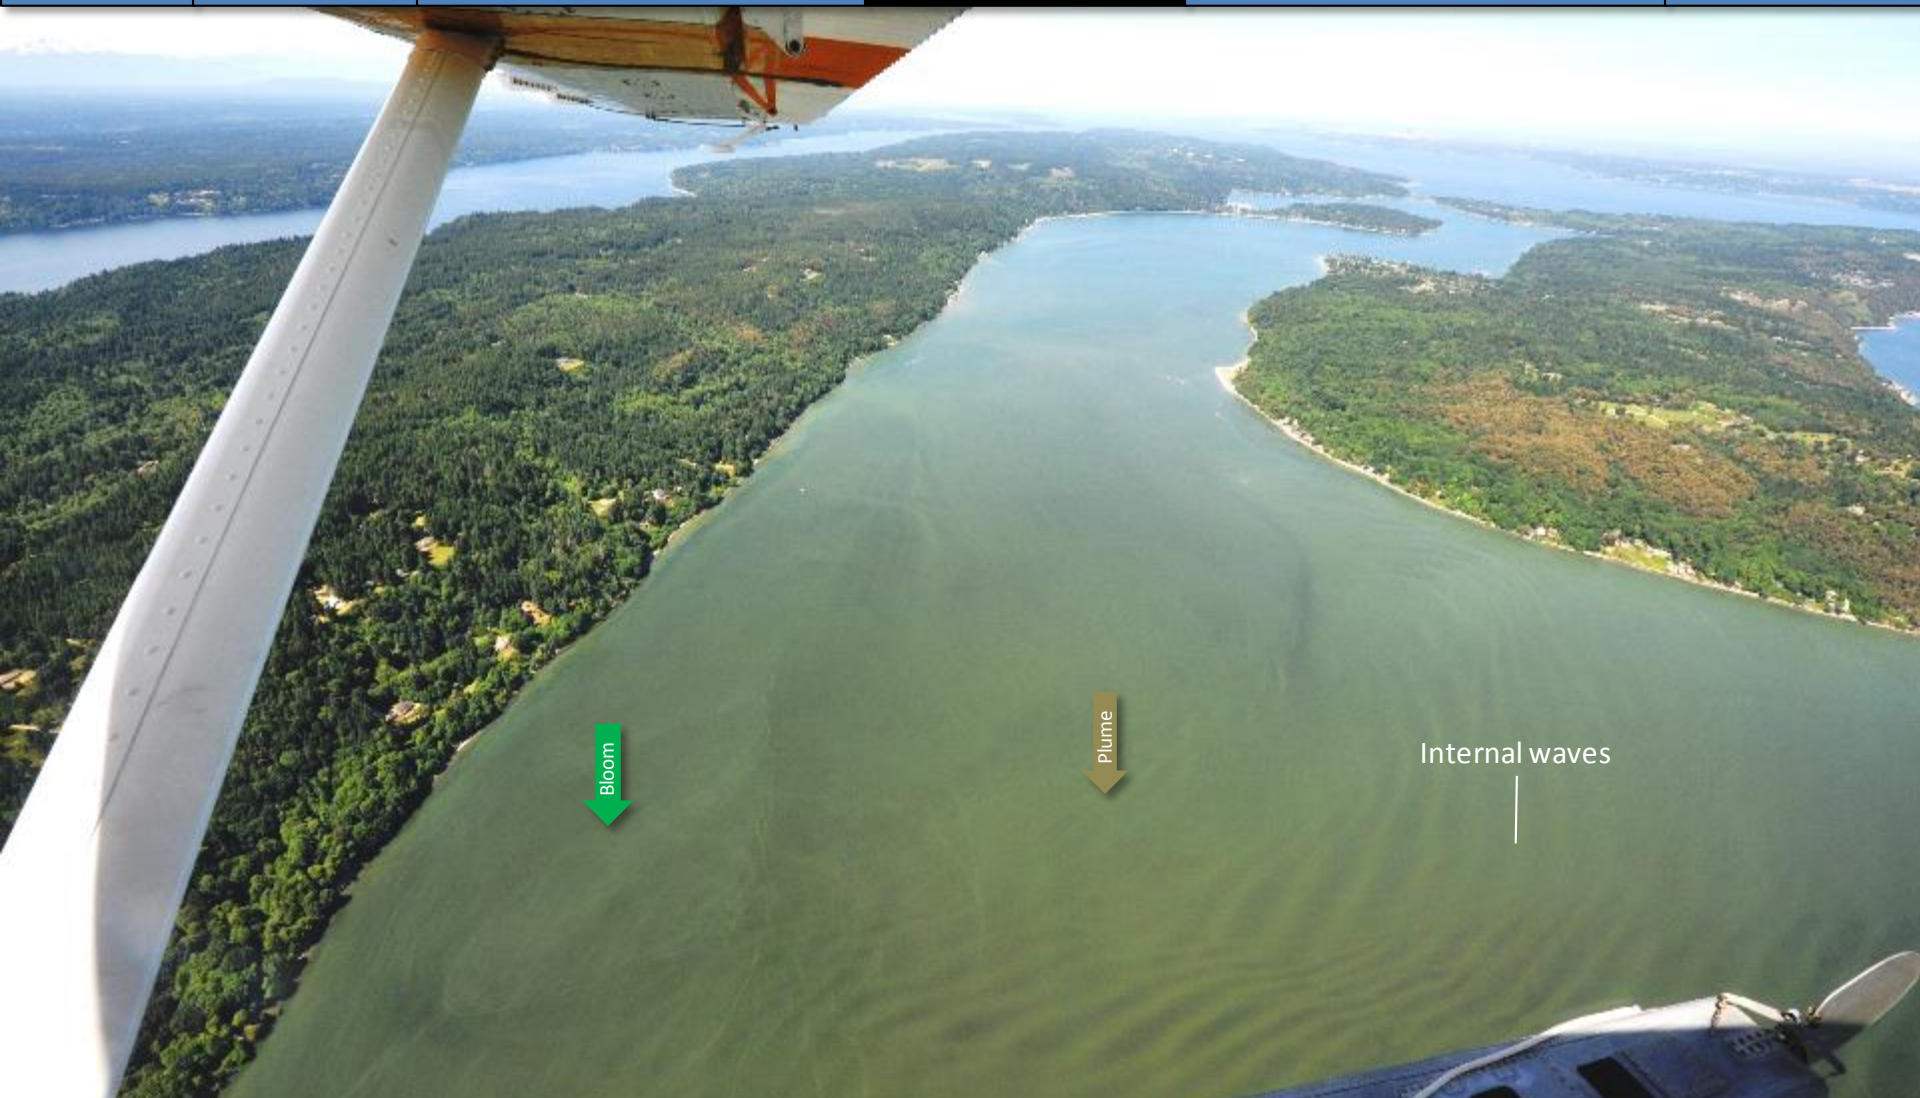
*Internal waves can be seen in sediment rich water of Puyallup River extending into Quartermaster Harbor.  
Location: Vashon Island (Central Sound), 2:36 PM.*

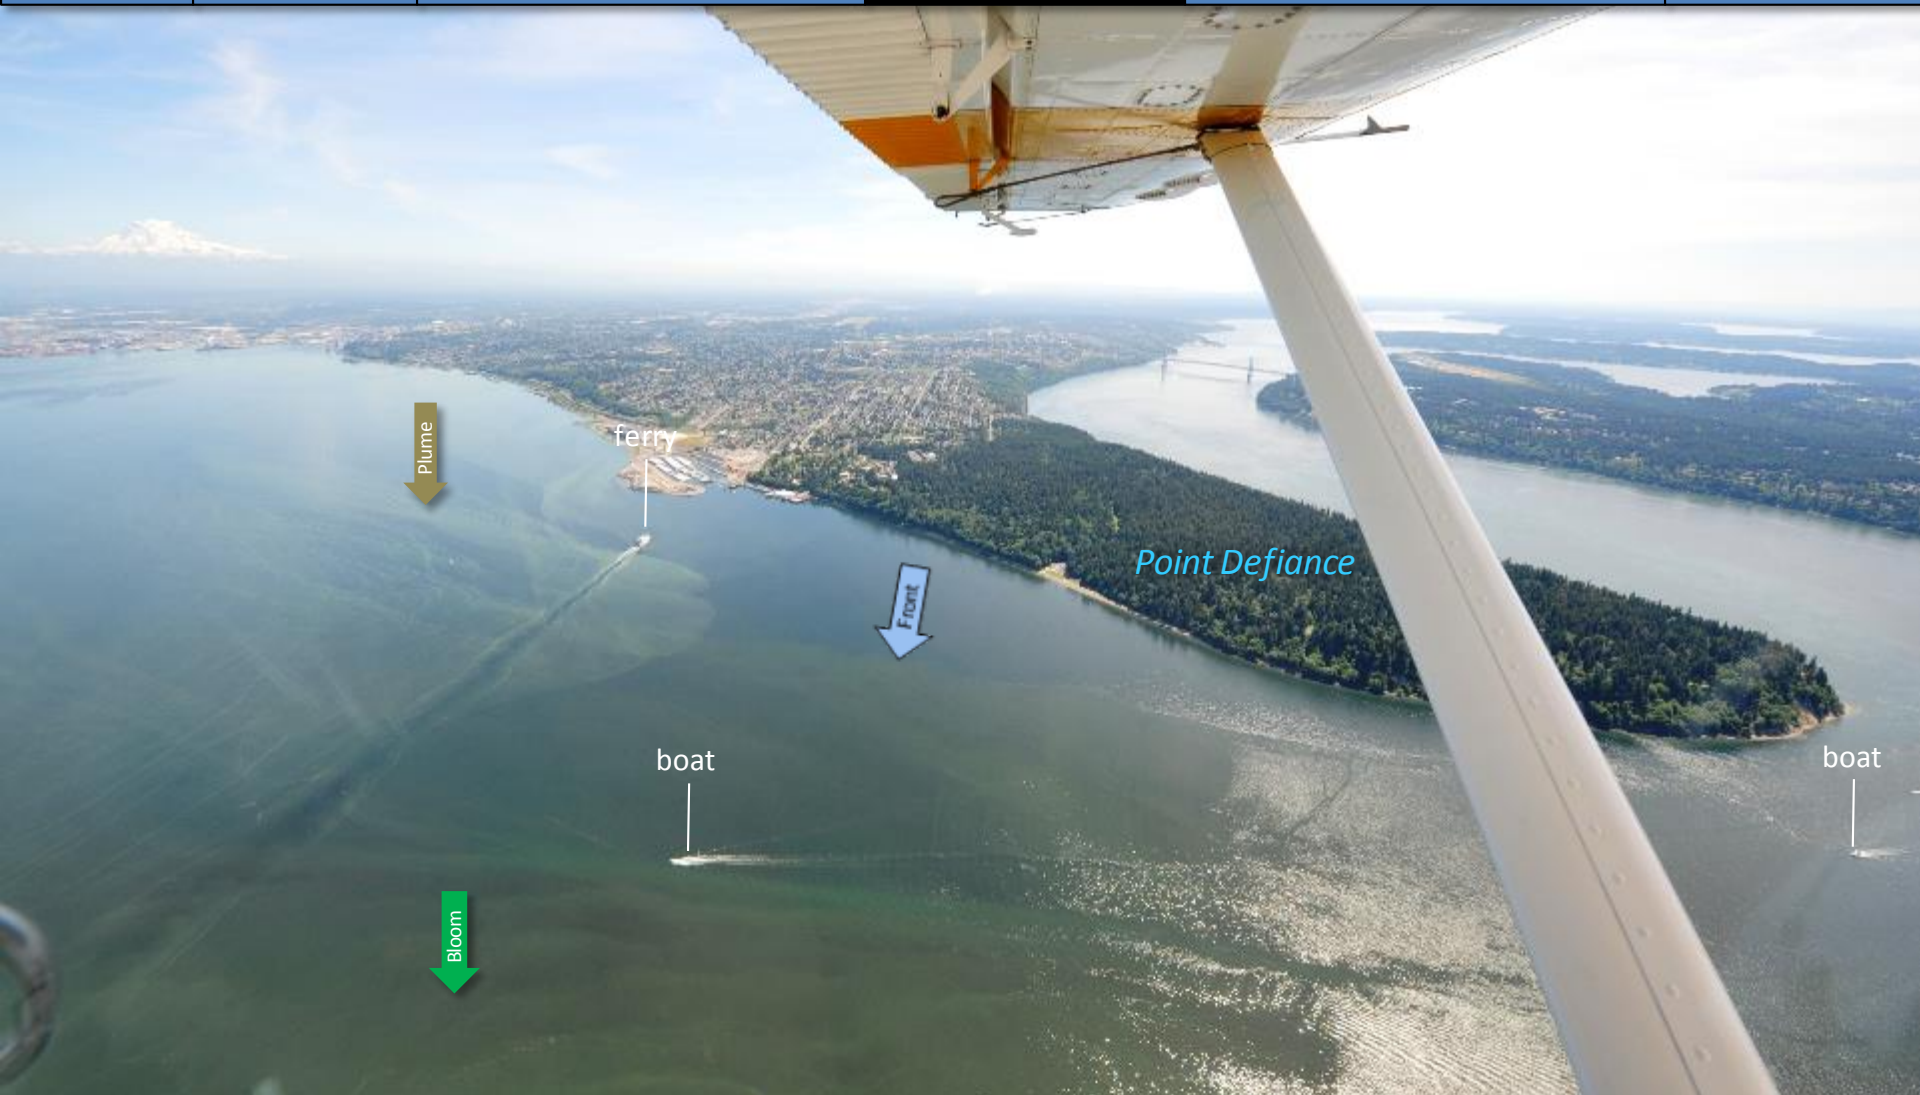
*Red-brown bloom in sediment-rich freshwater plume of the Puyallup River.  
Location: Point Defiance (Central Sound), 2:37 PM.*

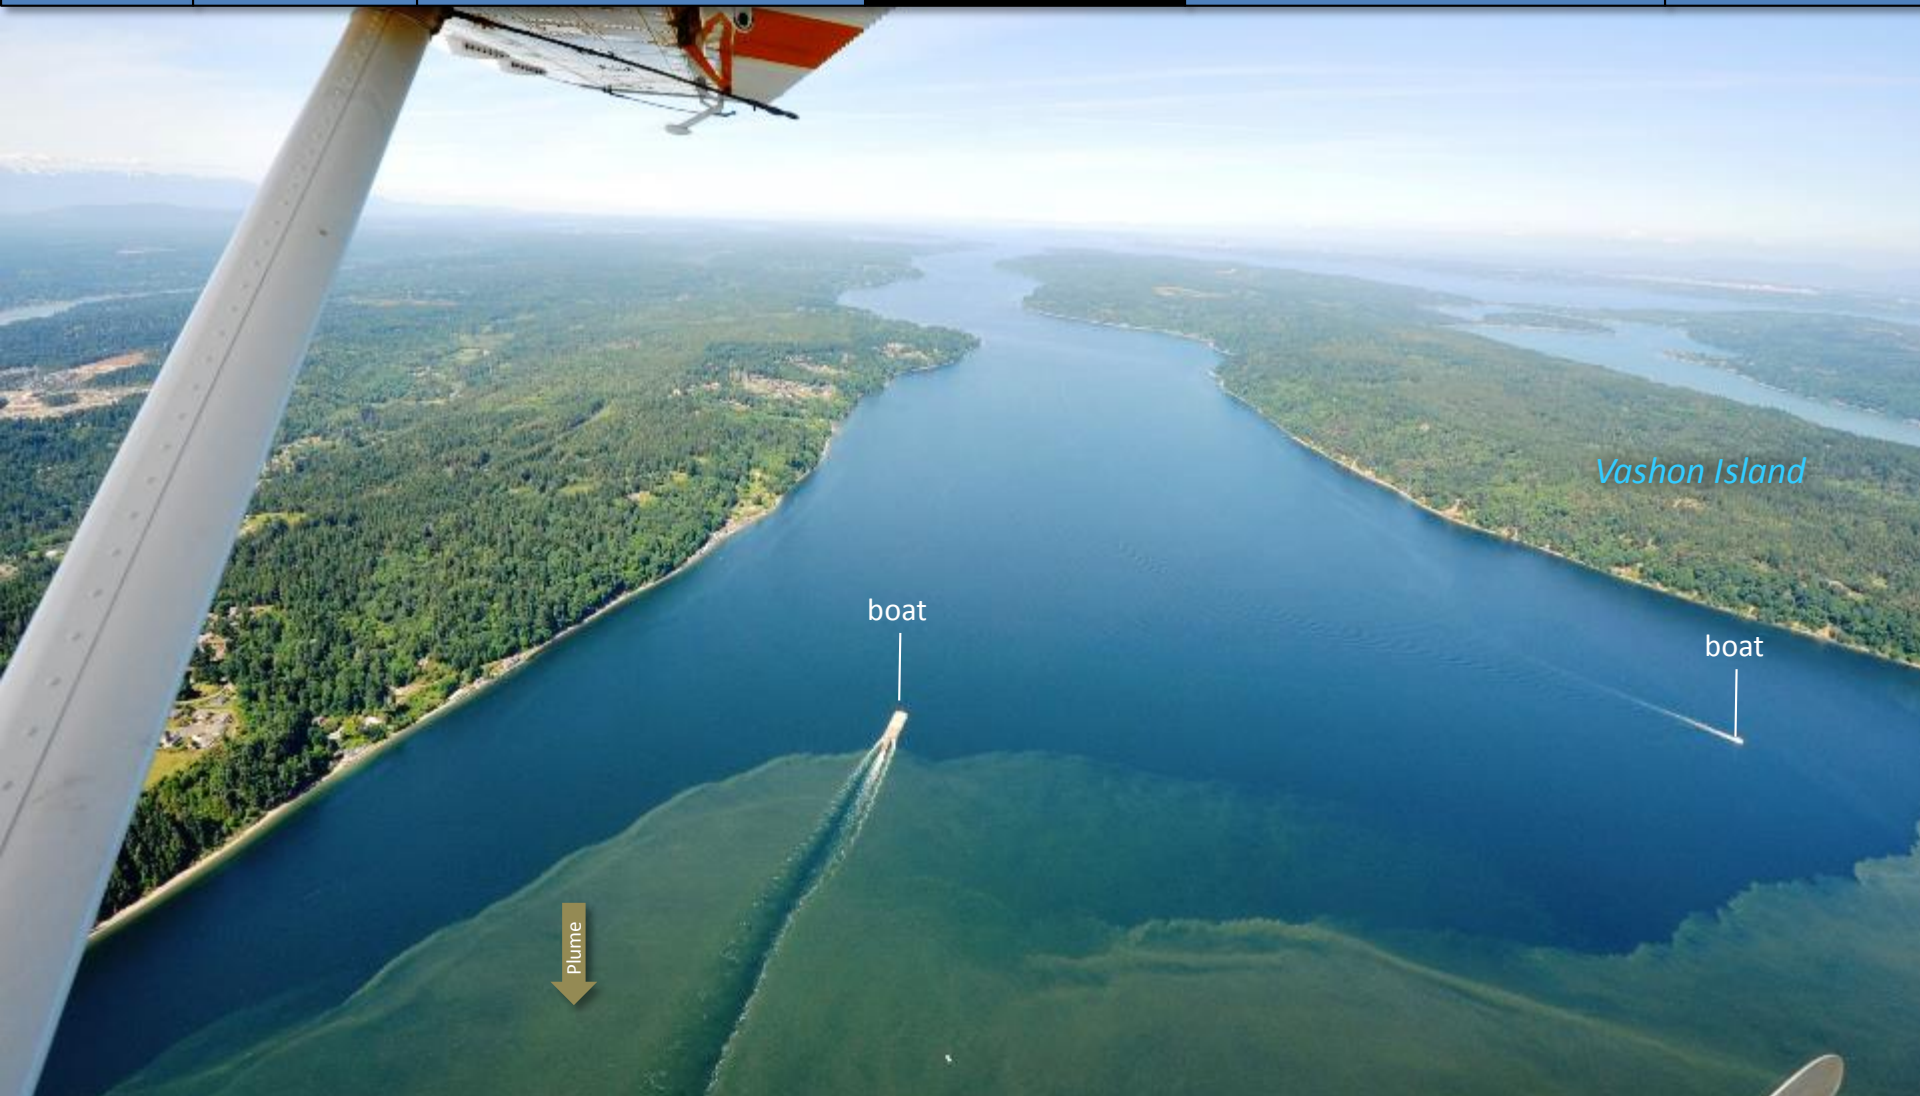
*Sediment plume of the Puyallup River at the entrance to Colvos Passage.  
Location: Point Defiance (Central Sound), 2:38 PM.*

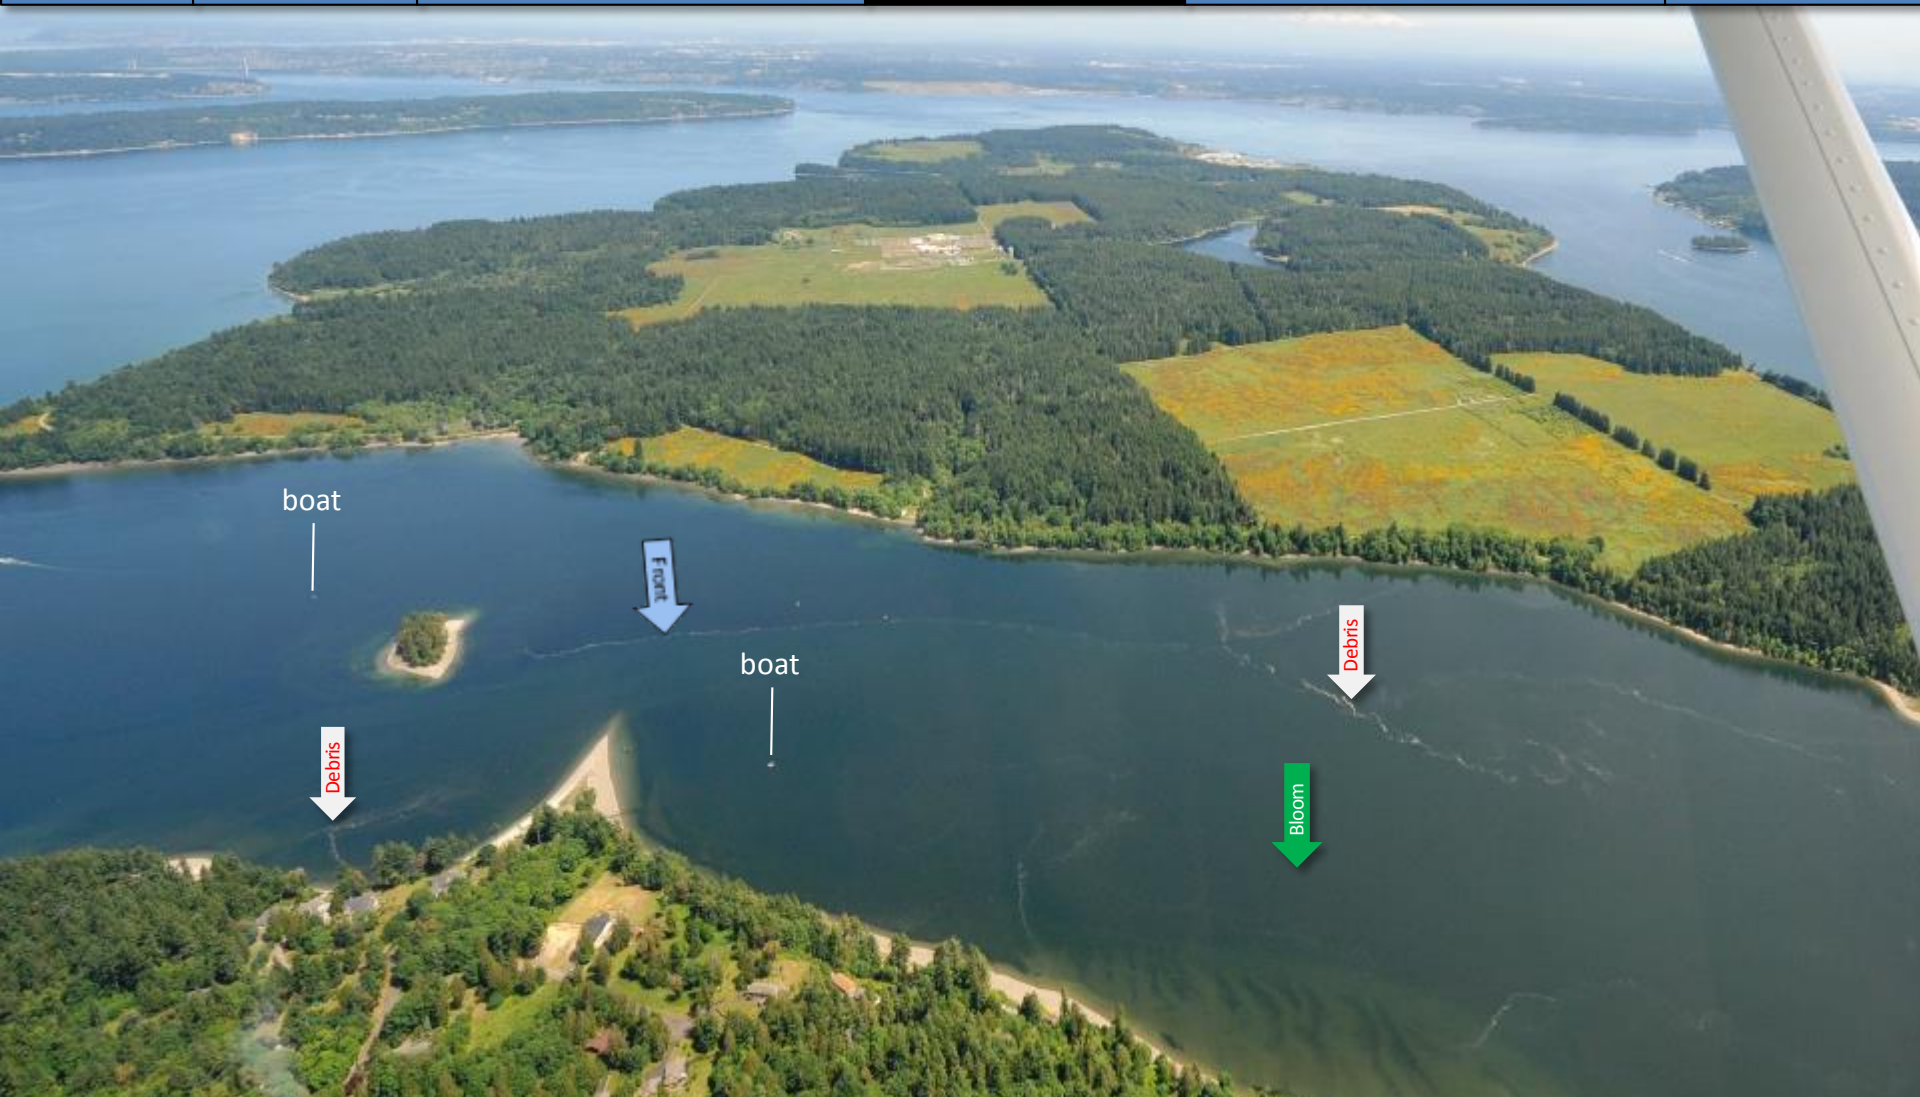
*Bloom and organic material accumulating along tidal fronts.*  
Location: Pitt Passage (South Sound), 2:45 PM.
