# Eyes Over Puget Sound

## Surface Conditions Report, *October 31, 2017*

*Up-to-date observations of water quality conditions in Puget Sound and coastal bays*

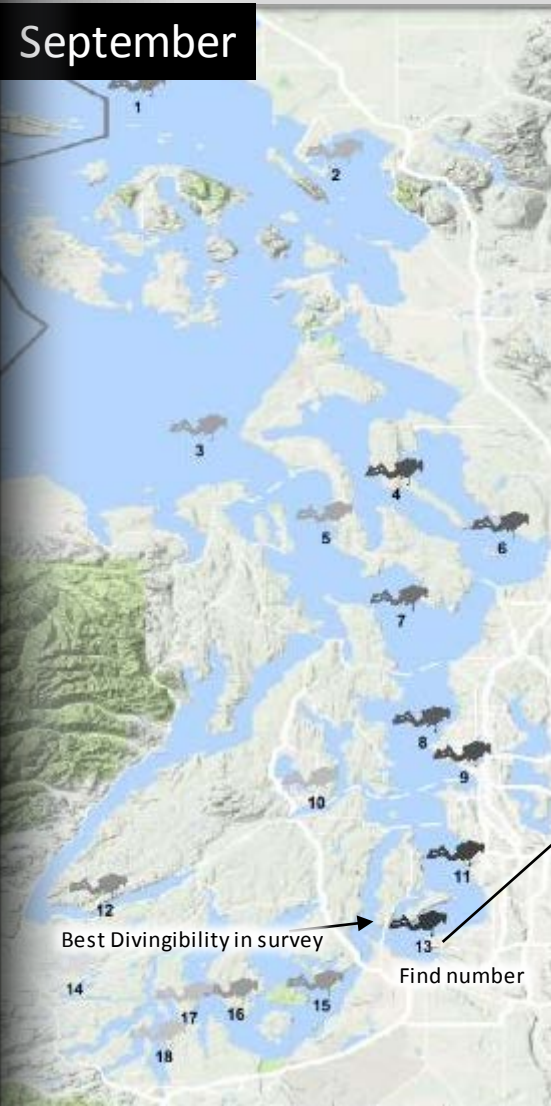
### Visibility (ft)/depth (ft)

- **Best Visibility** was nearly 50 feet south of Three Tree Point toward Browns Point and Commencement Bay.
- **Poor visibility** occurred in many places in South Puget Sound, but also in Bellingham Bay and near Bremerton/Silverdale.
- We use transmissometer readings from our CTD package and convert them into horizontal visibility. See our recent publication for details: Underwater visibility Maps – a Tool for Scuba Divers.

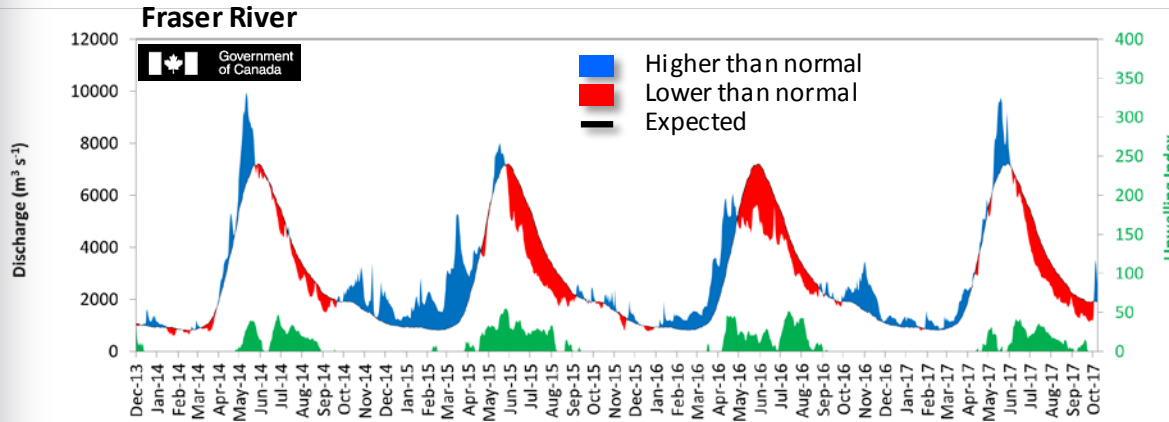
Historically, peaks of coastal upwelling and the [freshet](#) are in sync.

**The Fraser River is the major driver of estuarine circulation and water exchange with the ocean.**

Fraser River flows were higher than normal in July. Then flows got weaker. Lower Fraser River and weaker upwelling along the coast favored a reduced inflow of low-oxygen water from the coast and positively influence oxygen conditions.

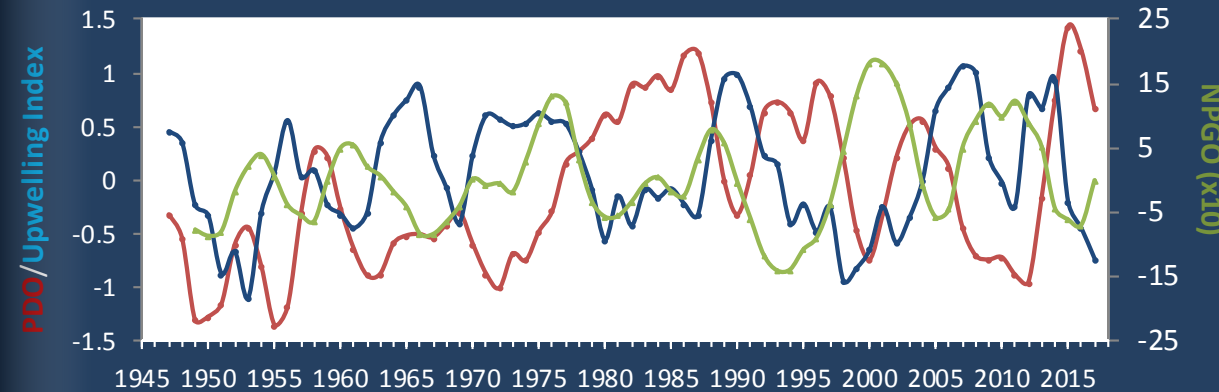
Three-year running average of PDO, Upwelling, and NPGO indices

Past years warm water is fading (PDO), upwelling of low oxygen and high nutrient ocean water are low (Upwelling Index anomaly), and surface productivity along the coast is near normal (NPGO).

Pacific Decadal Oscillation Index (**PDO, temperature, [explanation](#)**). Upwelling Index (anomalies) (**Upwelling, low oxygen, [explanation](#)**). North Pacific Gyre Oscillation Index (**NPGO, productivity, [explanation](#)**).

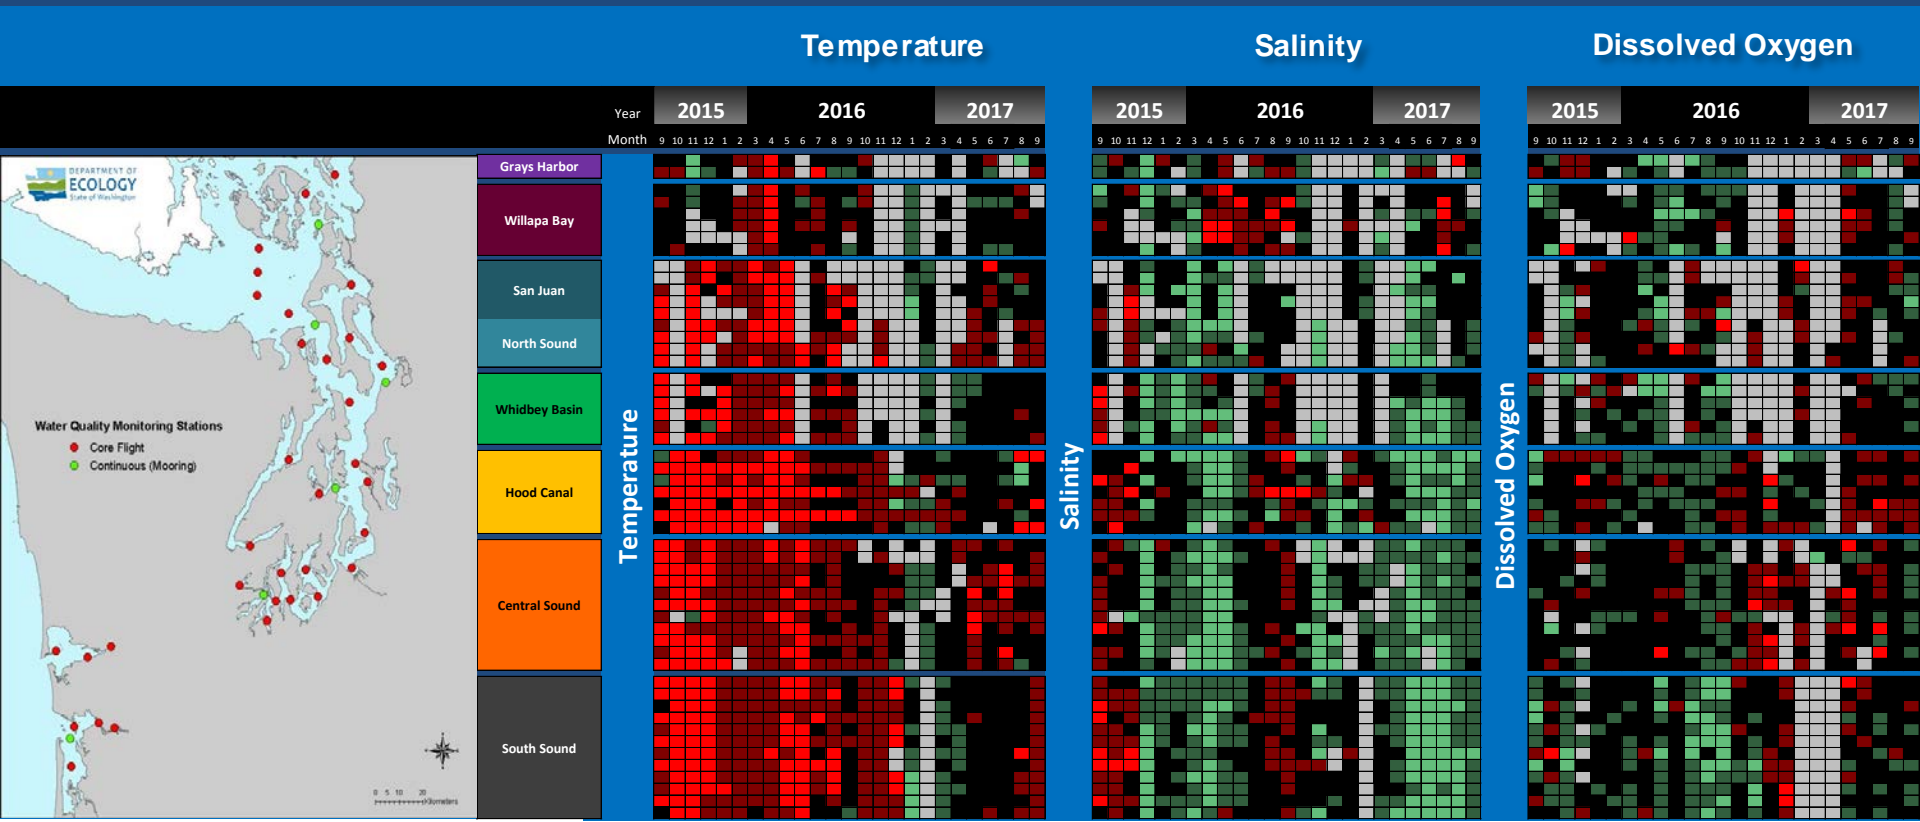
Ecology's monthly monitoring station network. Surface to full depth.

As of Sept 2017, warmer temperature persists in South Sound. **Very low salinity persists in Hood Canal, Central and South Sound.** Significantly fresher conditions in Puget Sound occurred since November, 2016. In September higher dissolved oxygen values continue in Hood Canal while dissolved oxygen is lower in Central Sound.

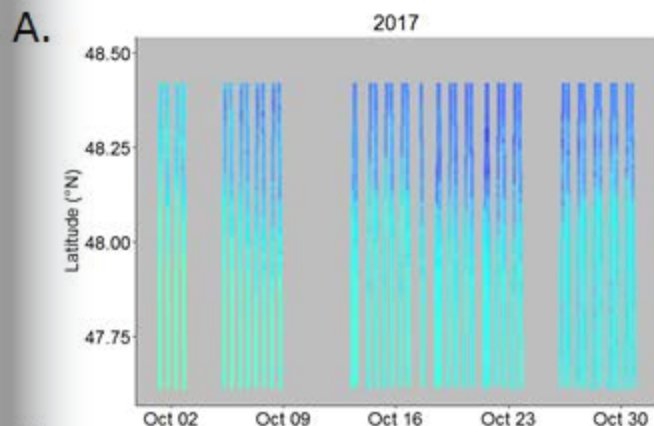
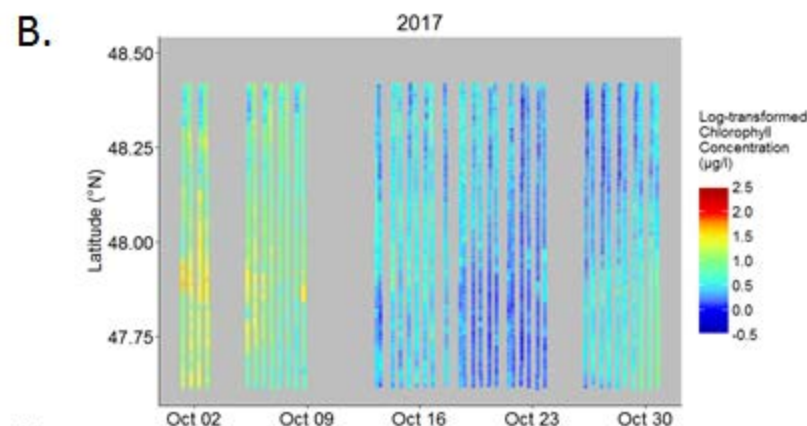
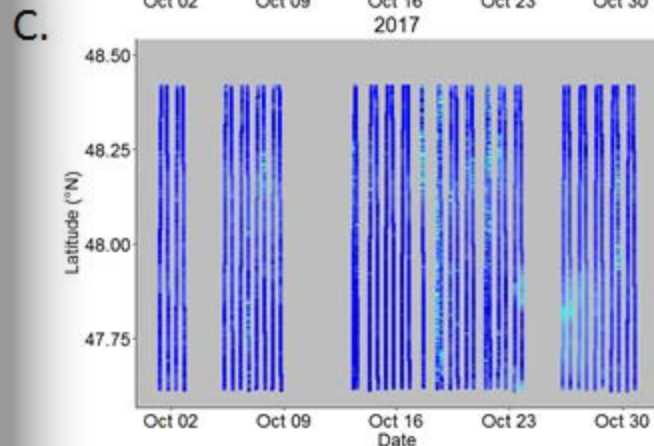
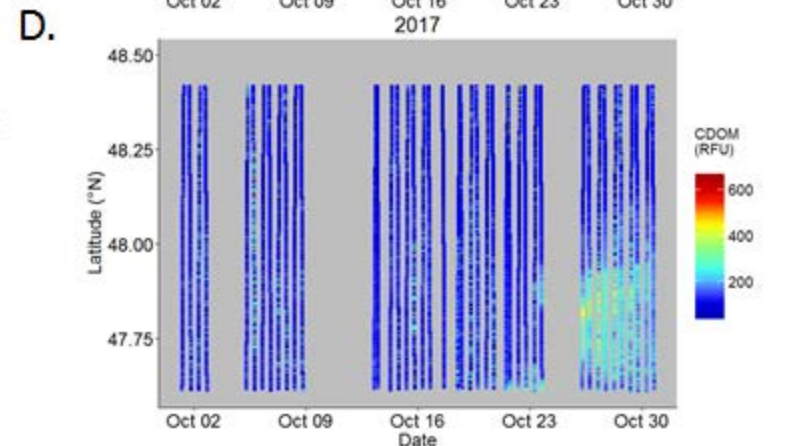
Surface water temperature cooled in the Strait of Juan de Fuca. Moderate chlorophyll concentrations in Puget Sound occurred in early October followed by clearing in mid-month. Turbidity and CDOM were noisy until late October when river outflows contributed to an increase near the Triple Junction. Gaps in the data are explained by the vessel remaining in port.

The *Victoria Clipper IV* carries sensors in its sea chest. The sensors allow us to plot over time transects of:

- A. Temperature
- B. Chlorophyll
- C. Turbidity
- D. CDOM

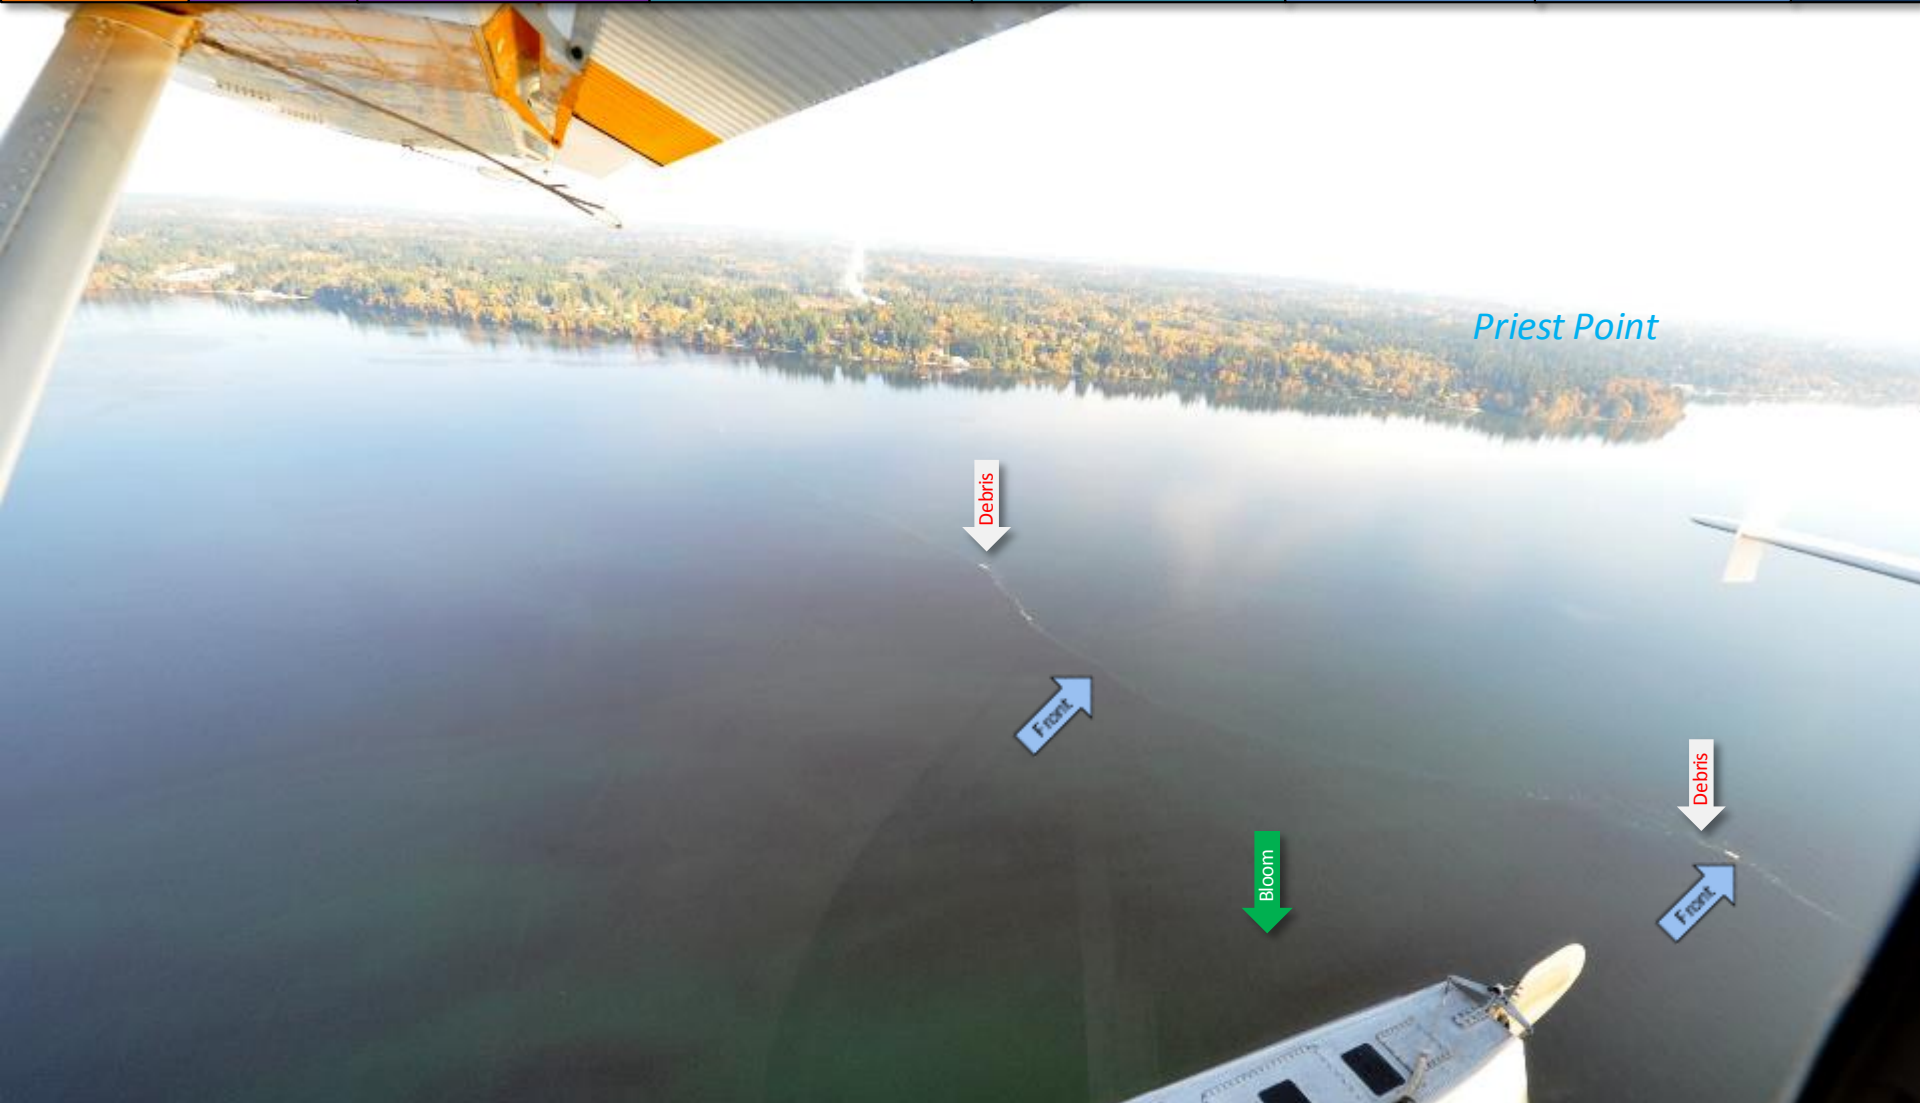
*Lower altitude. Red-brown bloom. Front of the Deschutes River with organic material debris.  
Location: Budd Inlet (South Sound), 2:47 PM.*

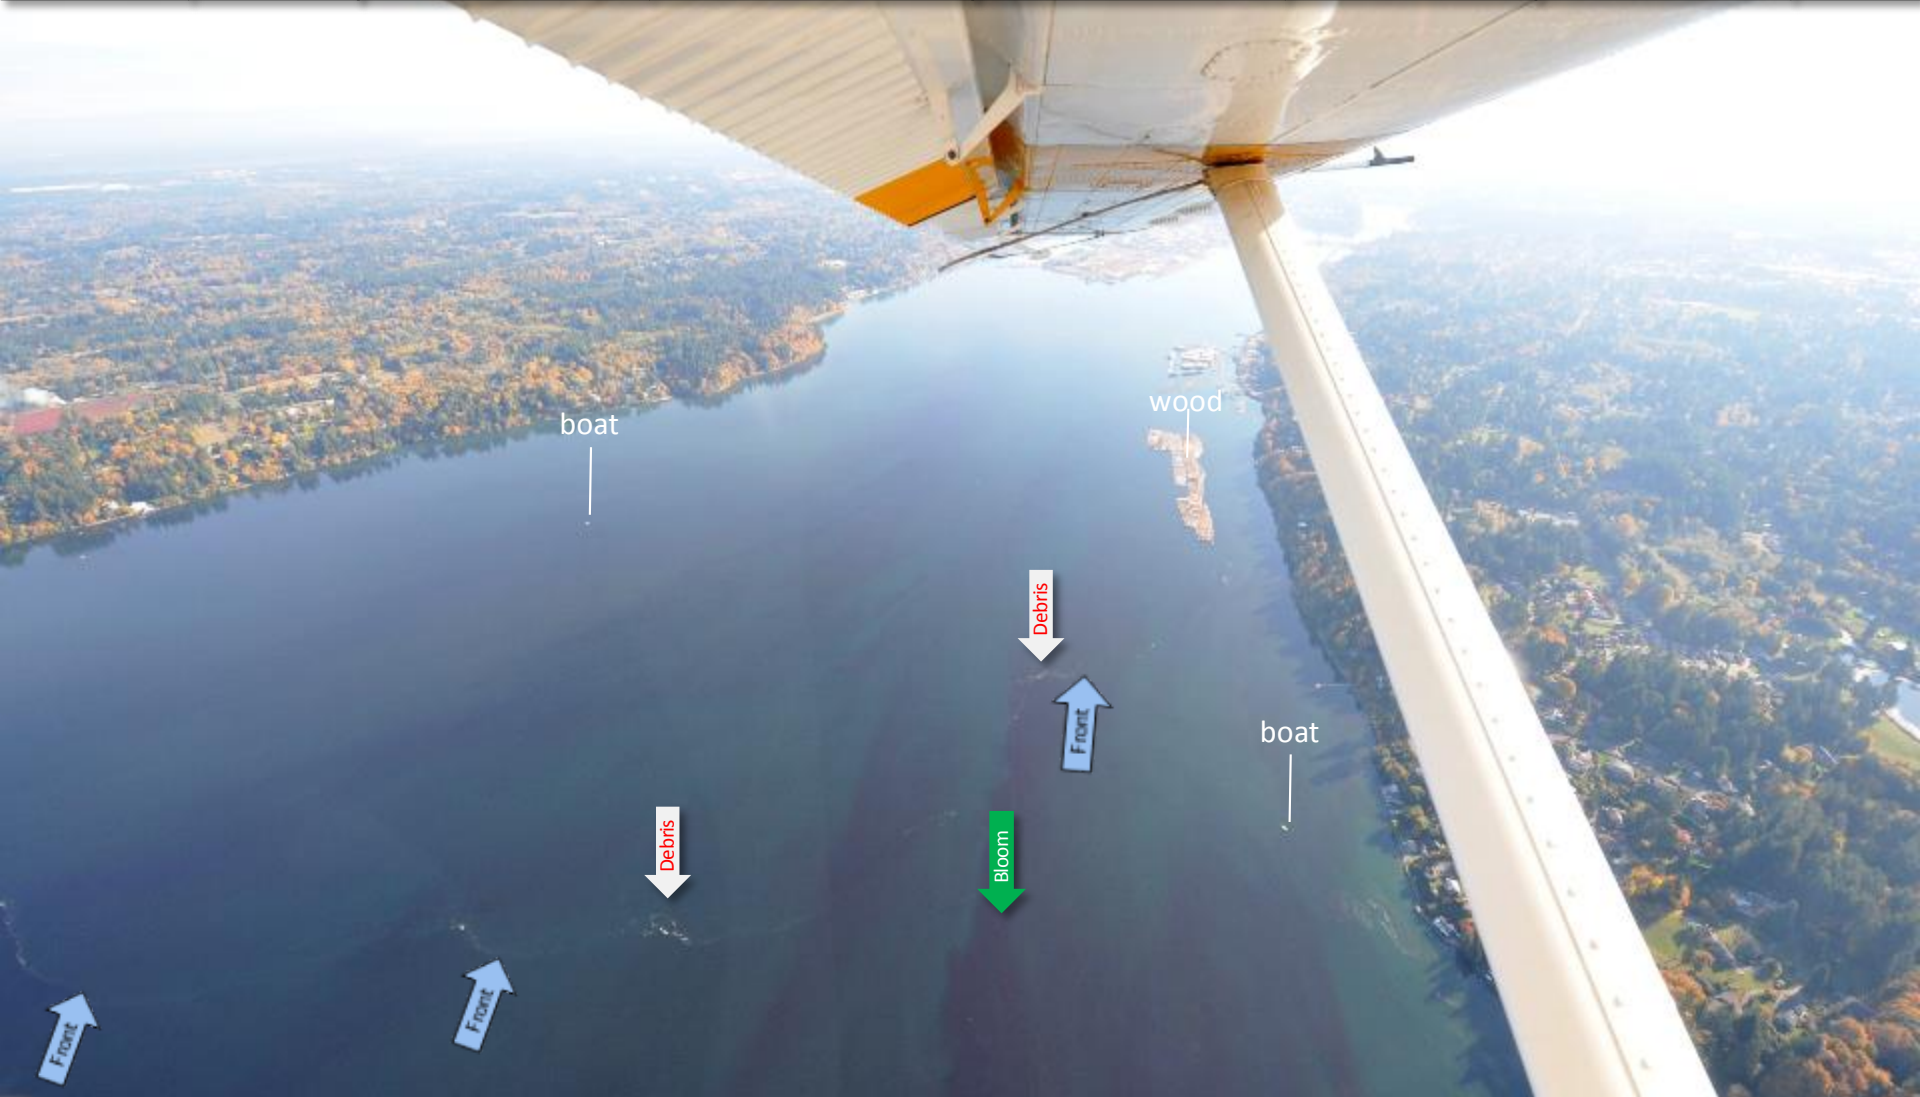
*Higher altitude. Red-brown bloom. Front of the Deschutes River with organic material debris.  
Location: Budd Inlet (South Sound), 2:49 PM.*

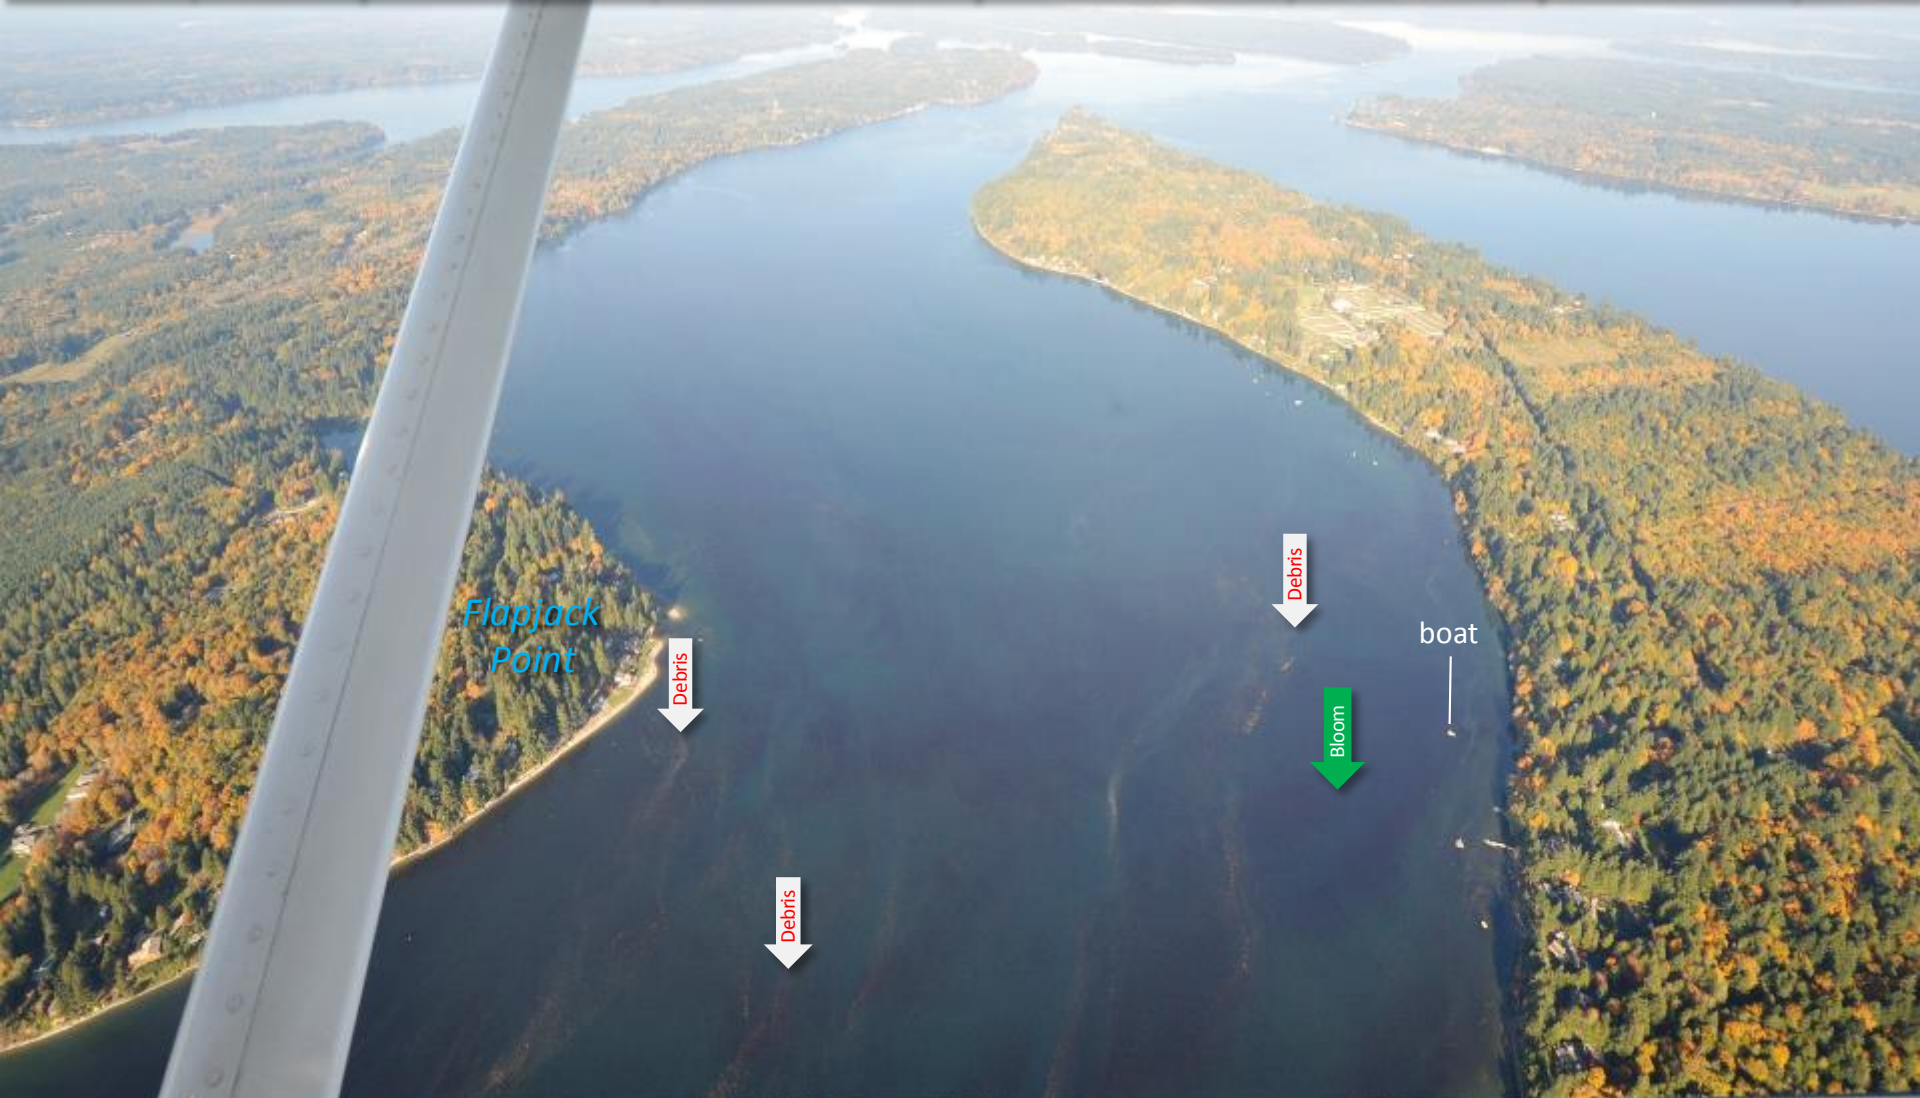
*Red-brown bloom and orange surface debris.  
Location: Eld Inlet (South Sound), 2:52 PM.*

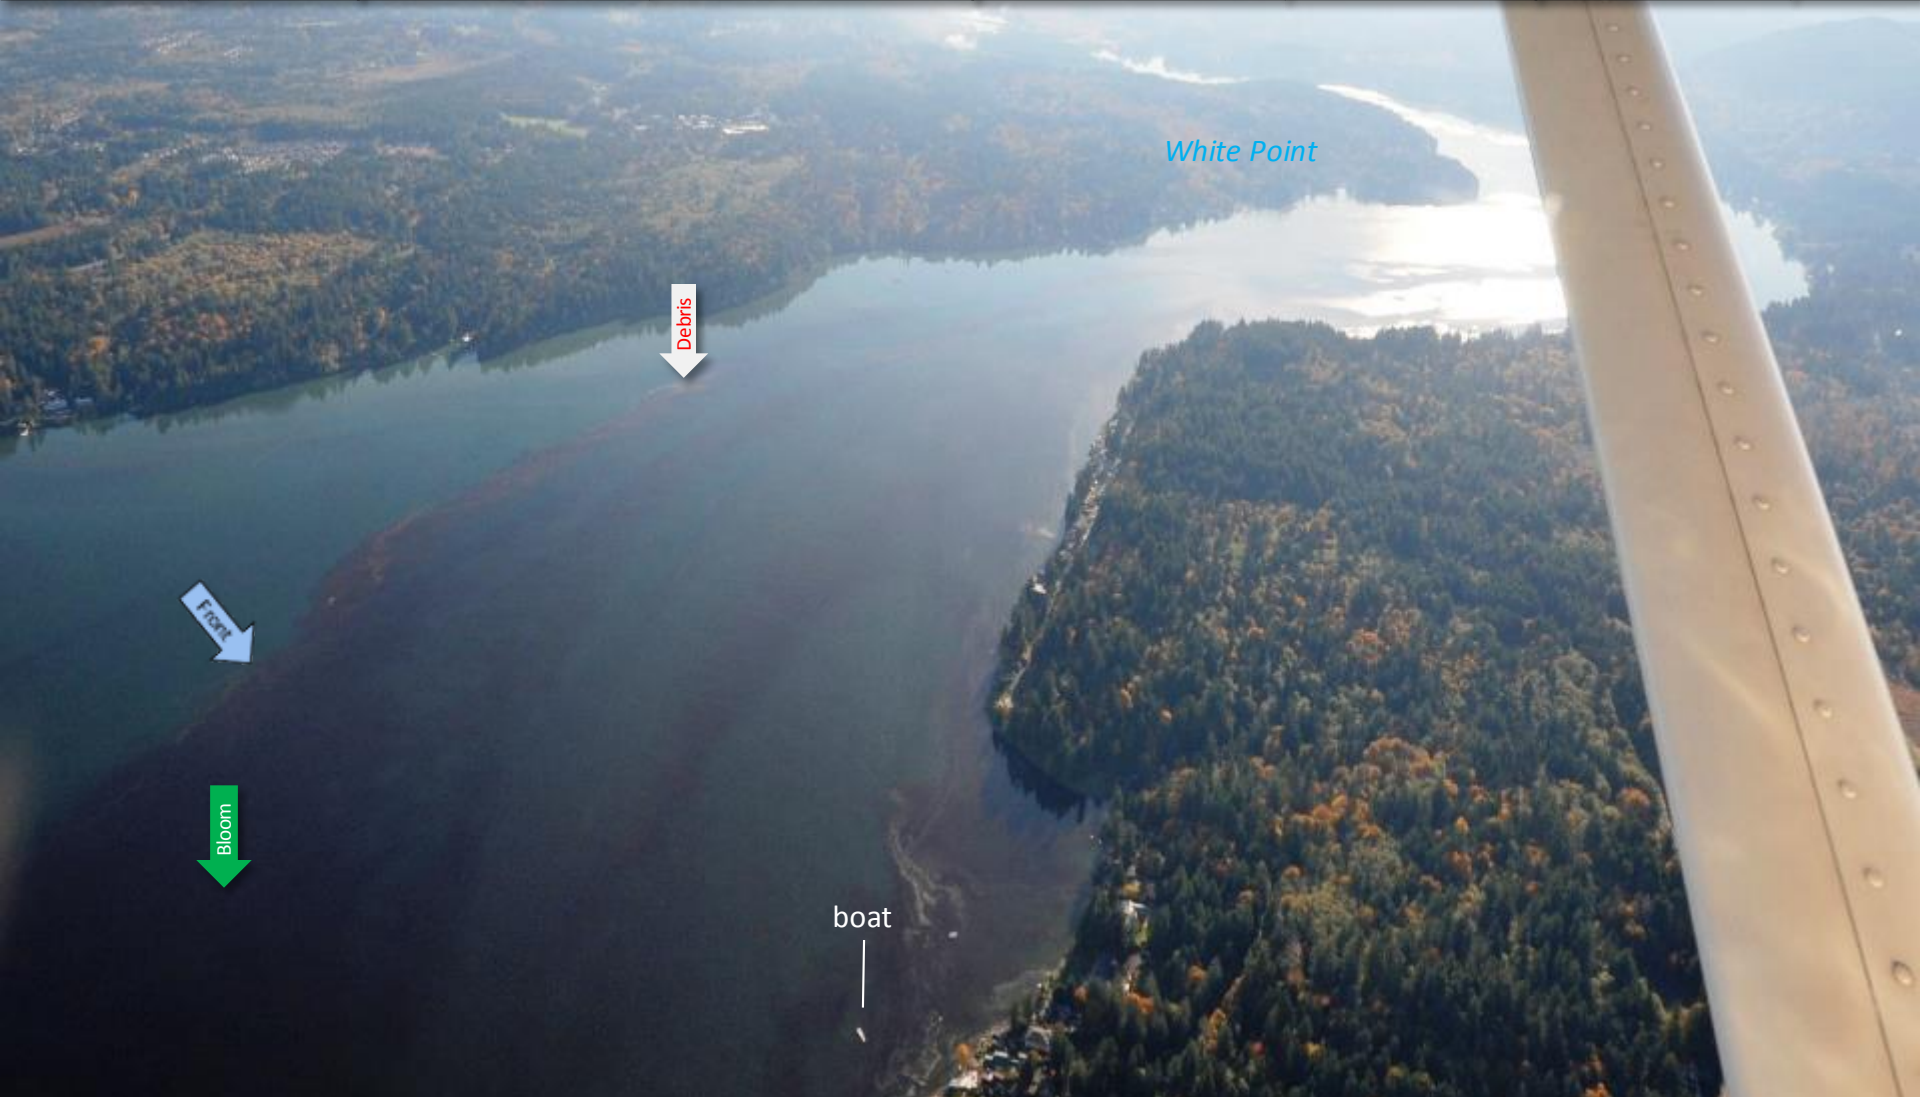
*Intense red-brown bloom confined to western side of the bay.  
Location: Eld Inlet (South Sound), 2:52 PM.*

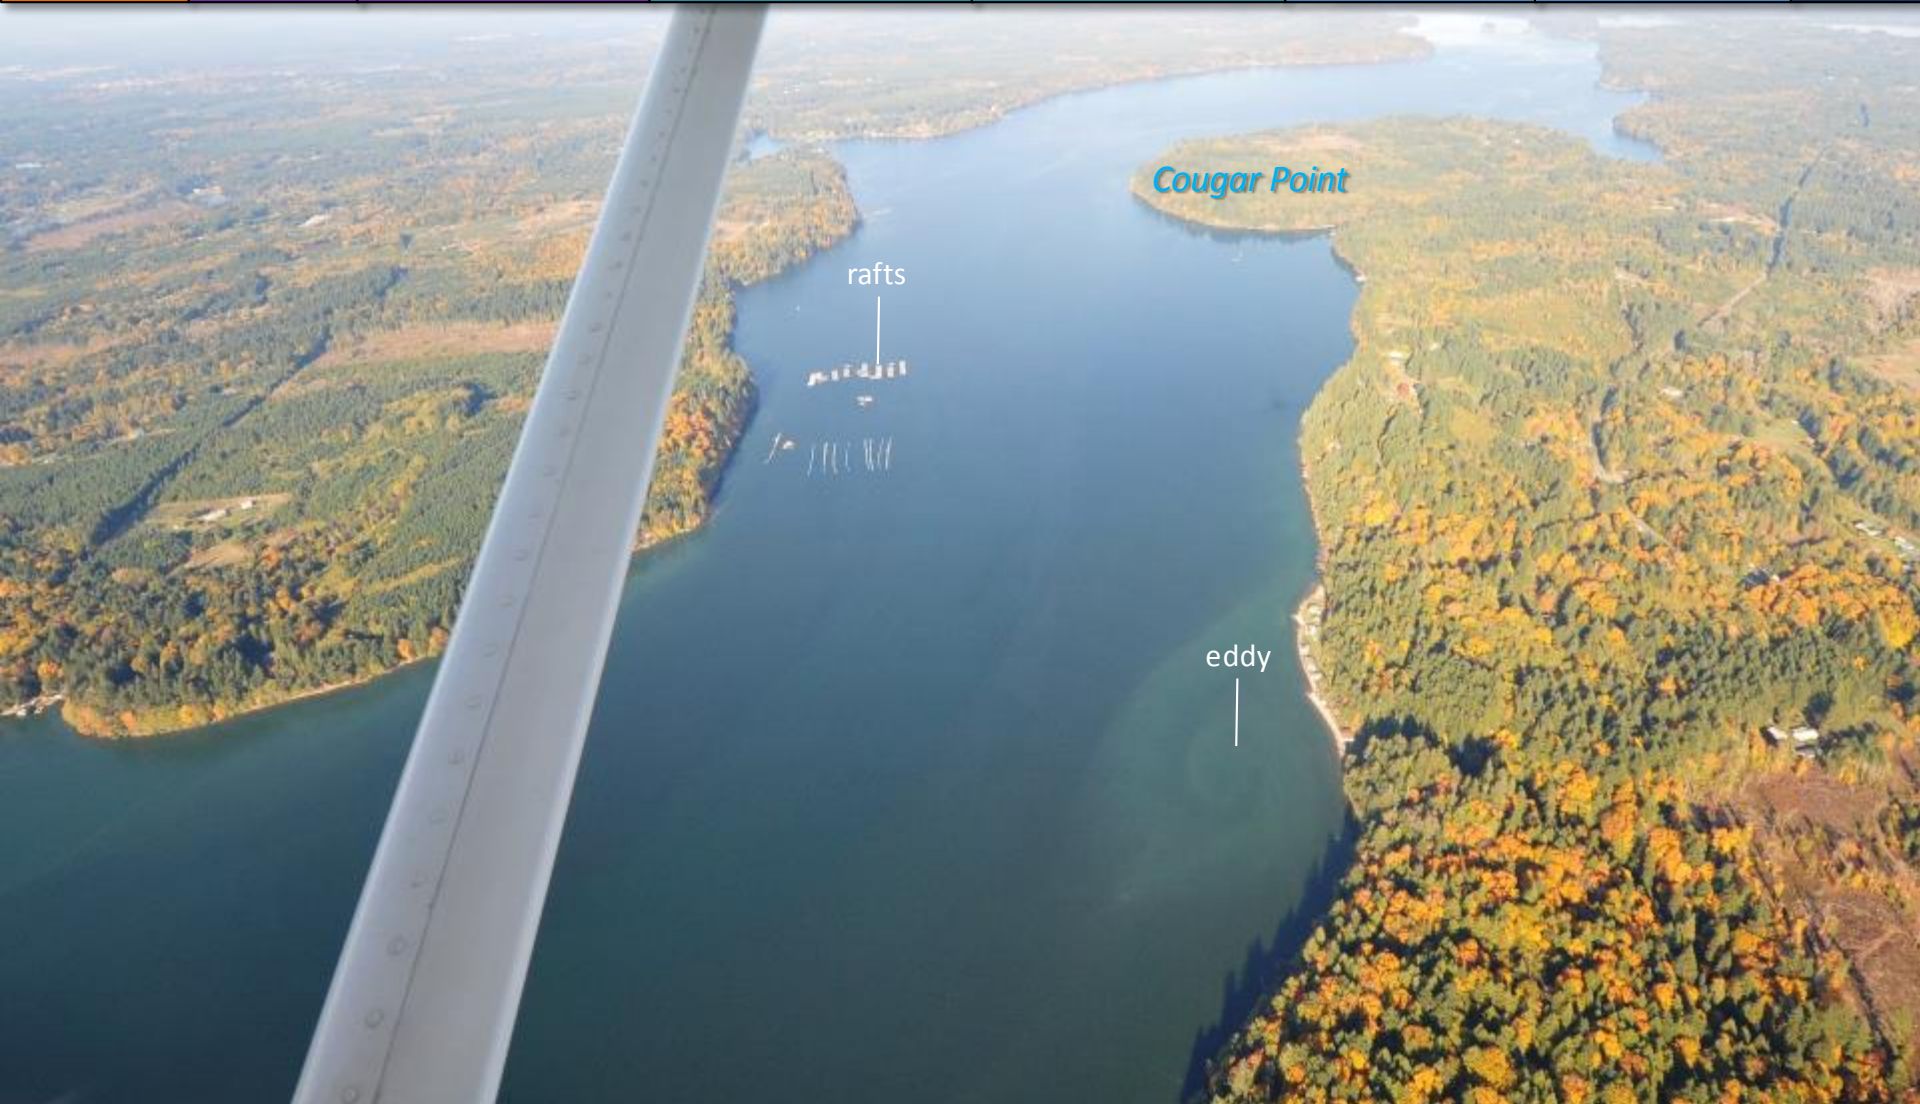
Location: Totten Inlet (South Sound), 2:54 PM.

*Tidal eddy.*

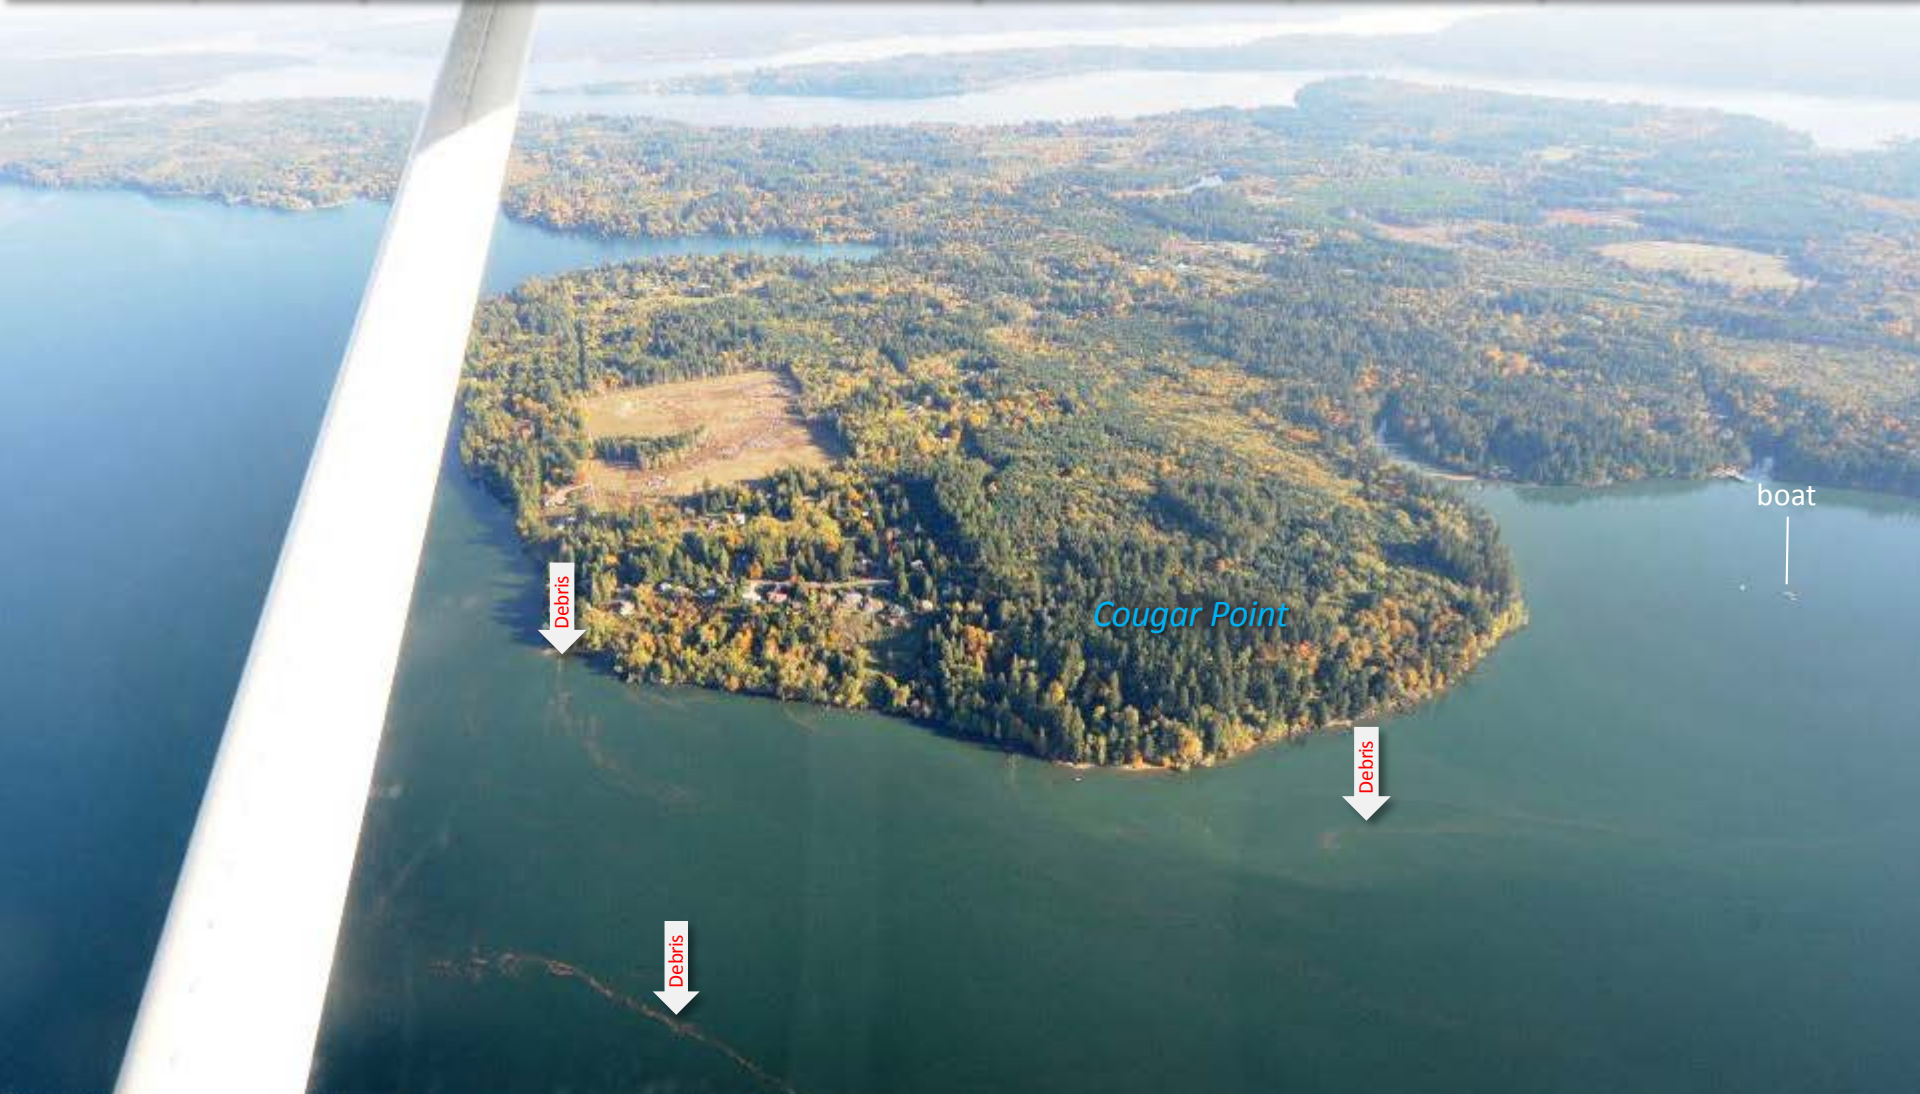
Location: Big Cove, Totten Inlet (South Sound), 2:55 PM.

*Orange surface debris.*

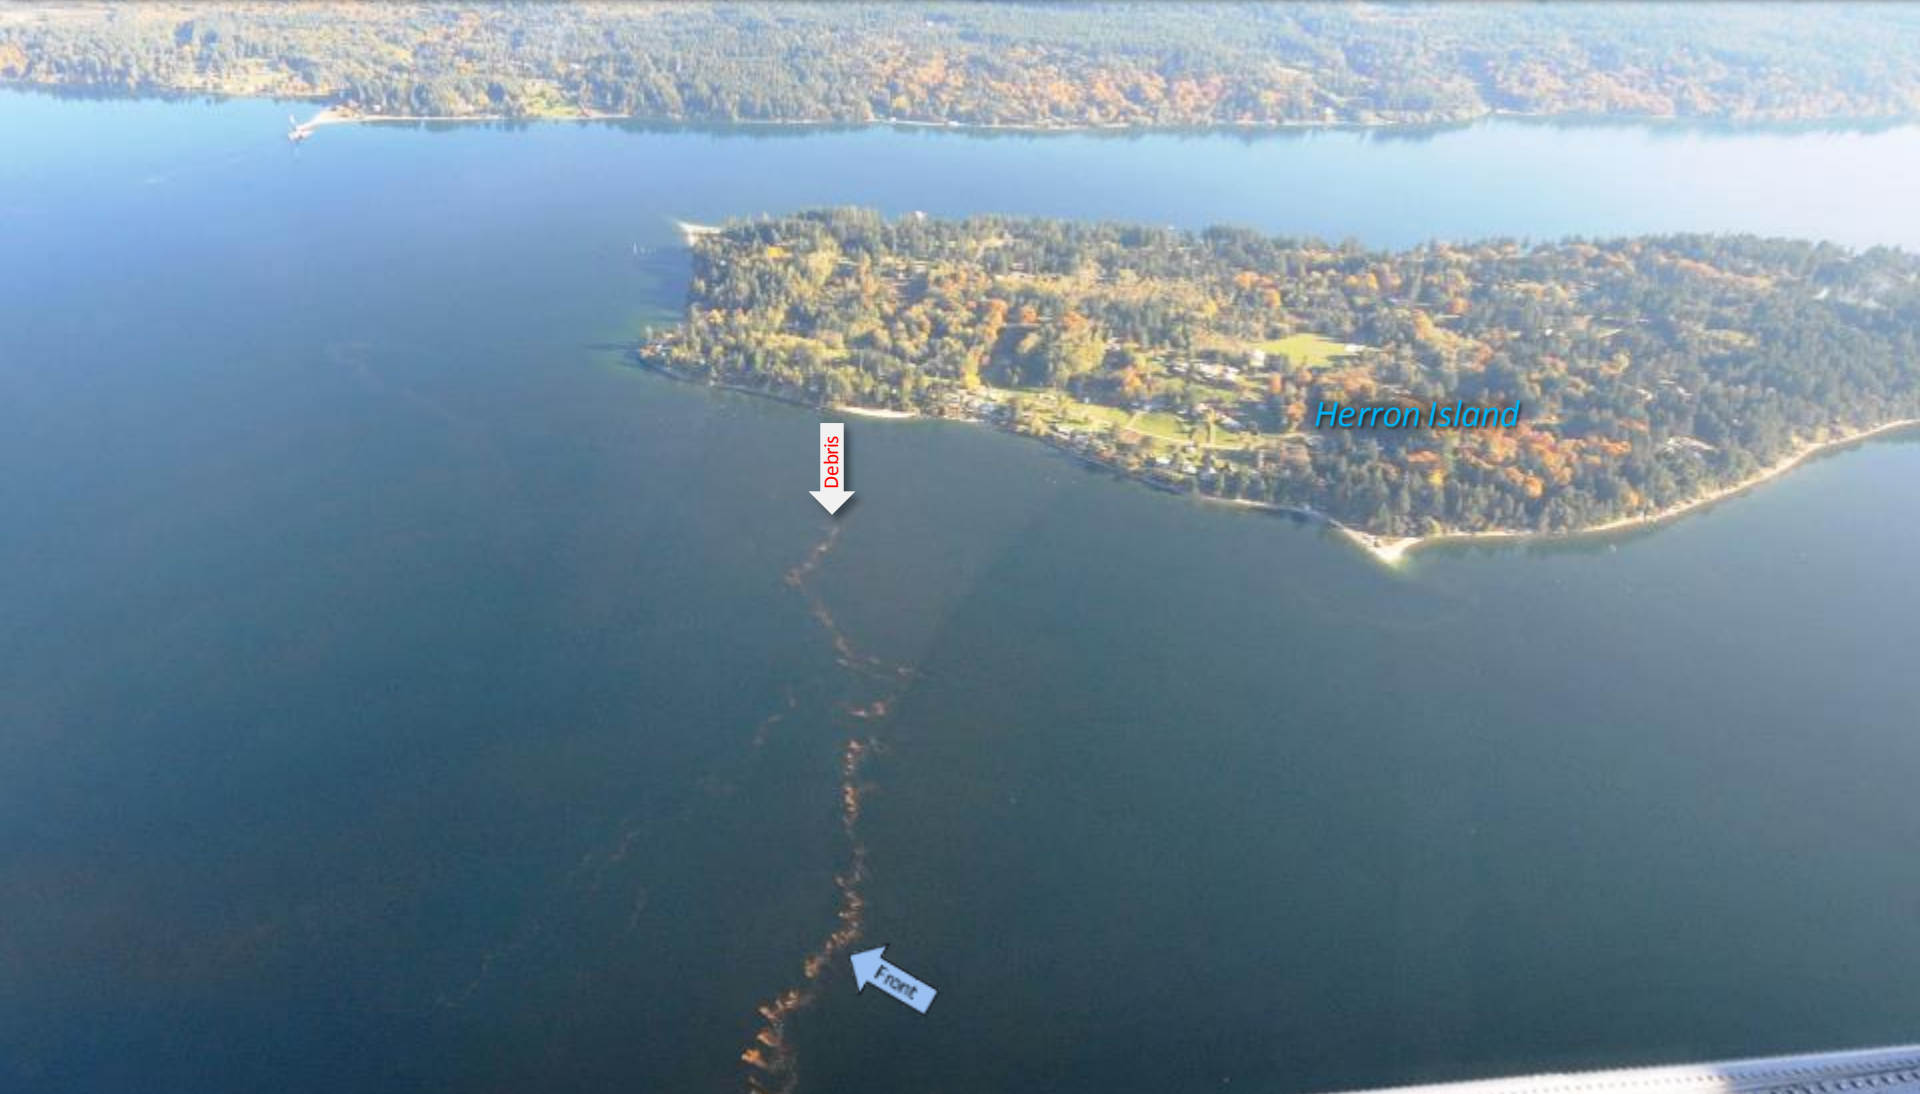
Location: Herron Island, Case Inlet (South Sound), 3:00 PM.

*Orange surface debris along front.*

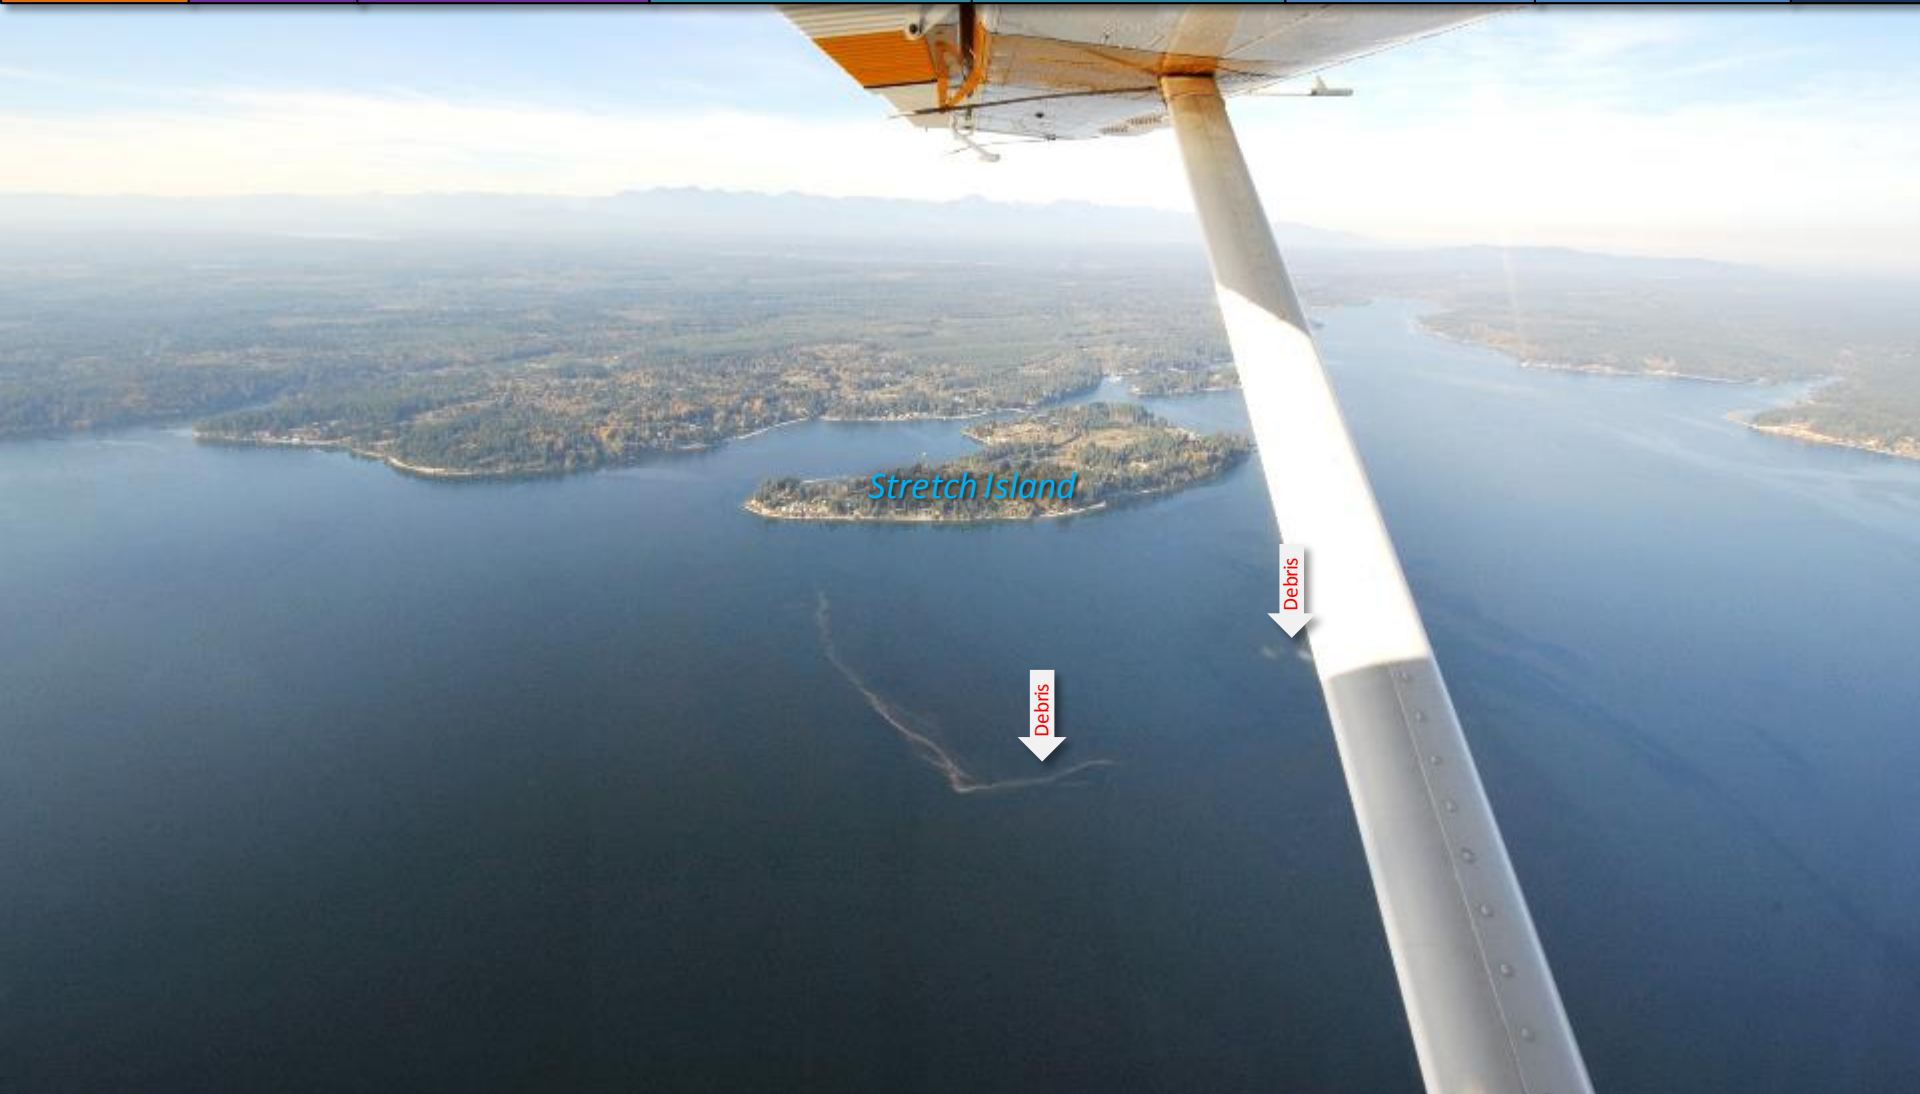
Location: Across Stretch Island, Case Inlet (South Sound), 3:02 PM.

*Orange surface debris along front.*
