# Eyes Over Puget Sound

## Surface Conditions Report, *October 31, 2017*

*Up-to-date observations of water quality conditions in Puget Sound and coastal bays*

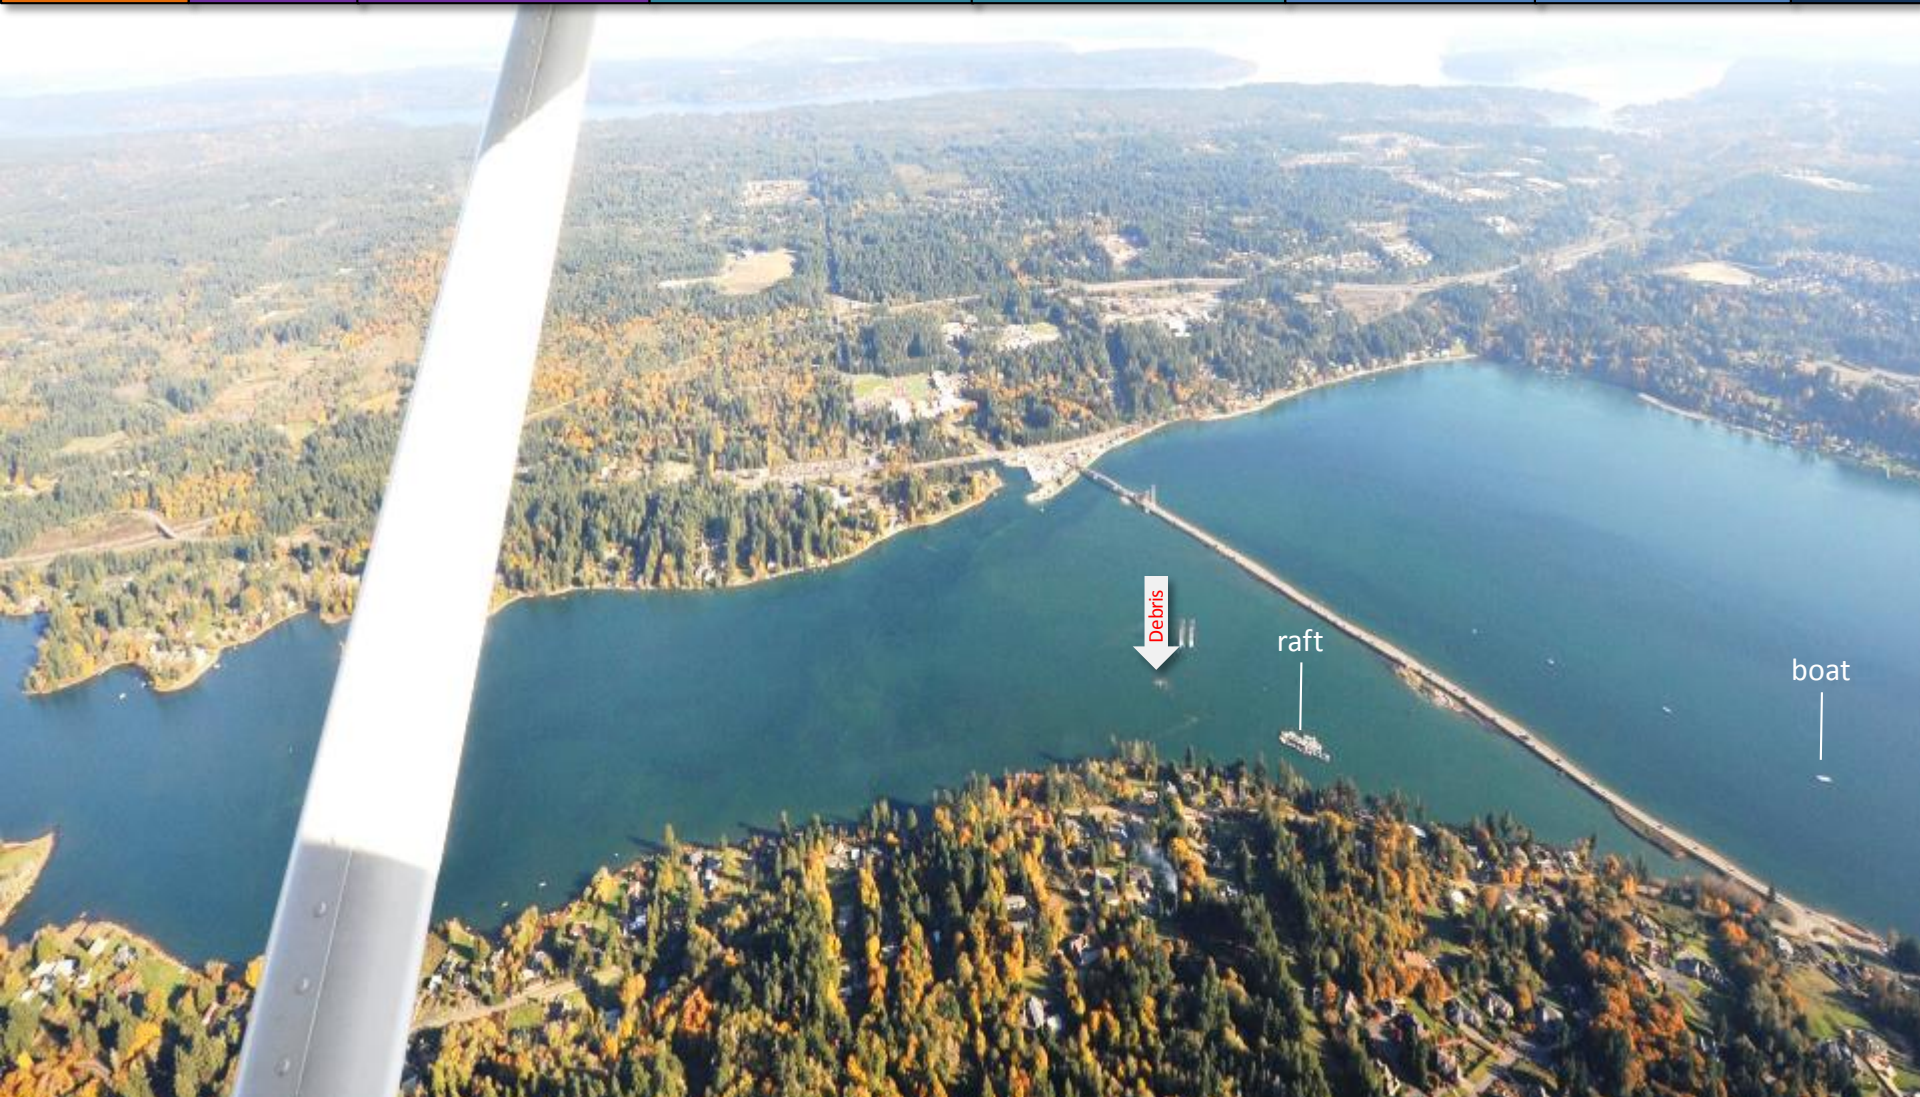
Location: Burley Lagoon, Carr Inlet (South Sound), 3:06 PM.

*Some surface debris.*

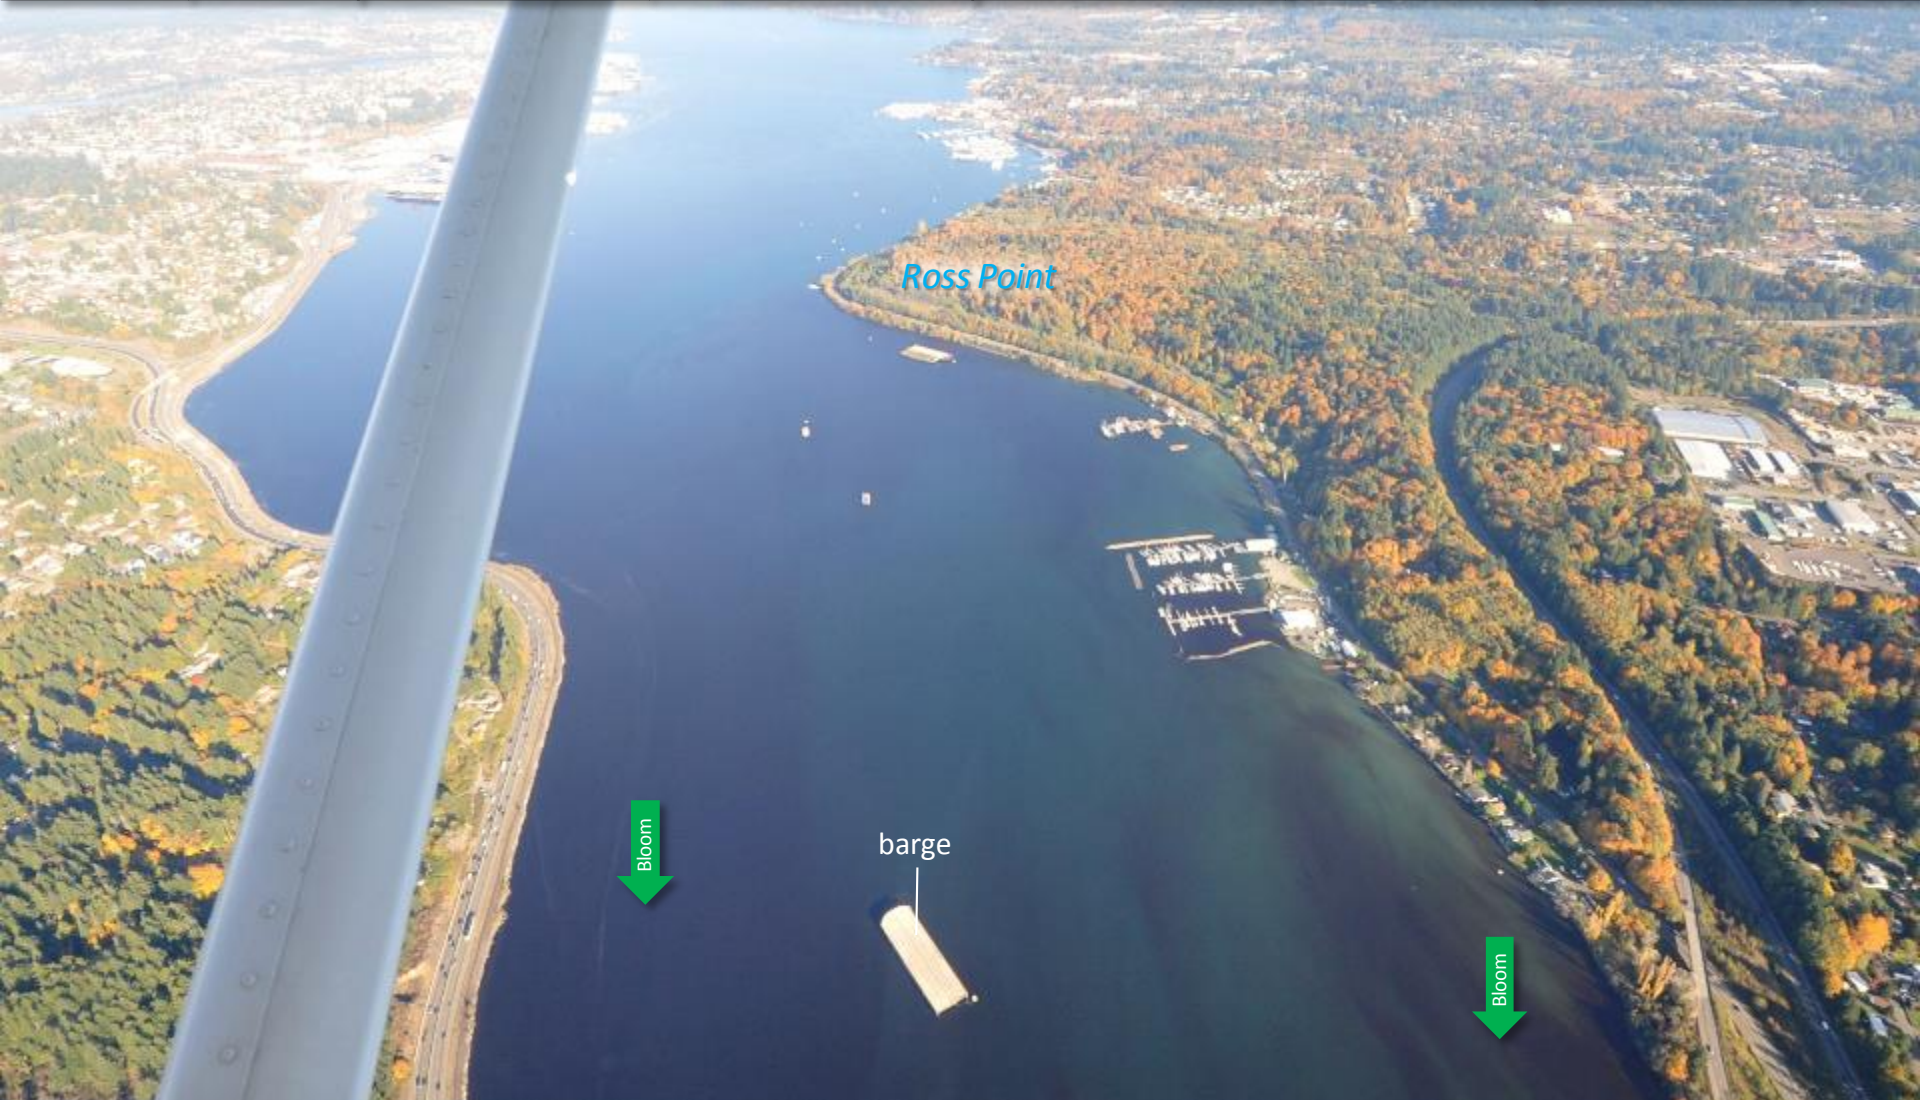
Location: Sinclair Inlet (Central Sound), 3:11 PM.

*Red-brown bloom.*

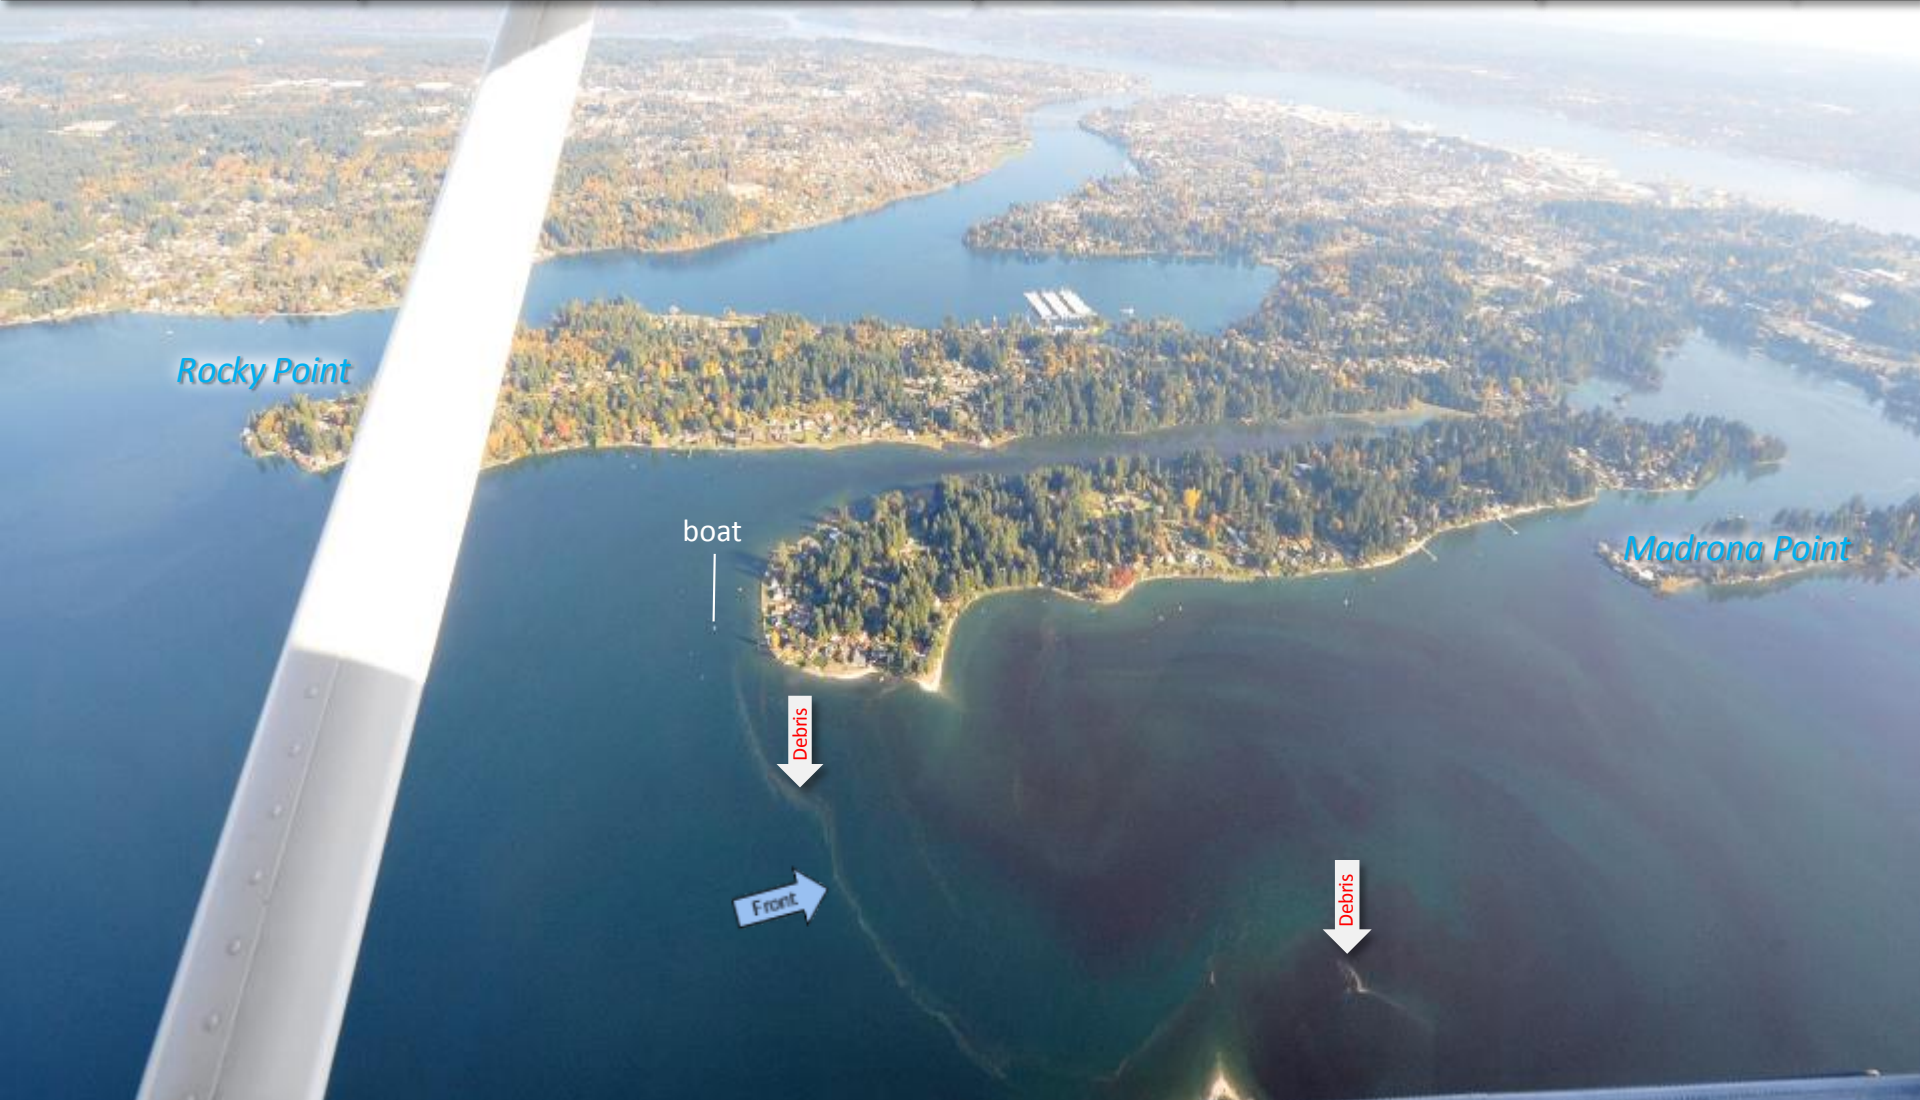
*Organic material accumulating at tidal front next to red-brown bloom.*  
Location: Entrance to Ostrich Bay, Dyes Inlet (Central Sound), 3:13 PM.

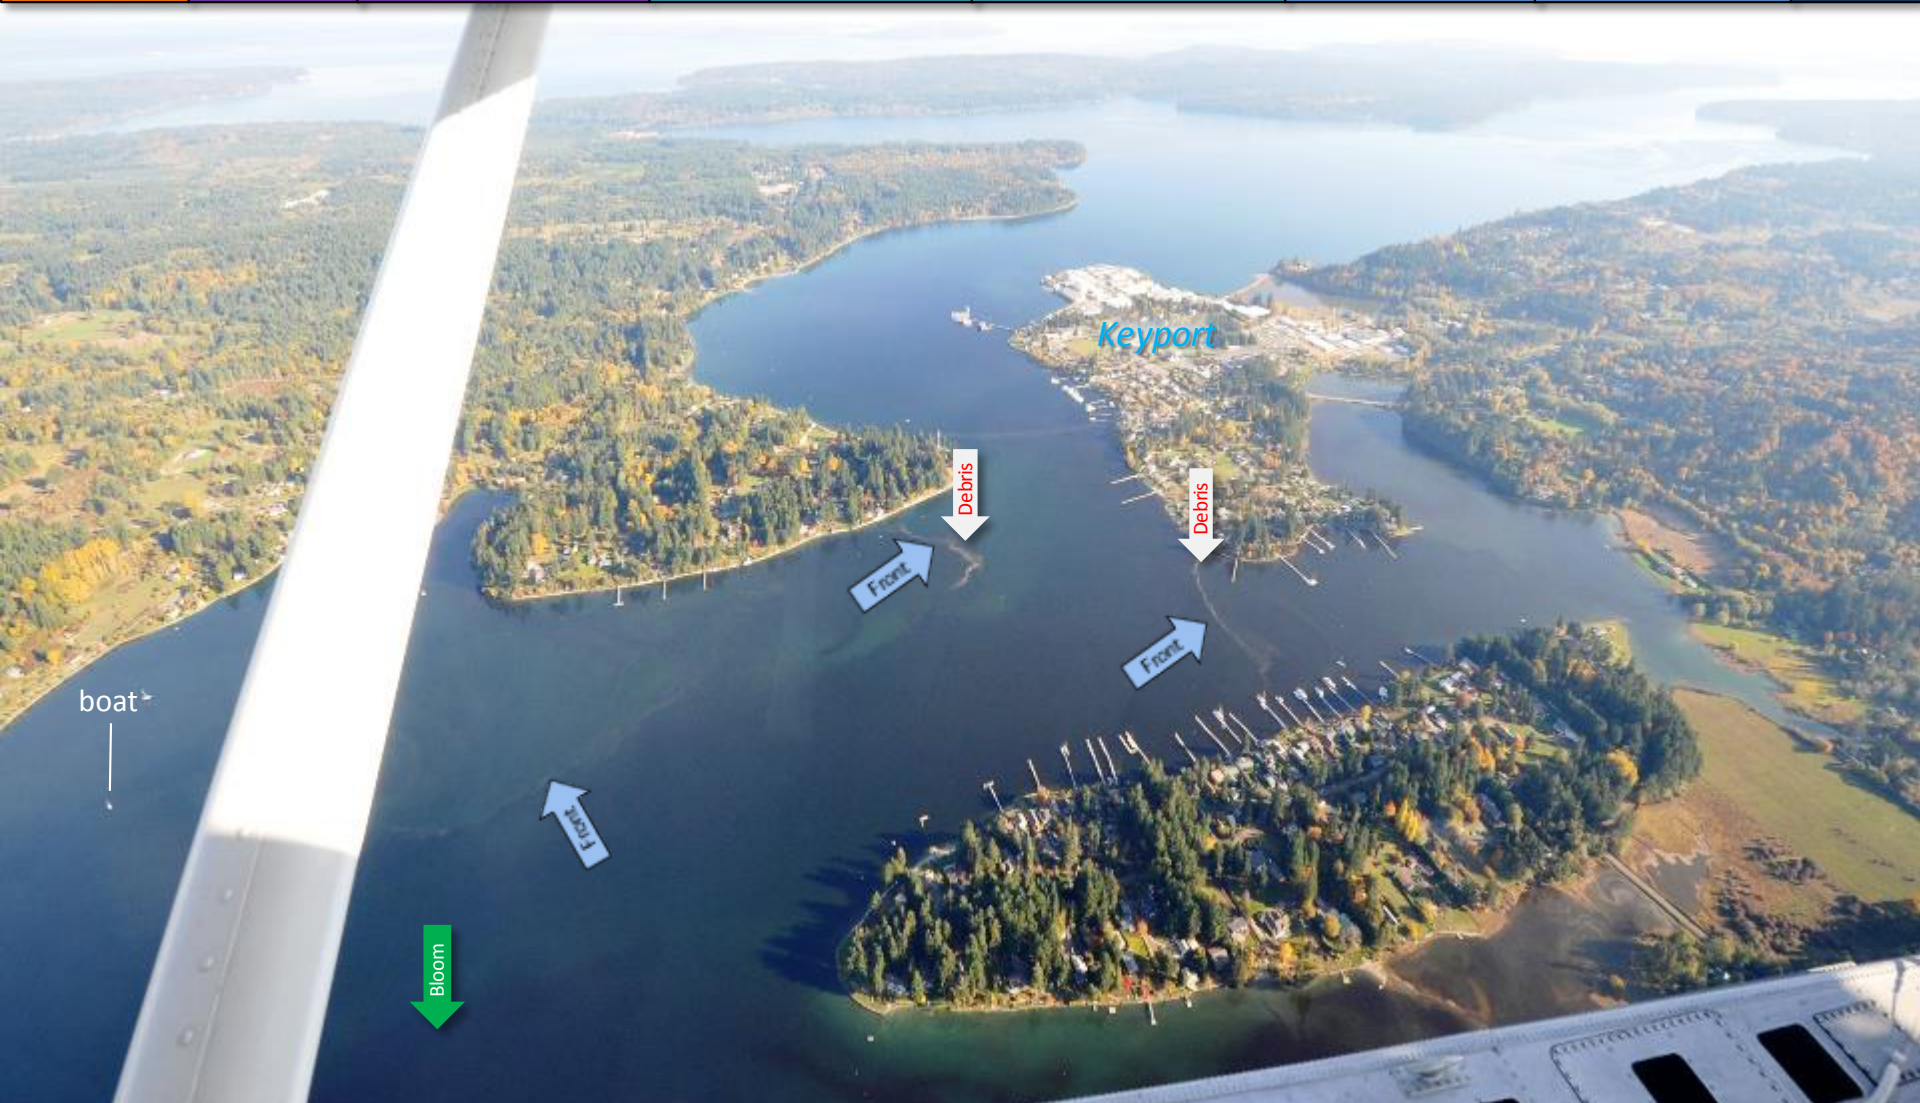
*Organic material accumulating at tidal front next to red-brown bloom.*  
Location: Liberty Bay (Central Sound), 3:17 PM.
