DEPARTMENT OF
ECOLOGY
State of Washington

Coastal morphology change in response to bulkhead removal at Edgewater Beach, South Puget Sound

February 2018
Publication 18-06-002

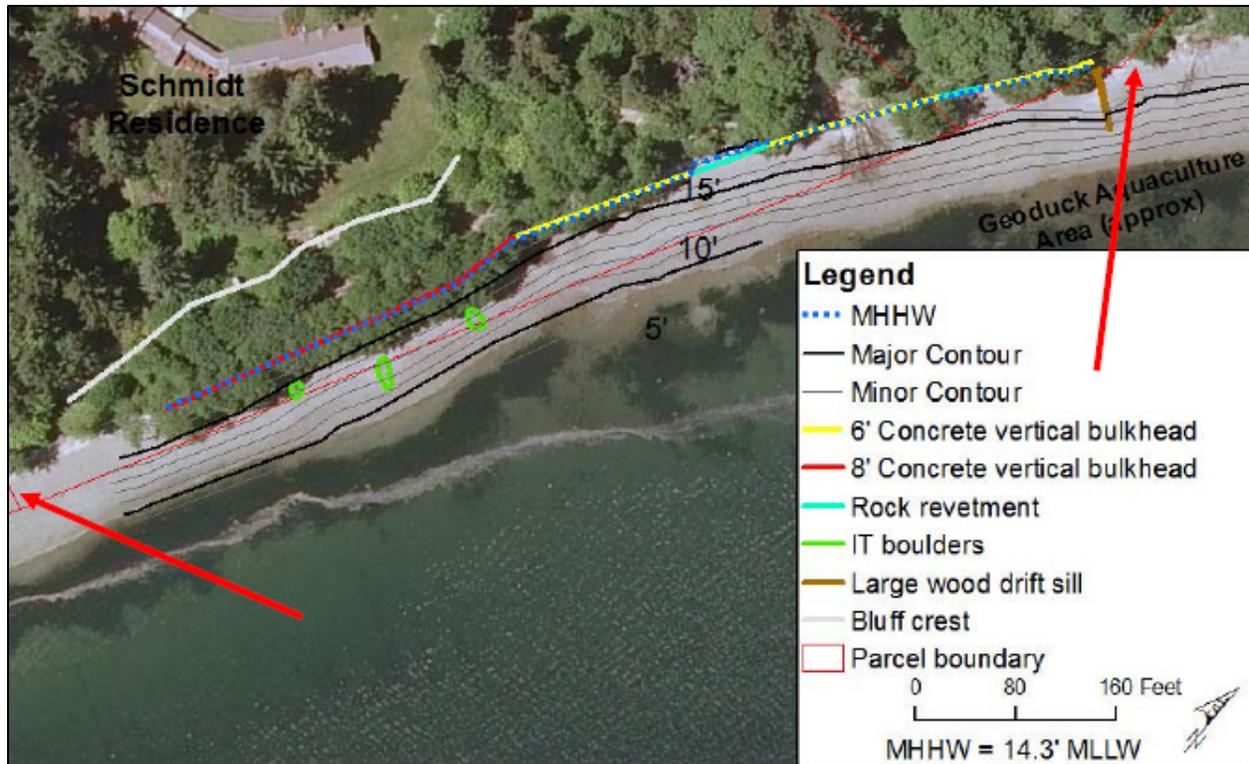
Figure 1: Plan view of the restoration site showing the extent of shoreline armor and approximate beach elevations as mapped by CGS in 2012; red arrows show habitat sampling locations by Dethier et al. (2015) [Excerpted from Dethier et al. (2015), which was modified from CGS's design memorandum (Johannessen and Blue, 2012)]

In late October/early November 2016, approximately 800 ft of shoreline armor was removed from the base of a historic feeder bluff at Edgewater Beach on the west shore of Eld Inlet near Olympia, Washington. Armoring at the site consisted of a 700 ft-long vertical concrete bulkhead, two rock revetments (30 ft and 61 ft-long), the remains of an old log bulkhead, a large wood and rock groin at the downdrift end of the bulkhead¹, and several non-native boulders in the intertidal zone (Figure 1).

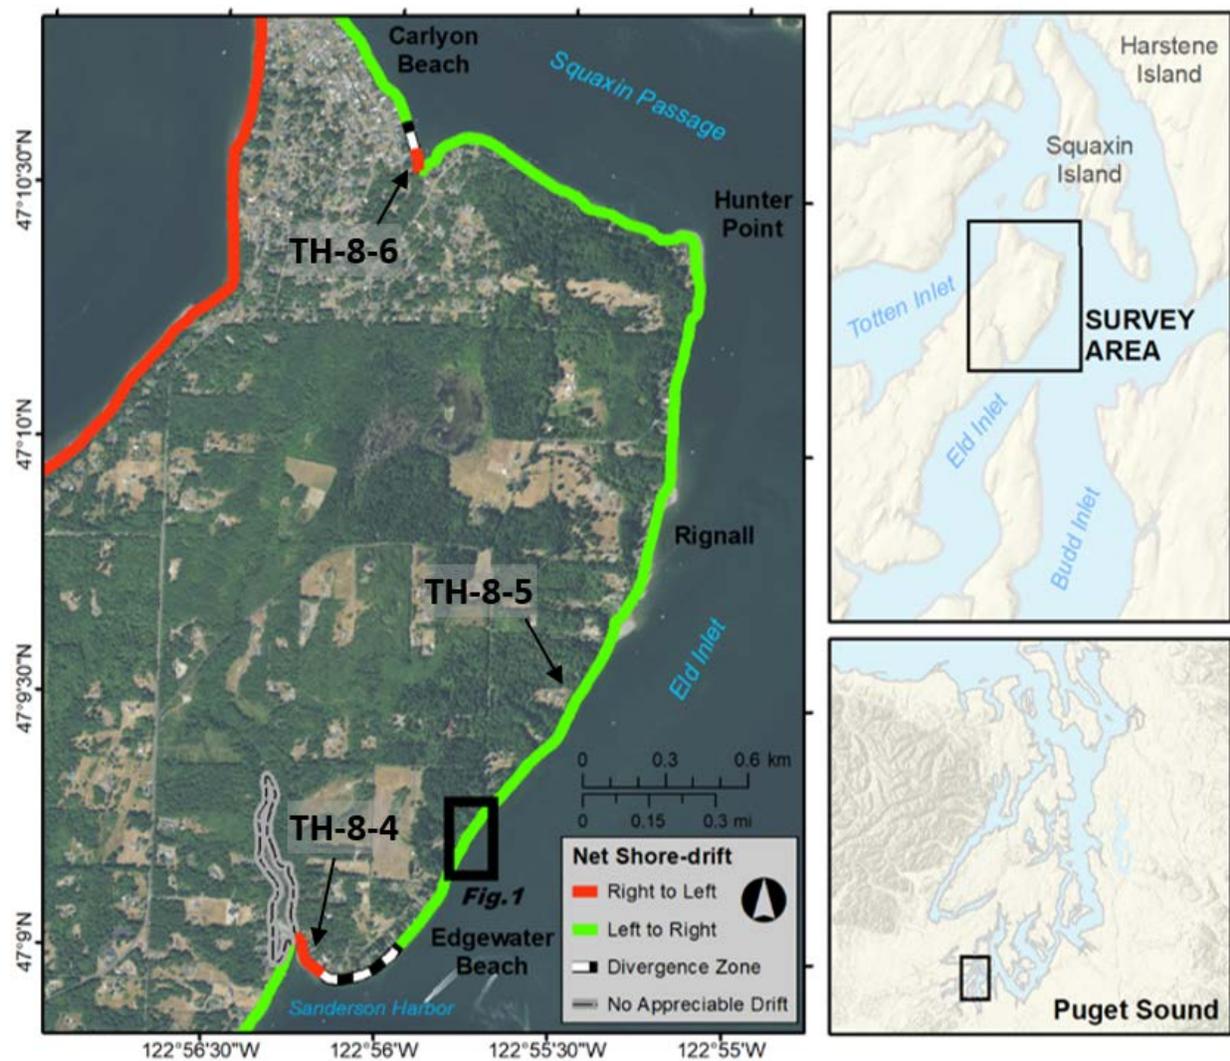
Figure 2: Survey area map, including net shore-drift directions

Lidar data were collected for the entire drift cell plus the two adjacent short drift cells on either side, totaling 5 km of shoreline. As mapped by Schwartz et al. (1991), the restoration site at Edgewater Beach is located near the south end of net shore-drift cell TH-8-5, which has a northward sediment-transport direction, while the adjacent drift cells, TH-8-6 to the north and TH-8-4 to the south, have an opposite transport direction (Figure 2).

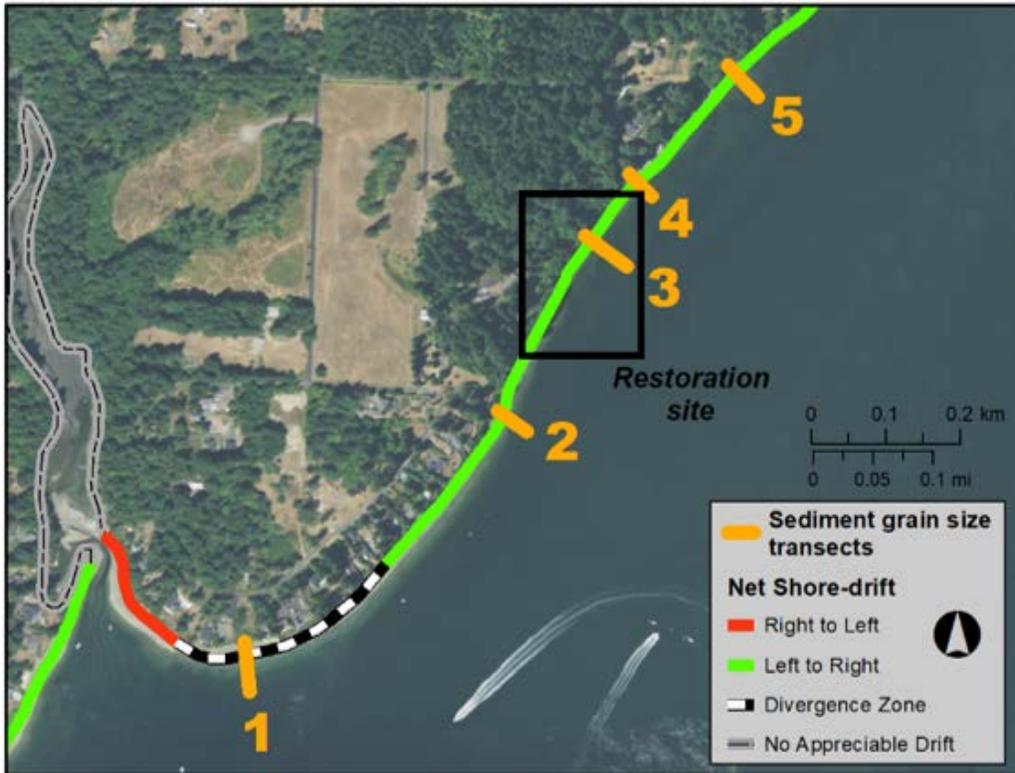
Figure 3: Map showing transect locations for sediment grain-size sampling at the southern end of the survey area

In addition to mapping coastal morphology, CMAP also collected sediment grain-size data along five transects at the south end of the Edgewater Beach drift cell (Figure 3). Changes in beach sediments can provide insight to sediment supply and transport processes as well as characterize potential habitat for species that require specific sediment grain sizes.

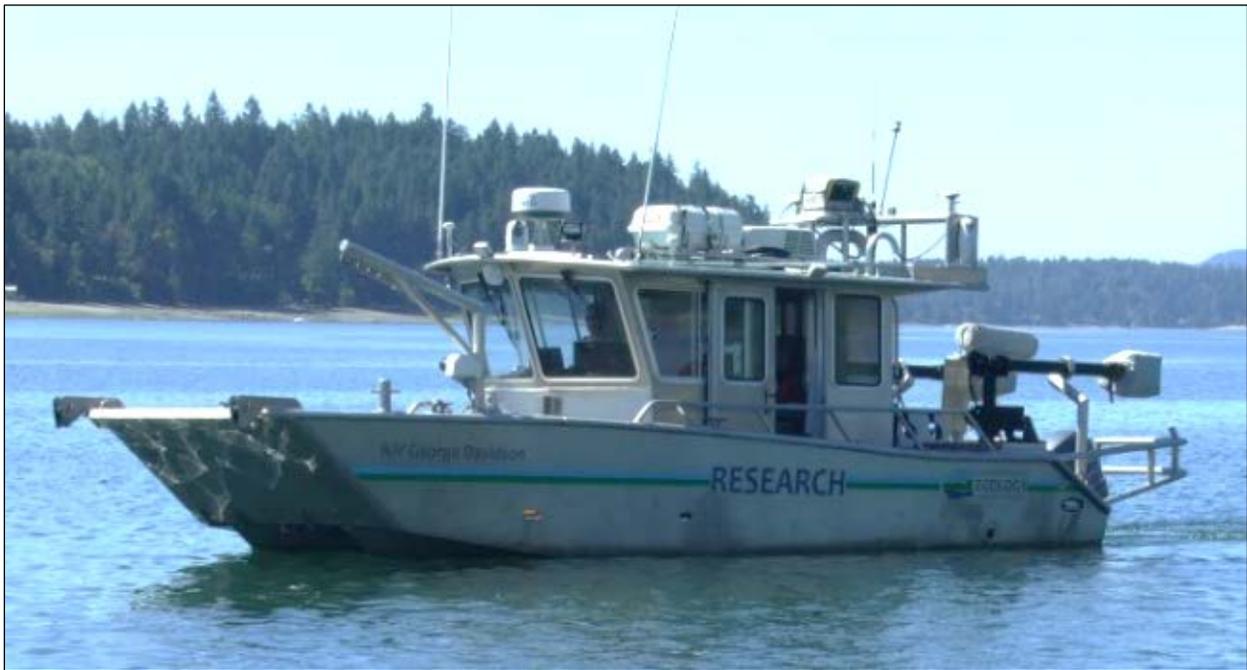
Figure 4: Ecology CMAP research vessel, the R/V *George Davidson*

Boat-based lidar data were collected using an Optech ILRIS HD-ER laser scanner with motion compensation deployed from Ecology's research vessel, the R/V *George Davidson*, a 28-ft aluminum, twin-hull landing craft (Figure 4). The laser scanner has a maximum range of up to 1,800 m and a repetition rate of 10,000 Hz. The raw positional accuracy of the scanner is specified to be 0.7 cm at a distance of 100 m, where it has a beam diameter of 1.9 cm. The laser has a narrow beam divergence of 0.15 mrad, which corresponds to an increase of only 1.5 cm in diameter per 100-m distance. The wavelength of the laser is absorbed by water, which allows for a distinct waterline where wave swash is not present; however, returns on wet beaches are sparse.

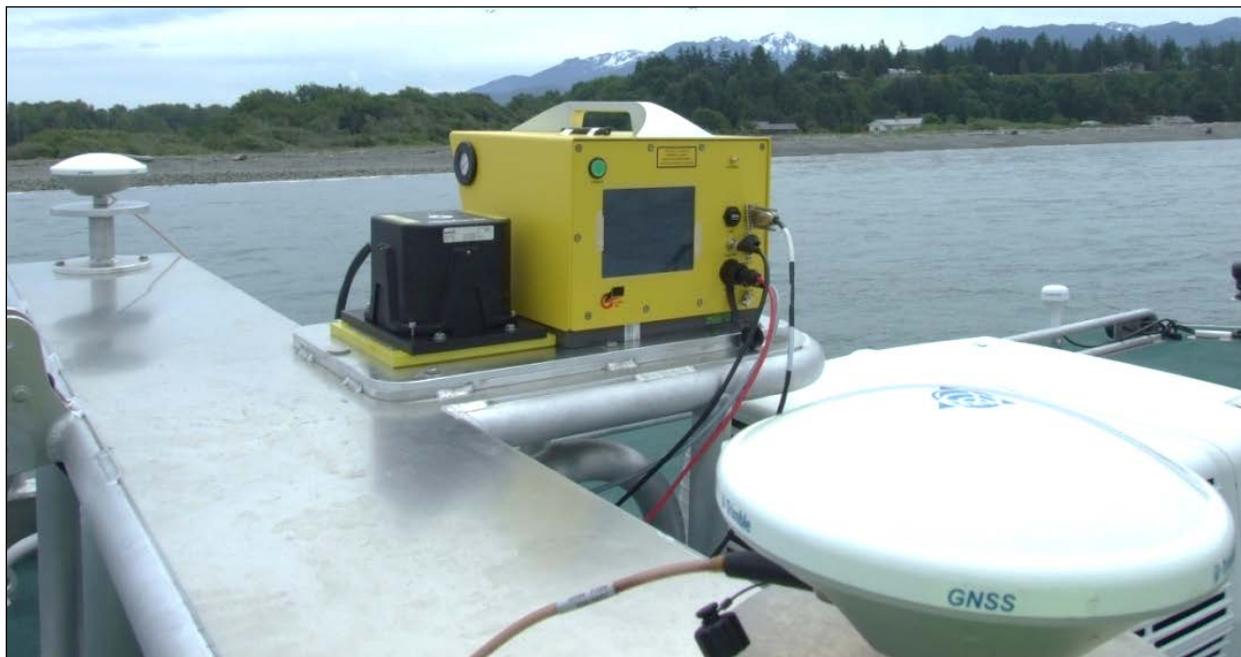
Figure 5: Laser scanner and IMU mounted to the cabin top of the R/V *George Davidson*

vessel receive real-time kinematic (RTK) corrections from a Trimble R7 GNSS base station via radio transmission, allowing for positional accuracies on the order of $\pm 8 \text{ mm} + 1 \text{ ppm} \times \text{baseline length}$ in horizontal and $\pm 15 \text{ mm} + 1 \text{ ppm} \times \text{baseline length}$ in vertical.

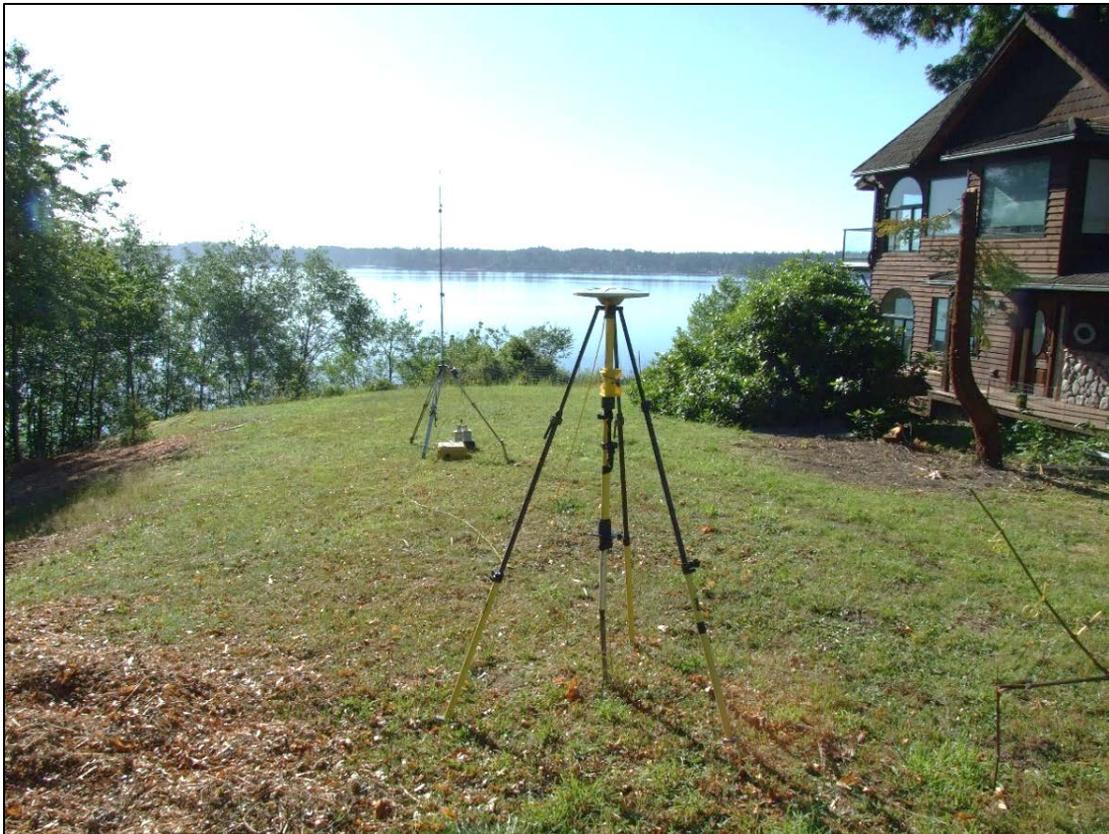
Figure 6: Local RTK-GNSS base station set up at survey site

A local GNSS base station was set up during each survey over the same known position to transmit RTK corrections to the POS MV and GNSS rovers (Figure 6). The base station also logged static GNSS raw data every second at its location for post-processing. During the first boat-based lidar survey, 5.5 hours of static GNSS data were logged followed by another 4.5-hour occupation performed the following day. In 2017, the base station receiver logged ~7 hours of raw GNSS data at the same location during the second boat-based lidar survey.

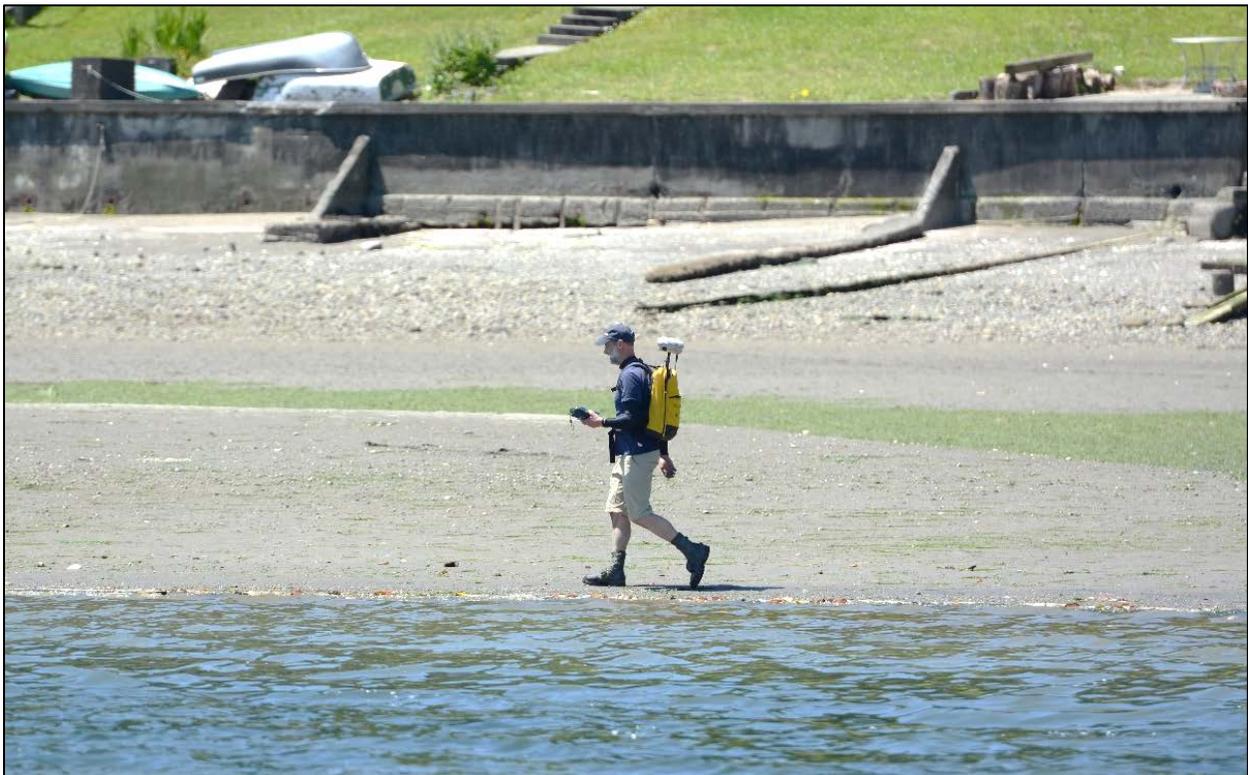
Figure 7: Surveyor collecting RTK-GNSS beach topography data

During the laser scanning, ground elevation data were collected by land-based surveyors walking on the beach with RTK-GNSS receivers mounted to backpacks (Figure 7). Data were collected along the shore, one point per meter, distributed throughout the survey area in locations that were clearly surveyed by the lidar system. These data are primarily used as a means of quality assurance to ensure accuracy in the vertical component of the laser data. In some cases, the ground-based GNSS data may help to supplement the lidar data by filling in gaps or shadows that can be present due to large objects on the beach or where the beach is wet.

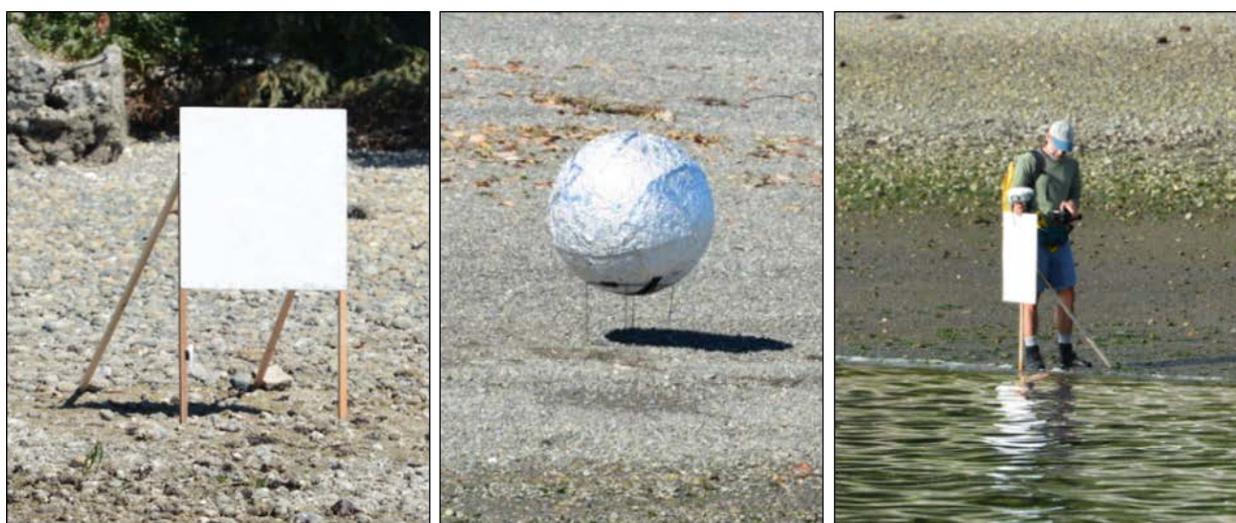
Figure 8: Lidar ground-control targets; left—rectangular sheet metal, middle—spherical, right—surveyor measuring the location of a target

Several ground-control targets were set up on the beach throughout the survey area for checking the positional alignment of the lidar point cloud with independently surveyed GNSS points (Figure 8). Targets made of 1 m × 1 m sheet metal, spray-painted flat white, were mounted to wooden stakes and placed on the upper beach. A smaller, rectangular sheet metal target (0.61 m high × 0.76 m wide), also spray-painted flat white, was set up near the water's edge and moved several times during the course of the survey. During the 2017 survey, a spherical target (0.73 m diameter) made from an inflatable ball covered in aluminum foil was also used as ground control. The advantage of the spherical target is that regardless of the direction the target is scanned, the spherical shape can be modeled from the lidar returns, and a more accurate target center can be obtained from the point cloud. After each target was set up level and plumb, surveyors on land measured the position of the target center by obtaining a 10-second average using RTK-GNSS.

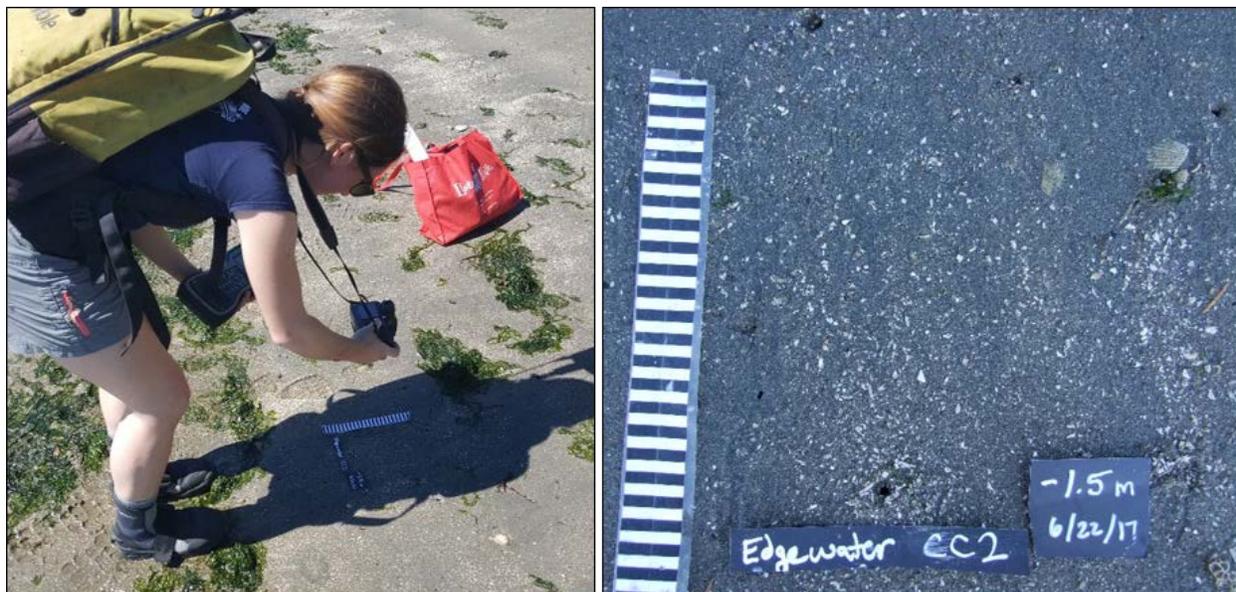
Figure 9: Surveyor taking photo for sediment grain-size analysis

A reference scale was included in each photograph to provide the means of determining the mm-to-pixel ratio of each picture. The distance of the camera from the substrate was dependent on the size of the sediment, set to include approximately 100 particles along the horizontal (long) axis of each photograph. The location of each sample and the cross-shore transects were collected with RTK-GNSS.

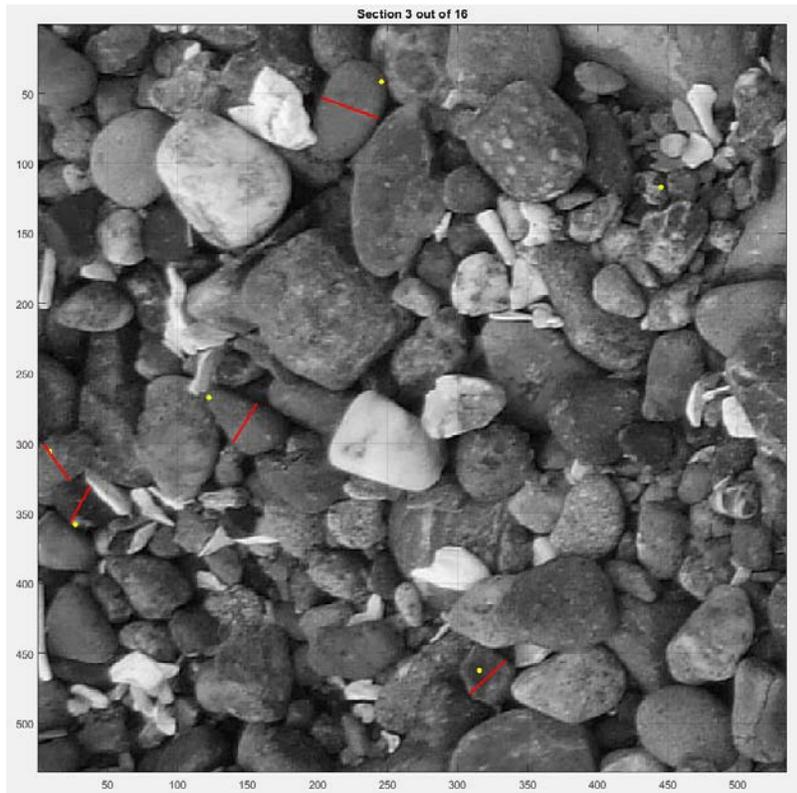
Figure 10: Photo showing an example where the intermediate diameter of randomly selected particles has been traced (red lines) to determine the grain-size distribution for a sediment sample

on the photo, identifying the particles in which the user will trace the intermediate diameter (Figure 10). Once 100 diameters have been traced, the algorithm uses a conversion factor to calculate the mm-length of each traced diameter. The particle diameters can then be used to calculate statistics that quantitatively describe the beach texture of each sample, including the median and range in grain size.

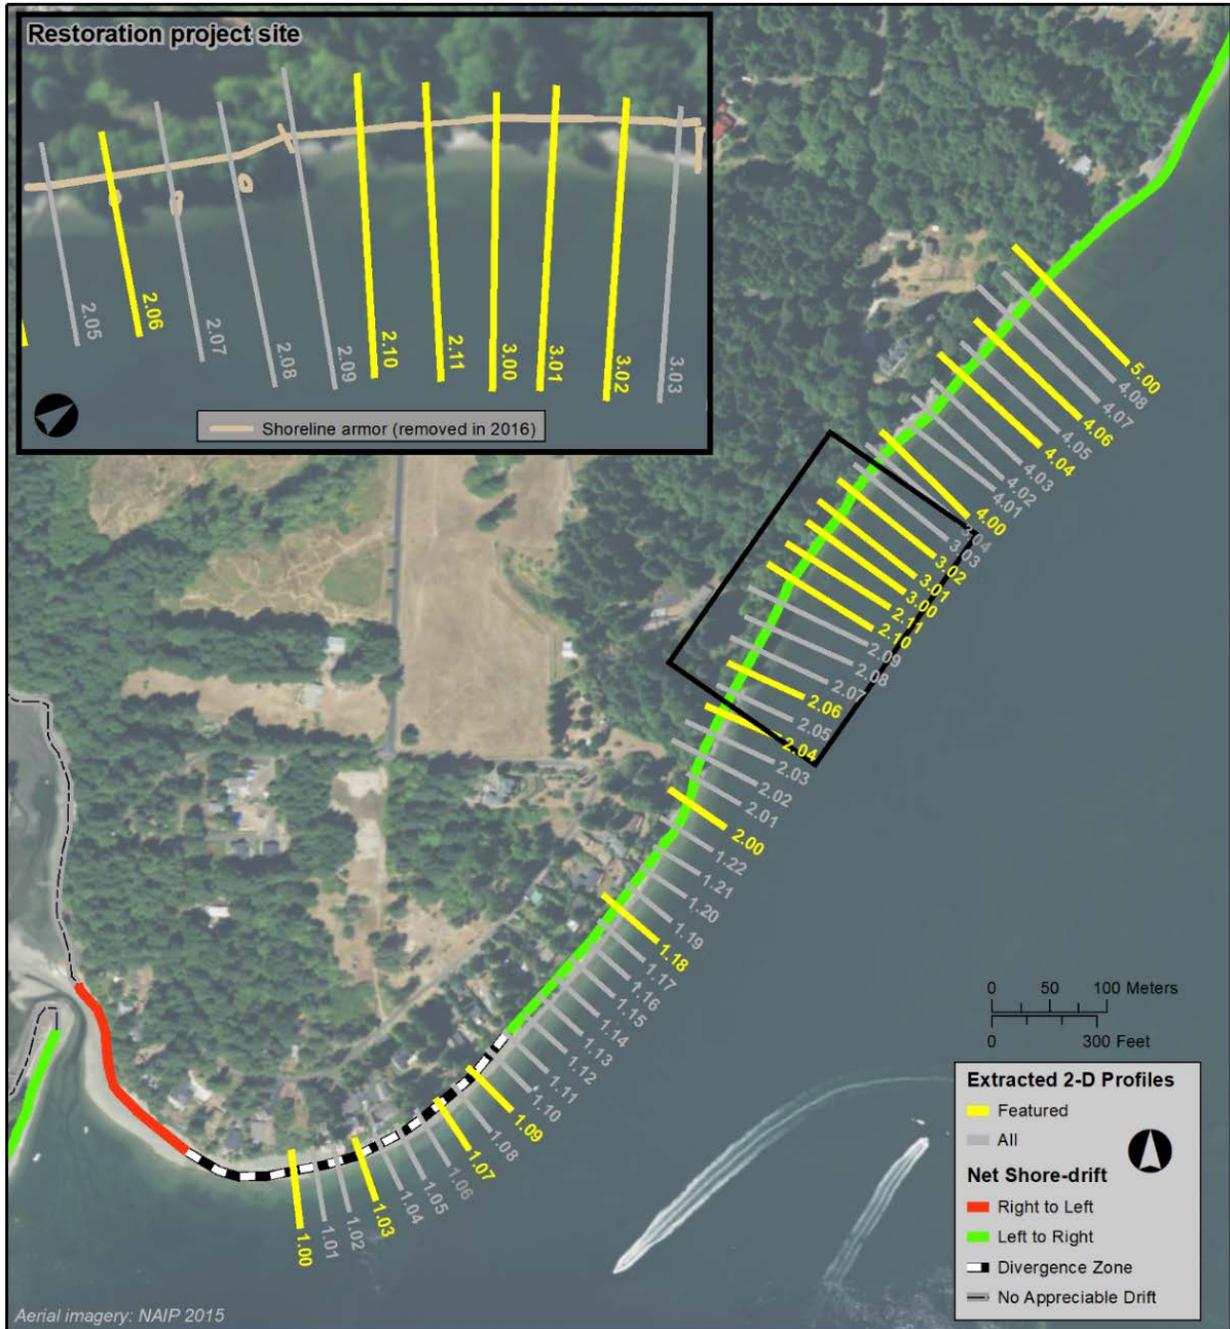
Figure 11: Map showing location of cross-shore profiles extracted from the lidar point clouds; featured profiles shown in yellow are included in this report

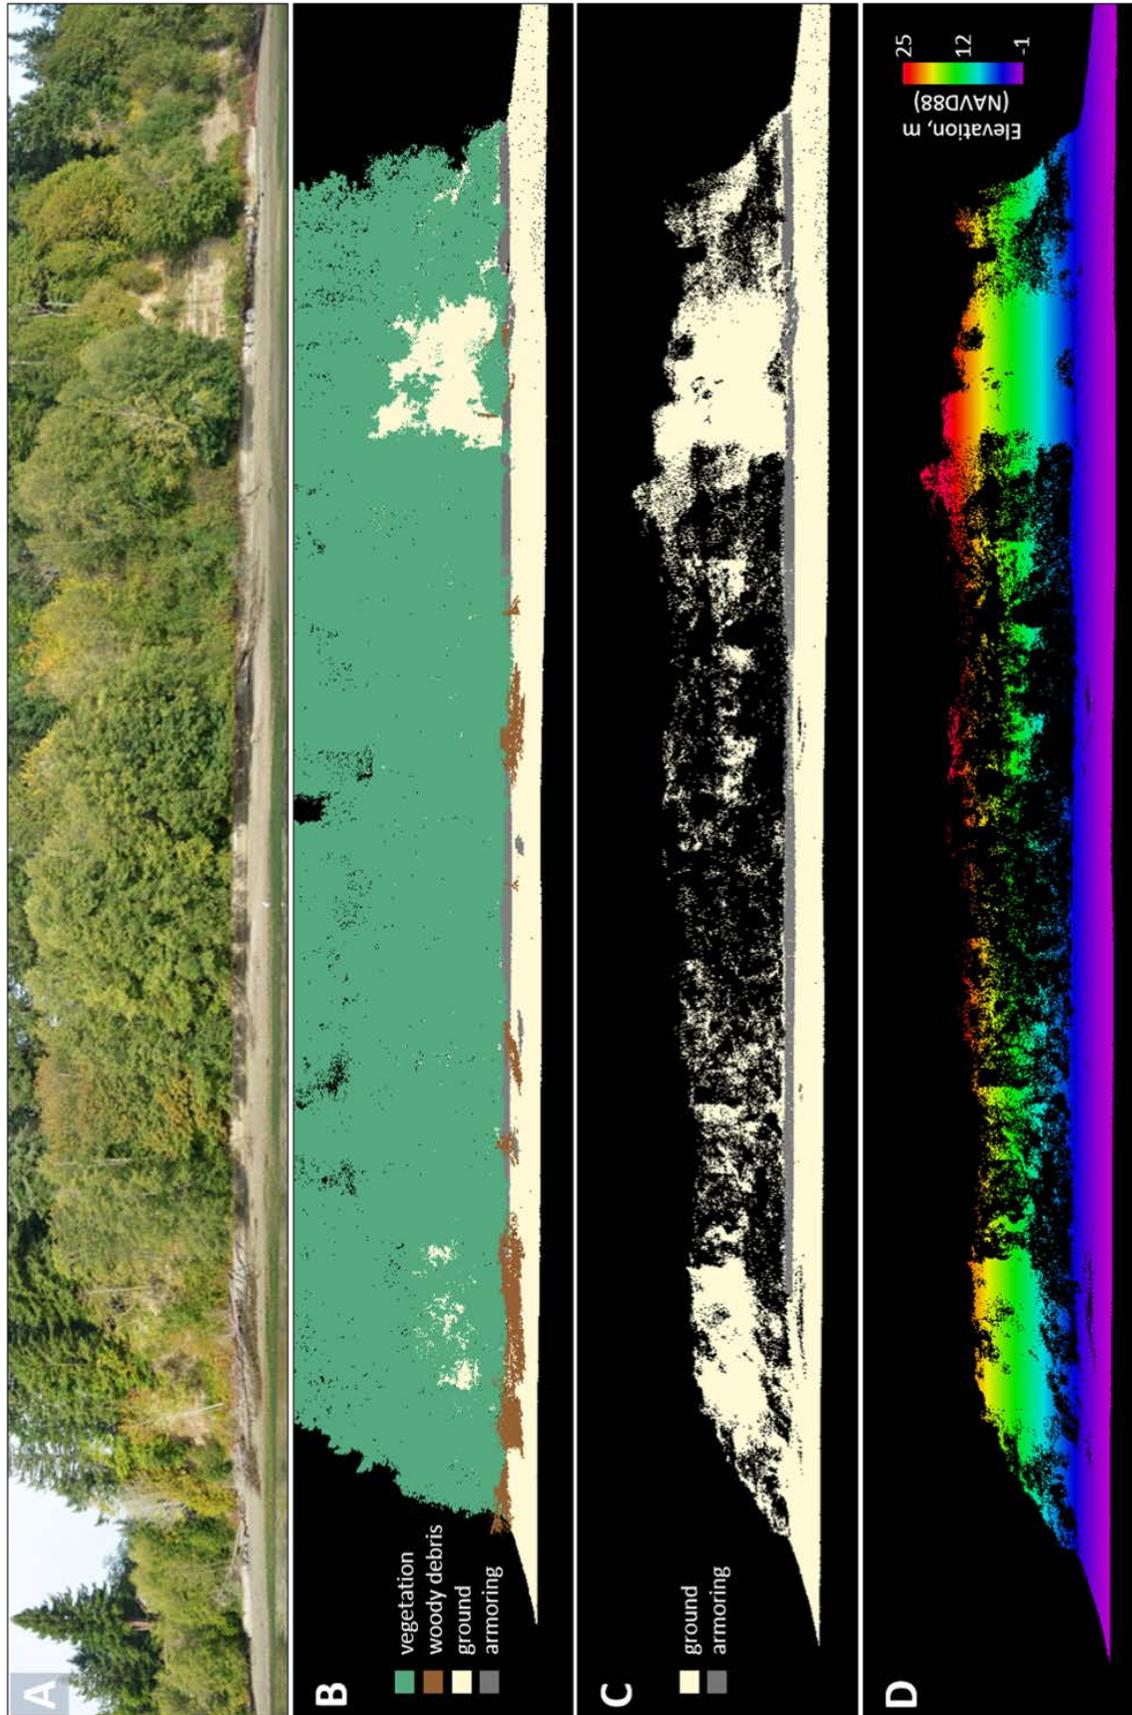
Figure 12: Photos and data of the Edgewater Beach restoration site collected during the 2015 survey; (A) shoreline panorama, (B) classified point cloud, (C) ground points colored by elevation, (D) ground points colored by elevation

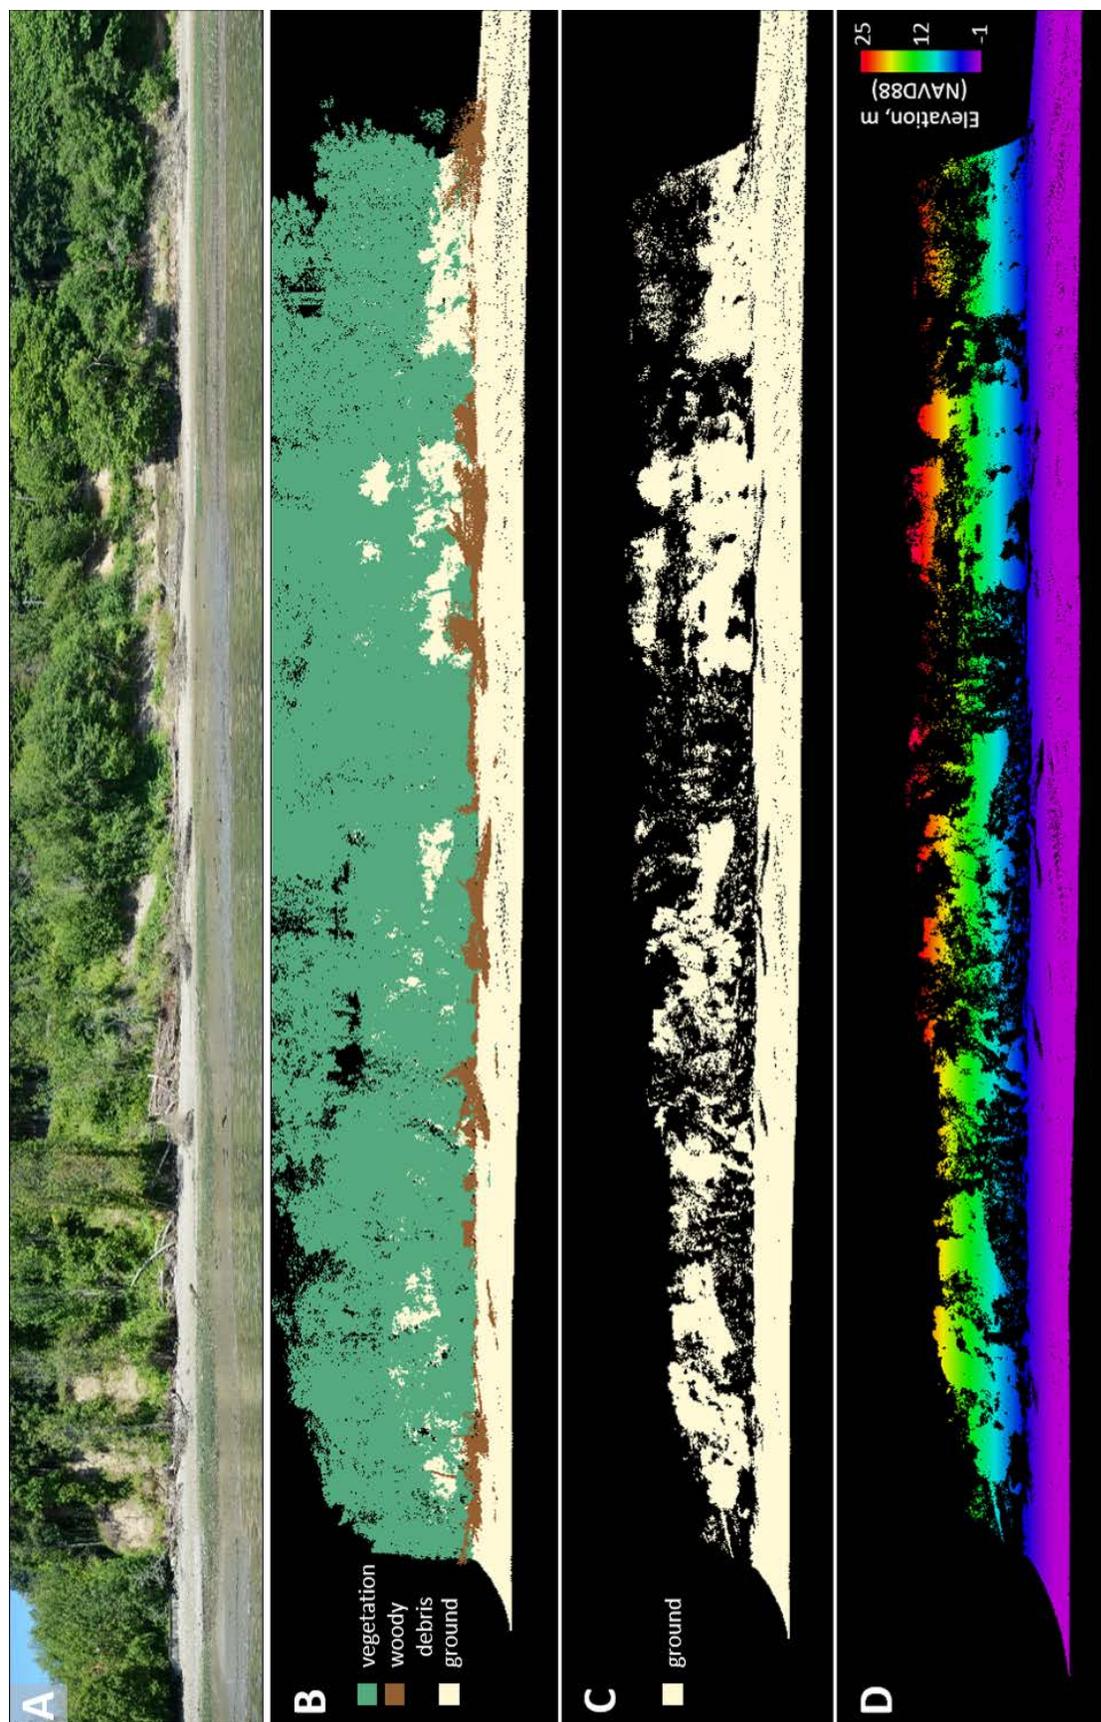
Figure 13: Photos and data of the Edgewater Beach restoration site collected during the 2017 survey; (A) shoreline panorama, (B) classified point cloud with vegetation and woody debris removed, (C) ground points colored by elevation

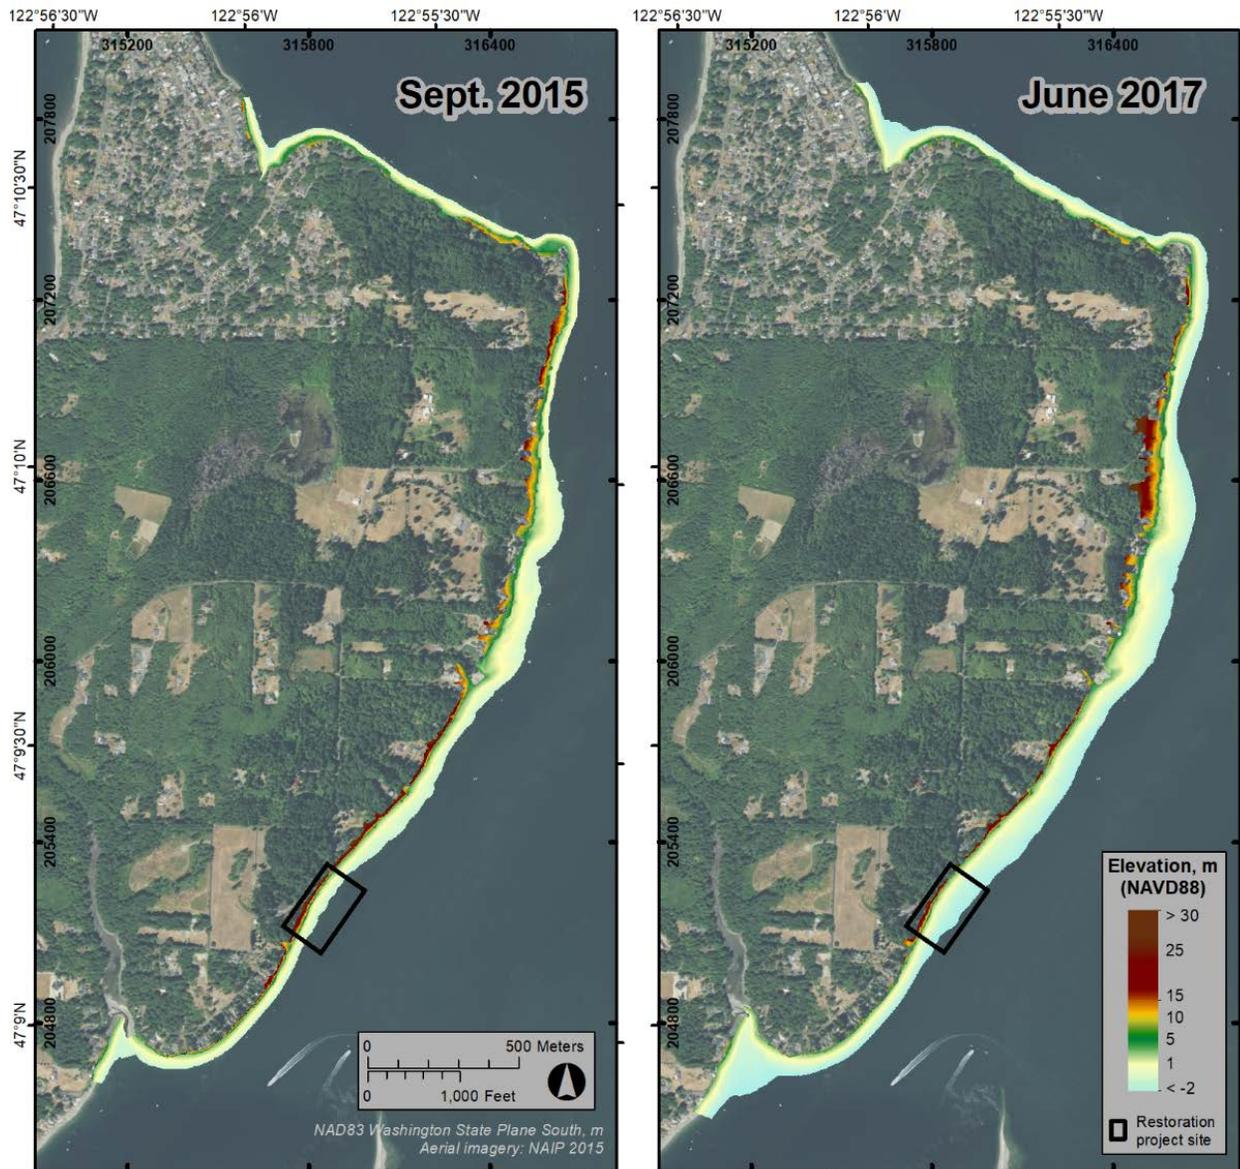
Figure 14: Half-meter, bare-earth DEMs from before (left) and after (right) bulkhead removal at Edgewater Beach

Figure 14 shows the 0.5-m DEMs created from the two boat-based lidar and RTK-GNSS beach topography surveys conducted before and after removal of the shoreline armor at Edgewater Beach. These DEMs document the coastal morphology conditions for the entire Edgewater Beach drift cell, and the adjacent smaller drift cells on either side, as of September 2015 and June 2017. During the survey in 2017, more coverage on the lower beach was obtained than in 2015 due to a lower tide level (-2.6 ft vs. 0.5 ft MLLW). The mean point density of the ground surface used to generate the DEMs was 42 points/m² for the 2015 dataset and 45 points/m² for the 2017 dataset, with a median point density of 29 points/m² and 27 points/m², respectively.

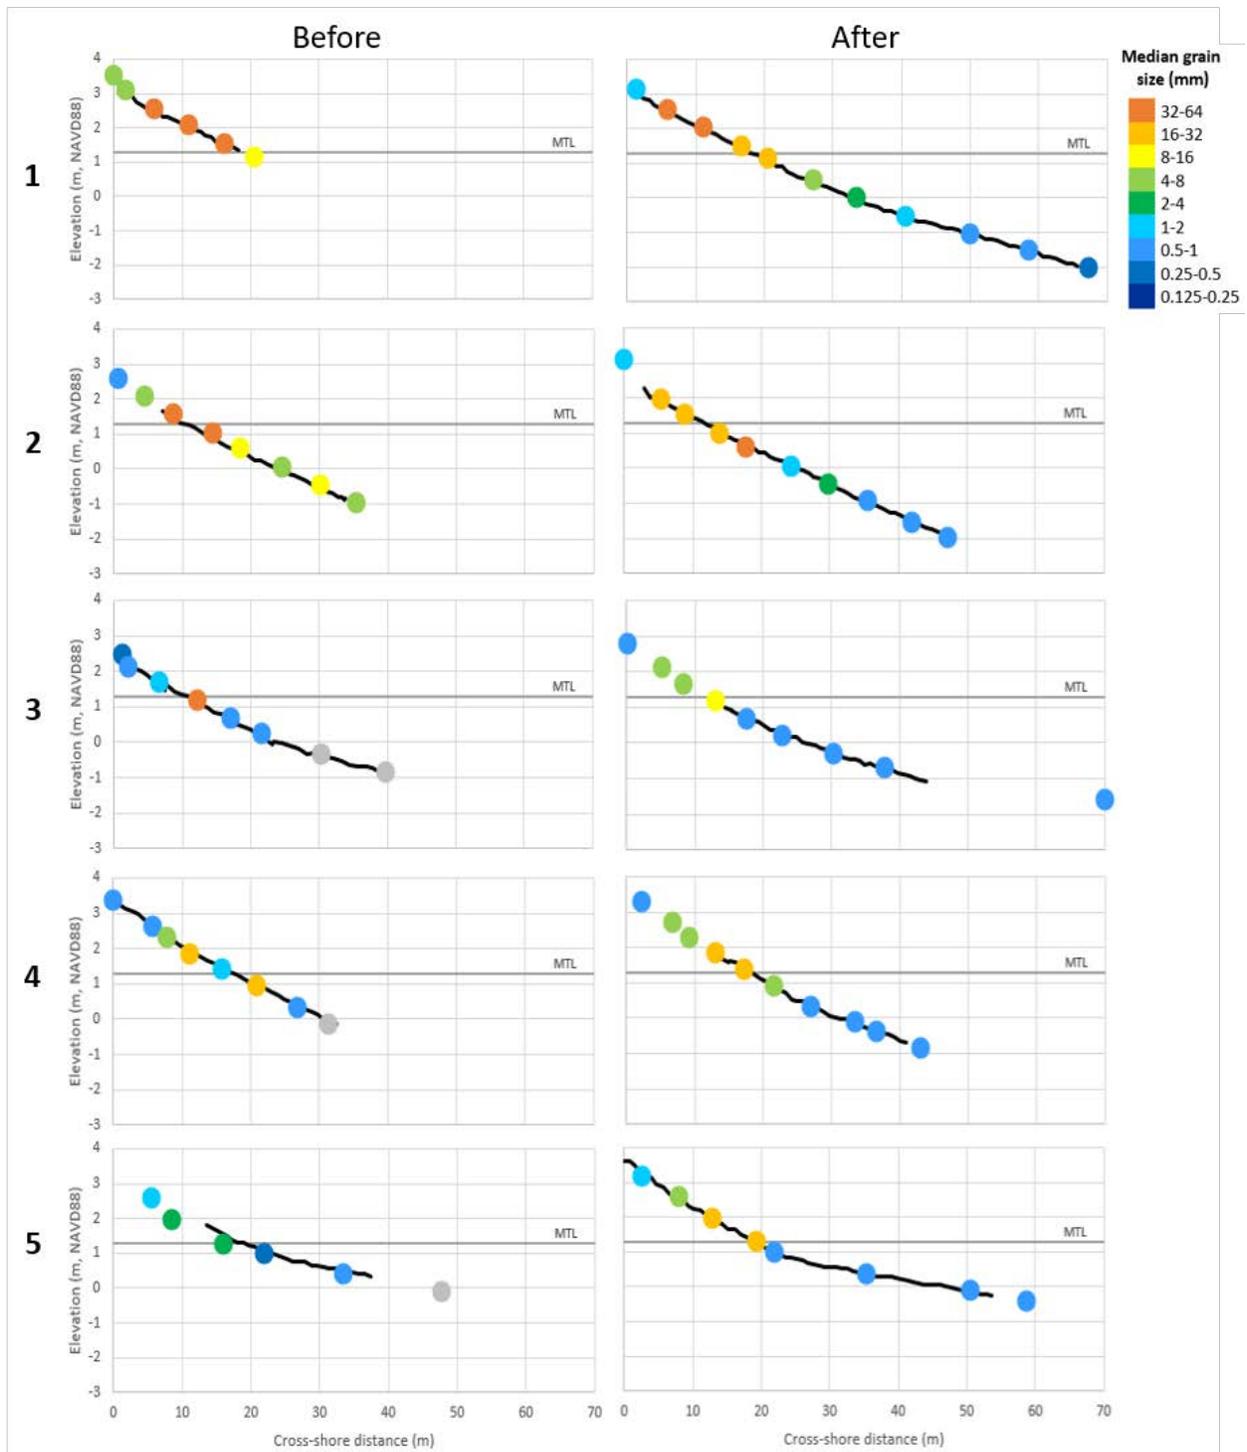
Figure 15: Sediment grain-size data collected at 0.5-meter elevation intervals along five cross-shore transects before and after bulkhead removal

Figure 15 shows the grain-size class associated with the median grain size (D_{50}) of each sediment sample collected at the five cross-shore transects before and after the shoreline armor was removed. In general, sediments found lower than about -0.5 m NAVD88 elevation on the beach profile are typically sand (2 mm or less), while coarser sediments are found on the mid to upper beach. See Table 4 in Appendix A for tidal datum conversions between NAVD88 and MLLW.

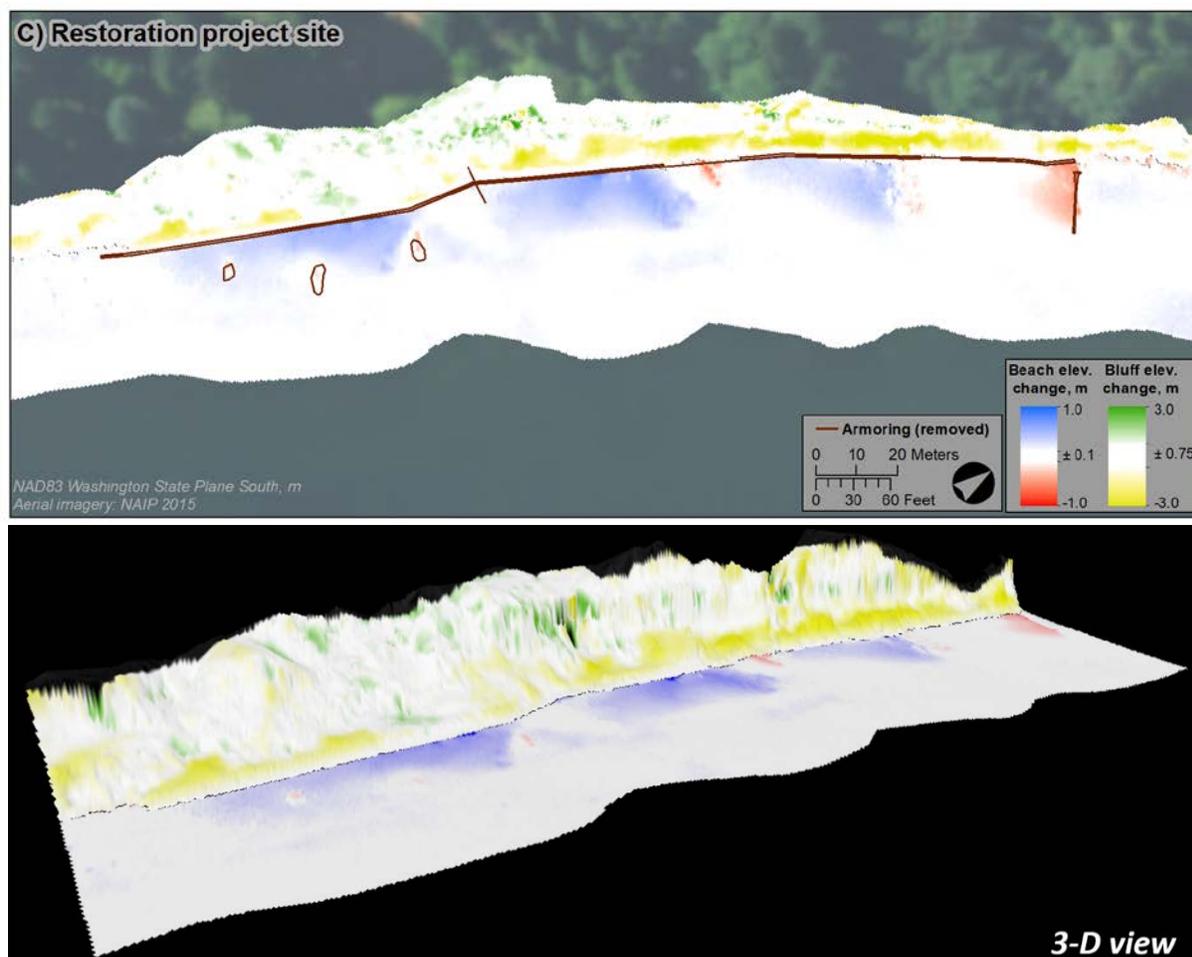
Figure 16: Change in beach and bluff elevation measured at the Edgewater Beach restoration site

On the upper beach, directly in front of the armor, an increase in sediment volume of 785 m³ was measured. This accreted material lies between the former toe of the armor (~2.5 m) and 1 m elevation, spanning a cross-shore distance of about 10-15 m. Because this net gain of sediment was measured more than seven months after the restoration occurred, it indicates the beach may persist in this form, providing more back beach habitat for many organisms. The remaining sediment that eroded from behind the bulkhead (620 m³) is expected to have been dispersed to the nearshore or transported northward.

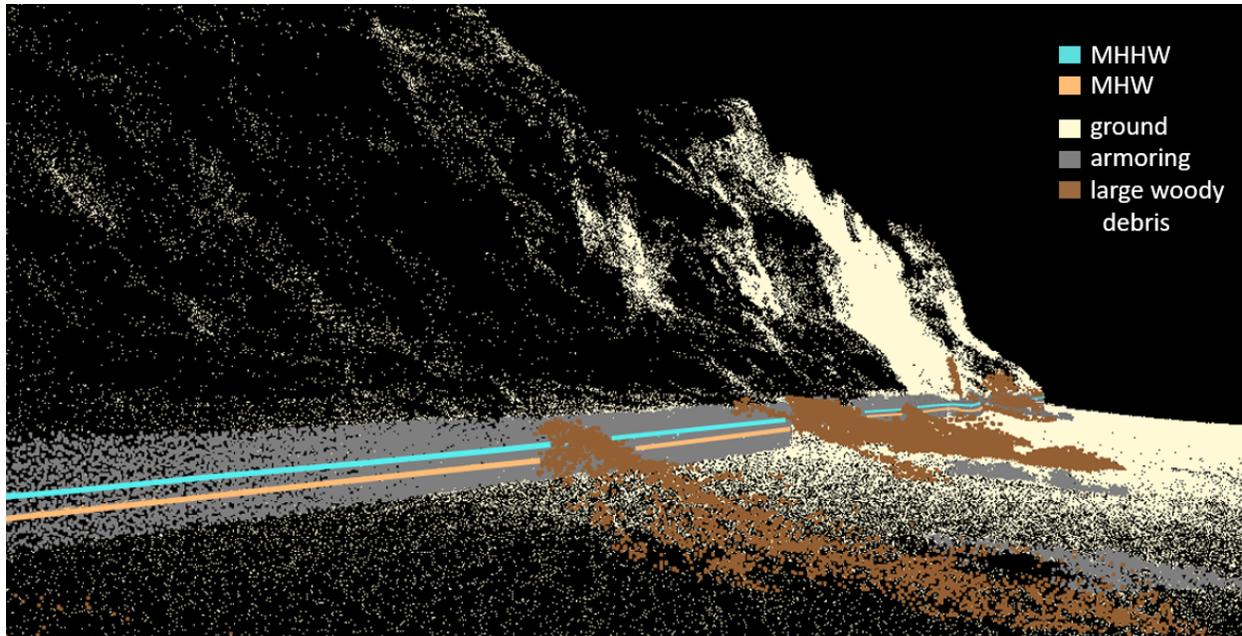
Figure 17: Classified lidar point cloud showing the location of MHW and MHHW contours with respect to the bulkhead in 2015

Before the shoreline armor was removed, the mean higher high water (MHHW; 3.15 m NAVD88) and mean high water (MHW; 2.86 m NAVD88) contours were along the face of the bulkhead (Figure 17). An average high tide would hit about 0.31 m (1.0 ft) up from the toe of the bulkhead, while the average of the highest tides would hit 0.60 m (~2.0 ft) up the bulkhead face.
