DEPARTMENT OF
ECOLOGY
State of Washington

Coastal morphology change in response to bulkhead removal at Edgewater Beach, South Puget Sound

February 2018
Publication 18-06-002

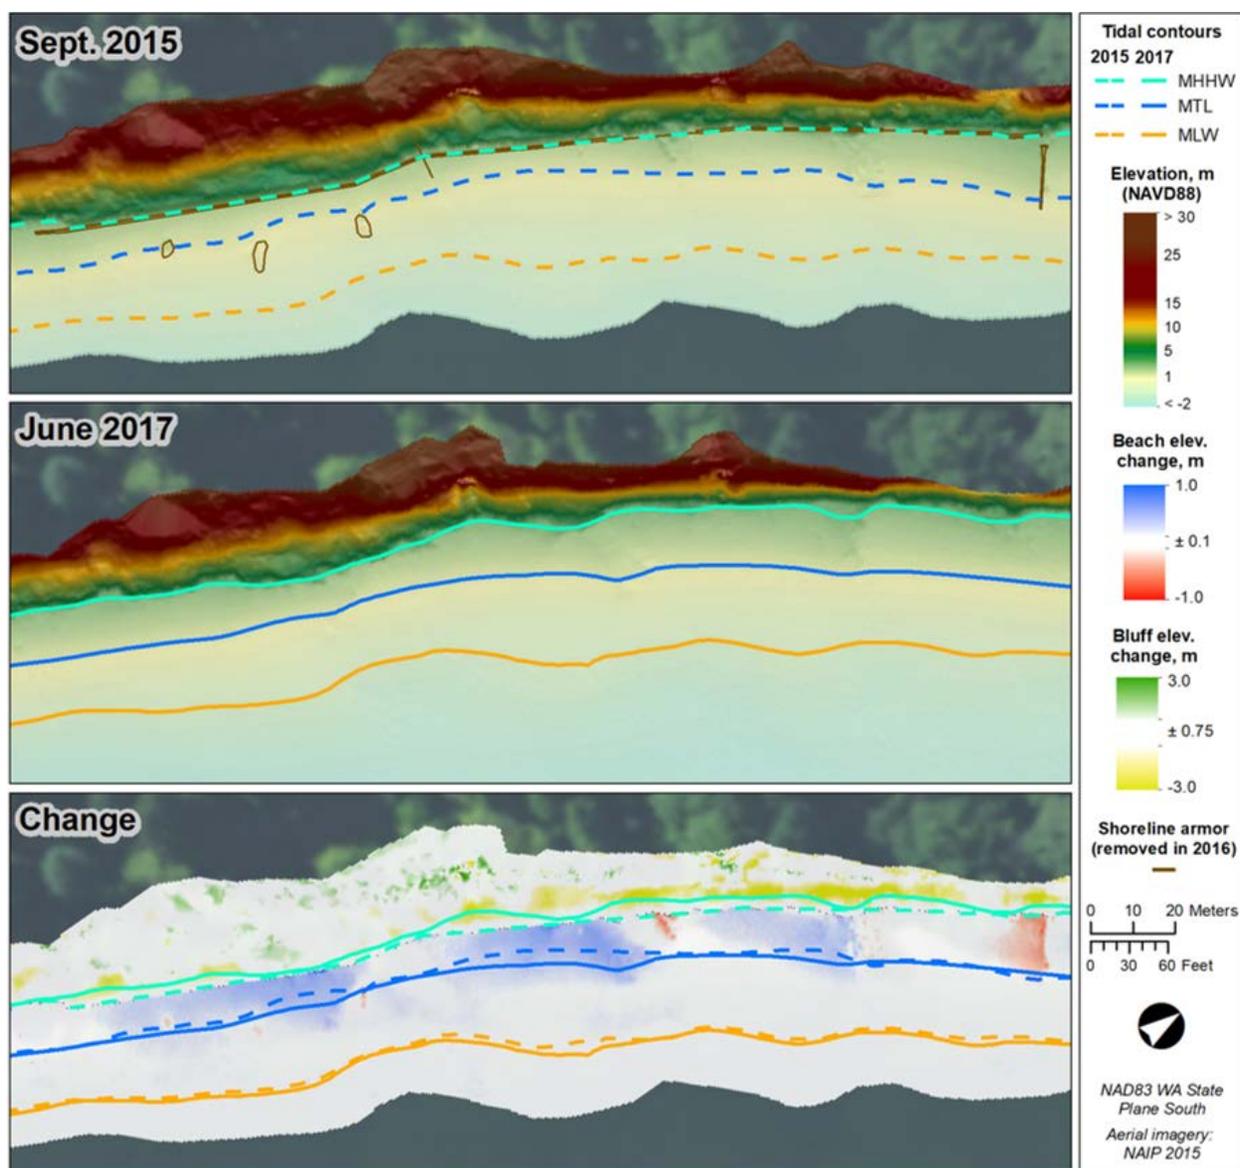
Figure 18: Change in tidal datums at the Edgewater Beach restoration site

After removal of the bulkhead, the MHHW contour moved landward at the restoration site by up to 3 m (9.8 ft) (Figure 18). The mean tide line (MTL; 1.28 m NAVD88) moved seaward by up to 4 m (13.1 ft) due to the increased sediment volume on the upper beach. The mean low water (MLW; -0.29 m NAVD88) contour moved seaward by about 1 m. More detailed cross-shore changes are presented in the reach-scale coastal profile change section. See Table 4 in Appendix A for tidal datum conversions between NAVD88 and MLLW.

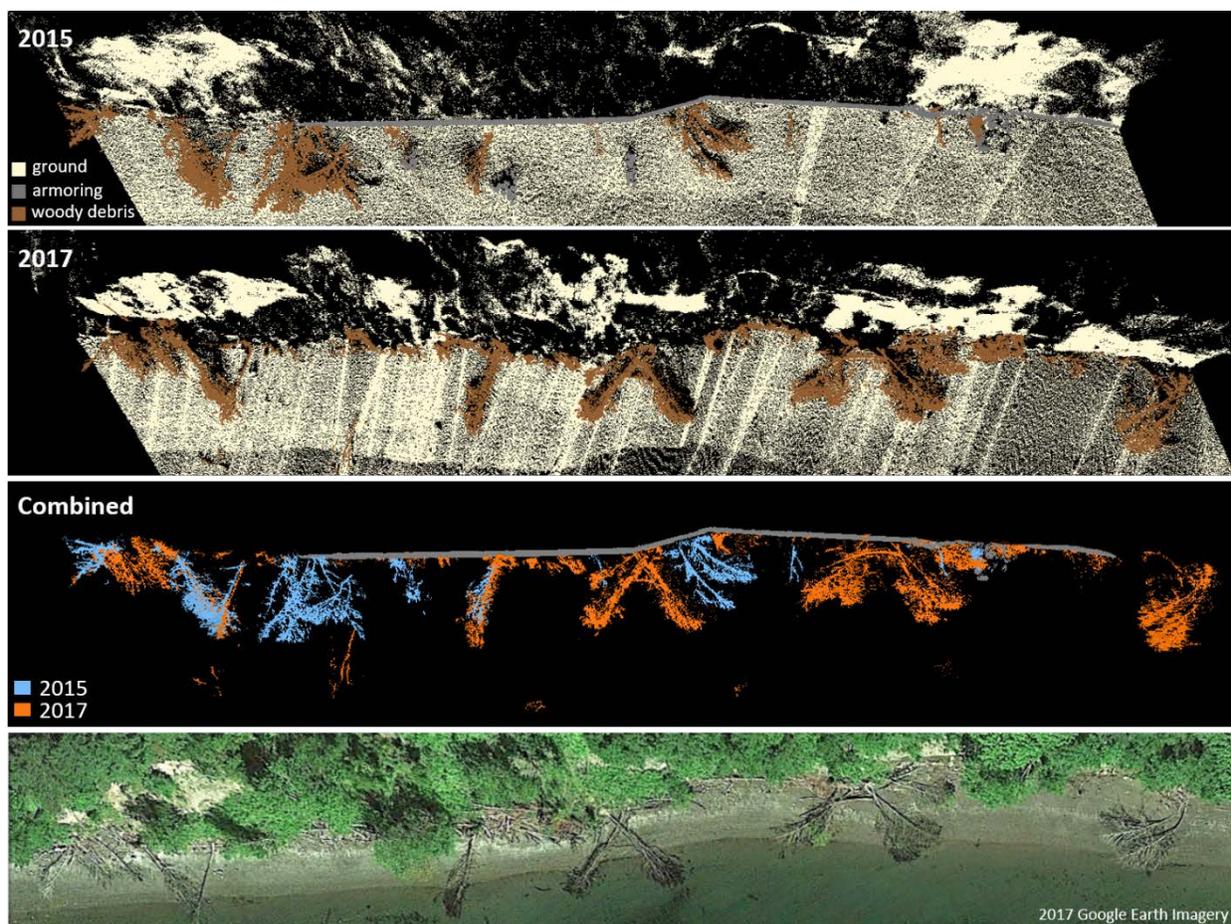
Figure 19: Increase in large woody debris between first and second surveys

this debris was pulled down or fell down during the restoration project, as opposed to natural recruitment after the project, and consisted predominately of small-to-medium deciduous species (mostly Alder) that are likely to deteriorate relatively quickly (B. Combs, pers. comm.). The bulk of the large woody debris is found between the bluff toe, at approximately 2.6 m NAVD88, and 0.4 m, with one tree extending down to 0.2 m, spanning a beach width of about 15-20 m.

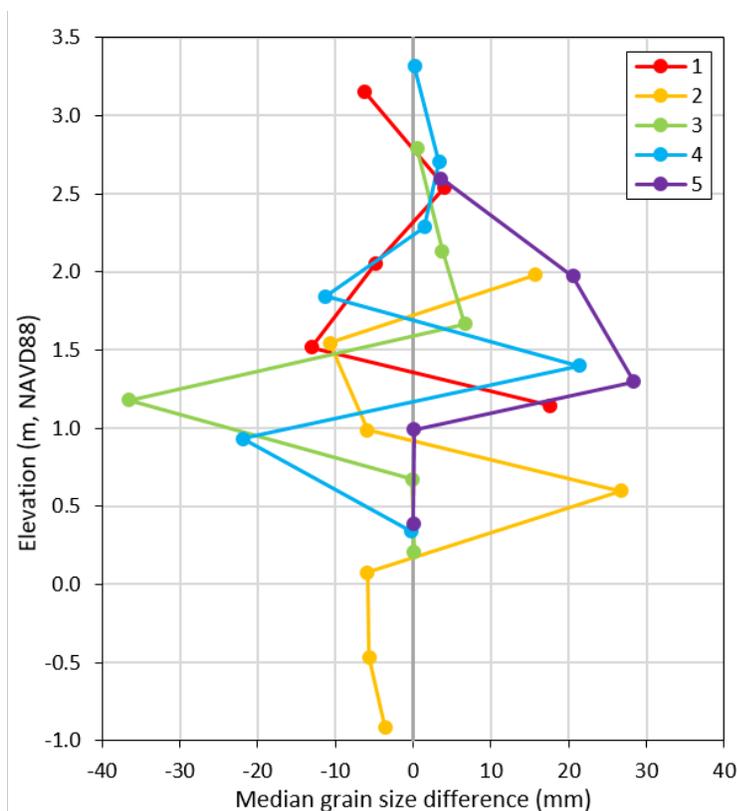
Figure 20: Plot showing difference in median grain size (D_{50}) for each sediment sample collected along five cross-shore transects

sediment sample collected at elevations common between the two surveys is shown in Figure 20. Along Transect 3, located at the restoration site, there is a slight coarsening of the sediments on the upper beach from very coarse sand to fine gravel for elevations of 1.7 and 2.1 m NAVD88. The D_{50} at these elevations changed from 1.2 and 0.9 mm, respectively, to 7.9 and 4.7 mm. In contrast, significant fining of the sediments located on the mid beach occurred along the same transect near MTL (1.28 m NAVD88), changing from a D_{50} of 45 to 8 mm (very coarse gravel to medium gravel) at 1.2 m elevation. These changes above MTL are favorable to surf smelt (*Hypomesus pretiosus*) spawning, with a preferred substrate grain size generally in the range of 1-7 mm diameter (Penttila, 2007).

Further north at Transect 5, an overall coarsening of the median grain size was observed along most of the transect between 1.0 to 2.6 m elevation (Figure 20), with the maximum change in D_{50} occurring at 1.3 m from 3.0 to 31.4 mm (very fine to almost very coarse gravel).

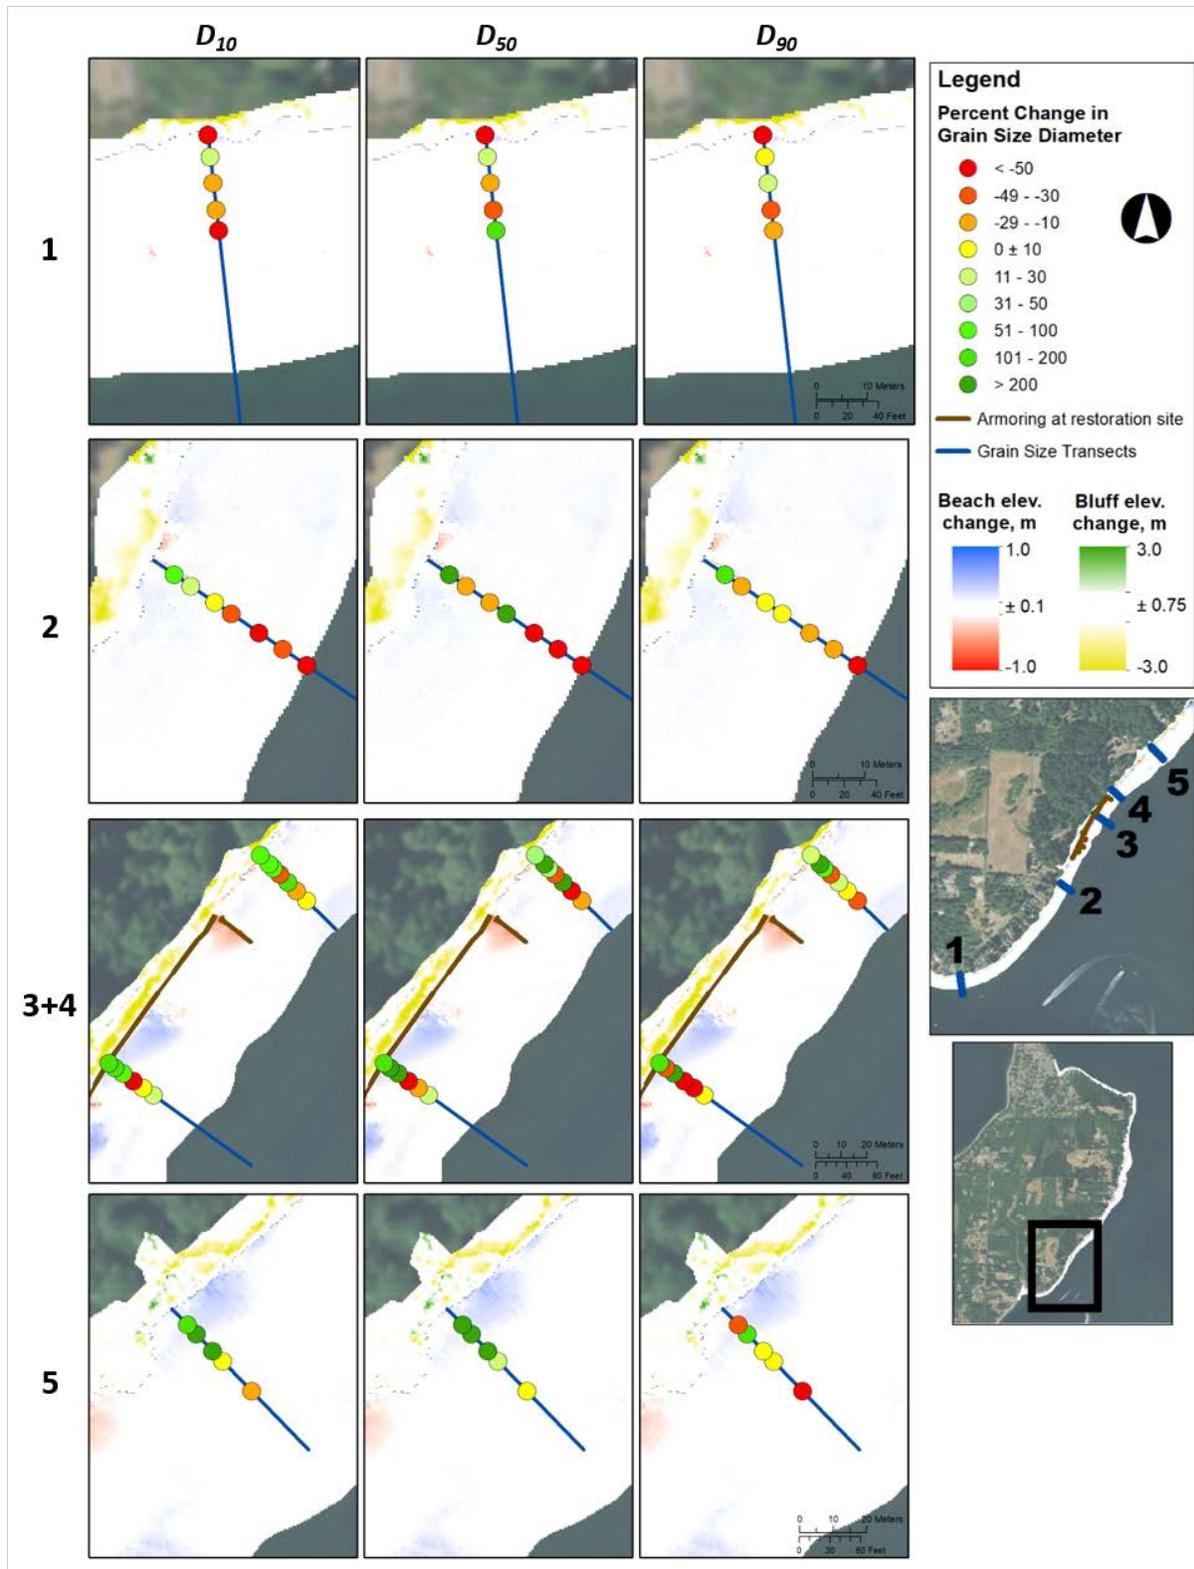
Figure 21: Percent change in median grain size (D_{50}), as well as representative fine (D_{10}) and coarse (D_{90}) fractions of the grain-size distribution, for each sediment sample collected at elevations common between the two surveys

Transect 4, located 30 m north of the restoration site, shows a somewhat similar trend but shifted in elevation: coarsening on the upper profile and fining on the lower profile. The largest change in class size on the upper profile was an increase in D_{50} from 0.7 mm (coarse sand) to 4.0 mm (very fine to fine gravel) at 2.7 m NAVD88, just below MHW (2.86 m NAVD88). At 1.8 m, there was a substantial decrease in the median grain size from 29.4 to 18.1 mm, but no change in size class (i.e., still coarse gravel). The largest increase in grain size occurred at 1.4 m from very coarse sand to coarse gravel (1.6 to 23.0 mm), which is lower than observed on Transect 3 (Figure 20) where the maximum increase occurred at 1.7 m from very coarse sand to fine gravel (1.2 to 7.9 mm). The largest decrease occurred at 0.9 m elevation from coarse to fine gravel (26.3 to 4.4 mm), which is also lower than observed on Transect 3 where the maximum decrease occurred at 1.2 m from very coarse to medium gravel (44.9 to 8.3 mm).

At Transect 4, located 30 m north of the restoration site, the fine and median grain-size diameters shows a similar pattern to Transect 3, with fining of sediments extending lower on the profile (0.3-0.9 m). These cross-shore trends suggest that sand and finer material is being moved from the upper to lower beach face, coarsening the upper beach and burying larger sediments found lower on the profile in 2015. The coarsening of the upper beach at Transect 4 at 2.3 and 2.7 m elevations still provides suitable surf smelt spawning substrate with median grain sizes of 5.5 and 4.0 mm, respectively. Similarly, the upper beach at Transect 5 has a median grain size of 5.3 mm at 2.6 m, while the beach at 1.3 and 2 m elevations became significantly coarser.

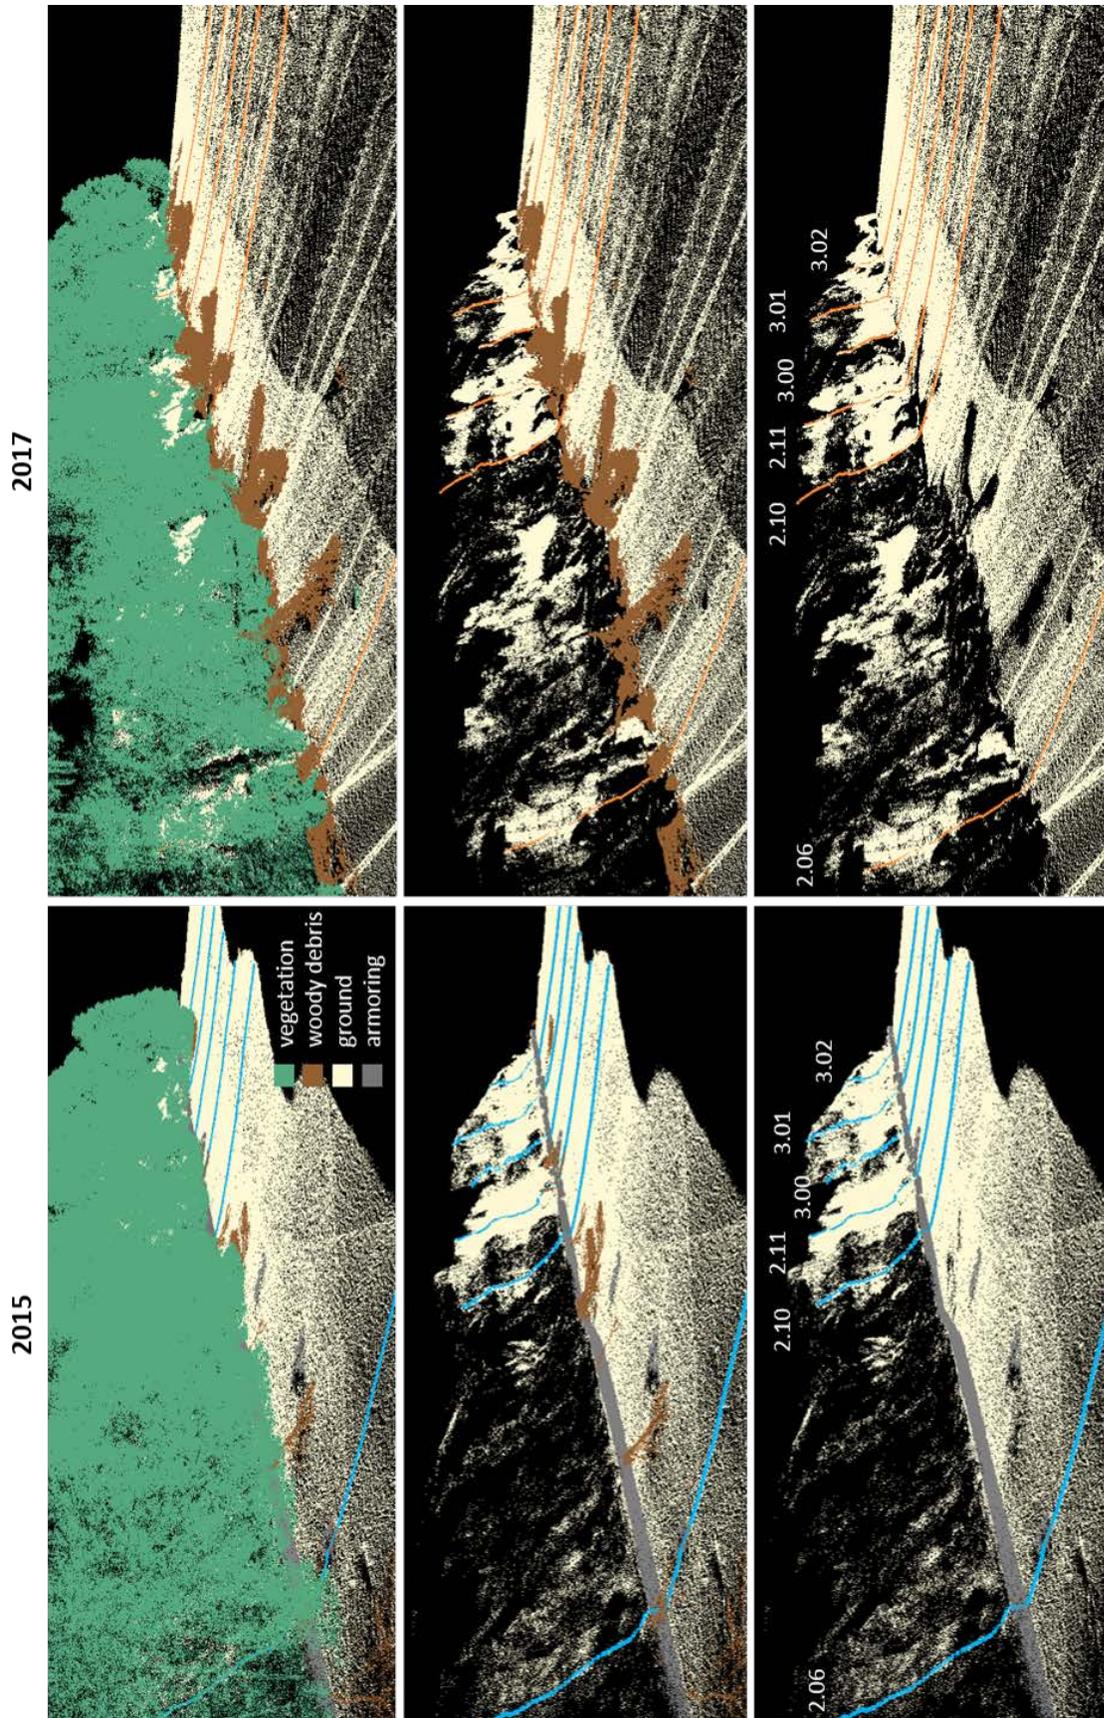
Figure 22: Three-dimensional view of cross-shore profiles at the Edgewater Beach restoration site overlain on the corresponding classified lidar point cloud for 2015 (left) and 2017 (right)

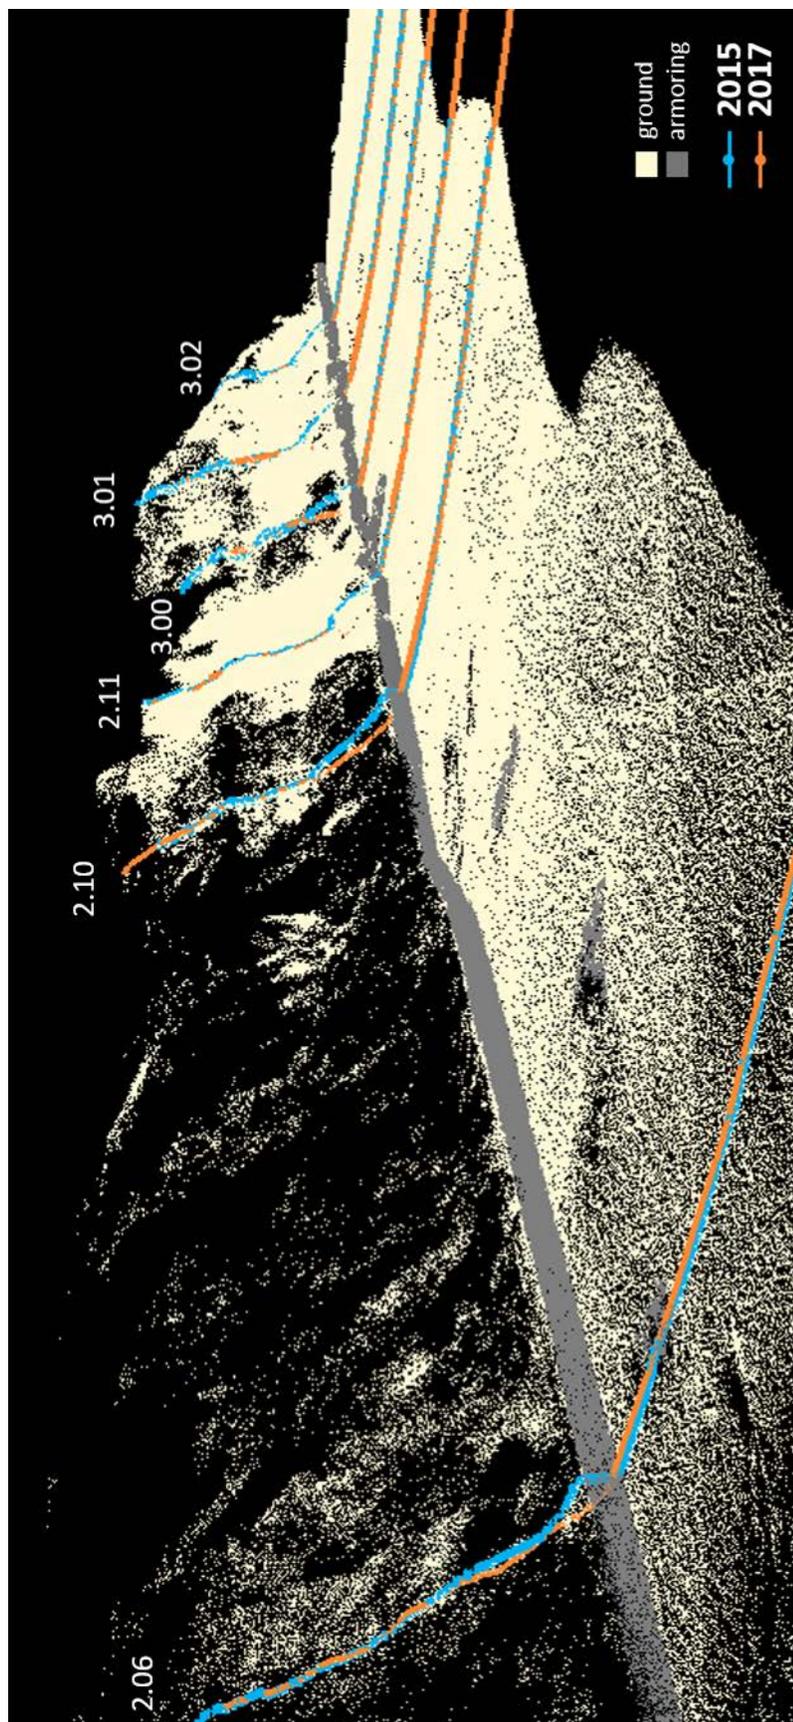
Figure 23: Three-dimensional view of cross-shore profile change at the Edgewater Beach restoration site overlain on the 2015 classified lidar point cloud

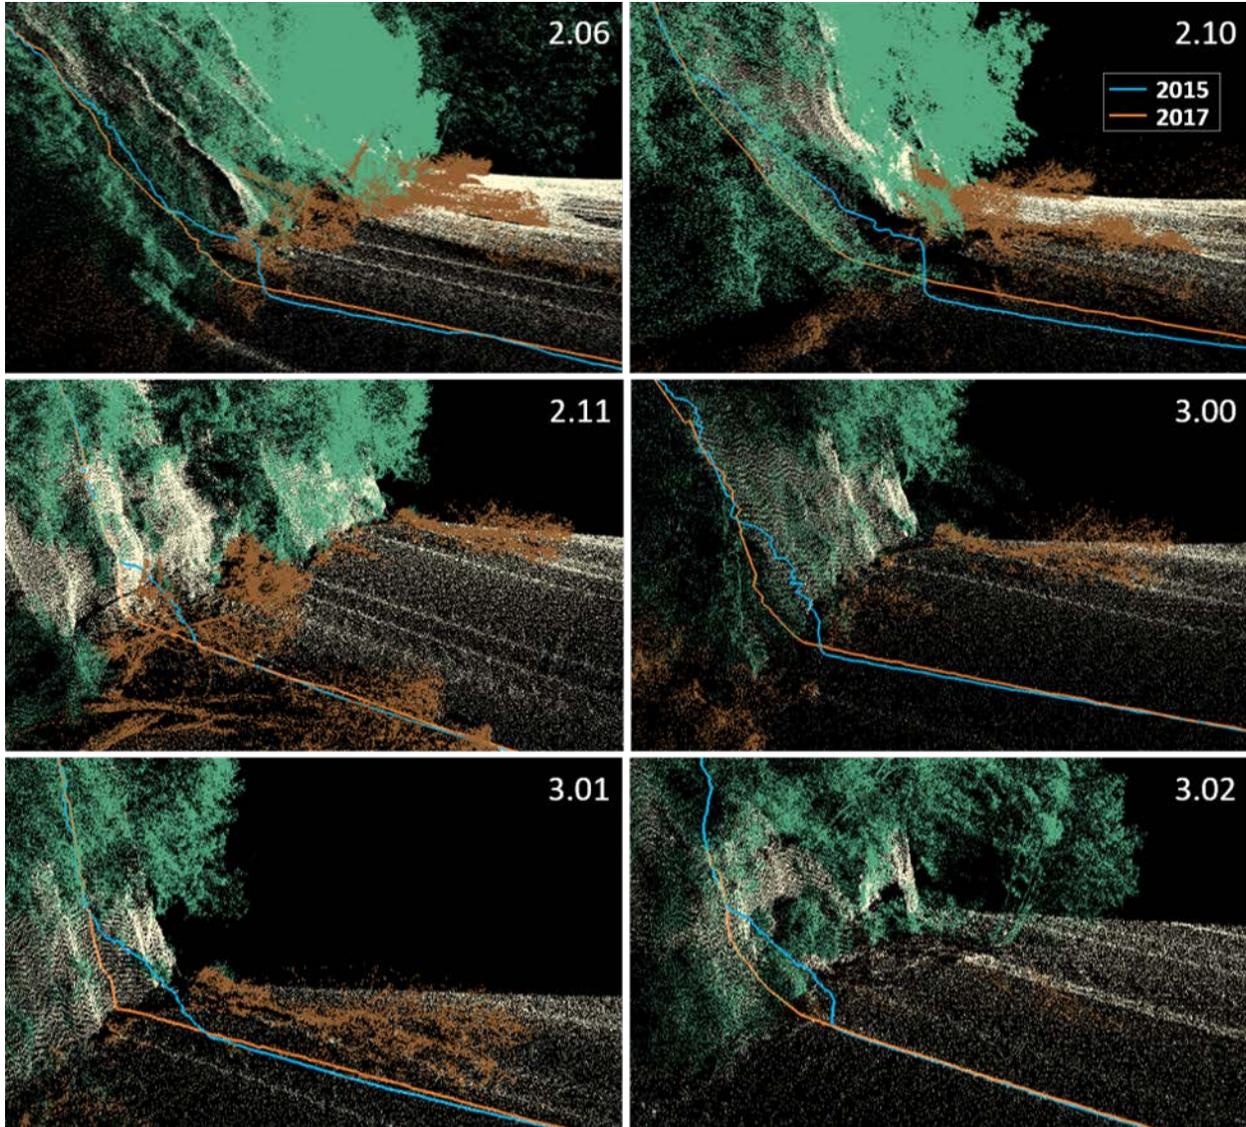
Figure 24: Close-up view of the bluff toe for cross-shore profiles at the Edgewater Beach restoration site overlain on the 2017 classified lidar point cloud

Figure 24 shows the change between the two-dimensional profiles focused on the lower bluff and upper beach within the context of the 2017 three-dimensional point cloud for selected profiles at the restoration site. Together, Figure 23 and Figure 24 illustrate the density of elevation measurements and the ability to detect profile change between September 2015 and June 2017 associated with armor removal in November 2016.

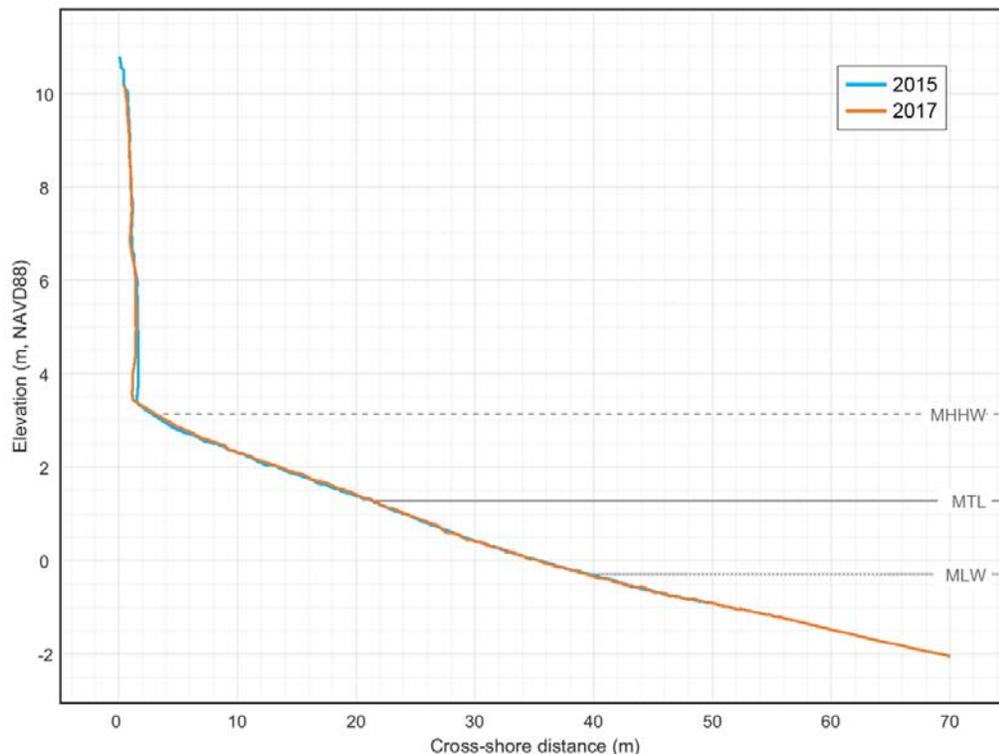
Figure 25: Cross-section of lidar point cloud along Transect 1.00 at south end of survey site

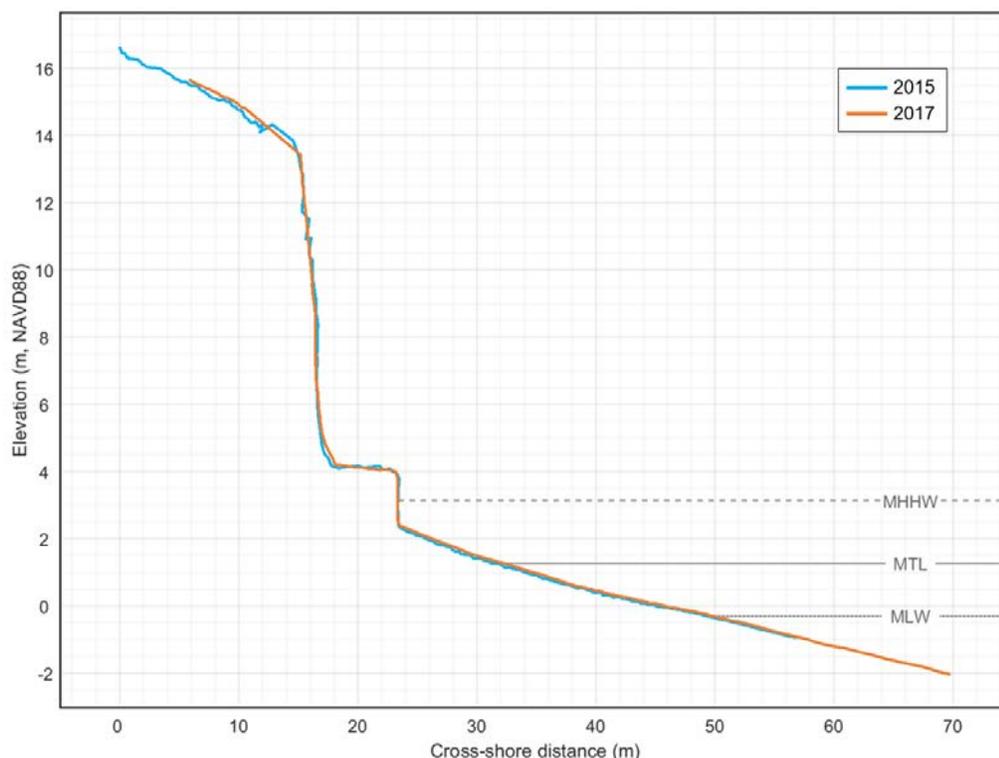
Figure 26: Cross-section of lidar point cloud along Transect 1.18 at south end of survey site

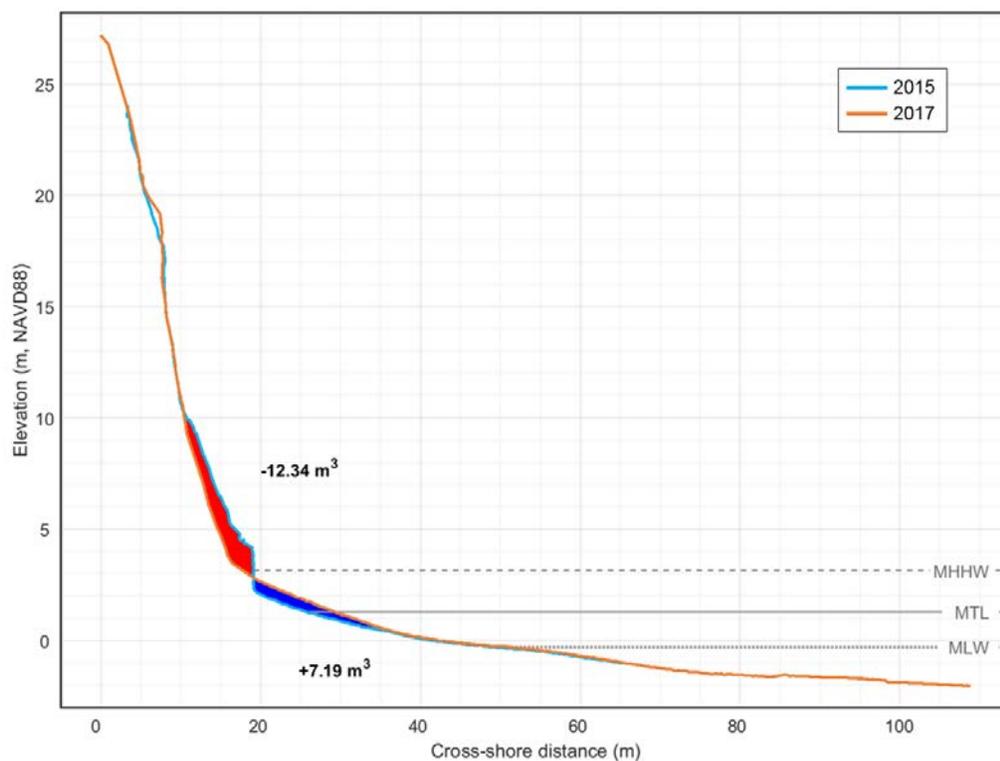
Figure 27: Cross-section of lidar point cloud along Transect 2.10 at the restoration site

The upper beach face retained a portion of the sediment eroded from the lower bluff ($+7.19 \text{ m}^3$; 9.4 yd^3), resulting in about a 60 cm (~2 ft) increase in beach elevation and a 4.9 m (16.1 ft) increase in beach width above MTL, increasing from 6.6 m (21.7 ft) in 2015 to 11.5 m (37.7 ft) in 2017. The toe elevation translated vertically from 79 cm (2.6 ft) below MHHW at the bulkhead in 2015 to 34 cm (1.1 ft) above MHHW at the bluff in 2017, and moved landward by 2.7 m, while the beach slope above MTL has remained consistently at about 10%, the steepest beach slope observed across all profiles examined.

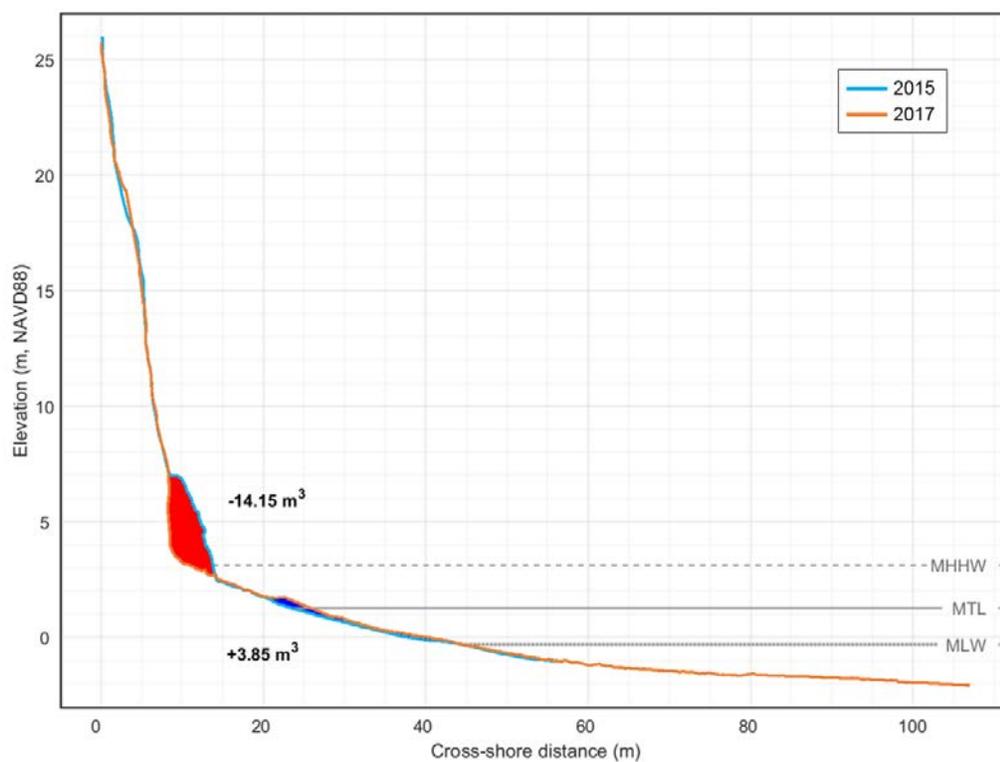
Figure 28: Cross-section of lidar point cloud along Transect 2.11 at the restoration site

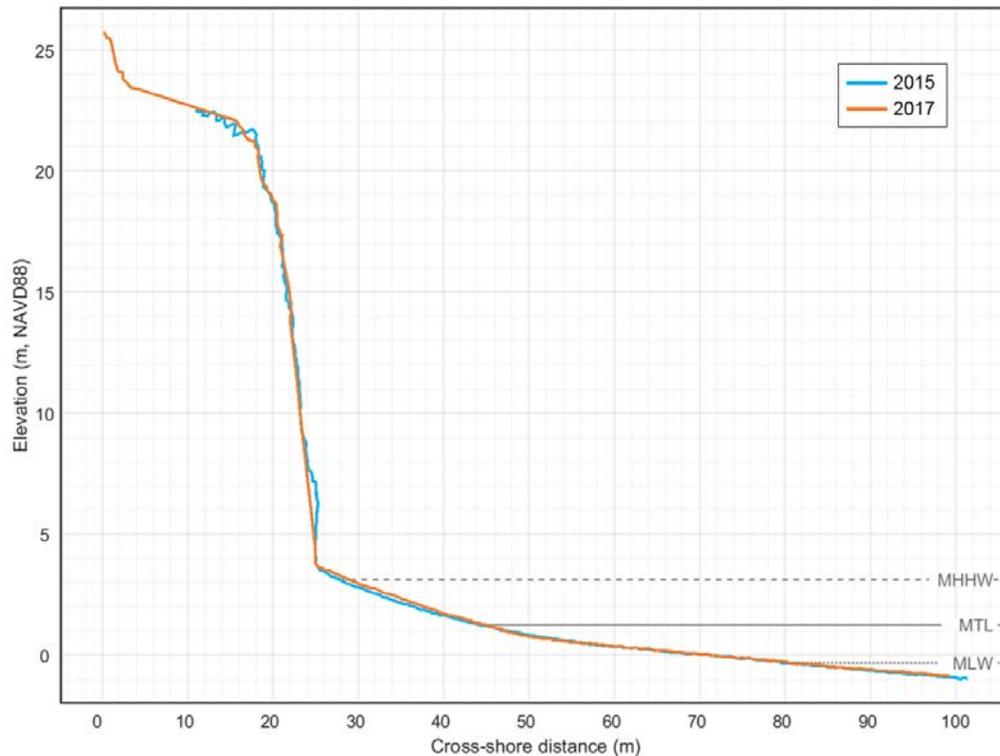
Figure 29: Cross-section of lidar point cloud along Transect 5.00 north of the restoration site

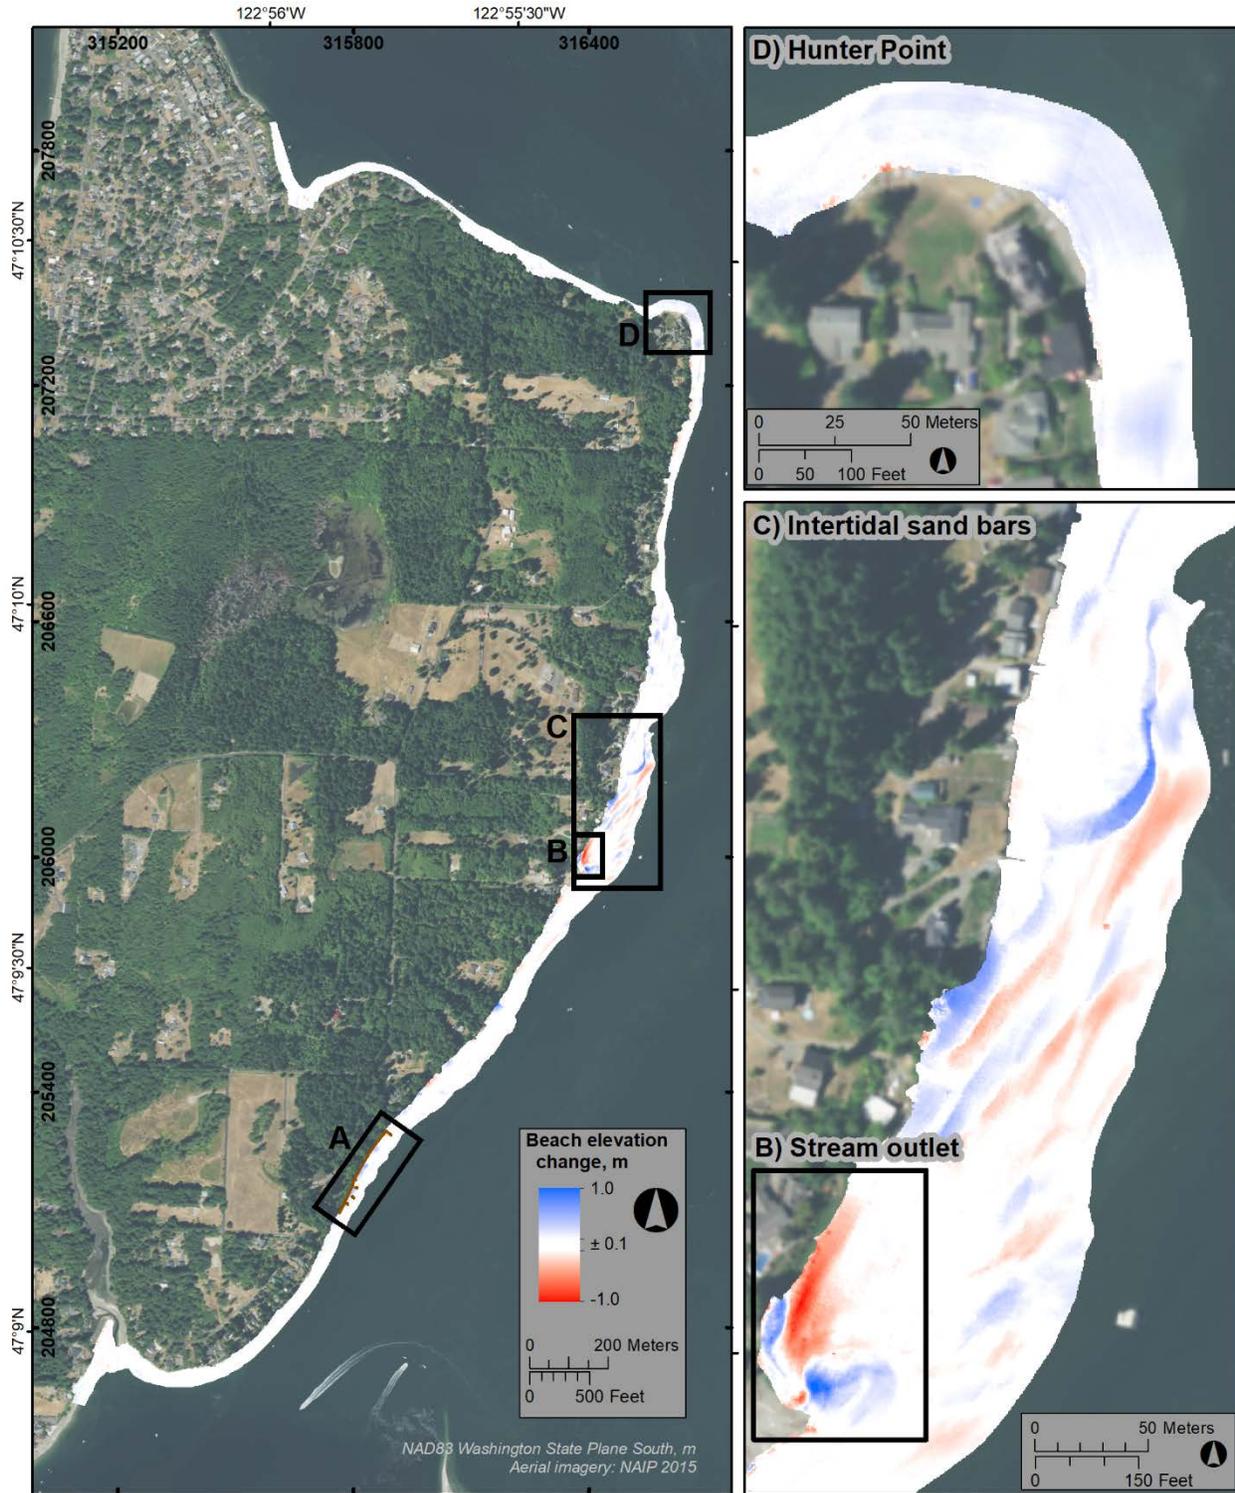
Figure 30: Change in beach elevation (greater than ± 10 cm) measured between the first and second survey; zoomed-in views of change at (B) stream outlet, (C) intertidal sand bars, and (D) Hunter Point (for Edgewater Beach restoration site close-up image, see Figure 16)

In comparison, relatively small morphological changes along the drift cell were observed outside of the restoration site. Figure 30 shows the difference in beach elevation measured between the first and second surveys, almost two years apart. Changes associated with the movement of a stream outlet south of the community of Rignall were observed, including accretion of the bar in front of the mouth (+293 m³), filling in of a trough along the base of the upland (+89 m³), and erosion of the upper beach (-532 m³) (Figure 30B). These changes resulted in an average elevation loss of 0.4 m and a change in the outflow position of the channel on the lee side of the bar. Figure 31 shows aerial photos of how this area changed between 2015 and 2017, as well as where the changes occurred based on the difference in beach elevation measured from the two boat-based lidar surveys.

In the center of the drift cell along a wide, accretionary beach near the community of Rignall, bands of erosion and accretion indicate migration of shallow intertidal sand bars (Figure 30C). The sand bars were observed to have migrated onshore by about 8-10 m (26-33 ft) to the northwest, with bar crests filling in landward troughs and leeward troughs developing in the area of the prior crests (Figure 32). The orientation of the bands confirms the net northward direction of sediment transport within the drift cell. The volume of accretion in this area closely equals the volume of erosion (1,845 vs. 1,550 m³) for a net gain in sediment of 295 m³. The migration volumes, which average to about 1,700 m³ of sediment in motion, provide an indication of the sediment transport capacity along the coast and can be expressed in terms of volume per unit time (975 m³/yr). The net gain of sediment indicates an influx of sediment into the area from the south or offshore.

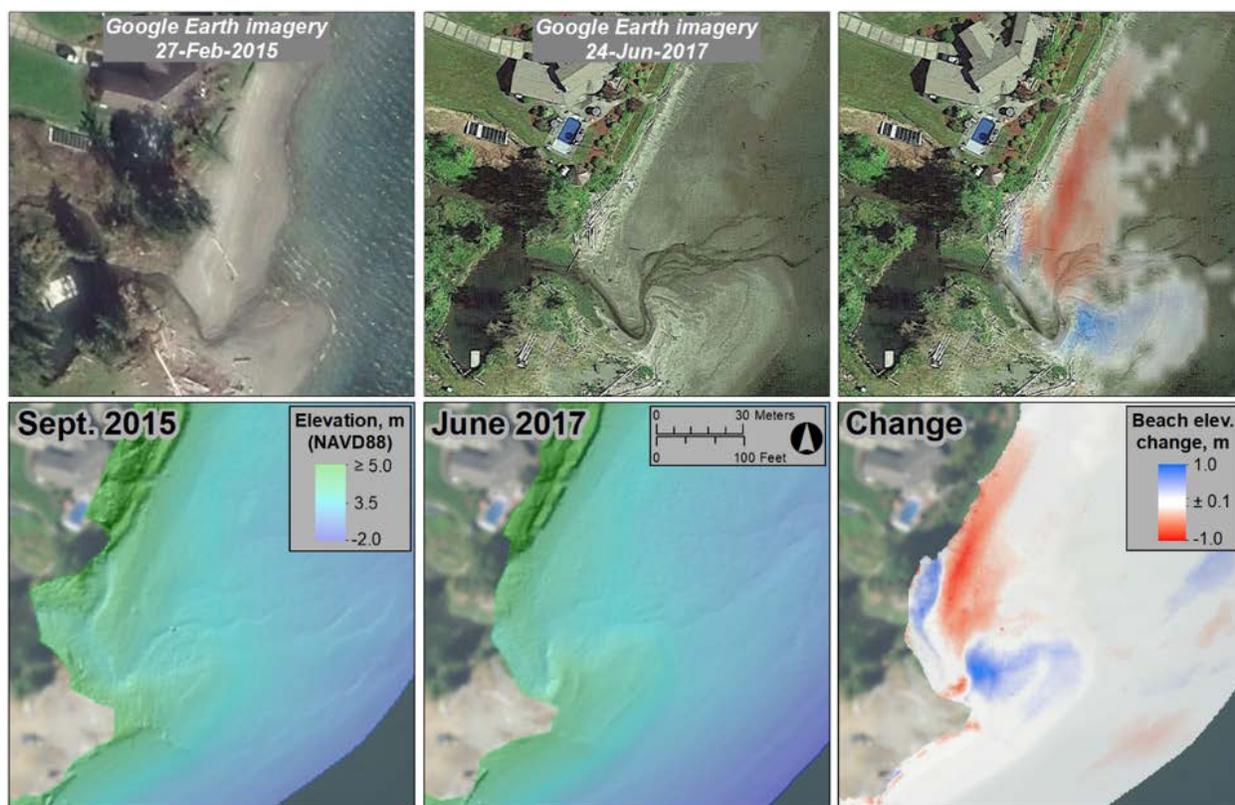
Figure 31: Stream outlet changes south of Rignall; *top*—Google Earth imagery taken near the time of the surveys, *bottom*—survey DEMs and difference surface

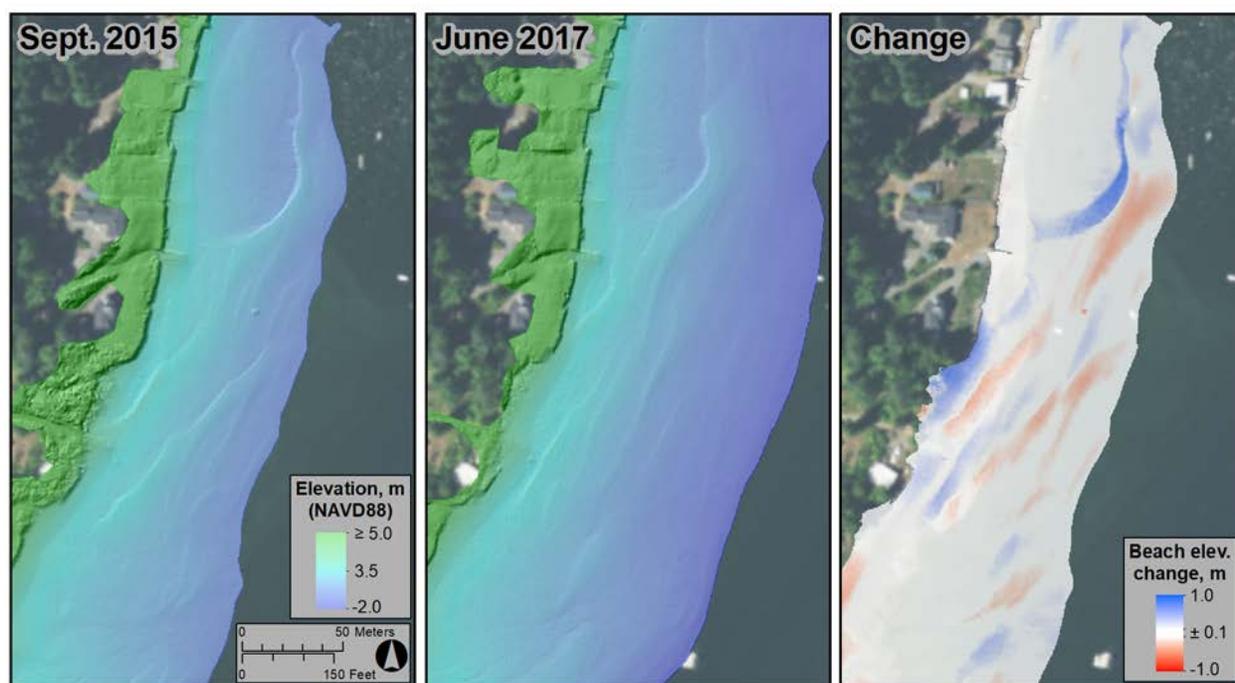
Figure 32: Intertidal sand-bar migration south of Rignall; survey DEMs and difference surface

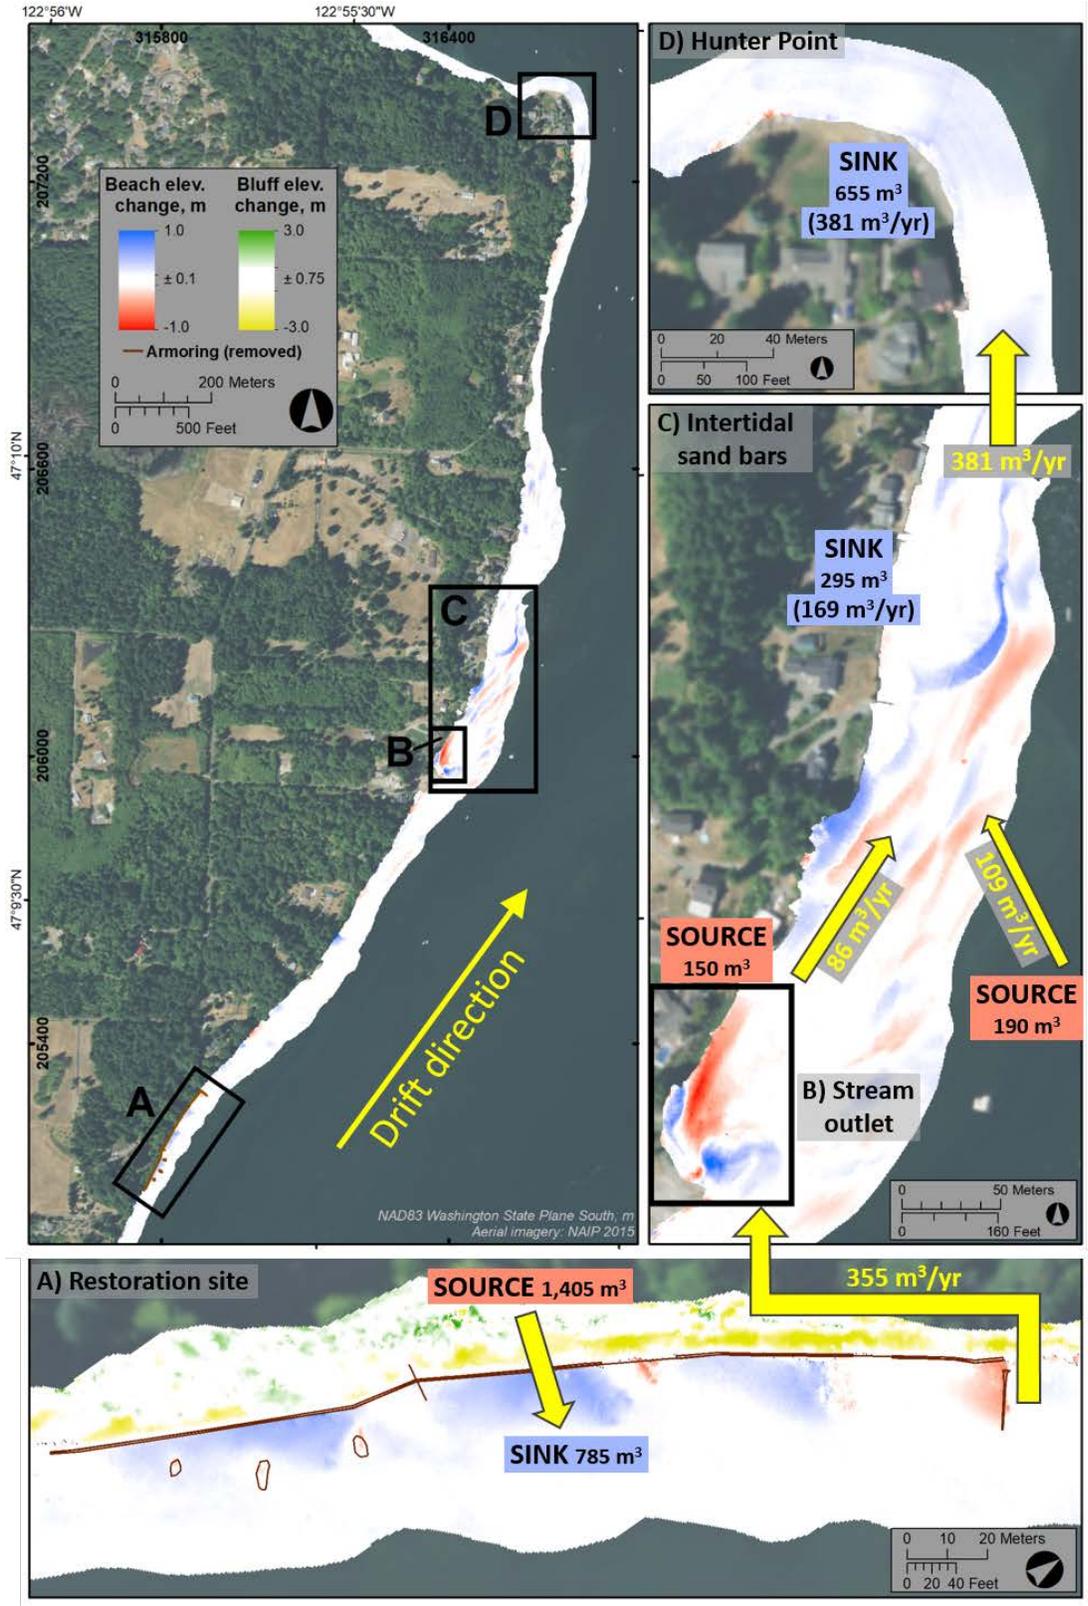
Figure 33: Preliminary, first-order sediment budget for the Edgewater Beach drift cell based on observed morphology changes between the September 2015 and June 2017 surveys

With only two surveys that did not include nearshore bathymetry, not all of the sources and sinks of sediment along the drift cell can be identified; however, a rough order of magnitude sediment budget can be estimated to assess the potential morphologic effect of the restoration project to the drift cell. As noted above, the observed changes in volume between the two surveys can be

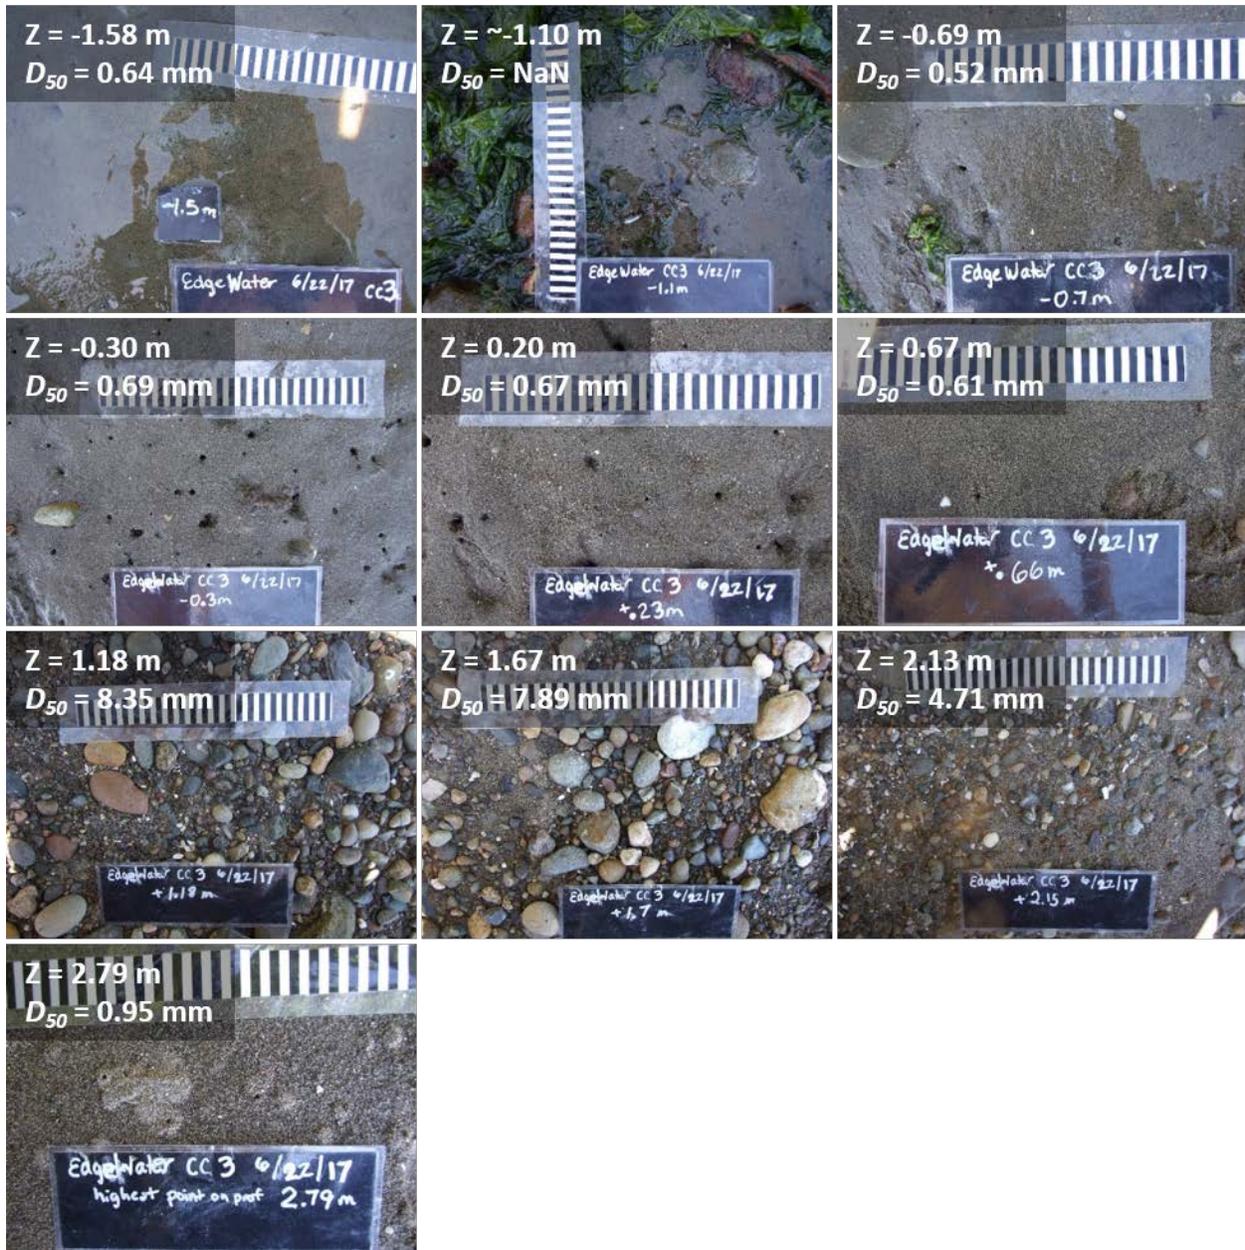
Figure 58: Sediment grain-size photos collected along Transect 3 on June 22, 2017
