DEPARTMENT OF
ECOLOGY
State of Washington

Coastal morphology change in response to bulkhead removal at Edgewater Beach, South Puget Sound

February 2018
Publication 18-06-002

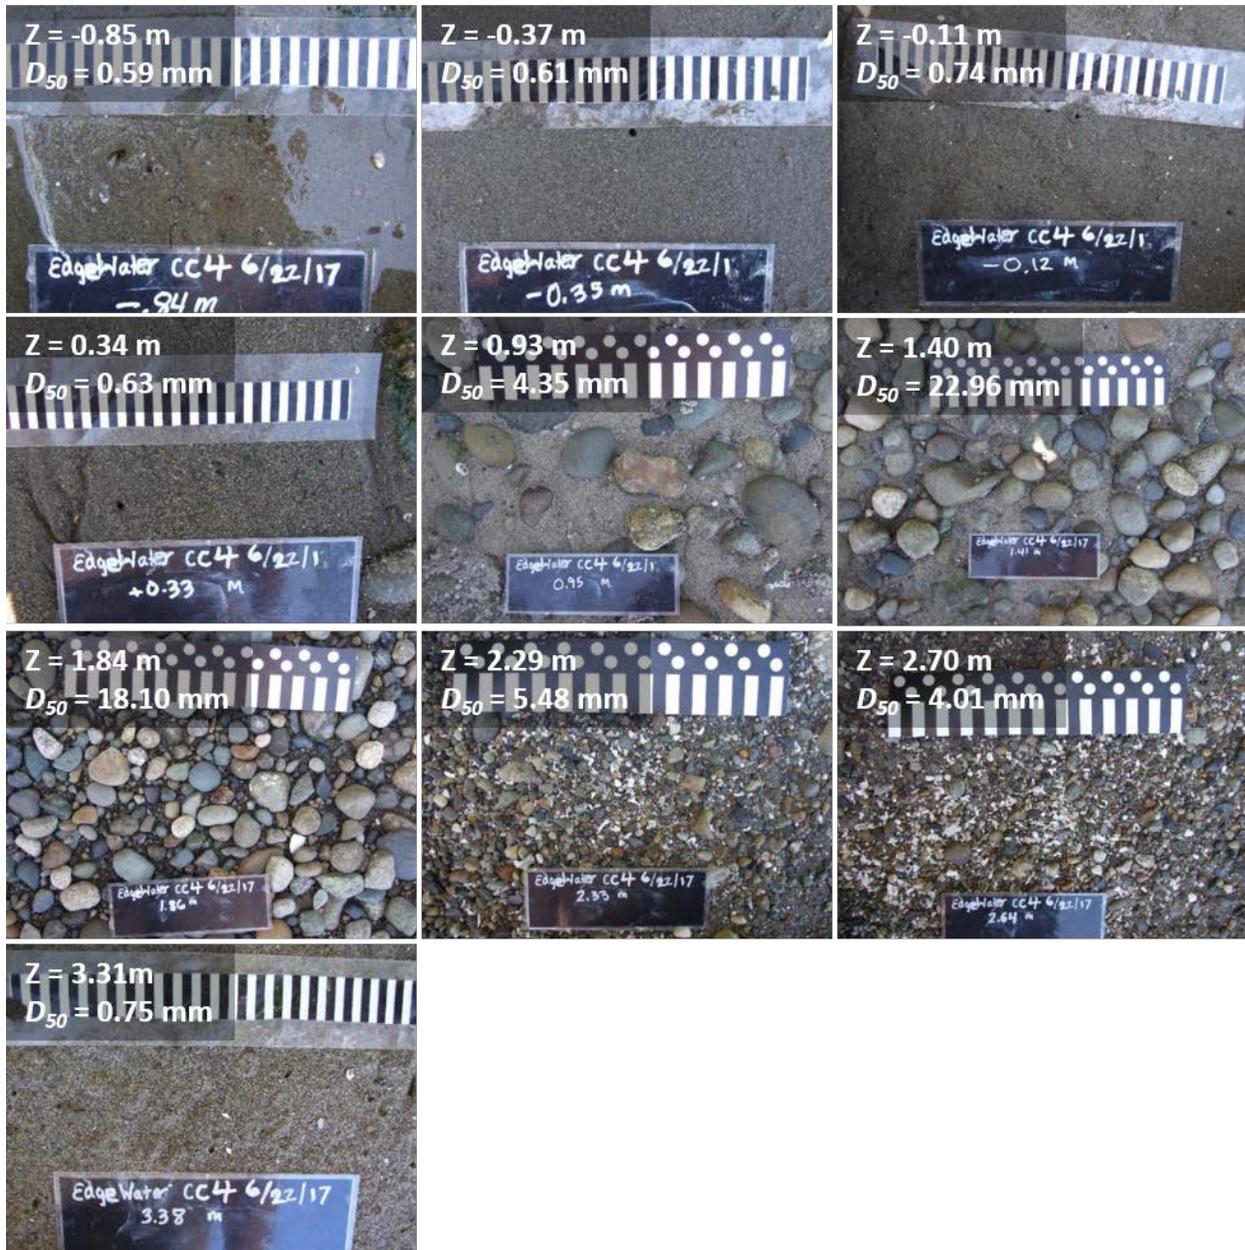
Figure 59: Sediment grain-size photos collected along Transect 4 on June 22, 2017

At Transect 4, located 30 m north of the restoration site, the fine and median grain-size diameters shows a similar pattern to Transect 3, with fining of sediments extending lower on the profile (0.3-0.9 m). These cross-shore trends suggest that sand and finer material is being moved from the upper to lower beach face, coarsening the upper beach and burying larger sediments found lower on the profile in 2015. The coarsening of the upper beach at Transect 4 at 2.3 and 2.7 m elevations still provides suitable surf smelt spawning substrate with median grain sizes of 5.5 and 4.0 mm, respectively. Similarly, the upper beach at Transect 5 has a median grain size of 5.3 mm at 2.6 m, while the beach at 1.3 and 2 m elevations became significantly coarser.

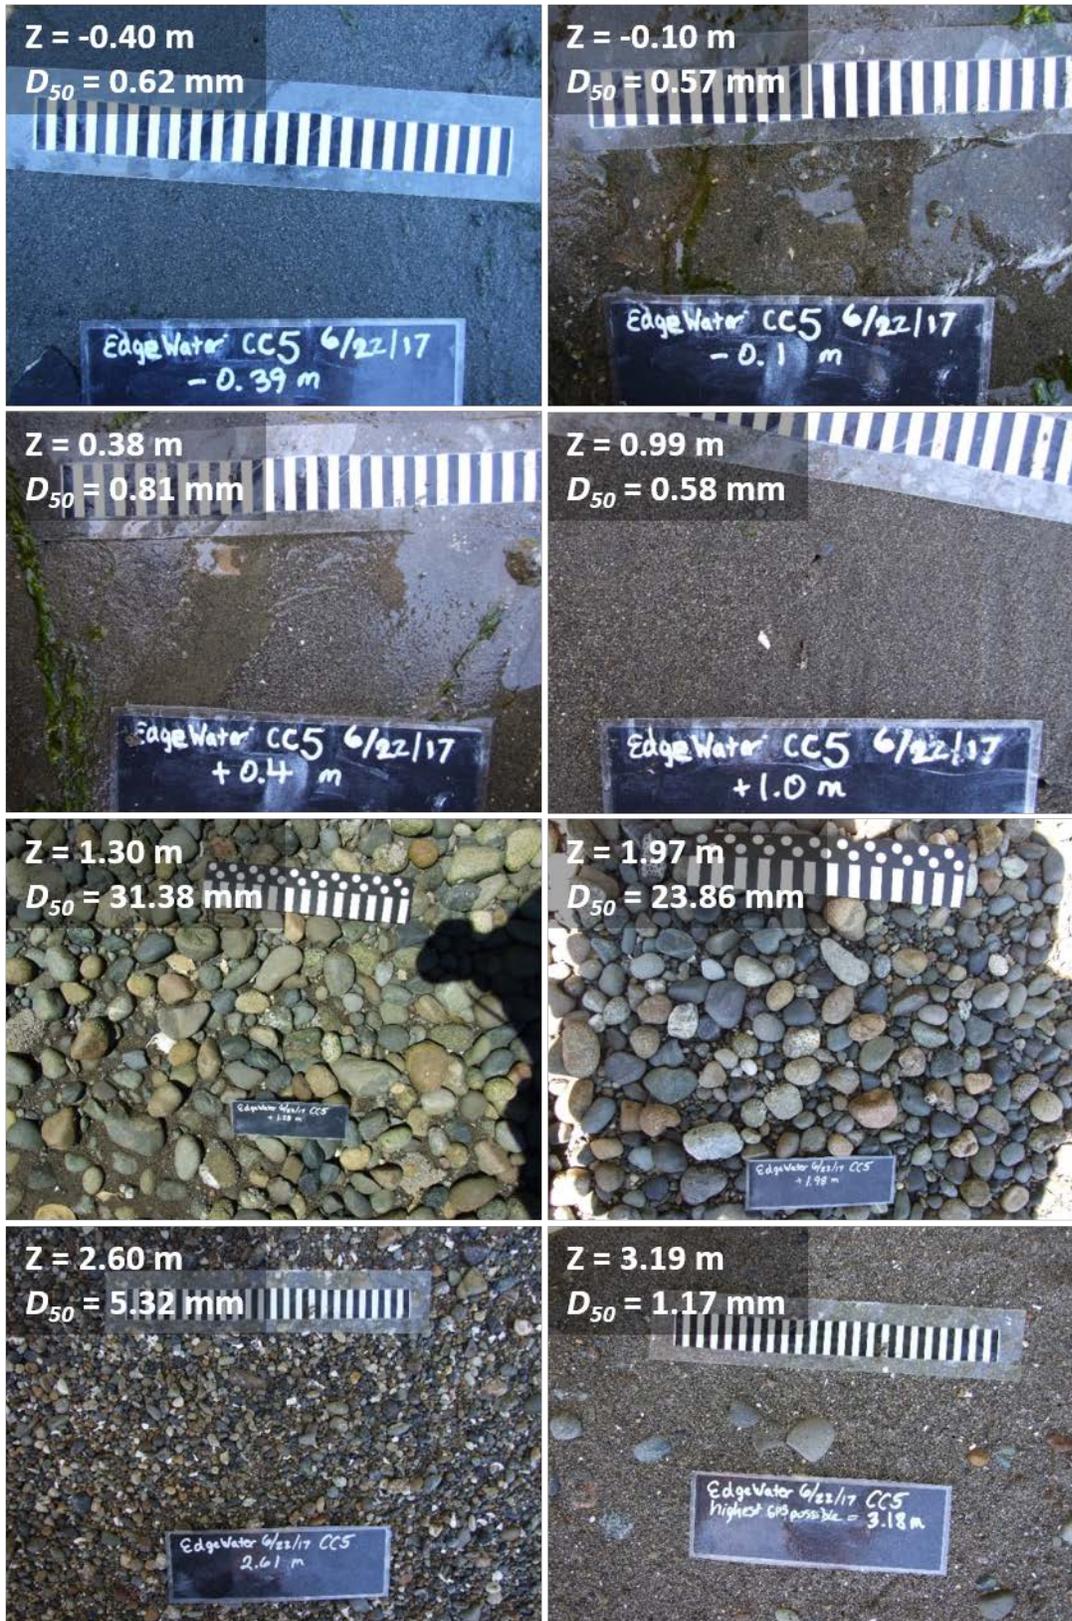
Figure 60: Sediment grain-size photos collected along Transect 5 on June 22, 2017

Further north at Transect 5, an overall coarsening of the median grain size was observed along most of the transect between 1.0 to 2.6 m elevation (Figure 20), with the maximum change in D_{50} occurring at 1.3 m from 3.0 to 31.4 mm (very fine to almost very coarse gravel).
