Characterization Results for Springbrook Creek Watershed, Bainbridge Island, Washington

Publication 18-06-006

July 2018

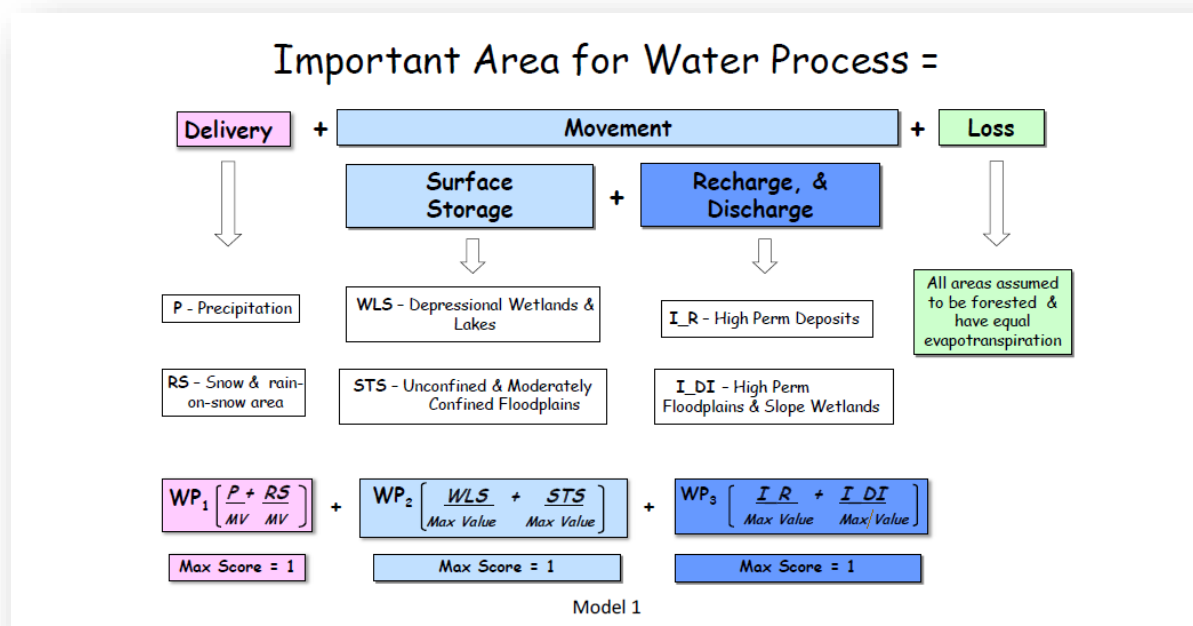
Figure 3. Diagram of the components that comprise the importance model. The physical features that control the delivery, movement and loss of water are represented by the “white boxes.” For example, a control for storage would be indicated by the presence of depressional wetlands and lakes.

The greater the number of controls within an individual PAU the higher its importance relative to other PAUs within that watershed. The importance model is designed to give the user a picture of how a watershed should function without the changes or impacts created by human development over the past 150 years. Figure 3 presents the “importance” model (i.e. model 1) and the indicators that it uses of landscape features that control the delivery, movement and loss of water.

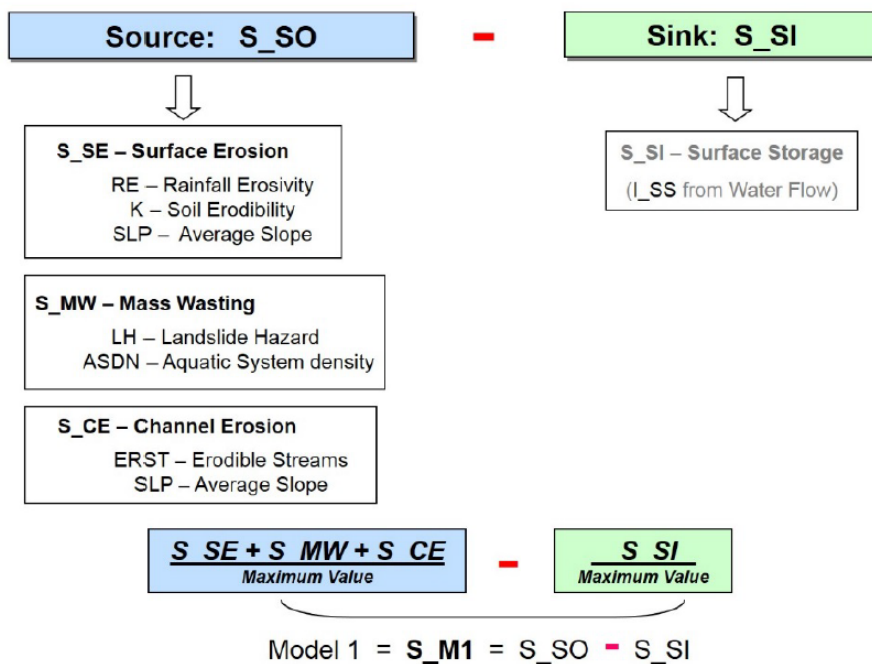
Figure 6. Diagram of the components that comprise the sediment export model. This model calculates the relative value of areas within a watershed that control sediment source and sink processes and takes the difference between those two values in order to obtain the relative export potential.

For the characterization of sediment impacts, a model structure similar to that of the water flow processes is used. This includes a model for assessing the export potential for sediment of individual assessment units. This includes identifying the features on the landscape that control the erosion of sediment sources, sediment transport and sinks which store sediment (Figures 6 & 9). For the Springbrook Creek Watershed, only the export potential for sediment was assessed and not how these sediment processes have been degraded.

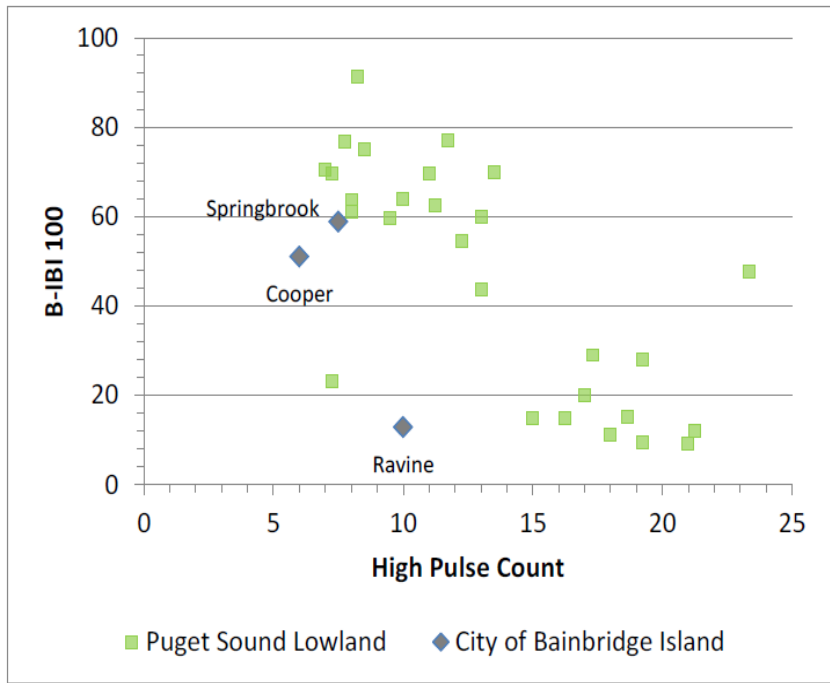
Figure 11. Comparison of the correlation of B-BIBI 100 and High Pulse data for Springbrook Creek watershed and WRIA 8 reference watersheds (green data points). Source: King County (DeGasperi 2015).

The results (Figure 11) show that while Springbrook Creek had a relatively low High Pulse Count (average of 8 per year), its Benthic Index of Biological Integrity (BIBI) scores were only fair. Streams with a lower High Pulse Counts are typically “healthier” hydrologically and biologically. Furthermore, Springbrook Creek appears to lie at the lower edge of BIBI data for WRIA 8 reference watersheds. The DeGasperi study states that fine sediment may be a contributing factor to these lower than expected BIBI scores and goes on to state that “any development within these basins may also be a contributing factor as well,

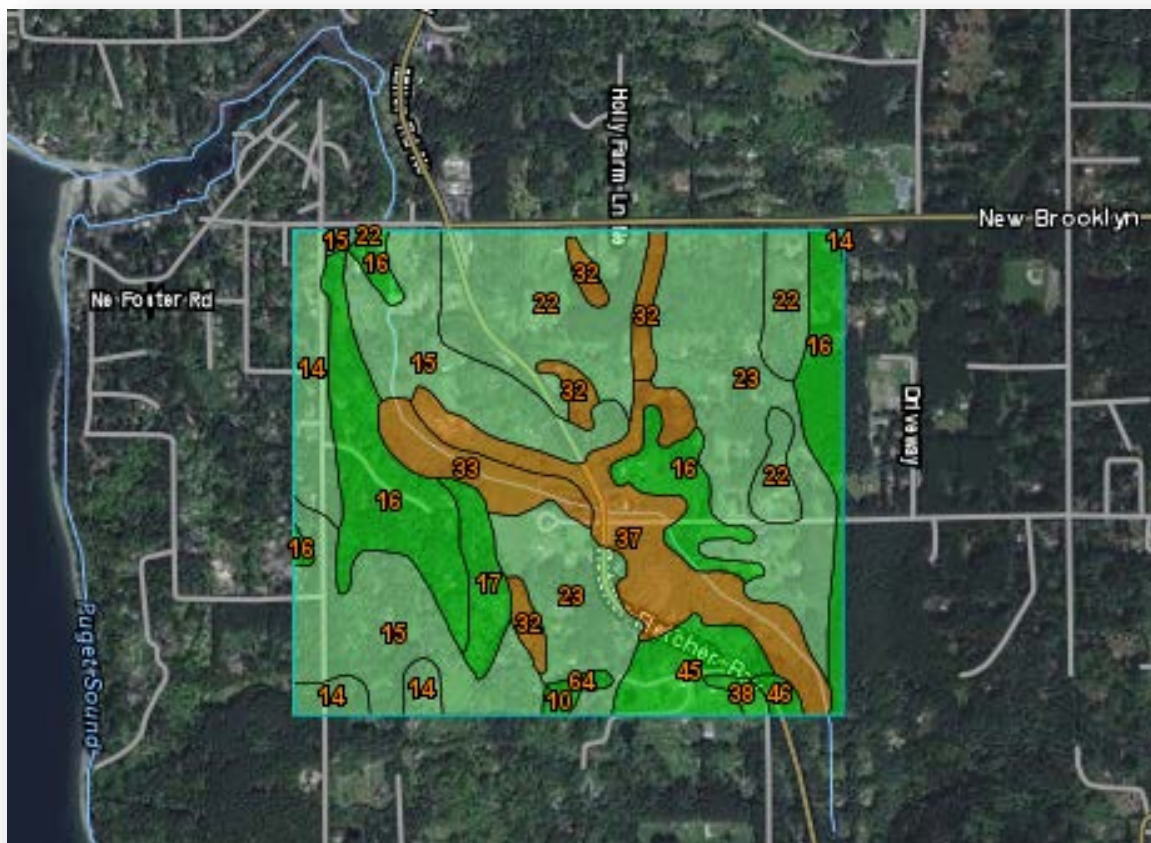
Figure 12. This soil map shows the location of hydric soils (tan colors) in PAU 4. Map unit 33 is a peat soil, indicating conditions of constant soil saturation over the past 10K+ years. Map unit 32 & 37 are mineral based hydric soils, and are also saturated for long periods of time during the year. Taken together these hydric soil units are key areas for groundwater discharge and retention of surface waters. Source: NRCS web based soil maps.

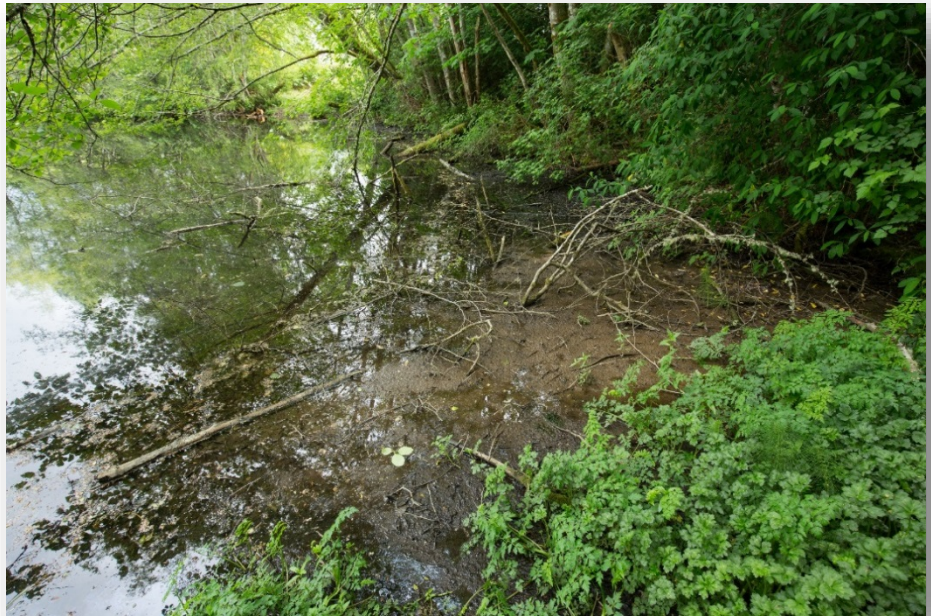
Figure 13. Fine sediment entering one of the upper ponds on the Johnson Farm property, assessment unit 7.

During the May 10th field inspection, sediment fans were observed at the Johnson Farms agricultural ponds (Figure 13). Upstream of these ponds are deposits of outwash material (see Figure 7), which have a relatively higher rate of erosion. Because storms in Puget Sound are showing an increase in intensity and duration, it is important the forest cover be left in place for assessment units that have erosive deposits.

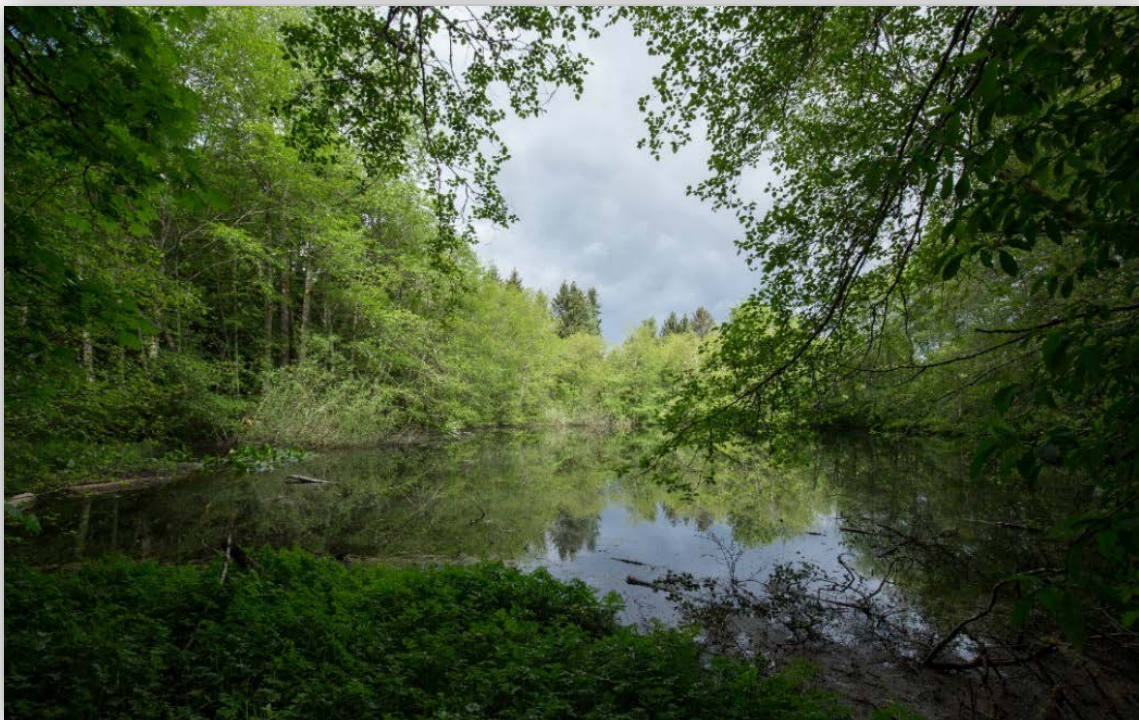
Figure 14. Upper agricultural pond on Johnson Farm, assessment unit 7. Note how the forested community shades most of the pond surface.

The open water in the agricultural ponds within the watershed is subject to increased solar heating during summer and fall months. Because these ponds are in line with Springbrook Creek, the warmer water from these ponds can influence downstream water temperature which in turn may negatively affect stream biota. In addition, open water that is held static in a pond tends to lose water through evaporation which may be

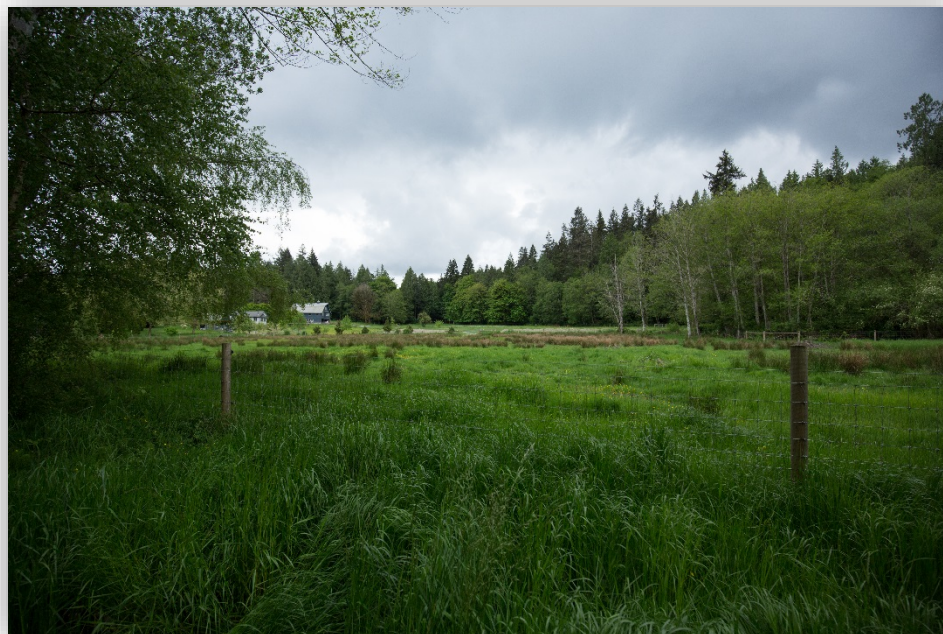
Figure 15. Example of conversion of depressional wetlands to pasture land in assessment unit 4. Hillside supports intact slope wetlands (Potential Project #7.5, Figure 8).

areas of historic forested depressional wetlands (Figure 15 & 18) into pasture lands. The creeks feeding into these systems have been channelized and flows moved to the edge of property lines away from the wetland complex. This has had the effect of partially draining these wetland systems, which has in turn changed their hydroperiods, allowing for the establishment and dominance by reed canary grass (Figures 15 & 16).

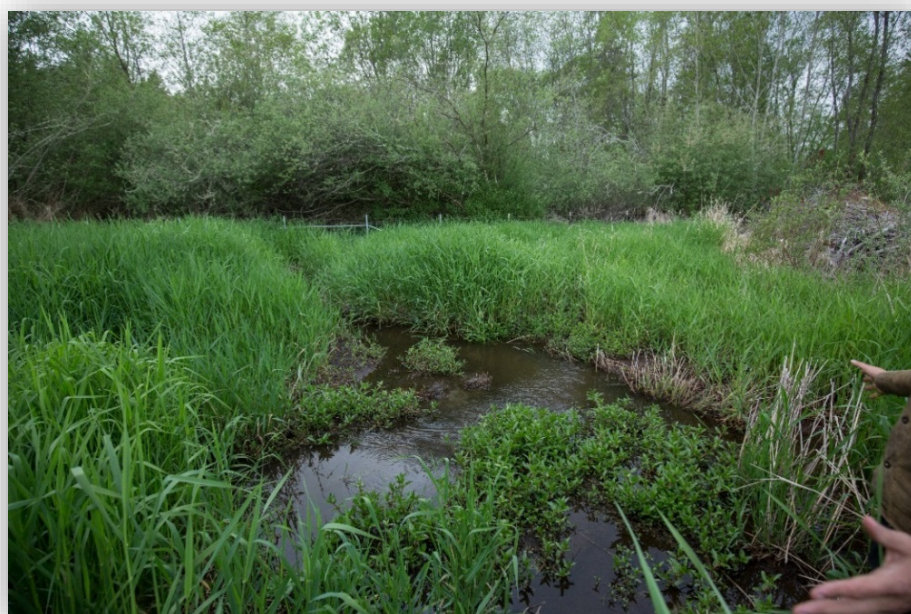
Figure 16. Channel clogged by reed canary grass in assessment unit 4 depressional Wetland, Potential Project #4. This also results in filling of channel with sediment.

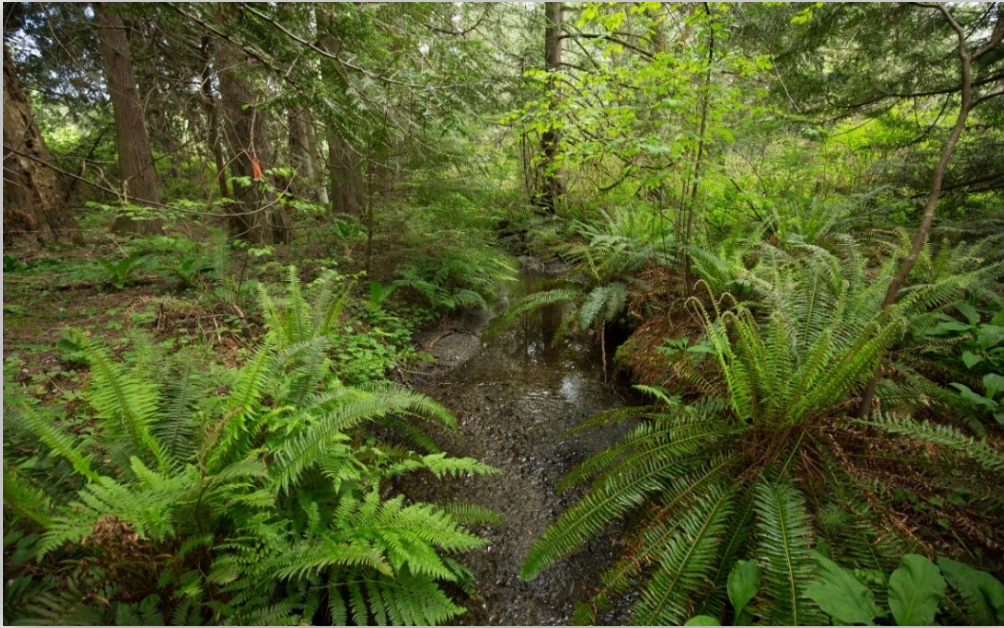
Figure 17. Example of a properly functioning stream system similar to historic conditions with forested canopy, scrub-shrub understory and sorted stream gravels without fine sediment impacts. Assessment unit 4, Potential Project #12.

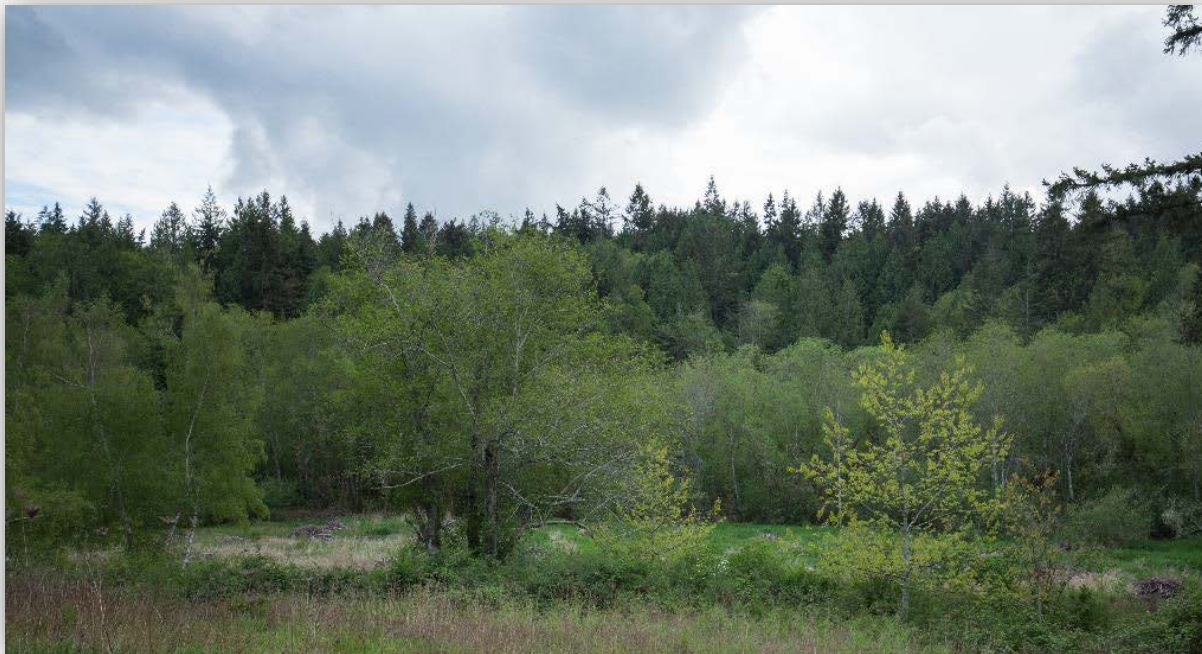
Figure 18. Clearing of forested riparian vegetation (note wood piles) in floodplain of Potential Project #4, has resulted in alteration of floodplain processes. The resulting establishment of reed canary grass has altered stream flow path and decreased habitat diversity. Native forest cover provides for more diverse habitat structure and allows for the establishment of a clearly defined channel(s) as seen in Figure 17.

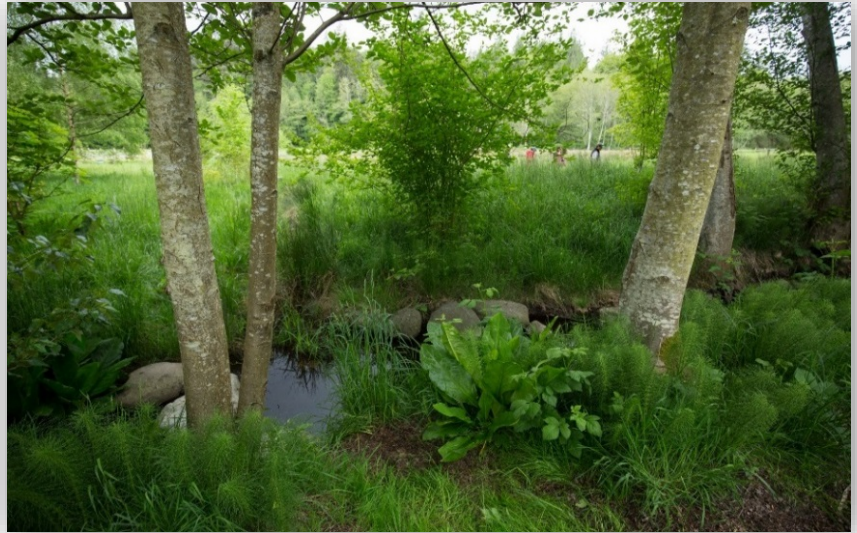
Figure 19. Example of measures to restore stream channel by fencing out livestock and replanting with a narrow forested buffer in assessment unit 4, Potential Project 7.5.

Efforts by landowners to restore watershed processes were evident throughout the watershed and included fencing off stream corridors and replanting buffers. This has the benefit of lowering stream water temperature through shading and eliminating reed canary grass which can completely choke the stream channel. These efforts should be continued with larger riparian buffers being created (Figure 19).

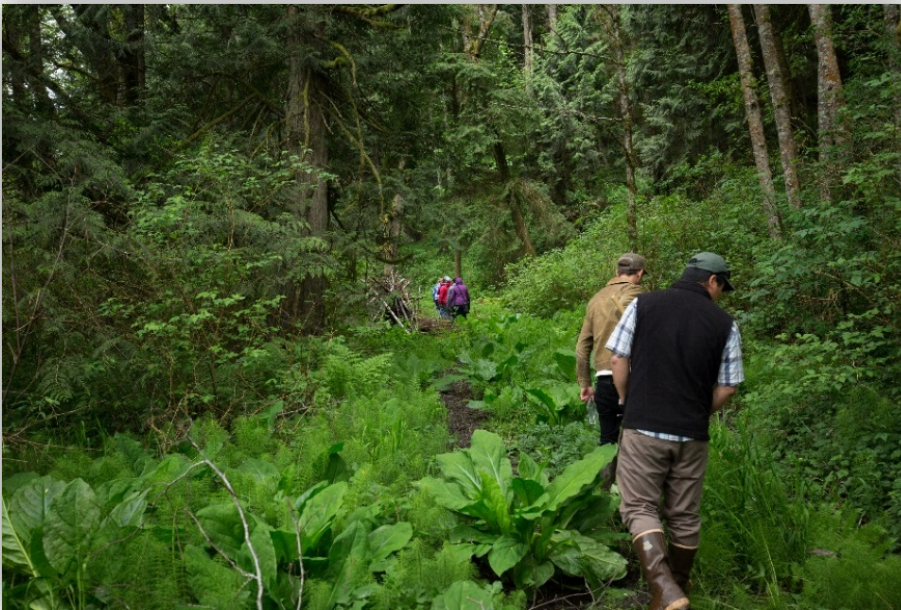
Figure 20. Forested, emergent slope wetland complex on the western boundary of Assessment Unit 4 (Potential Project #7.5). Note skunk cabbage, a wetland plant adapted to permanently saturated soils, in the foreground.

wetlands were present on the slope defining the western boundary of the depressional wetland complex in assessment unit 4 (Figure 20). The presence of skunk cabbage suggests that this area is saturated throughout the year and as such plays an important role in supporting baseflows in Springbrook Creek. These intact forested slope wetlands should be protected through conservation easements.

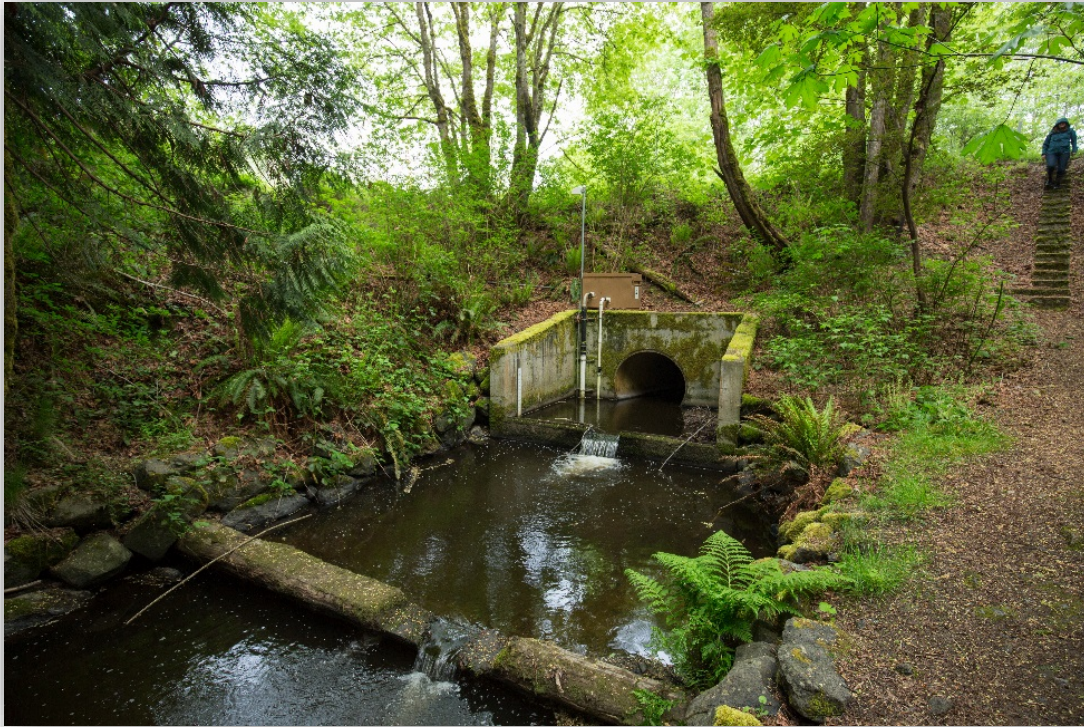
Figure 21. Culvert and weir system on Springbrook Creek just downstream of Fletcher Bay NE.

In PAU 1, as Springbrook Creek descends to meet its tidal channel and Fletcher Bay, it passes through a culvert under Fletcher Bay NE and through a series of downstream weirs (Figure 21).

This system was engineered to create an artificial stream gradient that met the elevation of the road culvert. The weir system, however, is beginning to fail, due to natural stream processes, which could result in the washing out of the weirs, headcutting and isolation of the culvert from the downstream streambed. This would make the upper watershed inaccessible to anadromous fish.

To avoid this, the existing culvert and weir system should eventually be replaced, with a larger bioengineered bottomless culvert that re-establishes the historic grade of the stream and eliminates the need for a “stepped” weir system.
