Reserve Silica - Comment Period for Agreed Order

Public comment invited

Site location and boundaries

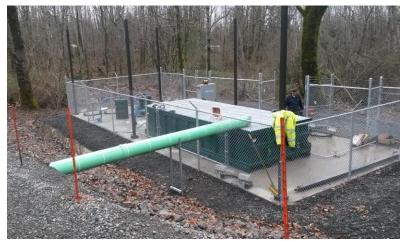
Figure 1. Treatment system installed to reduce pH and remove arsenic from the seepage.

In June 2016, Ecology's Water Quality Program issued a Notice of Violation for high pH water draining into the infiltration ponds. In 2017-2018, Holcim (US) Inc. installed a treatment system to lower the pH and remove arsenic from the seepage before it enters the infiltration ponds. (See Figure 1.) They extended the existing collection trench to the north to capture additional seepage. They also installed fencing around the seeps, drainage ditches, and infiltration ponds. Ecology and Public Health reviewed and approved the system design before construction. The treatment system began operating in 2018.

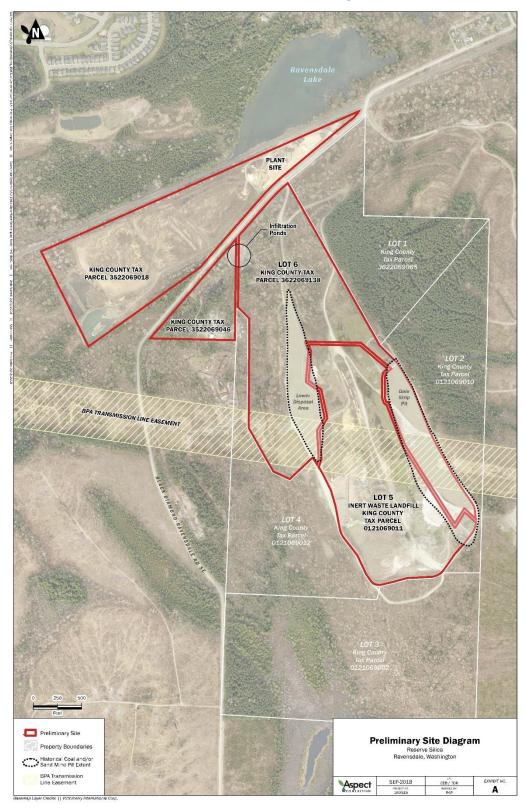
Reserve Silica site map

Figure 2. Satellite map of Reserve Silica site showing Lower Disposal Area, Dale Strip Pit, infiltration ponds, and King County Tax Parcels.

Earlier investigations suggest that the Site may be contained on King County Tax Parcel Numbers 3522069018, 3622069138, 0121069011, and 3522069046. (See map on page 3.) Under this Order, the results of the RI will determine the final boundaries of the Site.
