**Crystal Creek
Multi-Parameter
Total Maximum Daily Load**

**Water Quality
Effectiveness Monitoring Report**

Publication No. 18-10-007

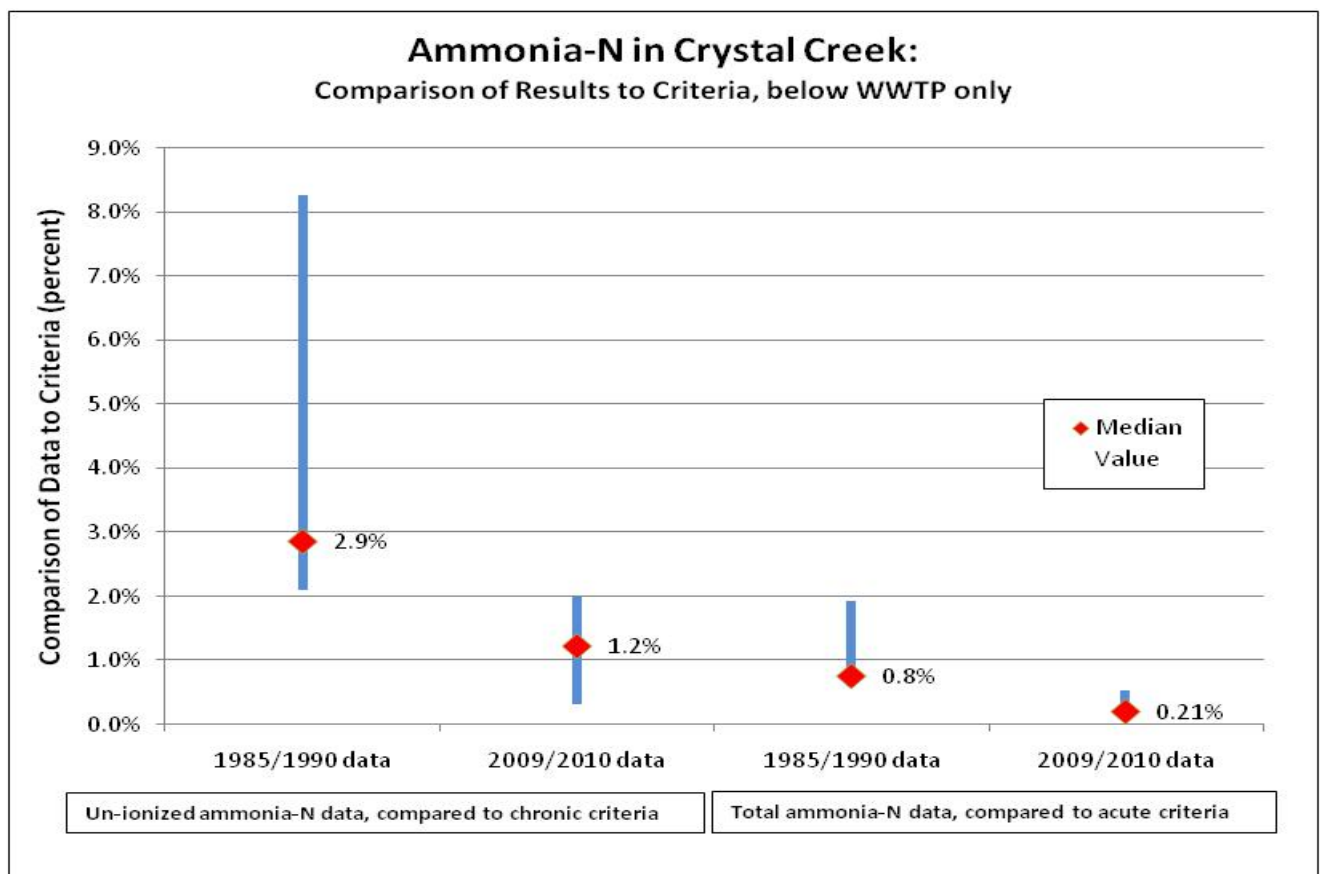
Figure 3: Change in ammonia-N levels in Crystal Creek, as compared to criteria, from 1985/1991 to 2009/2010. Points in chart represent data divided by criteria, shown as percent.

Water quality criteria for ammonia-N are dependent on stream temperature and pH at the time of the sample collection. See Appendix C. To assess variations in ammonia-N concentrations, we compared the change in the relationship between the criteria and the results. See Figure 3. Note that the high, low and median values, as compared to criteria, have decreased since the original TMDL data was collected.

The 2009/2010 samples were collected at site CRY2, about a mile downstream from the 1985/1990 sampling site. The site had to be moved downstream due to changes in property ownership and site access.

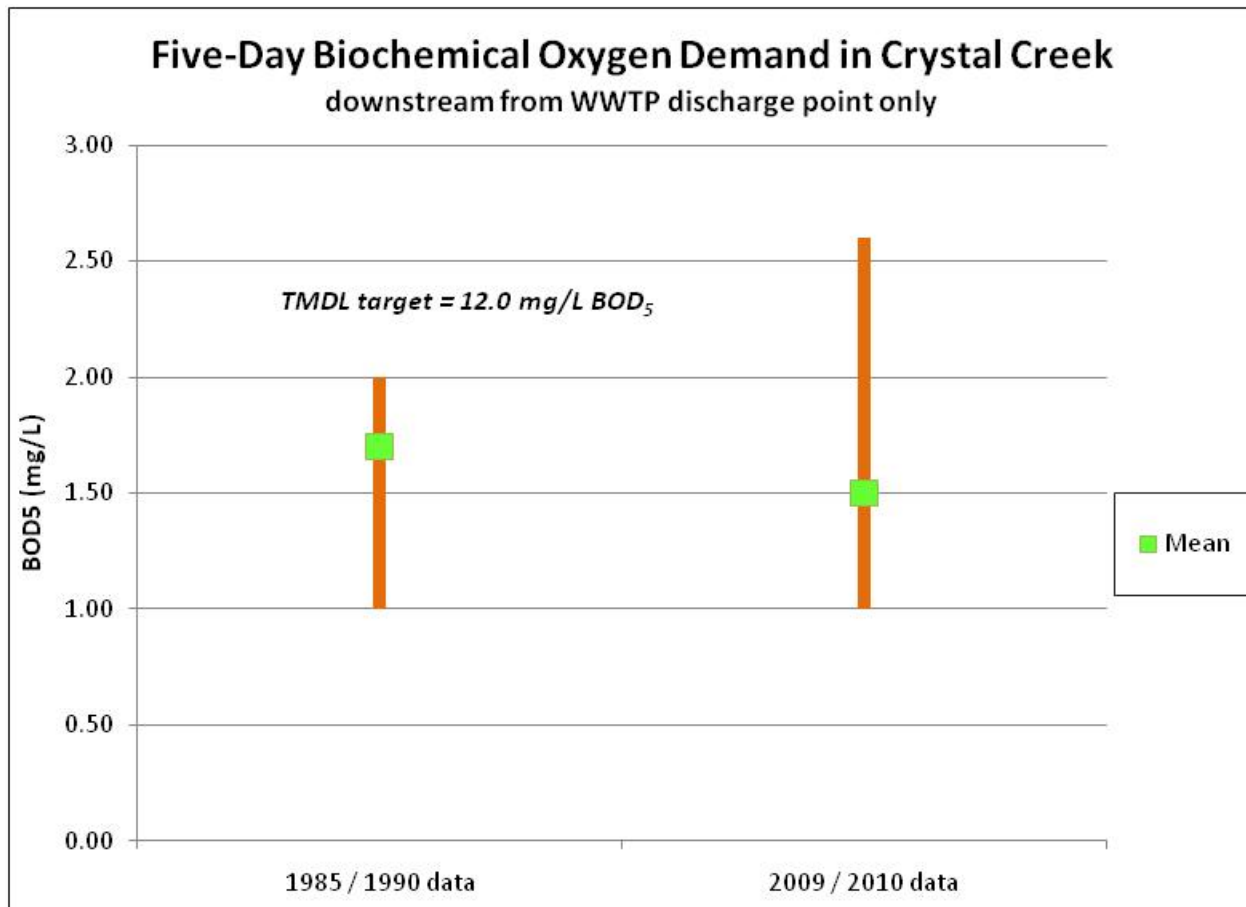
Figure 4: Five-day biochemical oxygen demand, Crystal Creek

BOD₅ in Crystal Creek decreased after the old Roslyn POTW stopped discharging effluent. While earlier results met DO water quality criteria for the creek, modeling showed that DO criteria might have been violated during very low flows. See Appendix D for BOD₅ data.

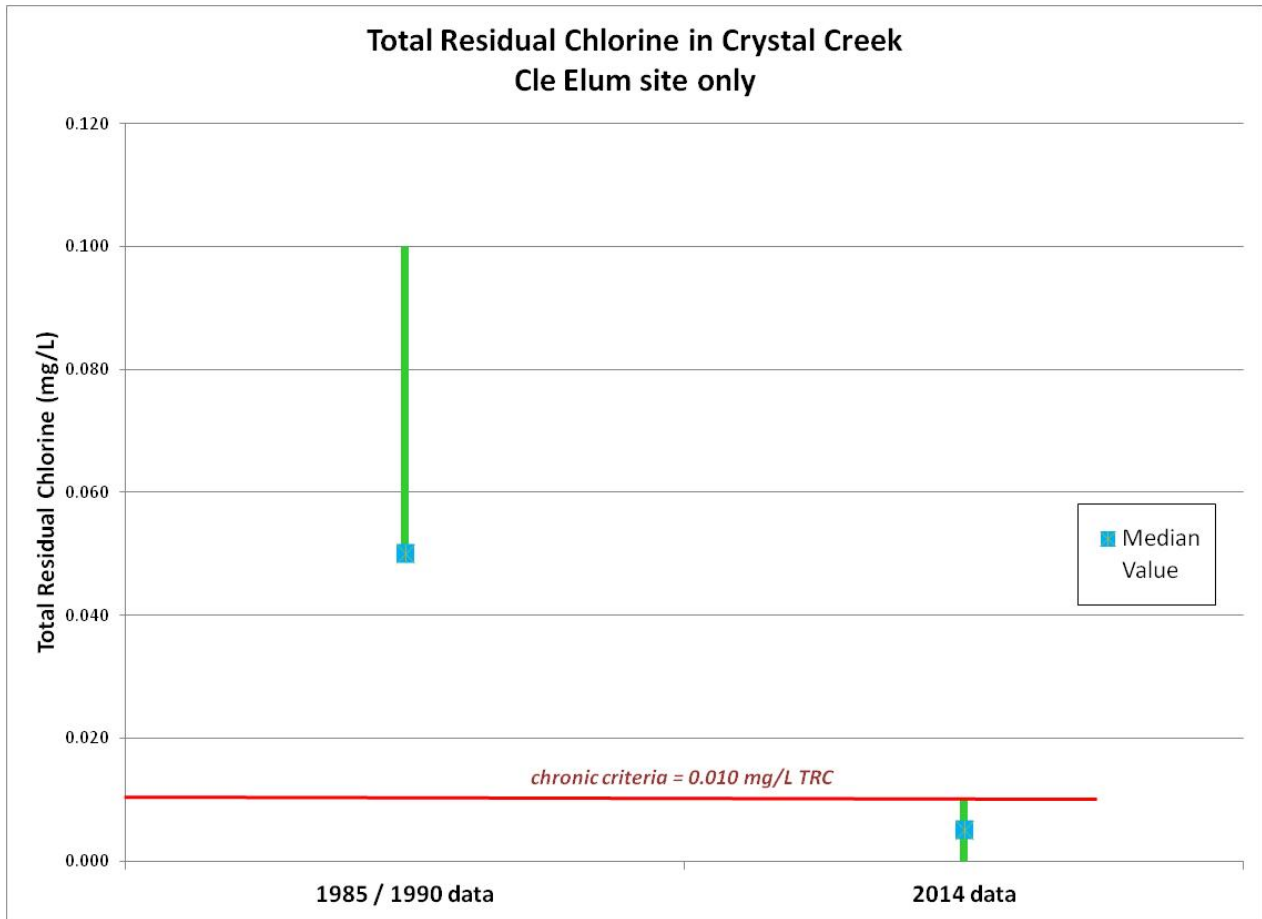
Figure 5: TRC in Crystal Creek

The original TMDL study showed exceedances of TRC criteria downstream from the old Roslyn POTW discharge site. Due to a change in creek accessibility following closure of the POTW, this monitoring project collected TRC samples about a mile downstream from the original site. Results from this effectiveness monitoring study found that the TRC data met criteria⁷. See Appendix F.

TRC. Following the testing equipment manufacturer's instructions on how to reduce or eliminate manganese interference, we found that TRC never exceeded state criteria. See Appendixes B for more detail on this procedure, and see Appendix F for resulting data.

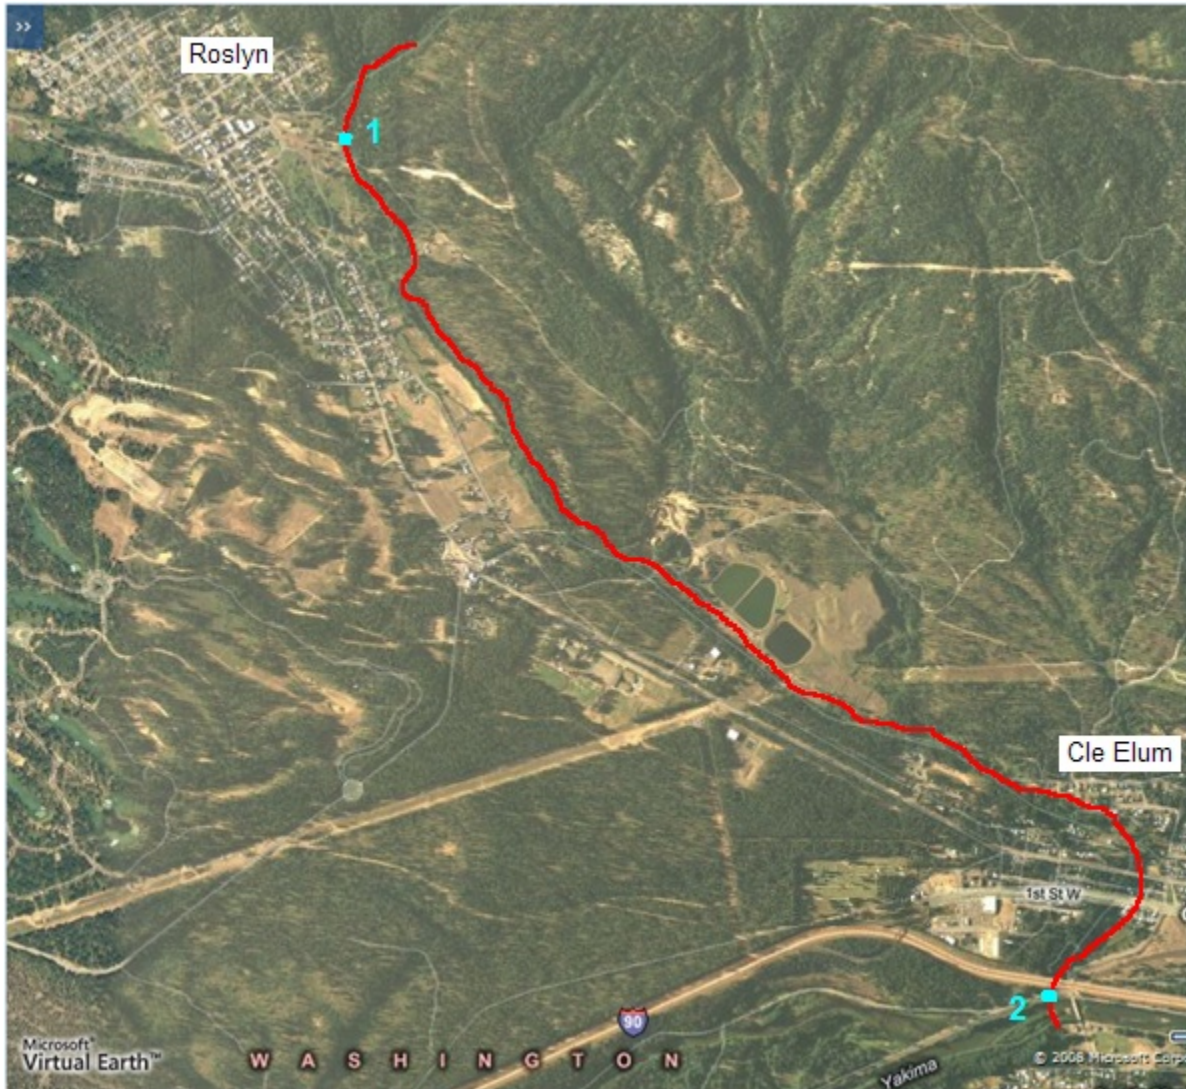
Figure A-1: Aerial view of Crystal Creek. Proposed sampling locations marked in blue.

The downstream site will be located where 1st Street West in Cle Elum crosses Crystal Creek. This site is about 1/3 mile from the confluence of Crystal Creek with the Yakima River.

See Figure A-1 (below) for location Crystal Creek and location of sampling sites.

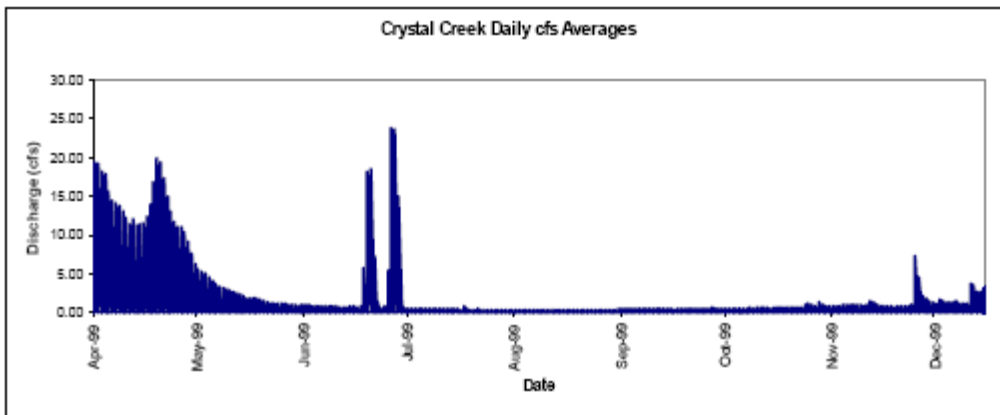
Figure A-2: 1999 flow data for Crystal Creek, collected just upstream of Site #2 for this project.
