Publication No. 21-03-075

Eyes Over Puget Sound

Surface Conditions Report: Sept 8, 2021

Up-to-date observations of water quality conditions in Puget Sound and coastal bays

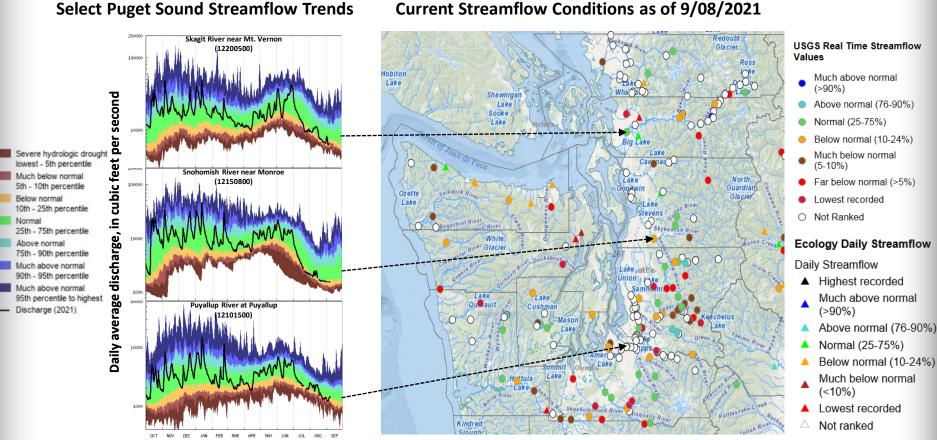
Current Streamflow Conditions as of 9/08/2021

normal (trend charts, left). Typically, snowmelt occurs gradually, which sustains streamflow later into the summer. **Spatial:** Streamflow conditions (map, right) currently vary from normal to the lowest recorded for a particular date at that location. Normal flow conditions are found at snow-dominated watersheds with reservoir storage, while low-flow conditions are found in rain-dominated watersheds, or those without reservoirs that can gradually release water.

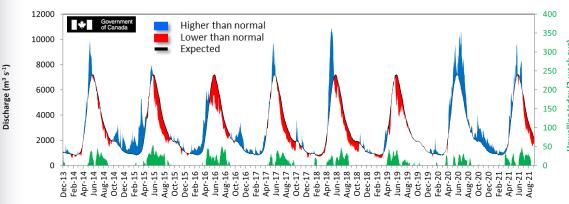
Fraser River (at midnight)

The Fraser River is the major driver of estuarine circulation and water exchange between the Salish Sea and the ocean. The Fraser River flows in summer 2021 were lower than expected. Upwelling off the coast appears earlier.

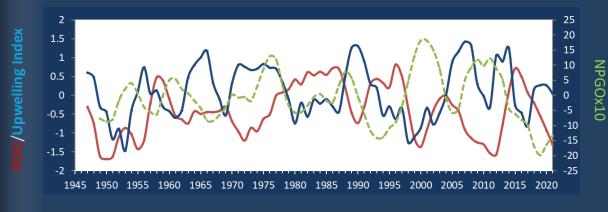
Three-year running average of PDO, Upwelling, and NPGO Indices

How do ocean boundary conditions affect the quality of water the Salish Sea exchanges with the ocean? Water has gradually cooled (PDO). Upwelling (Upwelling Index <u>anomaly</u>) is at expected level. Productivity in the eastern Pacific is lower (NPGO) (last updated June 2021).

Pacific Decadal Oscillation Index (**PDO, temperature**, <u>explanation</u>). Upwelling Index (anomalies) (**Upwelling, low** oxygen, <u>explanation</u>). North Pacific Gyre Oscillation Index (NPGO, productivity, <u>explanation</u>).

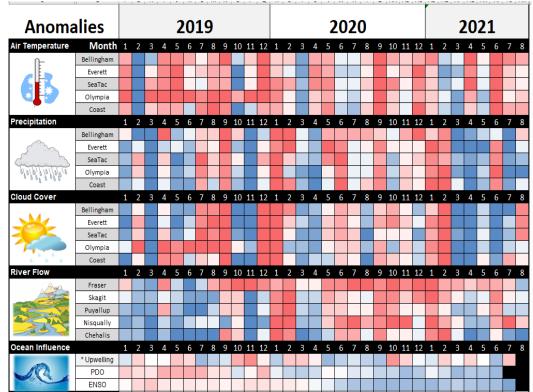
Conditions leading up to September:

Air temperatures have been mostly warmer this summer.

Precipitation has been much below normal since March, and is markedly lower than in 2020.

Cloud cover - Low cloud cover (sunny condition) follows low precipitation in 2021.

River flows are lower in 2021 than in 2020.

Upwelling has been variable this summer. PDO & ENSO are in cold phase (La Niña).

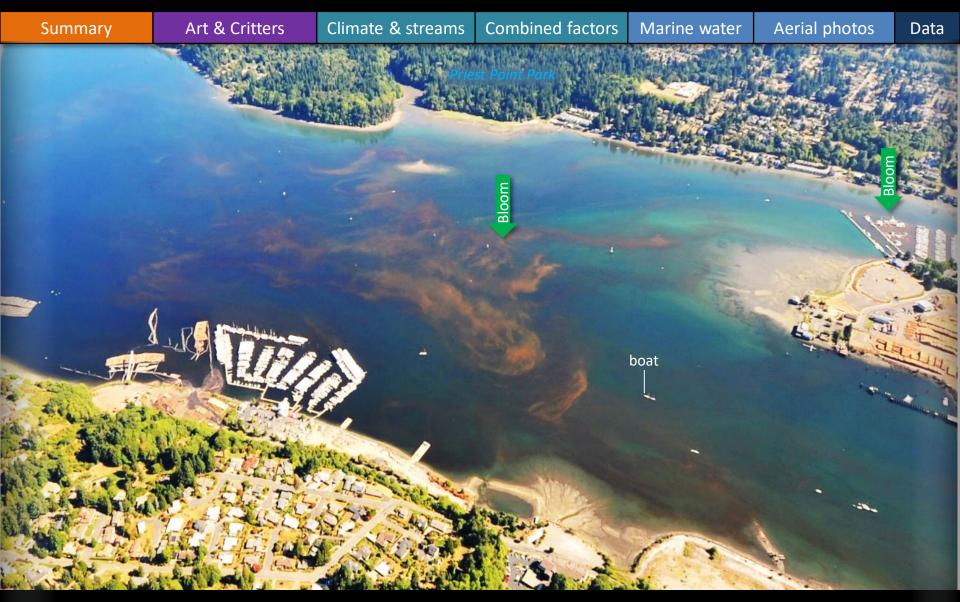
Strong red-brown bloom. Location: Budd Inlet (South Sound), 11:34 AM

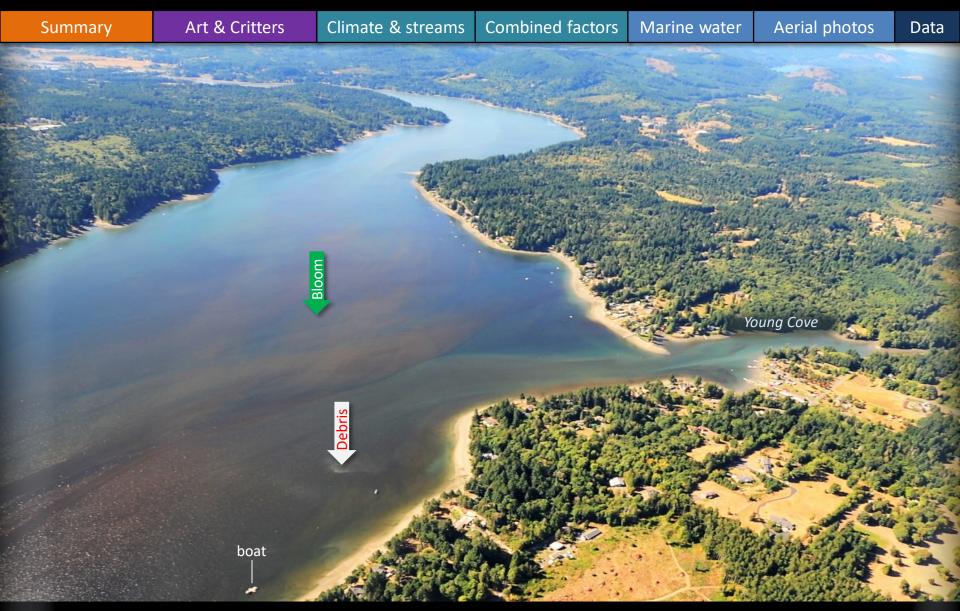
Red-brown bloom and milky-white water originating in Young Cove. Location: Eld Inlet (South Sound), 11:35 AM

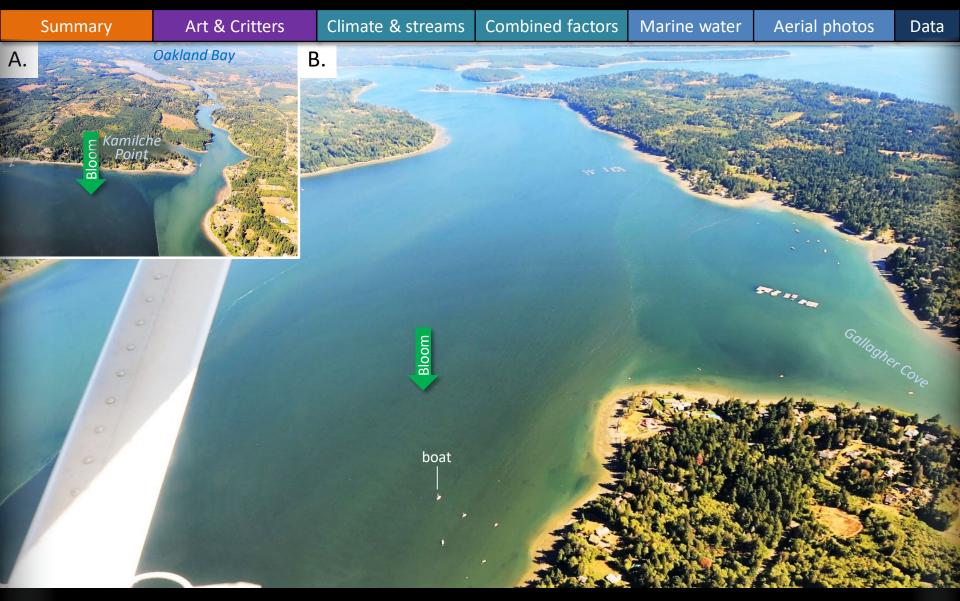
Different-colored water originating from A. Oakland Bay. B. Water remaining separated while flowing north. Location: Totten Inlet (South Sound), 11:38 AM

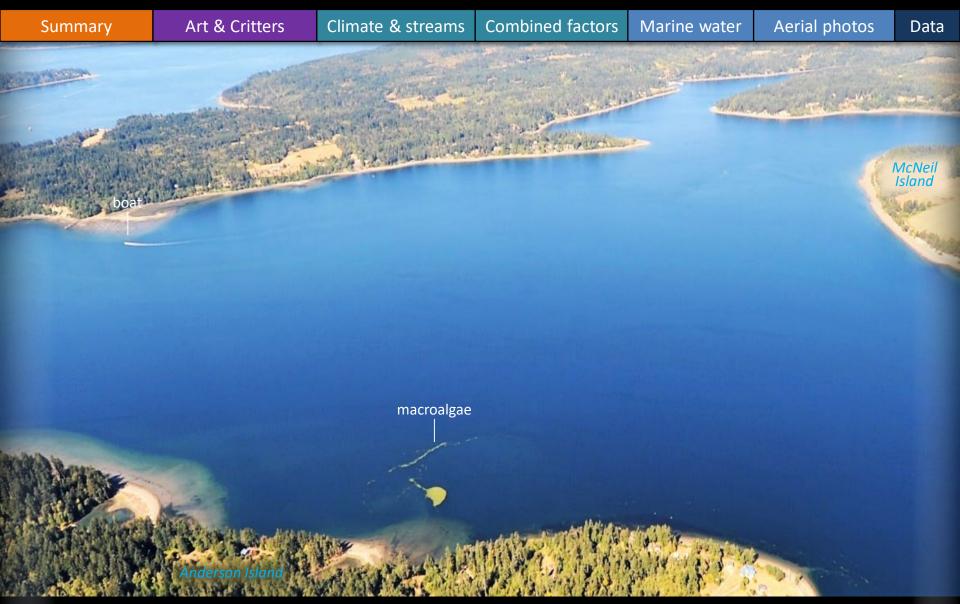
Large raft of organic material. Location: Anderson Island (South Sound), 11:46 AM

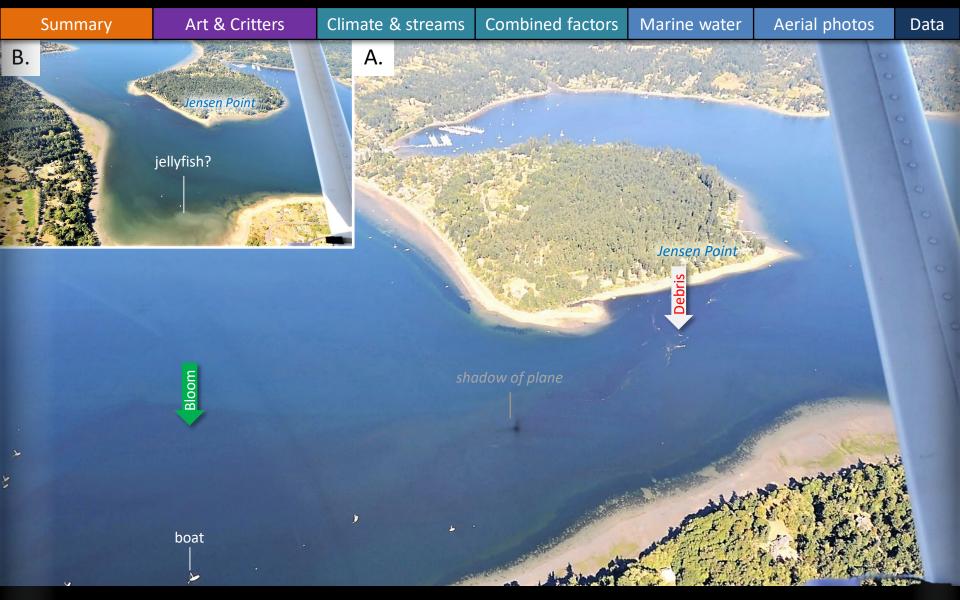
A. Weak brown-reddish bloom near Dockton. B. Whitish water, perhaps jellyfish, in Rabbs Lagoon. Location: Quartermaster Harbor (Central Sound) 11:55 AM DEPARTMENT OF ECOLOGY State of Washington

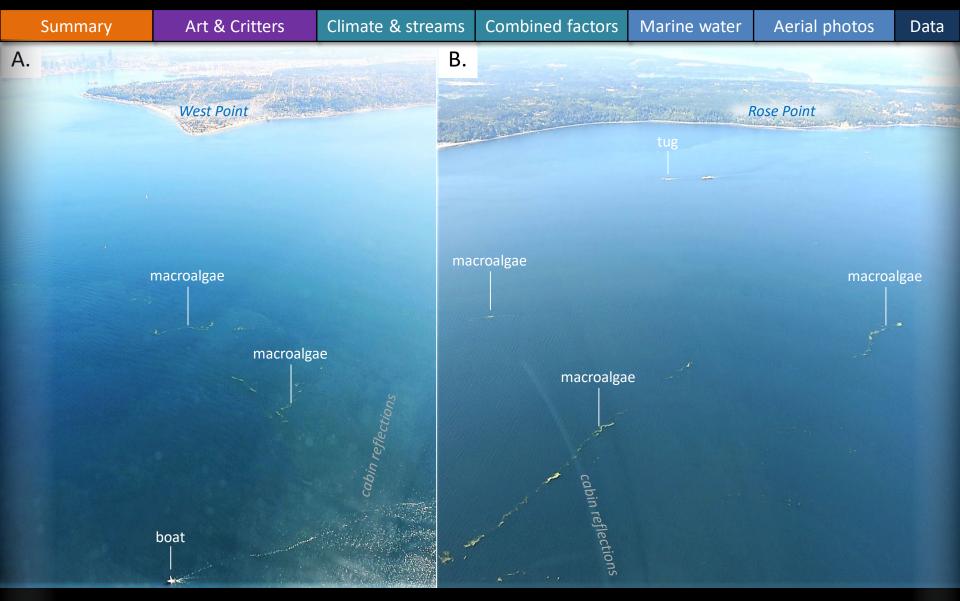
Large of organic debris drifting between A. West Point and B. Kingston. Location: Carr Inlet (Central Sound), 12:01 PM

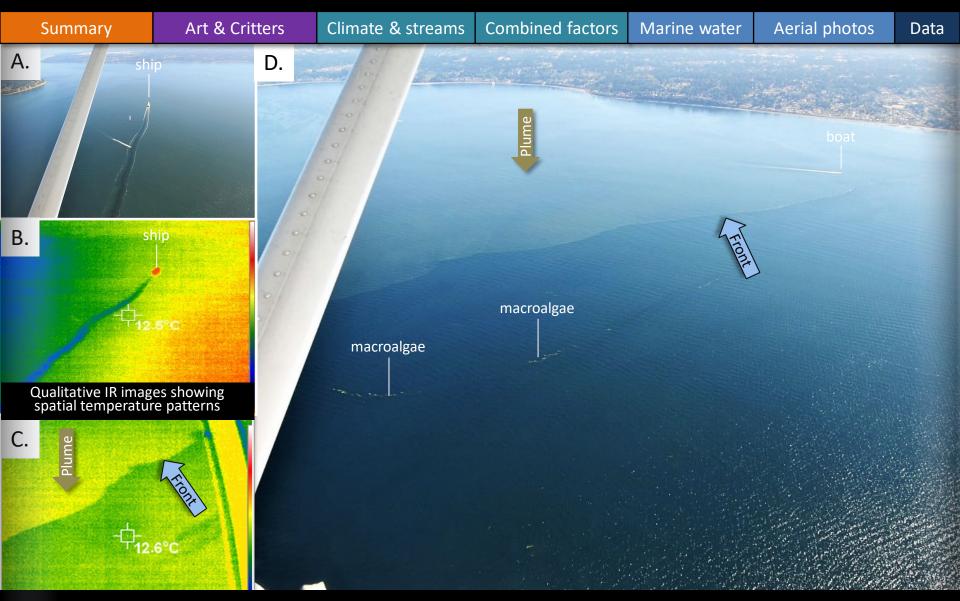
The wake of a boat reveals A. a thin surface layer of lower-density water and B-C. slightly warmer water from Whidbey Basin entering Central Sound. Location: Edmonds (Central Sound), 12:12 PM

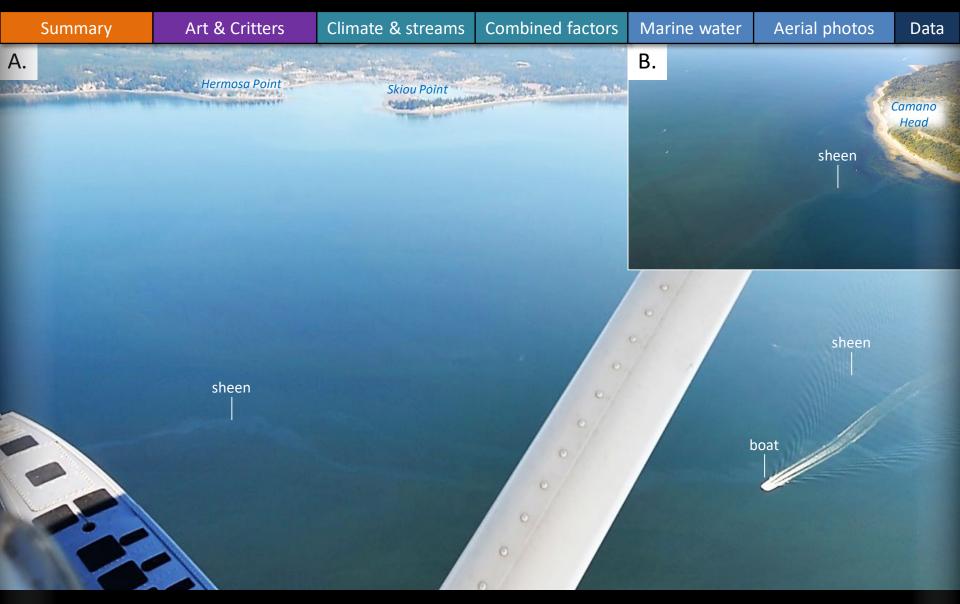
Long oil sheen stretching from Hat Island to Camano Head. Location: Entrance to Port Susan (Whidbey Basin), 12:17 PM 9 DEPARTMENT OF ECOLOGY State of Washington

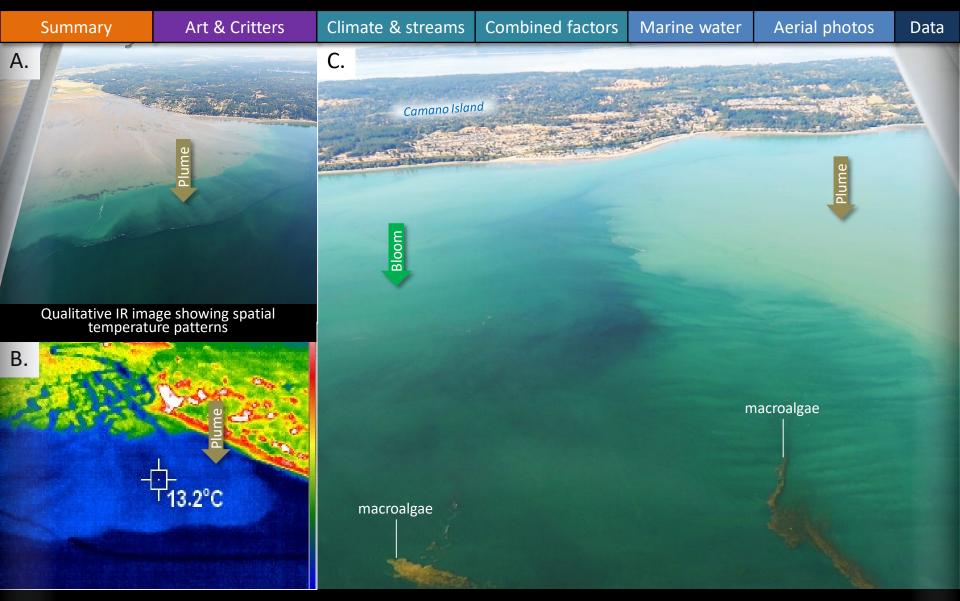
A. Stillaguamish estuary with B. relatively cool tideflat despite sunshine. C. Large rafts of organic material of different color and composition. Location: Port Susan (Whidbey Basin), 12:23 PM

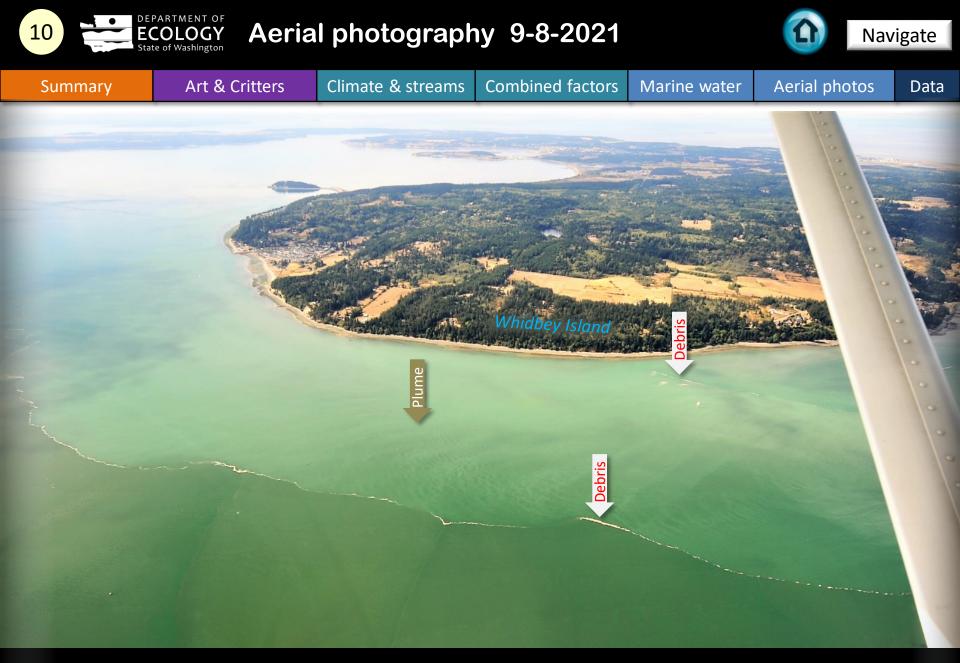
Organic material accumulating at edge of Skagit River plume. Location: Skagit Bay (North Sound), 12:28 PM

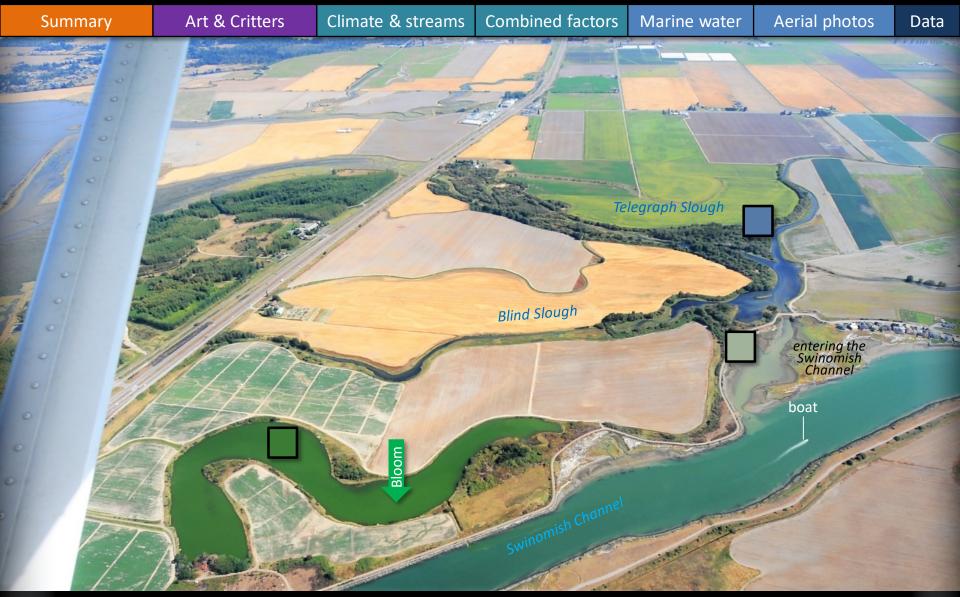
Very green bloom in an old disconnected slough. Very different water colors in Telegraph and Blind Sloughs and as the water enters the Swinomish Channel. Location: Swinomish Channel (North Sound), 12:33 PM

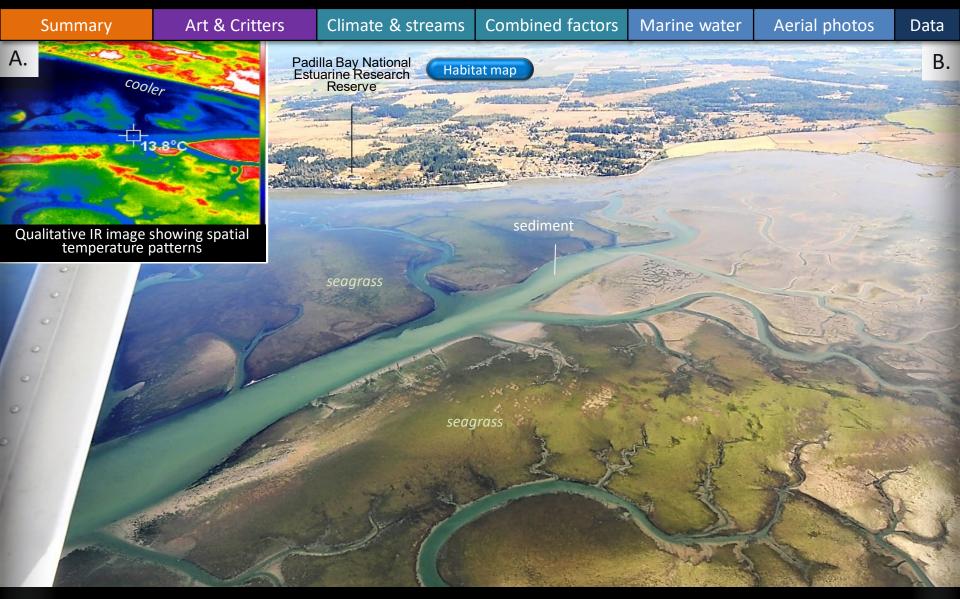
Padilla Bay seagrass experiences much cooler temperatures north of the tidal gully. Sediment from south of the gully discolors the water. Location: Padilla Bay (North Sound), 12:35 PM

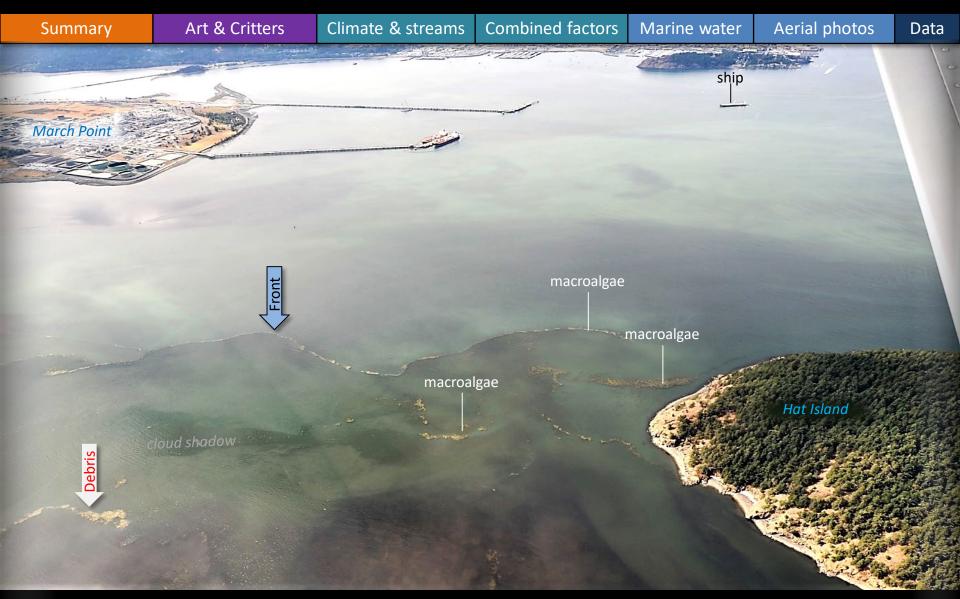
Large rafts of organic material drifting in water discolored by a bloom. Location: Padilla Bay (North Sound), 12:36 PM

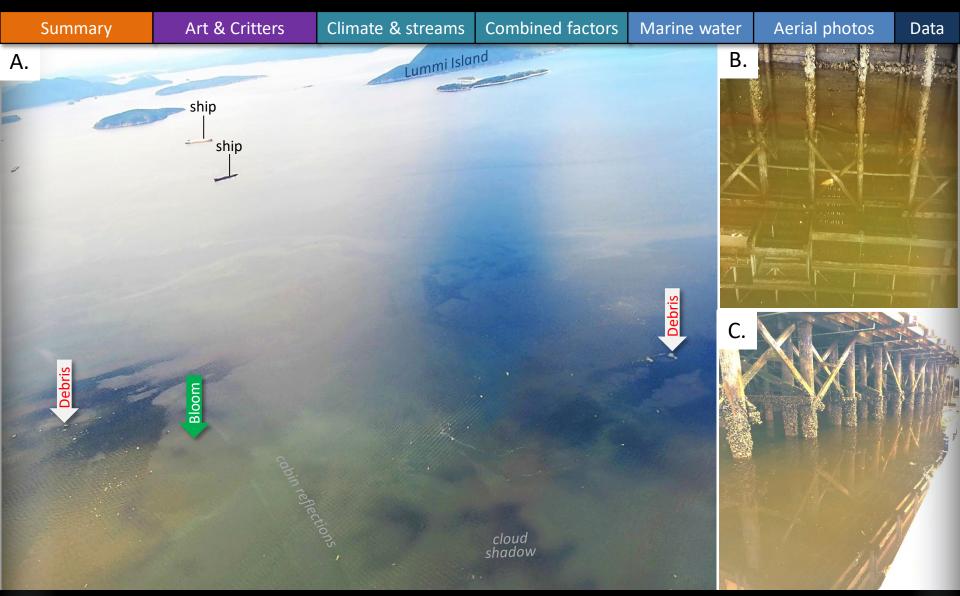
A. Strong red bloom and drifting organic material in Samish Bay. B-C. Red-brown bloom in Squalicum Harbor. Location: A. Samish Bay, B-C. Bellingham Bay (North Sound), 12:40 PM

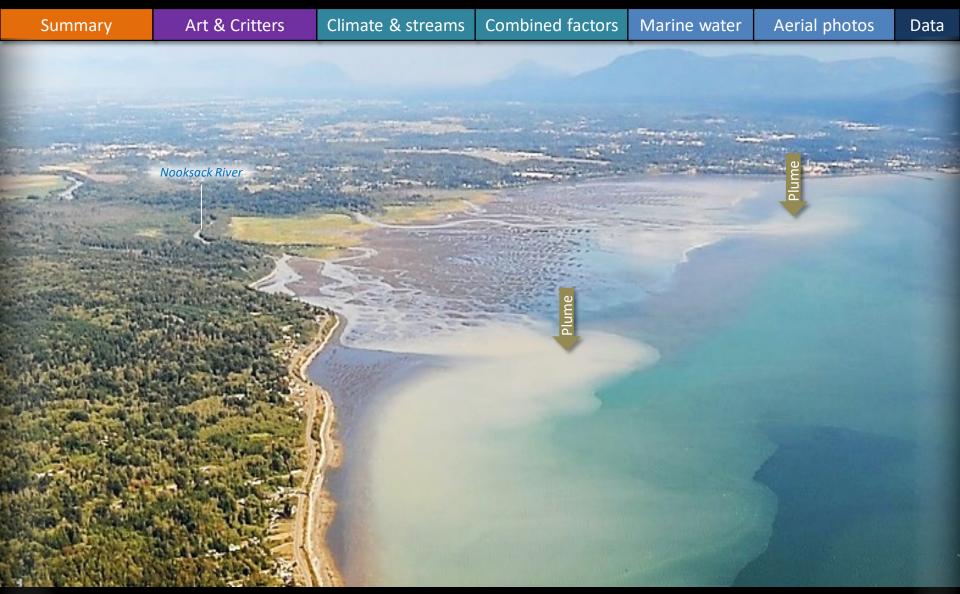
Plumes of the forks of the Nooksack River moving in opposite directions. Location: Bellingham Bay (North Sound), 12:46 PM

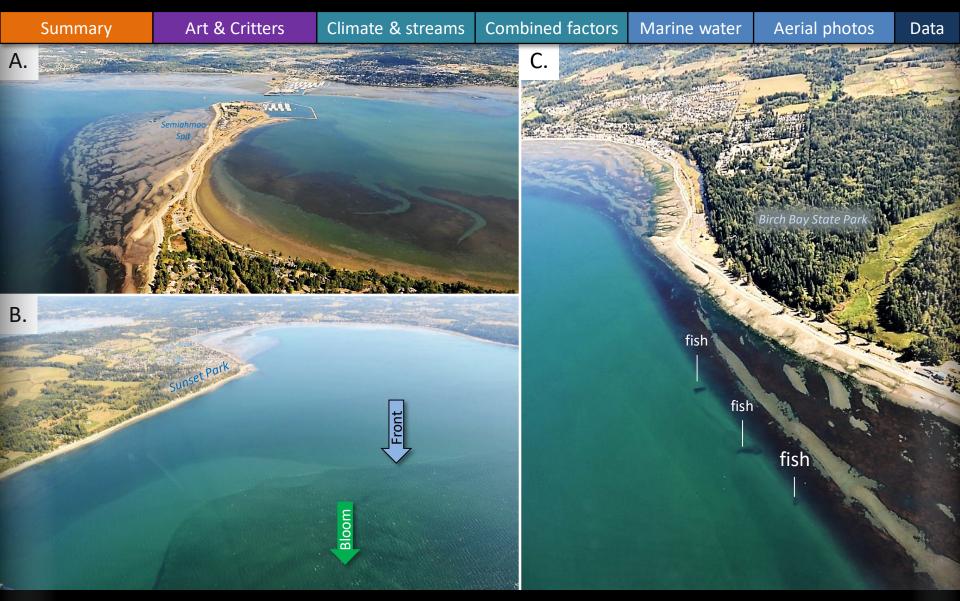
A. Drayton Harbor with seagrass. B. Front and different water masses at entrance to Birch Bay. C. Schools of fish near seagrass bed. Location: A. Drayton Harbor, B-C. Birch Bay (North Sound), 12:53 PM

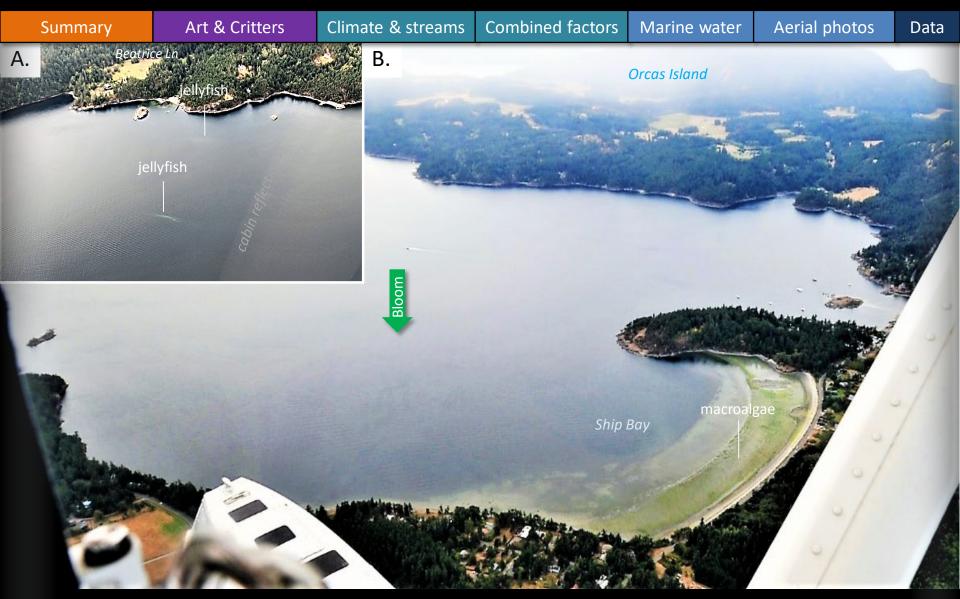
A. Patches of jellyfish, red-brown bloom (low visibility due to rain) and B. macroalgae on beach in Ship Bay. Location: East Sound, Orcas Island (North Sound), 1:07 PM

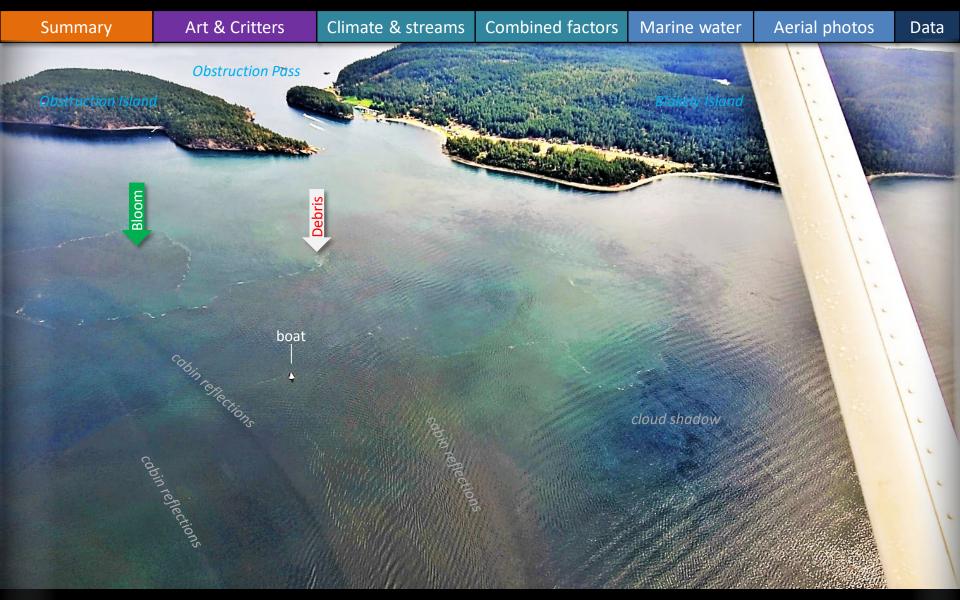
Red-brown algae bloom from East Sound mixing with clearer water entering via Obstruction Pass. Location: East Sound, Orcas Island (North Sound), 1:12PM

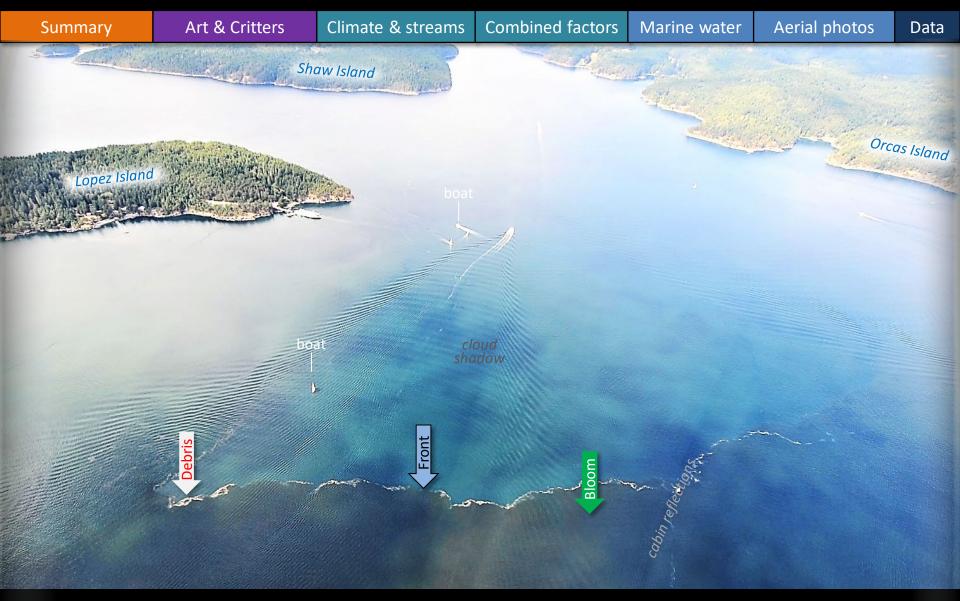
Strong brown bloom and organic material accumulating at a distinct front. Location: Shoal Bay (North Sound), 1:12 PM

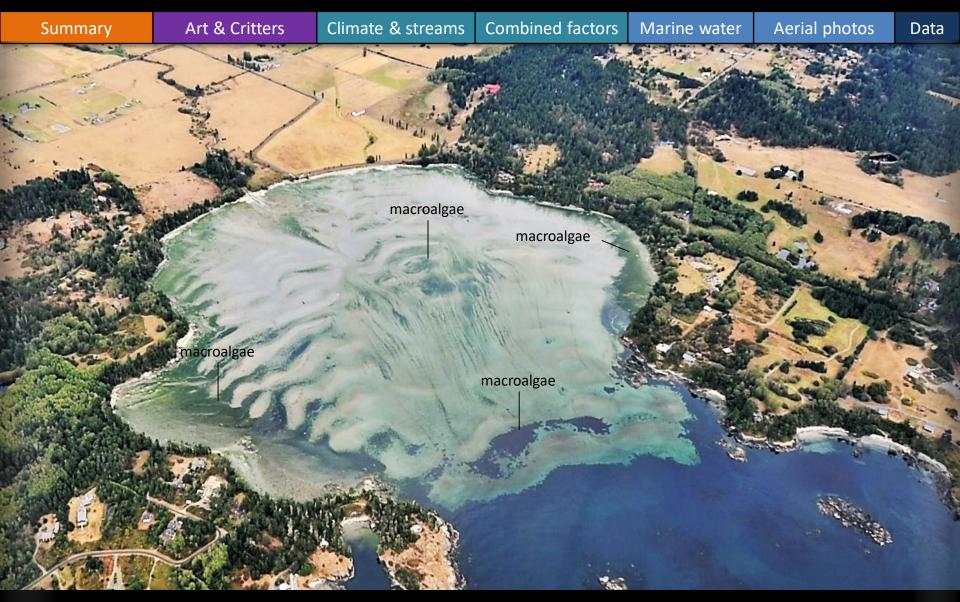
Macroalgae growing around perimeter of False Bay. Location: San Juan Island (San Juan Islands), 1:24 PM

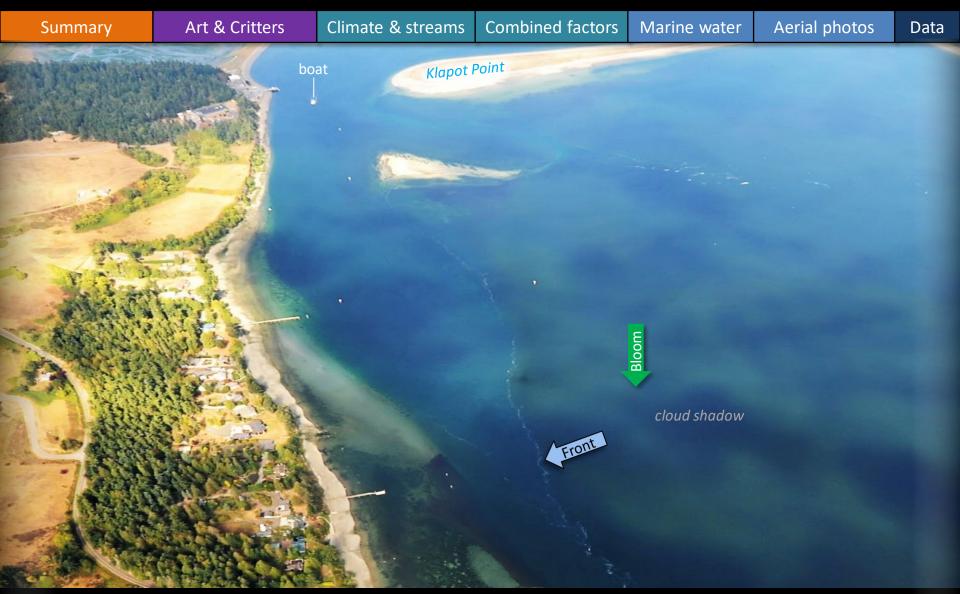
Bloom, tidal front, organic material, and suspended sediment near western shoreline. Location: Sequim Bay (North Sound), 1:40 PM

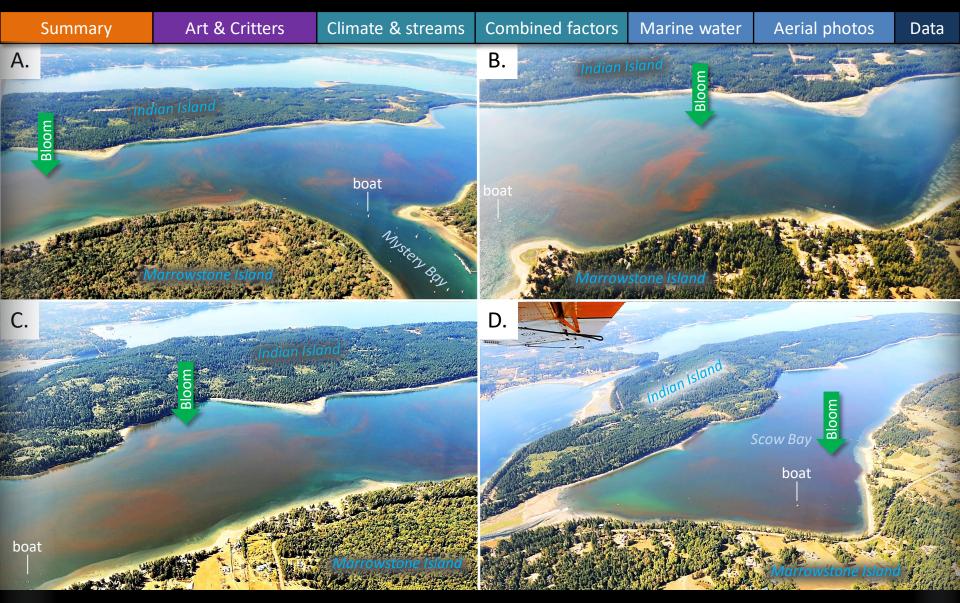
Very red-brown bloom spanning the entire length of Kilisut Harbor, from the entrance of the bay to Scow Bay. Location: Marrowstone Island (Central Sound), 1:50 PM

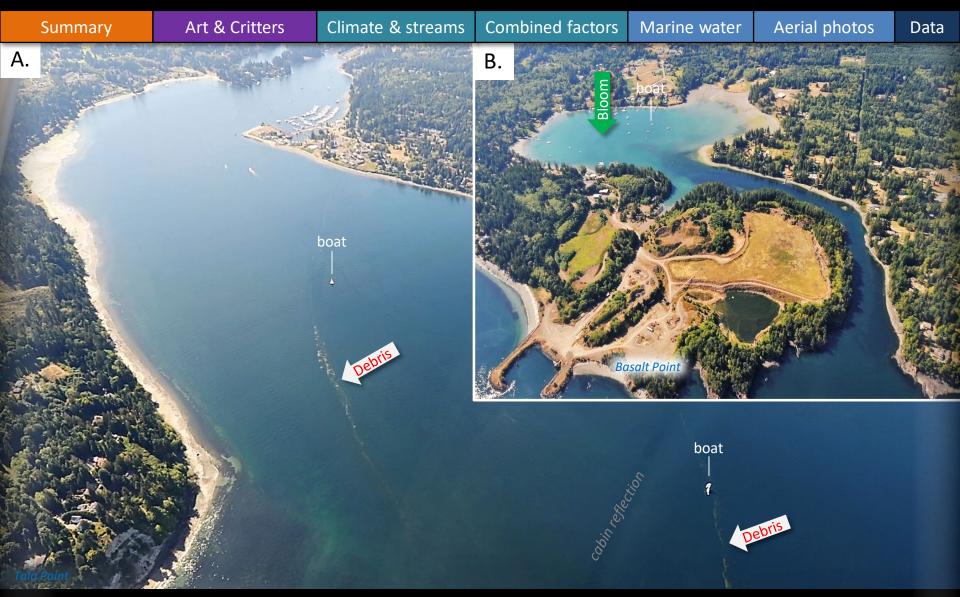
A. Long ribbons of organic material drifting at surface. B. Turquoise-colored water in Mats Mats Bay. Location: A. Port Ludlow, B. Mats Mats Bay (Central Sound), 1:54 PM

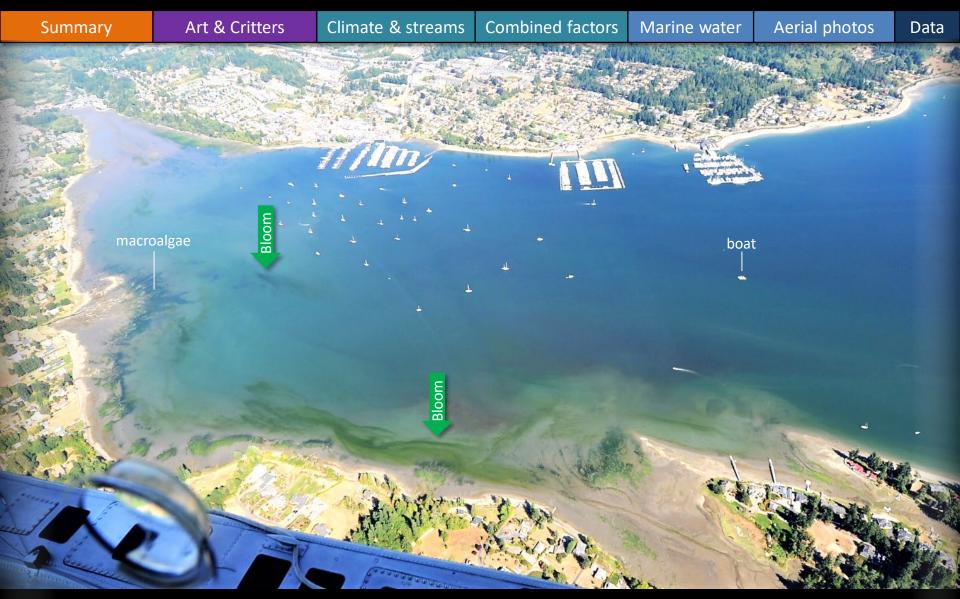
Bright-green bloom patches in shallow portions of Liberty Bay. Location: Liberty Bay (Central Sound), 2:02 PM

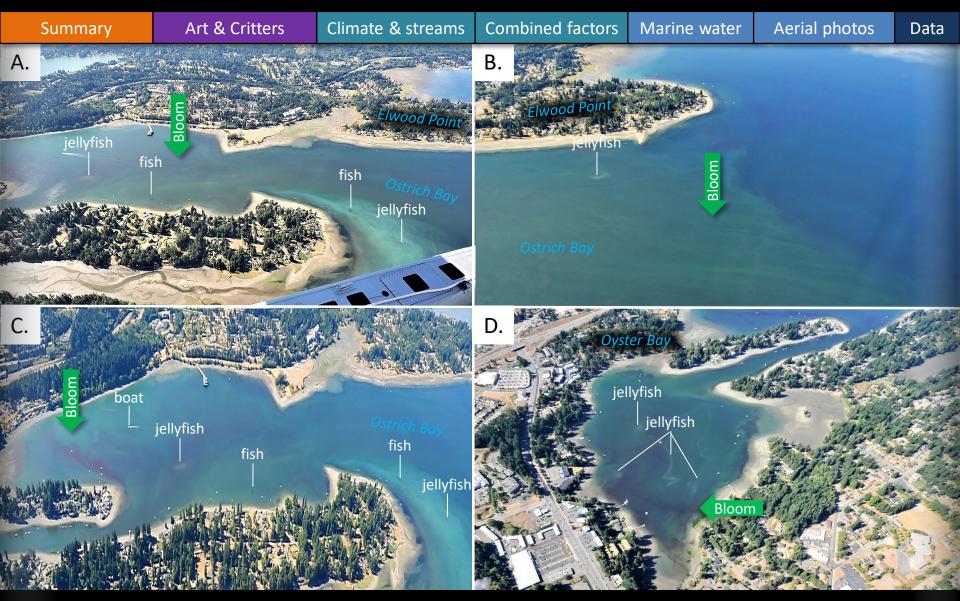
A. Milky-white patches and red-brown bloom in Ostrich Bay. B-D. Jellyfish patches in Ostrich and Oyster Bays. Location: Dyes Inlet (Central Sound), 2:08 PM

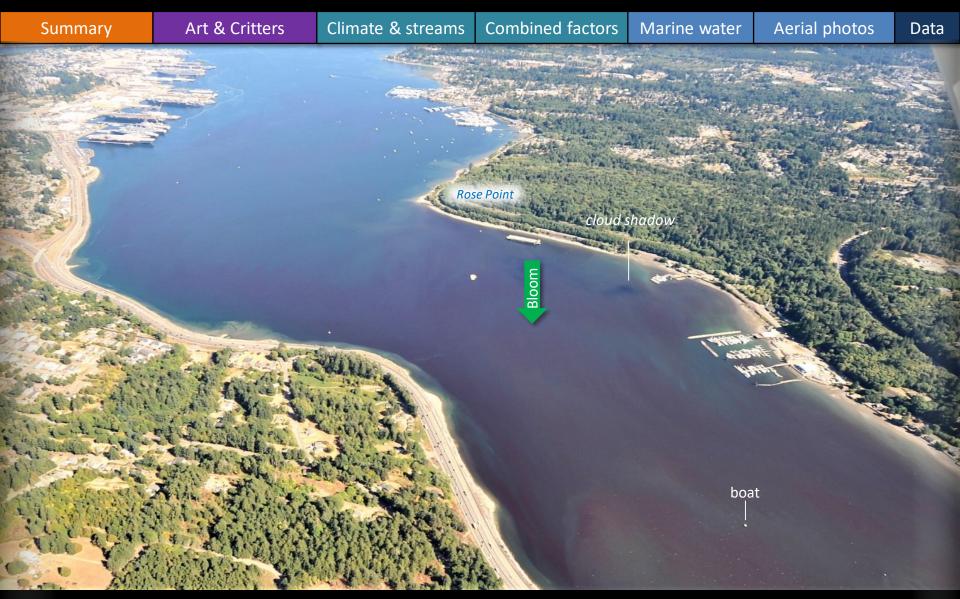
Strong red-brown bloom, but no jellyfish. Location: Sinclair Inlet (Central Sound), 2:11 PM

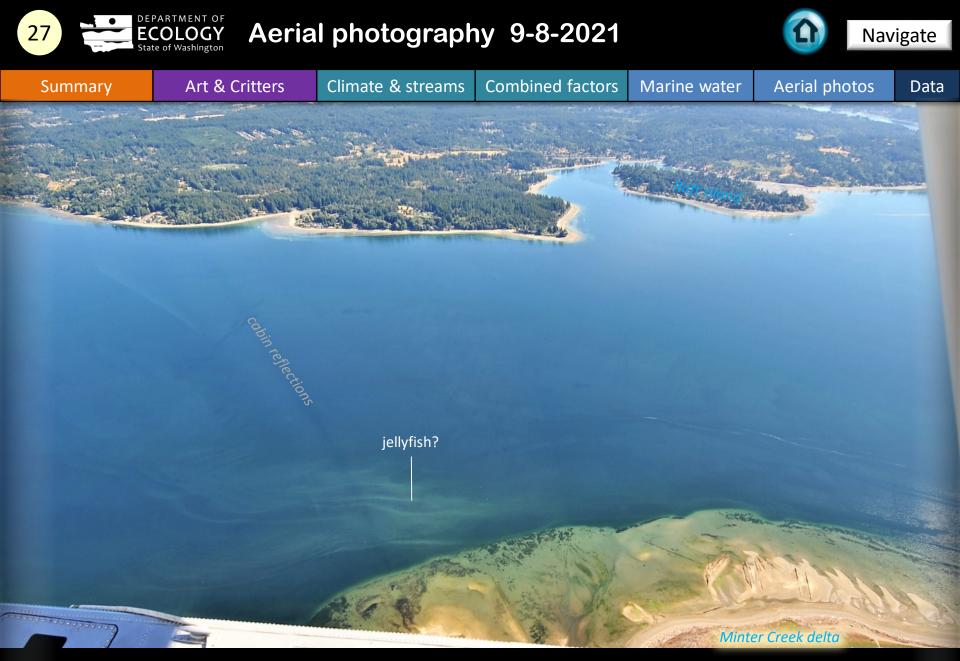
Turqouise patch that appeared granular, which could be a diffuse patch of jellyfish. Location: Carr Inlet (Central Sound), 2:18 PM

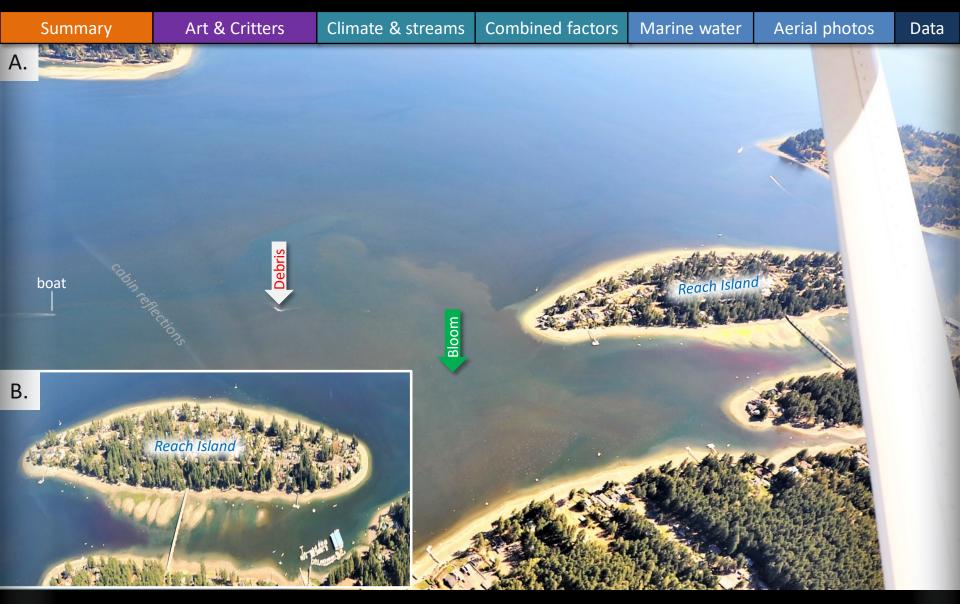
A. Red-brown and red bloom. B. It matters on which side of the bridge one takes a plankton sample! Location: Case Inlet (South Sound), 2:22 PM

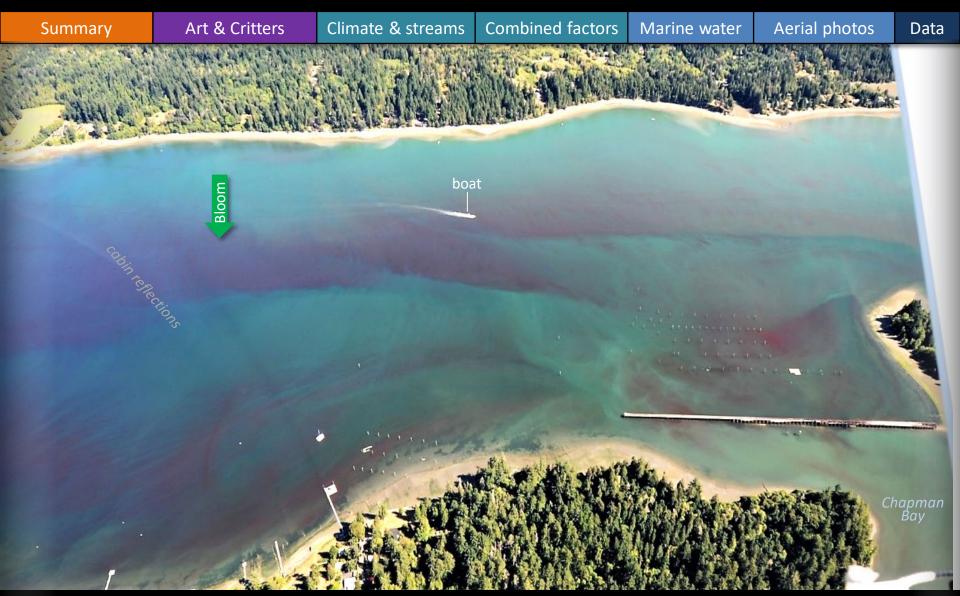
Strong red-brown bloom with turquoise water mixing in from Chapman bay. Location: Henderson Inlet (South Sound), 2:30 PM

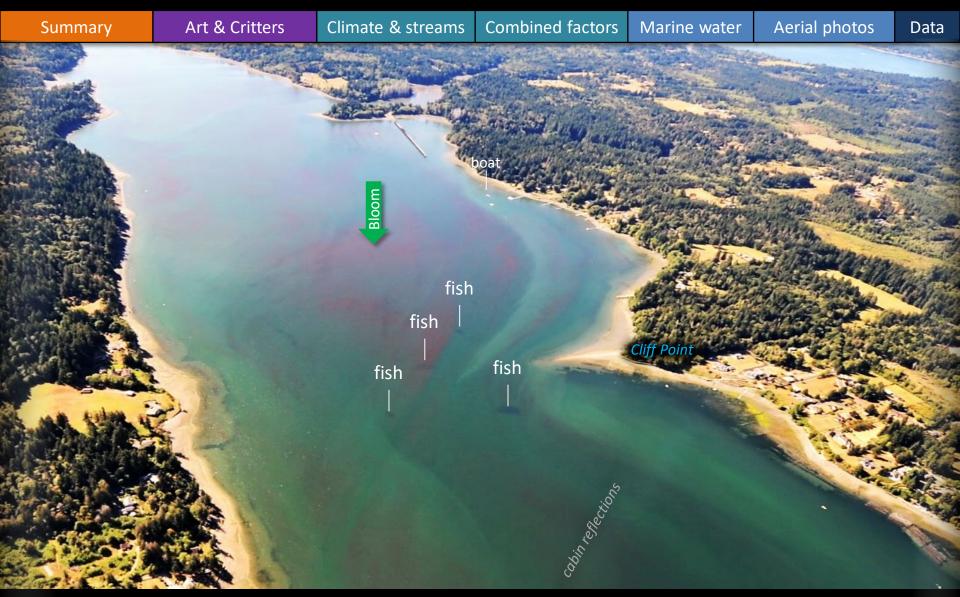
Strong red-brown bloom with turquoise water mixing in from Chapman bay. Schools of fish near Cliff Point. Location: Henderson Inlet (South Sound), 12:42 PM
