Sprague Lake Hydrologic Study

Flood-risk reduction alternatives analysis

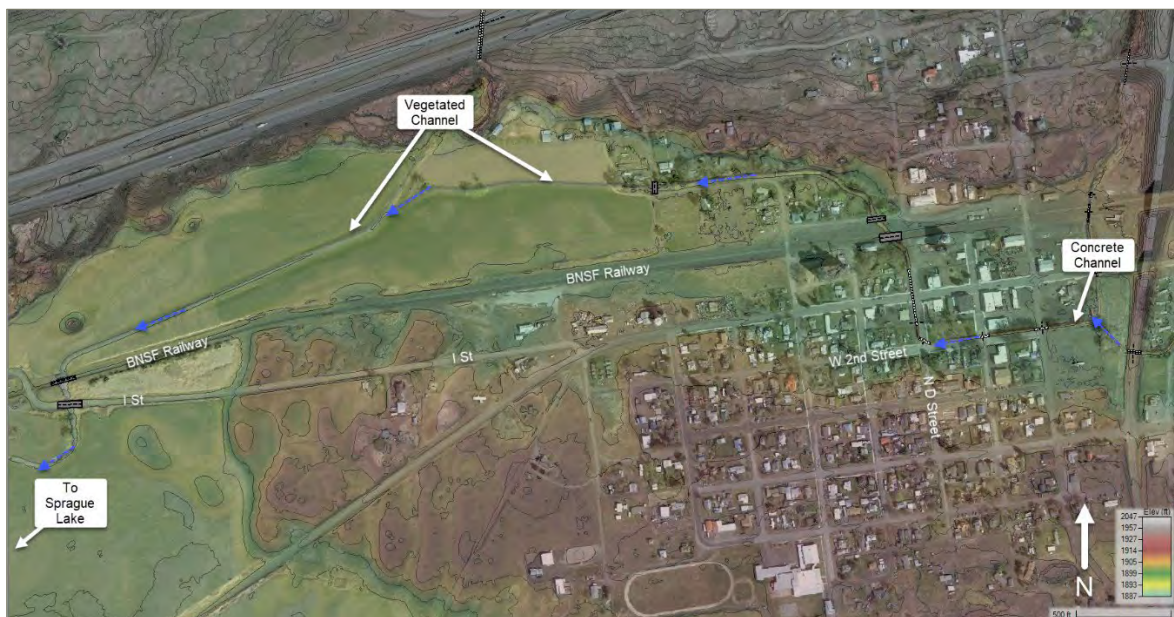
Exhibit 2-1: City of Sprague Drainage Network

The City surface water is drained by a series of concrete open channels and box culverts, which roughly follow West 2nd Street and North D Street. These channels collect stormwater throughout the City and discharge it under the BNSF railway to the north into a man-made vegetated channel. This vegetated channel meanders west and crosses the BNSF railway a second time, as well as I Street to the south. The vegetated channel then transitions into a natural streambed over the remaining 2 river miles as it winds through pastureland and eventually meets the shoreline of Sprague Lake (Exhibit 2-1).

This watercourse through the City is fed by three distinct tributaries that directly affect flooding in the City. An unnamed tributary to the northwest, draining 44 square miles, crosses I-90 and joins the man-made vegetated channel north of the BNSF railway. A second unnamed tributary to the northeast follows State Route (SR) 23 south, draining 2.8 square miles, crosses I-90 and discharges into the upstream end of the concrete channels through City. Negro Creek is the main tributary of the lake and drains 215 square miles of lakes, pasture, woodlands, and open range directly east of the City. It crosses SR 23 and transitions into the concrete channel complex. The two unnamed tributaries (2.8-square-mile North Tributary East and 43.8-square-mile North Tributary West) are dry bed and only saturated during rain events. Negro Creek can clearly be seen in aerial photography switching between surface water and subsurface flow (Exhibit 2-2).

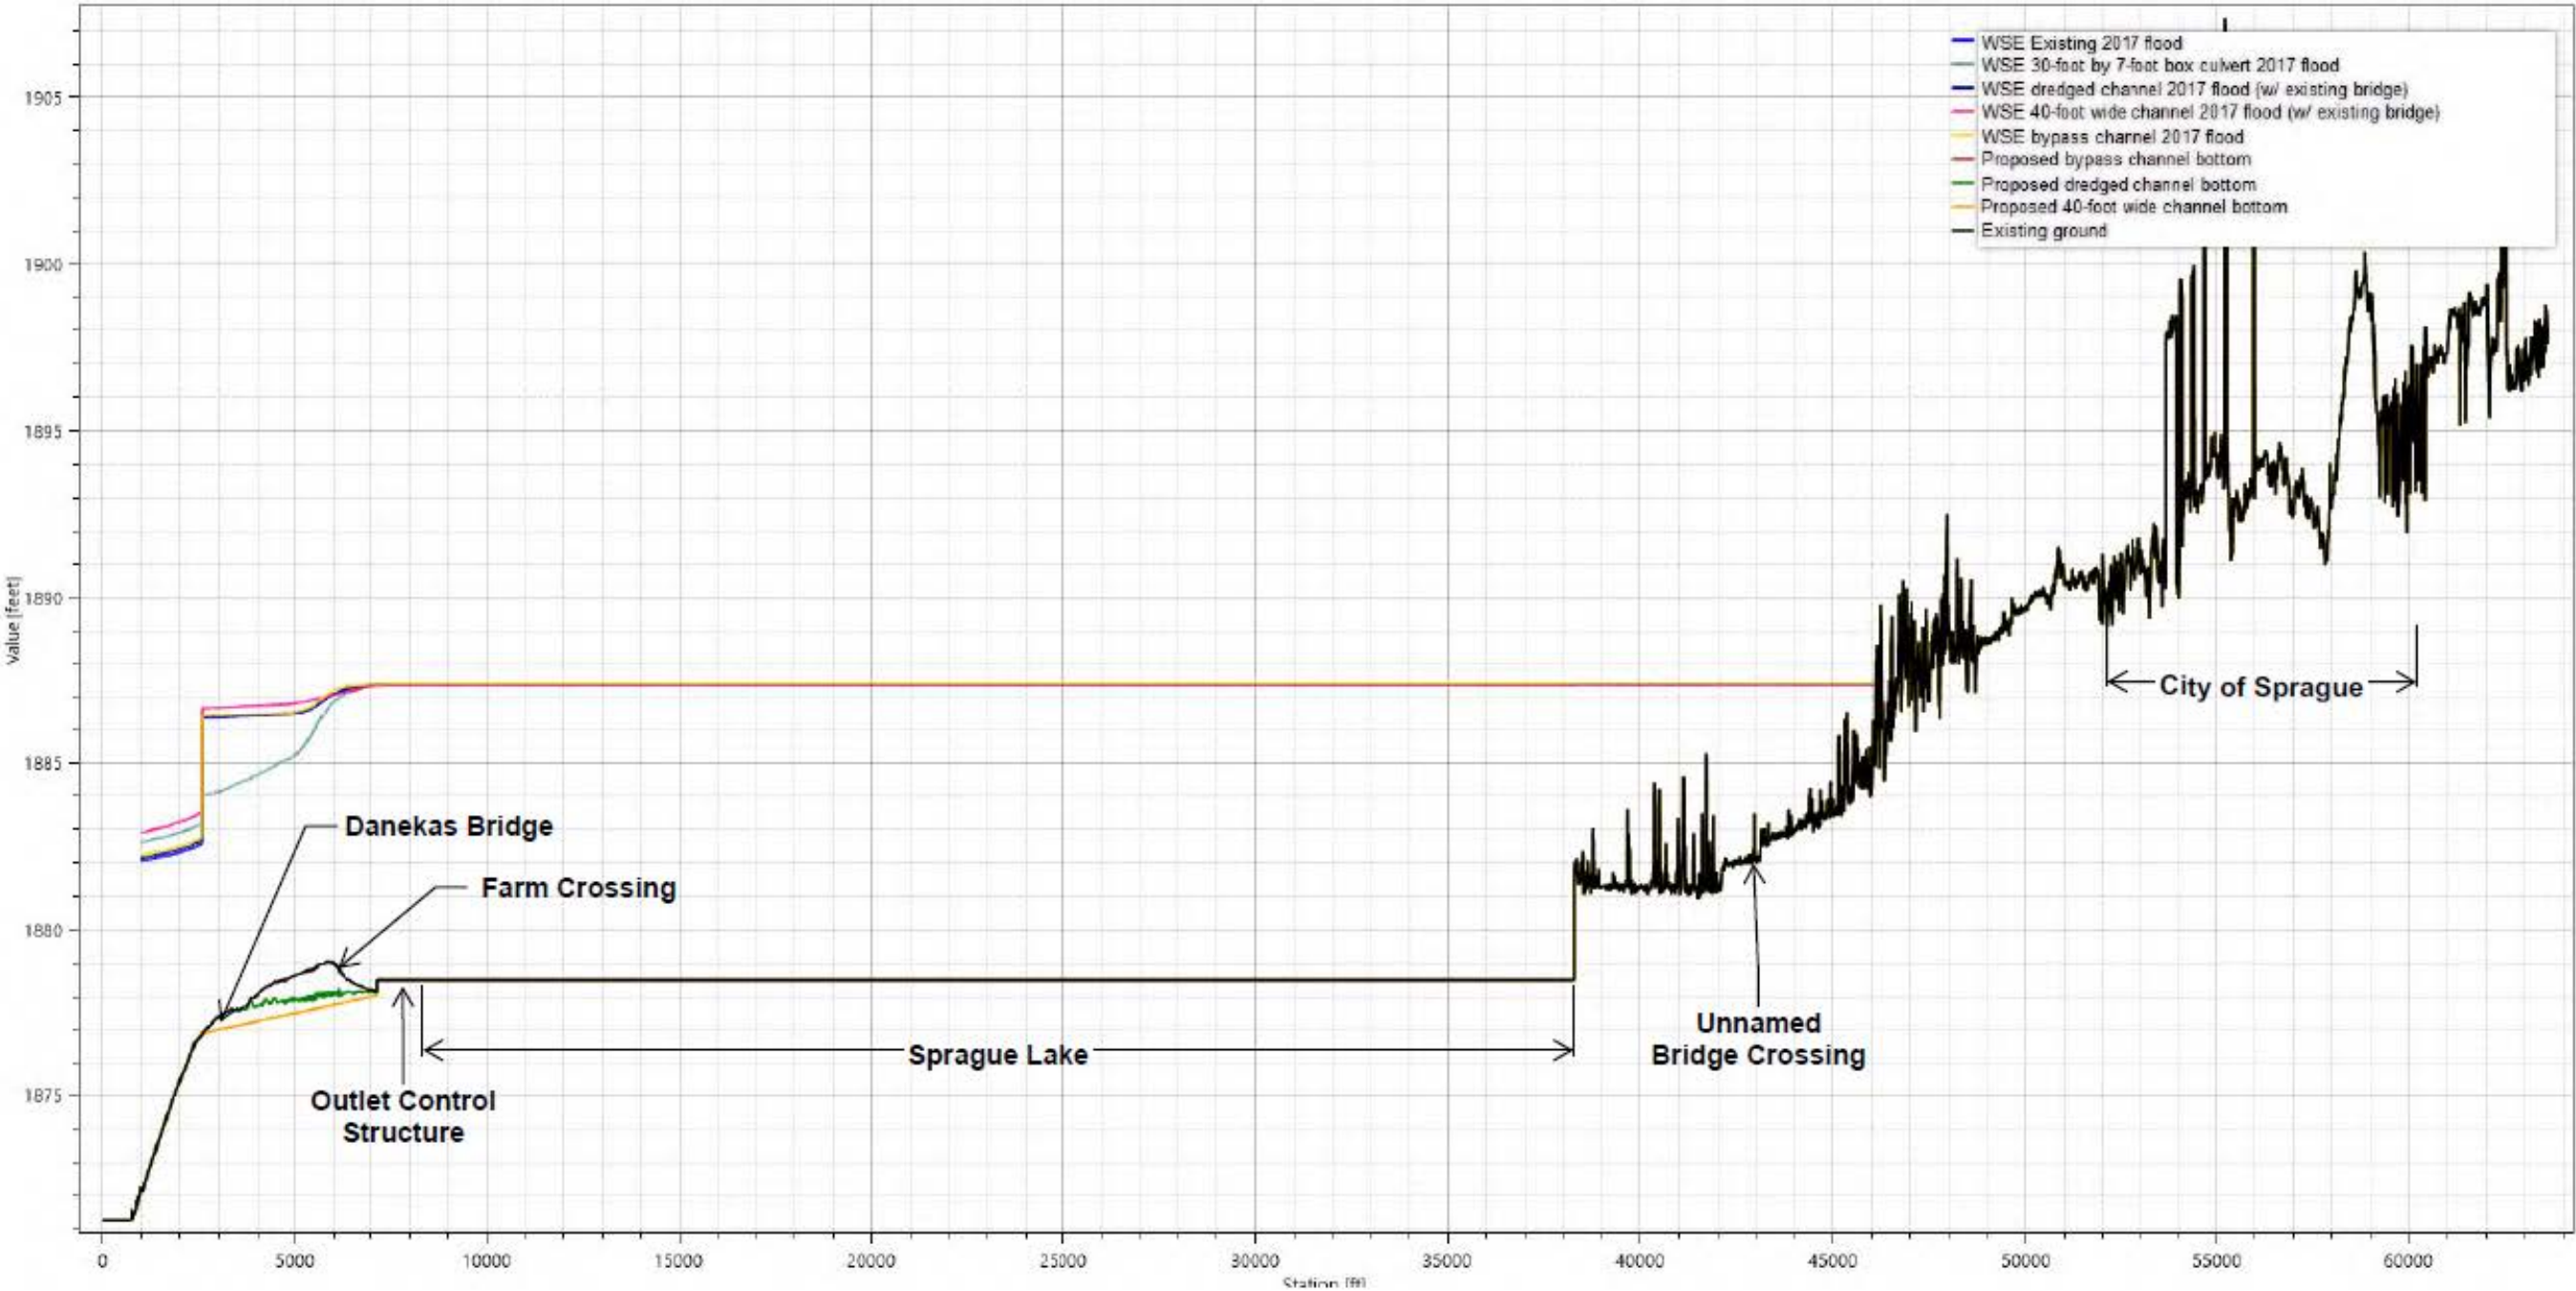
October 2023
2017 Flood Profile - Peak Water Surface Elevations
Figure 3

Shannon & Wilson approached the lake outlet constriction analysis from the viewpoint of Sprague Lake at its 2017 peak flood level, as shown in the Ecology gauge. The HEC-RAS model was filled to this level using an empty to full flow rate of 121k cfs to expedite model run times. The lake was then allowed to drain. We ignored effects of inflow for the constriction analysis, as the high lake levels are results of long periods of high groundwater as previously mentioned, and having calibrated the physical response of lake slope and Cow Creek function in our hydraulic model to logger data. Water surface profiles for the constriction analysis can be found in Figures 3 and 4.

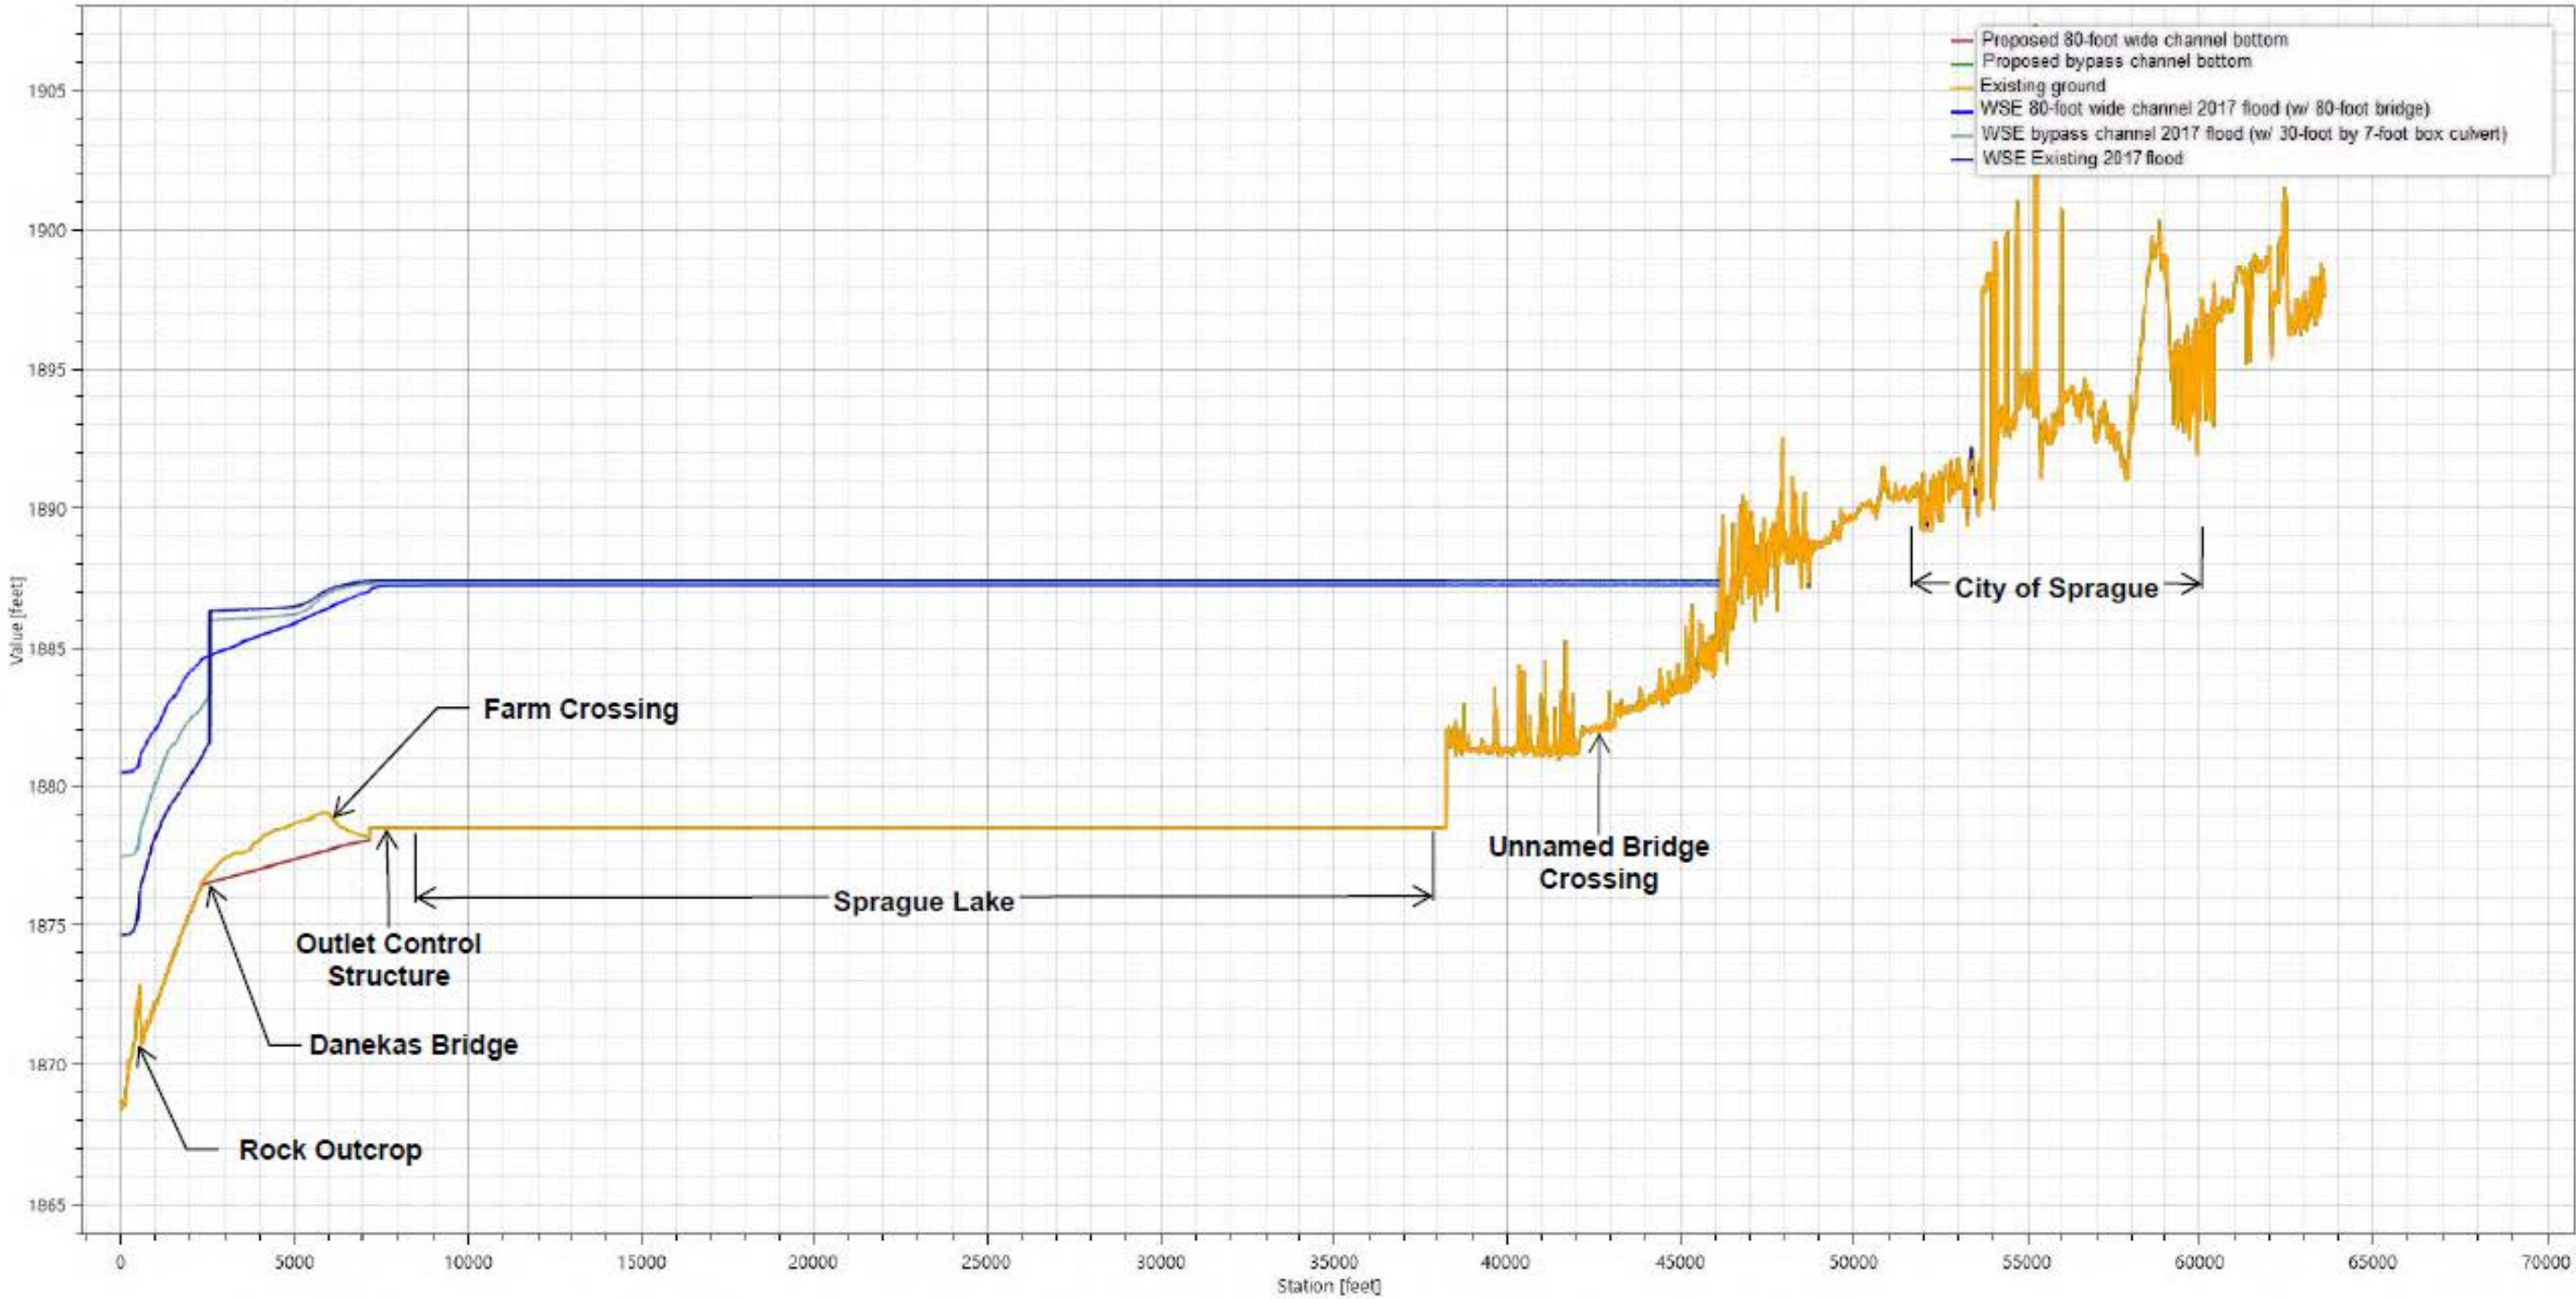
Figure 6

2017 Flood Profile - **Peak Water Surface Elevations Large Scale Alternatives**

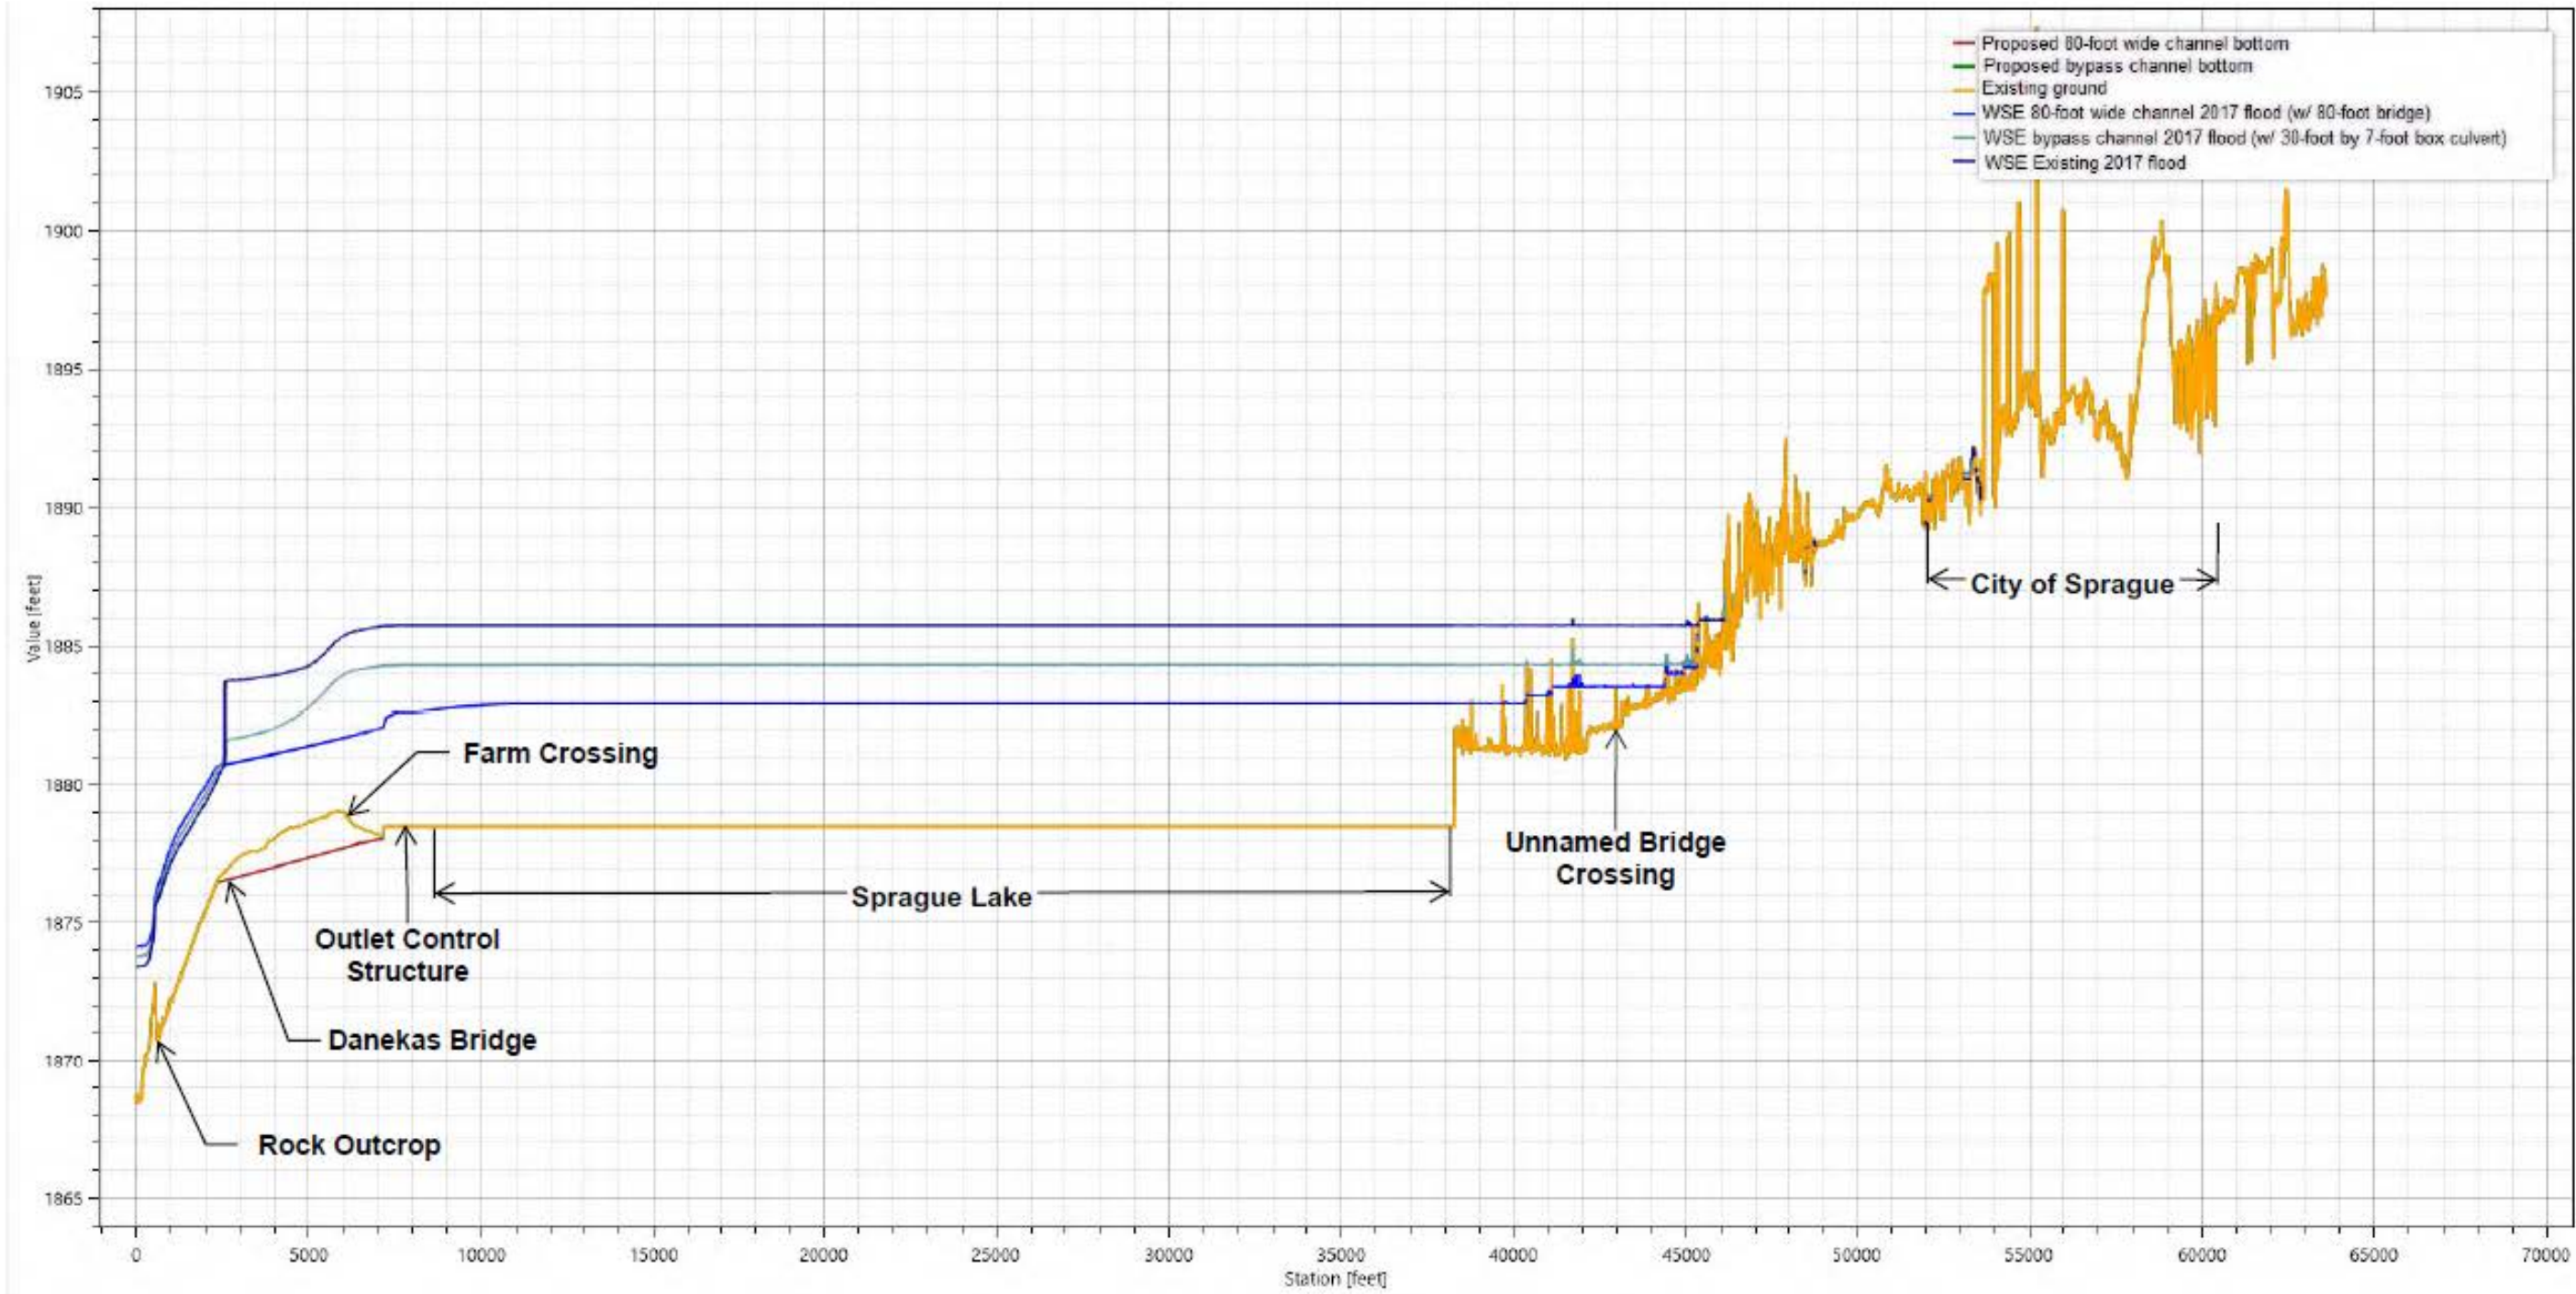
Figure 7

2017 Flood Profile - 4 Days Following Peak Water Surface Elevations Large Scale Alternatives

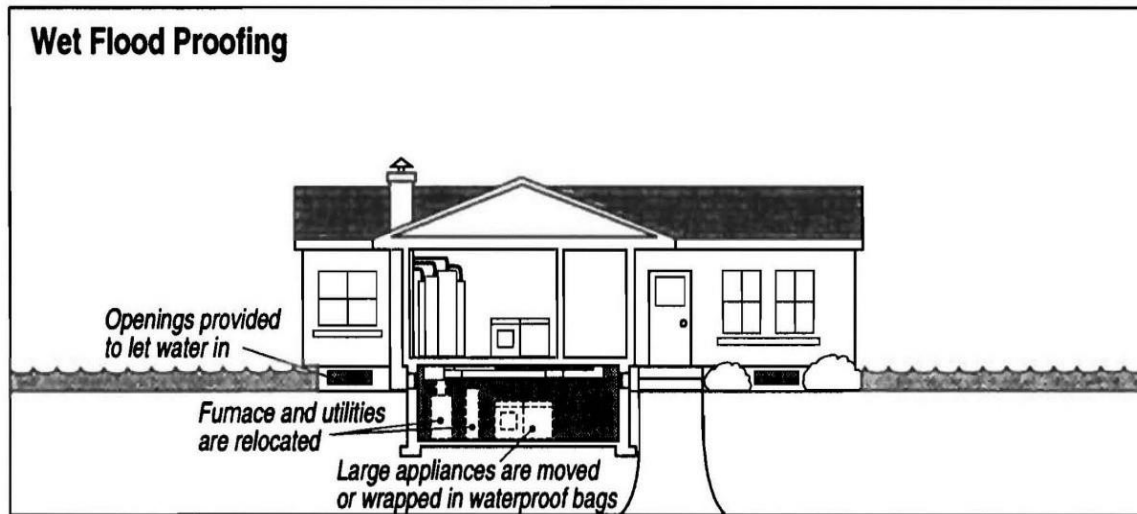
Figure 6. Wet Flood Proofing (Diagrammatic Detail).

3.3.6 Wet Floodproofing. Wet floodproofing is essentially making a structure resilient to flooding through the use of waterproof building materials up to the specified flood height, as shown in Figure 5. In wet floodproofing, water is allowed to enter and interact with a structure without damage. This NS measure can be a stand-alone measure, or combined with other measures such as elevation or dry floodproofing. All utilities and mechanical equipment must be elevated above the design flood elevation. Generally, wet floodproofing is not applicable to residential structures. It may, however, be able to provide commercial and industrial structures with a level of protection as long as the contents can be managed in such a way as to not be damaged during a flood. This measure is generally not applicable to large flood depths or high velocity flows due to the potential structure failure of walls.

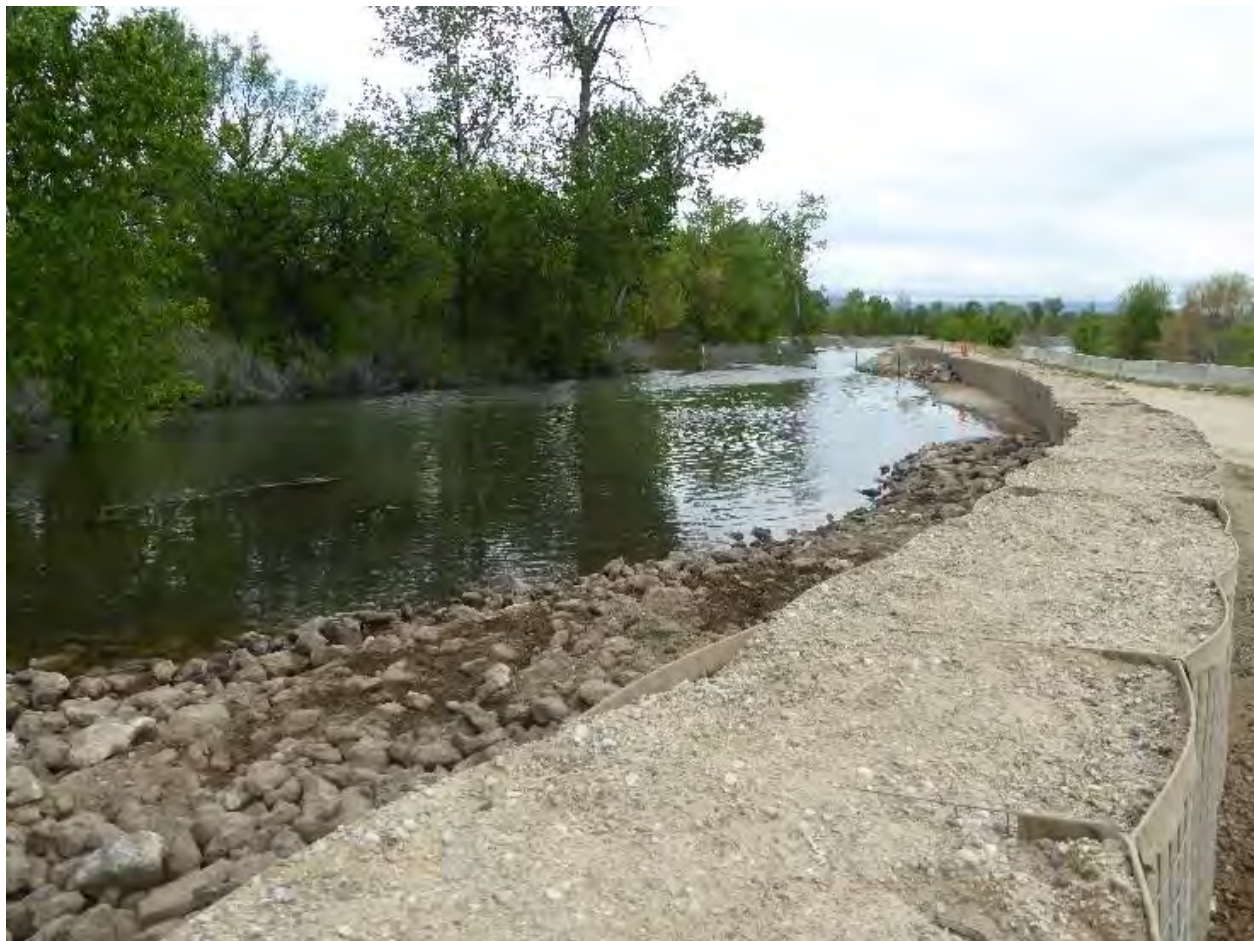
Figure 8. HESCO Barriers Deployed on the Boise River, Idaho, 2017.

HESCO barriers can also be effective in forming long flood barriers relatively quickly, as shown in Figure 7. The barriers are fabric-lined wire baskets that are linked together and filled with sand. They can be placed and filled with small equipment, including a skid steer loader. If placed correctly, they do not need to be wrapped in plastic. These are a specialty product, however, and may not be readily available locally. However, if the city, the county, or the state desired to create a stockpile of HESCO barriers that could be readily accessed, they can be purchased. The U.S. Army Corps of Engineers also has HESCO barriers in the national flood materials stockpile, which may be accessible if a Direct Assistance mission is authorized. The lead time required for the Corps to deliver materials may be slower than the speed with which a flood develops in the Negro Creek drainage, however.

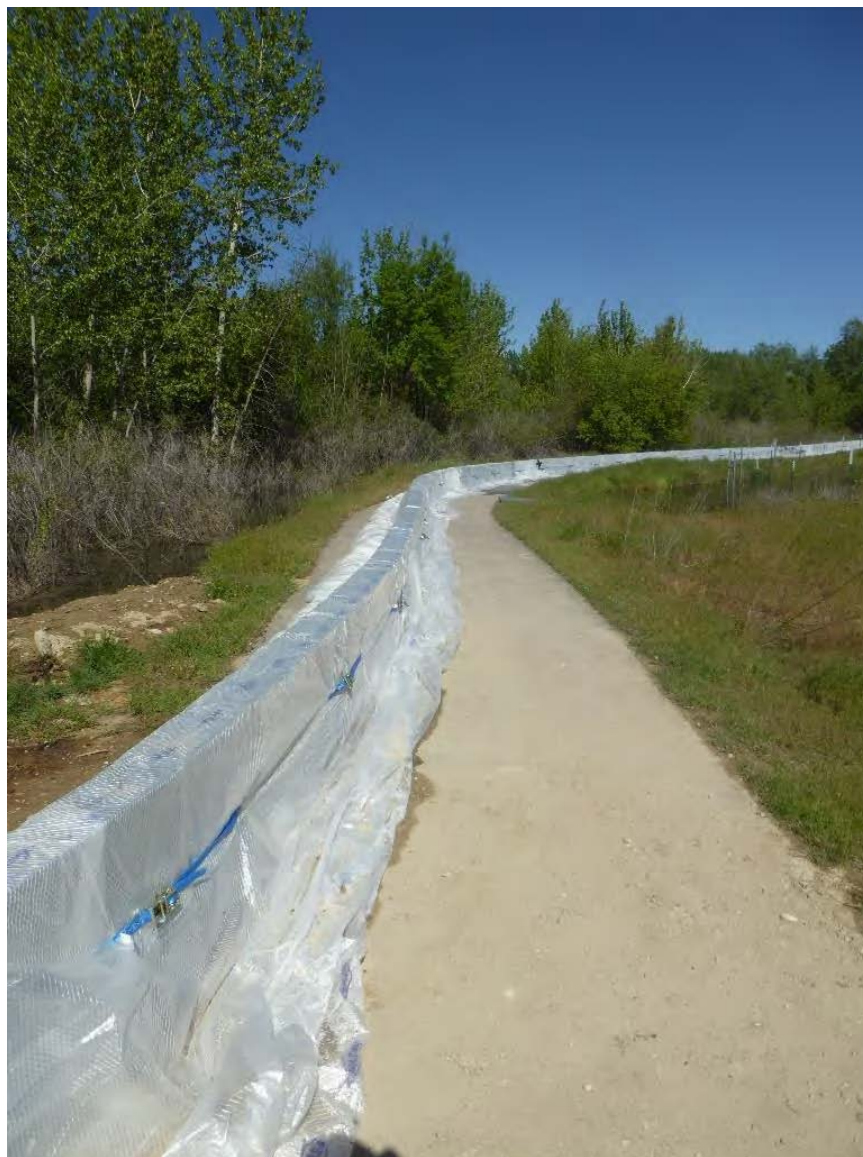
Figure 9. Muscle Wall Flood Barrier Deployed on the Boise River, Idaho, 2017.

There are a number of proprietary flood barrier products on the market that can be effective as well. Some can even be placed directly into moving water. While the Corps cannot recommend any one particular product over another, a general list and description is included here for further research and consideration. Water filled, linked flood control tubes such as Tiger Dams, AquaDams, or other similar products can be very effective at forming a temporary flood barrier and can be filled by the ready supply of water available during a flood. Harder barrier products, such as Muscle Walls, Aqua Fence, and others can also be highly effective when deployed. The Muscle Wall branded barriers are shown in Figure 8. Some of the harder barriers are water-filled and plastic-wrapped, and some are simply deployable walls that rely on water pressure on the wet side for stability.

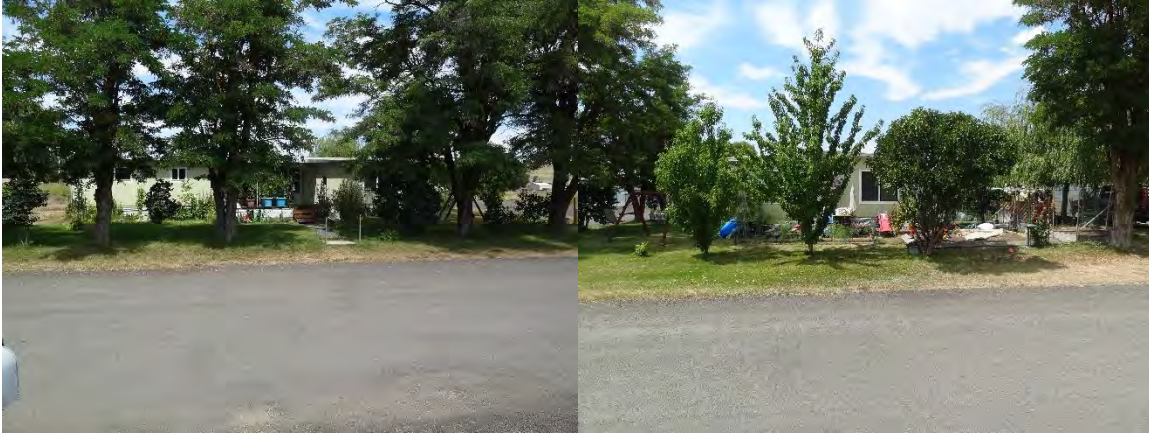
Property Address: 325 E Chestnut St

Foundation Type	Mechanical Equipment	Type
Piers	Unknown	Residential

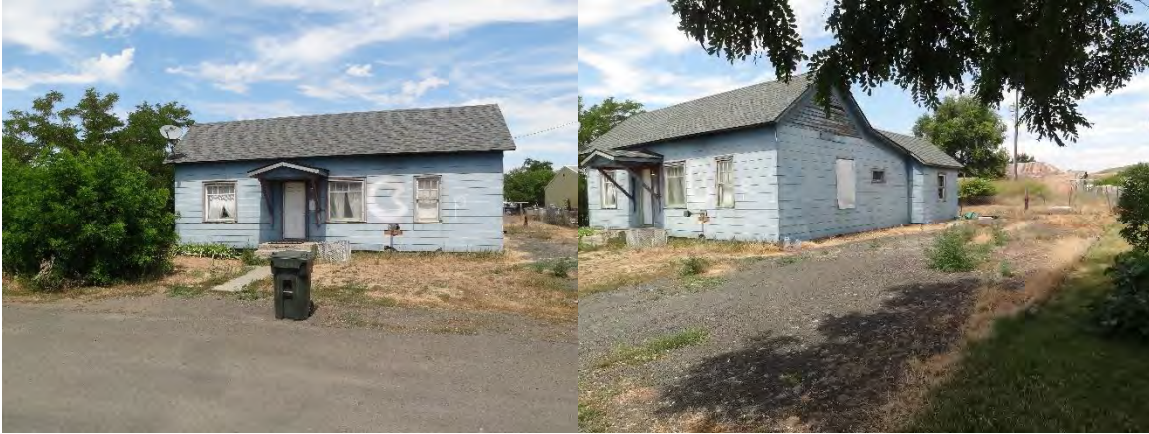
Property Address: 313 E Chestnut St

Foundation Type	Mechanical Equipment	Type
Slab on Grade	Unknown	Residential

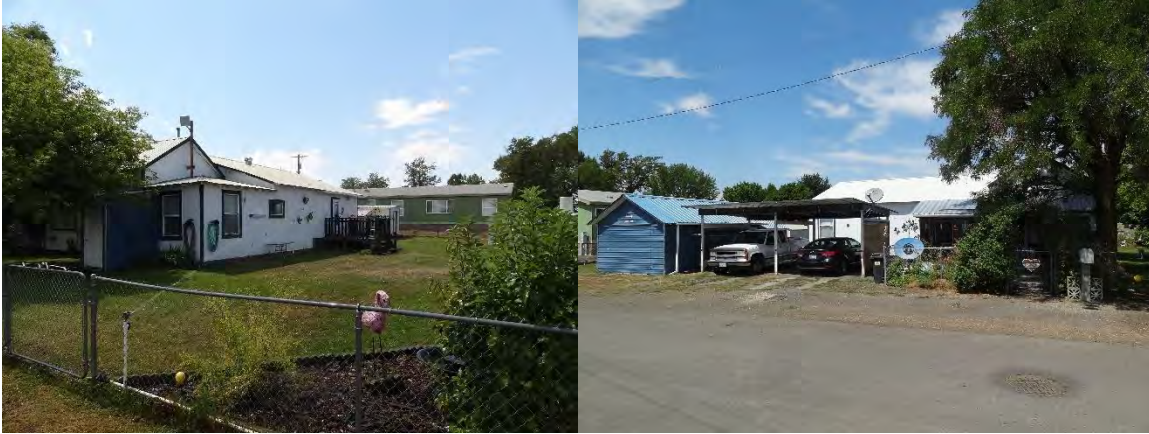
Property Address: 325 E Walnut St

Foundation Type	Mechanical Equipment	Type
Crawlspace	Unknown	Residential

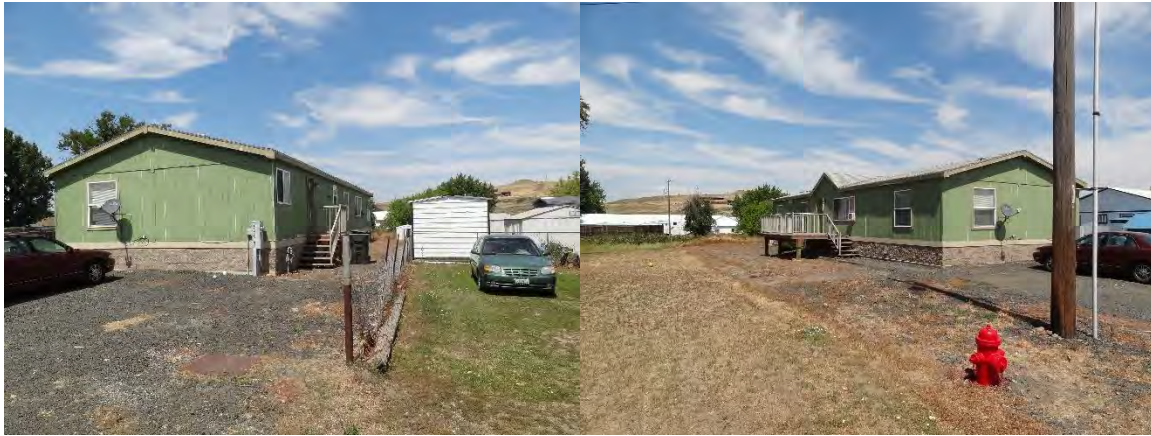
Property Address: 323 E Walnut St

Foundation Type	Mechanical Equipment	Type
Cinder block/piers	Window A/C	Residential

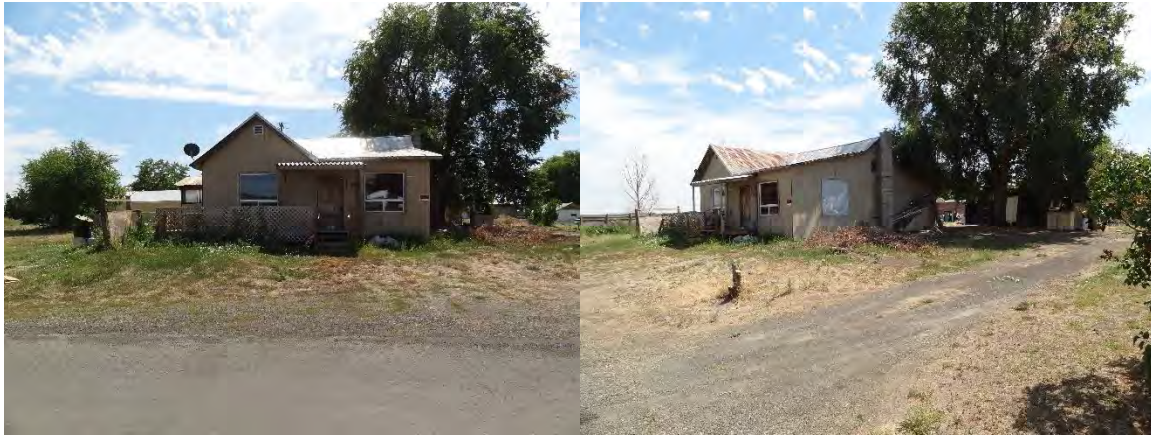
Property Address: 322 E Walnut St

Foundation Type	Mechanical Equipment	Type
Basement	Unknown	Residential

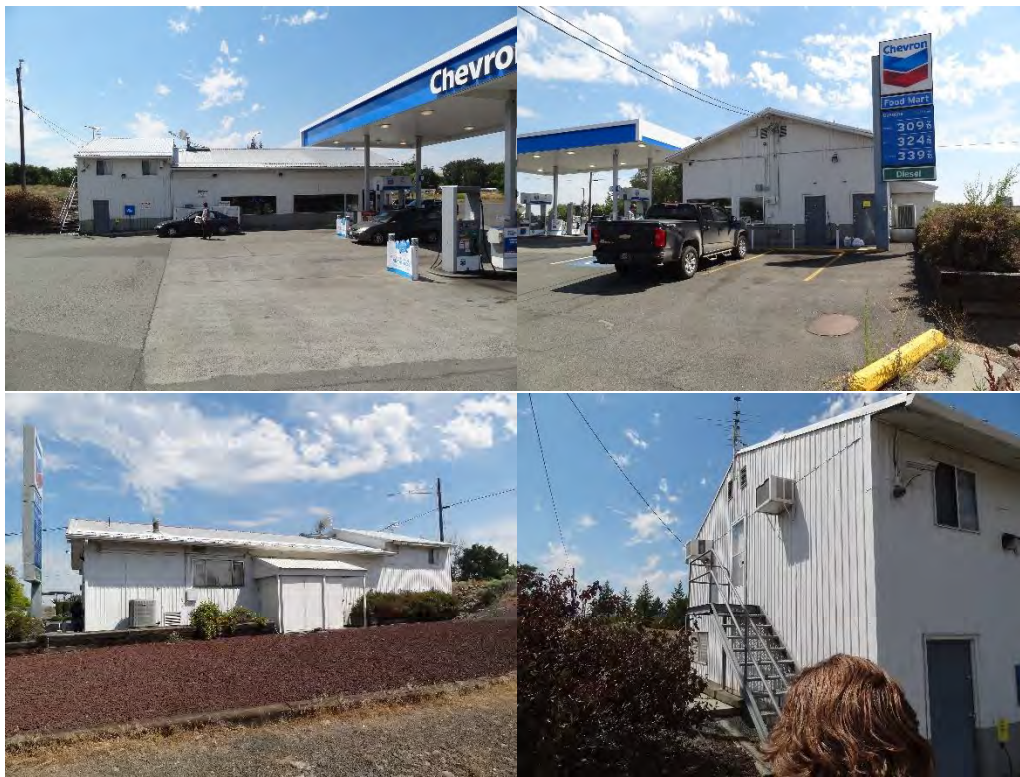
Property Address: 316 Colfax St

Foundation Type	Mechanical Equipment	Type
Slab on grade	Elevated A/C above grade	Non-Residential

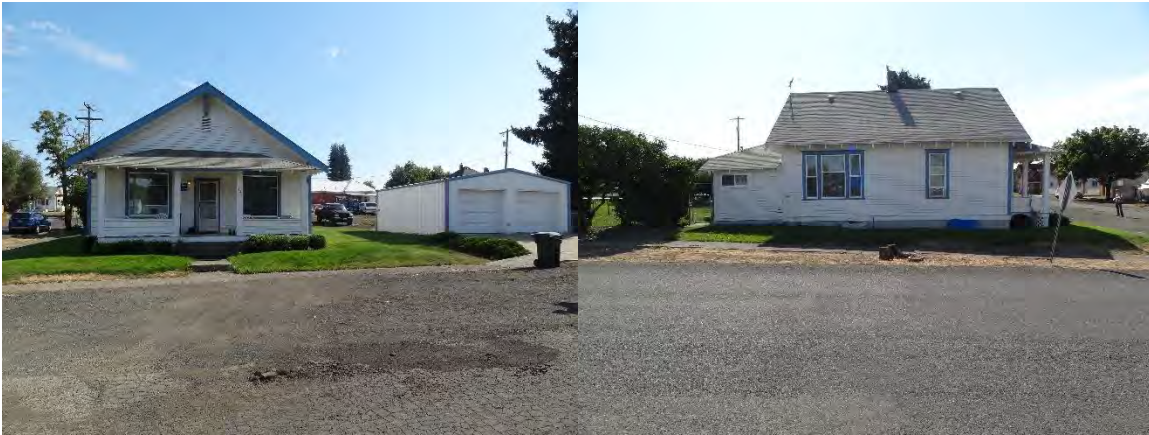
Property Address: 101 W 3rd St

Foundation Type	Mechanical Equipment	Type
Basement	Unknown	Residential

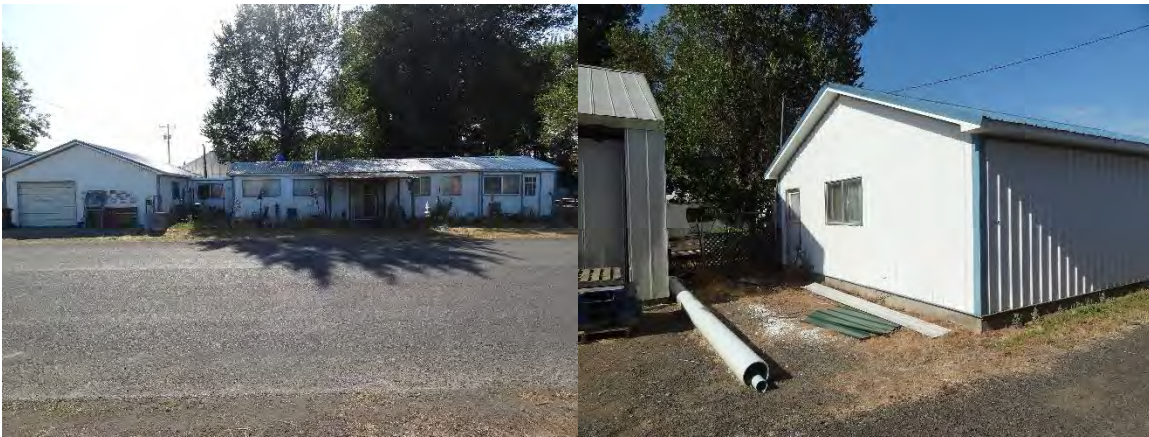
Property Address: 204 S B St

Foundation Type	Mechanical Equipment	Type
Crawlspace	Unknown	Residential

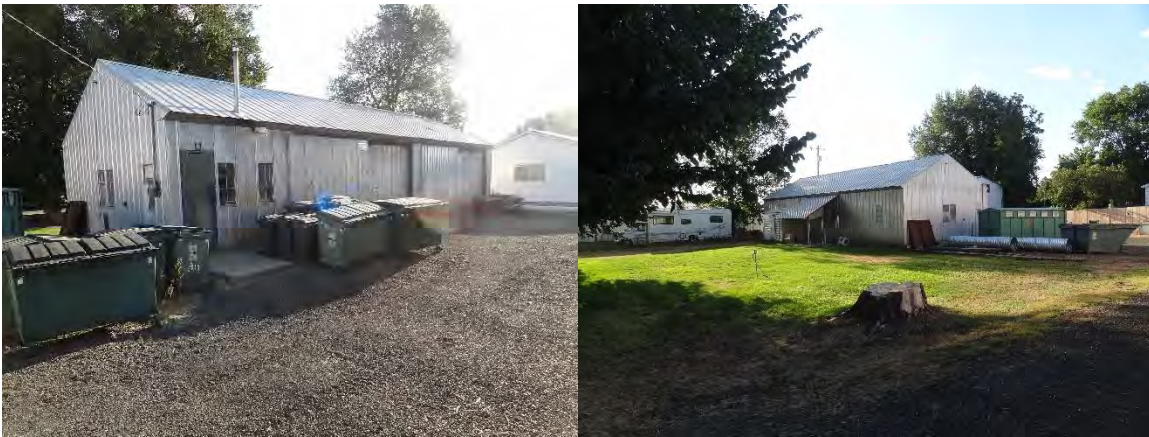
Property Address: 117 W 2nd St

Foundation Type	Mechanical Equipment	Type
Slab on grade	Unknown	Non-Residential

Additional Comments: Recommend a structural assessment, but unlikely that dry flood proofing can be applied up to 4 ft on structure.

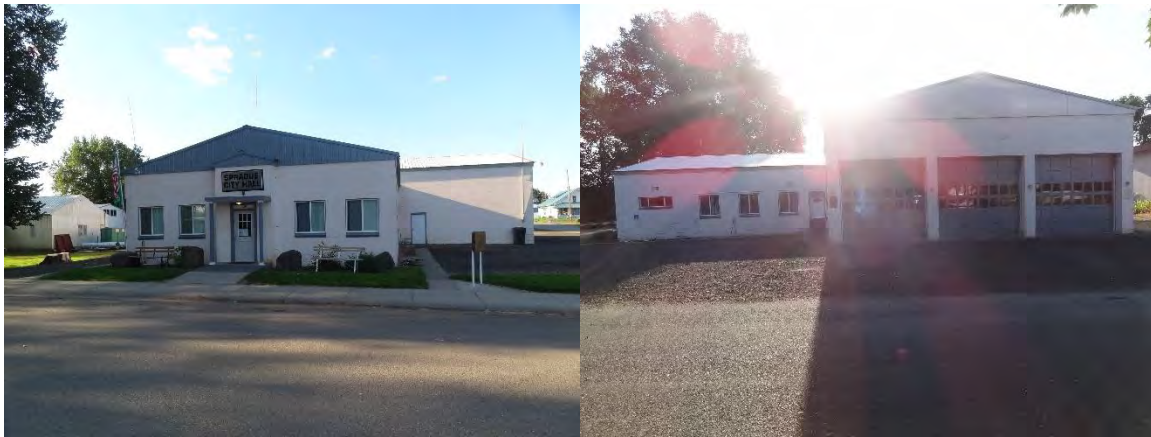
Property Address: 119 W 2nd St

Foundation Type	Mechanical Equipment	Type
Slab on grade	A/C on grade	Non-Residential

Additional Comments: Recommend a structural assessment prior to applying nonstructural measure.

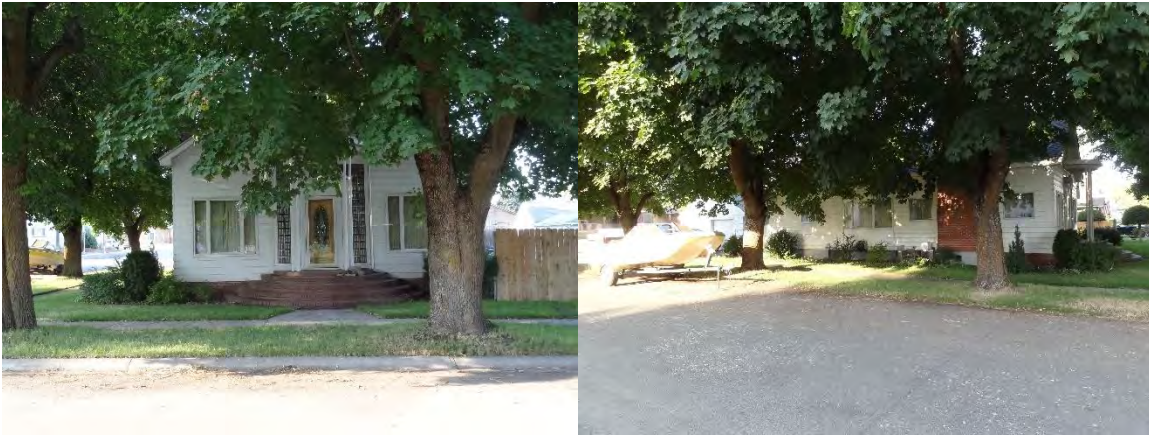
Property Address: 201 W 2nd St

Foundation Type	Mechanical Equipment	Type
Basement	A/C on grade	Residential

Permanent NS Measure: Fill basement and replace space with addition at grade plus 3 ft to stay above flood level. Elevate at-grade A/C unit.

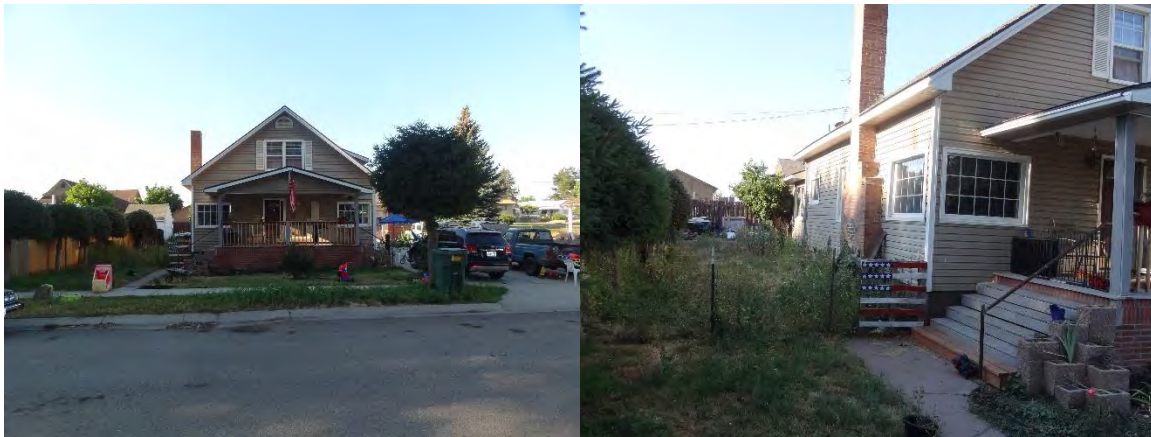
Property Address: 209 W 2nd St

Foundation Type	Mechanical Equipment	Type
Basement	A/C on grade	Residential

Permanent NS Measure: Fill basement and replace space with addition at grade plus 3 ft to stay above flood level. Elevate at-grade A/C unit.

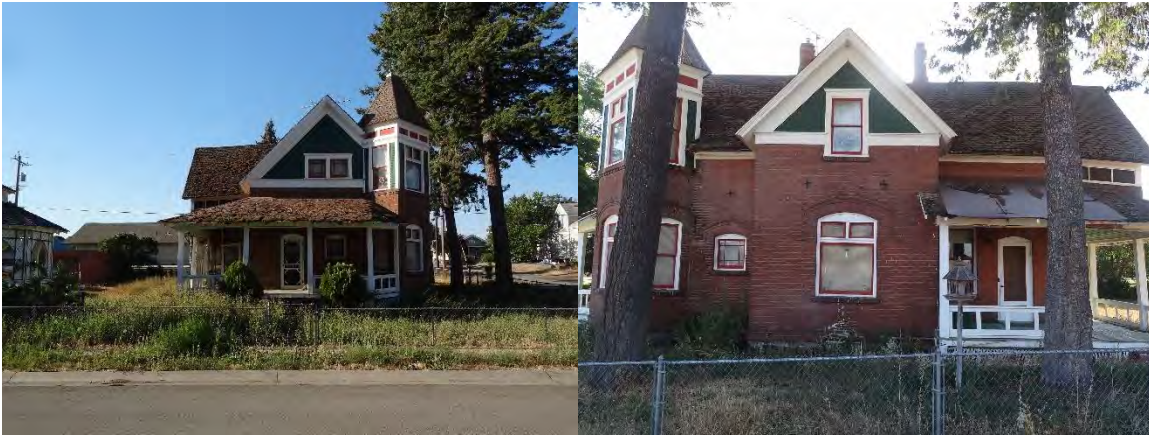
Property Address: 219 W 2nd St

Foundation Type	Mechanical Equipment	Type
Basement	A/C on grade	Residential

Permanent NS Measure: Fill basement and replace space with addition at grade plus 2 ft to stay above flood level. Elevate at-grade A/C unit.

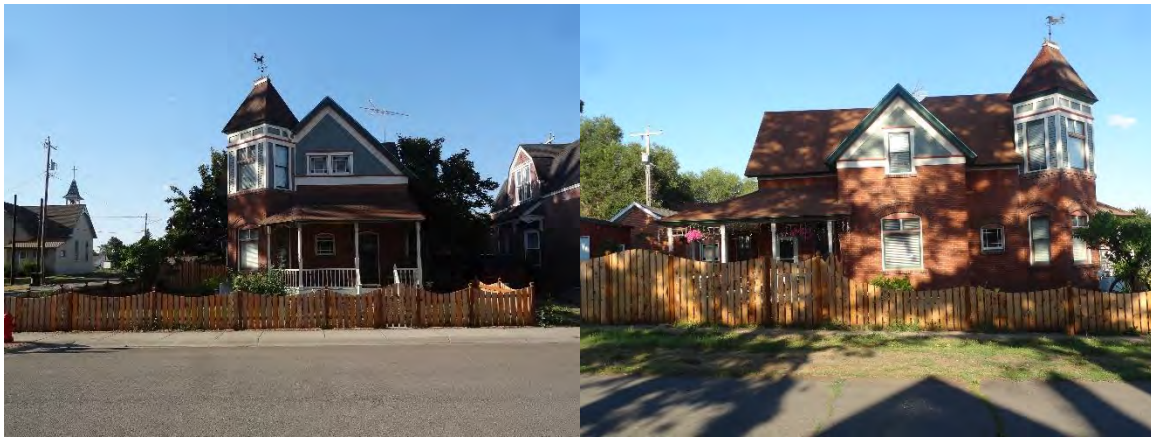
Property Address: 301 W 2nd St

Foundation Type	Mechanical Equipment	Type
Basement	A/C on grade	Residential

Permanent NS Measure: Fill basement and replace space with addition at grade plus 1 ft to stay above flood level. Elevate at-grade A/C unit.
