Sprague Lake Hydrologic Study

Flood-risk reduction alternatives analysis

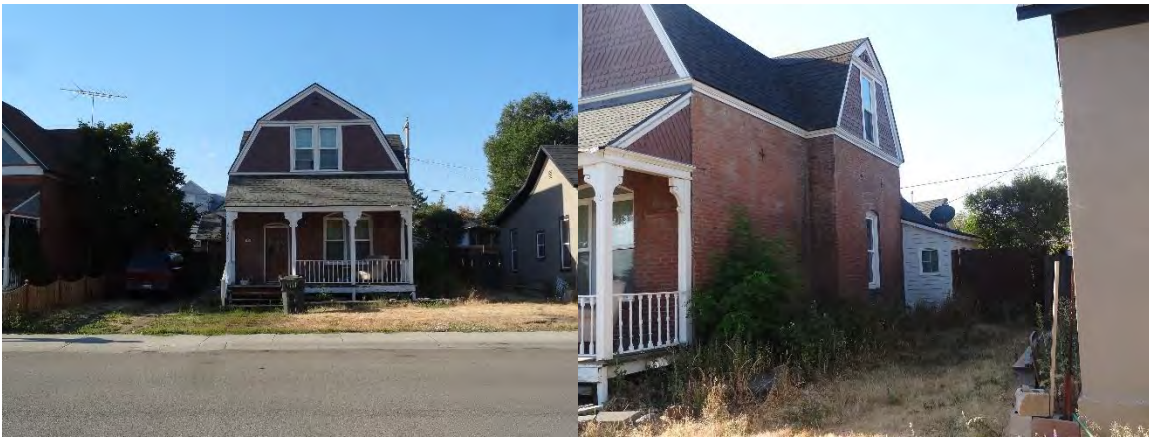
Property Address: 305 W 2nd St

Foundation Type	Mechanical Equipment	Type
Basement	Unknown	Residential

Permanent NS Measure: Fill basement and replace space with addition at grade plus 1 ft to stay above flood level. Elevate at-grade A/C unit, if present.

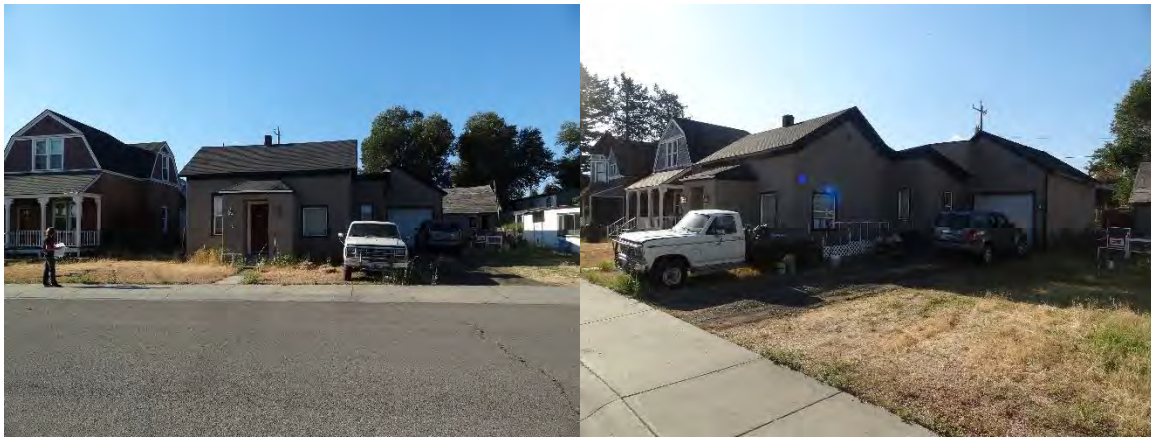
Property Address: 311 W 2nd St

Foundation Type	Mechanical Equipment	Type
Basement	Window A/C	Residential

Permanent NS Measure: Fill basement and replace space with addition at grade plus 1 ft to stay above flood level. Elevate at-grade A/C unit, if present.

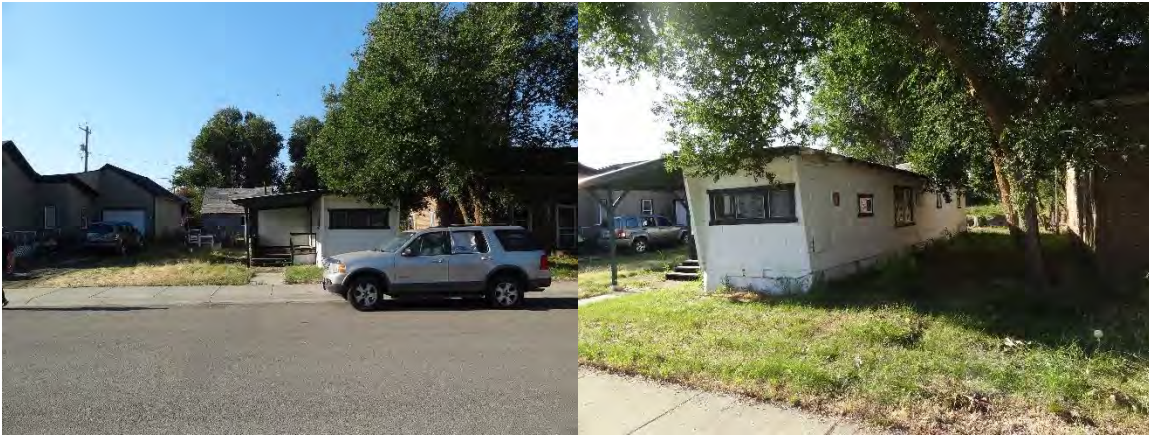
Property Address: 315 W 2nd St

Foundation Type	Mechanical Equipment	Type
Piers and skirting	Unknown	Residential

Permanent NS Measure: Water may be able to safely be under home with minimal damage.

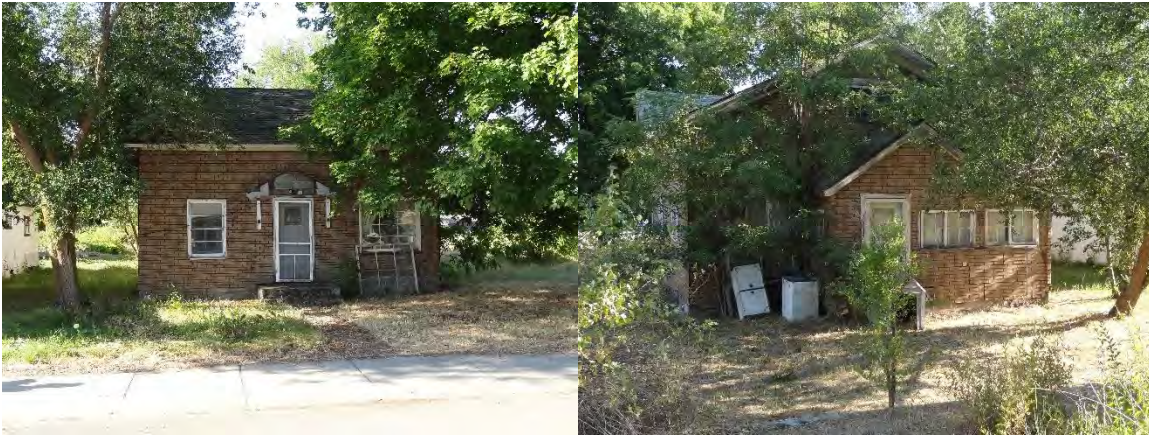
Property Address: 319 W 2nd St

Foundation Type	Mechanical Equipment	Type
Slab on grade	Unknown	Residential

Permanent NS Measure: Water may be able to safely be around home with minimal damage.

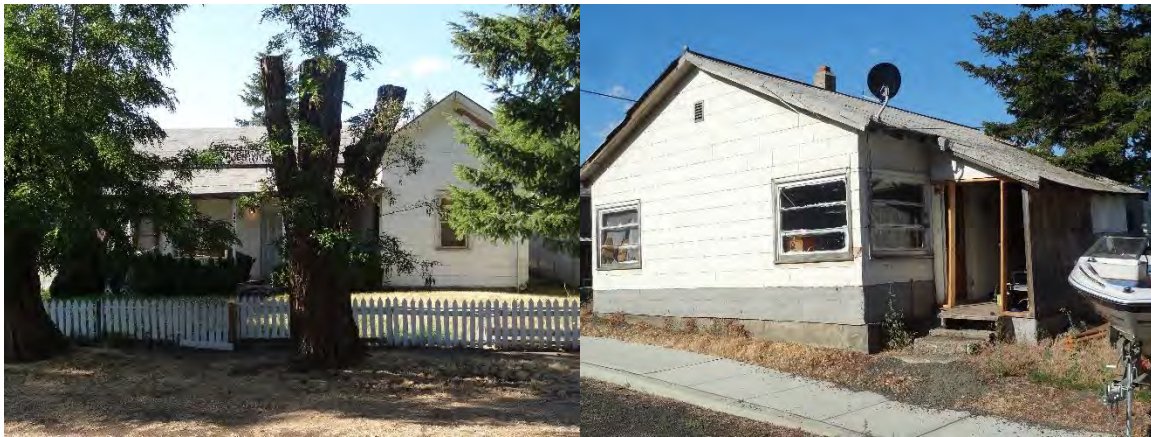
Property Address: 405 W 2nd St

Foundation Type	Mechanical Equipment	Type
Slab on grade	Unknown	Residential

Permanent NS Measure: Water may be able to safely be around home with minimal damage.

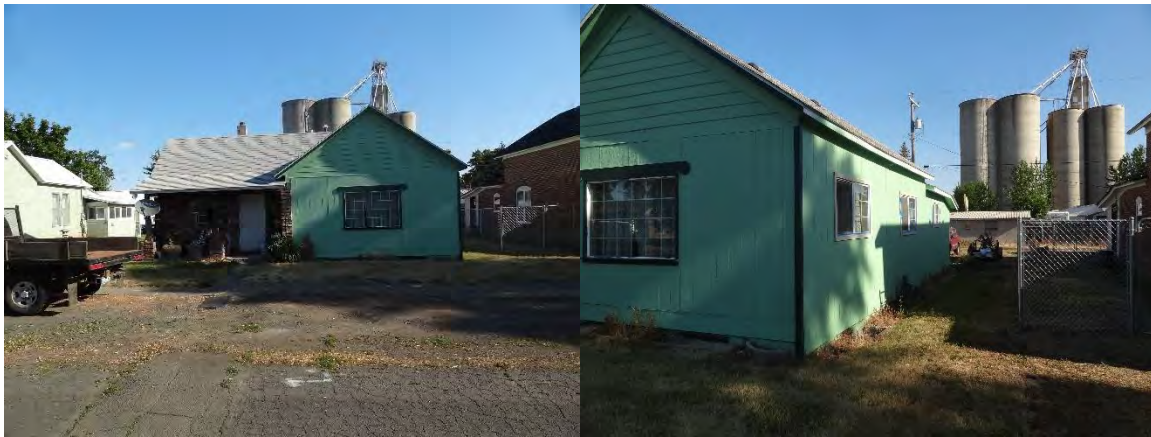
Property Address: 410 W 2nd St

Foundation Type	Mechanical Equipment	Type
Basement	Window A/C	Residential

Permanent NS Measure: Fill basement and replace space with addition at grade plus 3 ft to stay above flood level. Elevate home 3 ft above filled basement.

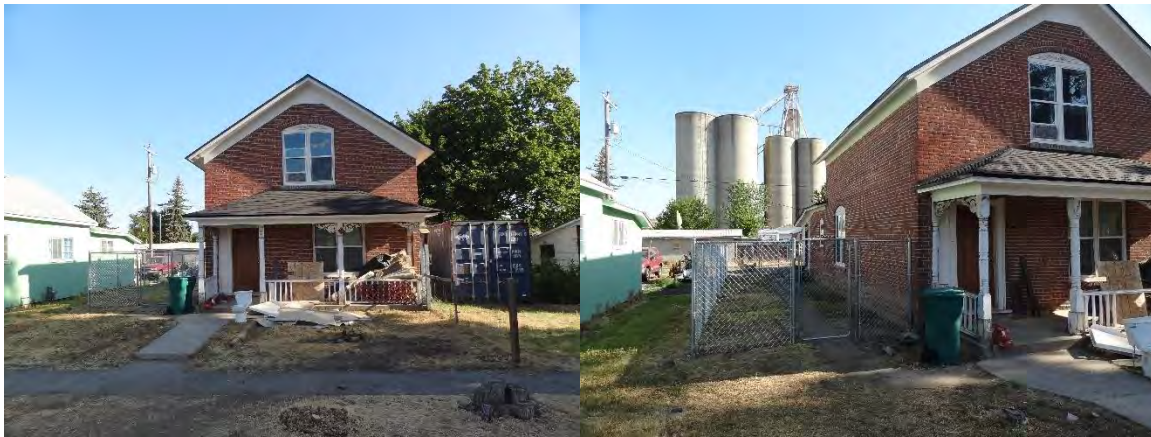
Property Address: 408 W 2nd St

Foundation Type	Mechanical Equipment	Type
Basement	Window A/C	Residential

Permanent NS Measure: Fill basement and replace space with addition at grade plus 4 ft to stay above flood level. Elevate home 4 ft above filled basement.

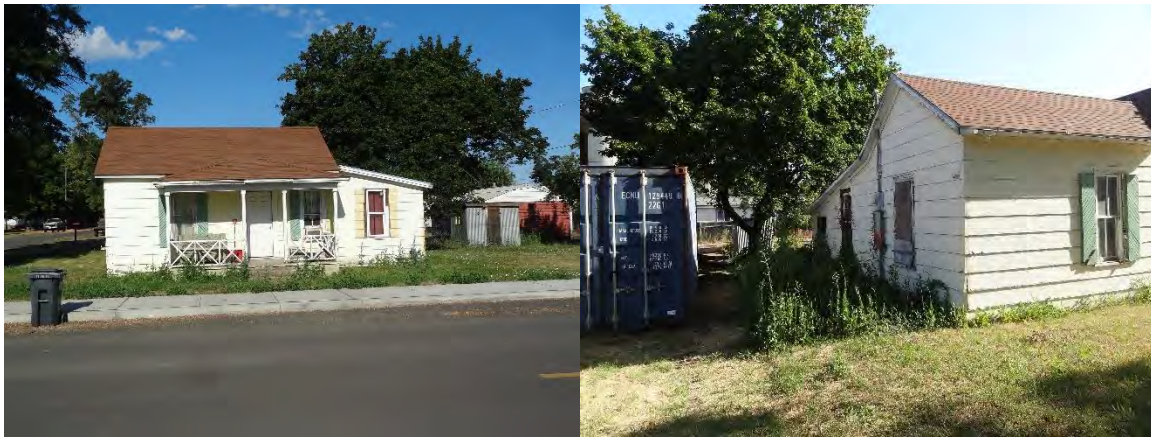
Property Address: 112 S E St

Foundation Type	Mechanical Equipment	Type
Slab on grade	Window A/C	Residential

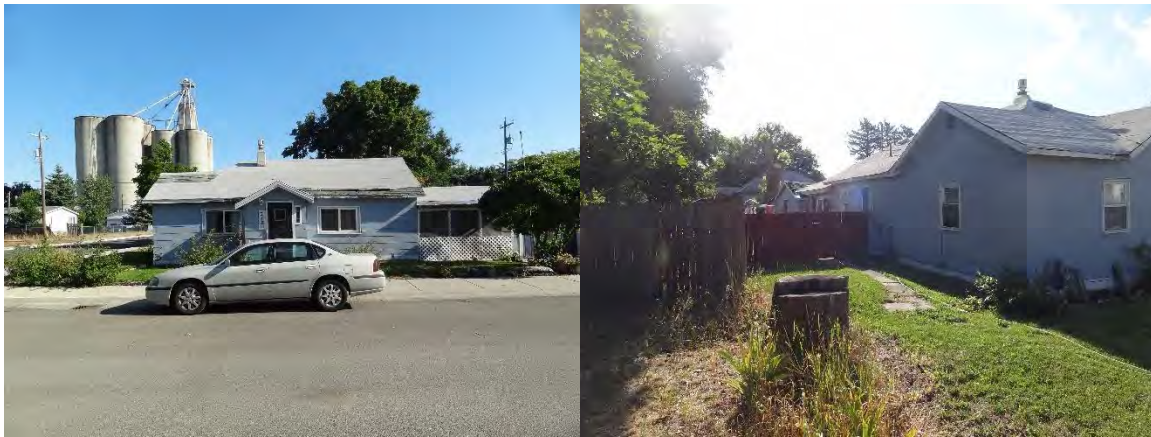
Property Address: 318 W 2nd St

Foundation Type	Mechanical Equipment	Type
Crawlspace	Unknown	Residential

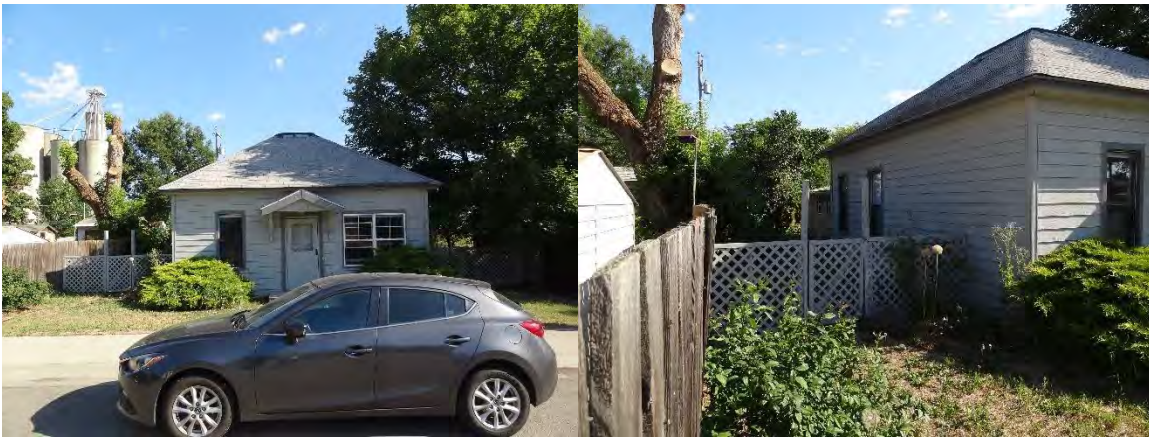
Property Address: 312 W 2nd St

Foundation Type	Mechanical Equipment	Type
Basement	Unknown	Residential

Permanent NS Measure: Fill basement and replace space with addition at grade plus 5 ft to stay above flood level. Elevate home 5 ft above filled basement.

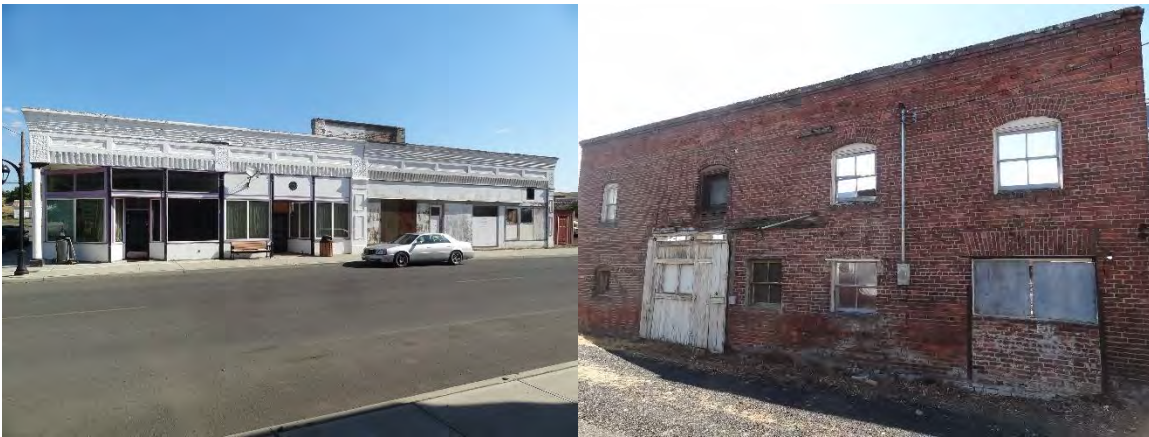
Property Address: 118 W 1st St

Foundation Type	Mechanical Equipment	Type
Slab on grade	Unknown	Non-Residential

Additional Comments: Recommend a structural assessment prior to applying nonstructural measure.

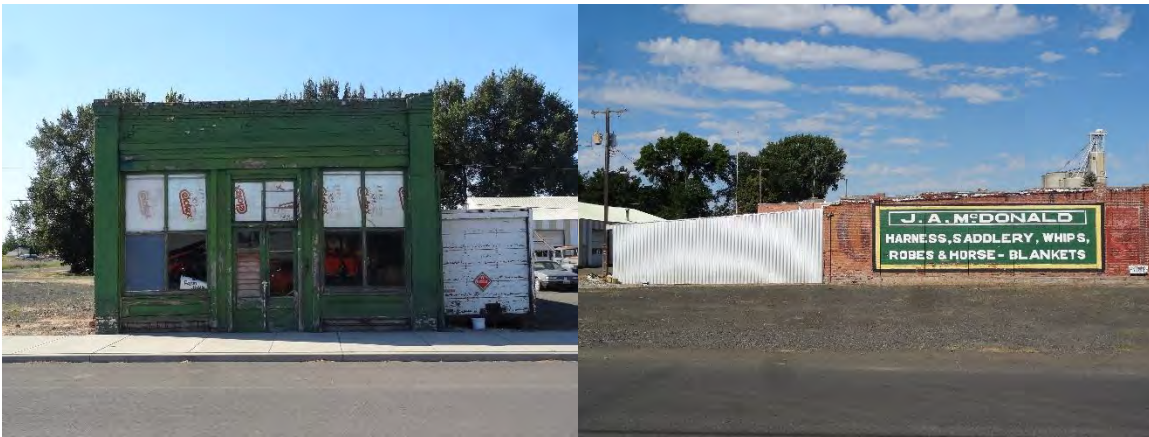
Property Address: 107 W 1st St

Foundation Type	Mechanical Equipment	Type
Slab on grade	Unknown	Non-Residential

Additional Comments: Recommend a structural assessment prior to applying nonstructural measure.

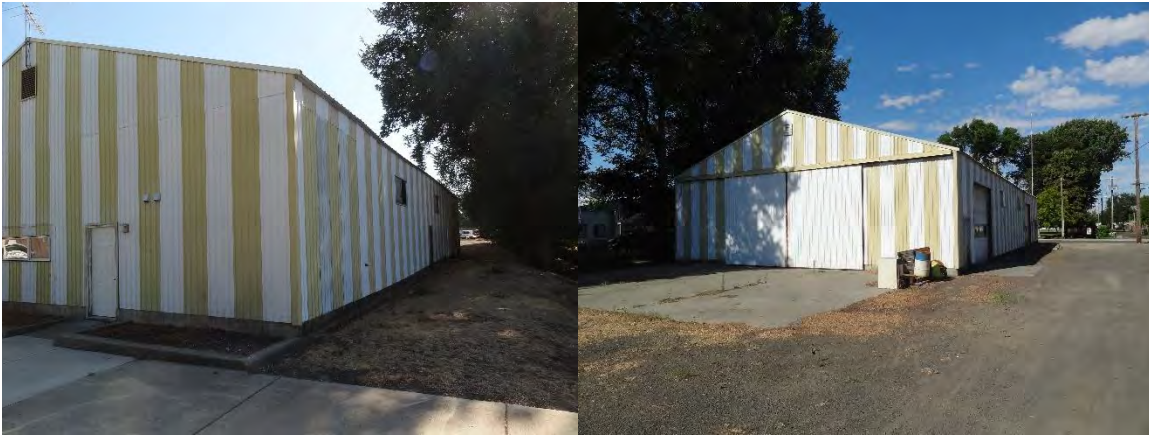
Property Address: 113 S C St

Foundation Type	Mechanical Equipment	Type
Slab on grade	Window A/C	Non-Residential

Additional Comments: Recommend a structural assessment prior to applying nonstructural measure.

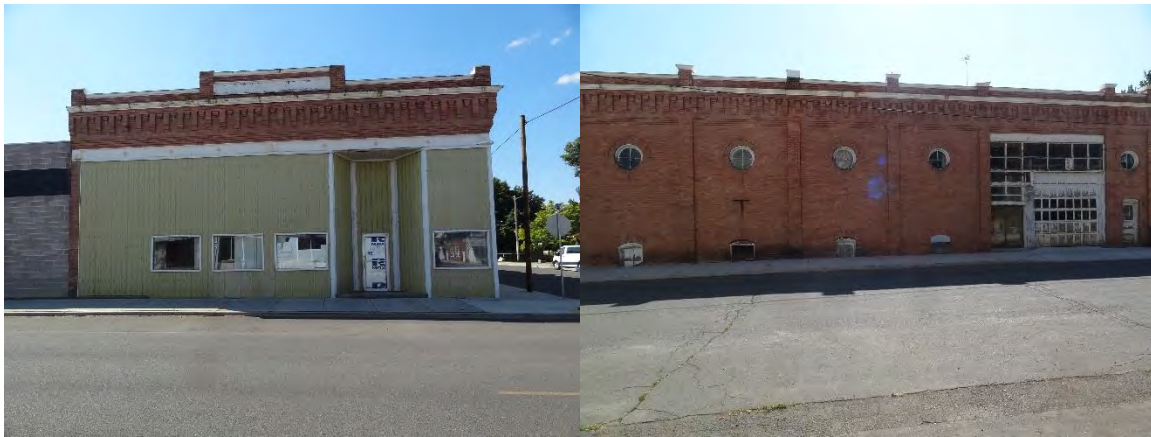
Property Address: 117 W 1st St

Foundation Type	Mechanical Equipment	Type
Slab on grade	Window A/C	Non-Residential

Additional Comments: Recommend a structural assessment prior to applying nonstructural measure.

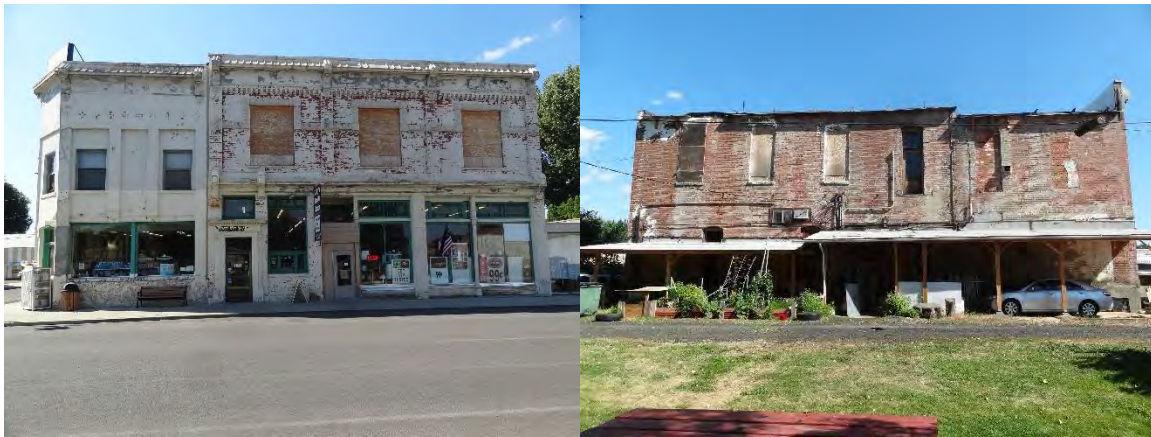
Property Address: 201 W 1st St

Foundation Type	Mechanical Equipment	Type
Slab on grade	Window A/C	Non-Residential

Additional Comments: Recommend a structural assessment prior to applying nonstructural measure.

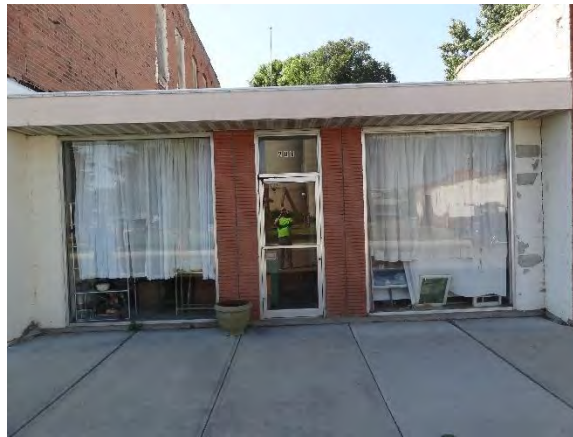
Property Address: 209 W 1st St

Foundation Type	Mechanical Equipment	Type
Slab on grade	Unknown	Non-Residential

Additional Comments: Recommend a structural assessment prior to applying nonstructural measure.

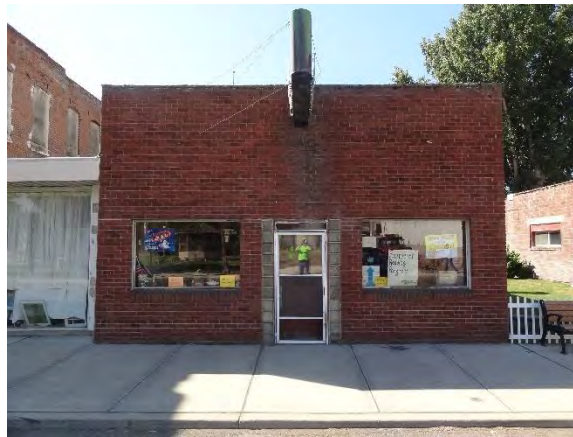
Property Address: 211 W 1st St

Foundation Type	Mechanical Equipment	Type
Slab on grade	A/C on grade	Non-Residential

Additional Comments: Recommend a structural assessment prior to applying nonstructural measure.

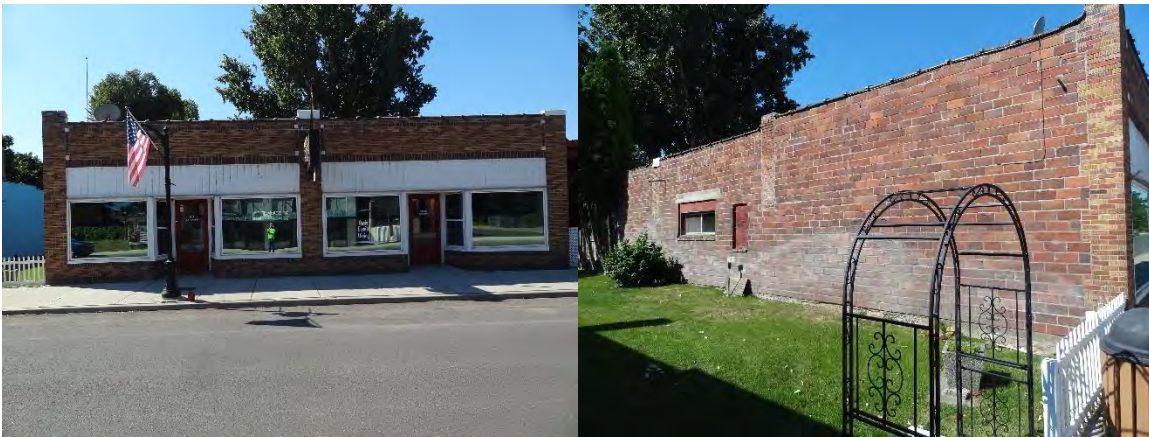
Property Address: 213 W 1st St

Foundation Type	Mechanical Equipment	Type
Slab on grade	Window A/C	Non-Residential

Additional Comments: Recommend a structural assessment prior to applying nonstructural measure.

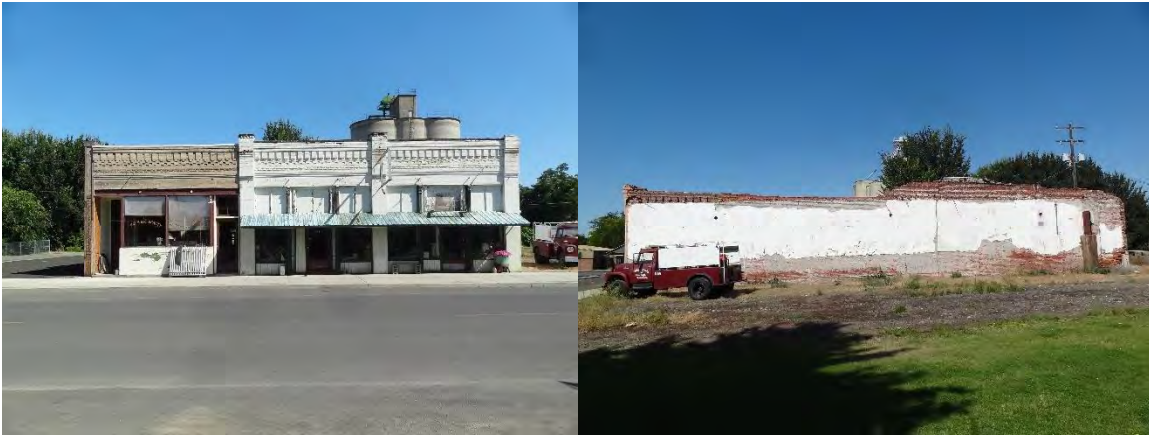
Property Address: 216 W 1st St

Foundation Type	Mechanical Equipment	Type
Slab on grade	Window A/C	Non-Residential

Additional Comments: Recommend a structural assessment prior to applying nonstructural measure.

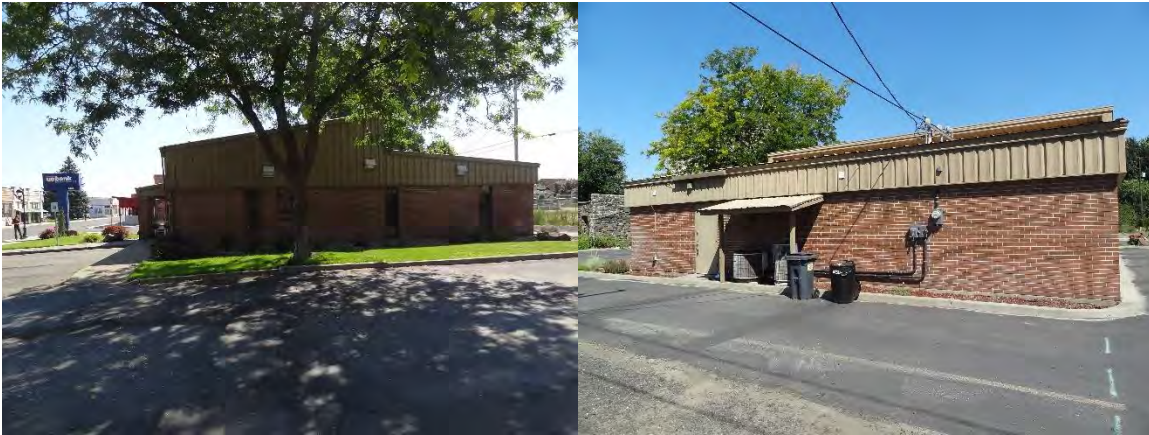
Property Address: 305 W 1st St

Foundation Type	Mechanical Equipment	Type
Slab on grade	A/C on grade	Non-Residential

Additional Comments: Recommend a structural assessment prior to applying nonstructural measure.

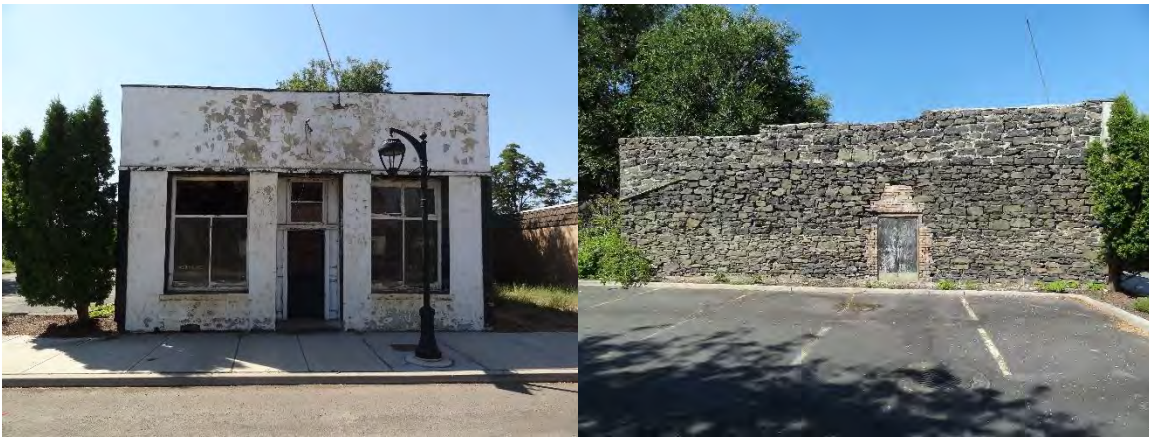
Property Address: 313 W 1st St

Foundation Type	Mechanical Equipment	Type
Slab on grade	Unknown	Non-Residential

Additional Comments: Recommend a structural assessment prior to applying nonstructural measure.

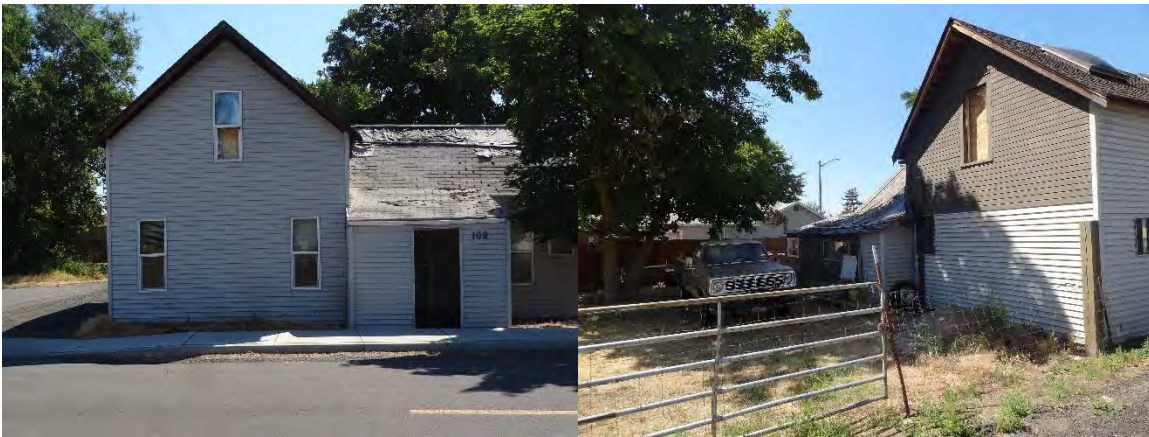
Property Address: 109 S E St

Foundation Type	Mechanical Equipment	Type
Slab on grade	Elevated A/C	Residential

Additional Comments: Recommend a structural assessment prior to applying nonstructural measure.

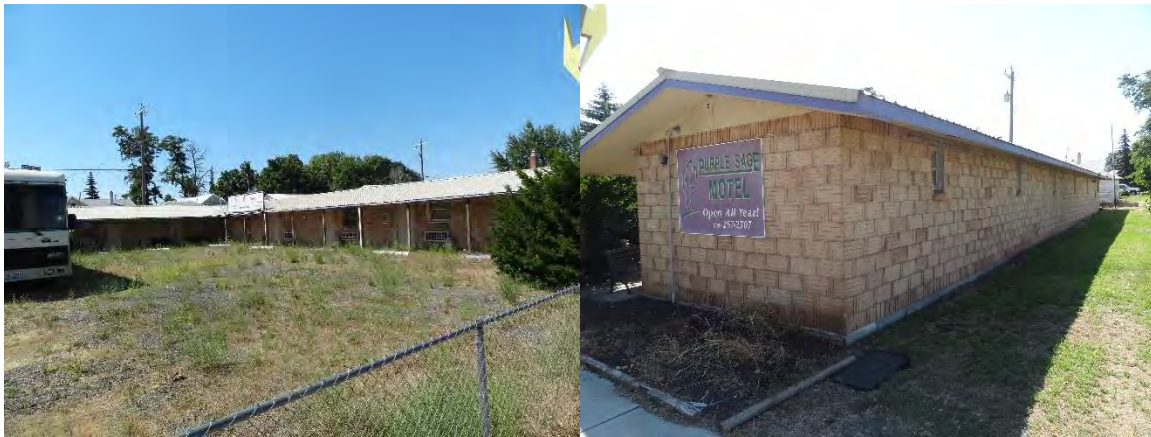
Property Address: 409 W 1st St

Foundation Type	Mechanical Equipment	Type
Slab on grade	Wall A/C	Non-Residential

Additional Comments: Recommend a structural assessment prior to applying nonstructural measure.

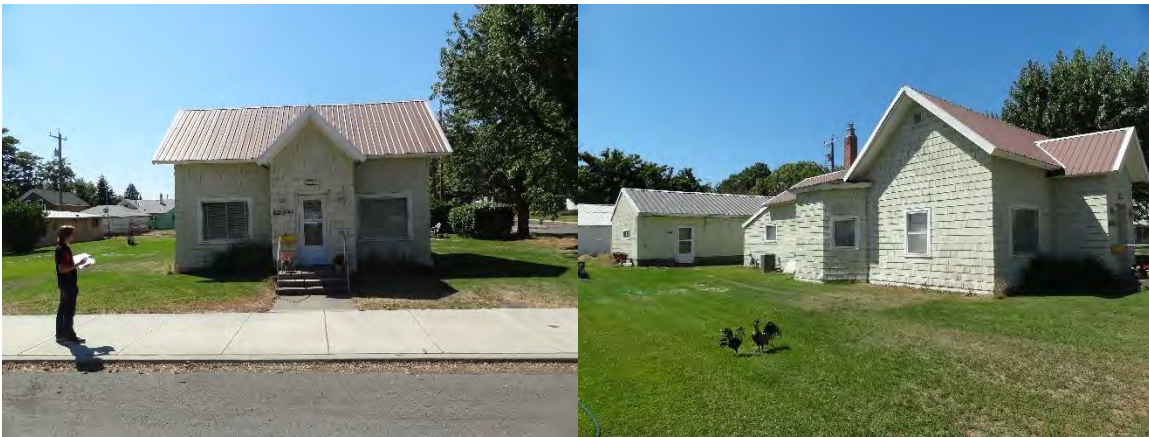
Property Address: 419 W 1st St

Foundation Type	Mechanical Equipment	Type
Crawlspace	A/C on grade	Residential

Additional Comments: Recommend a structural assessment prior to applying nonstructural measure.

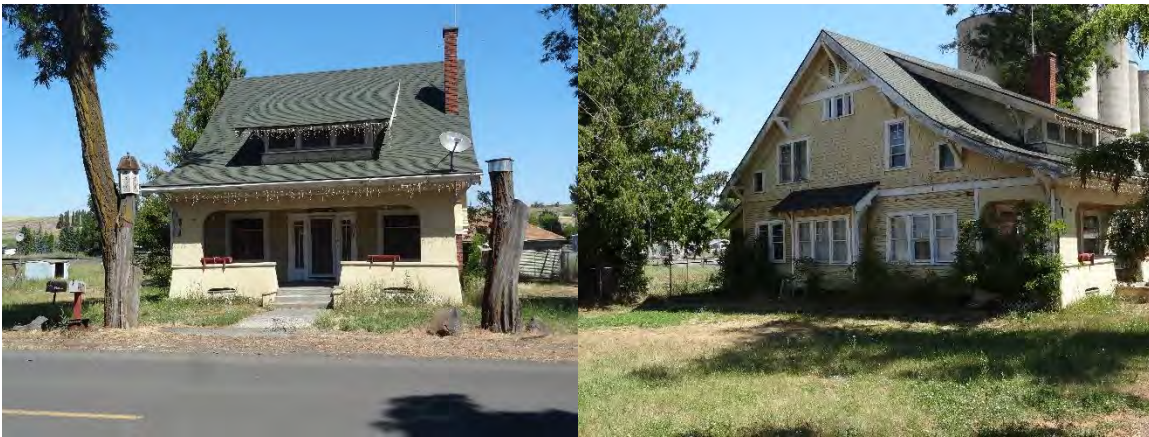
Property Address: 504 W 1st St

Foundation Type	Mechanical Equipment	Type
Basement	A/C on grade	Residential

Permanent NS Measure: Fill basement and replace space with addition at grade plus 2 ft to stay above flood level.

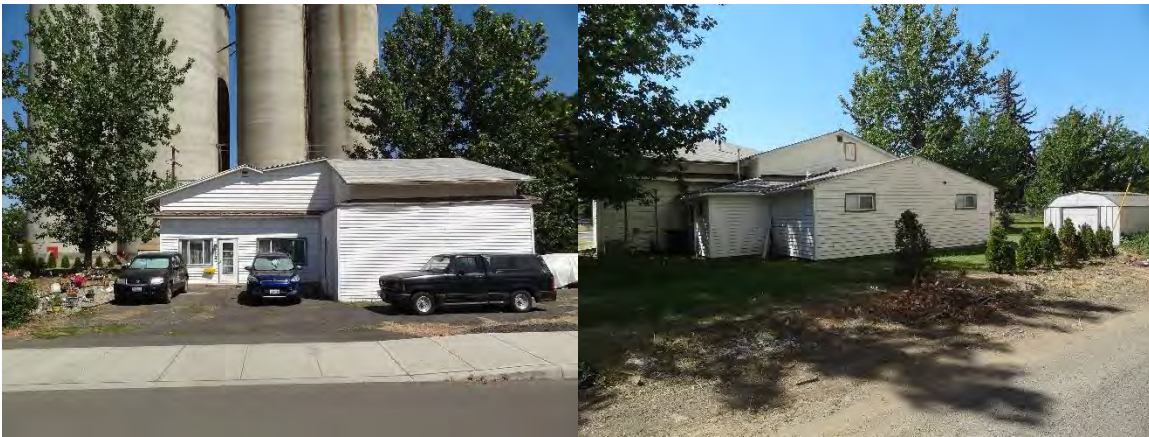
Property Address: 404 W 1st St

Foundation Type	Mechanical Equipment	Type
Slab on grade	Unknown	Residential

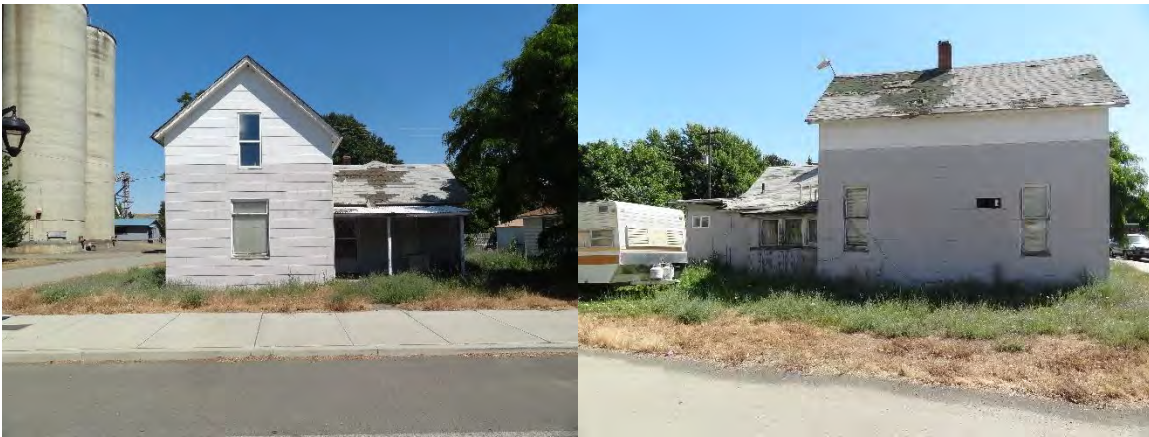
Property Address: 318 W 1st St

Foundation Type	Mechanical Equipment	Type
Slab on grade	A/C on grade	Residential

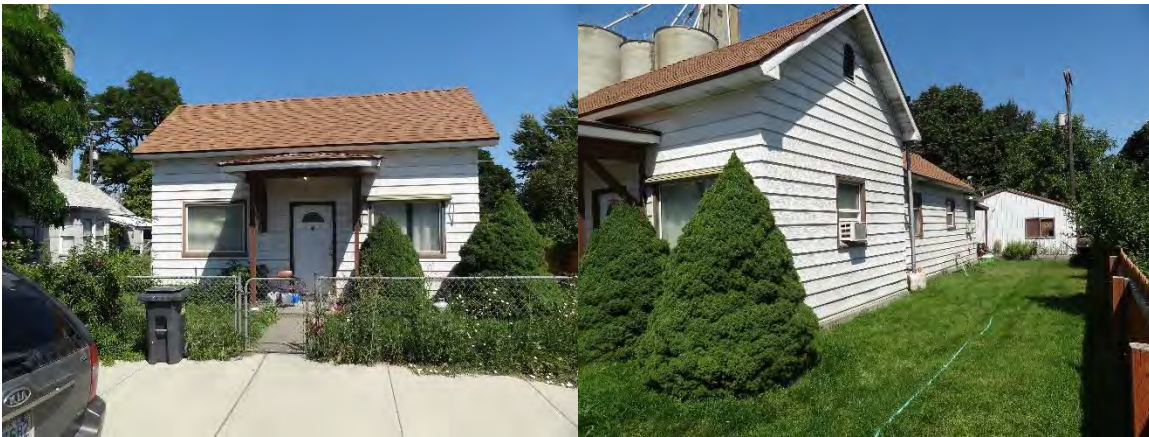
Property Address: 314 W 1st St

Foundation Type	Mechanical Equipment	Type
Slab on grade	Window A/C	Residential

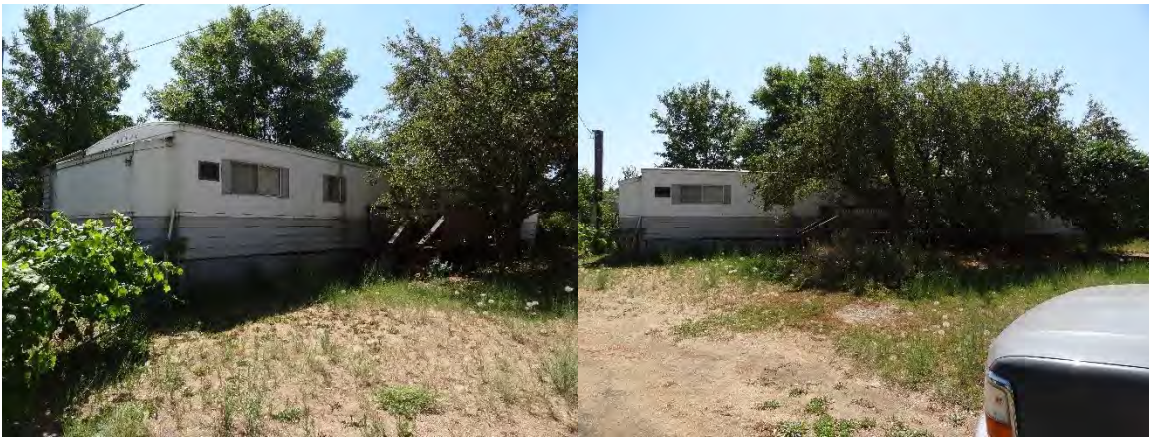
Property Address: 304 W 1st St

Foundation Type	Mechanical Equipment	Type
Piers and skirting	Unknown	Residential

Permanent NS Measure: Water may be able to safely be under home with minimal damage.

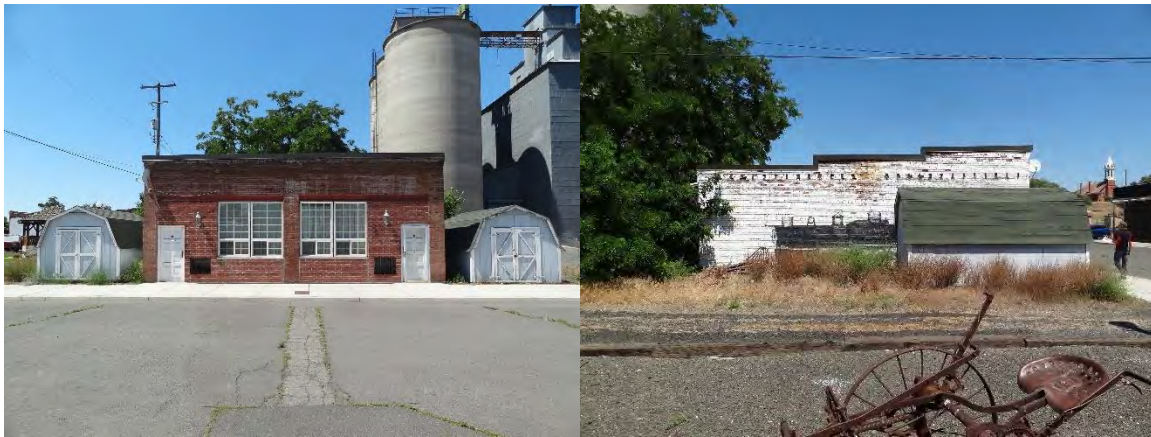
Property Address: 113 N C St

Foundation Type	Mechanical Equipment	Type
Slab on grade	Unknown	Non-Residential

Additional Comments: Recommend a structural assessment prior to applying nonstructural measure.

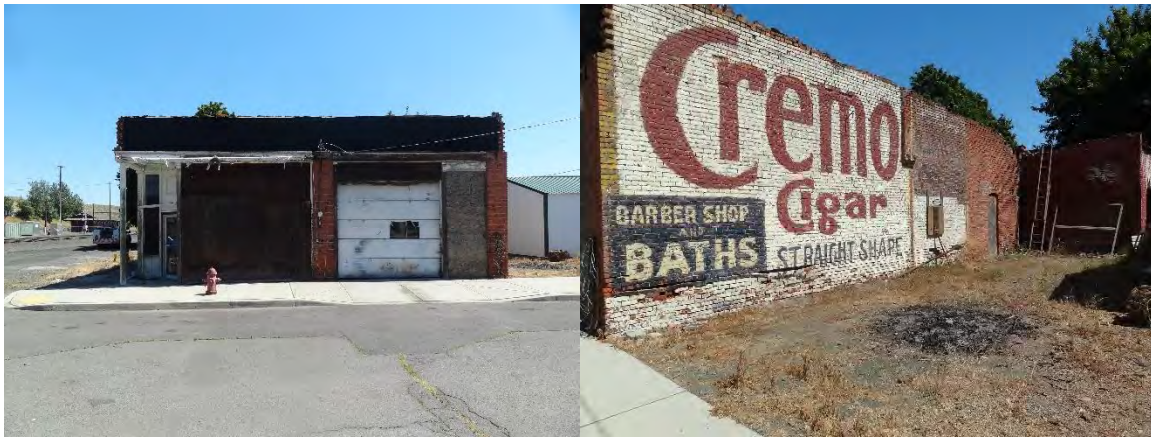
Property Address: 114 N C St

Foundation Type	Mechanical Equipment	Type
Slab on grade	Unknown	Non-Residential

Additional Comments: Recommend a structural assessment prior to applying nonstructural measure.

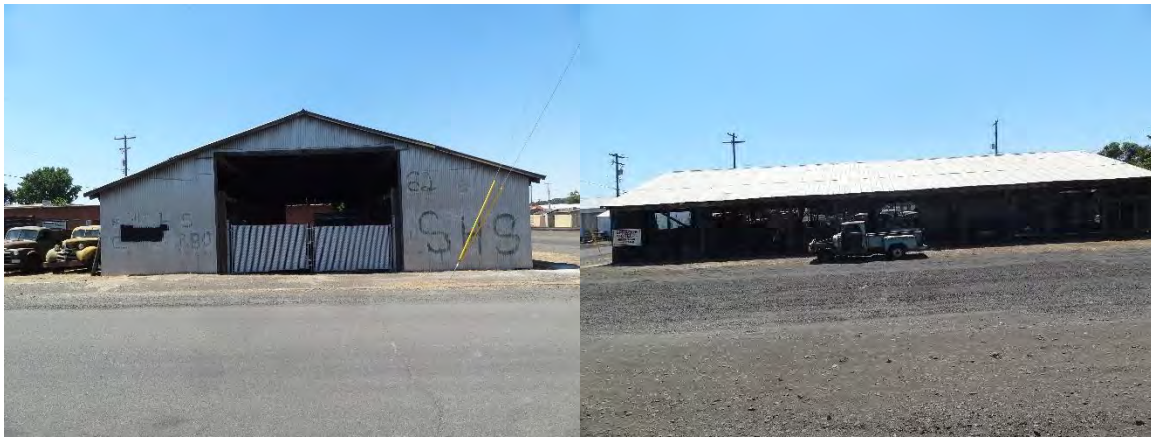
Property Address: Shed on B Street

Foundation Type	Mechanical Equipment	Type
Slab on grade	Unknown	Non-Residential

Temporary Flood Measure: Remove items that may be damaged by a flood prior to flood arrival.

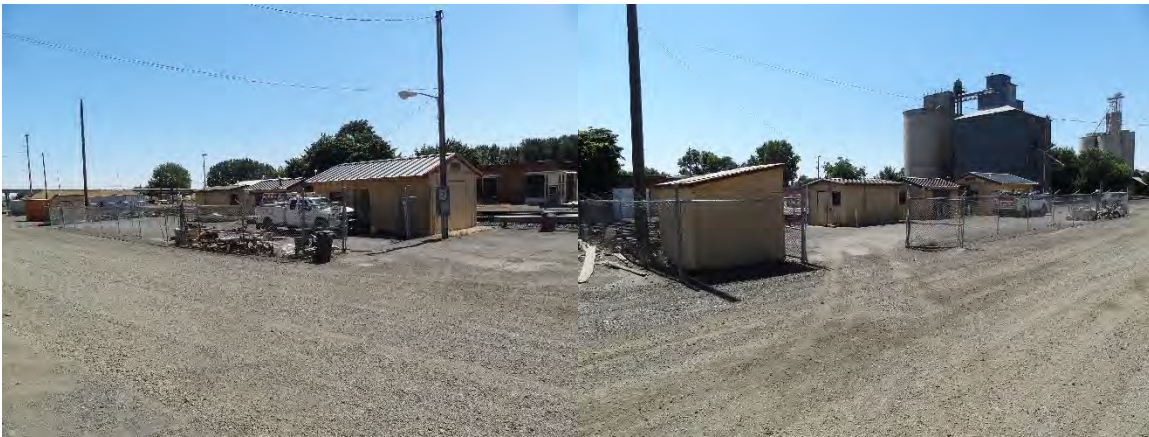
Property Address: BNSF Buildings on Railroad Ave

Foundation Type	Mechanical Equipment	Type
Slab on grade	Unknown	Non-Residential

Temporary Flood Measure: Remove items that may be damaged by a flood prior to flood arrival.

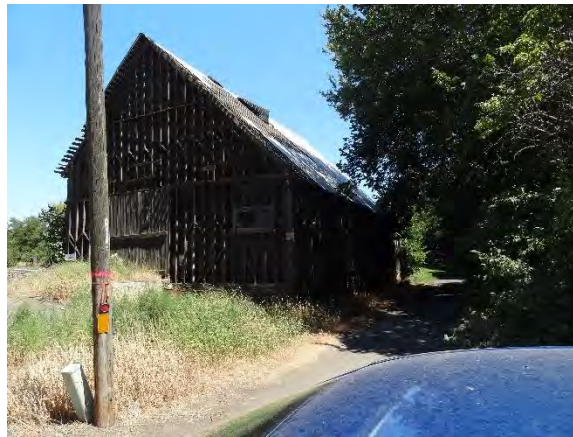
Property Address: Wood barn on S E St

Foundation Type	Mechanical Equipment	Type
Slab on grade	Unknown	Non-Residential

Temporary Flood Measure: Remove items that may be damaged by a flood prior to flood arrival.

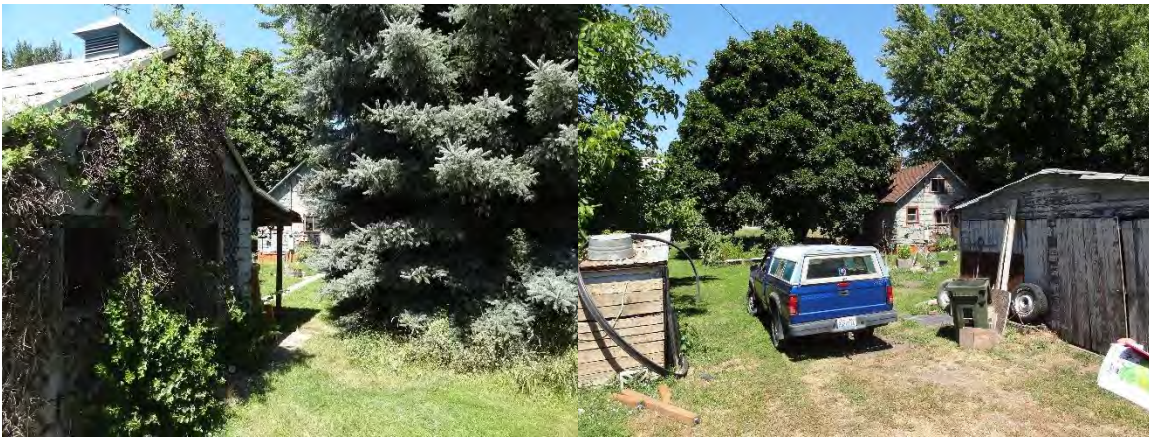
Property Address: 305 W Boxcar Ave

Foundation Type	Mechanical Equipment	Type
Slab on grade	Window A/C	Residential

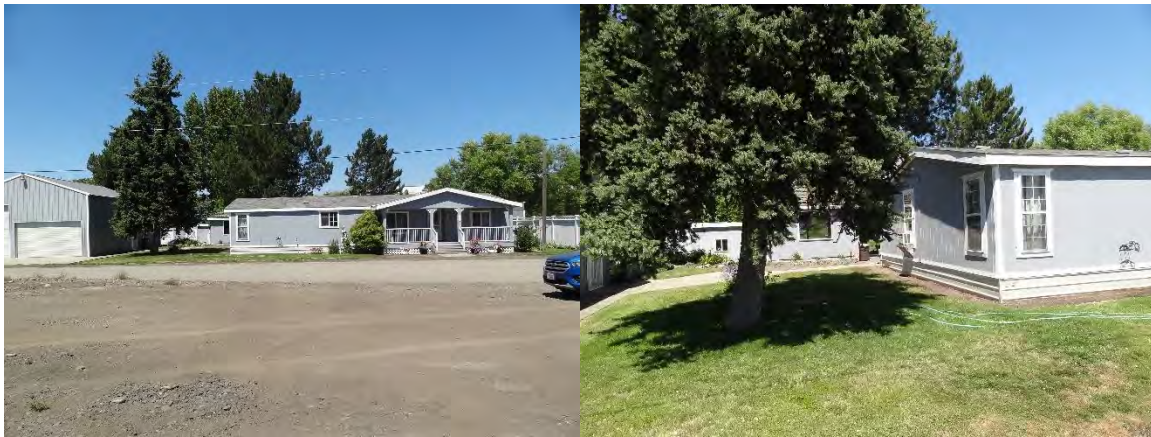
Property Address: 418 W Railroad Ave

Foundation Type	Mechanical Equipment	Type
Slab on grade	Window A/C	Residential

Permanent NS Measure: Water may be able to safely be around home with minimal damage.

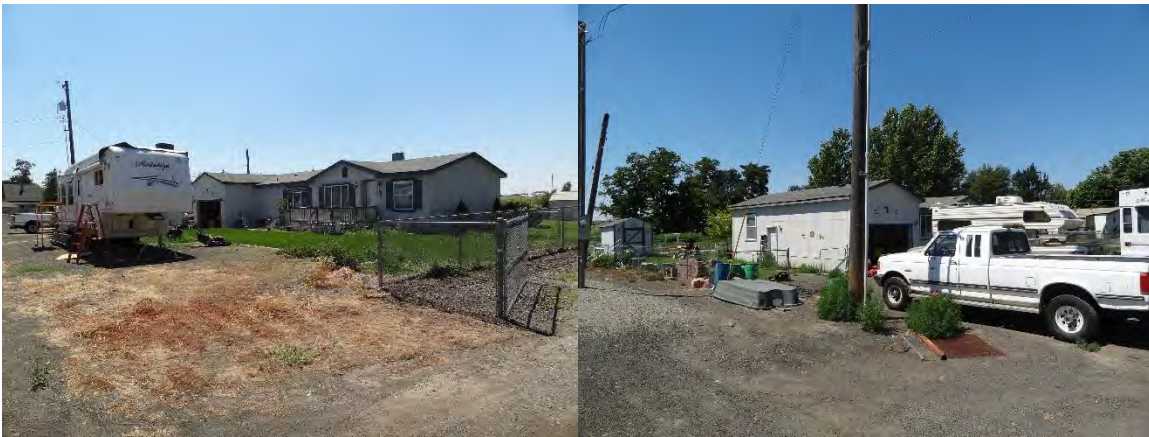
Property Address: 209 N F St

Foundation Type	Mechanical Equipment	Type
Piers	Unknown	Residential

Permanent NS Measure: Elevate structure an additional 2 ft. If using an extended foundation, include flood vents.

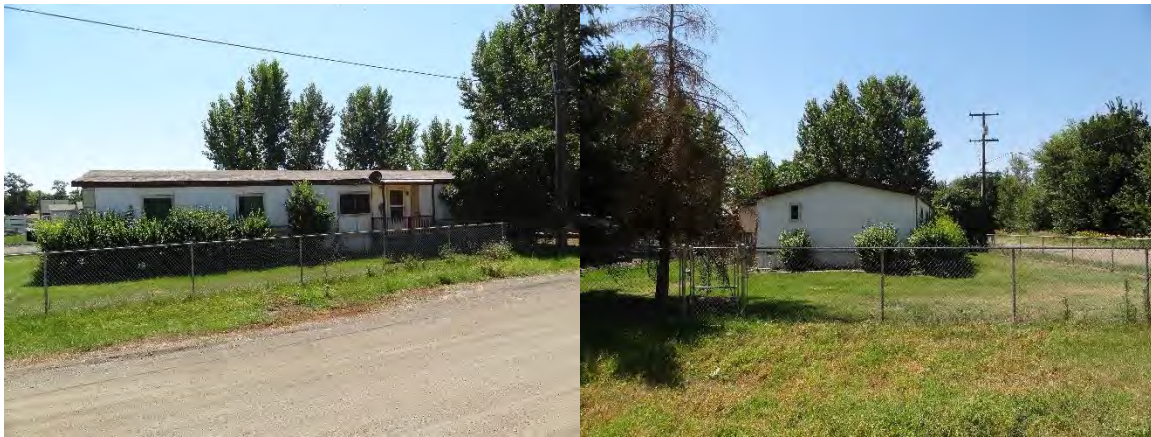
Property Address: 509 W Alder St

Foundation Type	Mechanical Equipment	Type
Piers and skirting	A/C on grade	Residential

Permanent NS Measure: Elevate structure an additional 1 ft. If using an extended foundation, include flood vents.

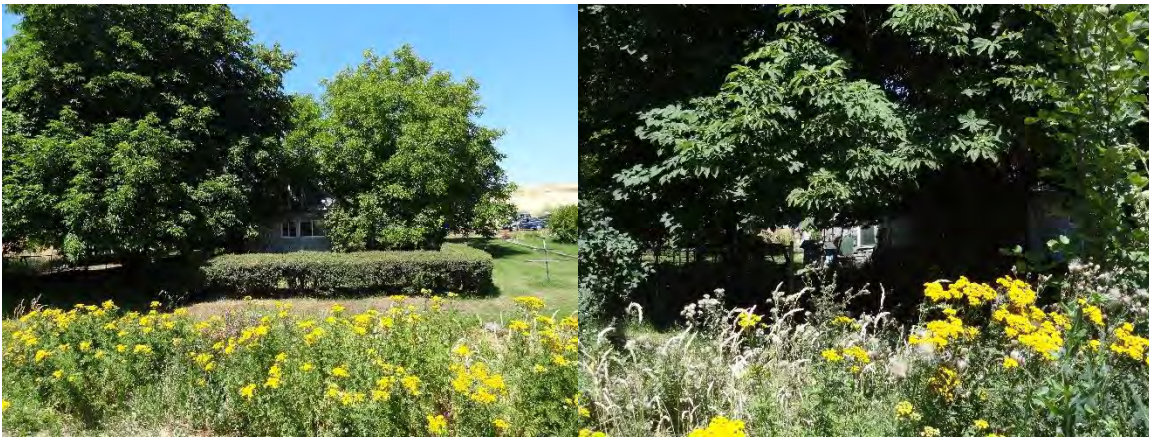
Property Address: 504 W Alder St

Foundation Type	Mechanical Equipment	Type
Slab on grade	Window A/C	Residential

Permanent NS Measure: Elevate structure 4 ft. If using an extended foundation, include flood vents.

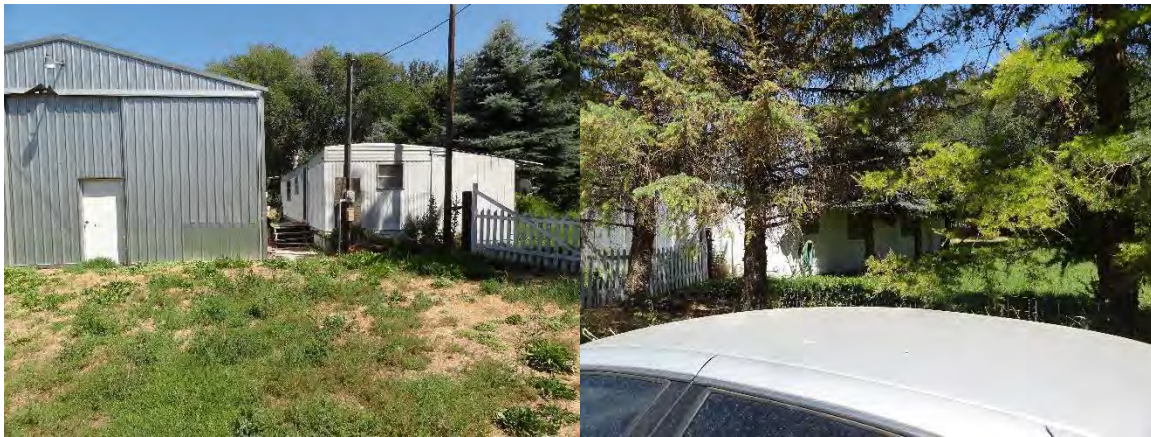
Property Address: 304 S H St

Foundation Type	Mechanical Equipment	Type
Piers and skirting	Unknown	Residential

Permanent NS Measure: Elevate structure 1 ft. If using an extended foundation, include flood vents.

Additional Comments: Recommend structural analysis before applying nonstructural measure.

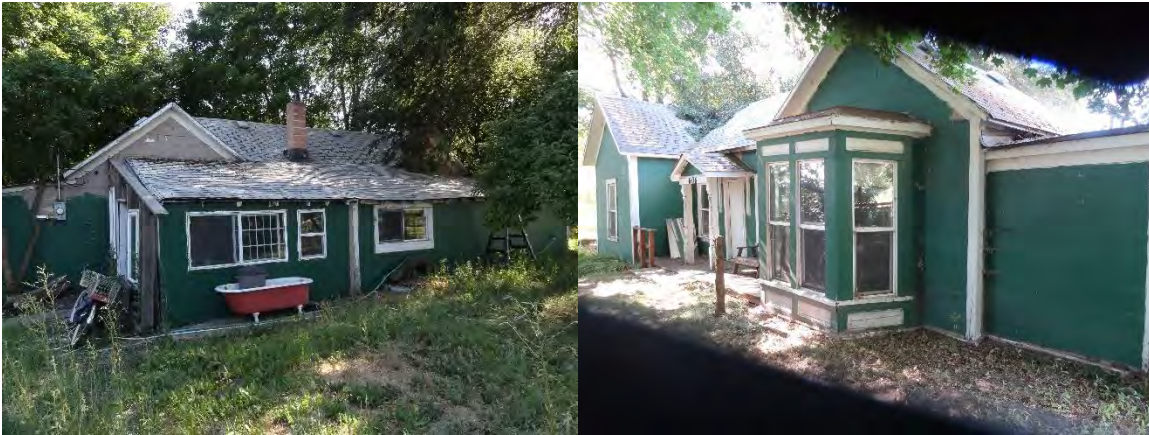
Property Address: 606 W Alder St

Foundation Type	Mechanical Equipment	Type
Slab on grade	Unknown	Residential

Additional Comments: Recommend structural analysis before applying nonstructural measure.

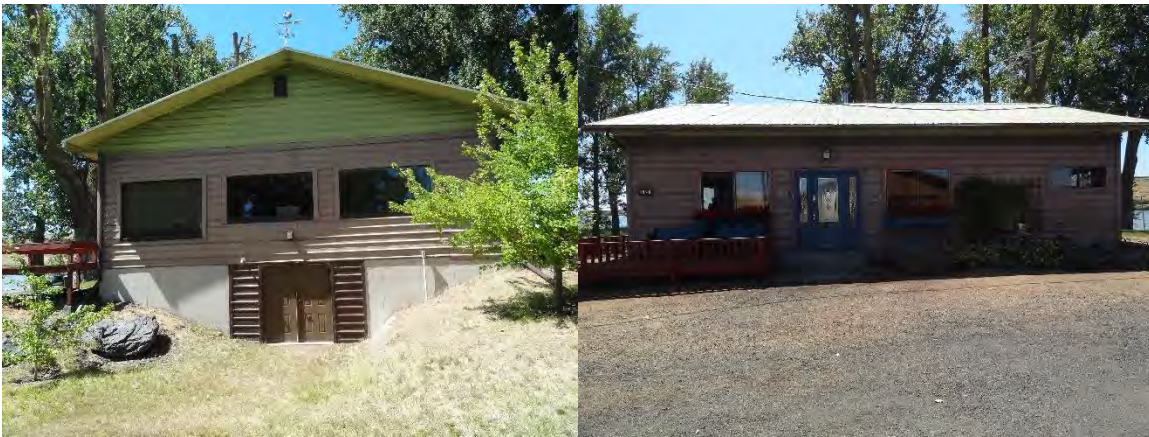
Property Address: 1999 Sprague Lake Resort Road

Foundation Type	Mechanical Equipment	Type
Daylight basement	Unknown	Residential

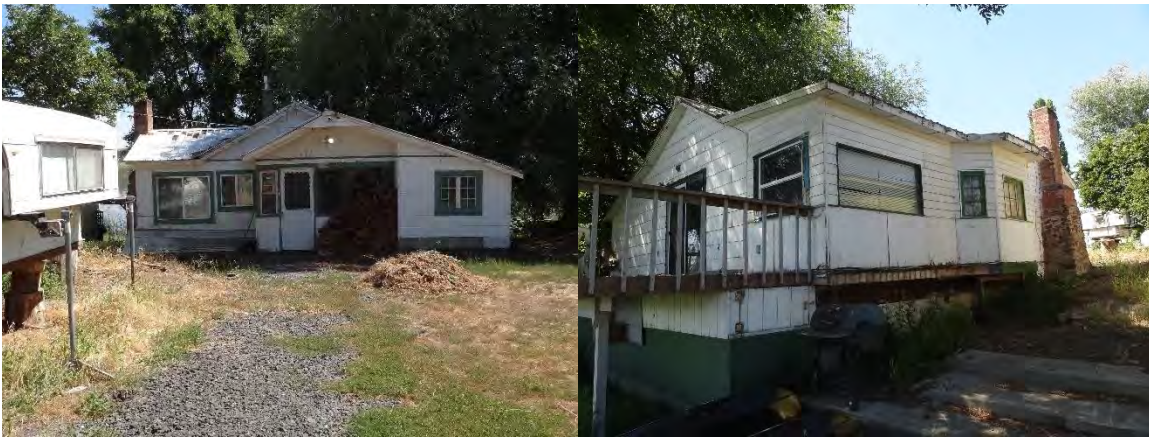
Property Address: 1983 Sprague Lake Resort Road

Foundation Type	Mechanical Equipment	Type
Basement	Unknown	Residential
