Sprague Lake Hydrologic Study

Flood-risk reduction alternatives analysis

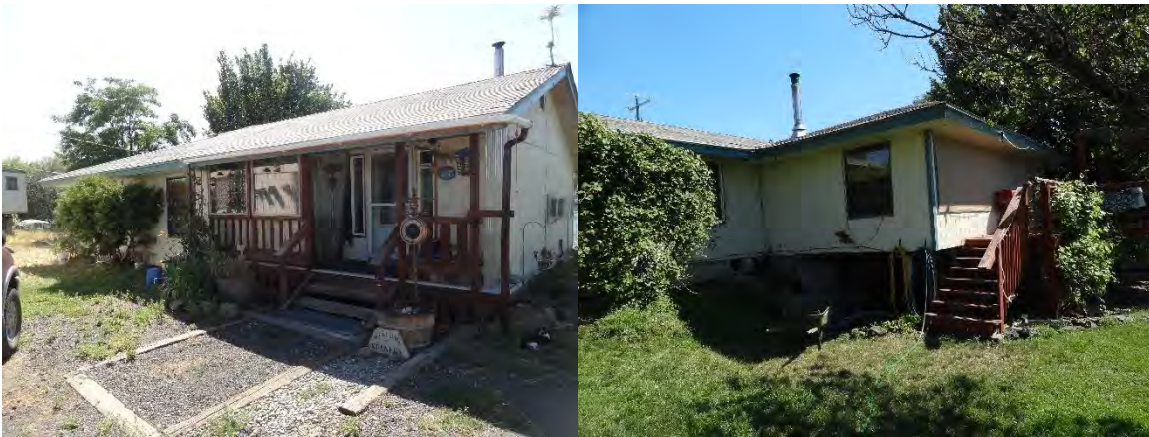
Property Address: 1873 Sprague Lake Resort Road

Foundation Type	Mechanical Equipment	Type
Basement	Unknown	Residential
