Stormwater Runoff Characterization for Evaluation of BMP Effectiveness

**Analysis of 6PPD-quinone and TAPE parameters
at the Ship Canal Testing Facility in Seattle,
Washington**

Meghan Elkey
King County Environmental Laboratory
King County Water and Land Resources Division
Department of Natural Resources and Parks

September 2025, Publication 25-10-077

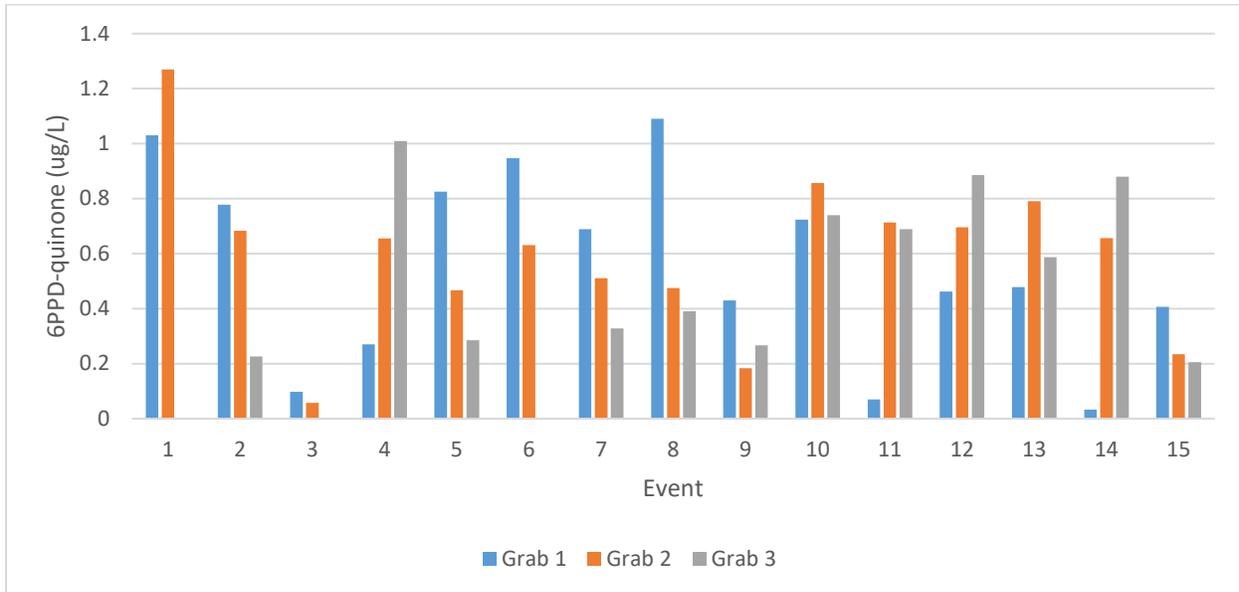
Figure 2. 6PPDQ concentrations in stormwater runoff.

In August of 2024, Ecology adopted an acute, freshwater Aquatic Life Toxics Criteria value for 6PPDQ of 0.012 ug/L under the 173-201A-240 Washington Administrative Code (Ecology, 2024). In this study, 6PPDQ concentrations in untreated stormwater runoff collected at SCTF had median concentrations of about 0.6 ug/L. All 6PPDQ results reported in this study exceeded the aquatic life criteria value by varying orders of magnitude.

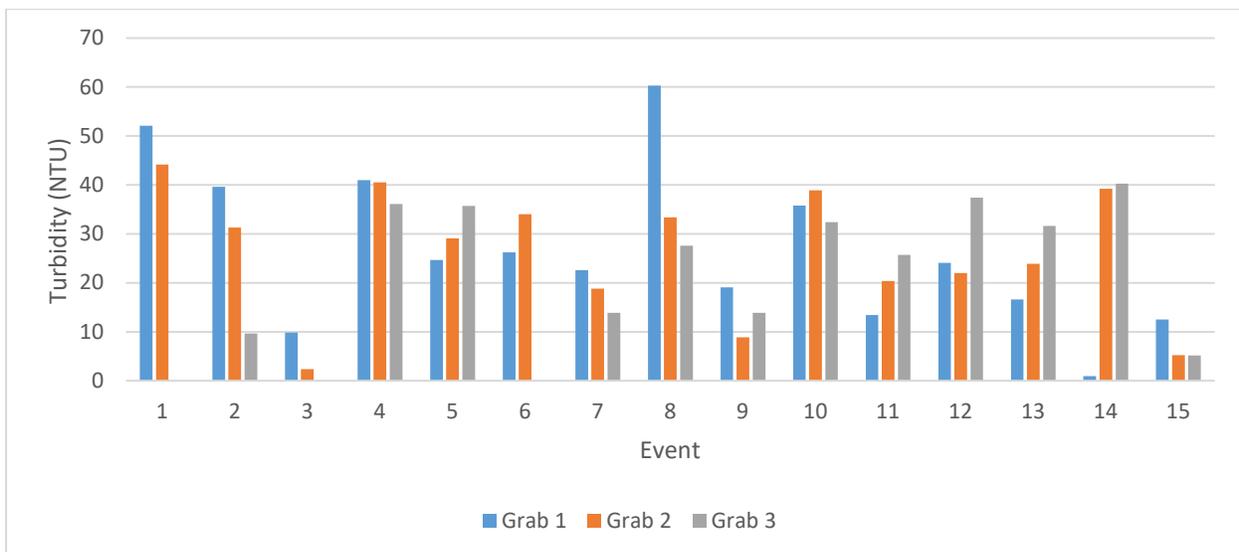
Figure 3. Turbidity of stormwater runoff.

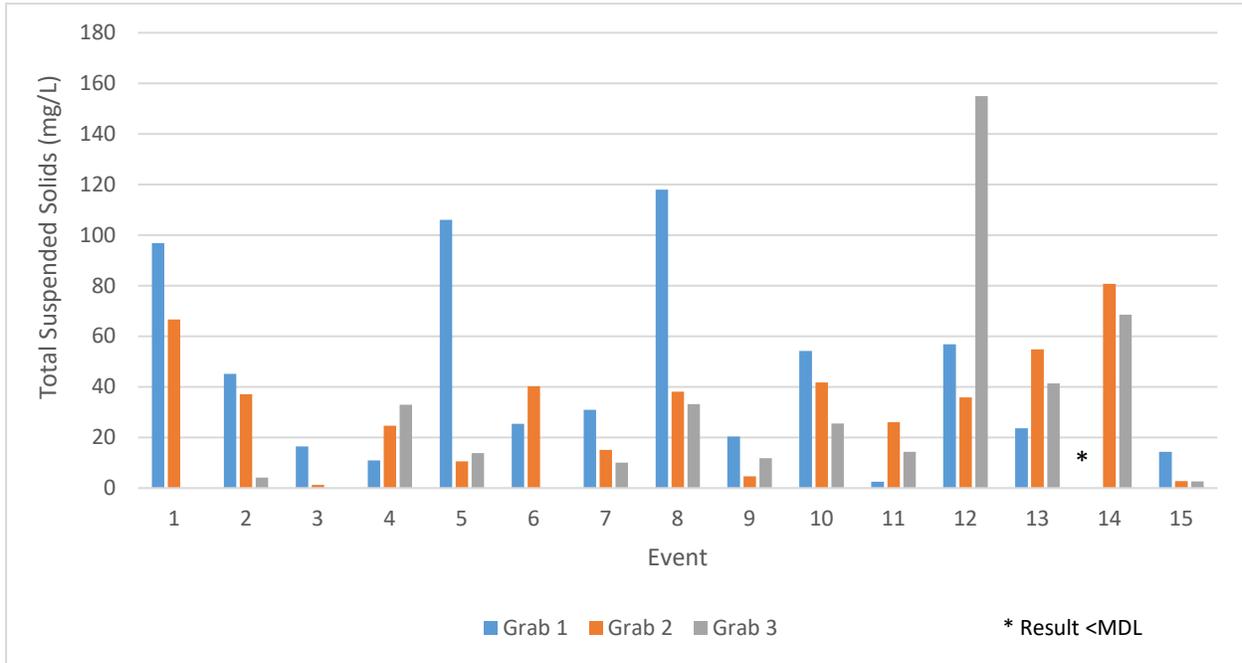
Figure 4. Total Suspended Solids in stormwater runoff.

- The method blank (MB) associated with the Total Suspended Solids (TSS) result for the second grab for Event 9 (January 31, 2024) had a result greater than the MDL. The TSS result was B qualified to indicate the qualifiable result was >MDL and <5x the contamination in the method blank before the dilution factor was taken into account. This sample result may have a potential positive bias due to MB contamination.

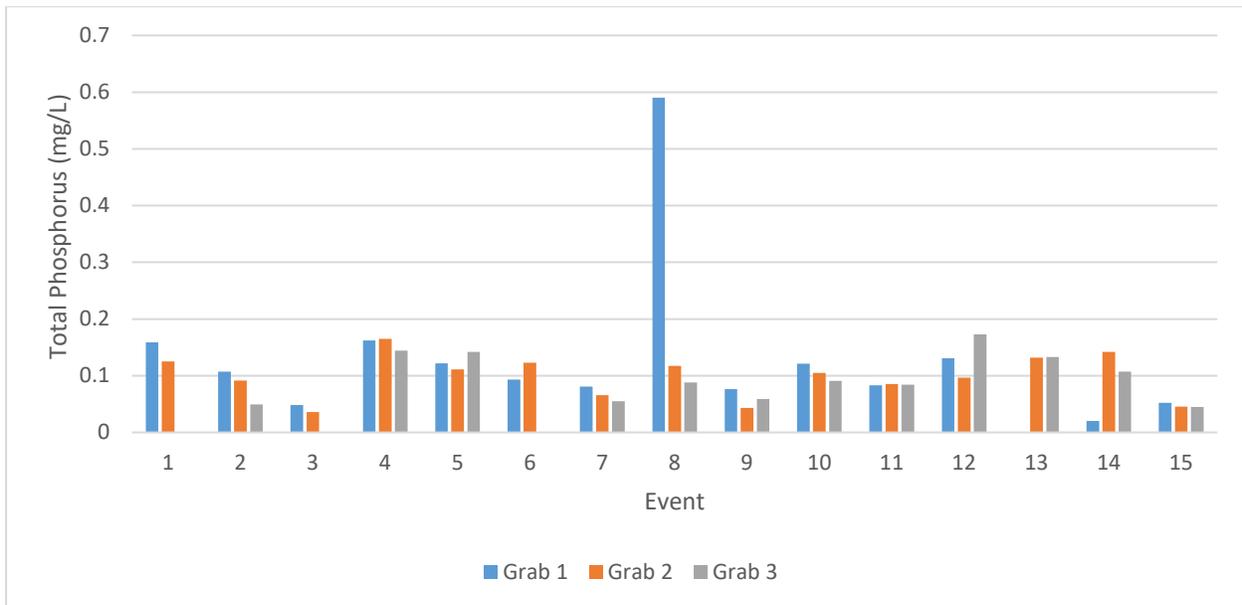
Figure 5. Total Phosphorus concentrations in stormwater runoff.

Grab 1 results for Event 13 not included for Orthophosphate Phosphorus (Figure 5) or Total Phosphorus (Figure 6) due to a comparison issue and subsequent estimated results.

- There was an unusual comparison between the Total Phosphorous and Orthophosphate Phosphorus results for the first grab for Event 13 (November 13, 2024). The Orthophosphate Phosphorus result was greater than the Total Phosphorous result, both sample results were J qualified, and the results are considered estimates.

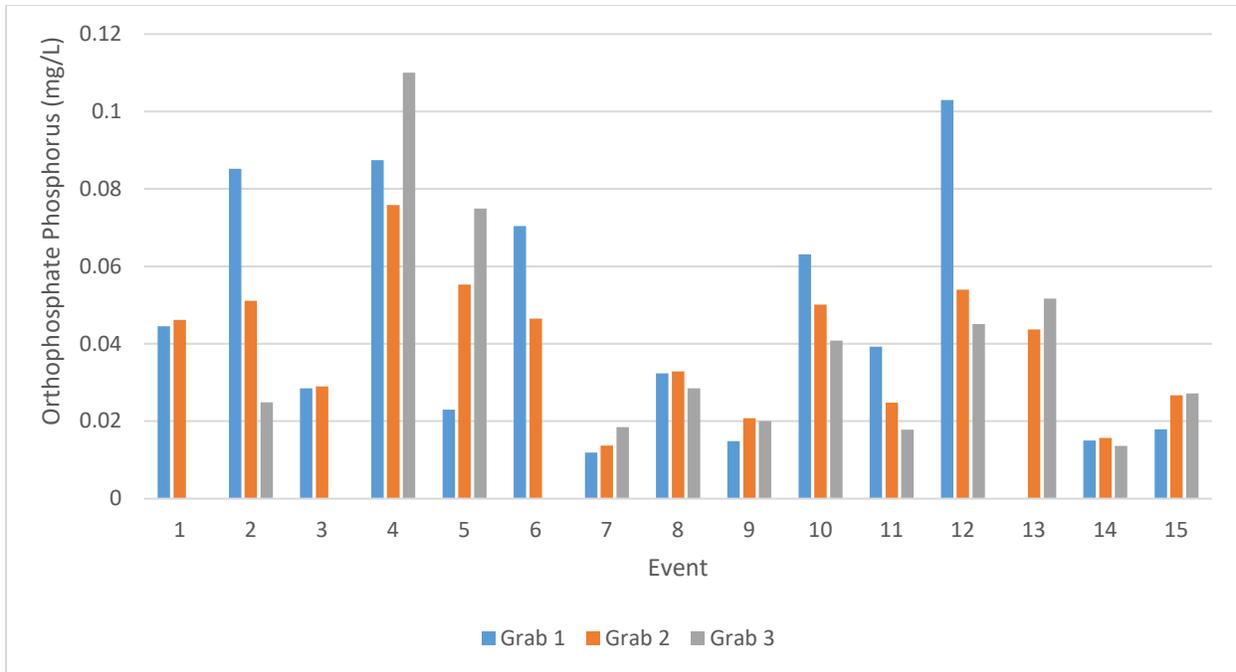
Figure 6. Orthophosphate Phosphorus concentrations in stormwater runoff.

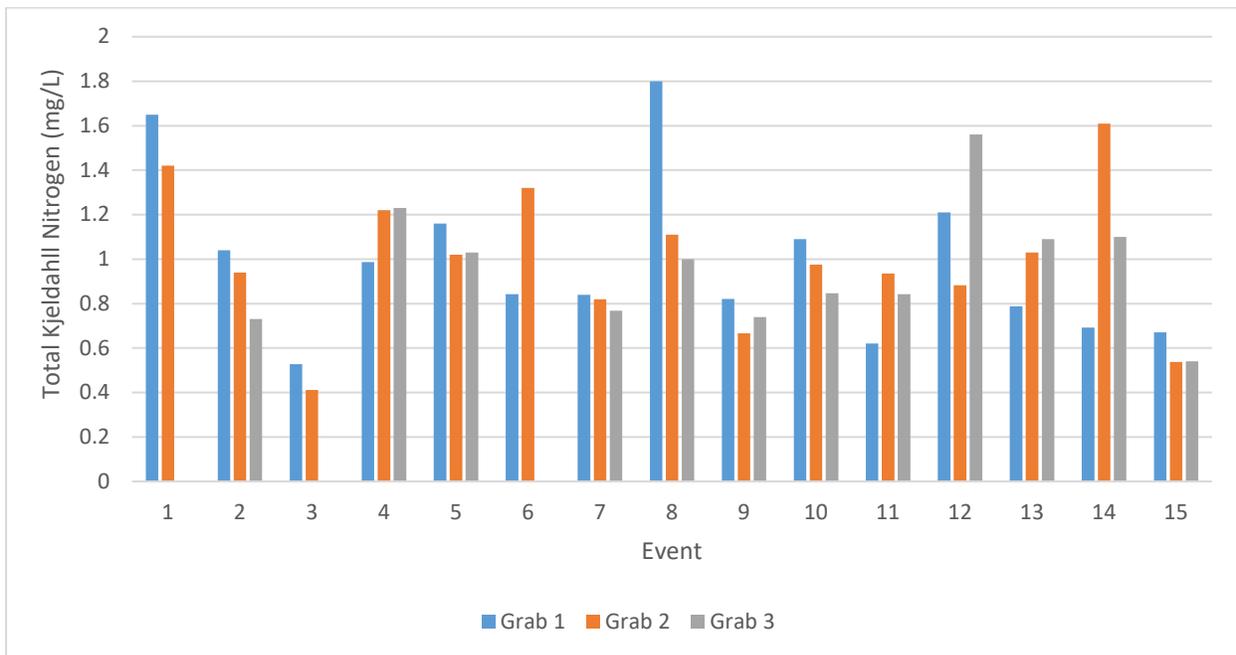
Figure 7. Total Kjeldahl Nitrogen concentrations in stormwater runoff.

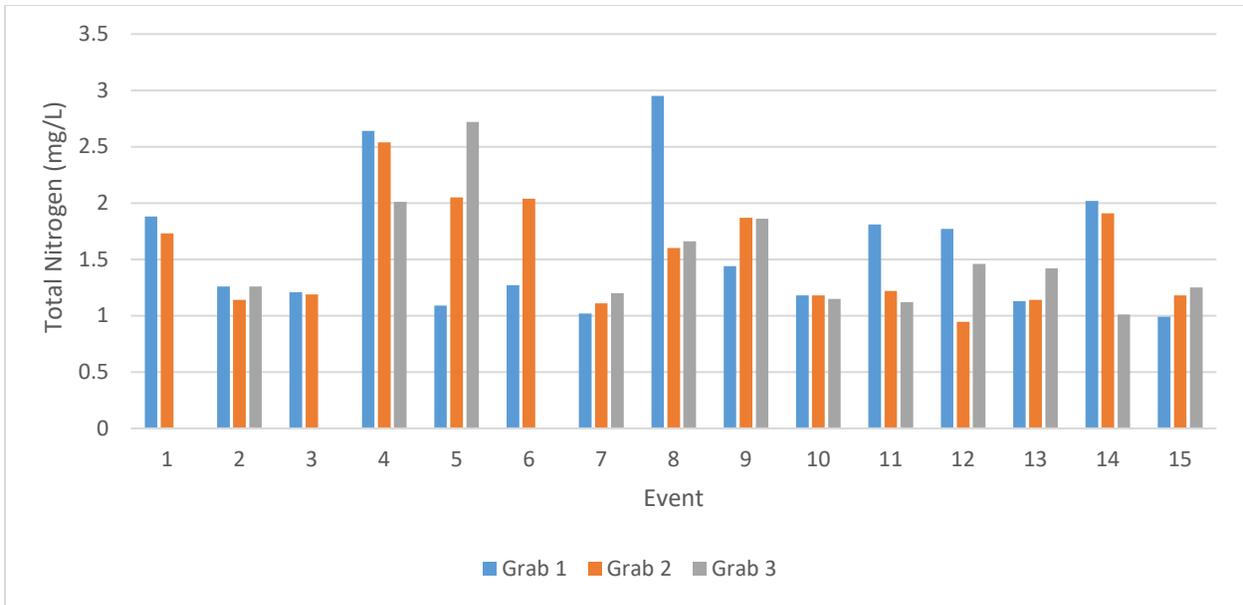
Figure 8. Total Nitrogen concentrations in stormwater runoff.

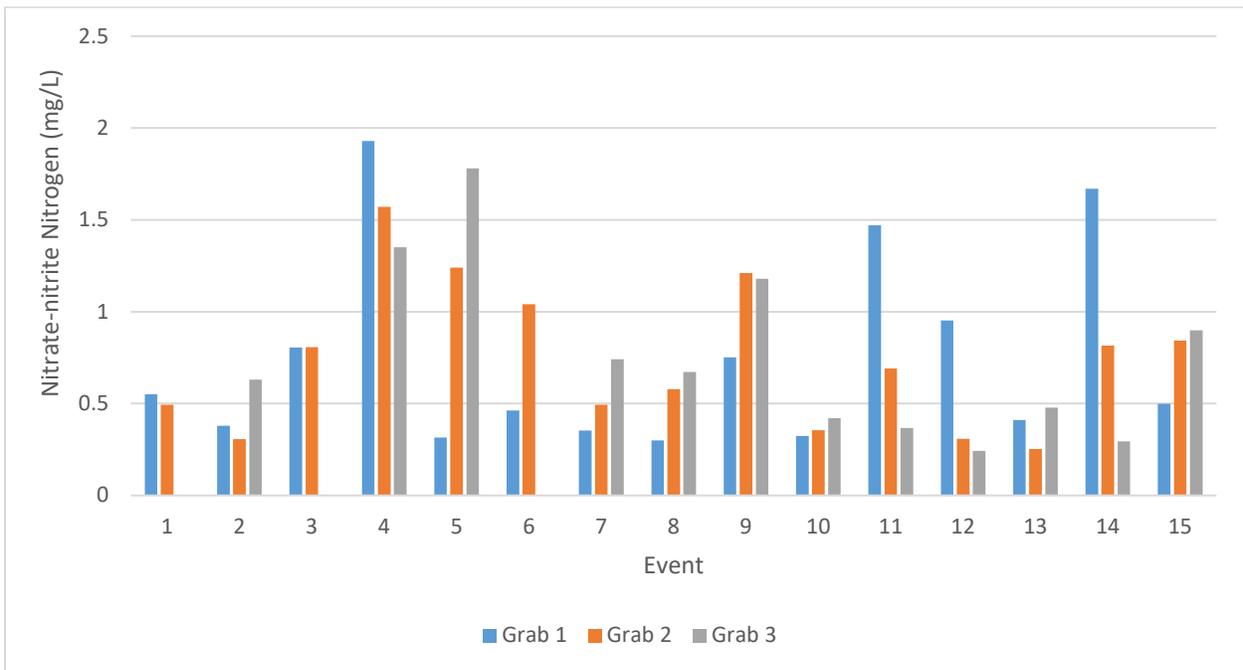
Figure 9. Nitrate-nitrite Nitrogen concentrations in stormwater runoff.

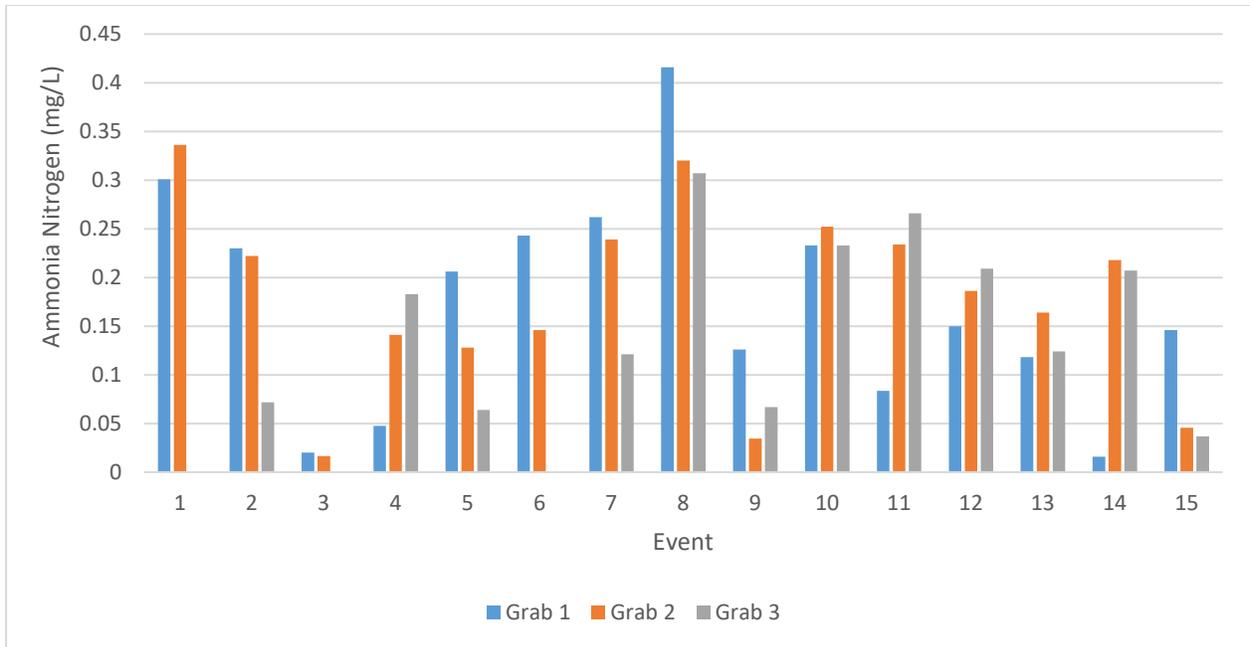
Figure 10. Ammonia Nitrogen concentrations in stormwater runoff.

- The Ammonia sample for the first grab for Event 5 (September 27, 2023) was reported above the calibration range of the analysis and it was not possible to dilute and reanalyze the sample. The affected sample result was J qualified, and the result is considered an estimate.

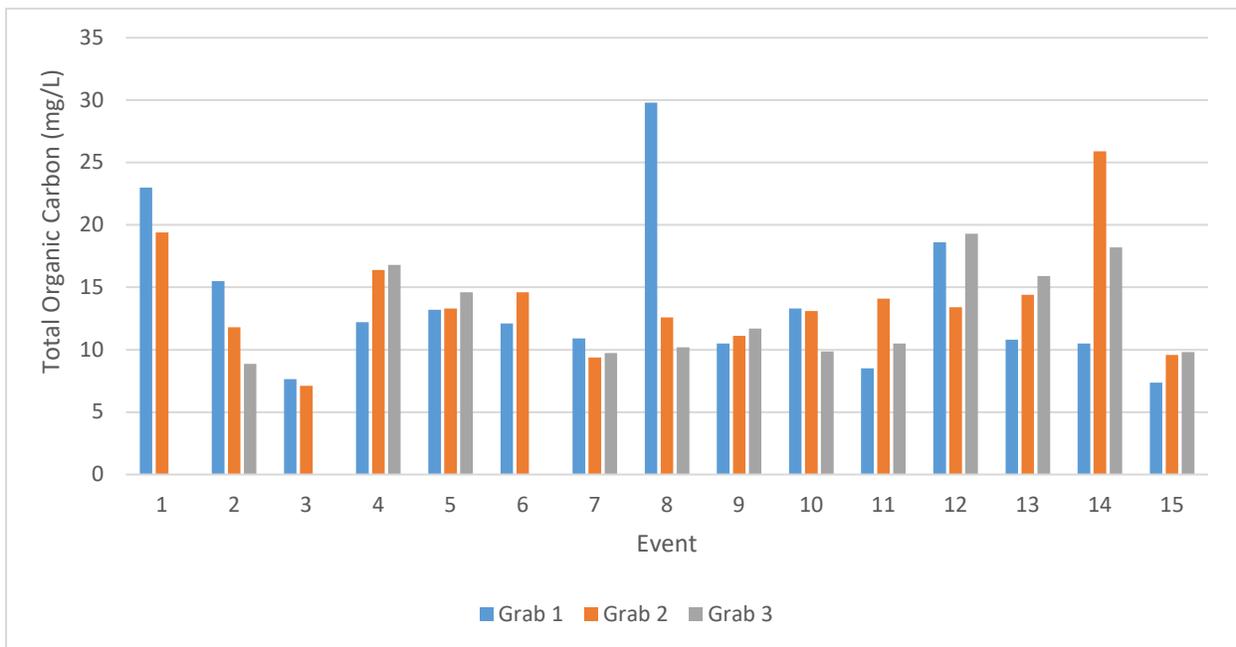
Figure 11. Total Organic Carbon concentrations in stormwater runoff.

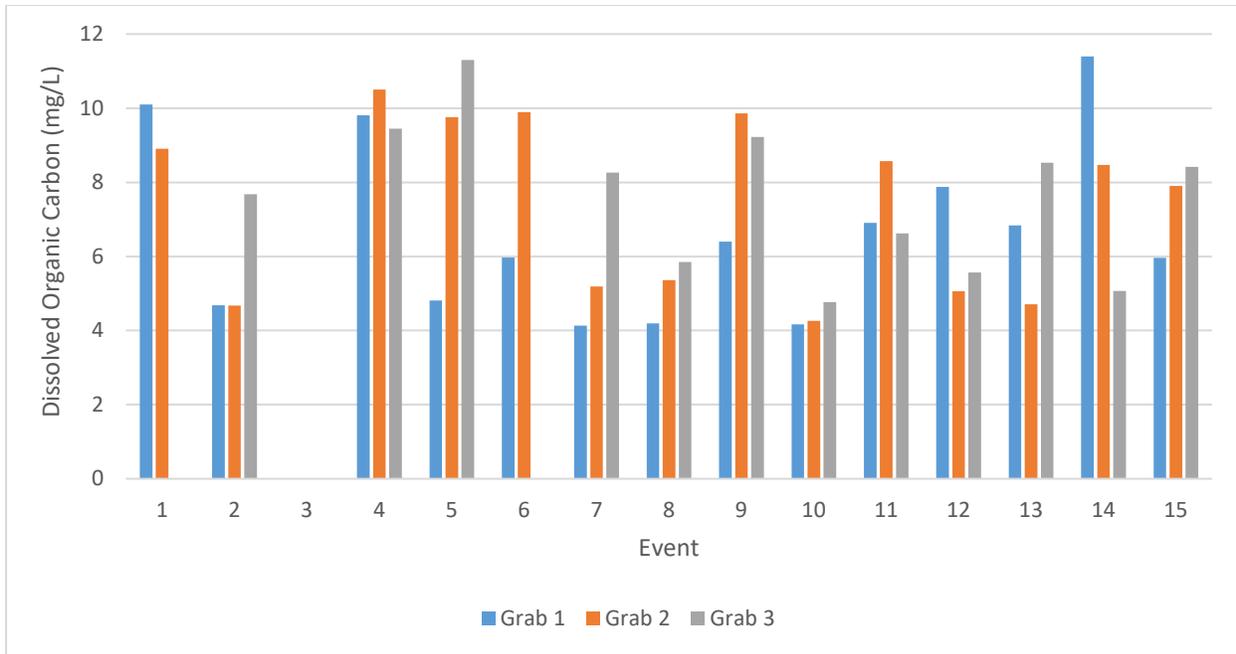
Figure 12. Dissolved Organic Carbon concentrations in stormwater runoff.

No Dissolved Organic Carbon data reported for Event 3, see Appendix A for details.

- Samples for Event 3 (April 18, 2023) were not lab filtered for Dissolved Organic Carbon (DOC) due to analyst oversight. The affected DOC results were rejected and reported as null values.

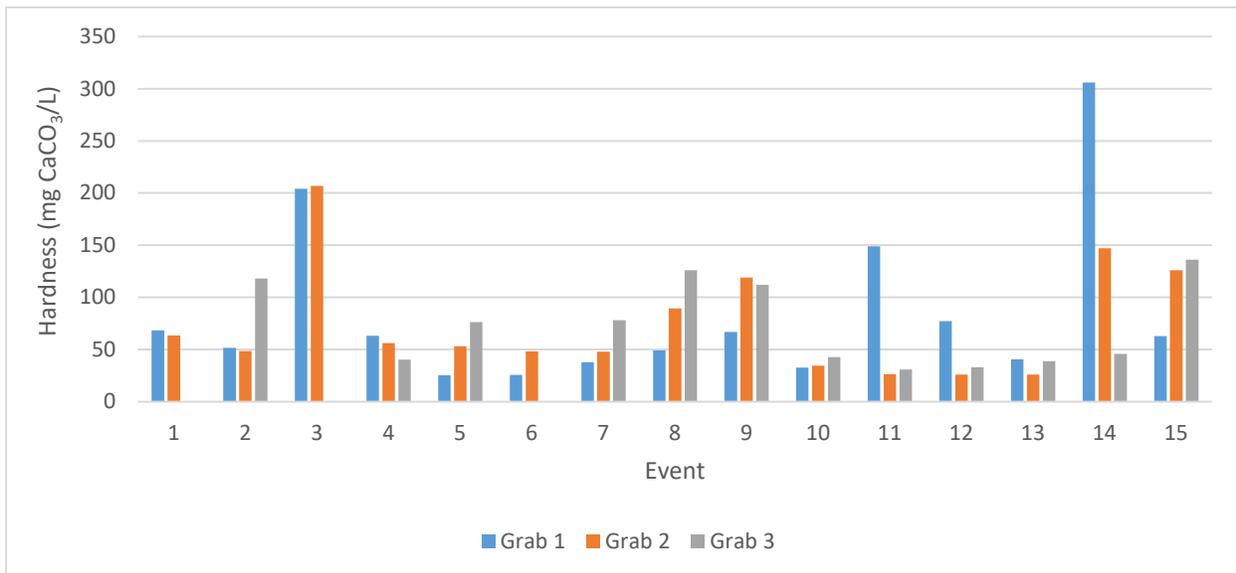
Figure 13. Hardness of stormwater runoff.

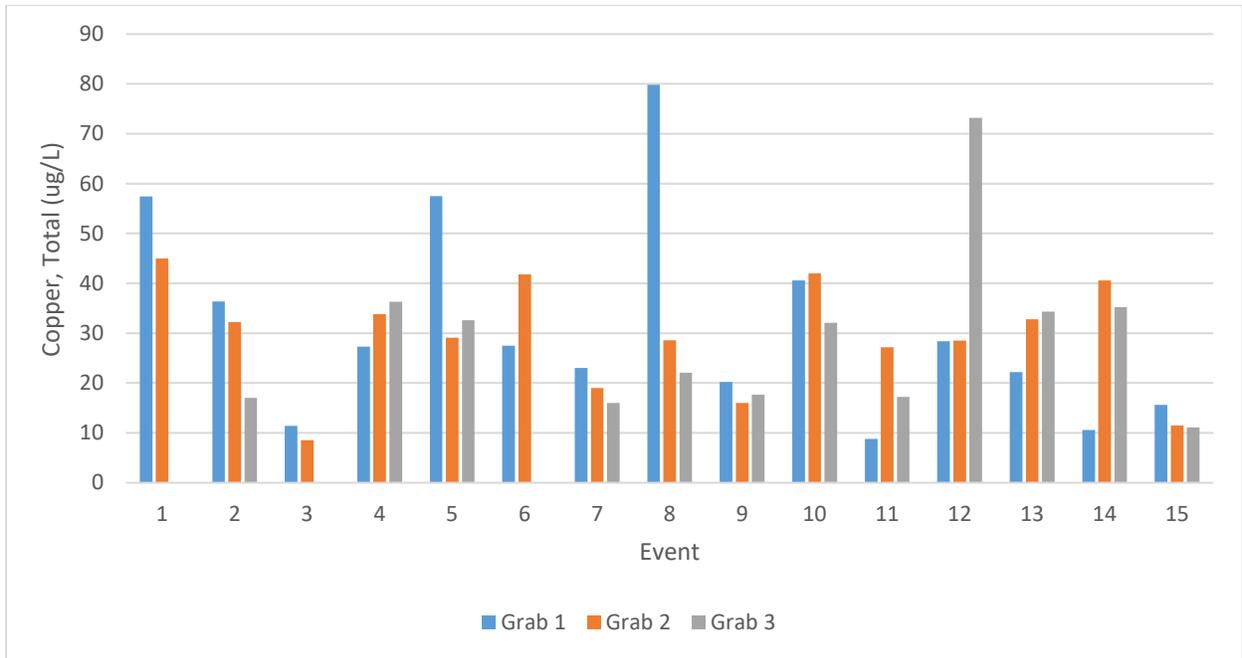
Figure 14. Total Copper concentrations in stormwater runoff.

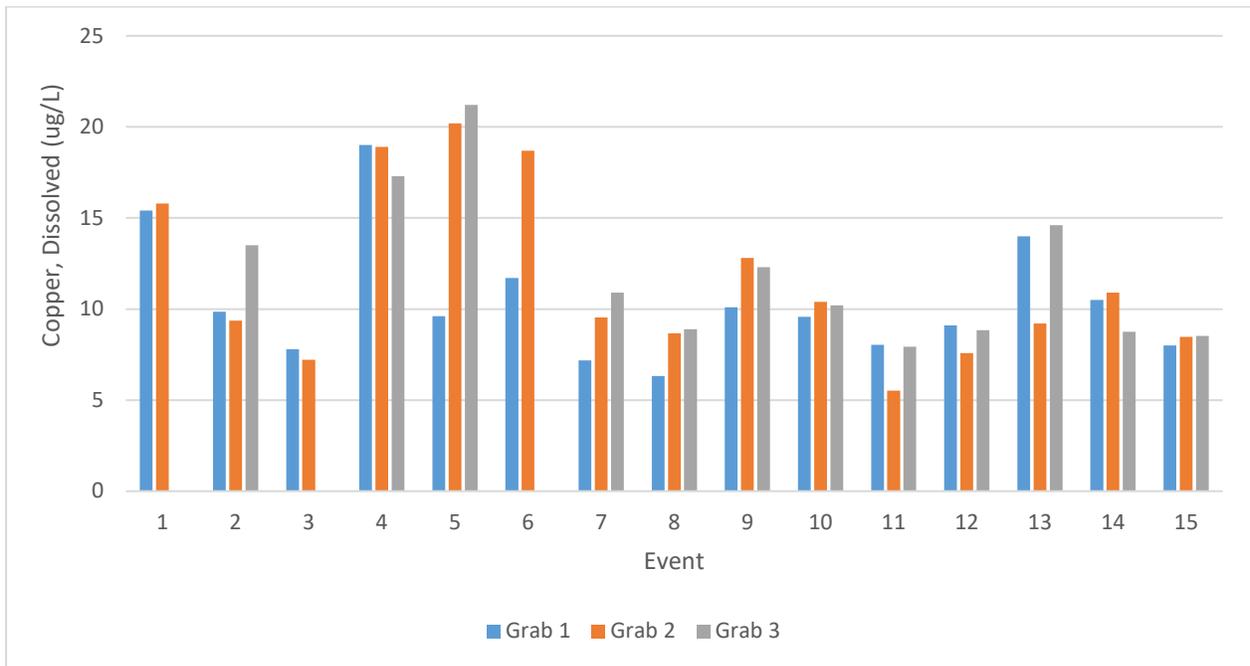
Figure 15. Dissolved Copper concentrations in stormwater runoff.

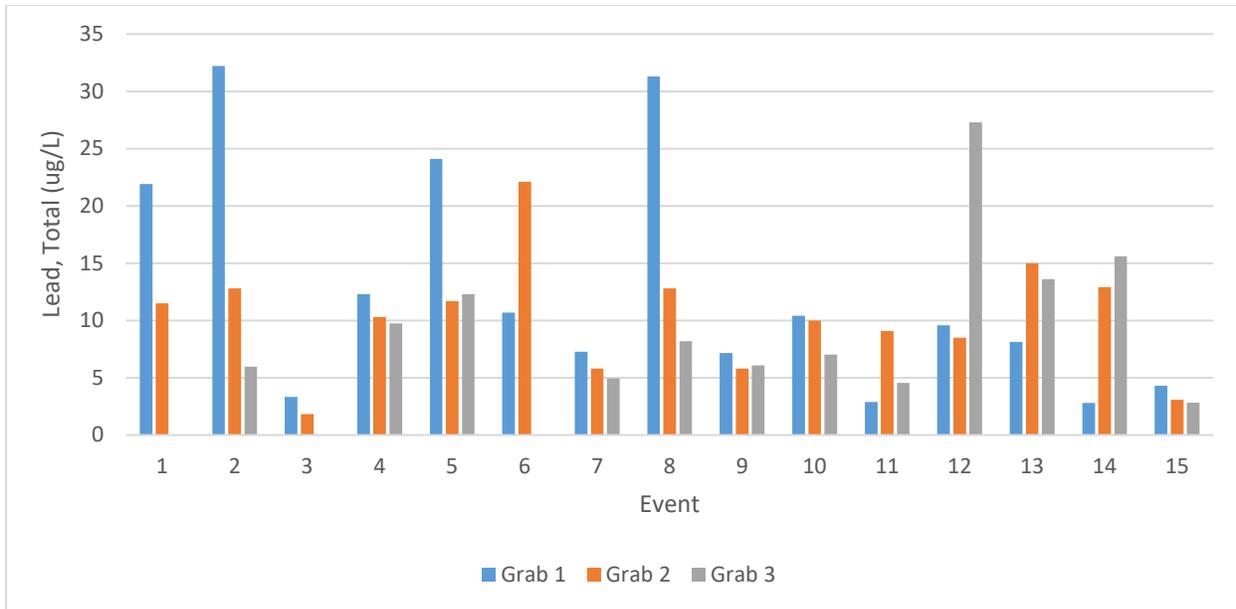
Figure 16. Total Lead concentrations in stormwater runoff.

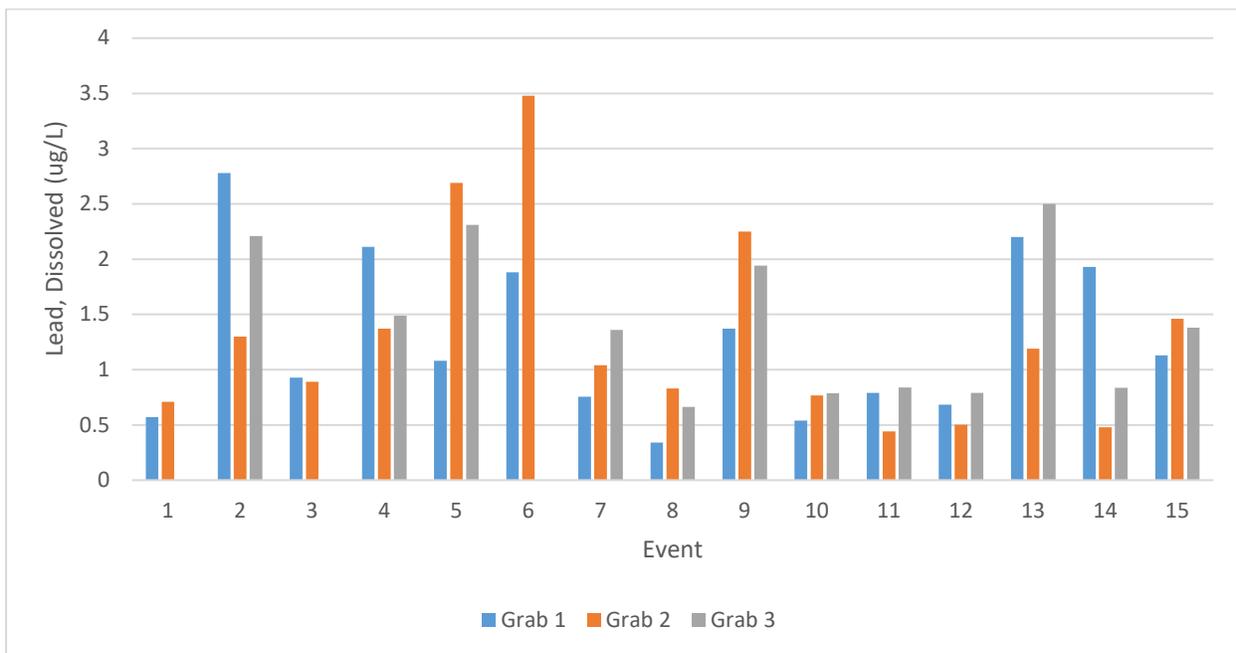
Figure 17. Dissolved Lead concentrations in stormwater runoff.

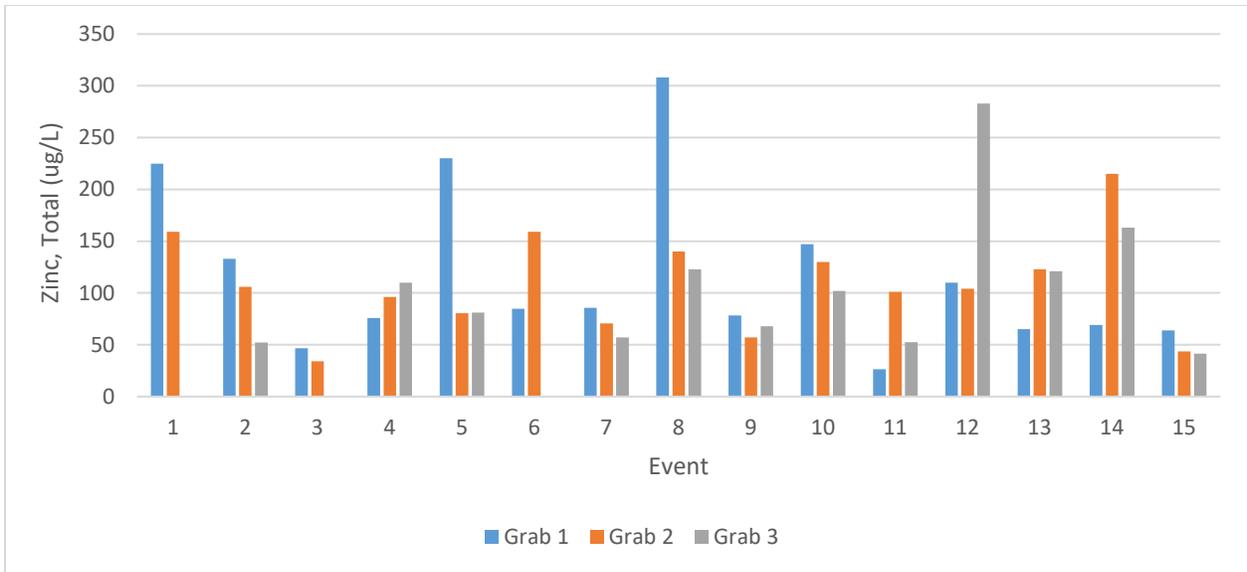
Figure 18. Total Zinc concentrations in stormwater runoff.

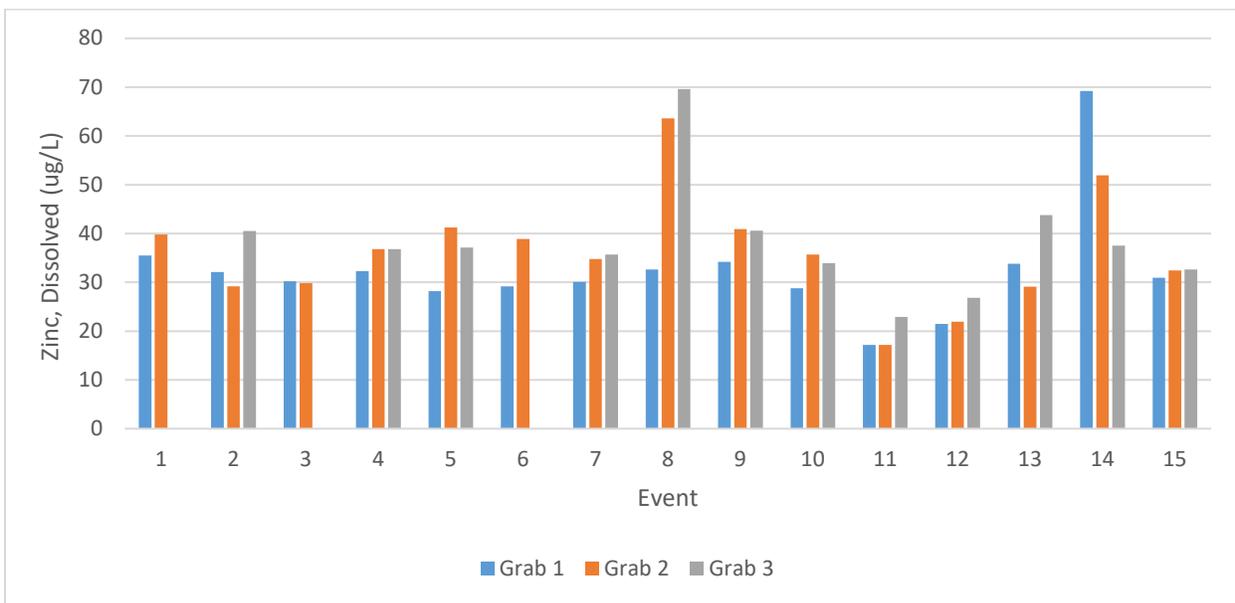
Figure 19. Dissolved Zinc concentrations in stormwater runoff.

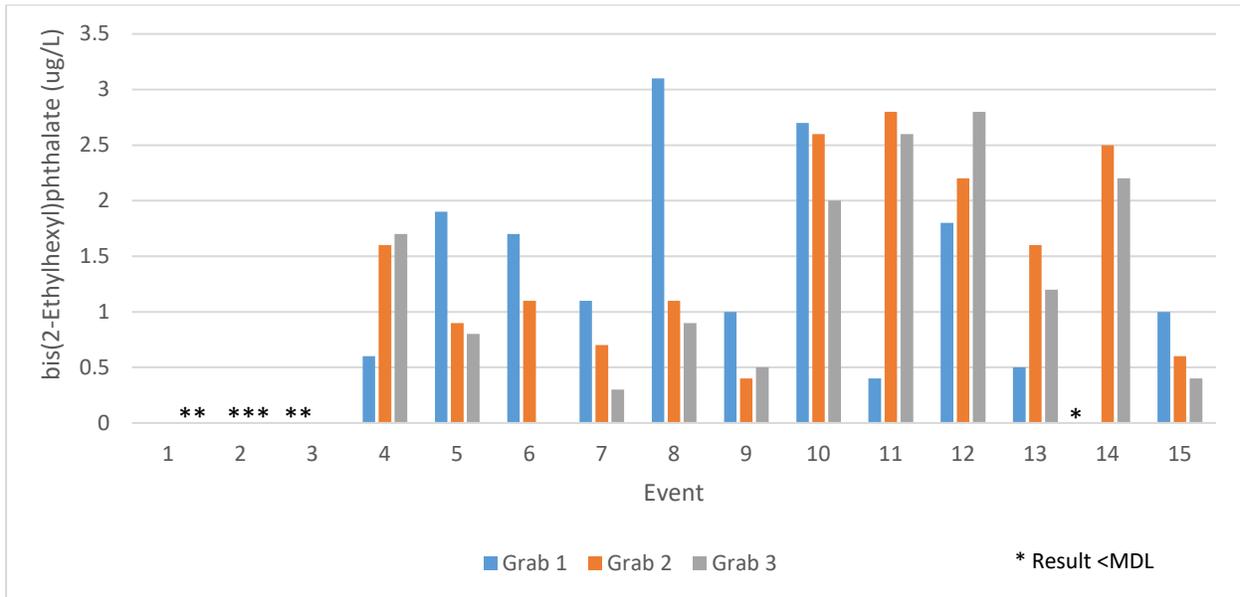
Figure 20. bis(2-Ethylhexyl)phthalate concentrations in stormwater runoff.

The only Semivolatile Organic Compound with reported results regularly \geq RDL was bis(2-Ethylhexyl)phthalate. Results for this compound are presented in Figure 20. Selected Semivolatile Organic compounds have summary statistics presented in Table 4.

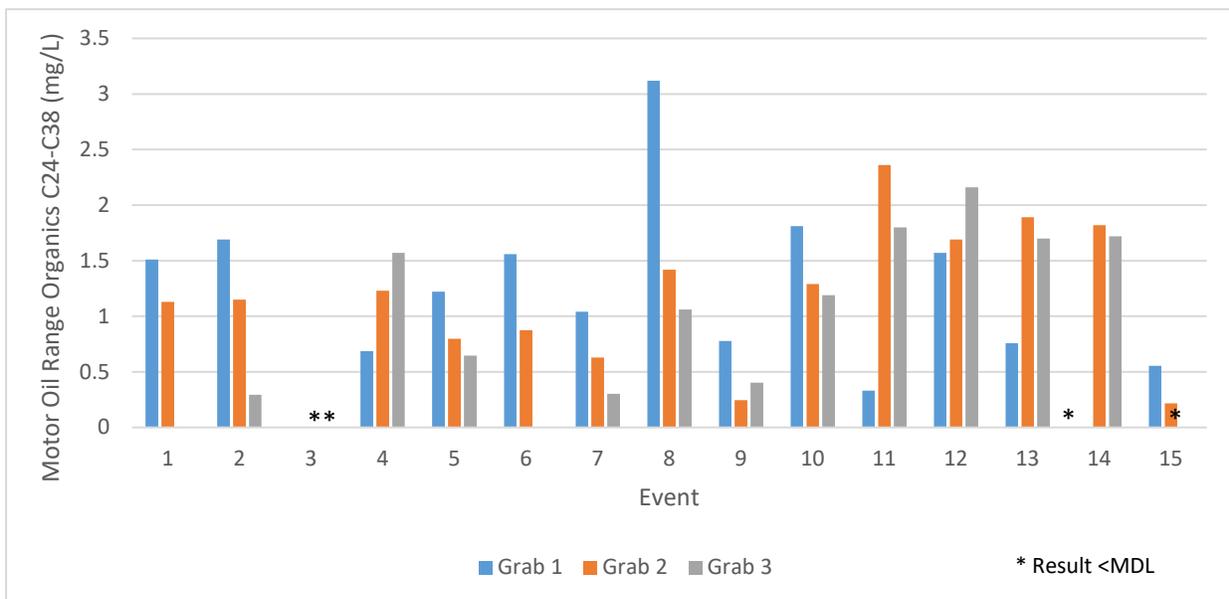
Figure 21. Motor Oil Range Organics (C24-C38) concentrations in stormwater runoff.

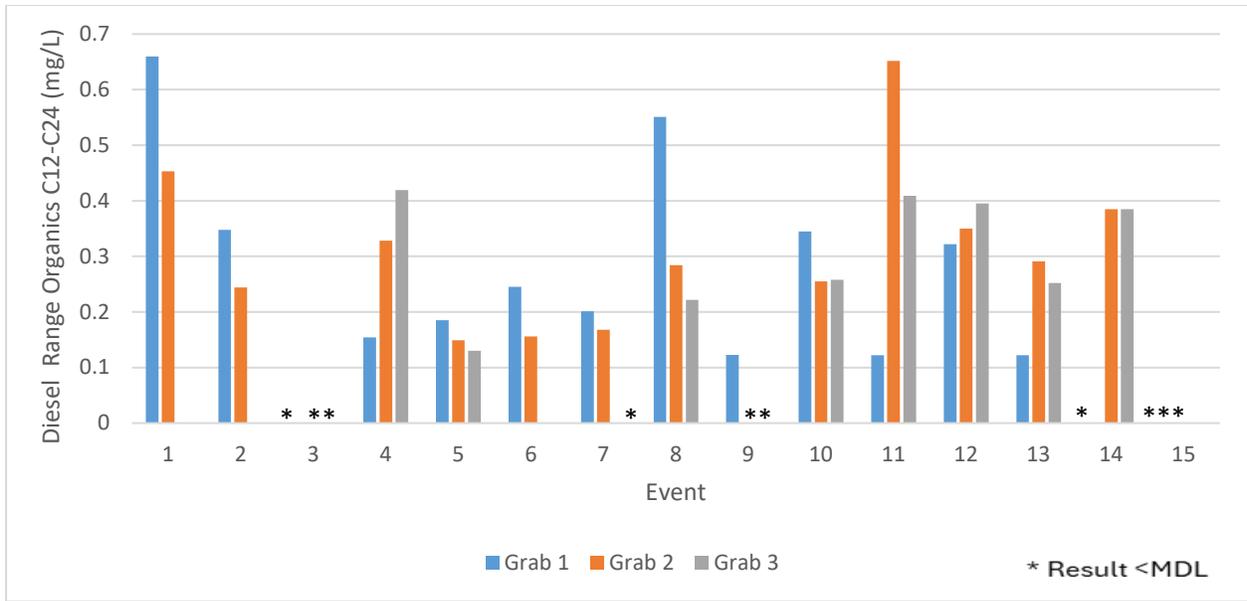
Figure 22. Diesel Range Organics (C12-C24) in stormwater runoff.

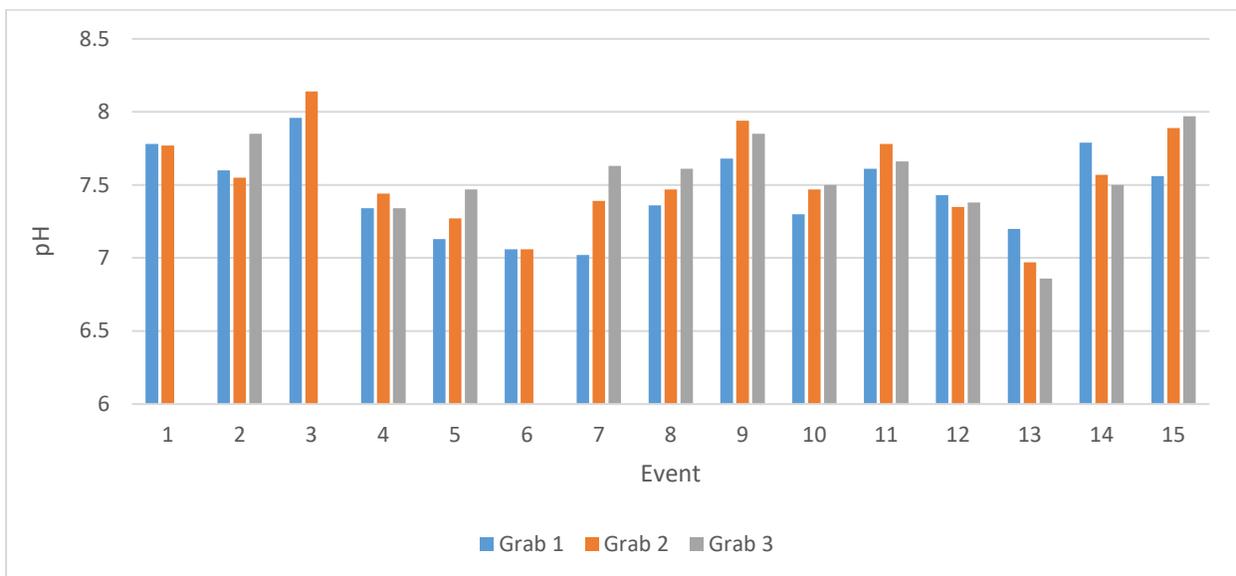
Figure 23. pH of stormwater runoff.

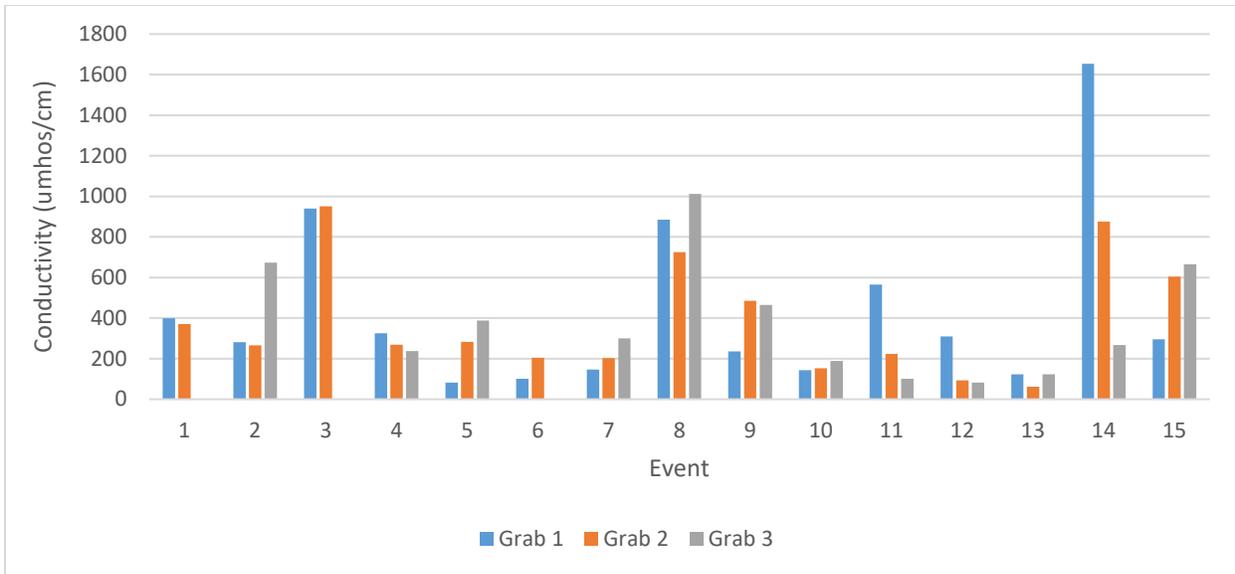
Figure 24. Conductivity of stormwater runoff.

- First grab collected at 10:54.
- Second grab collected at 12:15.
- Third grab collected at 13:30.
- 1.35 hours elapsed between grab 1 and 2.
- 1.25 hours elapsed between grab 2 and 3.
- Weather conditions: 0.41 inches of rain at start of sample collection, 0.59 inches of rain prior to collecting grab 2, 0.6 inches of rain prior to collecting grab 3.
- Site conditions: Very high Conductivity values, presumably due to deicer running off roadway.

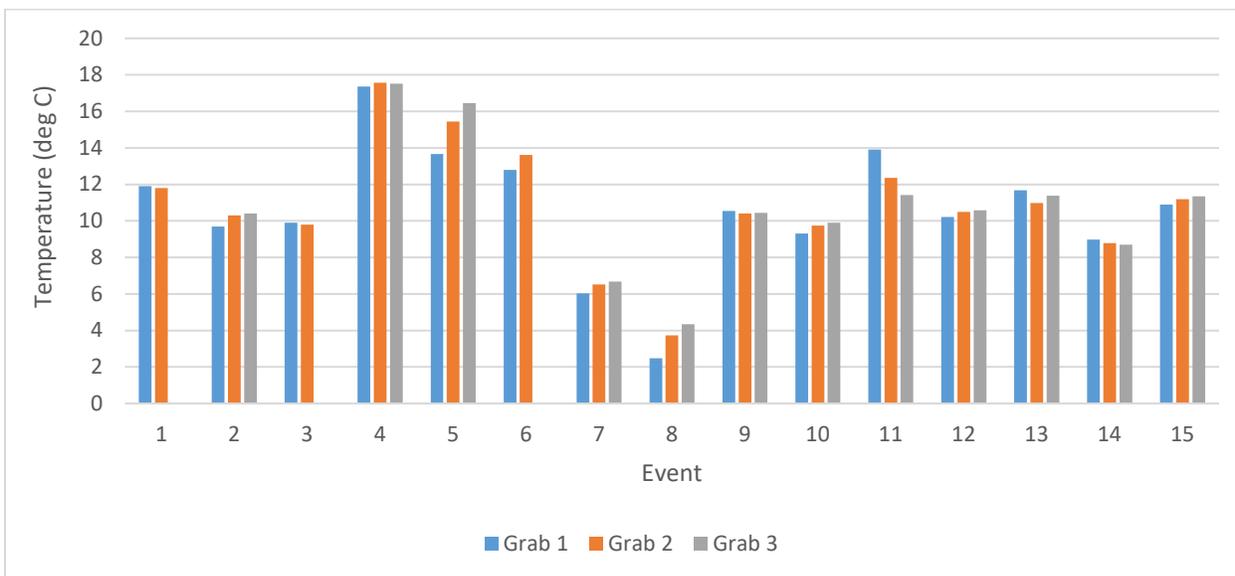
Figure 25. Temperature of stormwater runoff.

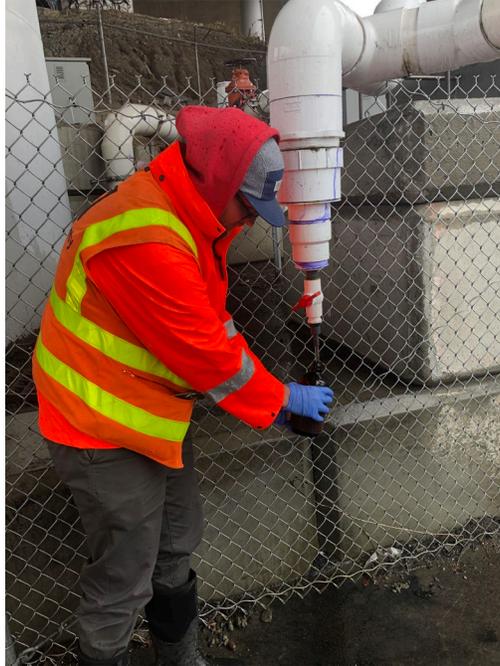
Figure 26. KCEL field staff collecting a sample at the SCTF from the sampling valve.

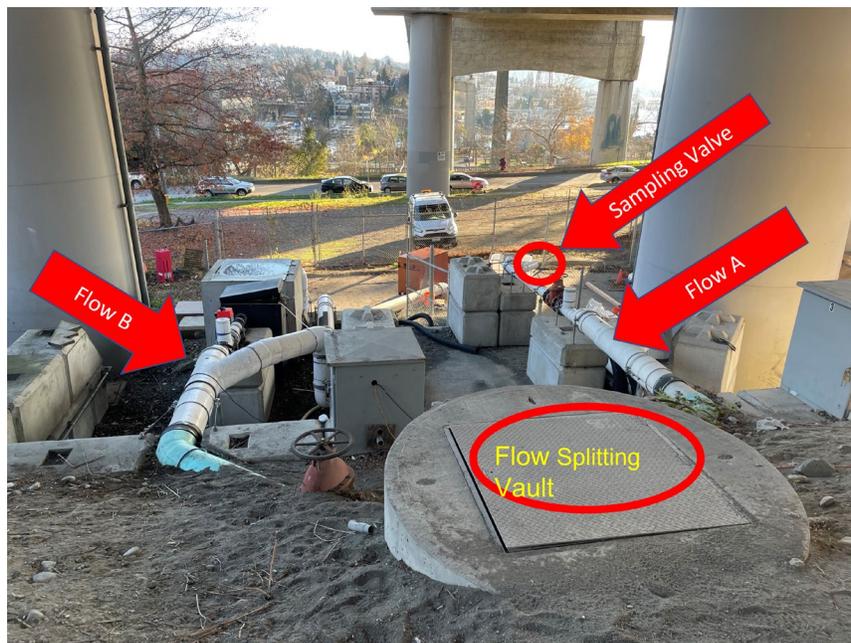
Figure 27. Layout of sampling area at SCTF.
