Subject: Olympia STP, Budd Inlet Dye Survey and Aerial Photographs

From: Ronald C. Devitt

DATE: FEB 1, 1974

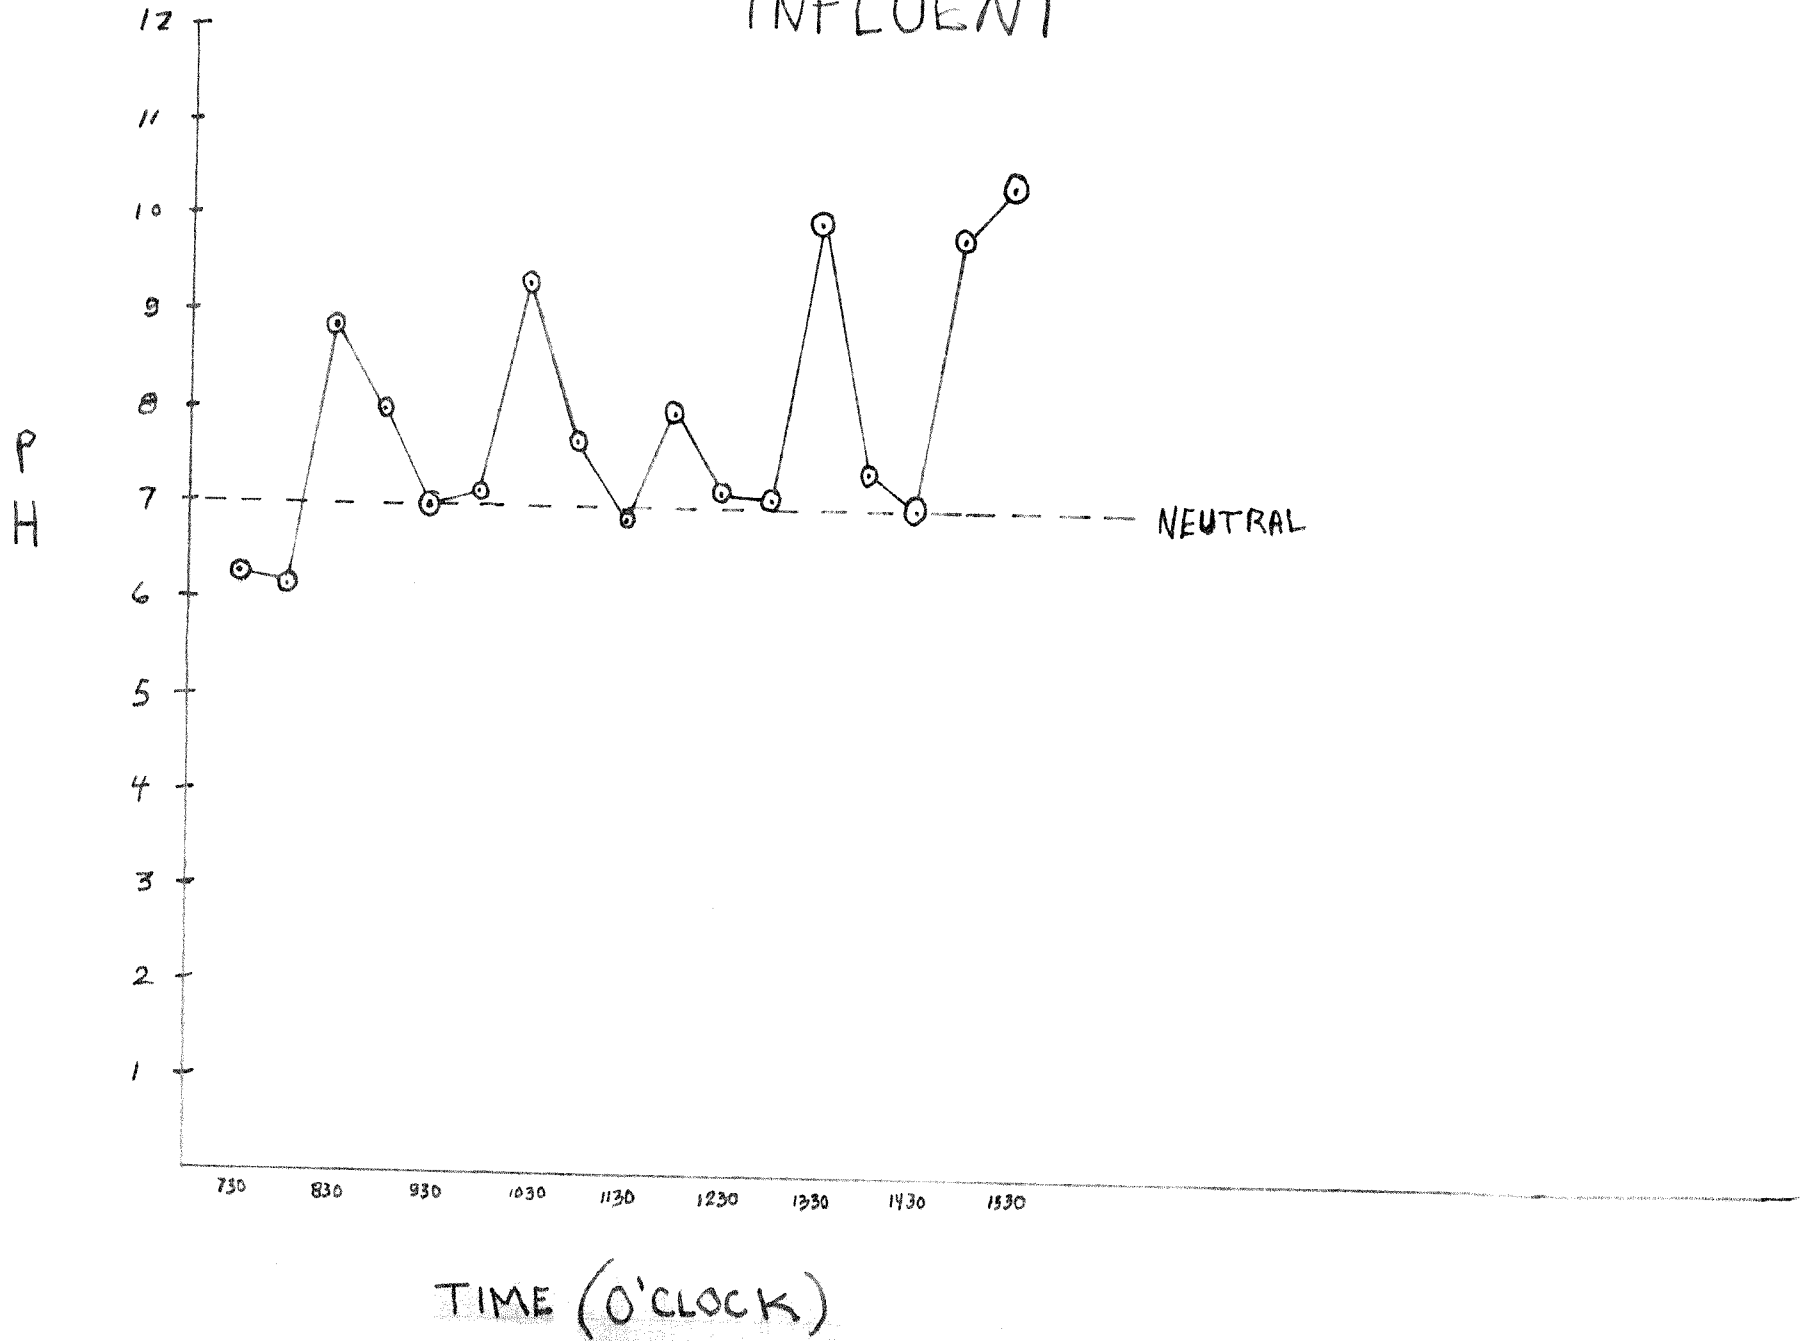
TABLE I

The temperature did not vary significantly. On the influent, the pH ranged from 10.4 to 6.2. The greatest change occurring within 30 minutes was 7.1 to 10.0. Other drastic pH changes were noted. (See table 1) The effluent was tested to have a pH of 9.0 at 1230 hours.

OLYMPIA STP INFLUENT

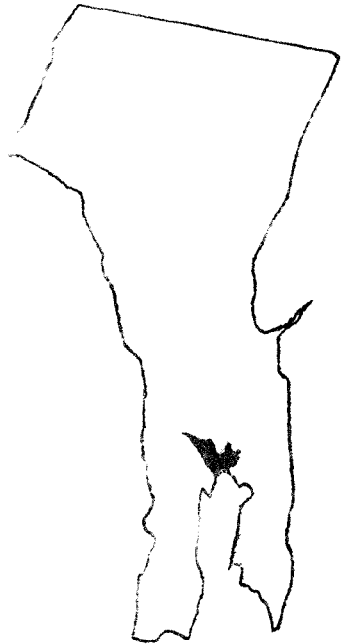
0925
from color (C)
BW
R

The dye was observed at station A at 0905 hours and the sewage travel was defined more clearly. Pictures taken at 0925 show the continued outward passage of the dye; in addition a splitting was observed. A portion traveled westerly toward red nun "8", and a portion easterly in front of the Jacarunda Restaurant. At 0940 dye (added until 0846) quit showing at Station A, establishing that the maximum chlorine detention time through the outfall line was fifty four minutes under these specific tide and flow conditions.

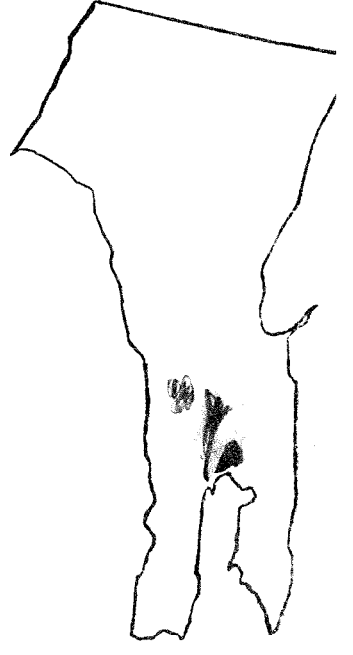
By 1110 hours, the first dye had separated into three clumps; one cloud was near shore by KGY Radio Station, another cloud had traveled north and was near the beginning of the entrance channel. The third was near the log booms to the west of the entrance channel.

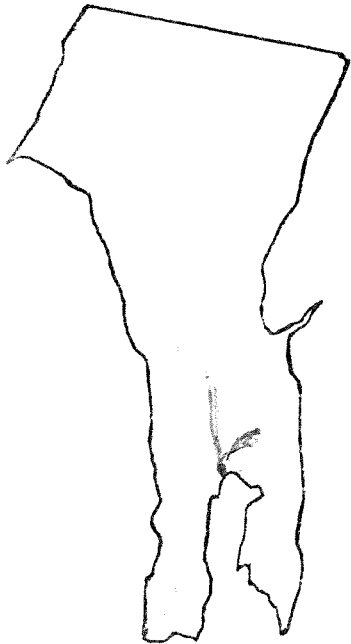
1127

At 1127, the dye near the log booms was no longer distinguishable. The main dye cloud at the outer channel traveled northerly. The patch near shore proceeded easterly.

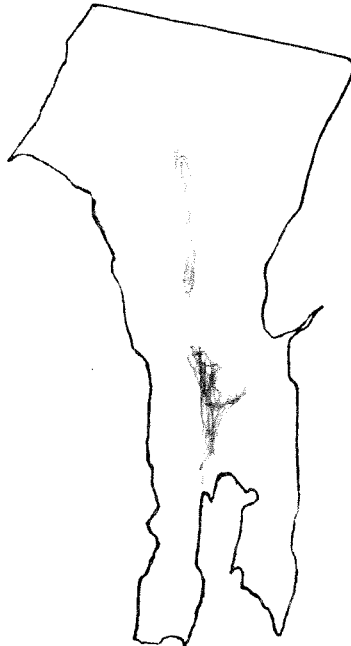
Another quantity of dye had been added and was visible at the surface. The tide was going out at a faster rate, and consequently dye movement was more rapid. By 1235 the first patch of dye had become unnoticeable except for a band south of Olympia Shoals. The second cloud had proceeded primarily north with a finger branching off toward Priest Point Park. Maximum chlorine contact time was 57 minutes.

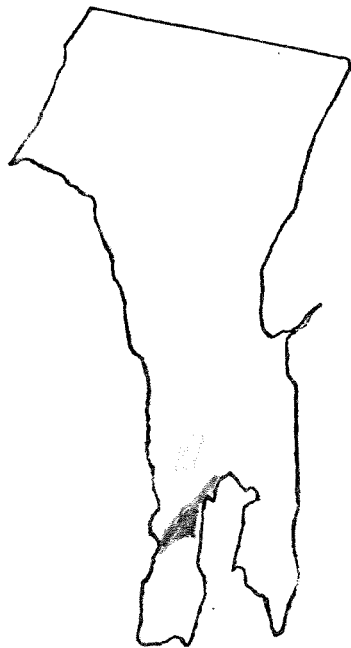
The tide changed at 1340 hours. The third dye addition arrived at the water surface at 1402 hours. The color picture taken by Bill Kimbel Photography showed the third dye plume traveling west and south diagonally to the opposite shore in the vicinity of red nun "14". More dye was dissipated in the general vicinity of Red Nun "10". It is thought that this is the second dye cloud. A portion of the dye was also trapped in the Marina.

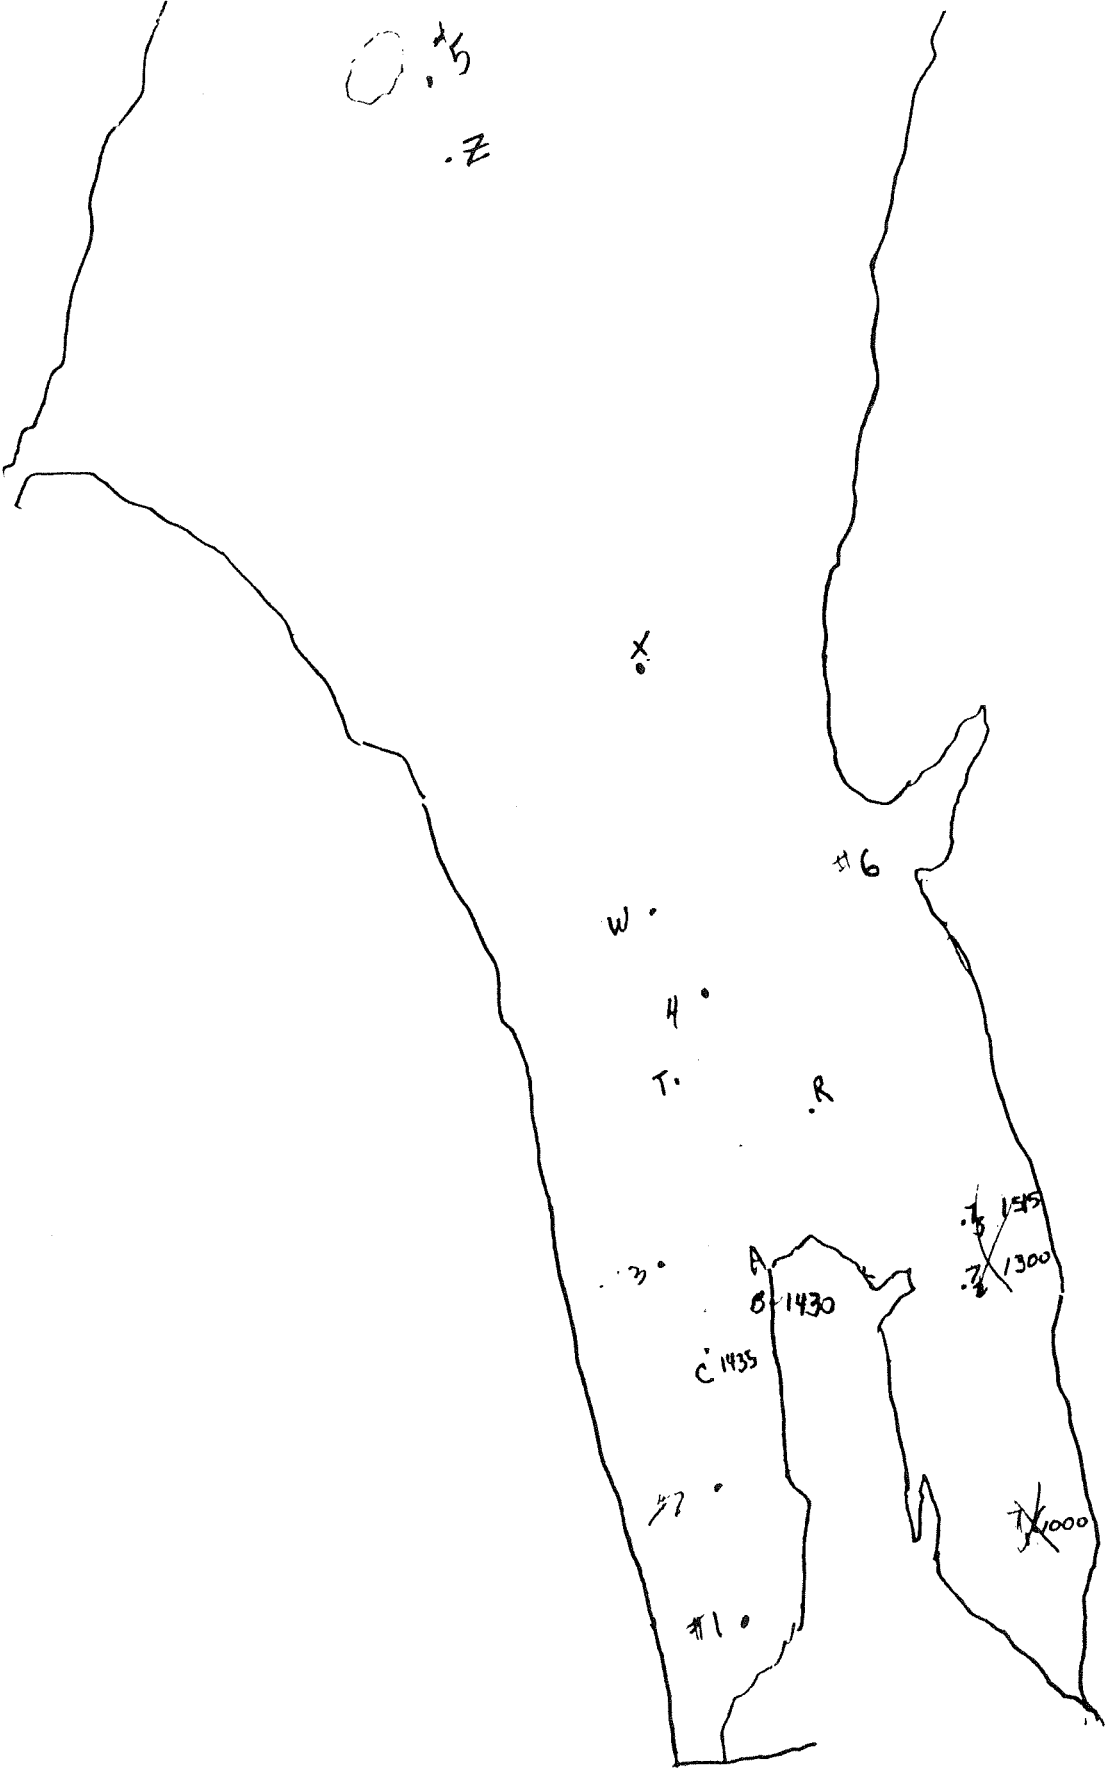
The sampling locations are shown by the map and are described below:

STATION	LOCATION
#1	(southernmost) Midchannel at Olympia Yacht Basin, center of most seaward pier.
#2	Midchannel between southern end of Olympia Port Dock and bouy # 10.
#3	Adjacent to bouy #10, channel side.
#4	Adjacent to light bouy #6, channel side.
#5	(northernmost) Southern side of Olympia Shoals adjacent to red light and horn.
#6	Ellis Cove- South of Priest Point Park.
#7	Eastern Fork of Budd Inlet.
A	At sewage treatment plant outfall.
R	Adjacent to Int. equal interval green 6 second bouy-40 ft.
T	50 yards from Bouy 8 at 205°
Z	300 yards from Flashing Green light 4 sec.-21 ft. at 120°
W	Center of outer channel between equal interval light 6 sec.-23 ft. and quick flashing light -14 ft.
X	400 yards from flashing dolphin-4 sec. at 90°
B	50 yards south of outfall.
C	50 yards west of red nun 14

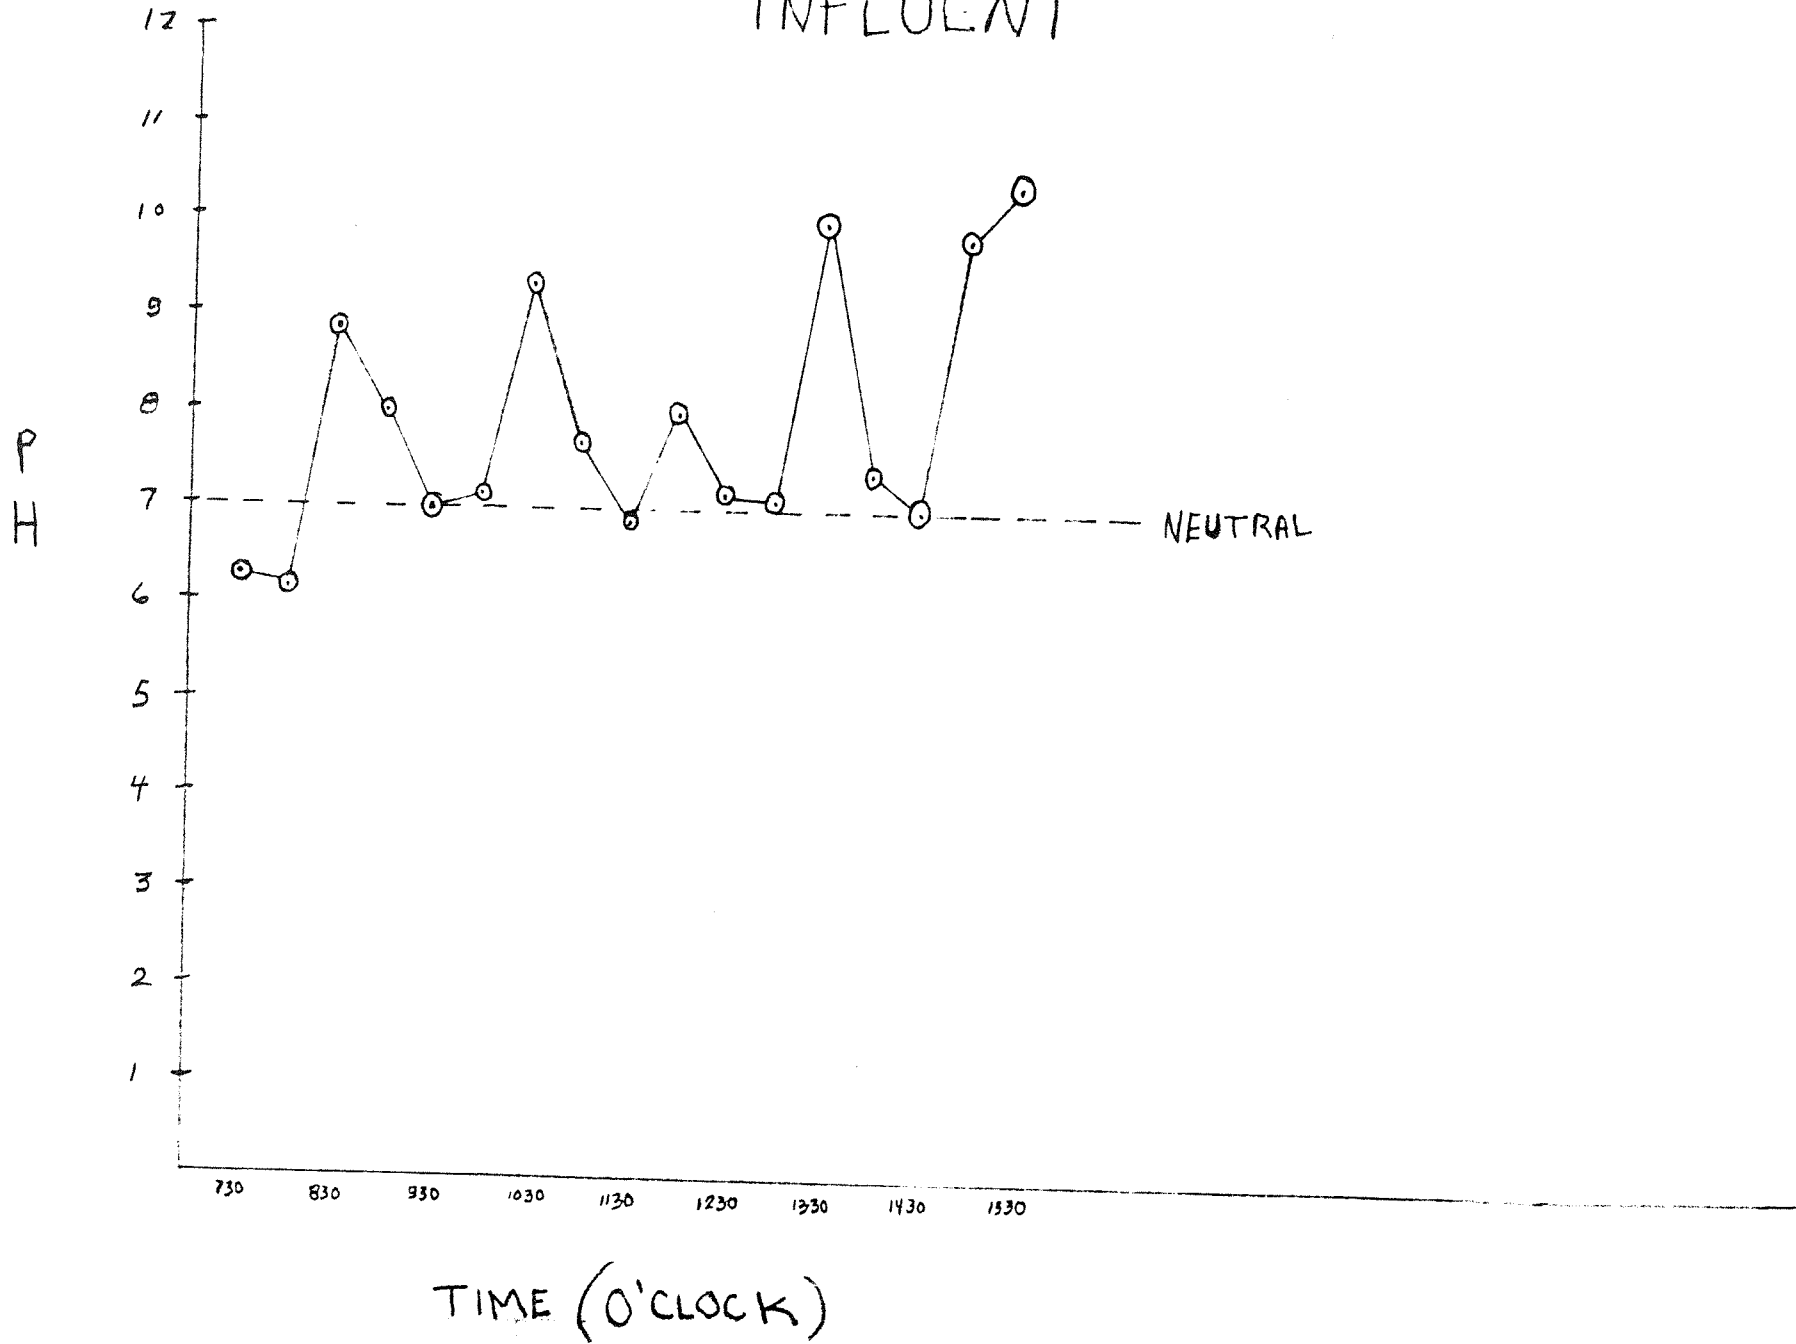
TABLE I

The temperature did not vary significantly. On the influent, the pH ranged from 10.4 to 6.2. The greatest change occurring within 30 minutes was 7.1 to 10.0. Other drastic pH changes were noted. (See table 1) The effluent was tested to have a pH of 9.0 at 1230 hours.

OLYMPIA STP INFLUENT

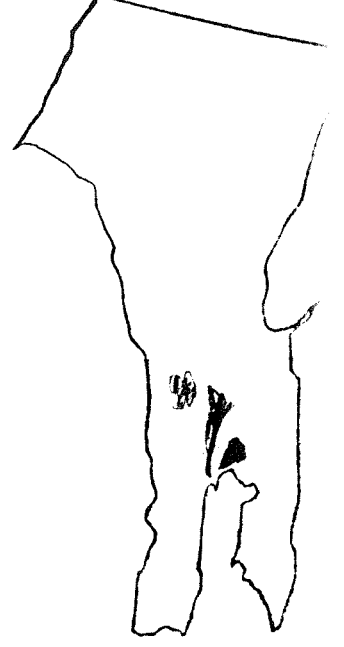
By 1110 hours, the first dye had separated into three clumps; one cloud was near shore by KGY Radio Station, another cloud had traveled north and was near the beginning of the entrance channel. The third was near the log booms to the west of the entrance channel.

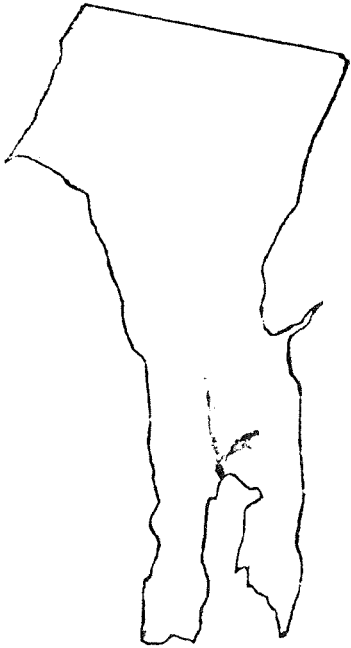
1127

At 1127, the dye near the log booms was no longer distinguishable. The main dye cloud at the outer channel traveled northerly. The patch near shore proceeded easterly.

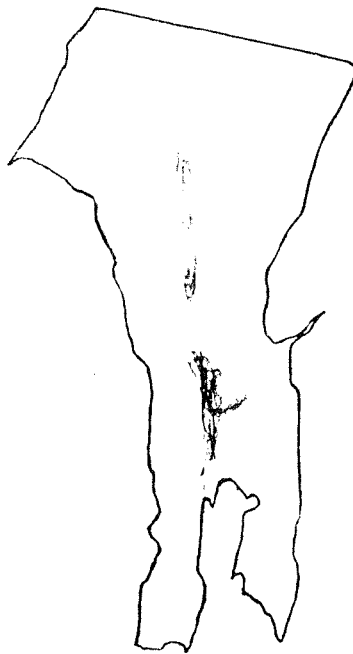
Another quantity of dye had been added and was visible at the surface. The tide was going out at a faster rate, and consequently dye movement was more rapid. By 1235 the first patch of dye had become unnoticeable except for a band south of Olympia Shoals. The second cloud had proceeded primarily north with a finger branching off toward Priest Point Park. Maximum chlorine contact time was 57 minutes.
