# Identification of Holden Mine Tailing Pile Particulate Matter in Railroad Creek.

Dickey D. Huntamer

December 8, 1996

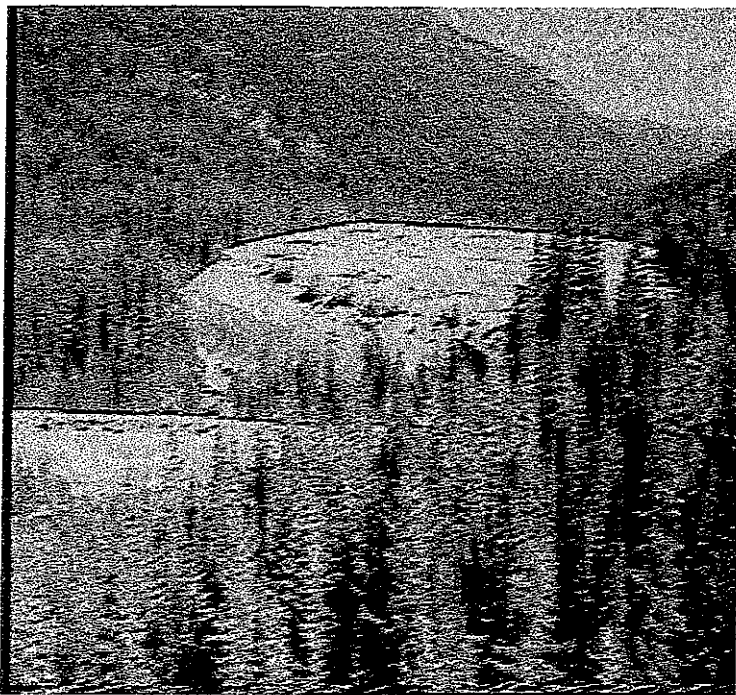
**Figure 2. View of lower tailing piles from upper tailing pile near the mine entrance.**

Over the years attempts have been made to stabilize the tailing piles by capping them with native soils and planting vegetation along with placing fiber mats on the sides to stabilize the slopes. The unvegatated top of the tailing piles and one of the fiber mats (the darker band on the lower slope of the pile) used to stabilize the pile can be seen in Figure

2. The success of these endeavors has not been determined. Large areas of the tailing piles remain exposed to the elements. Consequently material from the tailing piles is available for both wind and water transport to Railroad Creek and subsequently Lake Chelan.

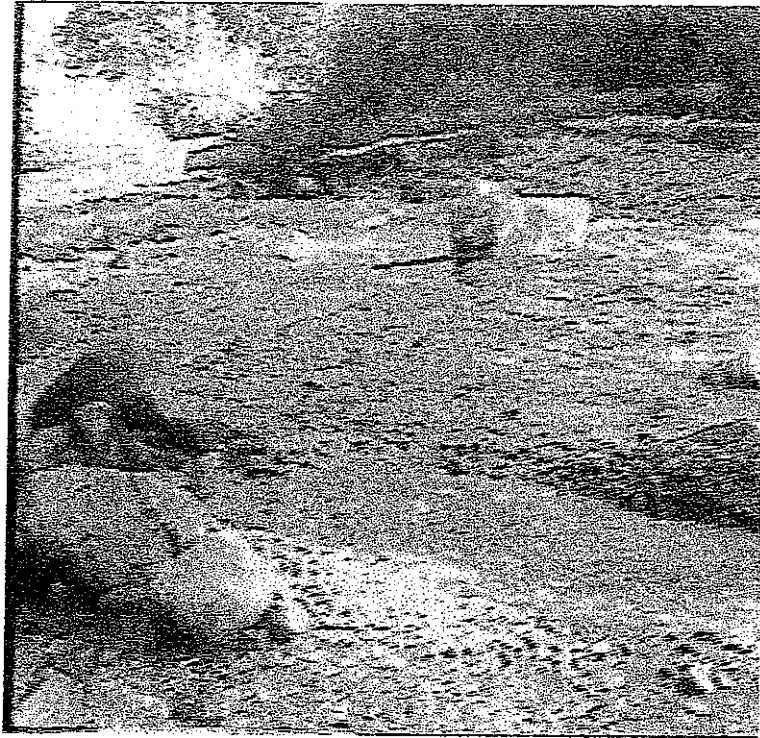
**Figure 3. Railroad Creek at Station RC-1.**

The impact of the mining operation on the creek, almost thirty years after operations ceased, is still visually apparent. Upstream, Station RC-1, the creek has a natural grayish color. Figure 3, whereas adjacent to the mine and downstream of the tailing piles, Station RC-4, the creek -bed becomes a brownish-red color, Figure 4. Near Lucerne, Station RC-3, at the mouth of the creek discoloration is still present in the stream but the stream is starting to regain it's normal color.

One of the most striking things about Railroad Creek is the change in the stream bed color, Figure 3 above the mine tailings compared to below the mine, Figure 4. Obviously the mine tailings contribute to the coloration of the stream bed but how the tailing material interacts with the creek is not as obvious.

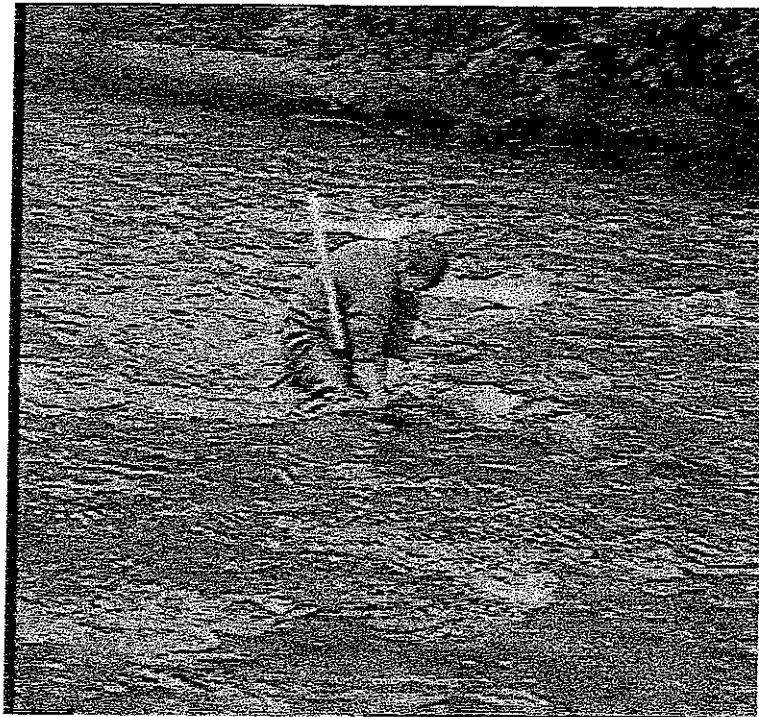
**Figure 4. Railroad Creek at Station RC-4**

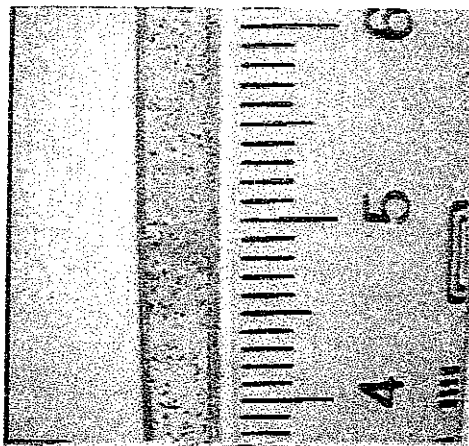
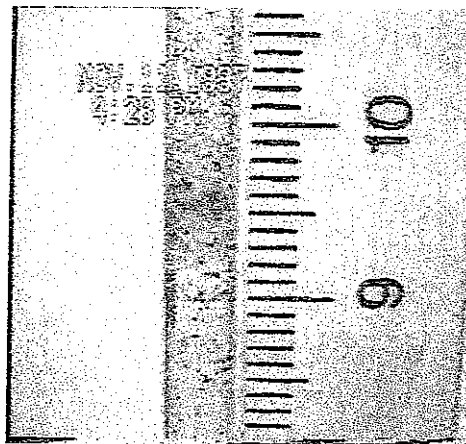
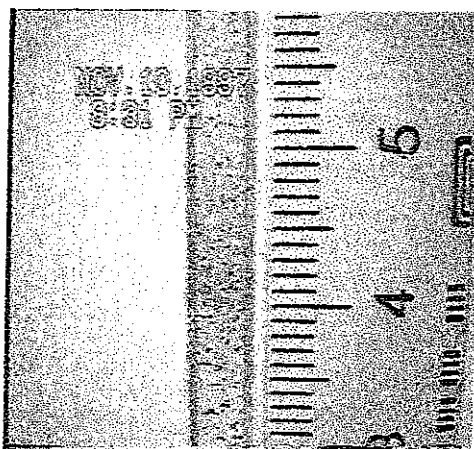
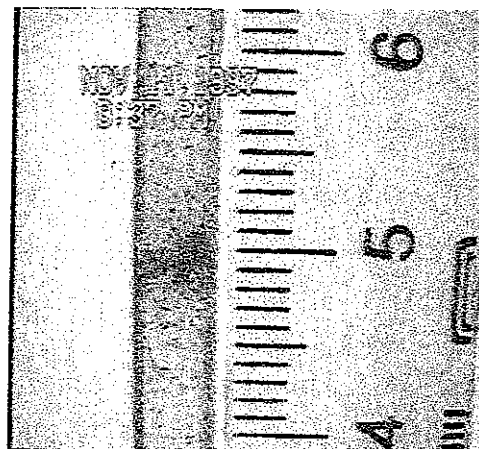
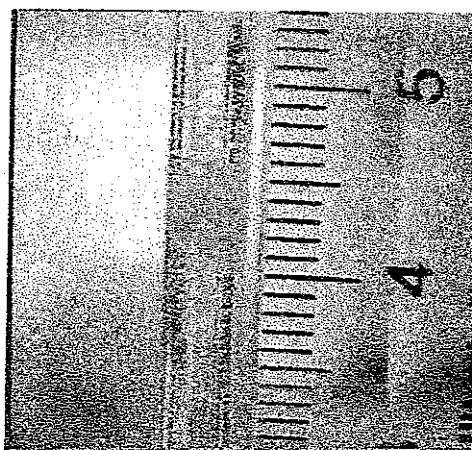
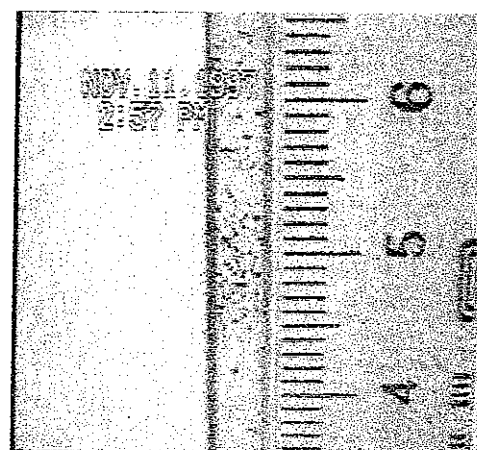
Figure 5 a-f. Density Column separations for Railroad Creek and Tailings Pile. Density range 3.05 to 3.13.

a: Station RC-1 2.4X

b: Station RC-1 2.3X

c: Station RC-2 2.1X

d: Station RC-4 2.5X

e: Tailing Pile TP-2 2.5X

f: Station RC-3 2.0X

After the density gradient had stabilized the zones where the mineral grains had settled were noted and their heights recorded, Figures 5 a-to f. Each fraction was collected as it eluted from the column for microscopical analysis, Figure 6 and Figure 7. A small aliquot of the toluene-methylene iodide density solution was also taken so that each layer was bracketed. The refractive index was then measured using a Milton Roy refractometer and compared to a calibration curve of density versus refractive index of known toluene-methylene iodide mixtures.

The density separations on the tailing pile samples showed that both samples were very similar in behavior. The bulk of the material ended in a relatively well defined band with a scattering of particles above and below. The density of the band ranged from 3.07 to 3.13 gm/cc. Heavy minerals (>3.3 gm/cc) were relatively infrequent in the tailings pile material, but were relatively common in the stream sediment samples. This probably reflects how the material was handled and treated to separate the ore minerals before deposition in the tailings pile. The iron minerals and hornblende present in the stream sediments were separated by the density column from the lighter tailing pile material.

The upstream site RC-1 Figure 5 a, and b, failed to show a orange-yellow band in the density column similar to that produced by the tailing pile samples, Figure 5e. The sample collected at RC-2 gave a definite orange-yellow band at a density of about 3.05 to 3.13. This was also true for sample RC-4 Figures 5c and d. The particle characteristics were similar to those of the tailings pile, Figure 9, showing the orange to yellow coatings on the many of the mineral grains in that density band. The orange-yellow band was nearly indistinguishable in RC-3, Figure 5f, although some grains characteristic of the tailing piles were found under the microscope, Figure 14.

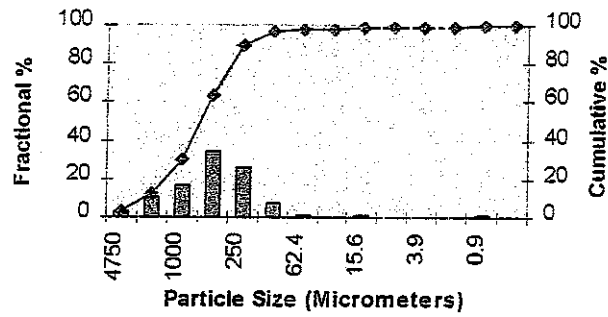
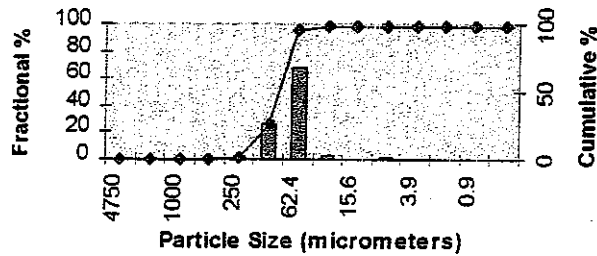
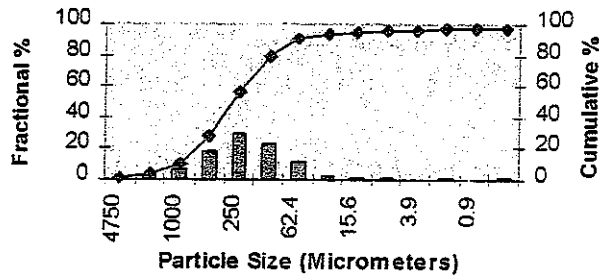
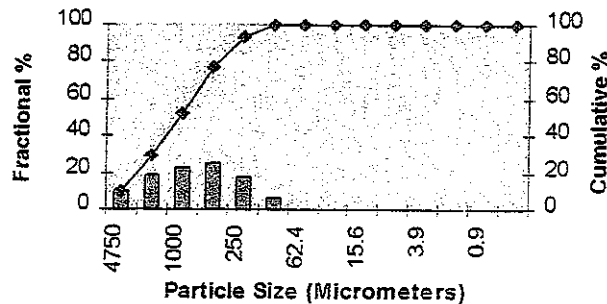
Figure 8. Particle Size Distribution for RC-1, Tailing Pile, RC-2 and RC-3

RC-1 Particle Size Distribution

Holden Mines Tailing Pile Particle Size Distribution

RC-2 Particle Size Distribution

RC-3 Particle Size Distribution

percentages (line graph) for Stations RC-1, RC-2, RC-3 and the tailing pile, TP-2 are shown in Figure 8.

The particle size analysis shows that the mine tailings are concentrated in a narrow size range, from 250 micrometers to 31 micrometers. Figure 8 a, b, and c graphically compares the particle size analysis results for the tailing pile material and stations RC-1, RC-2 and RC-3. The particle size data alone fails to distinguish the differences between the stations. The larger material in the creek overwhelms the tailing pile size fraction.

The tailing pile material (96378321) showed a near normal distribution around 250 to 31 micrometers, Figure 8a. Almost 97% was between 62 and 250 micrometers in size. Only one percent was greater than 250 micrometers, (i.e. 250 to 500) and the other two percent was less than 31 micrometers. The corresponding size distribution for RC-1 (96378284) was 8%, Figure 8b, RC-2 (96378295) was 37%, Figure 8c, RC-4 (96378326) was 67% and for RC-3 (96378306) 6%.

The two stations, RC-2 (37%) and RC-4 (67%) below the tailing pile had a significant increase in the 32 to 250 micrometer size range compared to the reference station RC-1 (8%). Station RC-3 (6%) had less in the tailing pile size range than the upstream sample RC-1 but a significantly greater number of the individual particulate grains in that size fraction were comparable to those found in the mine tailings samples.

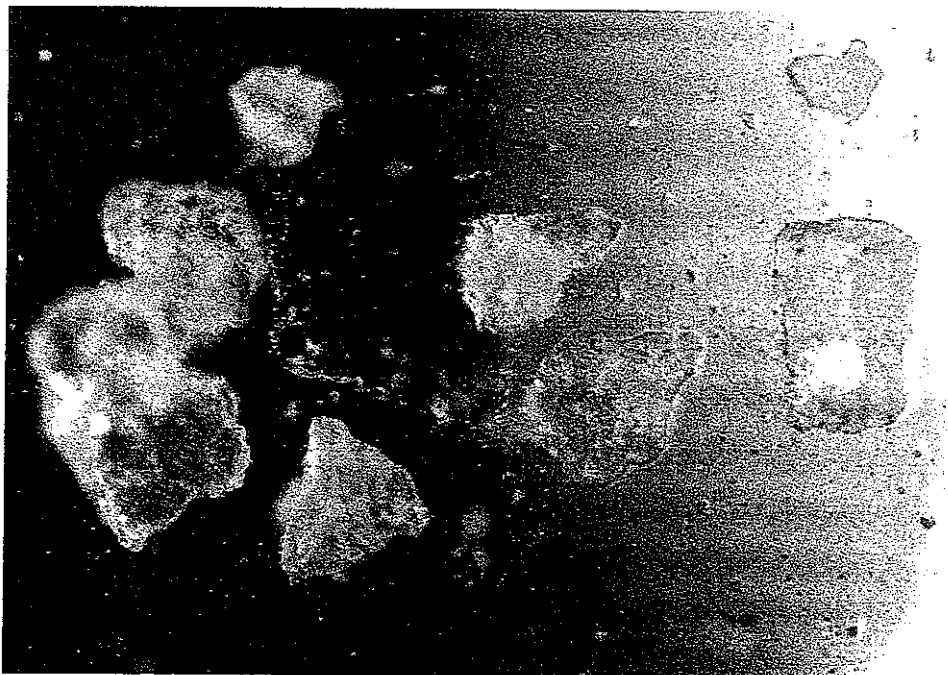
**Figure 9. Tailing pile TP-2, Sample 96378322, 100X oblique light. Note the orange-yellow coating on the clear mineral grains.**

This orange-yellow coating, Figure 9 appears to be the most distinguishable feature and it was used to help identify tailing pile grains from native grains in the samples. The presence of naturally occurring "yellow colored" minerals complicates the observations but generally these are solid colors extending all the way through the mineral grain not just a surface coating. The coating was easily visible using oblique illumination on the

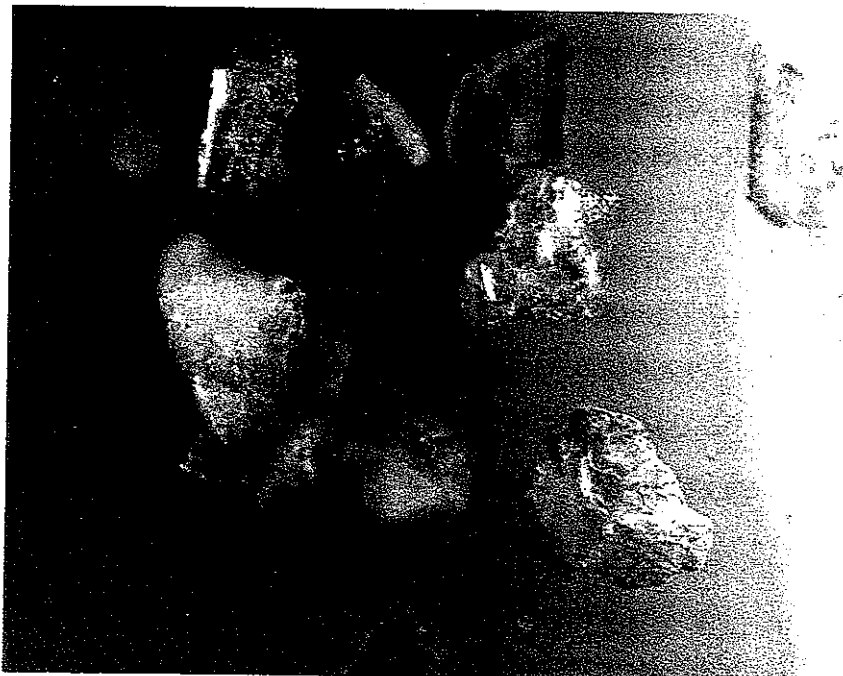
**Figure 10. Tailing pile TP-2, Sample 96378322 after removal of orange-yellow coating with nitric acid. 100X oblique light**

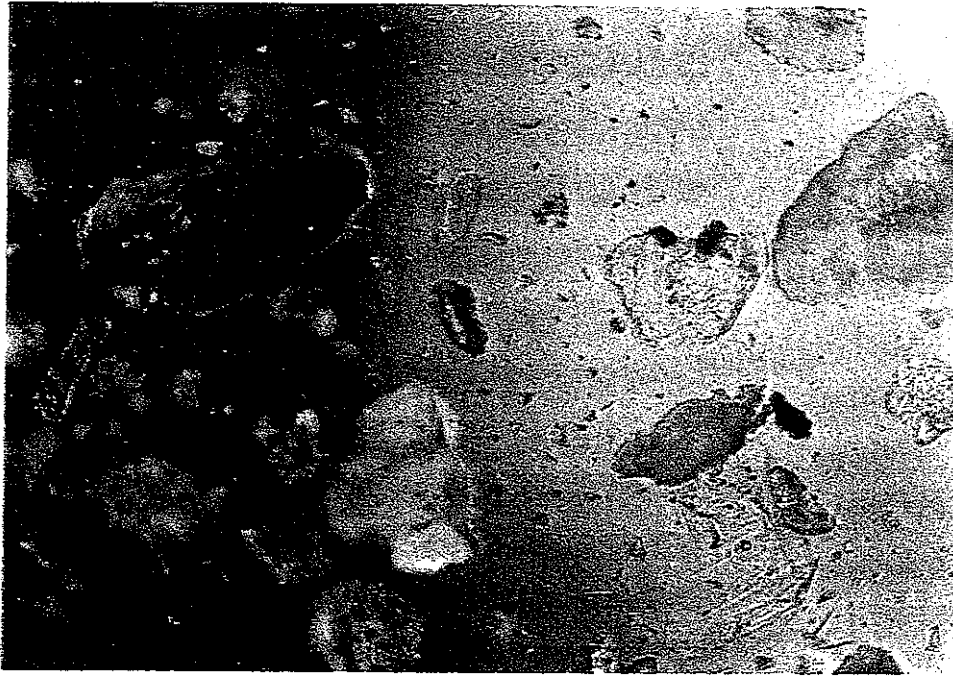
**Figure 11. Sample RC-1, Station 96378284. 100X oblique illumination  
Note solid orange-yellow mineral grains and absence of coated grains.**

microscope. The coating could also be distinguished from the naturally colored minerals by a solubility test with hydrochloric acid. Grains showing the orange-yellow coating collected from the density separations are shown in Figure 11, RC-1, Figure 12, RC-2, Figure 13, RC-4 and Figure 14, for RC-3

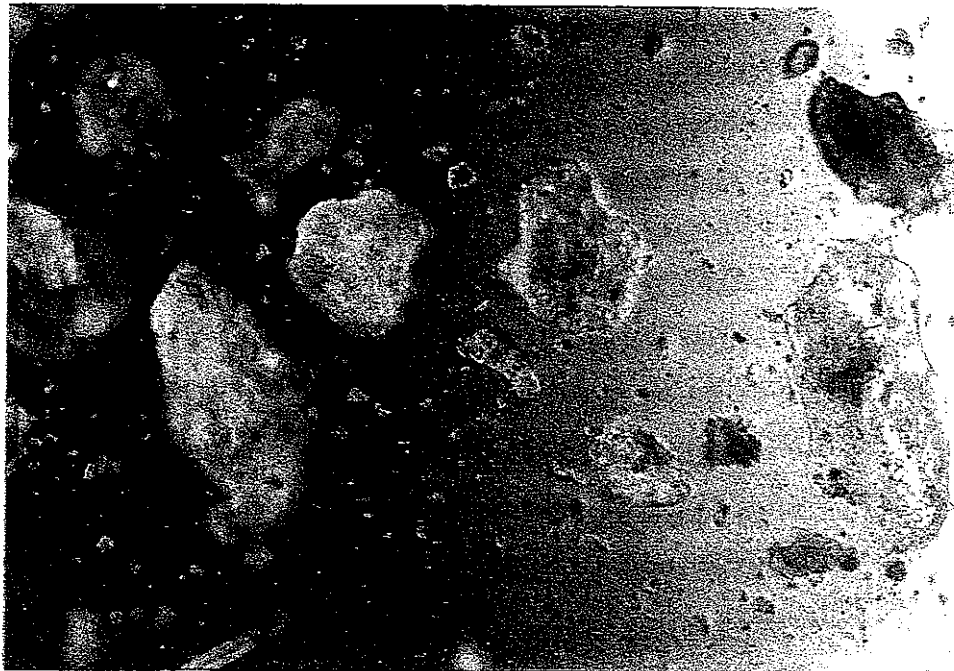
**Figure 12. Station RC-2, Sample 96378295, 100X oblique illumination.  
Note orange-yellow coating in transparent mineral grains.**

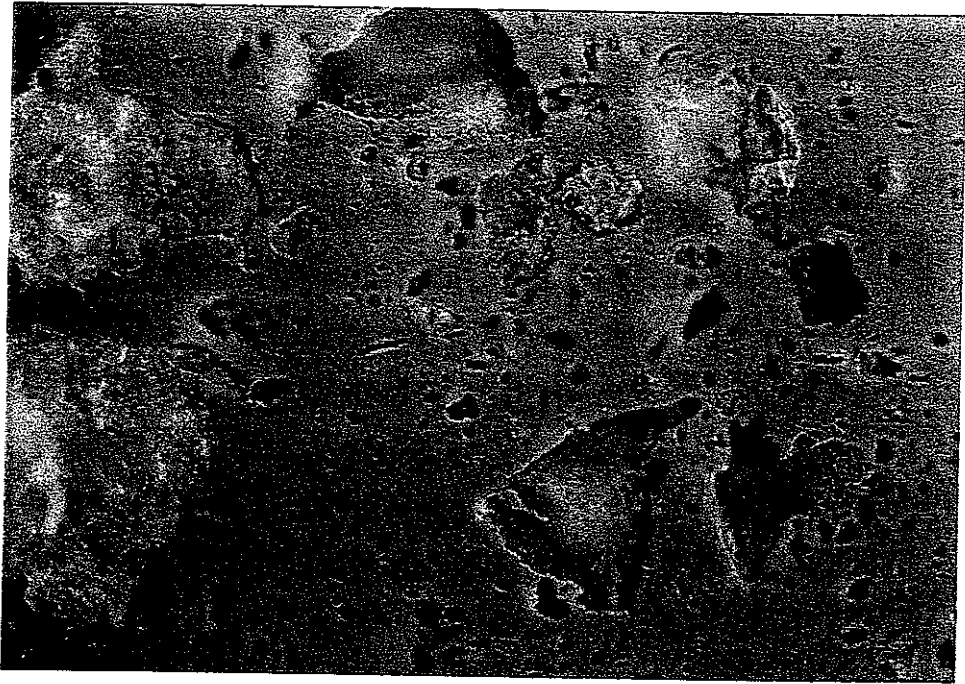
**Figure 13. Station RC-4, Sample 96378326, 100X Oblique illumination**

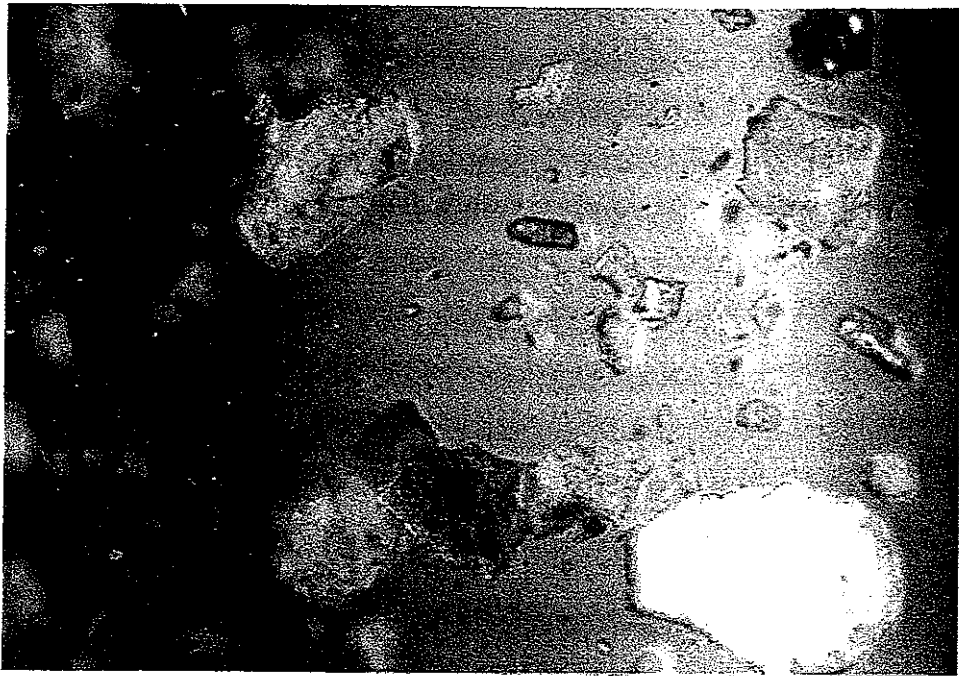
**Figure 14. Station RC-3, Sample 96378306 100X oblique illumination**

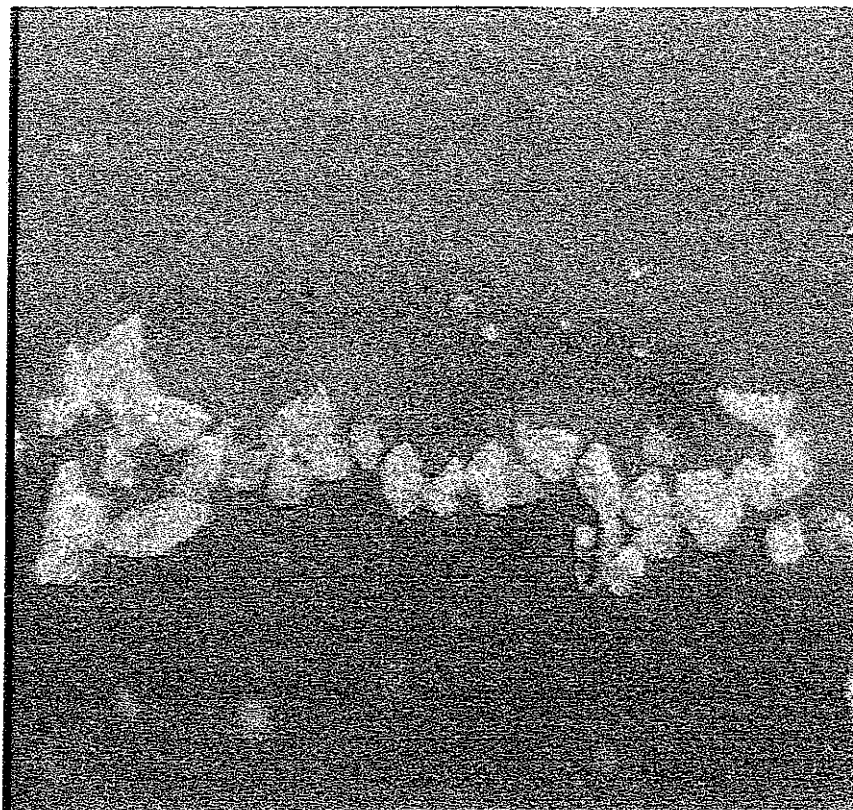
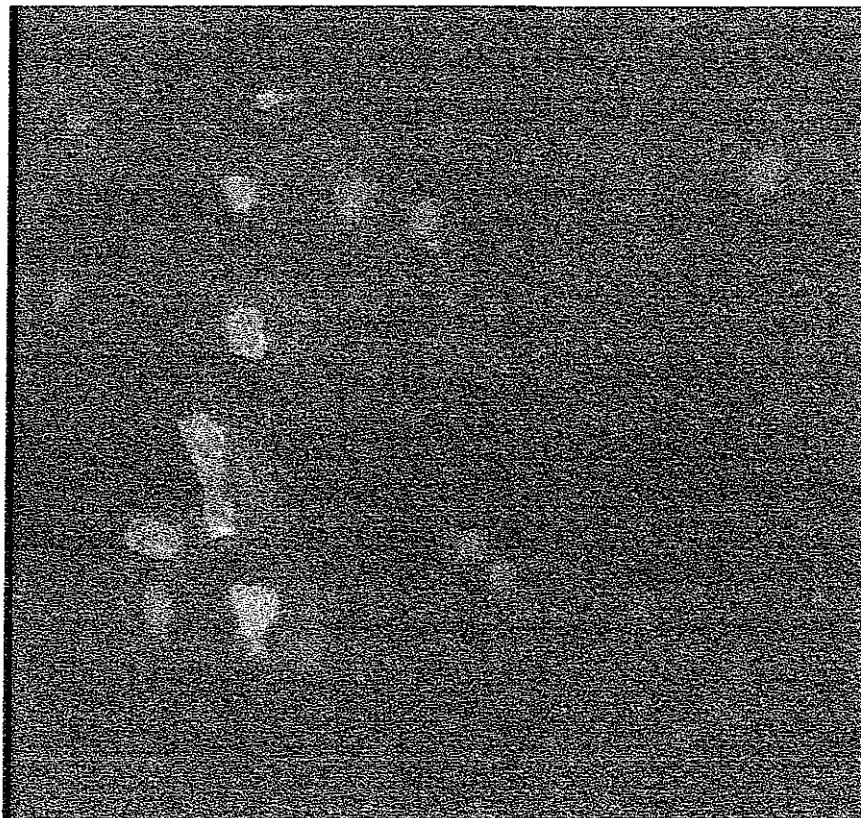
Figure 15 a, b. Hydrochloric acid test for goethite- Sample RC4 (96378326).  
Dissolution of orange-yellow coating in warm hydrochloric acid. Stereo 50X

Before Warming in 5N Hydrochloric Acid

After warming in 5N Hydrochloric Acid. Orange coating dissolved.

An aliquot of the density fractions, 3.05 to 3.15, collected from the density column separations were placed on a microscope slide and the particulate grains coated with an orange-yellow material were separated out using a stereo microscope and tungsten needle. Only a few grains were found in sample RC-1 whereas 50 to 100 grains were easily separated out from samples RC-2, RC-3 and RC-4. The sample of orange-yellow grains was split into two groups of ten to fifteen grains each for microchemical testing. Grains from the tailing pile sample TP-2 (96378322), were used as a control. One fraction was treated with cold 5N hydrochloric acid. Initially no reaction was observed. When the 5N hydrochloric acid was warmed slightly, the orange-yellow coating on the mineral grains rapidly dissolved. This is illustrated for sample, RC-4 in Figure 15a, cold 5N hydrochloric acid and Figure 15b, after slight warming of the 5N hydrochloric acid.

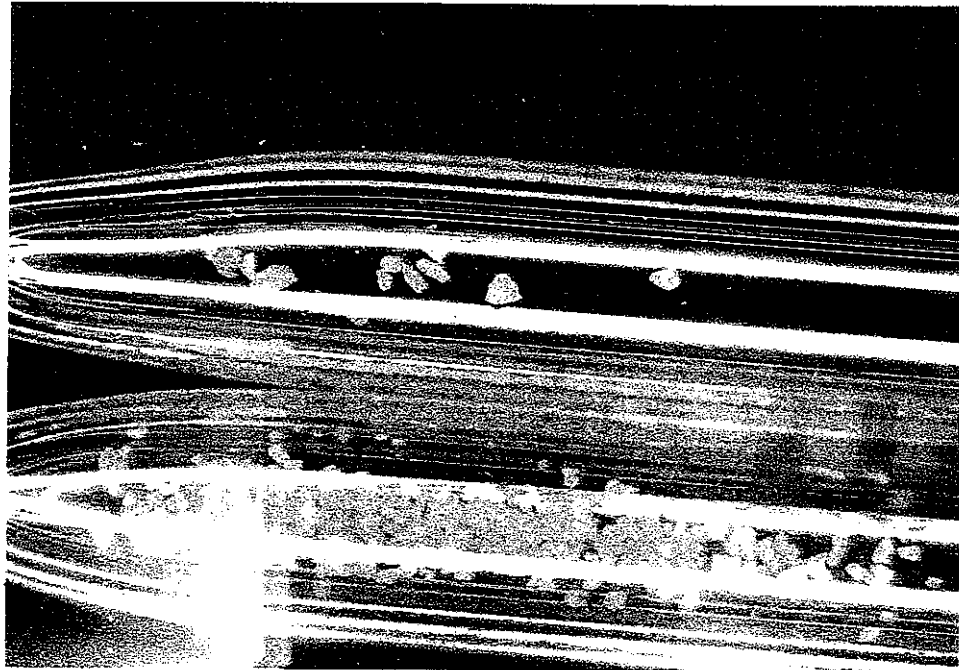
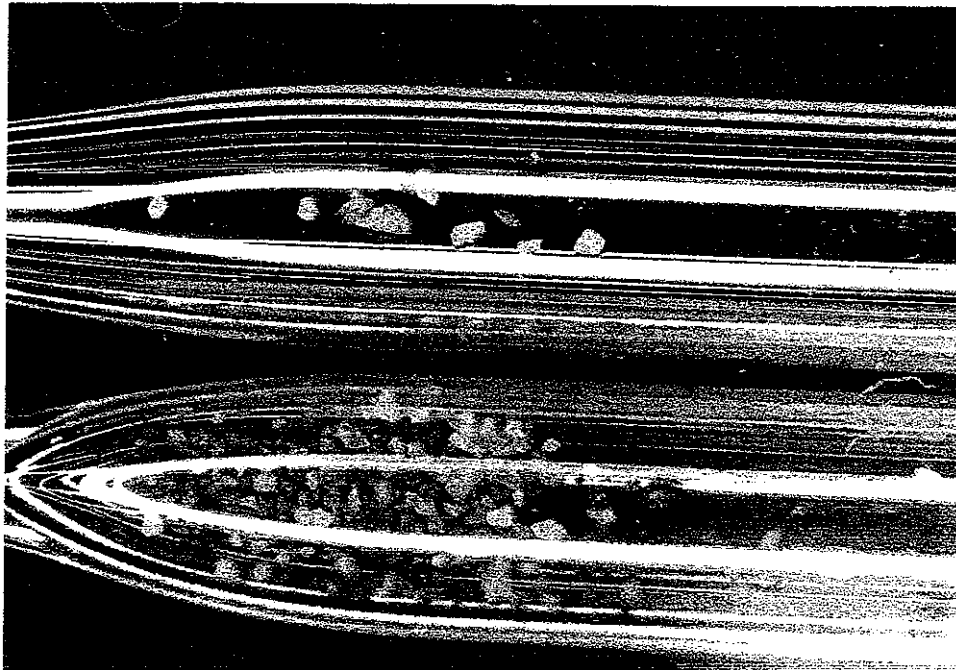
Figure 16 a, b. Capillary test for goethite. Station RC-2 (96378395) top. Lower tube is Tailing Pile (96378322). Color change from orange-yellow to reddish-brown (hematite). Stereo 17X.

Another aliquot, from RC-4 was tested for goethite by placing the coated mineral grains in a 2 mm OD capillary tube sealed on one end. The other end was sealed and the end with the grains was placed in a butane microtorch flame for one second. The orange-yellow coating on the mineral grains was changed to a reddish-brown color as the goethite was converted to amorphous  $\text{Fe}_2\text{O}_3$ , top capillary Figure 16a, before heating and 16b after heating. If sample size is large enough water vapor can be observed condensed on the capillary tube walls. The capillary test is also shown for the tailing pile sample, TP-2 (bottom capillary) in Figure 16a, and 16b.

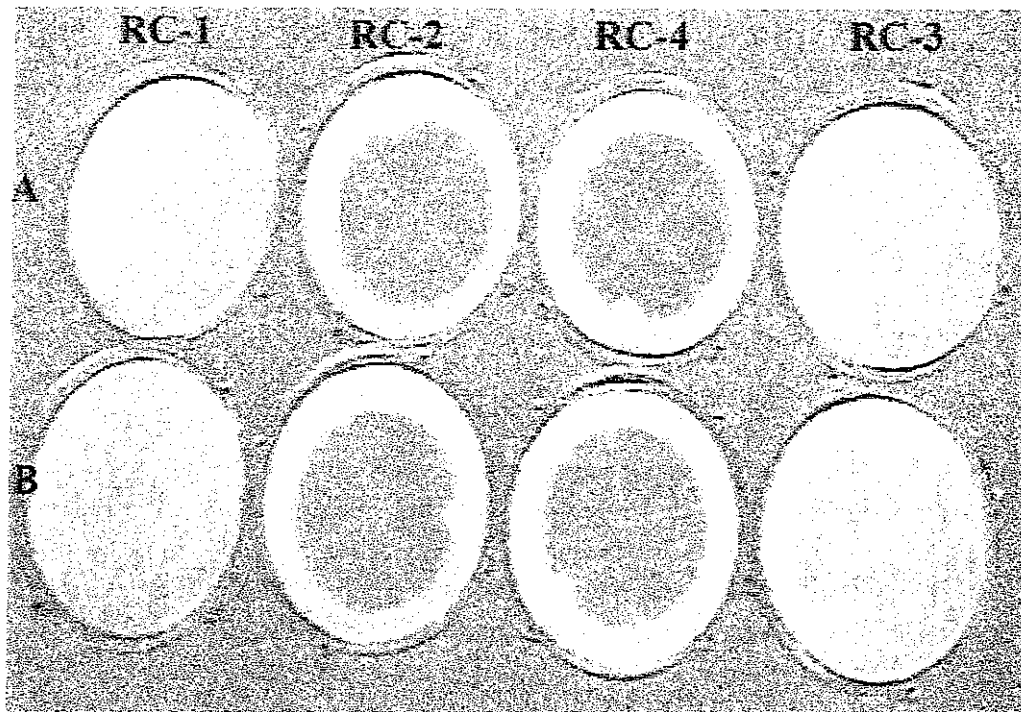
Figure 17. Glass fiber filters from Total Suspended Solids test. Upstream RC-1, RC-2 just below tailing pile, RC-4 3 miles downstream and RC-4 near mouth of Railroad Creek. Magnification 0.8X

Examination of the TSS filters and dissolved solids filters, Figures 17 and 18, did not show a large number of goethite coated mineral grains or many other mineral grains either. The particulate matter consisted primarily of yellow to orange yellow flakes, Figure 19. The material appears isotropic and had a refractive index greater than 1.660. The material exhibited the same behavior as the orange-yellow coating on the mine tailing grains. It dissolved rapidly in warm HCl and when heated in a closed capillary tube exhibited a change in color from orange-yellow to reddish-brown. The orange color on the filters is not directly due to an abundance of mine tailing grains suspended in the creek but appears to be the orange-yellow coating from the grains which may have been dislodged from the grains by turbulence. Due to their "flake like" nature they remain suspended and impart an orange color to the filters when concentrated. The darker orange color of the TSS filters is due to their drying at 105° C for 24 hours which may have started converting the goethite to amorphous Fe<sub>2</sub>O<sub>3</sub>.

Scraping off some of the coating from the "cementation" fragment, Figure 20, resulted in orange-yellow flakes similar to those on the filters, Figure 17 and 18. Characteristics under the microscope, isotropic refractive index greater than 1.660 were also similar to the filter particles, Figure 19.

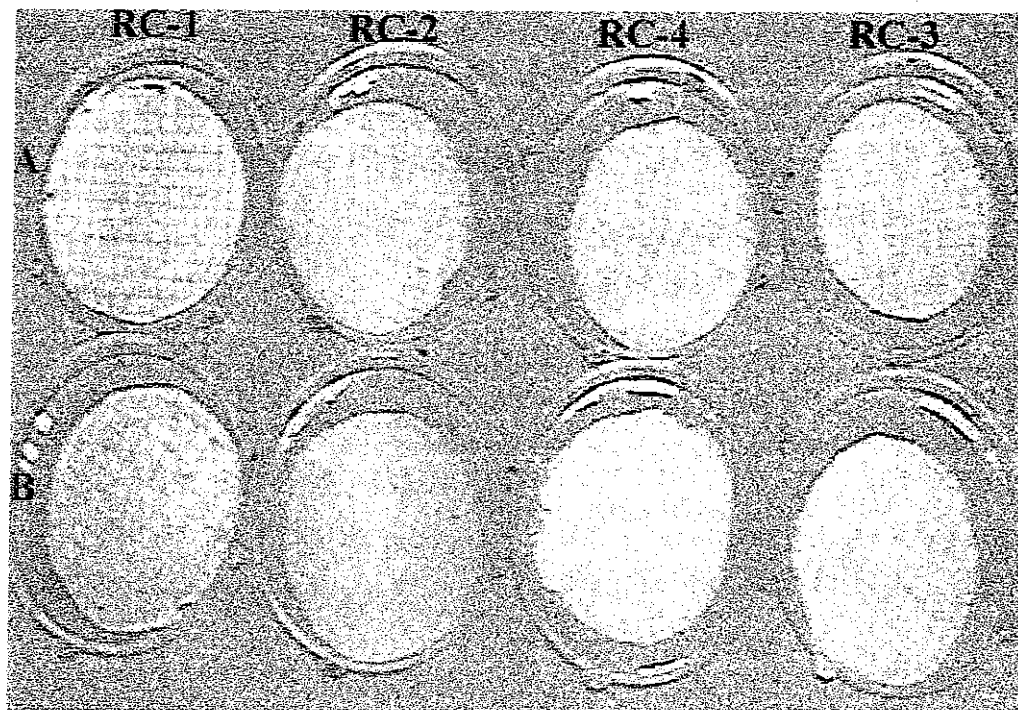
Figure 18. Membrane filters from dissolved metals samples. Upstream RC-1, RC-2 just below tailing pile, RC-4 3 miles downstream and RC-4 near mouth of Railroad Creek. Magnification 0.8X

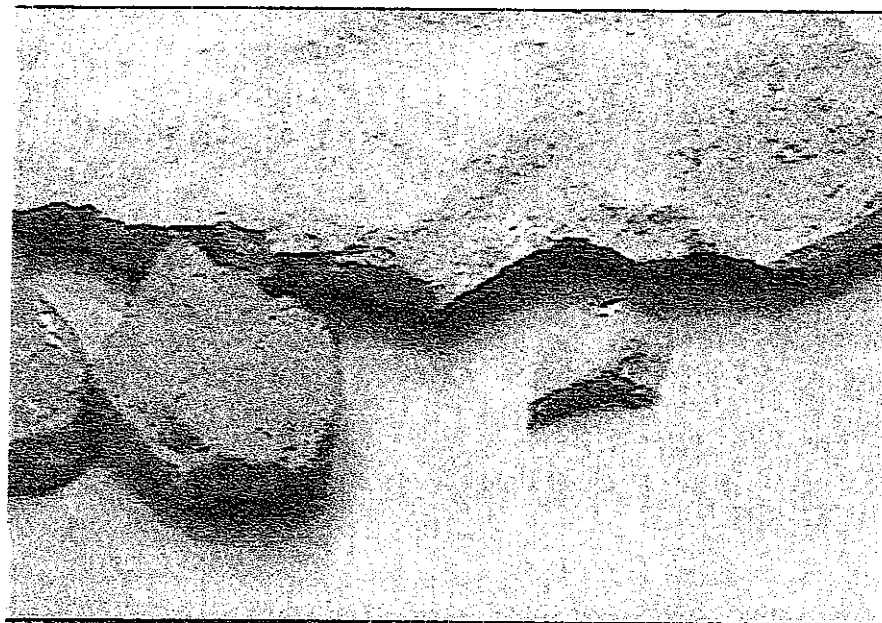
**Figure 20. Fragments of cemented creek bed collected from Railroad Creek just below lower tailing pile. Fragment broken off to observe cross-section and sampling. Magnification 1.1X.**

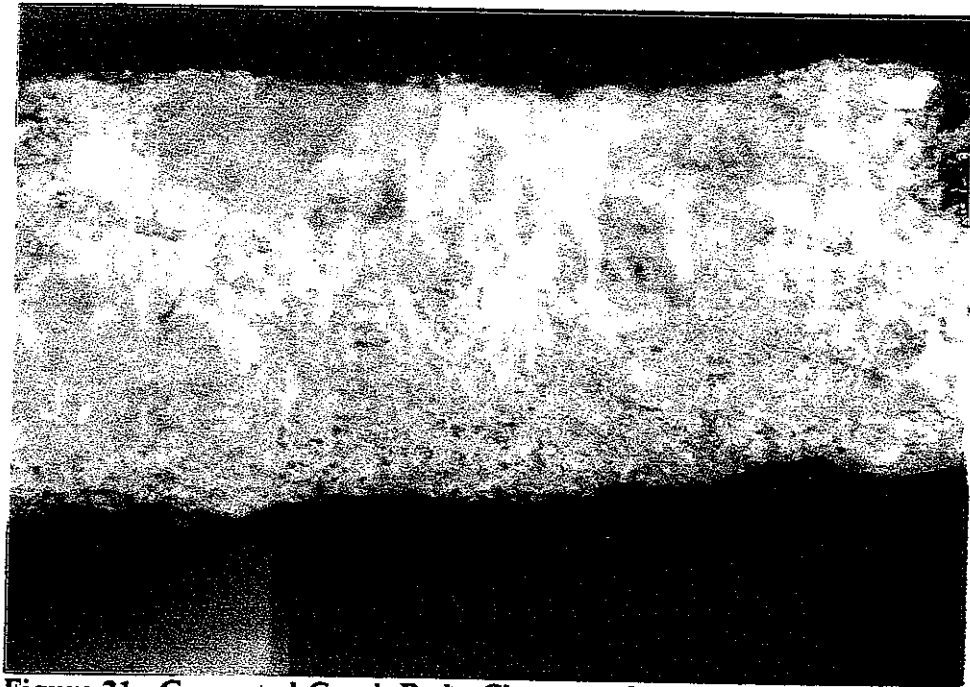
**Figure 21. Cemented Creek Bed - Close up of cross-section from Figure 15. Stereo 35X**

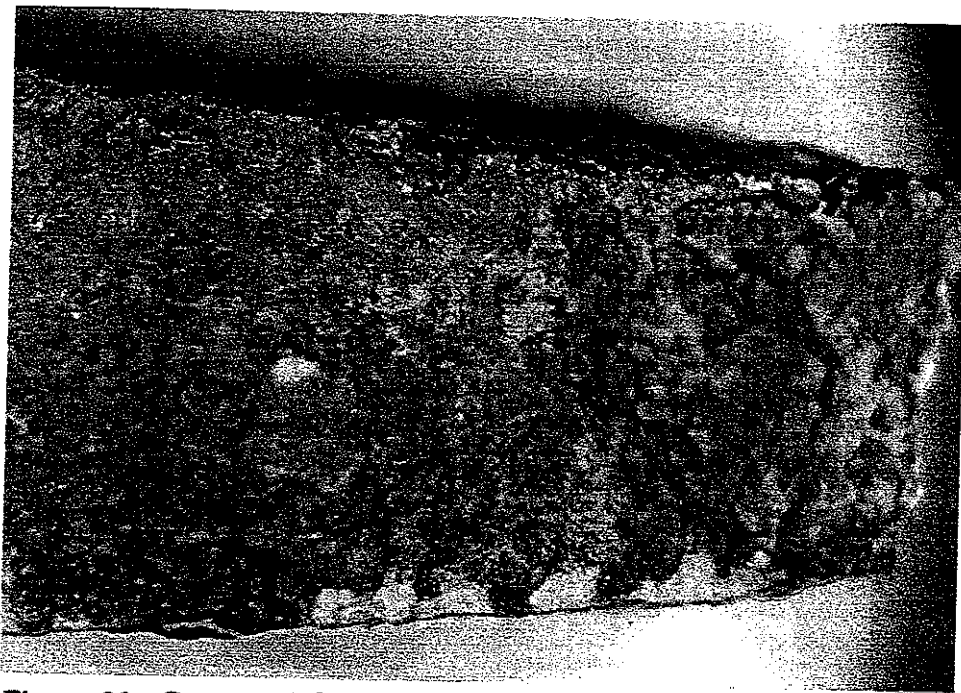
**Figure 22. Cemented Creek Bed - Close up of edge showing mineralization and orange "goethite" coating. Stereo 35X**

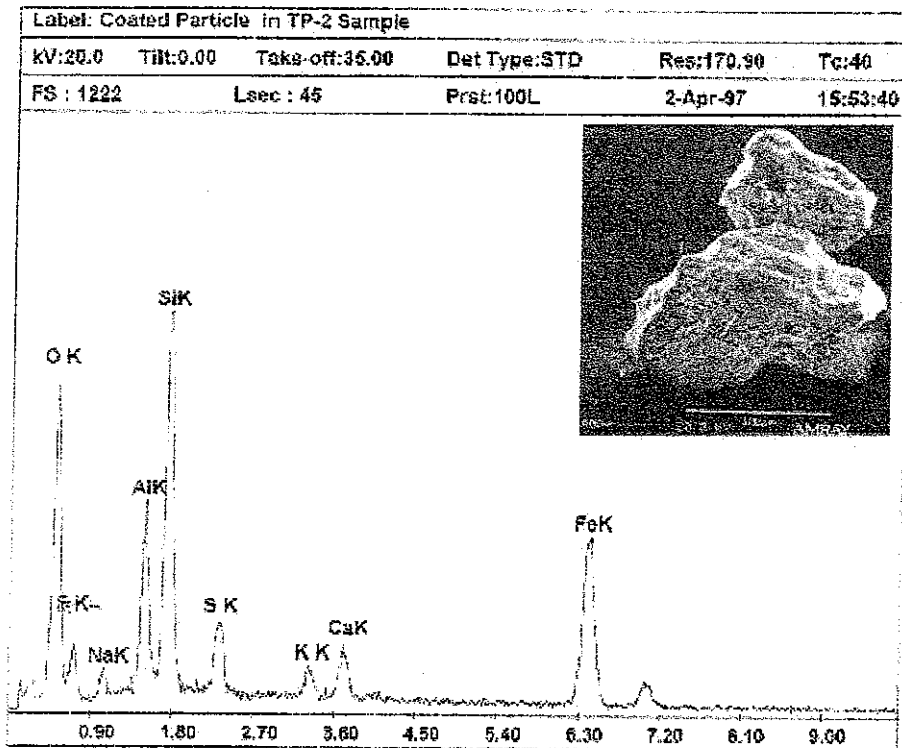
Figure 23. Tailing Pile, TP-2 SEM-X-ray microanalysis of orange coating. White size bar under photo is 100 micrometers long.

Scanning Electron Microscopy and X-ray microanalysis of the coating on the tailing pile grains Figure 23, Station RC-2, Figure 24 and the orange coating on the "cementation" sample, Figure 25, showed similar chemistries. Elements detected in all three samples included iron, oxygen, aluminum, silicon, and calcium. The coating on the tailing pile grains and Station RC-2 also showed some sodium, potassium and sulfur.

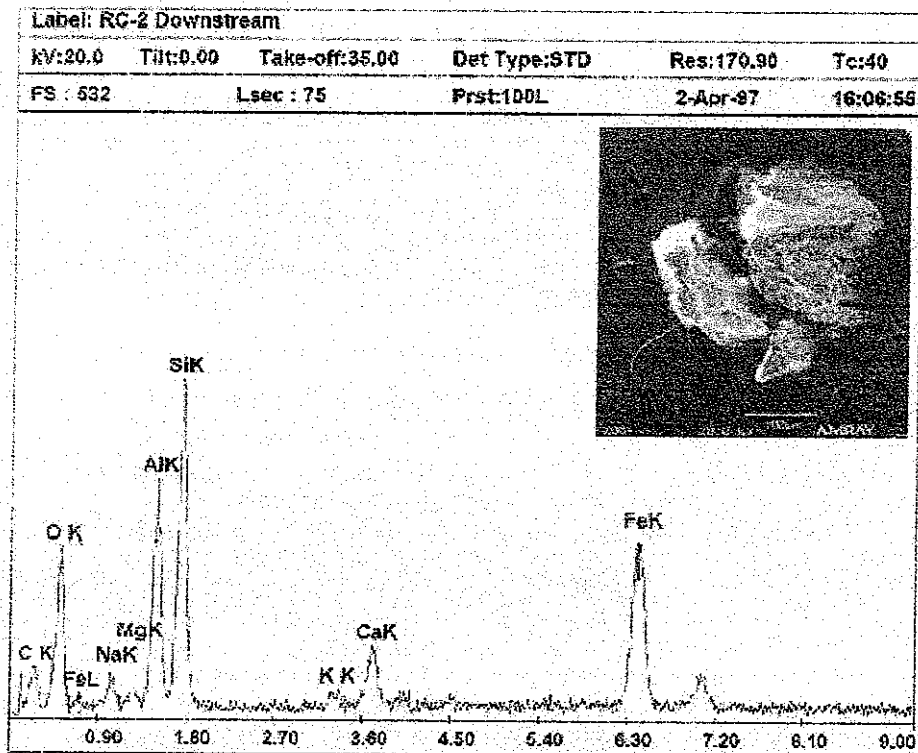
Figure 24. Railroad Creek, RC-2, SEM-X-ray microanalysis of orange coating. White size bar under photo is 100 micrometers long.

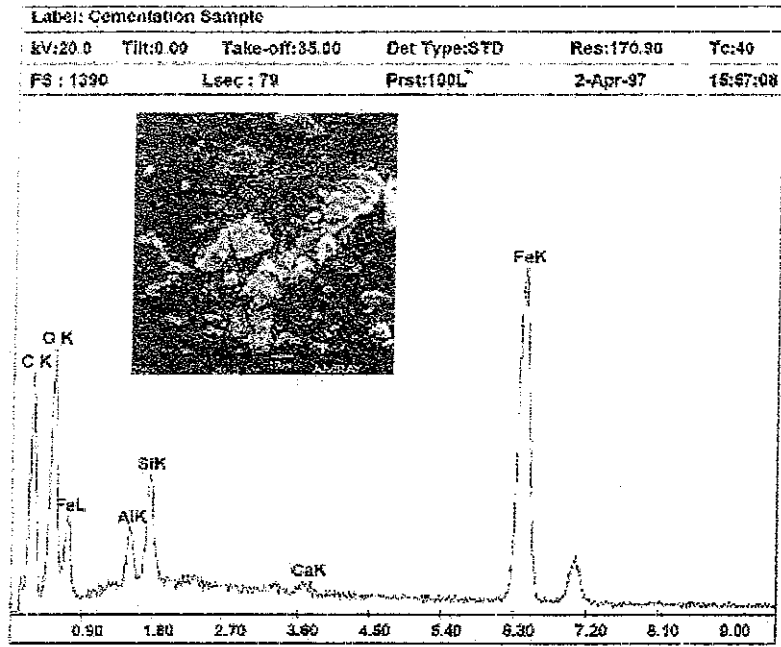
**Figure 25. SEM/X-ray microanalysis of Cementation fragment orange coating. White size bar under grains is 10 micrometers**

The loss of sodium, potassium and sulfur in the cementation coating makes sense in the aqueous environment of the stream. The "cementation" sample coating also contained small amounts of carbon. The carbon may be due to biological activity on the cemented grains.
