Shoreline Changes at North Beach, Samish Island

Publication 98-101

Prepared by: **Hugh Shipman**

WASHINGTON DEPARTMENT OF ECOLOGY
Shorelands and Environmental Assistance Program
Olympia, Washington

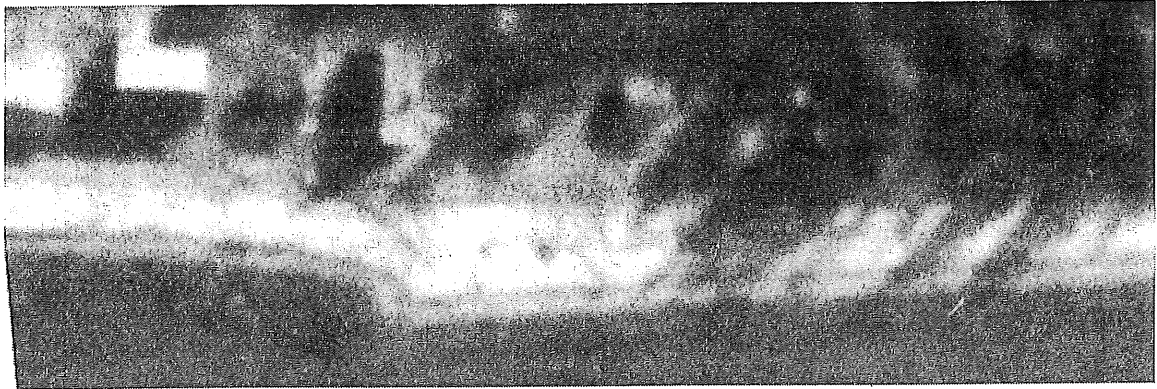
Figure 2. 1937 Aerial Photograph - beach offset near Youngquist property

We believe this structure may be the rock and metal structure referred to in notes by Marge Dunnington (Appendix B.1); where logs were reportedly brought to the beach during the 1920s. Discussions with other residents hinted at the presence of this structure, but accounts varied regarding its location and exact nature.

Aerial photographs from the mid and late-1960s show no evidence of this offset, although there is some evidence that the beach in the area to the west remains anomalously wide (Figure 3). This indicates that the structure itself may have largely been destroyed or removed, but that the beach retained some of the form caused by its presence. We believe that the broad convex-seaward curve to the shoreline centered at Dunnington may be a relic of this historical modification to the shoreline.

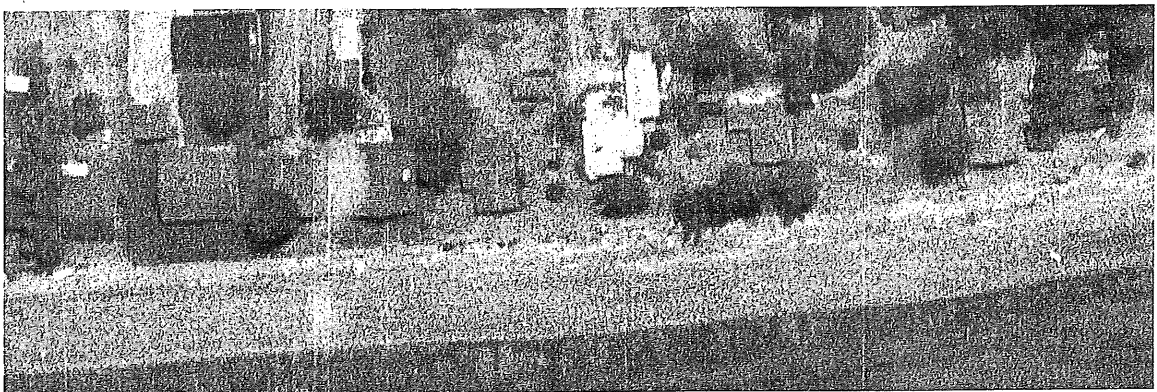
*Figure 3. 1966 Aerial Photograph
Same general area as Figure 5.*

In the mid-1960s, there appears no evidence of significant erosion from the Youngquist property westward to the bulkhead at the McCurdy/ Newman residence. The beach is wide and drift logs are easily noted in the aerial photos and family photos. Sometime in the 1960s Mercer Road was extended down the bluff at the western most end of North Beach. Concrete groins were also constructed in this vicinity at about the same time (Figure 4 and Figure 5). These groins remain in place today. Sediment has accumulated on their western sides.

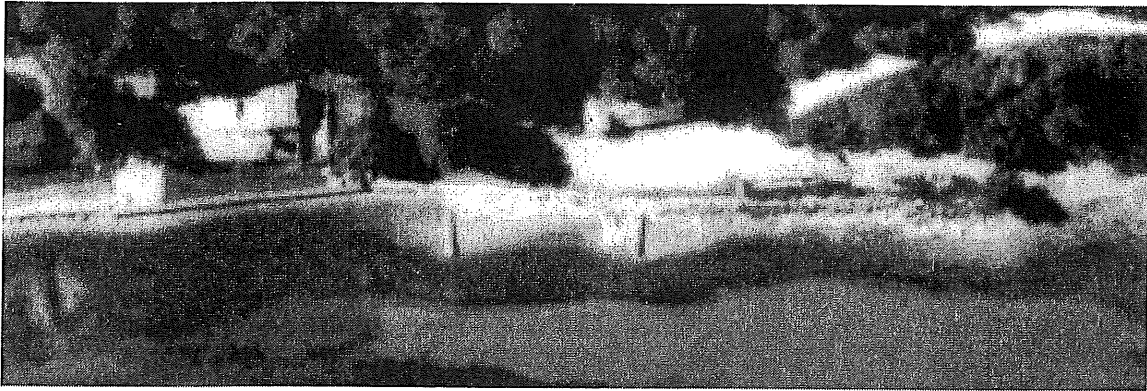
Figure 5. 1995 aerial photograph of groins

Two concrete groins were constructed at the western end of North Beach in the 1960s. These groins, each about 20-30 feet long and about 100 feet apart, have trapped sediment on their western (updrift) sides (Figure 4). The volume of sediment trapped behind these structures may amount to several tens of cubic yards of material.

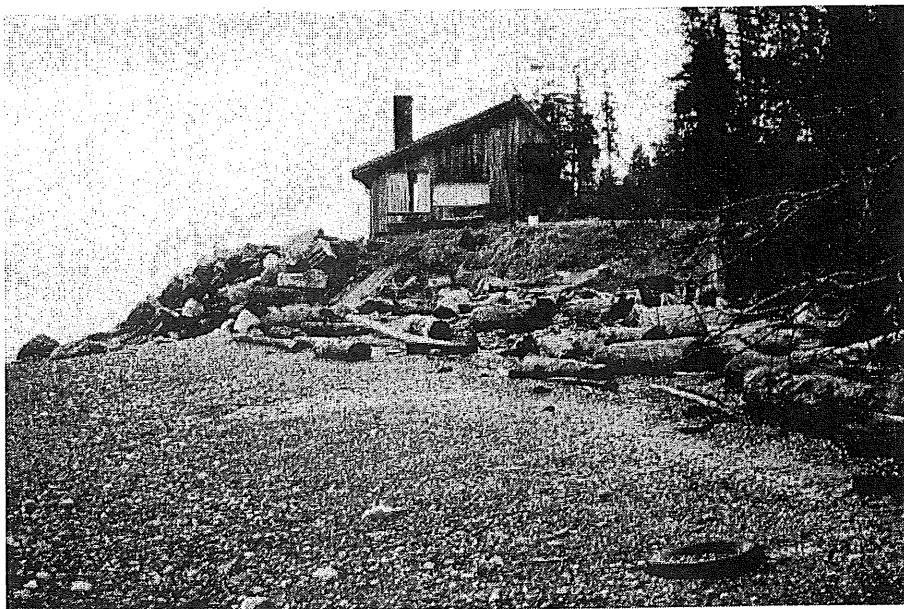
Figure 10. Cabin constructed on artificial promontory seen in Figure 9. (Photo: 1997)

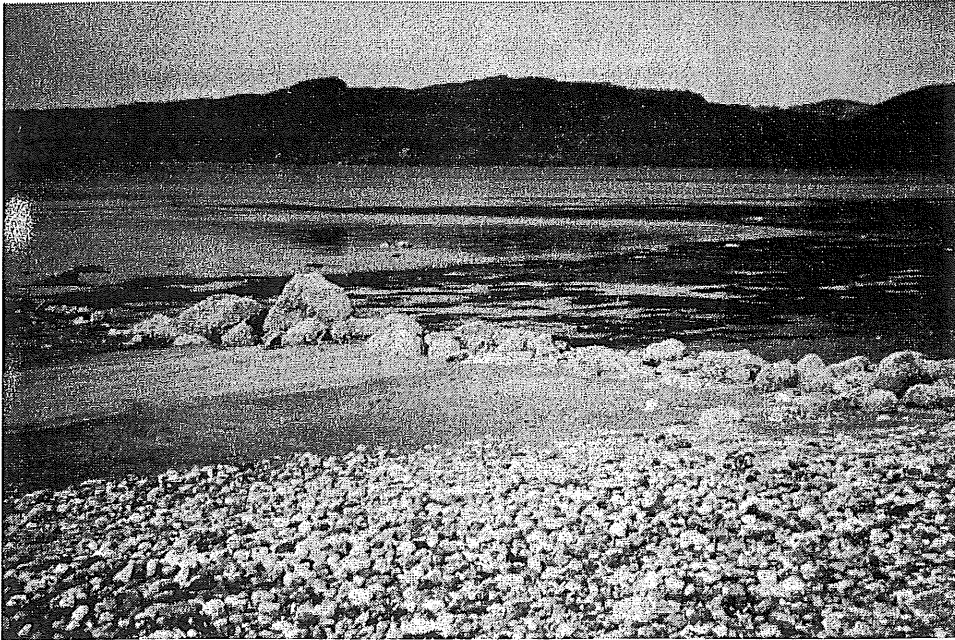
*Figure 11. Largest of groins seen in Figure 9.
(Photo: 1997)*

Groins. Numerous rock groins, some extending more than 100 feet offshore, are observed along the shoreline toward the narrows (Figure 9 and Figure 11). Although these structures do not trap large amounts of material, they may be sufficient to trap much of the relatively small amount of sediment still in the littoral system.

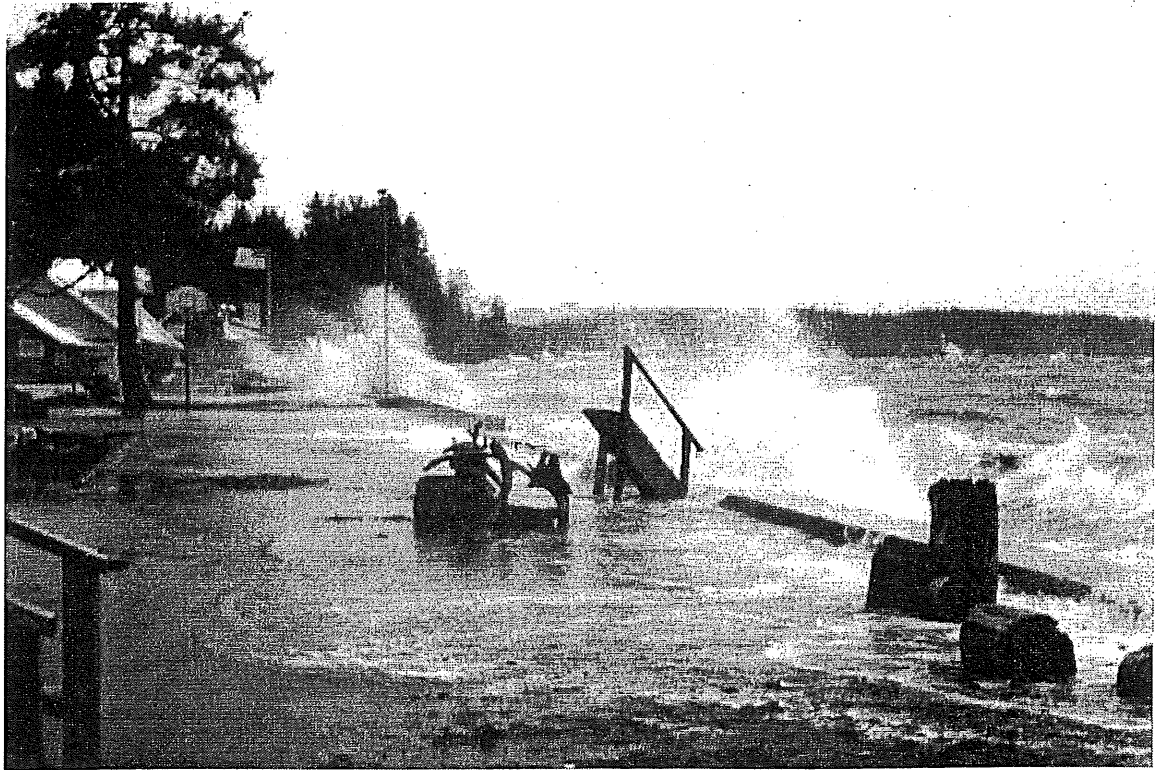
*Figure 12. Storm conditions during November, 1996.
(Photo: C. Herzog, 1996)*

Residents reported that this winter's flooding was more extensive and more persistent than in the past (Figure 12 and Figure 13). This may reflect in part the unusually high amount of precipitation, combined with the windstorms in November and December that resulted in significant wave overtopping of bulkheads, but it may also be a symptom of increased runoff from upland areas and restricted drainage. The failure of the "ecology" block bulkheads (Stewart, Jordan, Worley, and Dunnington) in late December, 1996, appeared to be largely due to excessive hydrostatic pressure behind the poorly drained bulkheads - combined with the force of storm waves and lowering of the beach in front of the walls. Unrelieved buildup of hydrostatic pressure behind retaining walls is a common source of failure.

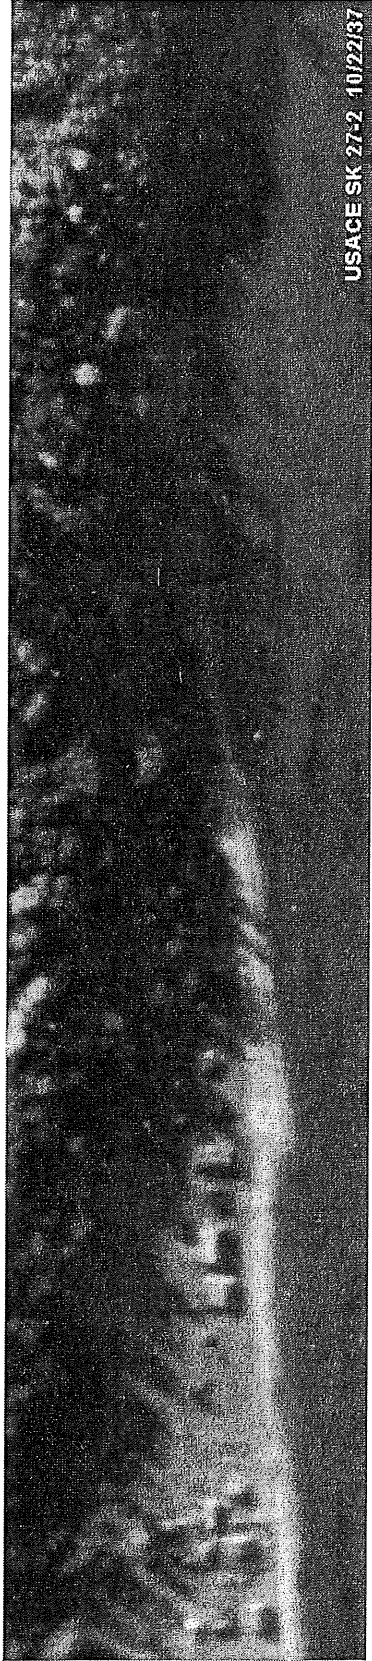
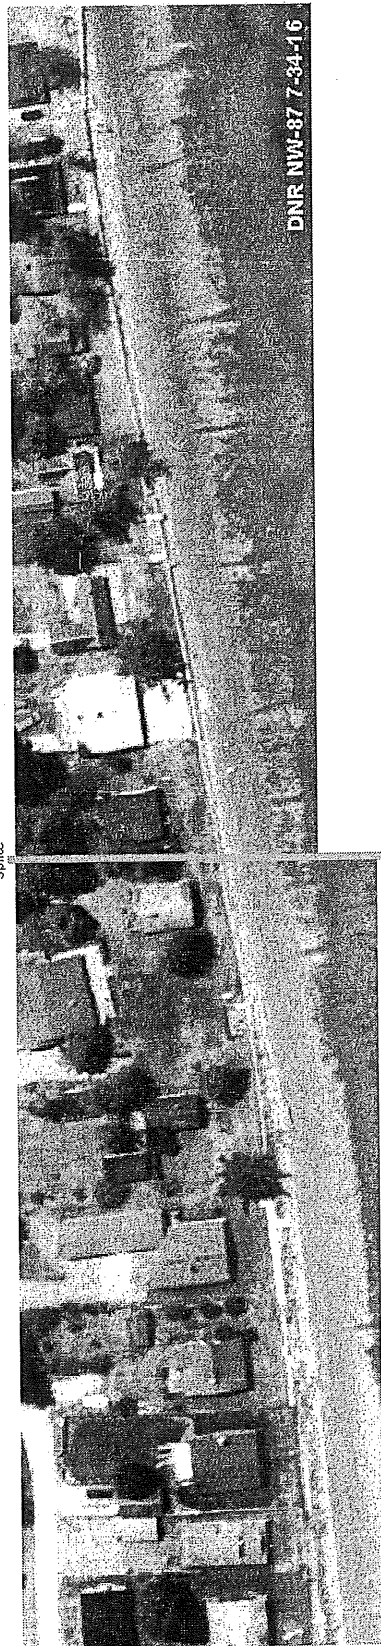
Figure
A-1

USACE SK 27-2 10/22/37

USACE S704-92-8 2/26/70

DOE Skagit 42B-3 4/5/77

USACE S88020-92-6 8/13/83
