**Effectiveness of Forest Road
and Timber Harvest Best Management Practices
with Respect to Sediment-Related
Water Quality Impacts**

May 1999
Publication No. 99-317

Submitted to:
Timber/Fish/Wildlife Cooperative Management, Evaluation, and Research Committee

Washington State Department of Ecology
Environmental Assessment Program
Watershed Ecology Section
PO Box 47710
Olympia, WA 98504-7710

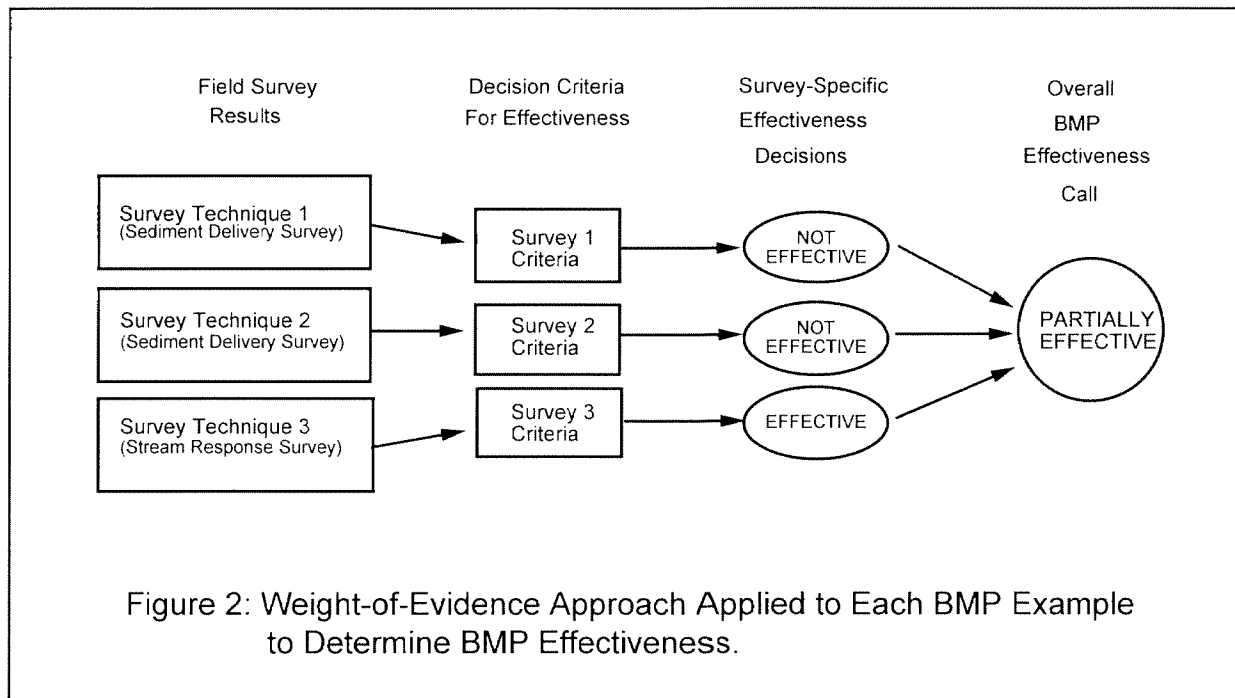
The weight-of-evidence approach is illustrated conceptually in Figure 2. The results of each survey were evaluated using decision criteria that relate survey results to the water quality effects and/or erosion processes the BMP is intended to control. In some cases a survey technique was applied at multiple locations at the forest practice operation to assess the same BMP. Survey-specific effectiveness calls fall into one of three categories: "Effective", "Partially Effective", or "Not Effective". In a few cases, the result is "Indeterminate", meaning site-specific effectiveness could not be determined for this BMP example with the survey technique used. Indeterminate calls were made where: 1) interference from other sediment sources did not allow adequate evaluation of a particular forest practice example; 2) site-specific conditions were not appropriate for a particular survey (as when a significant runoff event did not materialize during road runoff surveys); or 3) the survey technique was not appropriate for a site-specific impact study but rather provided information for pooled data analysis (such as with the amphibian surveys).

The evidence from the different survey techniques employed at the site to evaluate one or both aspects of BMP effectiveness (sediment delivery and/or stream response), was then used collectively to determine the effectiveness of that particular BMP example. The overall effectiveness call for each case study of a BMP example is then determined to be either "Effective", "Partially Effective" (in the case of mixed results), or "Not Effective". Each survey used at a given site was given equal weighting, provided that it

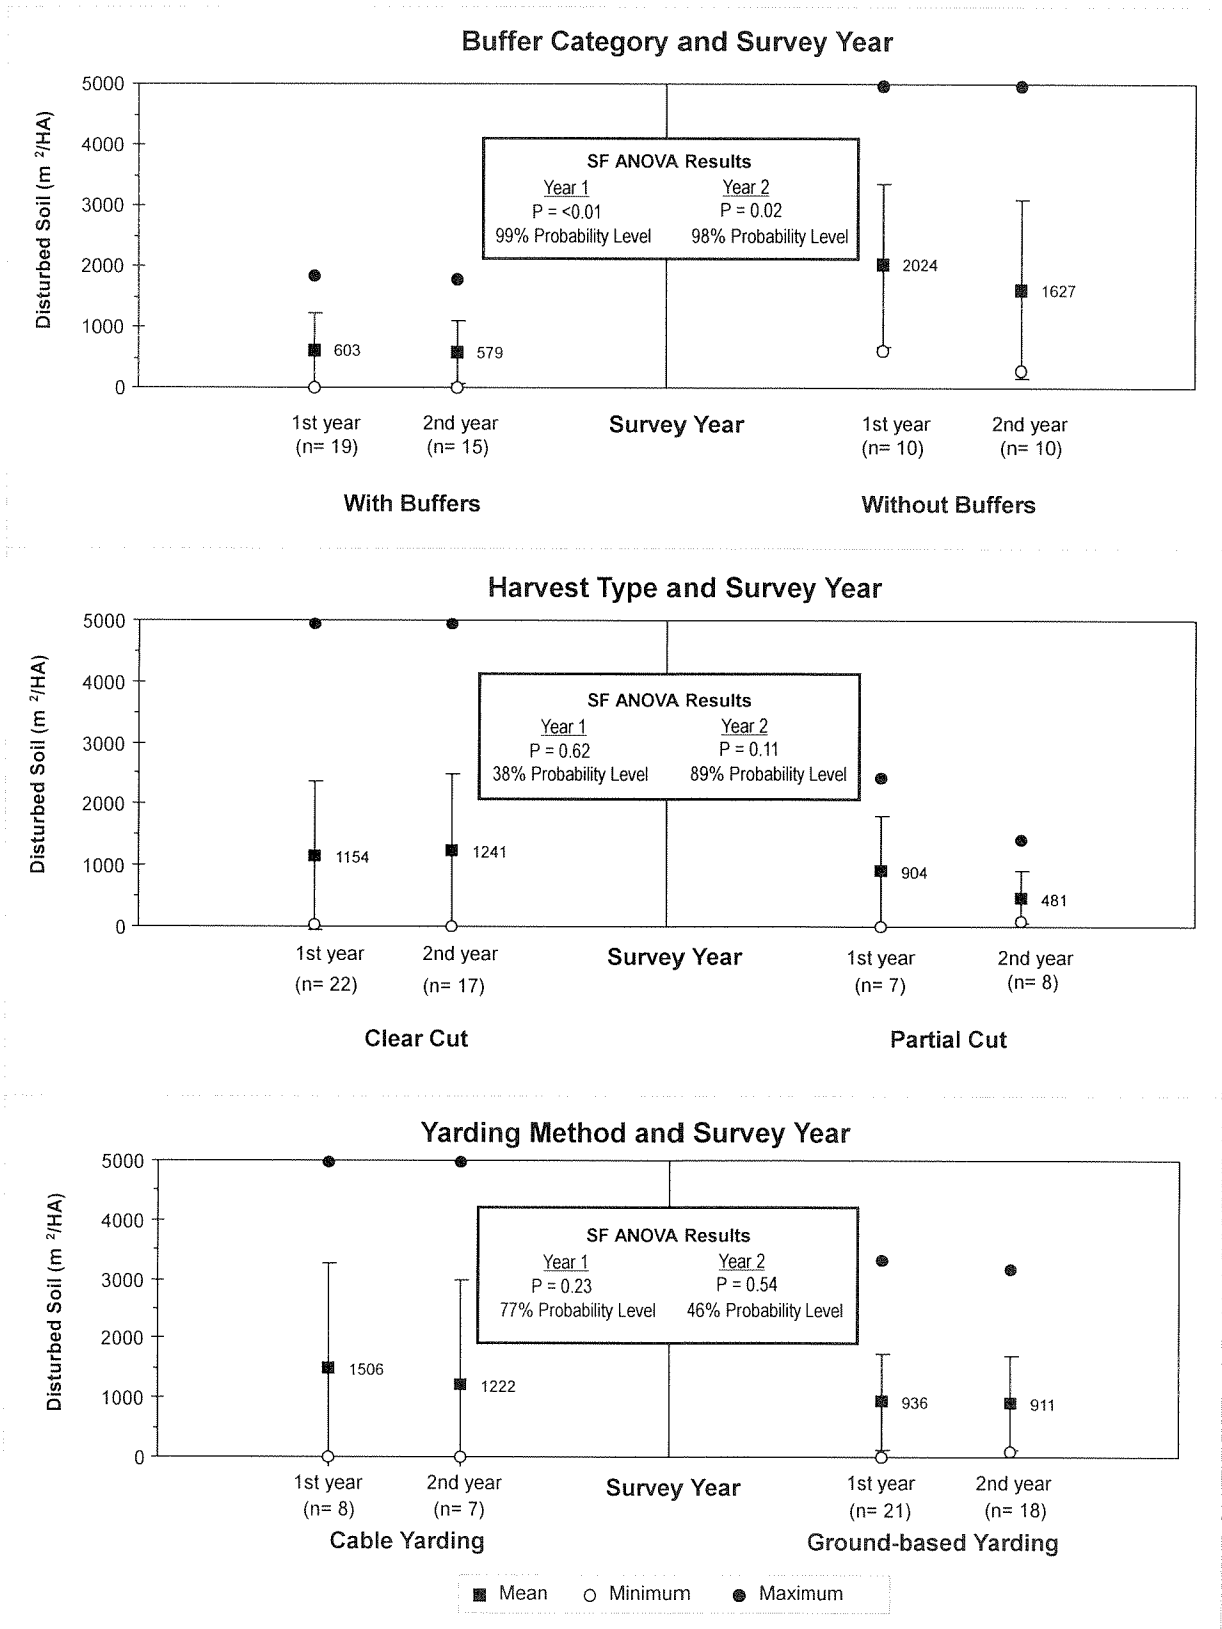
Figure 6: Comparison of Mean Disturbed Soil per Hectare by Buffer Category, Harvest Type, and Yarding Method.

These findings of more ground disturbance with cable yarding methods contrast with comparisons reported in various reviews of forestry BMPs (see for example Craig *et al.*, 1993 and EPA, 1993), which indicate that ground-based yarding typically results in greater soil disturbance than cable yarding techniques. We evaluated whether the fact that a greater proportion of our ground-based sites were partial cut harvests in the eastern Washington climate region might explain why our comparison found the opposite relationship. However, even when the comparison is restricted to clearcut harvest units in western Washington, we found the average level of disturbed soil per hectare to be 1.3 and 1.2 times greater at cable yarding sites. Also, it should be noted that the proportions of cable and ground-based sites in our sample that were harvested with stream buffers are approximately equal. The greater degree of soil disturbance associated with cable-yarding at our study sites is probably partly a function of the steeper slope angles at some of the cable sites as compared to ground-based yarding sites. However, it may also be associated with other differences between ground and cable yarding methods, such as a higher density of high-lead yarding routes at cable sites, as compared to sites where a lower density of skid or shovel trails were used. Another reason why our comparison of yarding methods differs from

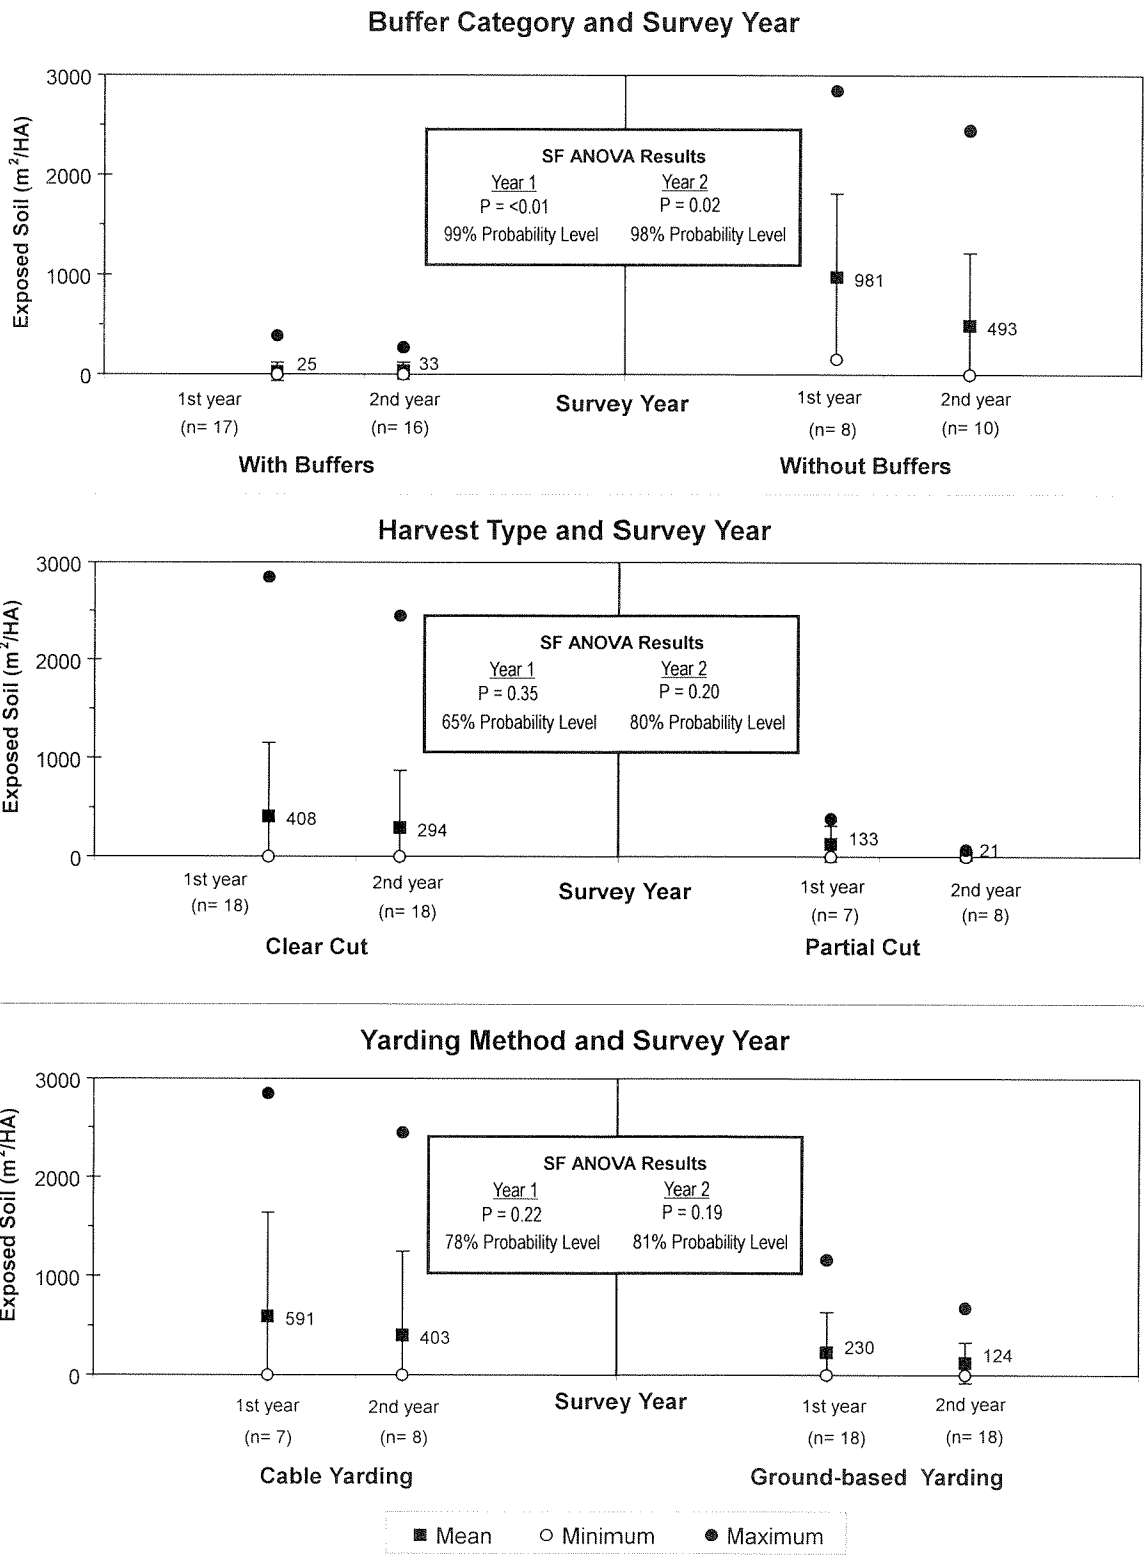
Figure 9: Comparison of Mean Exposed Soil per Hectare for Harvest Erosion Features that Delivered Sediment to Streams, by Buffer Category, Harvest Type, and Yarding Method.

Further comparisons of the relative area of exposed soil associated with erosion features that delivered sediment to streams are provided in Figure 9, which shows the mean exposed soil per hectare along with the standard error, range of values, and single-factor ANOVA results. Figure 9 is based on harvest features that delivered; exposed soil associated with windthrow, wildlife, fluvial erosion, and other features not directly attributable to harvest practices is excluded. The relative area of exposed soil associated with delivered features is compared by buffer category, harvest type, and yarding method, with first and second year survey results shown separately. Based on a comparison of means, the practice of harvesting without buffers resulted in 39 times more exposed soil associated with features that delivered during the first year (981 m²/HA versus 25 m²/HA), and 15 times more chronic erosion (493 m²/HA versus 33 m²/HA), than where stream buffers were used. These differences between mean values for harvest with stream buffers and harvest without buffers are statistically significant at the 99% and 98% probability levels for first and second year comparisons, respectively.

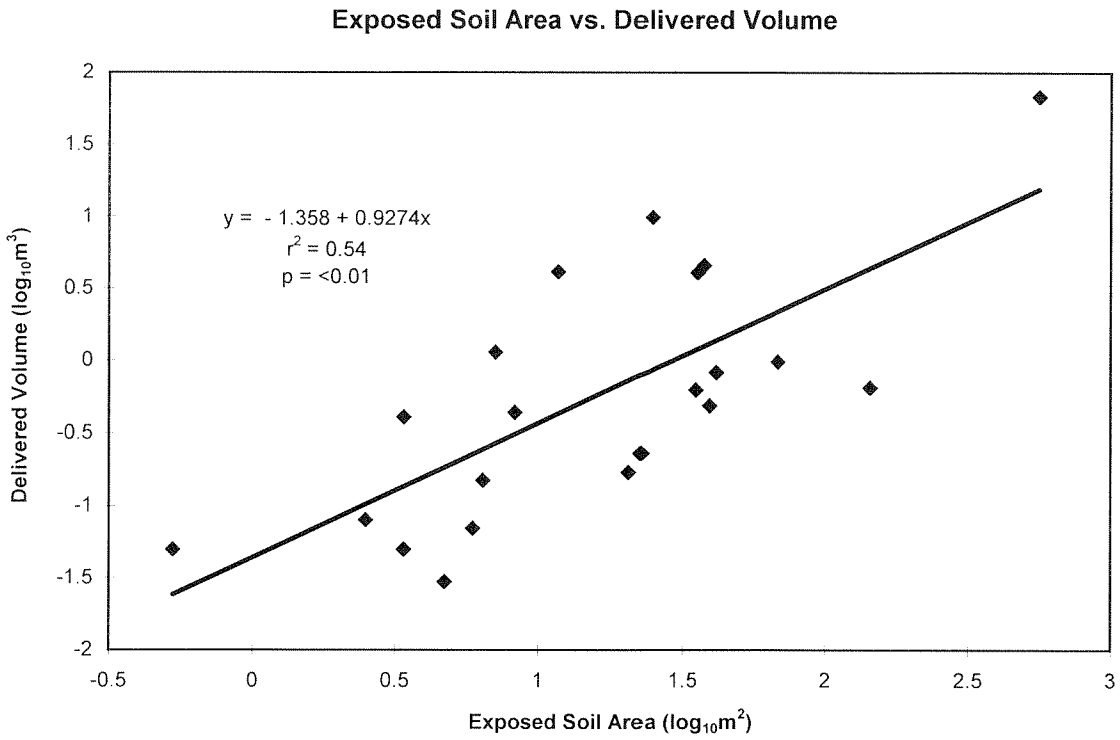
Figure 13: Relationship of Volume of Sediment Delivered to Streams to Disturbed Area and Exposed Soil Area of Erosion Features.

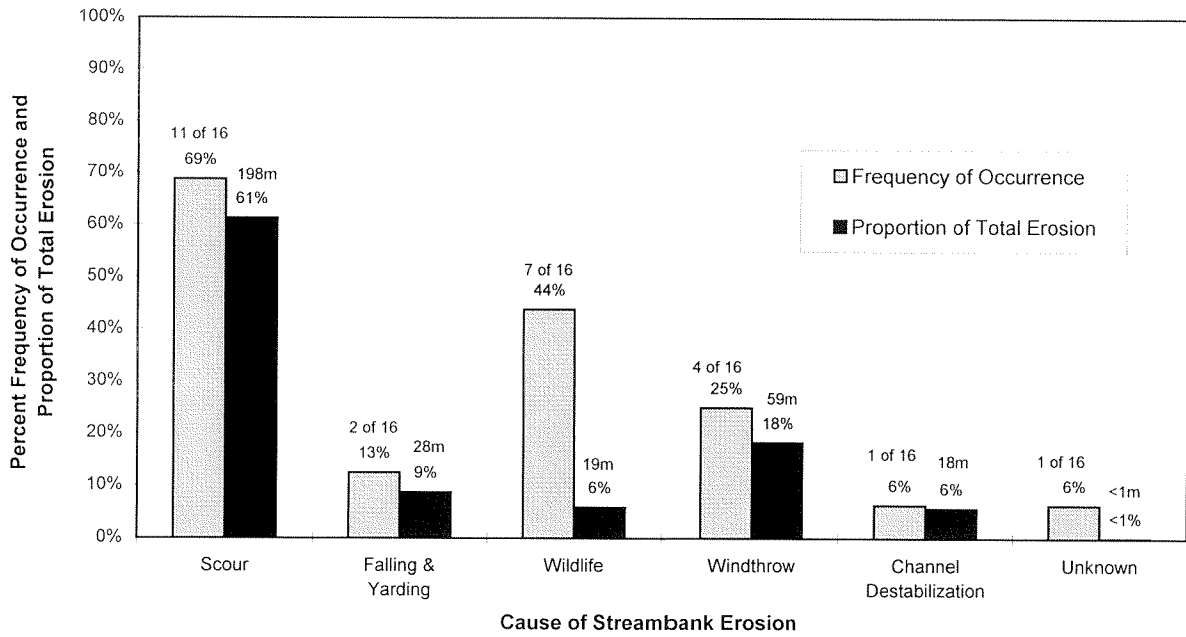
Figure 16: Frequency of Occurrence and Proportion of Total Erosion at Survey Reaches by Cause of Stream Bank Erosion.

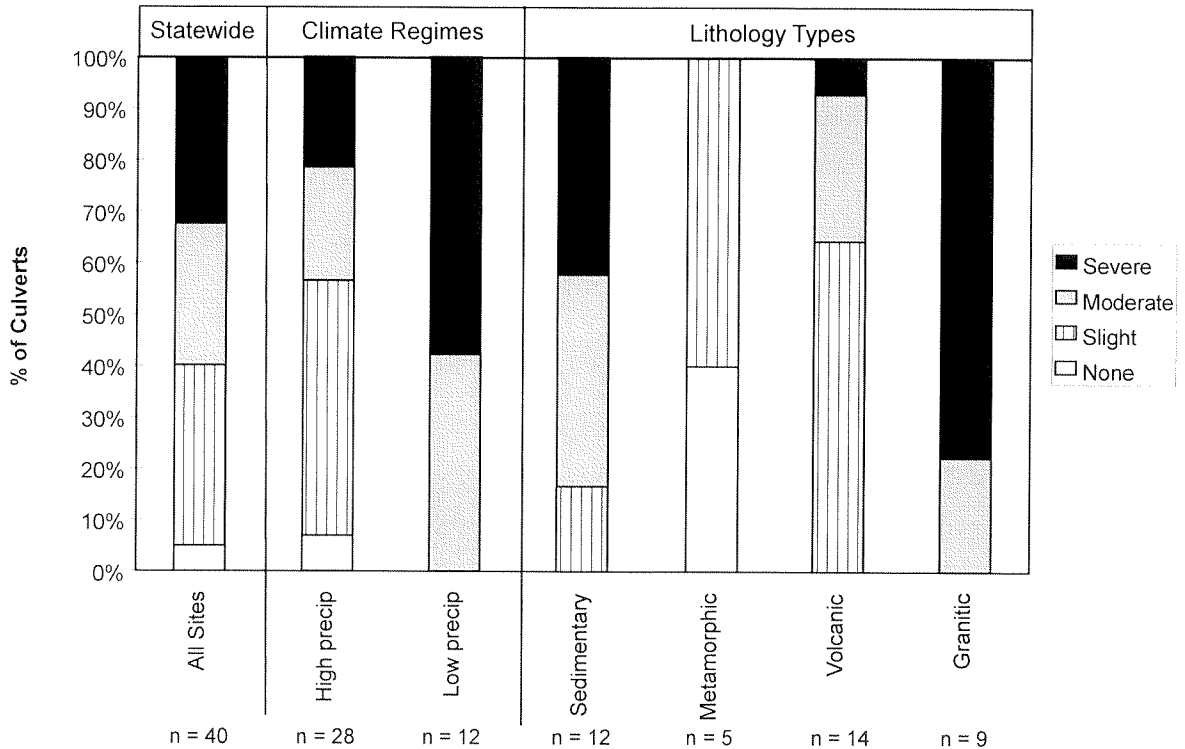
Figure 19a: Erosion Severity at Inflow Side of Fill

Figure 19b: Erosion Severity at Outflow Side of Fill

Figure 19: Severity of Erosion on Culvert Fills at: a) Inflow Side and b) Outflow Side of Road, Showing Statewide Results and Results for Different Climate and Lithology Categories.

Figure 19 shows the comparisons of erosion severity on culvert fills for the two climate regimes and the four lithology types, as well as statewide results (*i.e.*, all sites lumped together). The top half of Figure 19 shows erosion severity on the inflow side of the road, and the bottom shows the outflow side. The erosion severity calls are based on culvert condition surveys conducted during the second year of road life, or following at least one growing season for the establishment of ground cover. As defined in the culvert condition survey protocol, “severe” erosion means that greater than 50% of the fill over the

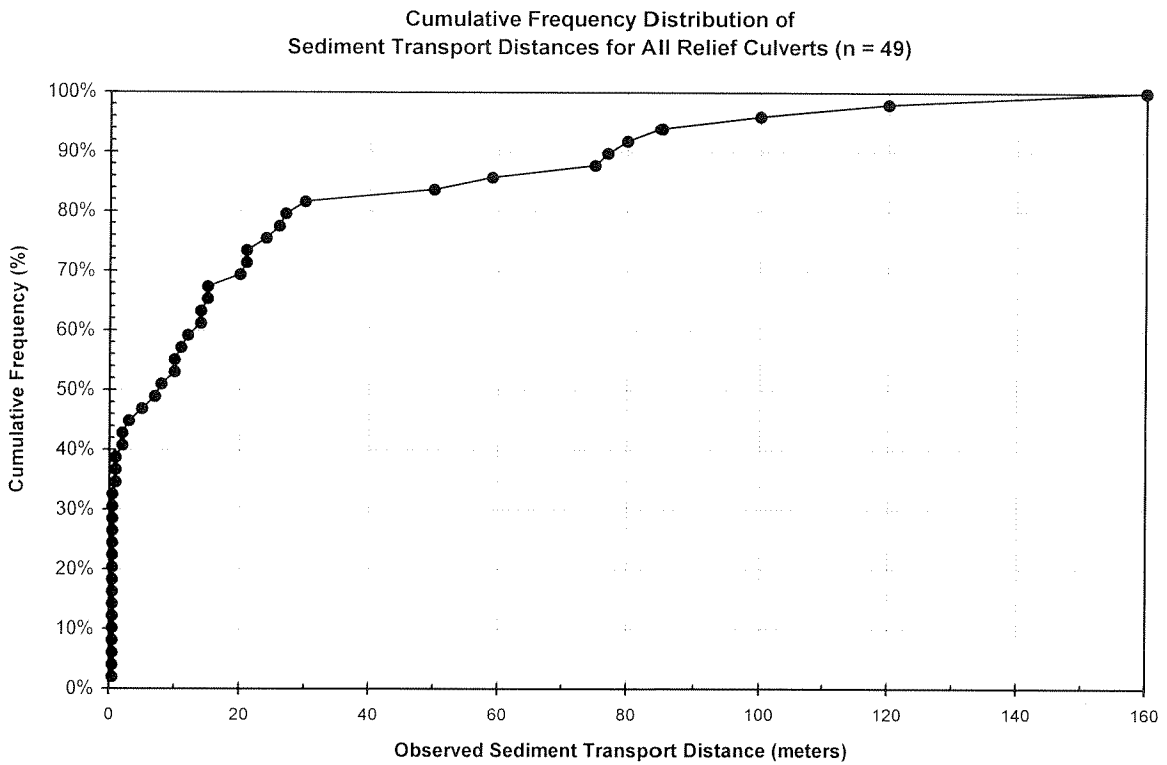
Figure 21: Cumulative Frequency Distributions of Sediment Transport Distance Below Relief Culverts.

Cumulative frequency distributions of sediment transport distances are presented in Figure 21 for all 49 culverts, and for the same culverts grouped according to bedrock lithology types. These distributions are useful for evaluating situations where relief culvert discharges are likely to reach streams. For instance, using the 90th percentile of the distribution for all relief culverts, a spacing of 80 meters between relief outfalls and streams would have a high probability of preventing sediment delivery

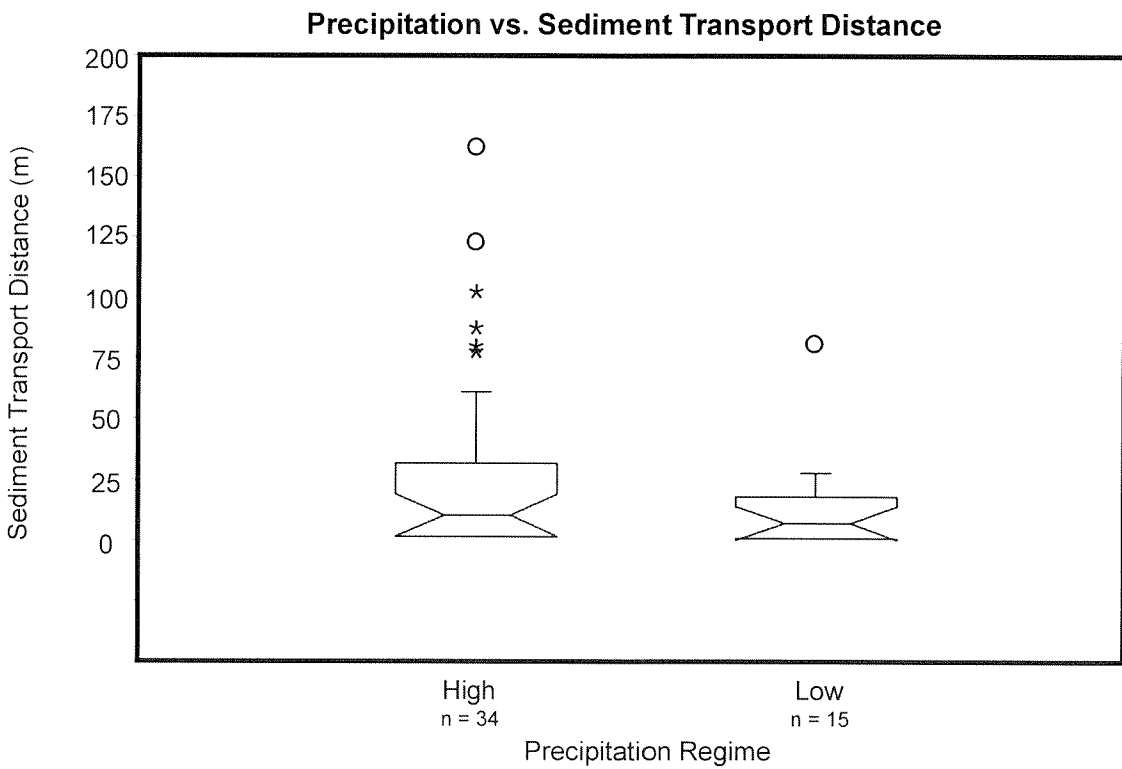
Figure 22: Comparison of Sediment Transport Distance Below Relief Culverts by Lithology Type and Precipitation Regime.

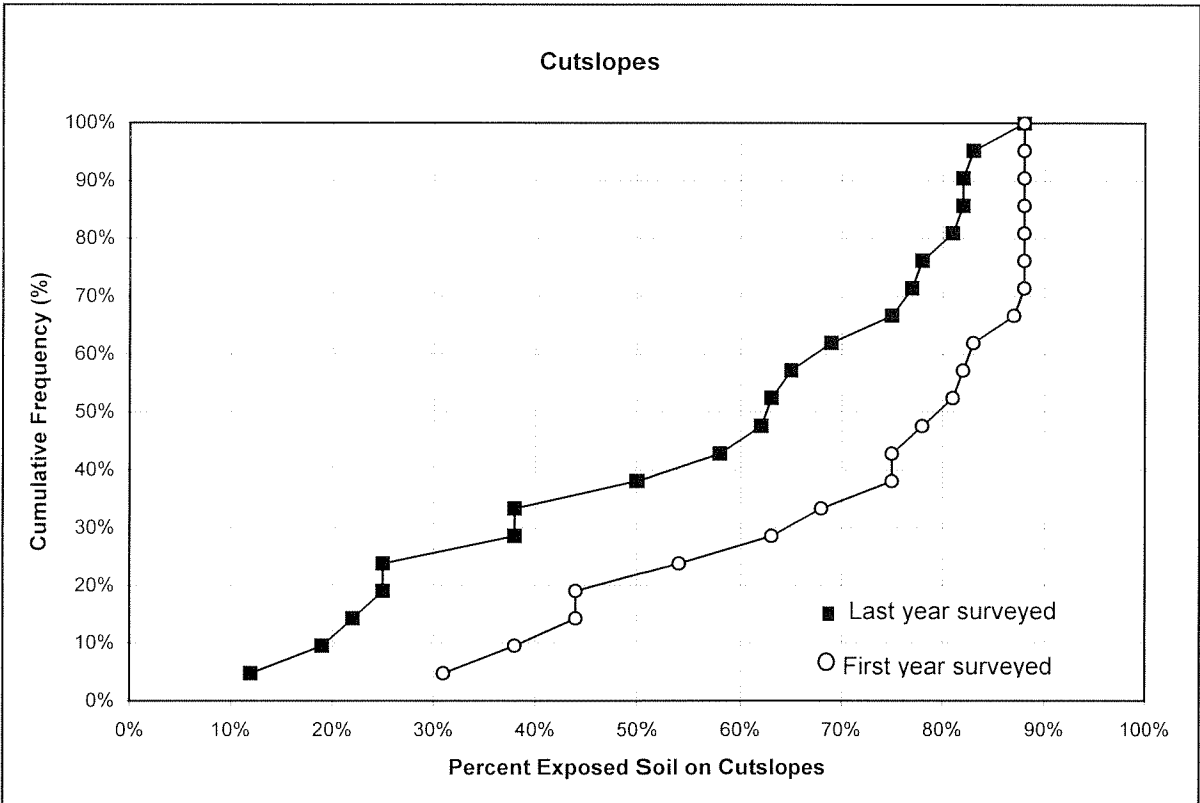
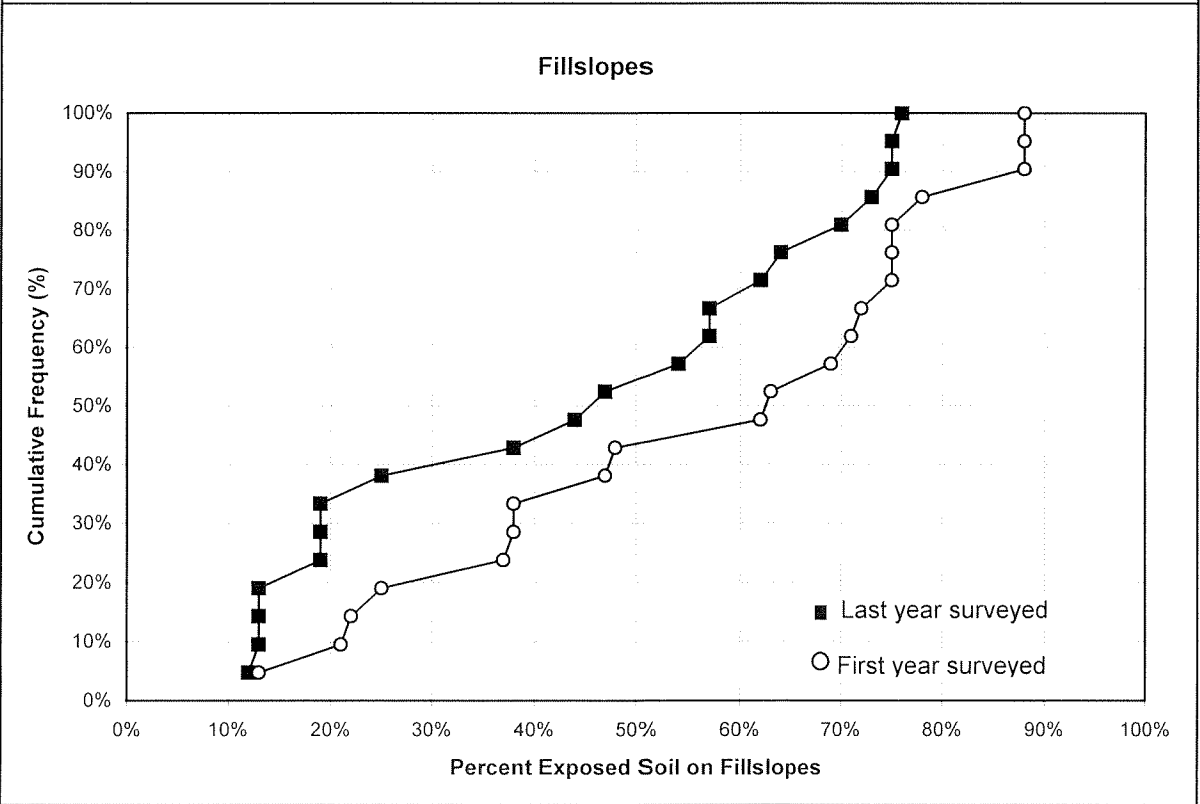
Figure 27: Cumulative Frequency Distributions of Percent Exposed Soil on Cutslopes and Fillslopes.

We examined the distribution of exposed soil levels on both cutslopes and fillslopes to evaluate the range of conditions observed statewide, for both the construction phase (reflected in first-year survey results) and the last follow-up survey conducted at each site. Figure 27 shows the cumulative frequency distribution of the percent exposed soil for each time period. About 78% of all sites had greater than 50% exposed soils on cutslopes during the construction phase, and cutslopes at half of the sites were more than 80% exposed. At the time of the final follow-up surveys, about 62% of all cutslopes remained at least 50% exposed, with 20% of the cutslopes more than 80% exposed soil. Timing for these follow-
