August 31, 2021 (revised September 3, 2021)

Re: Second Quarter 2021 Environmental Monitoring Report
Hansville Landfill, Kitsap County, Washington
Project No. 160423-005-05.1

2021 Second Quarter Environmental Monitoring
Report Hansville Landfill
Kitsap County, Washington

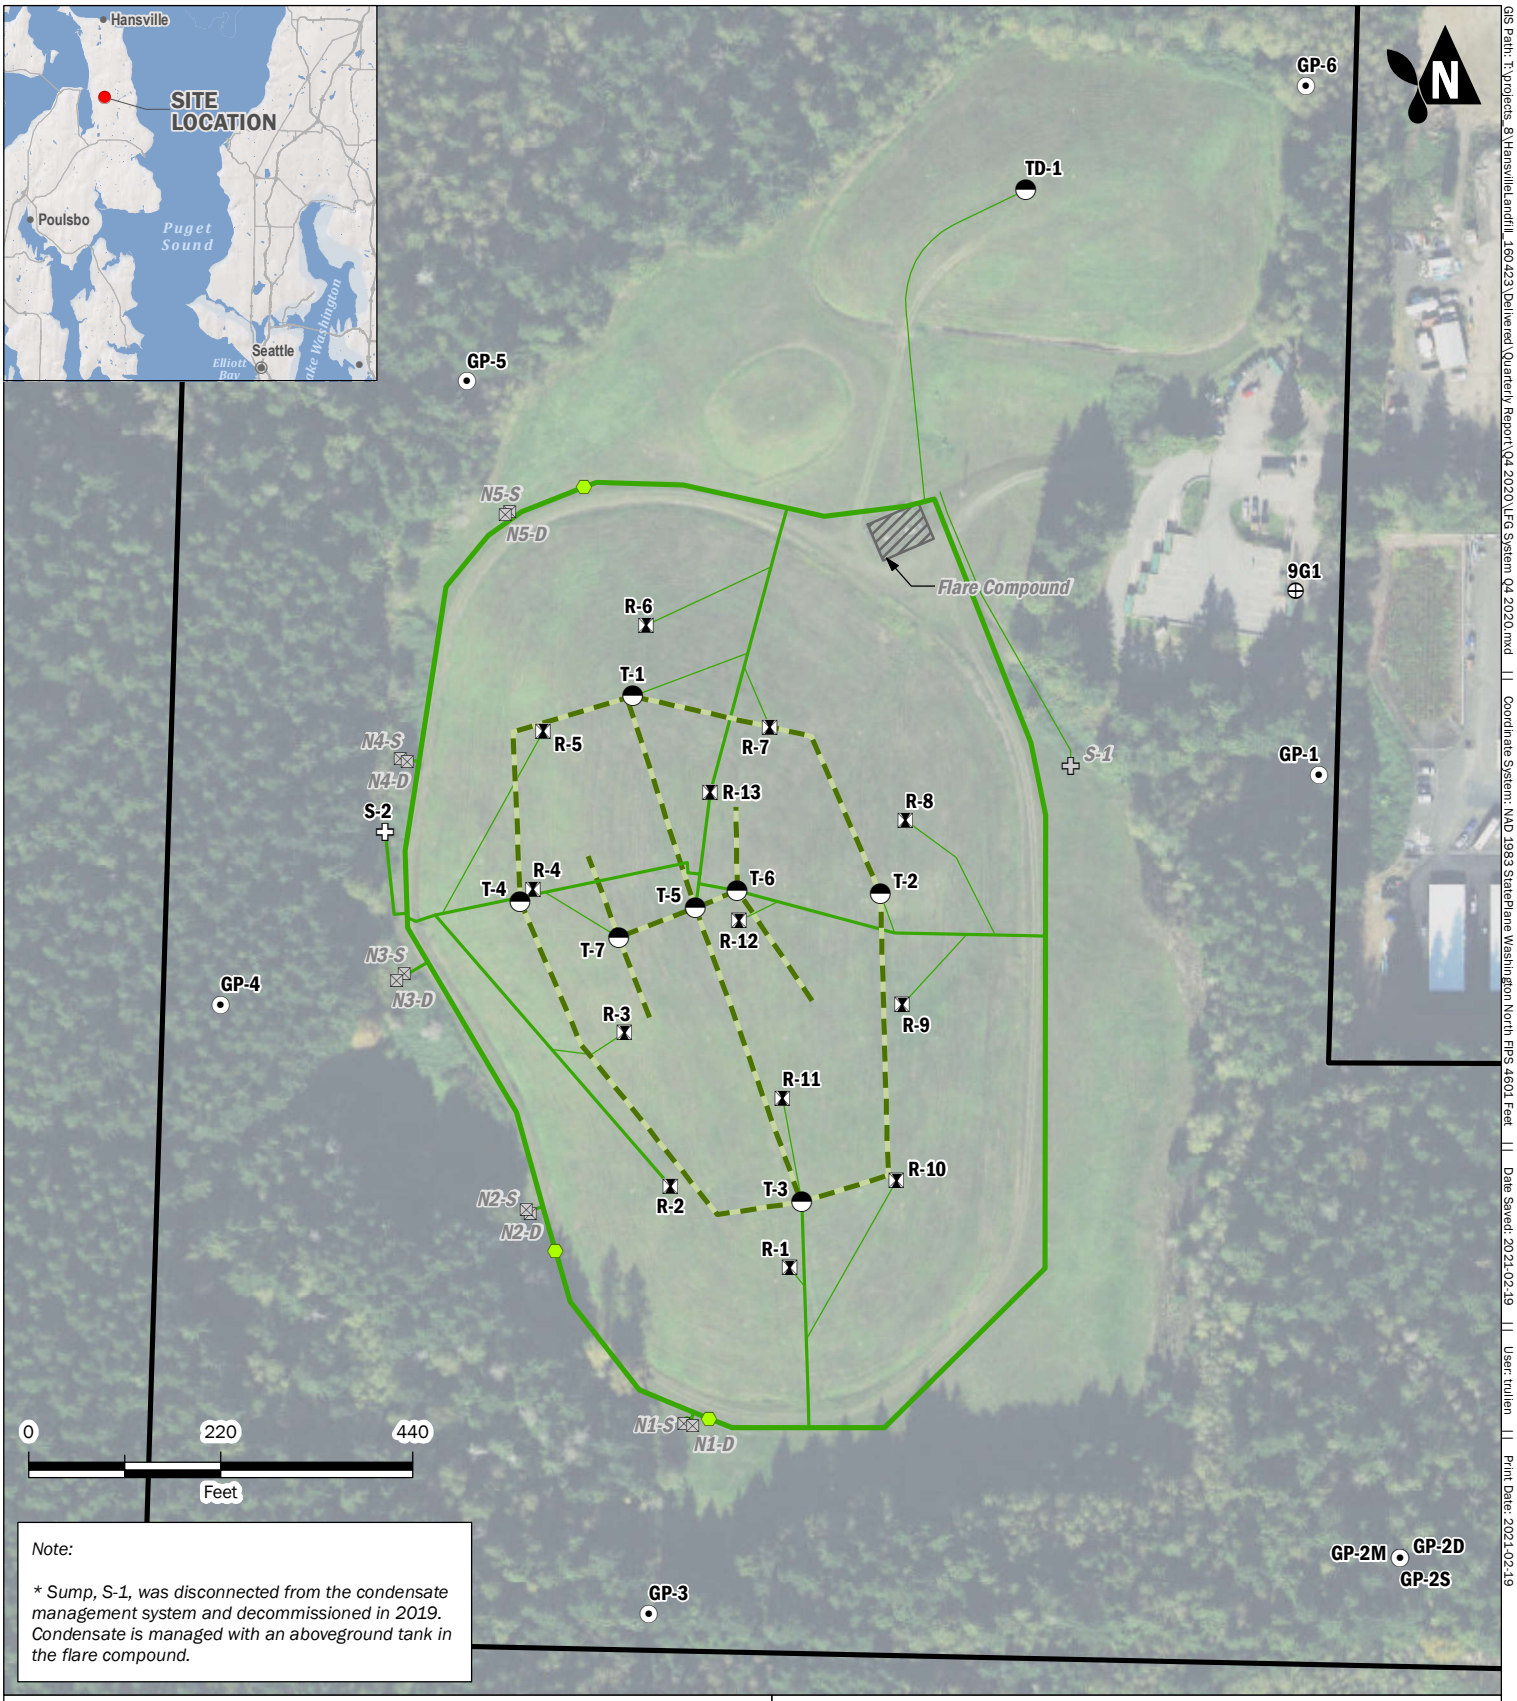
Aspect Consulting	APR-2021	BY: MLK / RAP	FIGURE NO. A-1
	PROJECT NO. 160423	REVISED BY: MLK

The following sections provide a discussion of landfill gas monitoring and gas extraction system performance. The layout of the landfill gas extraction system is shown on Figure A-1.

Reduced vacuum was previously observed in the southeast portion of the wellfield during previous events. To better understand the cause, the vacuum was measured at the four lateral connections. Vacuum at the north and west laterals was approximately 4-inches water column compared to approximately 0.5-inches water column at the south and east laterals. Based on those measurements, there are likely blockages in the perimeter header. The western condensate sump was observed to be full, and service was requested to remove the condensate.

On June 17, 2021, the 2,000-gallon condensate storage tank inside the flare compound contained approximately 1,150 gallons of landfill gas condensate. The condensate sump pump was tested and found to be in good working order. The condensate storage tank was installed in December 2018 and has not been emptied. Condensate collection rates have ranged between 0 and 100 gallons per month.

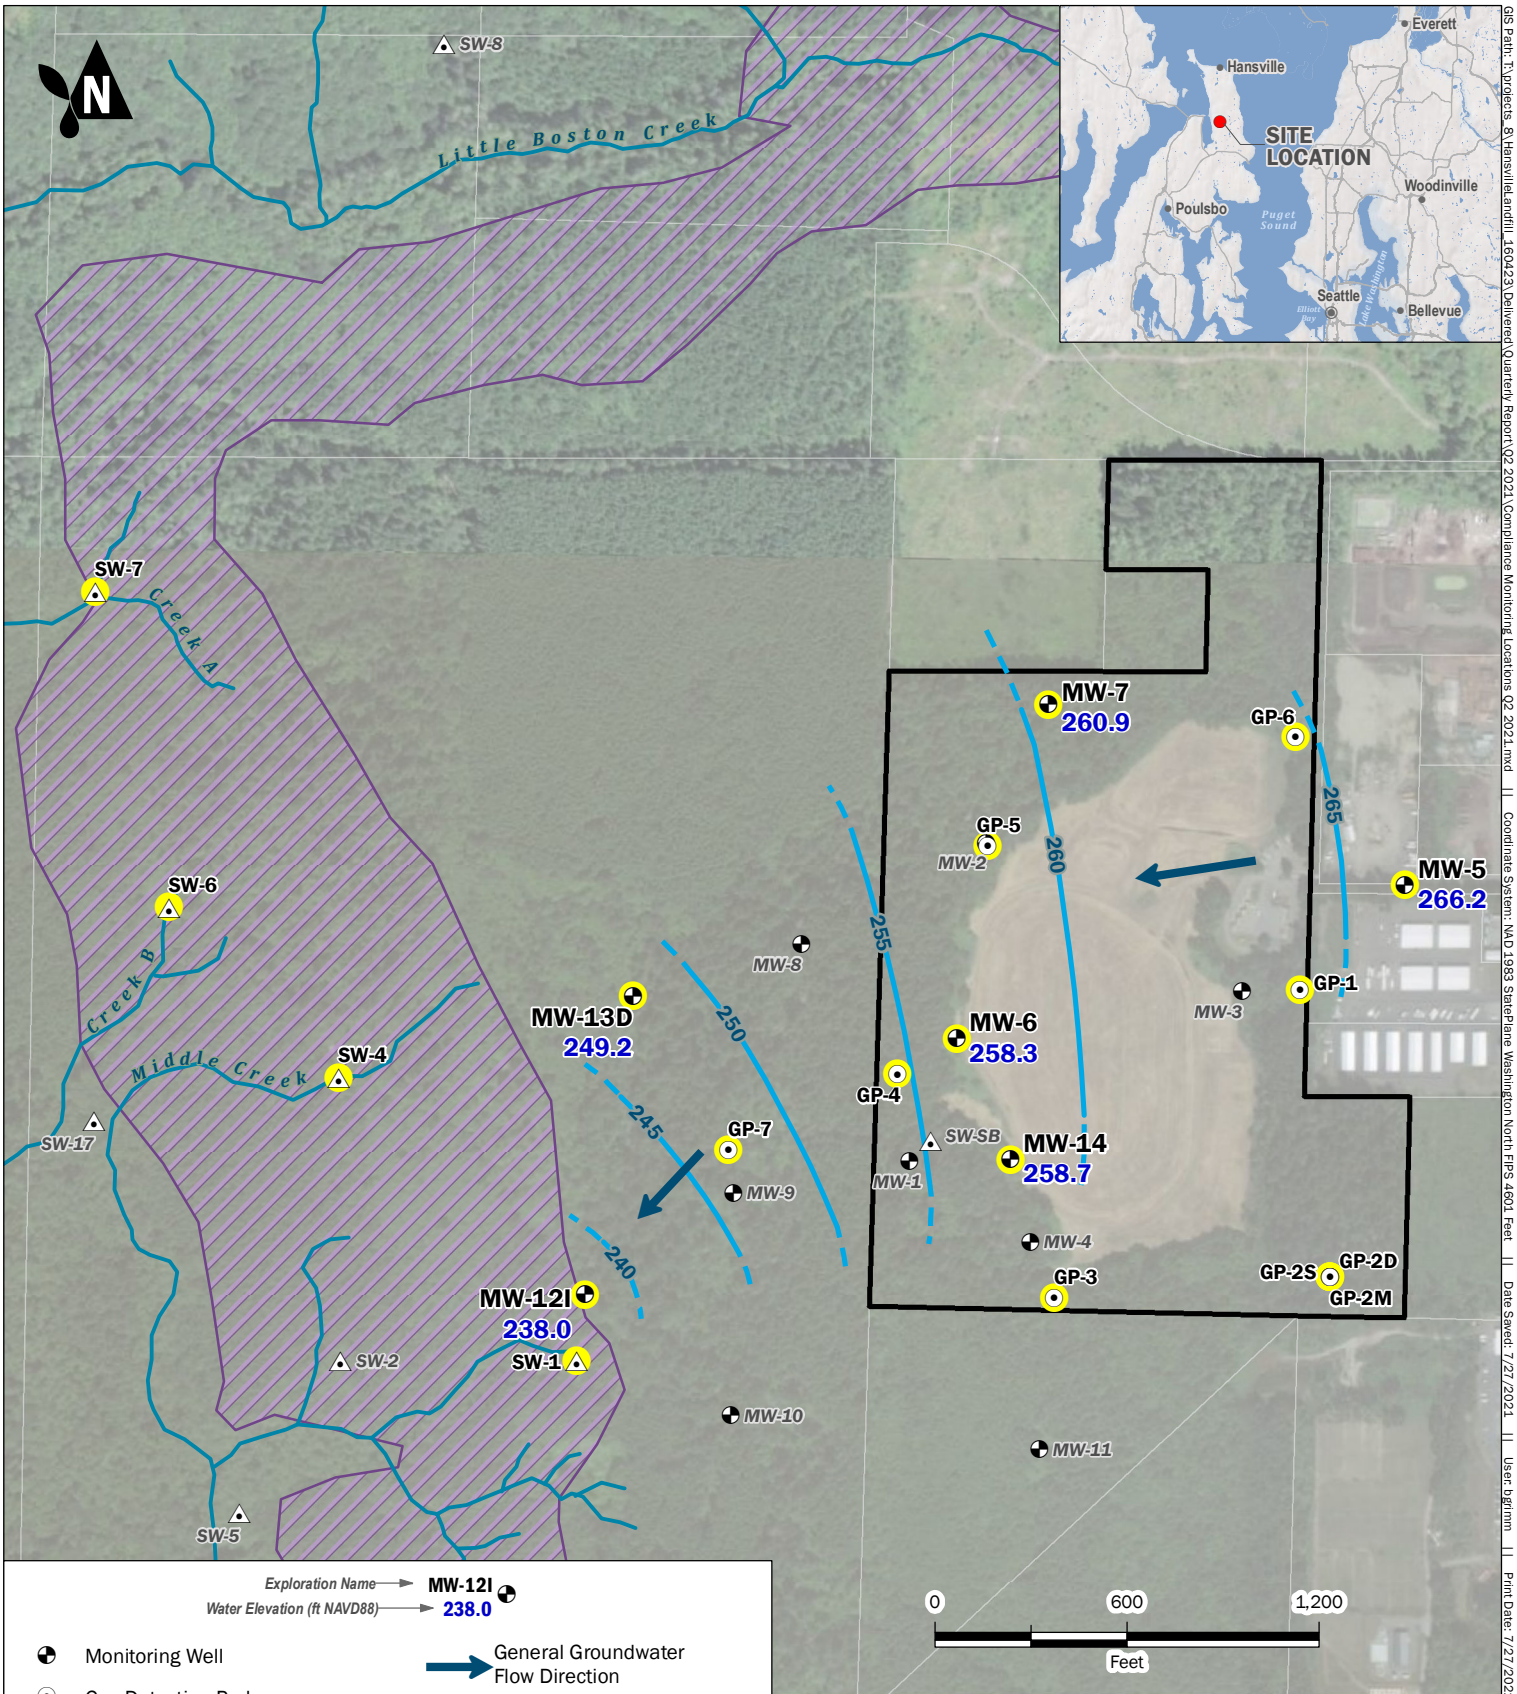
Aspect Consulting	JUL-2021	BY: MLK / RAP	FIGURE NO. B-1
	PROJECT NO. 160423	REVISED BY: WEG

This section addresses groundwater and surface water conditions based on the monitoring event on April 21, 2021. Samples were collected from six groundwater monitoring wells and from four surface water monitoring locations (see Figure B-1) for laboratory analysis.

Groundwater flow conditions during the second quarter of 2021 were consistent with those observed during previous monitoring events. Groundwater surface elevations were calculated using water levels measured April 21, 2021 (see Table B-1). Groundwater elevations ranged from 238.0 feet North American Vertical Datum of 1988 (NAVD88) in MW-12I to 266.2 feet NAVD88 in the upgradient, background monitoring well MW-5. The direction of groundwater flow at the Site was generally west across the landfill then shifts southwest, consistent with historical observations. Groundwater gradients ranged from 0.005 feet over feet (feet/feet) in the upgradient areas, to 0.011 feet/feet further downgradient, with the gradient steepening near the groundwater discharge area (Figure B-1).

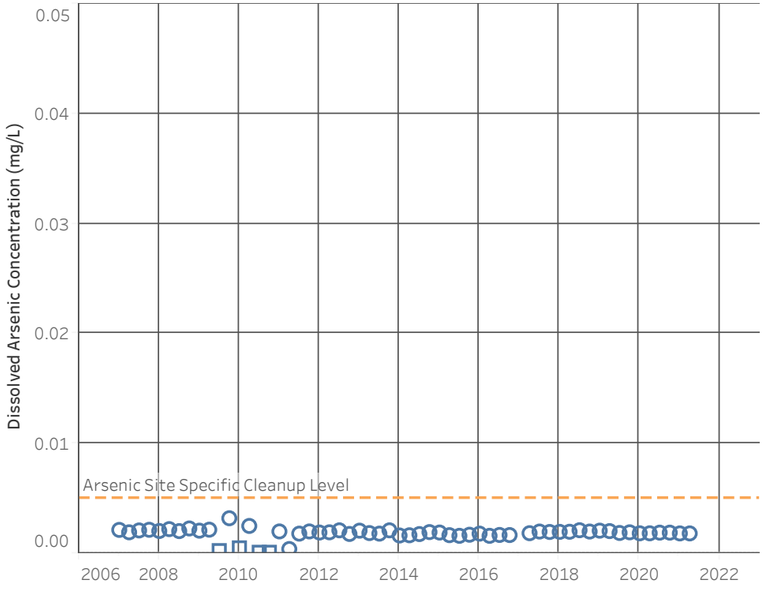
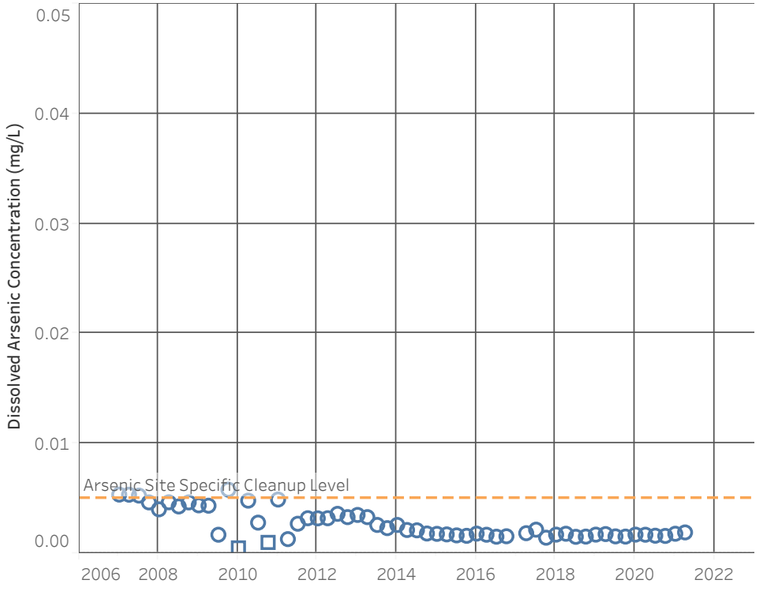
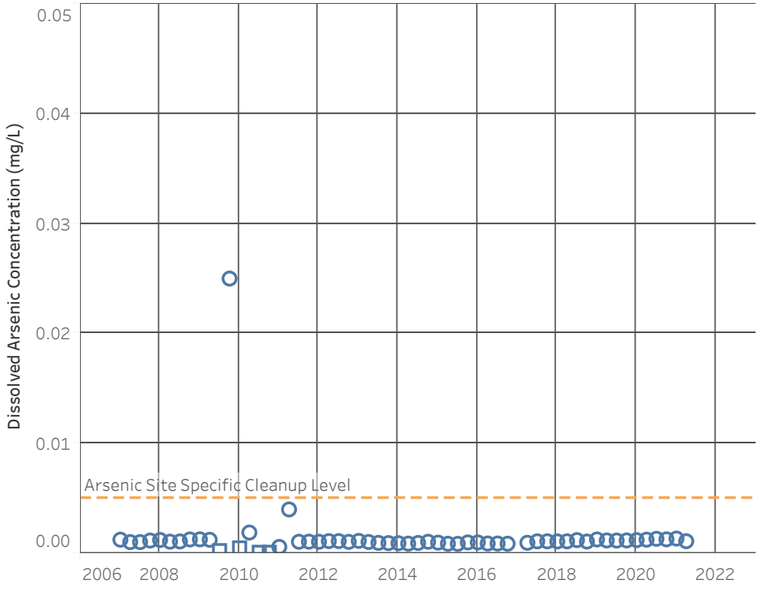
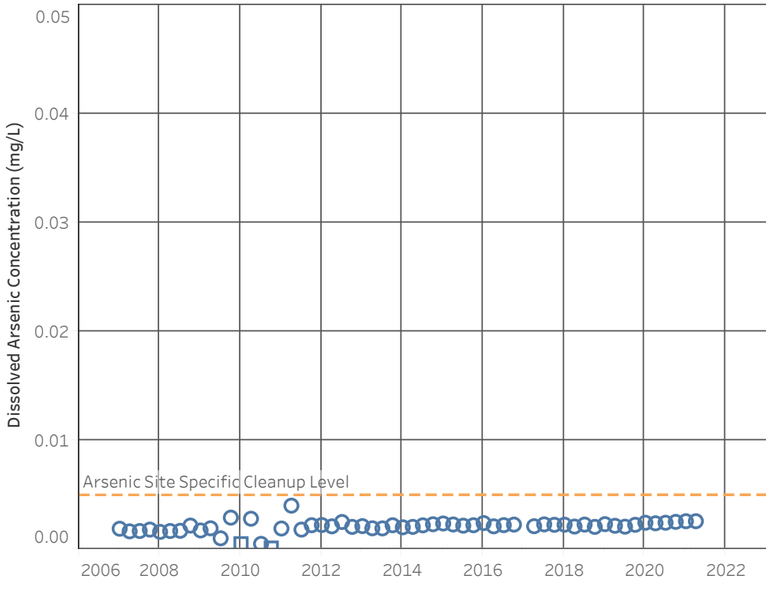
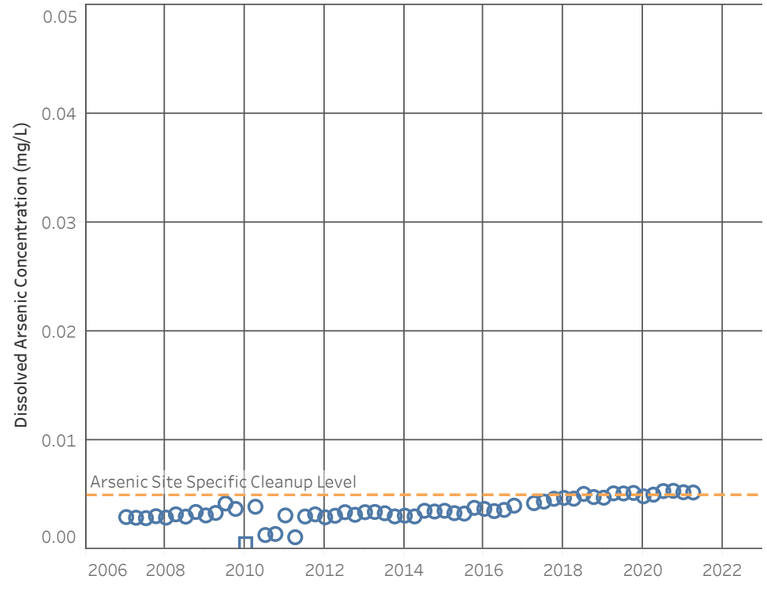
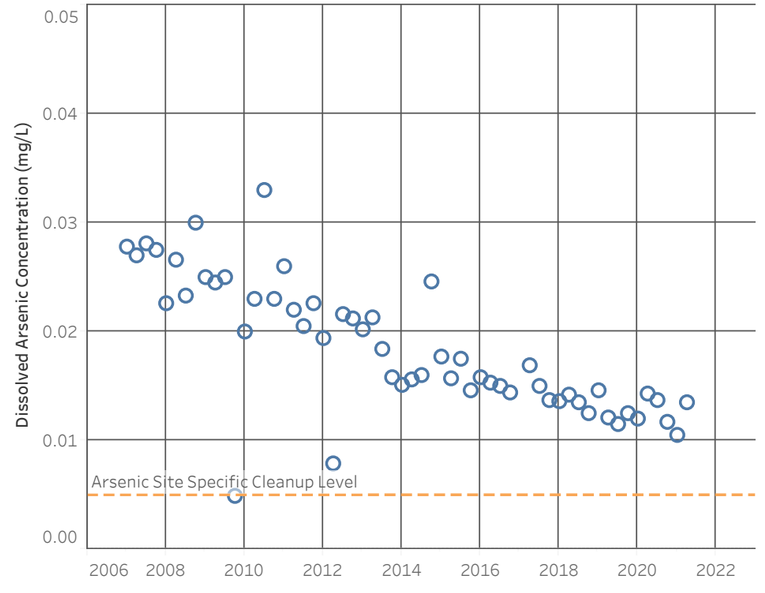
Figure C-1 - 2021 Second Quarter Dissolved Arsenic Sampling Results
2021 Second Quarter Environmental Monitoring Report
Hansville Landfill
Kitsap County, WA

Groundwater sampling results since 2007 are shown on time-series plots for dissolved arsenic (Figure C-1) and vinyl chloride (Figure C-2) at all compliance monitoring locations. Figure C-1 shows that dissolved arsenic concentrations in groundwater have been less than the cleanup level of 0.005 mg/L at MW-5 (background well), MW-6, MW-7, and MW-12I. Historically, dissolved arsenic concentrations at MW-13D were below the cleanup level and have gradually increased to

exceed the cleanup level, doing so for the first time in the second quarter 2020. This increasing trend is evaluated and discussed in the following section. Dissolved arsenic concentrations at MW-14 have historically exceeded the Site-specific cleanup level and have been decreasing steadily over time.

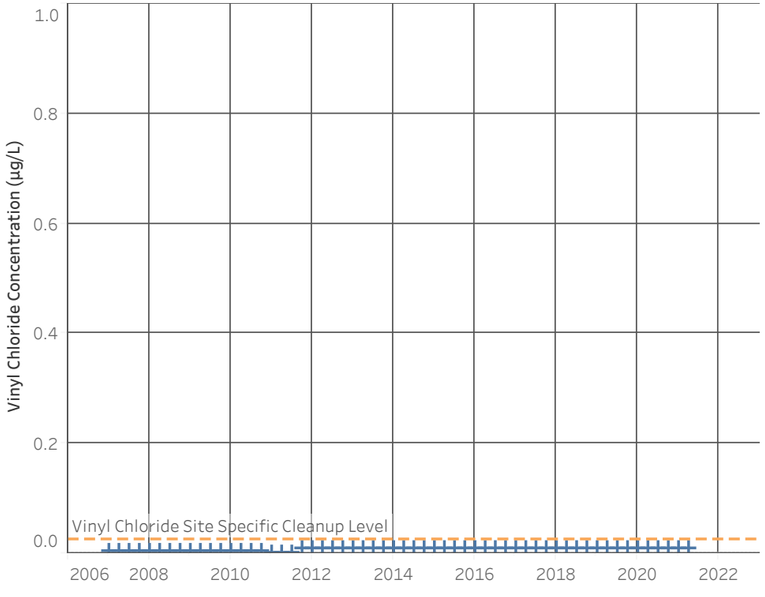
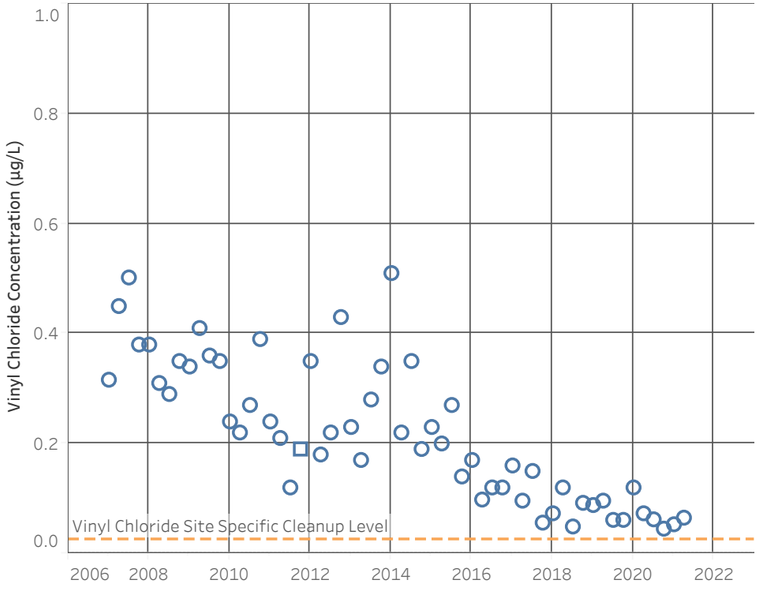
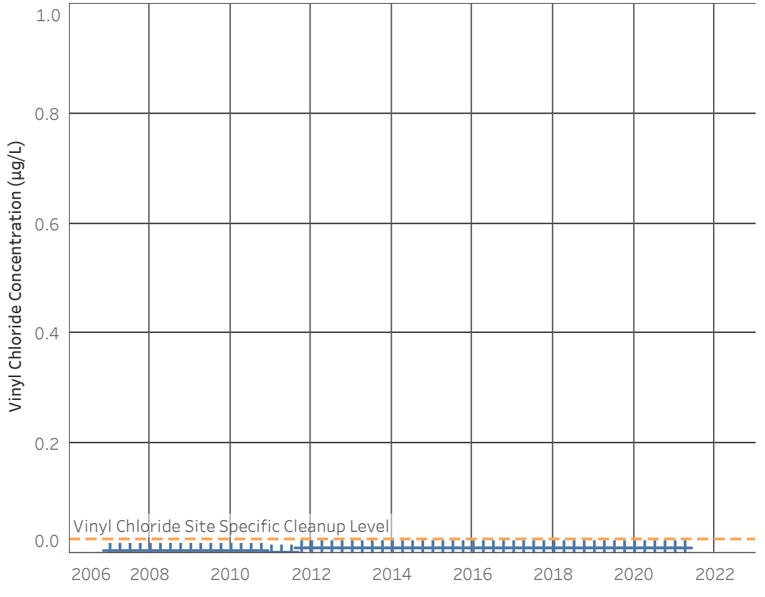
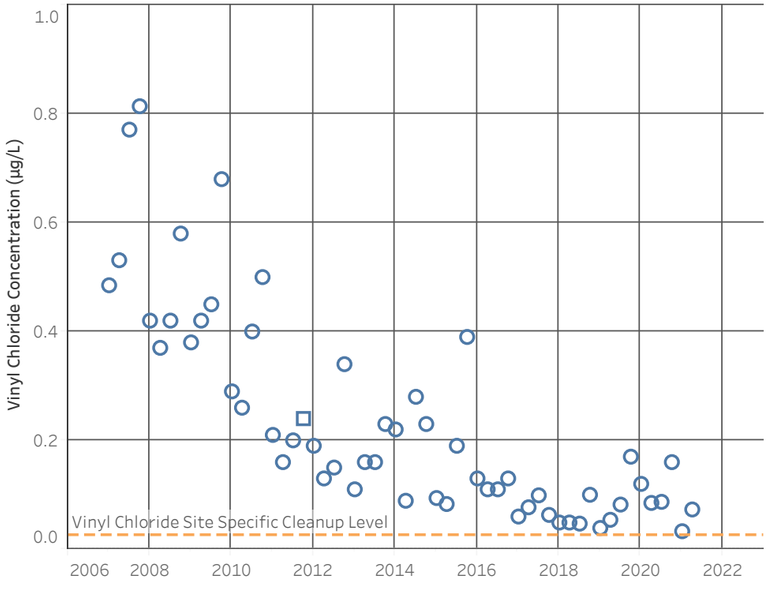
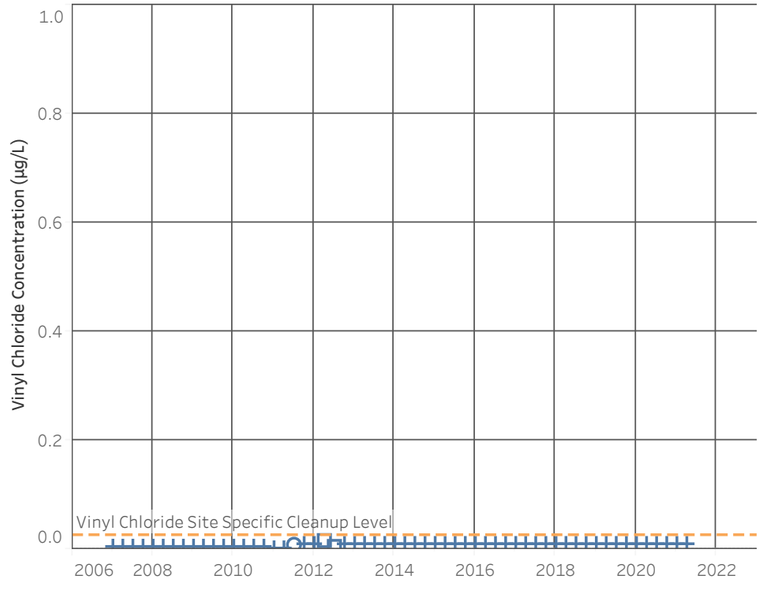
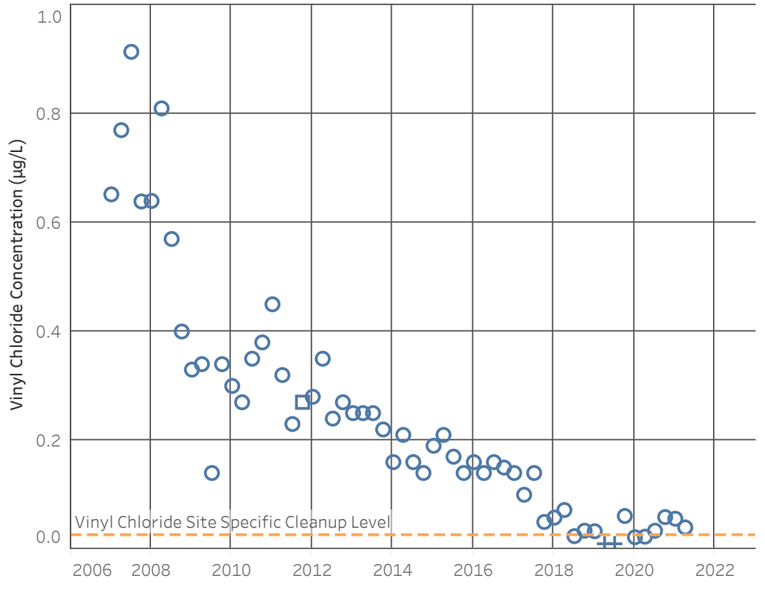
Figure C-2 - 2021 Second Quarter Vinyl Chloride Sampling Results
2021 Second Quarter Environmental Monitoring Report
Hansville Landfill
Kitsap County, WA

Figure C-2 shows vinyl chloride concentrations in groundwater have been less than the cleanup level of 0.025 µg/L at MW-5 (background well), MW-7, and MW-13D. The concentrations of vinyl chloride at MW-6, MW-12I, and MW-14 have historically exceeded the Site-specific cleanup level and have been decreasing over time. Variability in rates of decreasing concentrations is attributed to inconsistent landfill gas collection system performance, which is being corrected through well head maintenance.

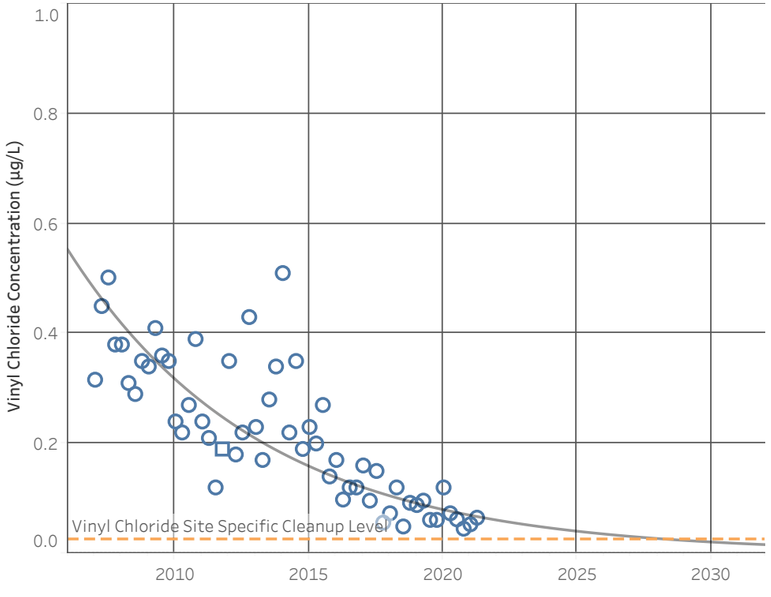
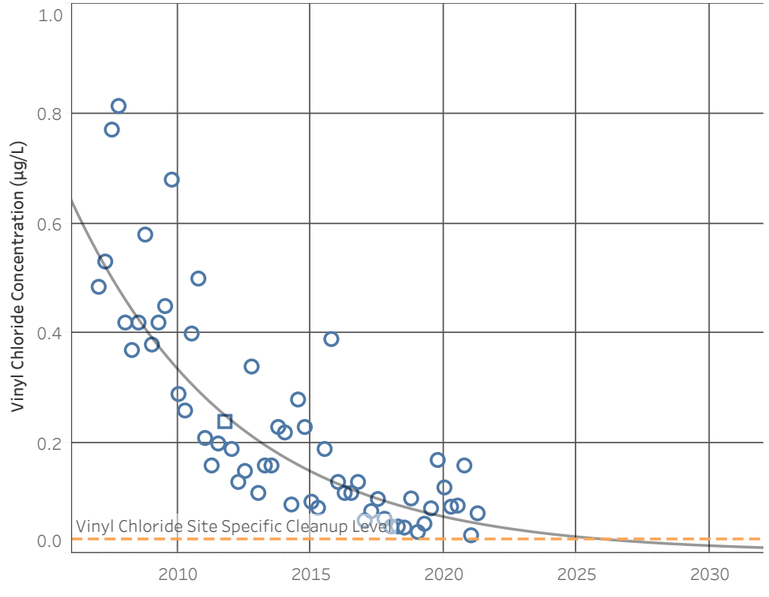
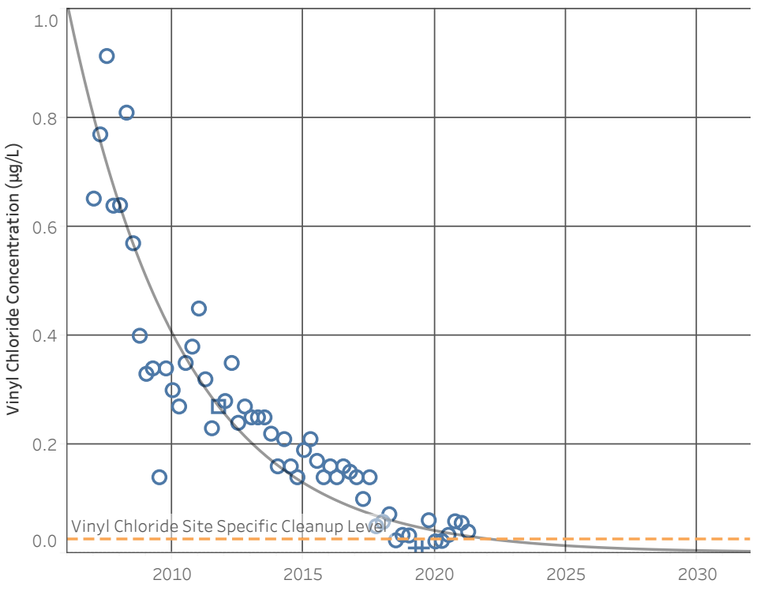
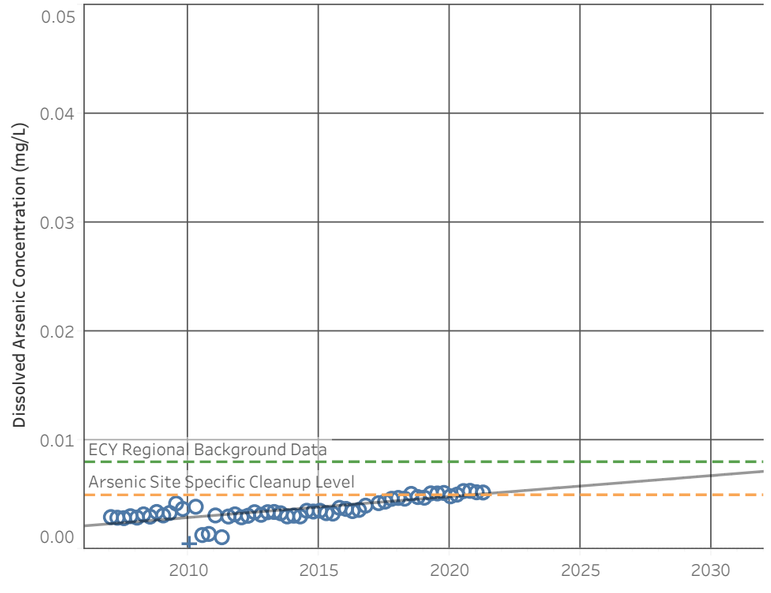
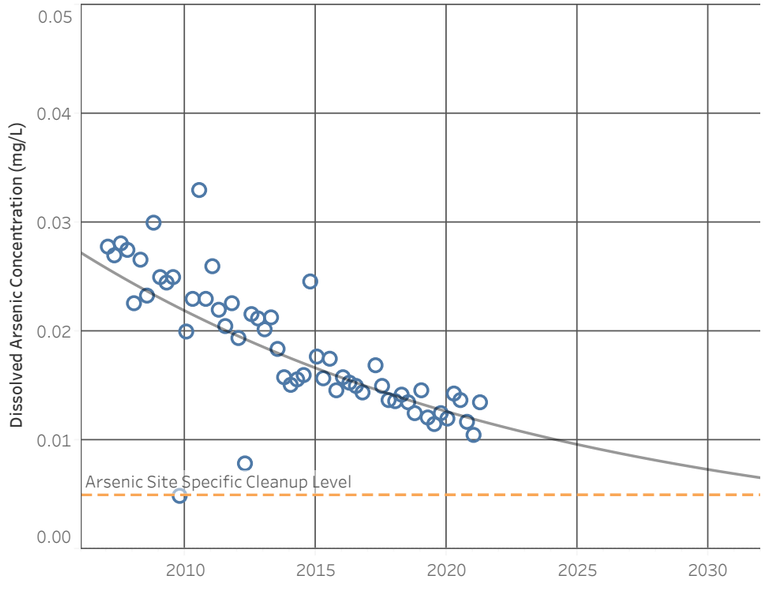
Figure C-3 shows time-series plots of historical and 10-year projected groundwater concentrations for MW-6 (vinyl chloride), MW-12I (vinyl chloride), MW-14 (vinyl chloride and arsenic), and MW-13D (arsenic). The projected restoration time frames for vinyl chloride concentrations range from approximately 2 to 10 years. In the event that the slowly increasing trend for dissolved arsenic at MW-13D continues, concentrations may regularly exceed the cleanup level but will remain below the Puget Sound regional background of 8 µg/L (Ecology, 2016) for more than 10 years. The projected restoration time frame for arsenic in groundwater at MW-14 is more than 10 years. Maintaining landfill gas collection performance may achieve groundwater cleanup levels within a shorter time frame than shown on Figure C-3.

Statistically significant decreasing trends in dissolved arsenic and/or vinyl chloride concentrations were identified at monitoring wells MW-6, MW-12I, and MW-14. We attribute the decreasing trends to the cleanup actions at the Site, and project concentrations will continue to decrease to Site-specific cleanup levels as described above and shown on Figure C-3.

A statistically significant increasing trend in dissolved arsenic concentrations was identified at monitoring well MW-13D. Dissolved arsenic concentrations exceeded the Site-specific cleanup levels during this monitoring period but remain below the regional natural background value provided by Ecology (Ecology, 2016; Ecology, 2021) as shown on Figure C-3. The statistical trend analysis for dissolved arsenic concentrations in MW-13D was first conducted as part of the 2019 Annual Environmental Monitoring Report (Aspect, 2020) and included an evaluation of potential sources. As previously noted, based on the data available, it is likely that arsenic concentrations since 2007 reflect natural variations or off-Site influences, as opposed to effects from the Hansville Landfill Site. Dissolved arsenic concentrations in MW-13D and other locations will continue to be closely monitored and evaluated.
