NW 2701
N. Woodinville 195 LLC
2nd Q

April 4, 2012

JN-28260-4

Subject: **GROUNDWATER SAMPLING EVENT - FEBRUARY 2012**
Former Woodinville Auto Auction Site
13820 NE 195th Street
Woodinville, Washington

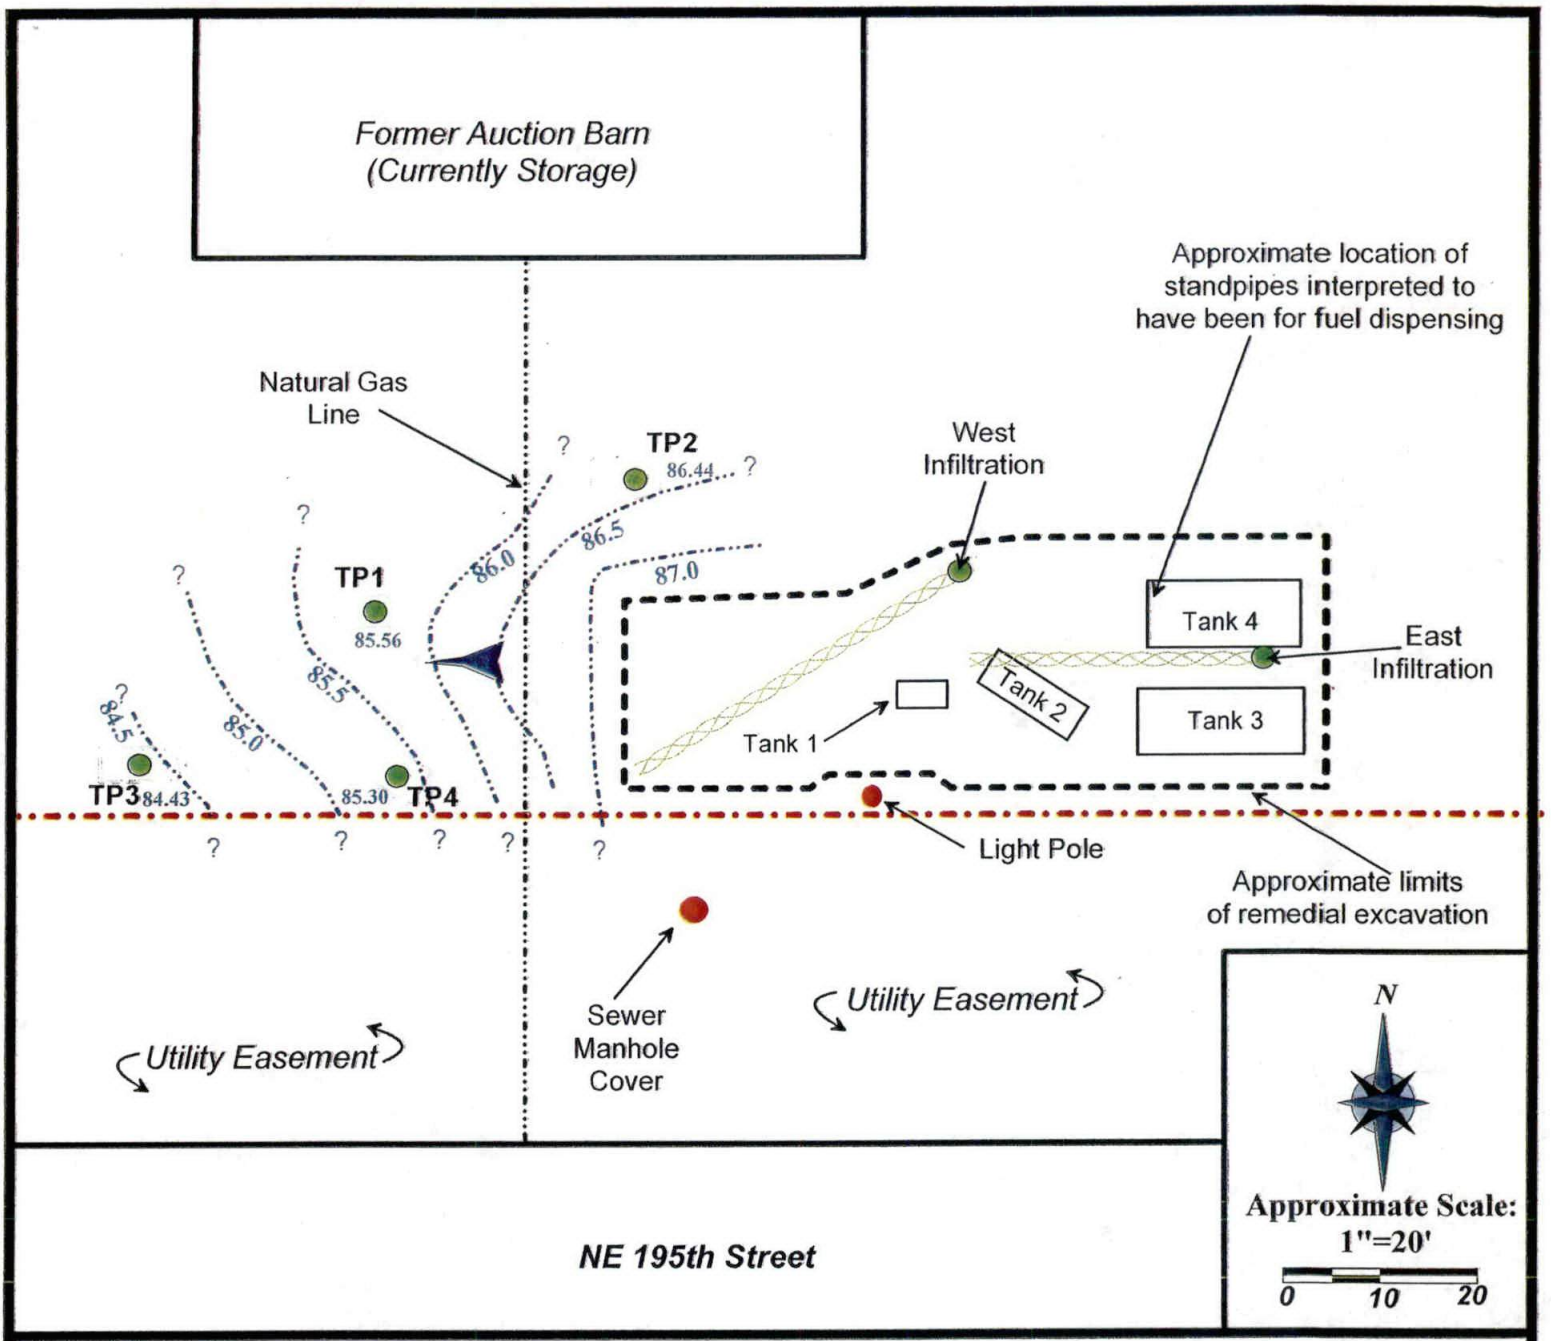
DETAILED SITE PLAN

At the conclusion of excavation and remedial activities, six (6) separate sections of slotted and/or perforated 2"-diameter PVC piping were installed in the subsurface at locations noted on Plate 4 in conjunction with site restoration. These various sections of piping were installed to provide a means to sample groundwater, and to facilitate application of Oxygen Releasing Compound (ORC) or other products to enhance degradation of remaining subsurface contaminants if desired.

As stated above, in conjunction with site restoration following UST removal, six (6) separate sections of 2-inch diameter slotted PVC piping were installed on the subject property. These include the installation of two (2) approximately 35-foot horizontal runs of pipe in the remedial excavation, and four (4) vertical stand-pipes installed in the four test pits. All six (6) installations were brought to grade using at least 12" of 2"-diameter PVC pipe, and protected by traffic grade monument boxes placed in a concrete surround. For additional details regarding the construction of this piping network, the reader is referred to our February 12, 2009 report. On February 23, 2012, the six (6) segments of piping were accessed and groundwater samples were recovered.

Prior to sampling, an electronic meter was utilized to measure the depth to the shallow groundwater surface below the top of each pipe casing. These measurements along with prior casing elevation survey data were used to deduce the relative elevation of the water table at each location, as presented in Table 1, attached. As presented on Plate 4, Detailed Site Plan, the shallow groundwater within the study area appears to be flowing westward. As the depths to water measured in the two horizontal pipe segments do not represent the water elevations at discrete locations, these data points were not used in generating water table contours.
