INITIAL INVESTIGATION FIELD REPORT

WASHINGTON STATE DEPARTMENT OF ECOLOGY

Site Name (Name over door):	Site Address (including City, State and Zip):	Phone / Email
Firestone 31A3	351 Rainier Ave S Renton, WA 98057	
Site Contact, Title, Business:	Site Contact Address (including City, State and Zip):	Phone / Email
Site Owner, Title, Business: Toula Properties, LLC	Site Owner Address (including City, State and Zip):	Phone / Email
Site Owner Contact, Title, Business: Andy Rigel Hillis Clark Martin & Peterson P.S.	Site Owner Contact Address (including City, State and Zip): 999 Third Avenue Suite 4600 Seattle, WA 98104	Phone / Email andy.rigel@hcmp.com
Previous Site Owner(s):	Additional Info (for any Site Information Item):	
Alternate Site Name(s):

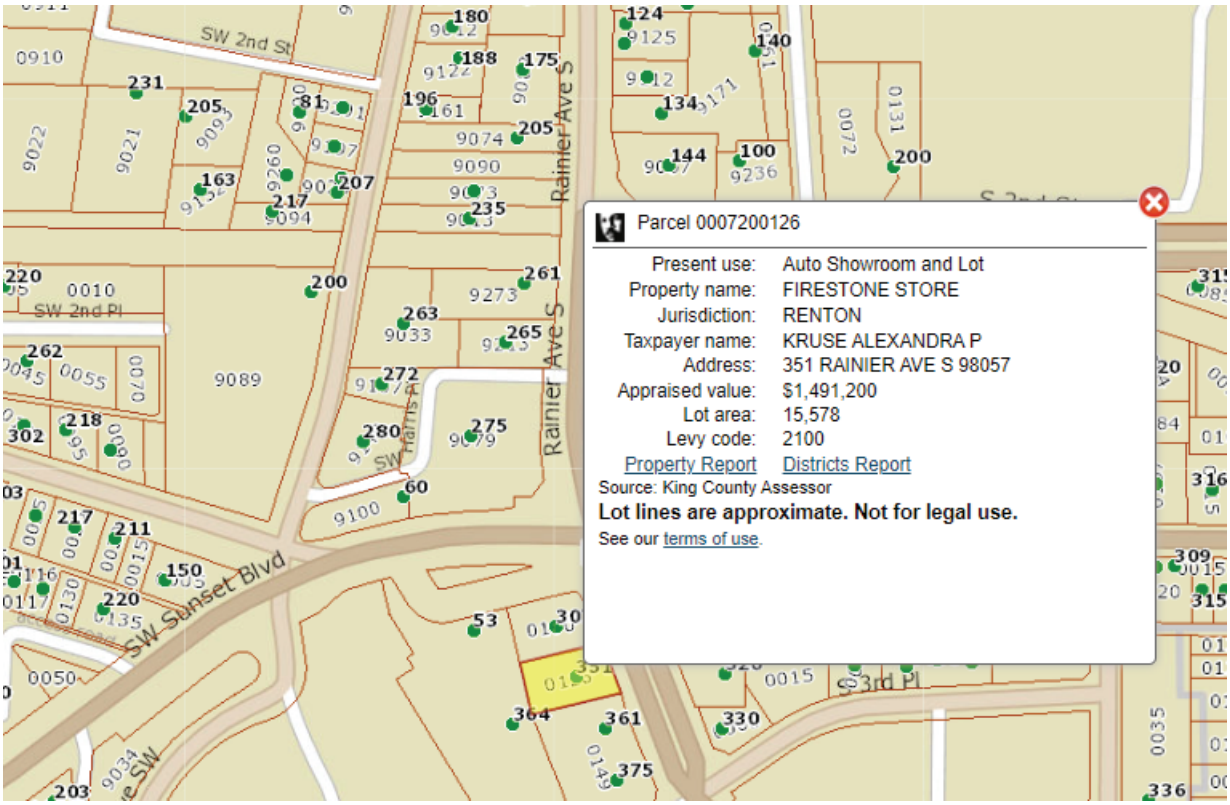
Two areas of contamination were identified, both in the central area of the Firestone building where auto hoists had been located (see figure below). Overall, contaminants present above Method A cleanup levels were petroleum hydrocarbons in both soil and groundwater and arsenic and tetrachloroethene (PCE) in soil. PCE and naphthalene were also present in soil vapor samples above the applicable Method B screening levels.

There is an existing Ecology UST ID for a removed waste oil tank at this site. The information in Ecology's database indicates the tank was removed in approximately 1996. It is unclear from the available information if this is the same waste oil tank indicated on the figure below, or if there were multiple generations of waste oil tanks on the property.

Sampling locations. Soil and groundwater samples were collected from all 20 borings. Soil vapor samples were collected at locations B5, B9, and B10. Figure from Release Report.

Remedial actions appear to be progressing independently at the property, based on recent interactions with other Ecology programs to receive a contained-in determination for removed soil and registering of injection wells for the application of Petrofix to address contaminated groundwater.
