Received Fm: Snoh Co Solid Waste

Lake Goodwin Landfill 2010 2nd Quarter Groundwater Monitoring Report

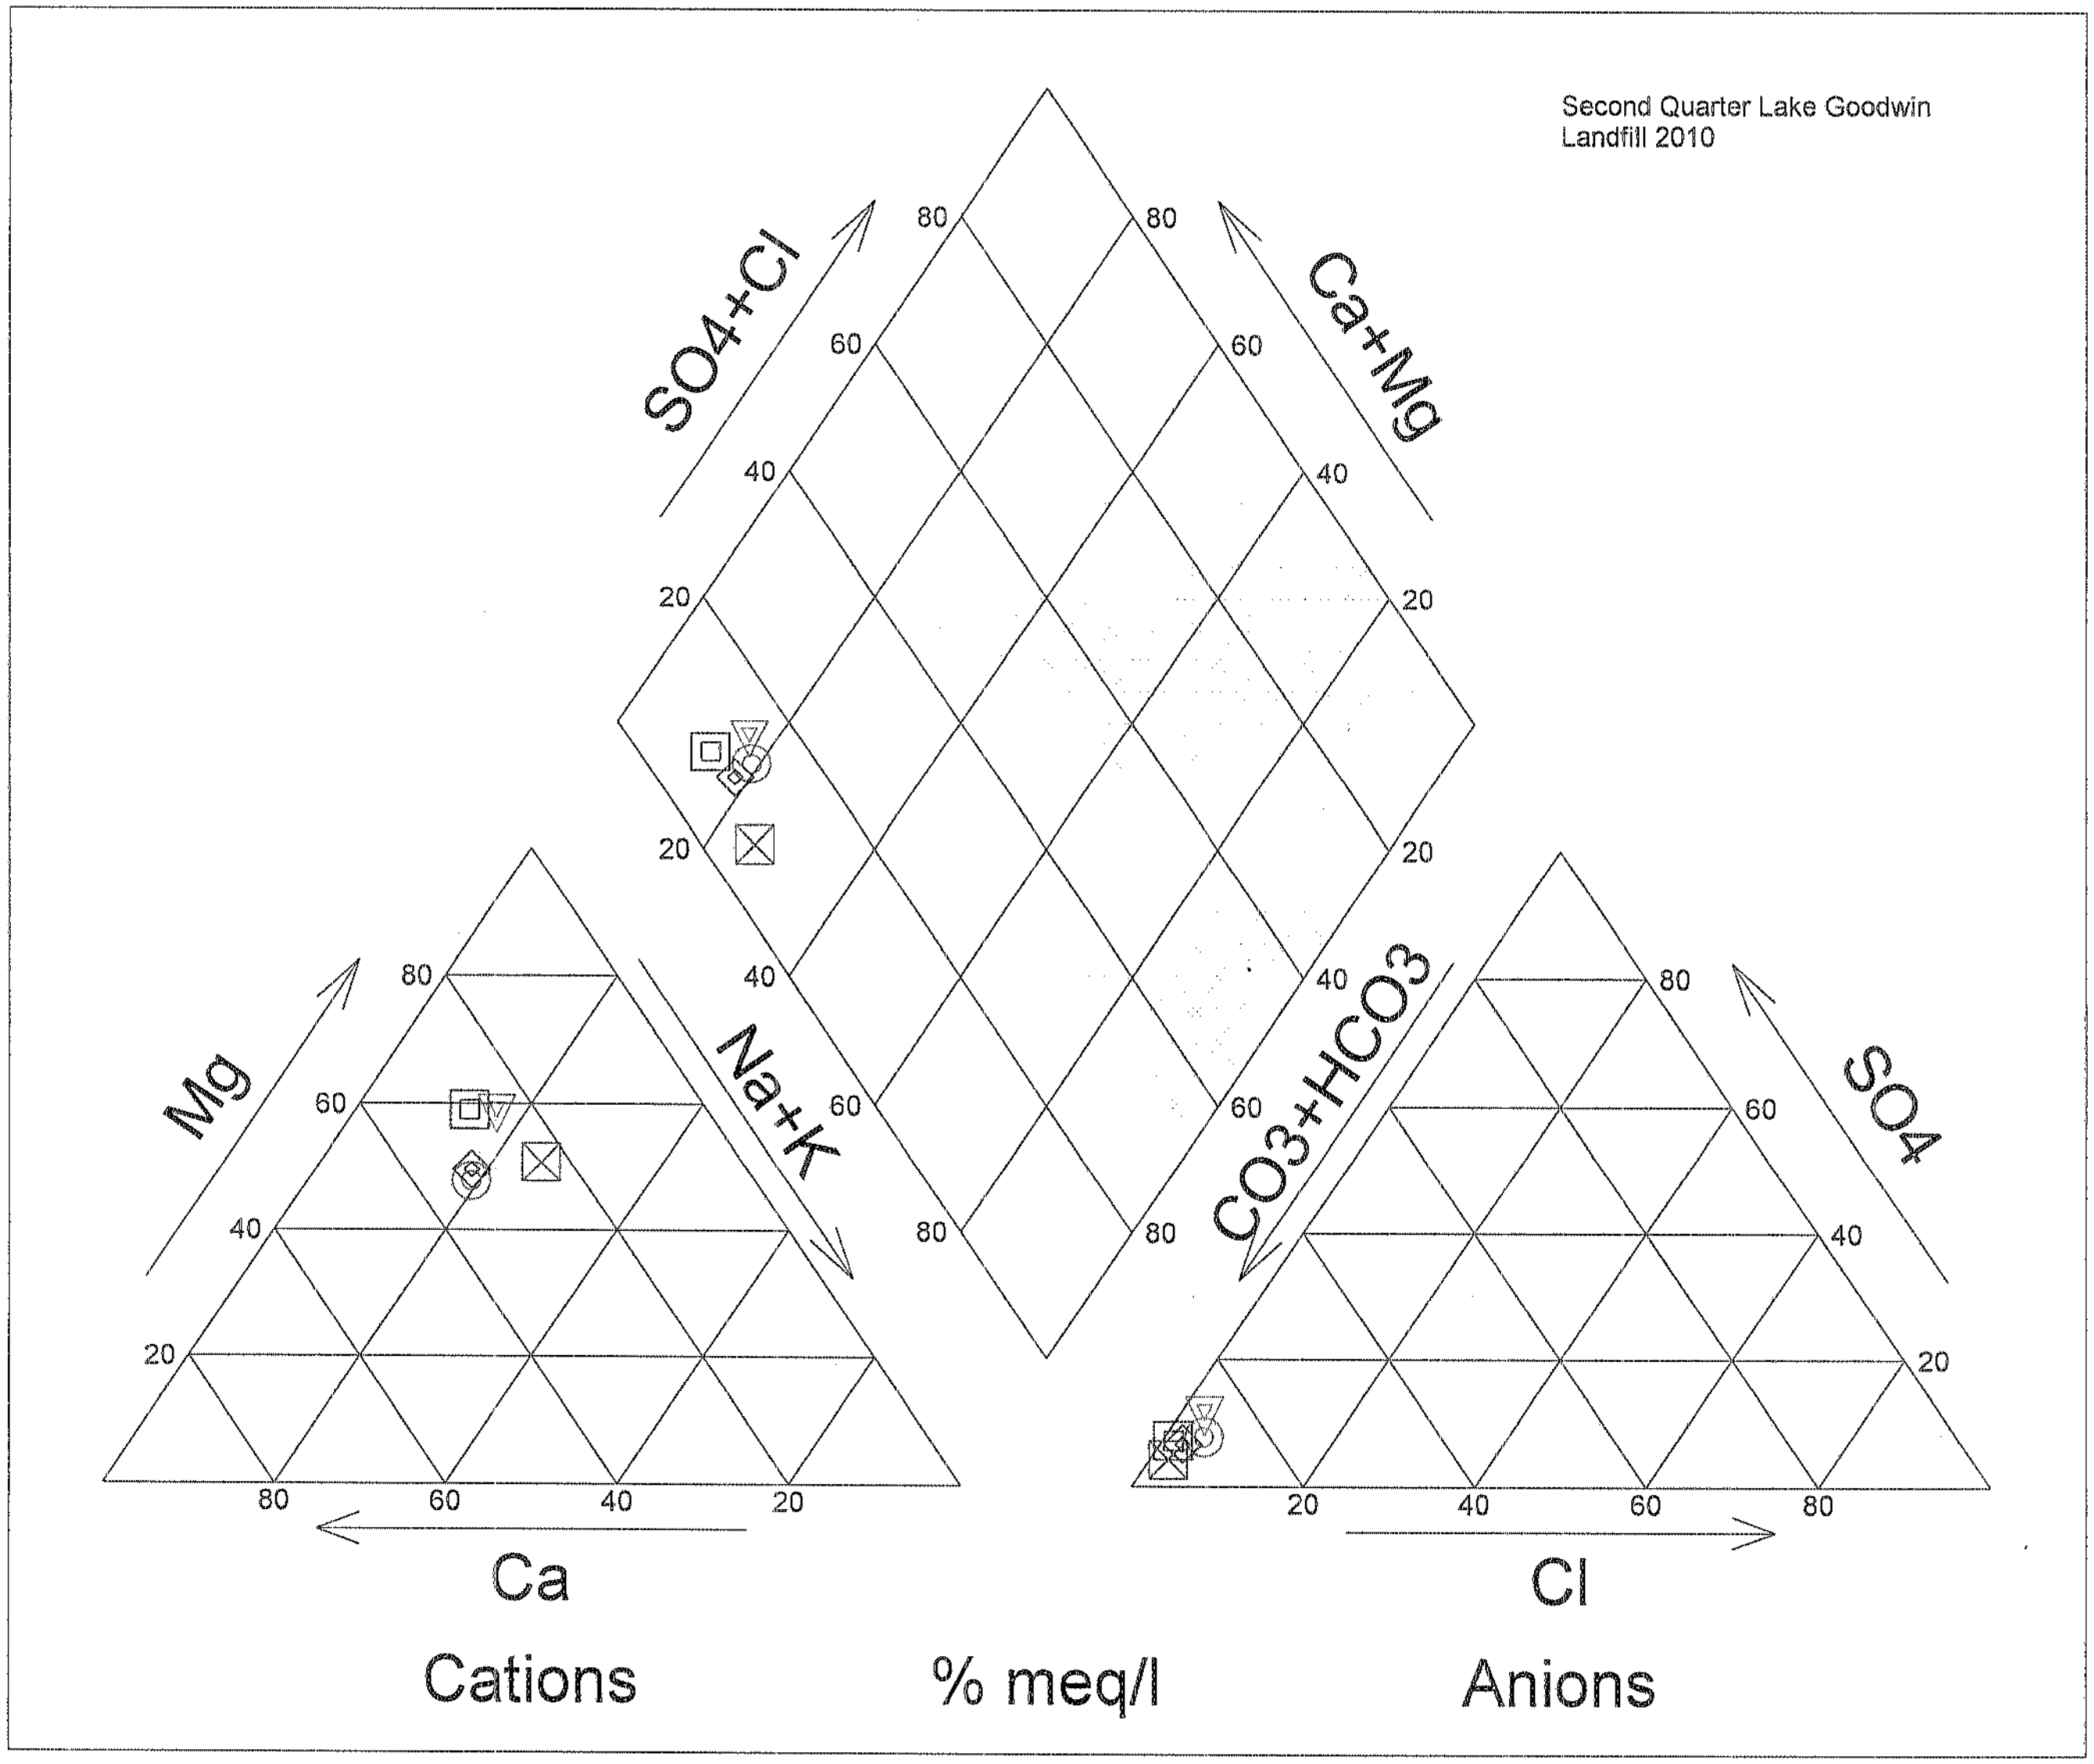
LG-01	4/20/2010 (-34.3%,448.9ppm)
LG-02	4/20/2010 (-27.6%,217.1ppm)
LG-03	4/20/2010 (-34.5%,1015.7ppm)
LG-04	4/20/2010 (-27.8%,330.3ppm)
LG-05	4/20/2010 (-31.4%,786.3ppm)
