Lake Goodwin Landfill 2011 3rd Quarter Groundwater Monitoring Report

1.0 INTRODUCTION

The following report presents the third quarter ground water monitoring results for 2011 at the Lake Goodwin Landfill (*Lake Goodwin Landfill, Site*). The site is located immediately west of Frank Waters Road in northwestern Snohomish County, about one and one half (*1.5*) miles northwest of Lake Goodwin and about five-(*5*) miles south of Stanwood (*T31N, R4E, sections 17, 20 Willamette Meridian*). The landfill is located at 18520 Frank Waters Road, Stanwood, Washington, 98292. The location of the site relative to existing municipal improvements is shown on the **Vicinity Map** (*figure 1*).

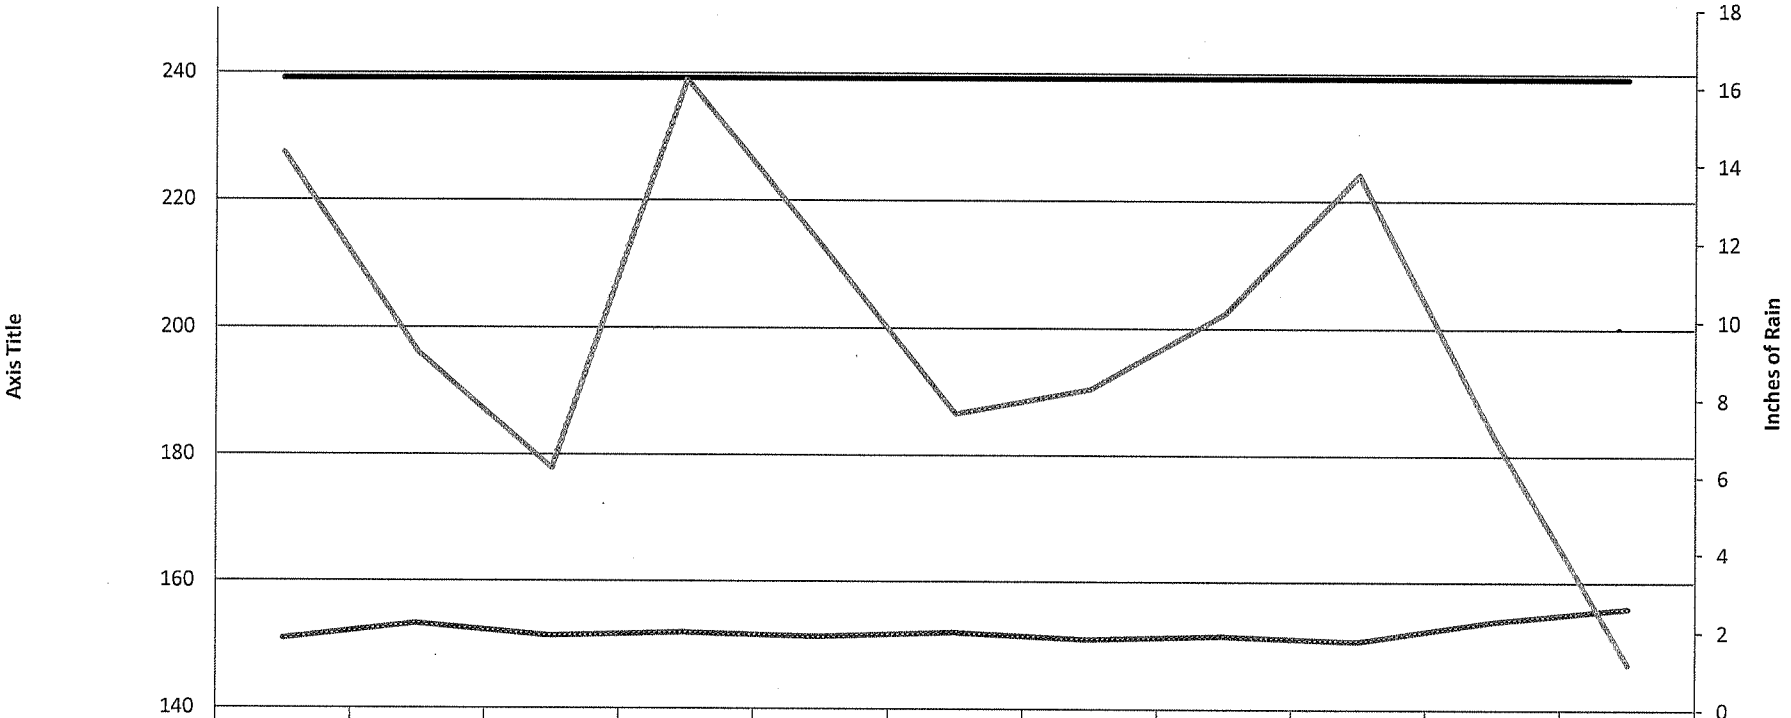
Lake Goodwin Well LG-01

Third Quarter Ground Water Measurements are shown in *Table 1* below. **Hydrographs** of the third quarter 2011 monitoring well readings are contained in *Appendix A* of this report. Third Quarter well readings indicate an overall increase in ground water elevation below the site. Down-gradient wells LG-01, LG04, and LG-05 showed a 2+ foot increase in ground water elevation over their previous readings. This fairly rapid change in the ground water elevation

has occasionally been observed in these wells in the past. However, rapid aquifer elevation change is not consistent with observed aquifer behavior and may possibly be due to reading error. Readings suggest that the aquifer is unconfined in the immediate vicinity of the site. The **Third Quarter Ground Water Contour Map** developed from the field data is shown in *Figure 6* of this report.

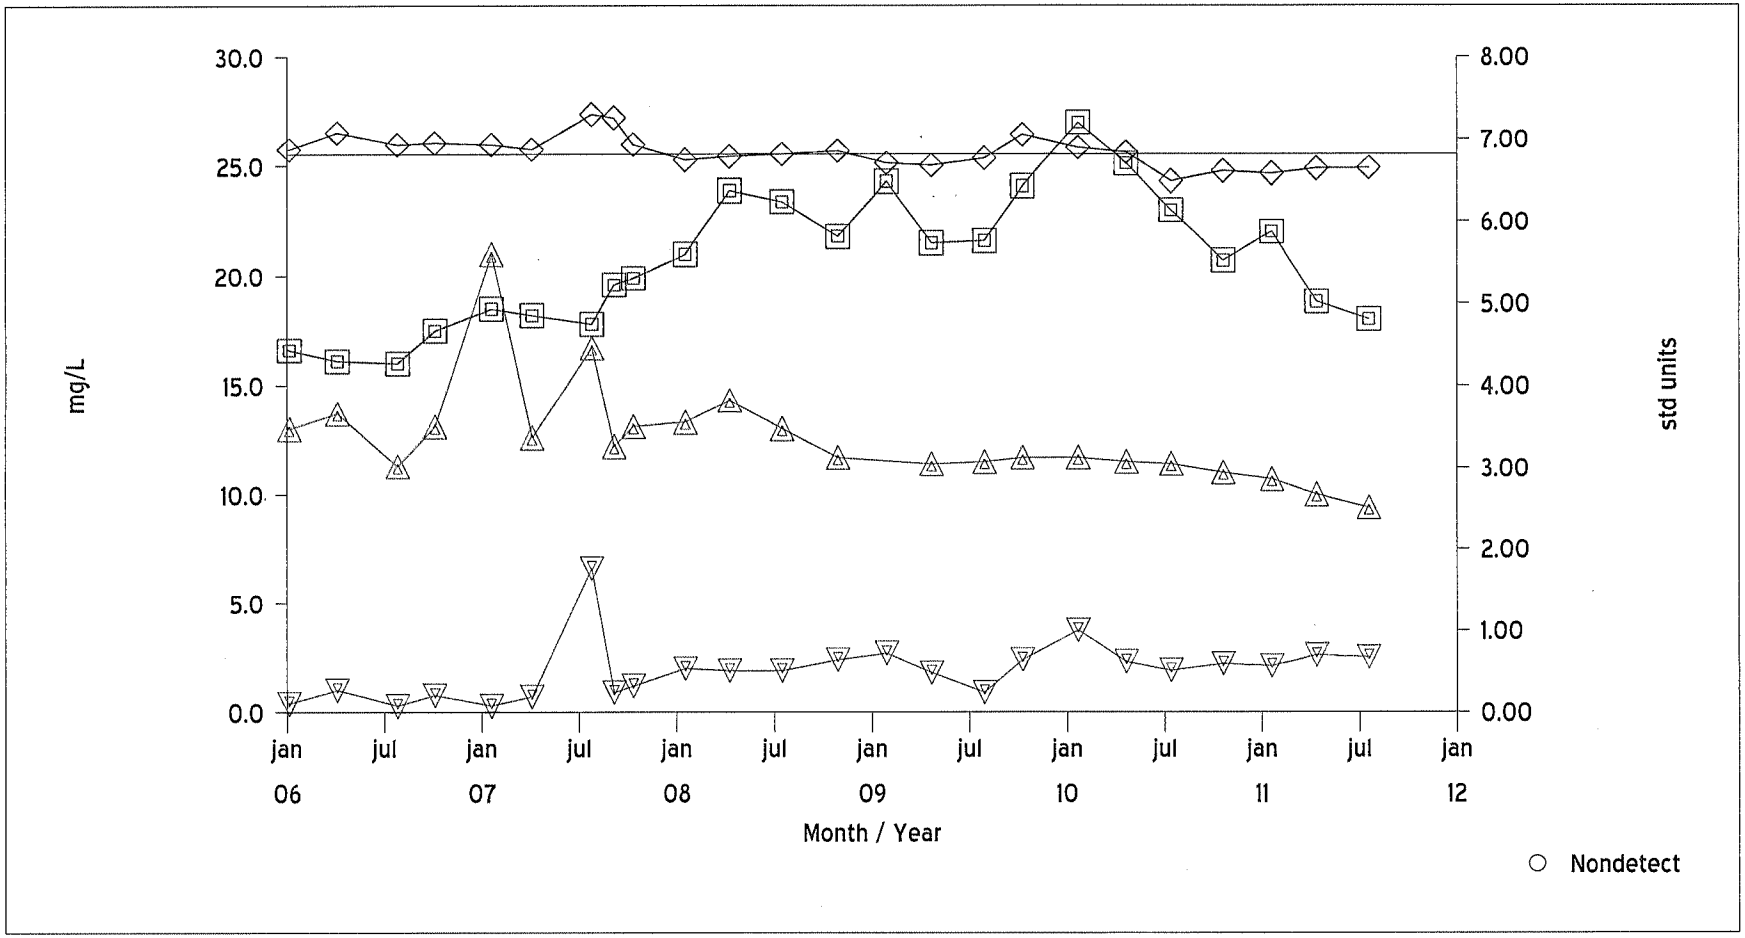
Time Series Plot for LG-01

large number of significantly decreasing trends which would suggest that the leachate impact to the ground water below the landfill is decreasing at this time, however, two increasing trends have been monitored in down gradient well LG-01 and at least one increasing trend was found in LG-03. The data also suggests that the leachate plume impacting ground water extends beyond the landfill boundaries following the ground water gradient to the north-northeast through LG-03 and LG-05.
