Lake Goodwin Landfill 2013 3rd Quarter Environmental Monitoring Report

1.0 INTRODUCTION

The following report presents the third quarter ground water monitoring results for 2013 at the Lake Goodwin Landfill (*Lake Goodwin Landfill, Site*). The site is located immediately west of Frank Waters Road in northwestern Snohomish County, about one and one half (*1.5*) miles northwest of Lake Goodwin and about five-(*5*) miles south of Stanwood (*T31N, R4E, sections 17, 20 Willamette Meridian*). The landfill is located at 18520 Frank Waters Road, Stanwood, Washington, 98292. The location of the site relative to existing municipal improvements is shown on the **Vicinity Map** (*figure 1*).

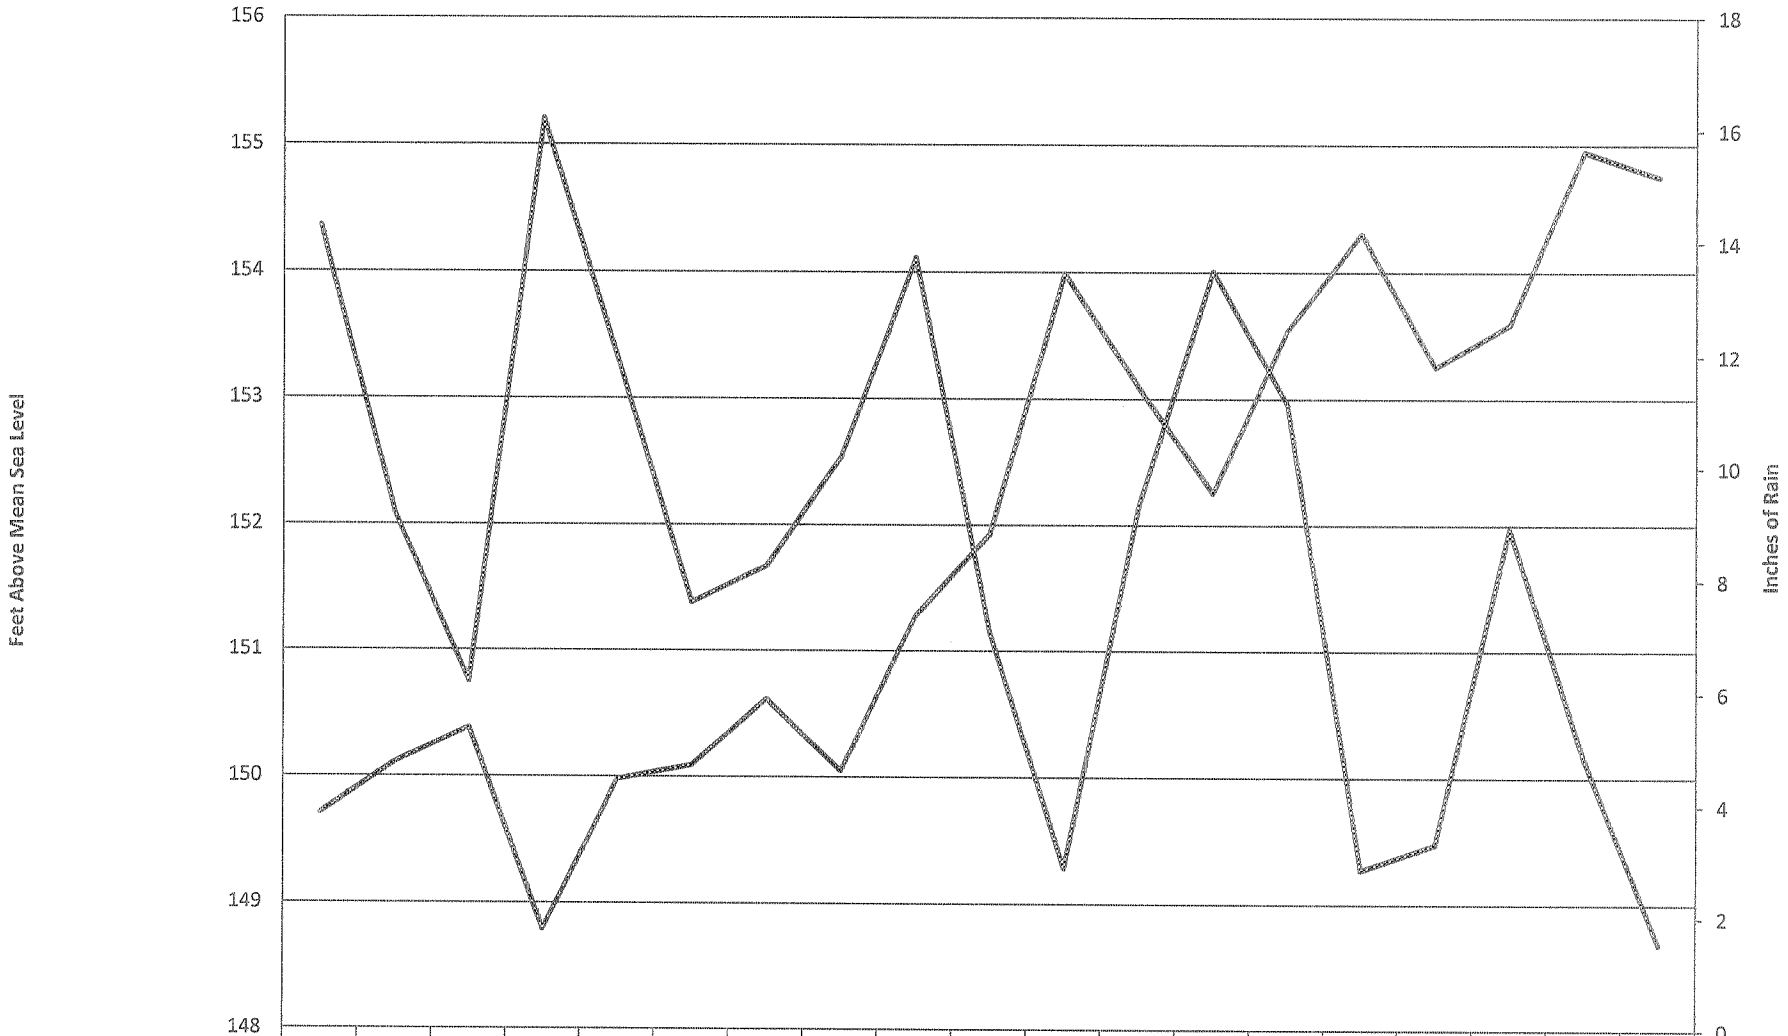
Lake Goodwin Well LG-05

Third Quarter: Other than arsenic in all wells and pH in LG-01, LG-04 and LG-05, there were no measured exceedances of the MCL's in any well except LG-05. There were measured exceedances of the MCL's for conductivity, nitrate nitrogen, pH, sodium, total dissolved solids

and arsenic in well LG-05. No other dissolved metals were observed exceeding WAC level MCL's during this sampling event.

- The conductivity level observed at well LG-05 was significantly higher than the surrounding wells during this sampling event.
- Statistical analysis did show significant impacts to well LG-05. Lesser impacts where indicated in wells LG-01 and minimal impacts were measured for LG-04. Time series plots based on the **DUMPStat** analysis indicates that there were more significant decreasing trends *(11)* than increasing trends *(8)* during this sampling event.

Third quarter 2013 data indicates a continued moderate leachate impact to the underlying Advance Outwash (*Qva*) aquifer below the Lake Goodwin Landfill. Statistical analysis indicates a large number of significantly decreasing trends which would suggest that the leachate impact to the ground water below the landfill is decreasing at this time, however, increasing trends were calculated for down gradient well LG-01 during this sampling event. Interpretation of the data suggests that a leachate plume impacting ground water extends beyond the landfill boundaries following the ground water gradient to the north-northeast in the immediate vicinity of LG-05.
