Lake Goodwin Landfill 2013 4th Quarter Environmental Monitoring Report

1.0 INTRODUCTION

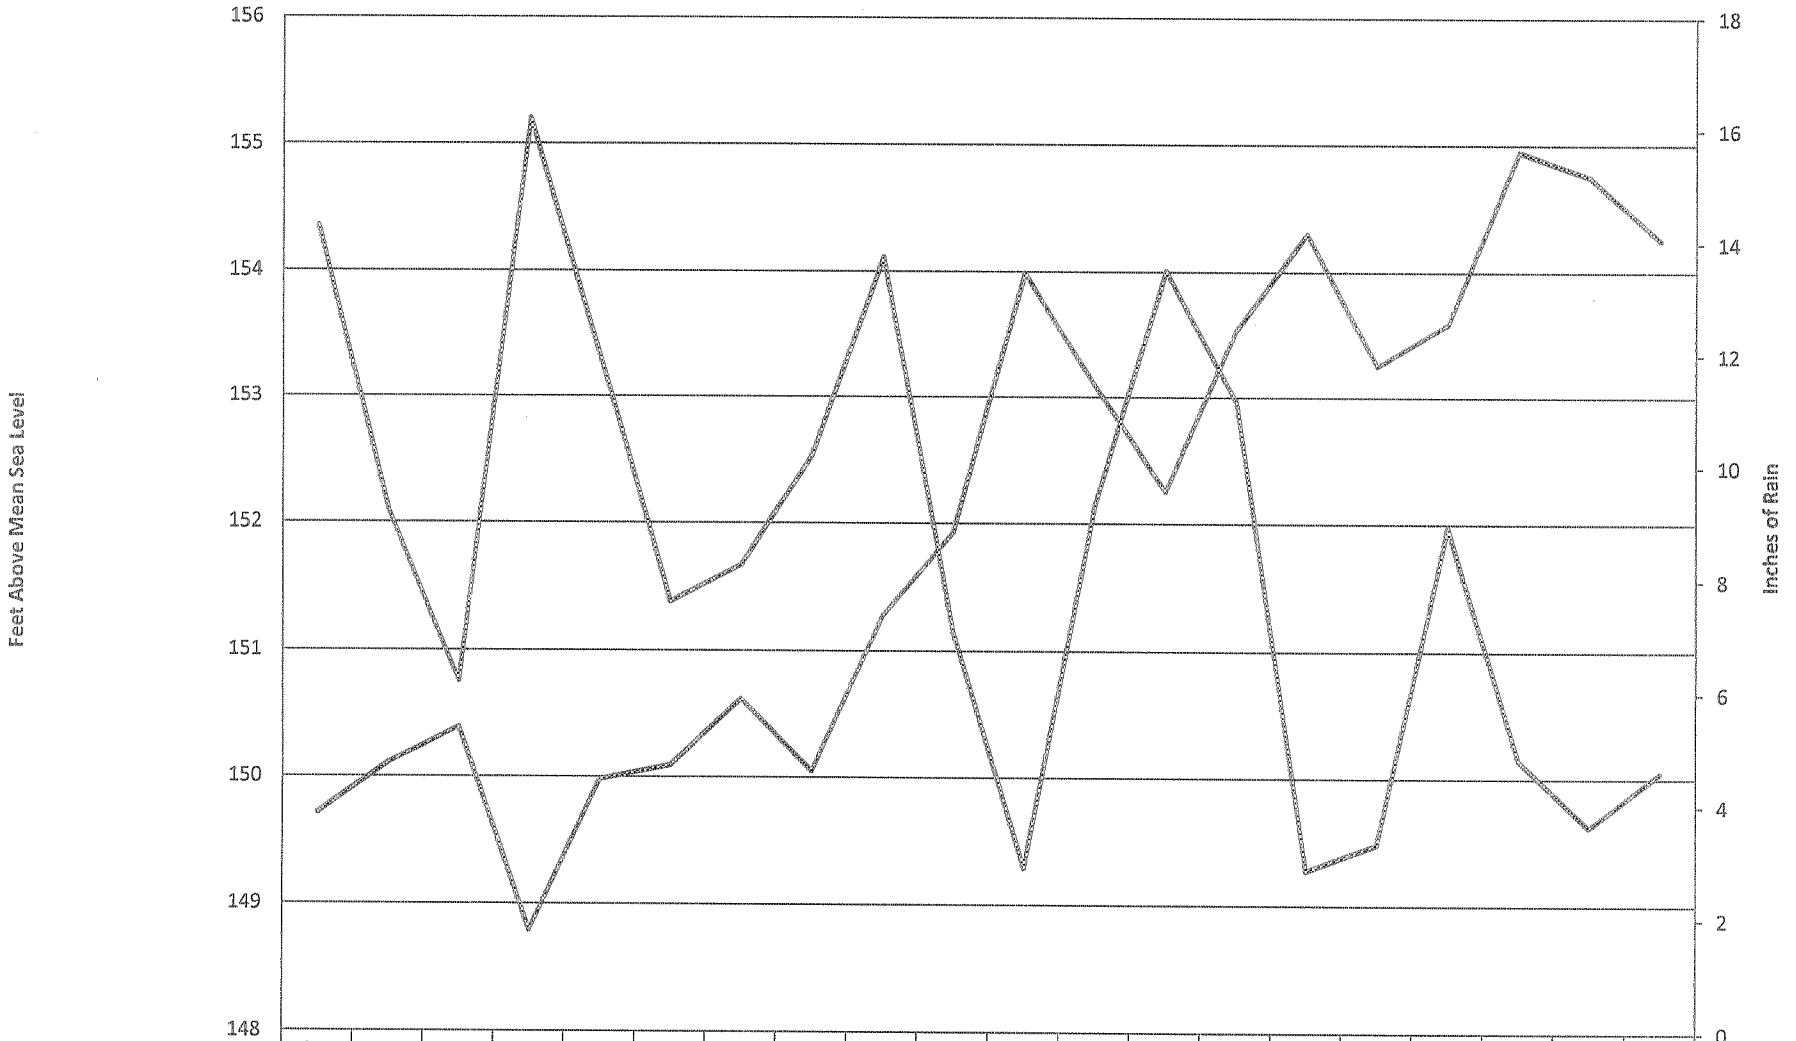
Lake Goodwin Well LG-05

Fourth Quarter: Other than arsenic in all wells and pH in LG-04, there were no measured exceedances of the standards in any well except LG-05. There were measured exceedances of the groundwater standards for conductivity, nitrate nitrogen, pH, sodium, total dissolved solids

and arsenic in well LG-05. No other dissolved metals were observed exceeding WAC level groundwater or secondary drinking water standards during this sampling event.
