ATTACHMENT 4
9/30/2003 CEI

Re: Treated Pole Yard Catch Basin Closure
J.H. Baxter Arlington Facility
7026-03

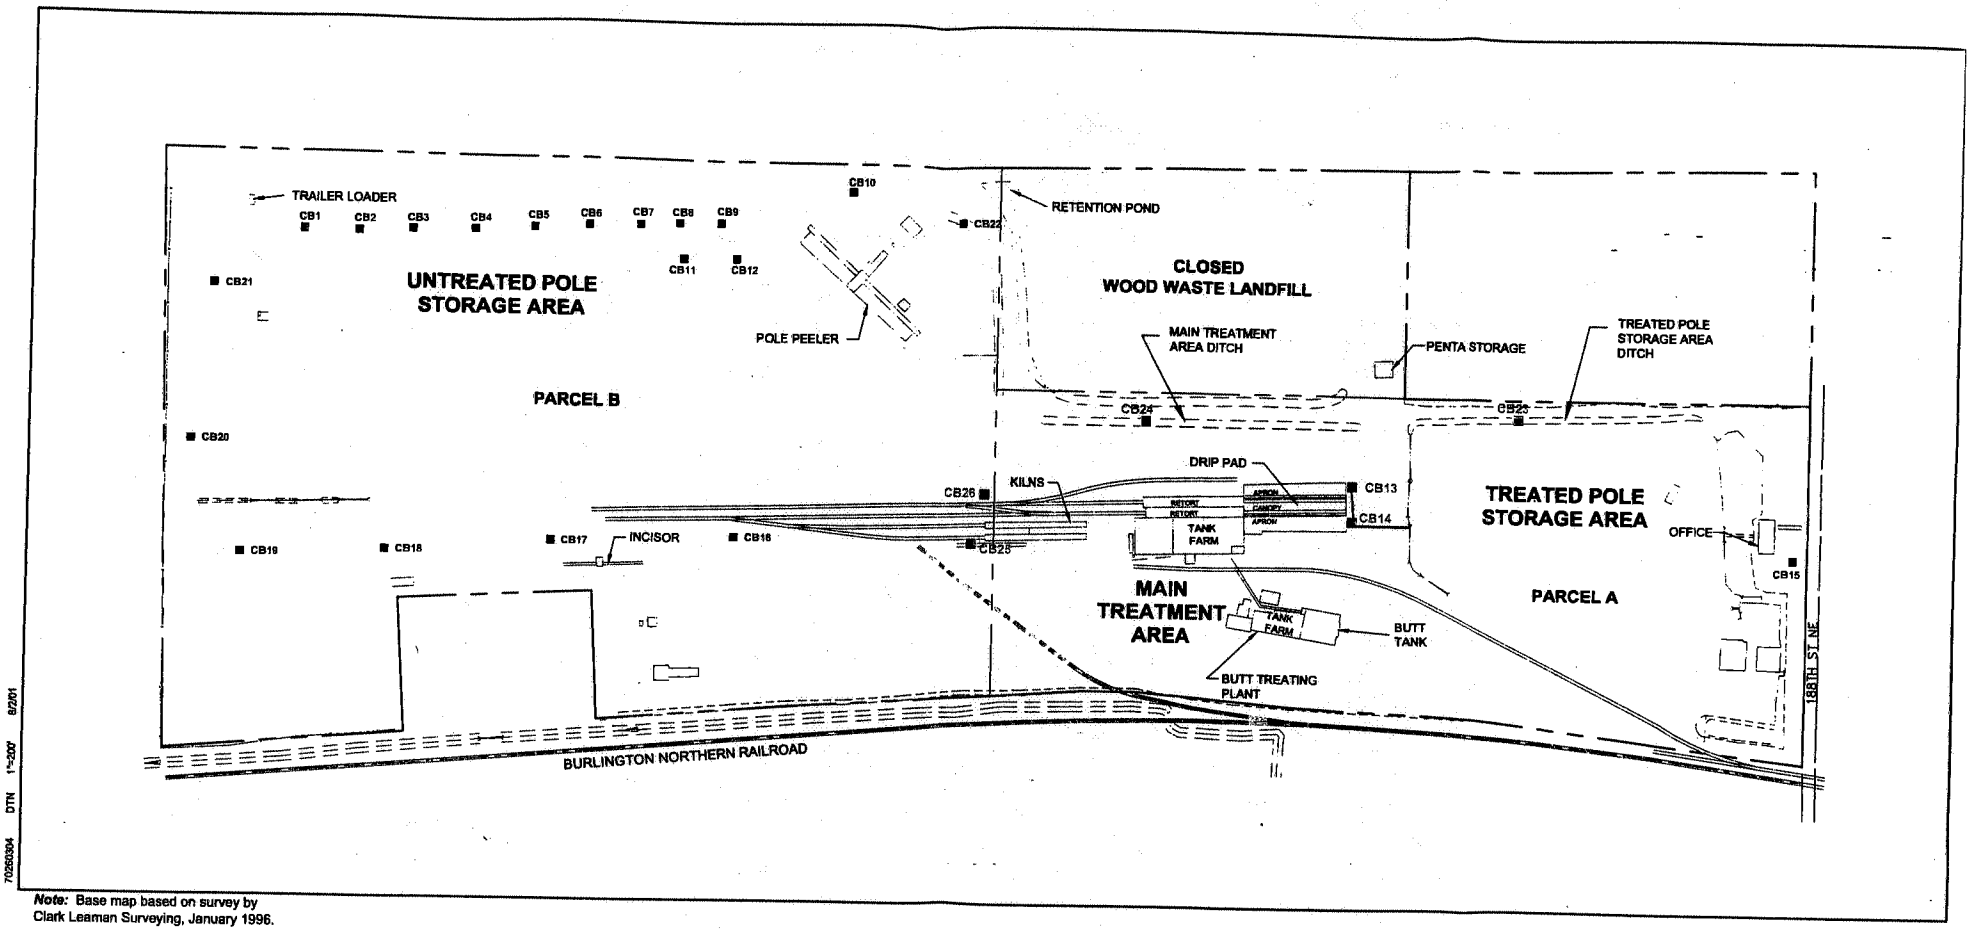
French Drain and Monitoring Location Map

On July 11, 2001, Baxter retained the services of Jerry's Bulldozing and Hart Crowser to address additional closure in the area of the former french drains catch basins CB 13, CB 14, CB 23, CB 24, CB 25, and CB 26 (Figure 1). Jerry Hagenson with Jerry's Bulldozing operated the backhoe and was the same operator used to do the initial closure. Tyson Carlson with Hart Crowser and Mary Larson with J.H. Baxter observed and directed the activities. Photographs 1 through 3 on Figure 2 provide a pictorial summary of the process.
