First Quarter 2023 Groundwater Sampling and Analysis Report

Camp Bonneville
23201 NE Pluss Road
Vancouver, Washington 98682

July 2023
PBS Project 76151.011

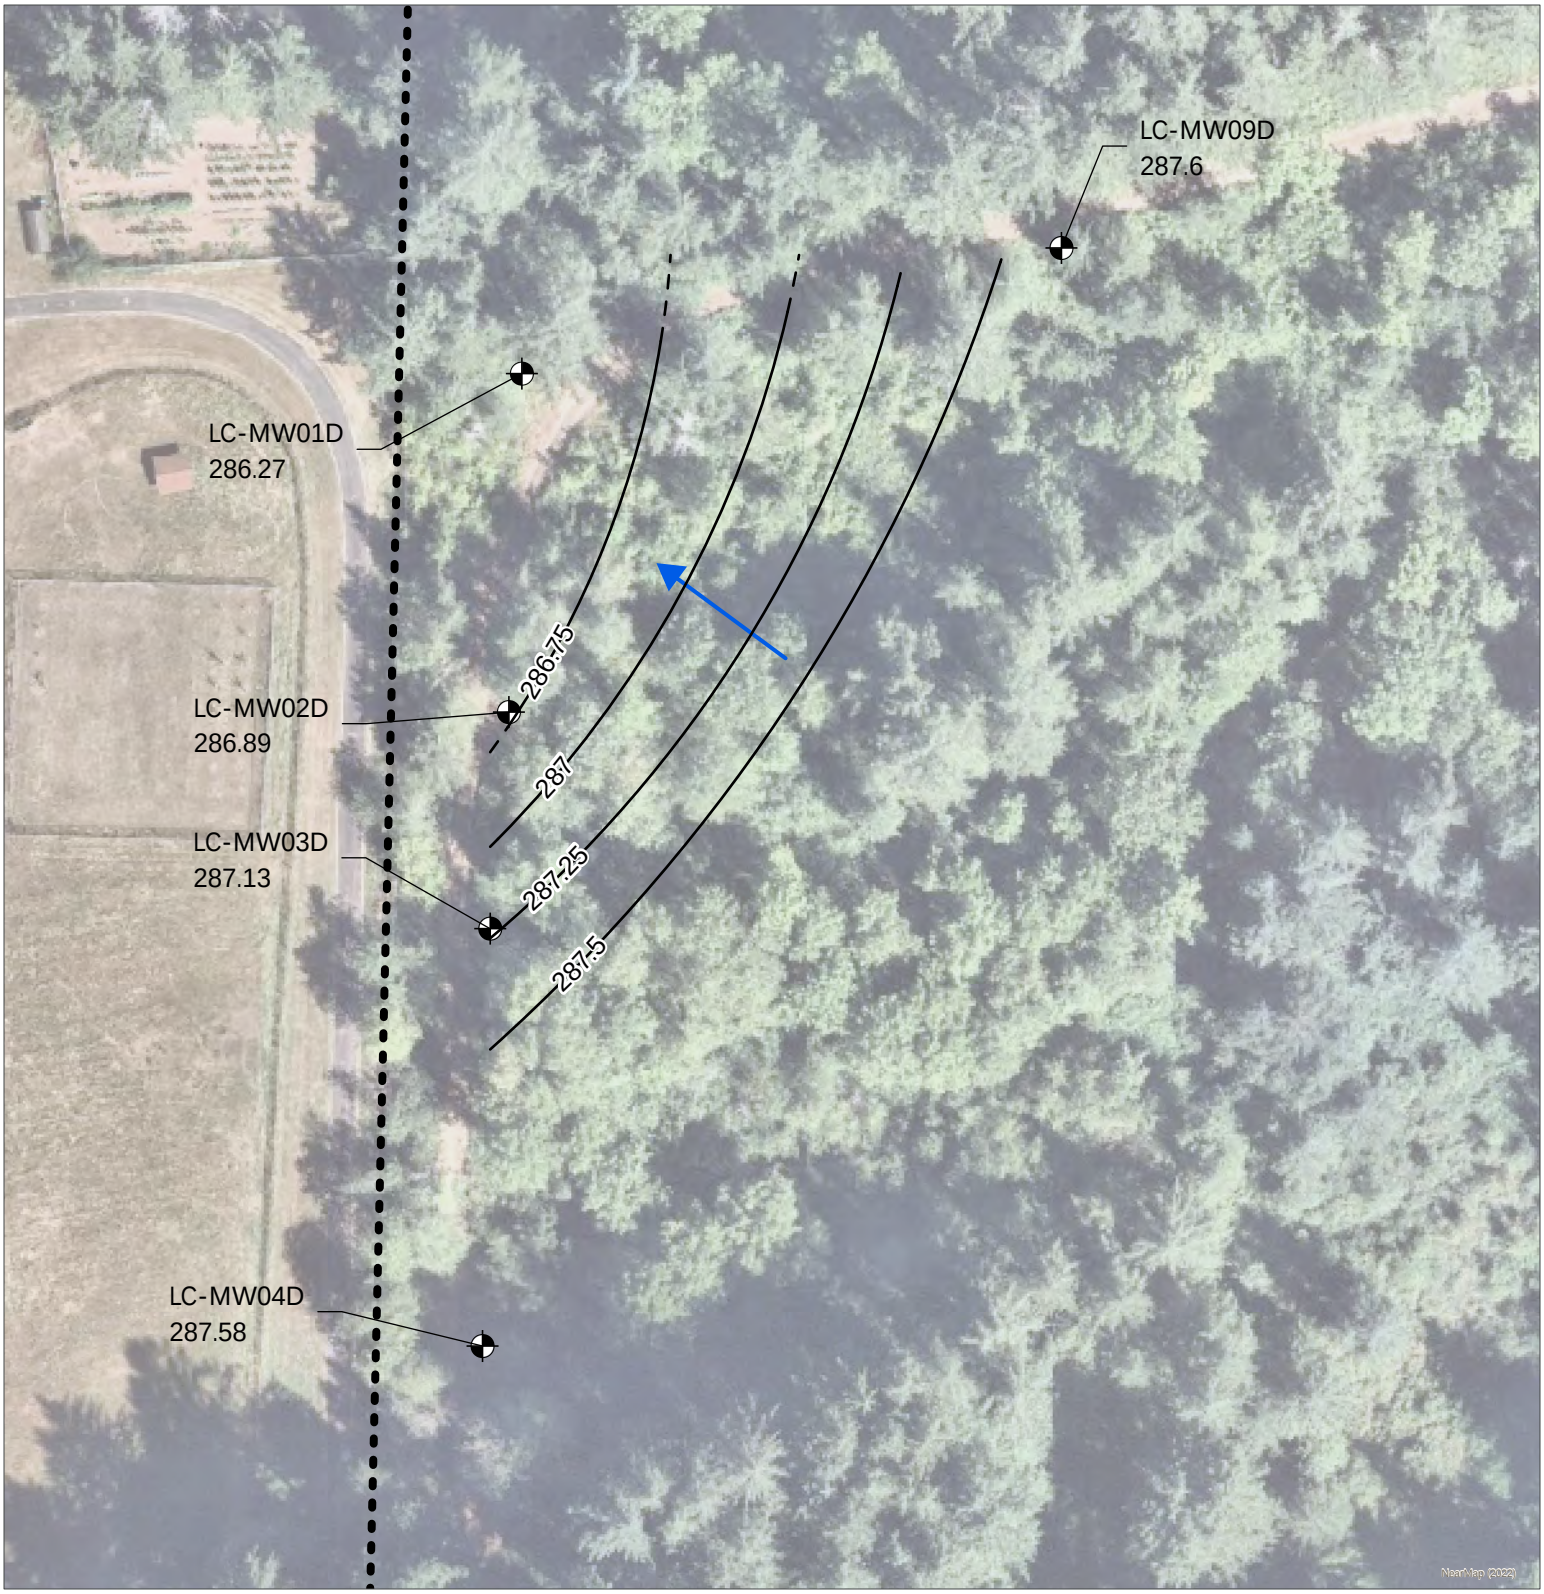
Shallow Base Boundary Monitoring Wells: Groundwater Elevation

Groundwater elevations and field parameters are provided in Table 2 for the first quarter 2023. Figure 5A illustrates groundwater contours and flow direction for the Base Boundary shallow wells, and Figure 5B for the Base Boundary deep wells.

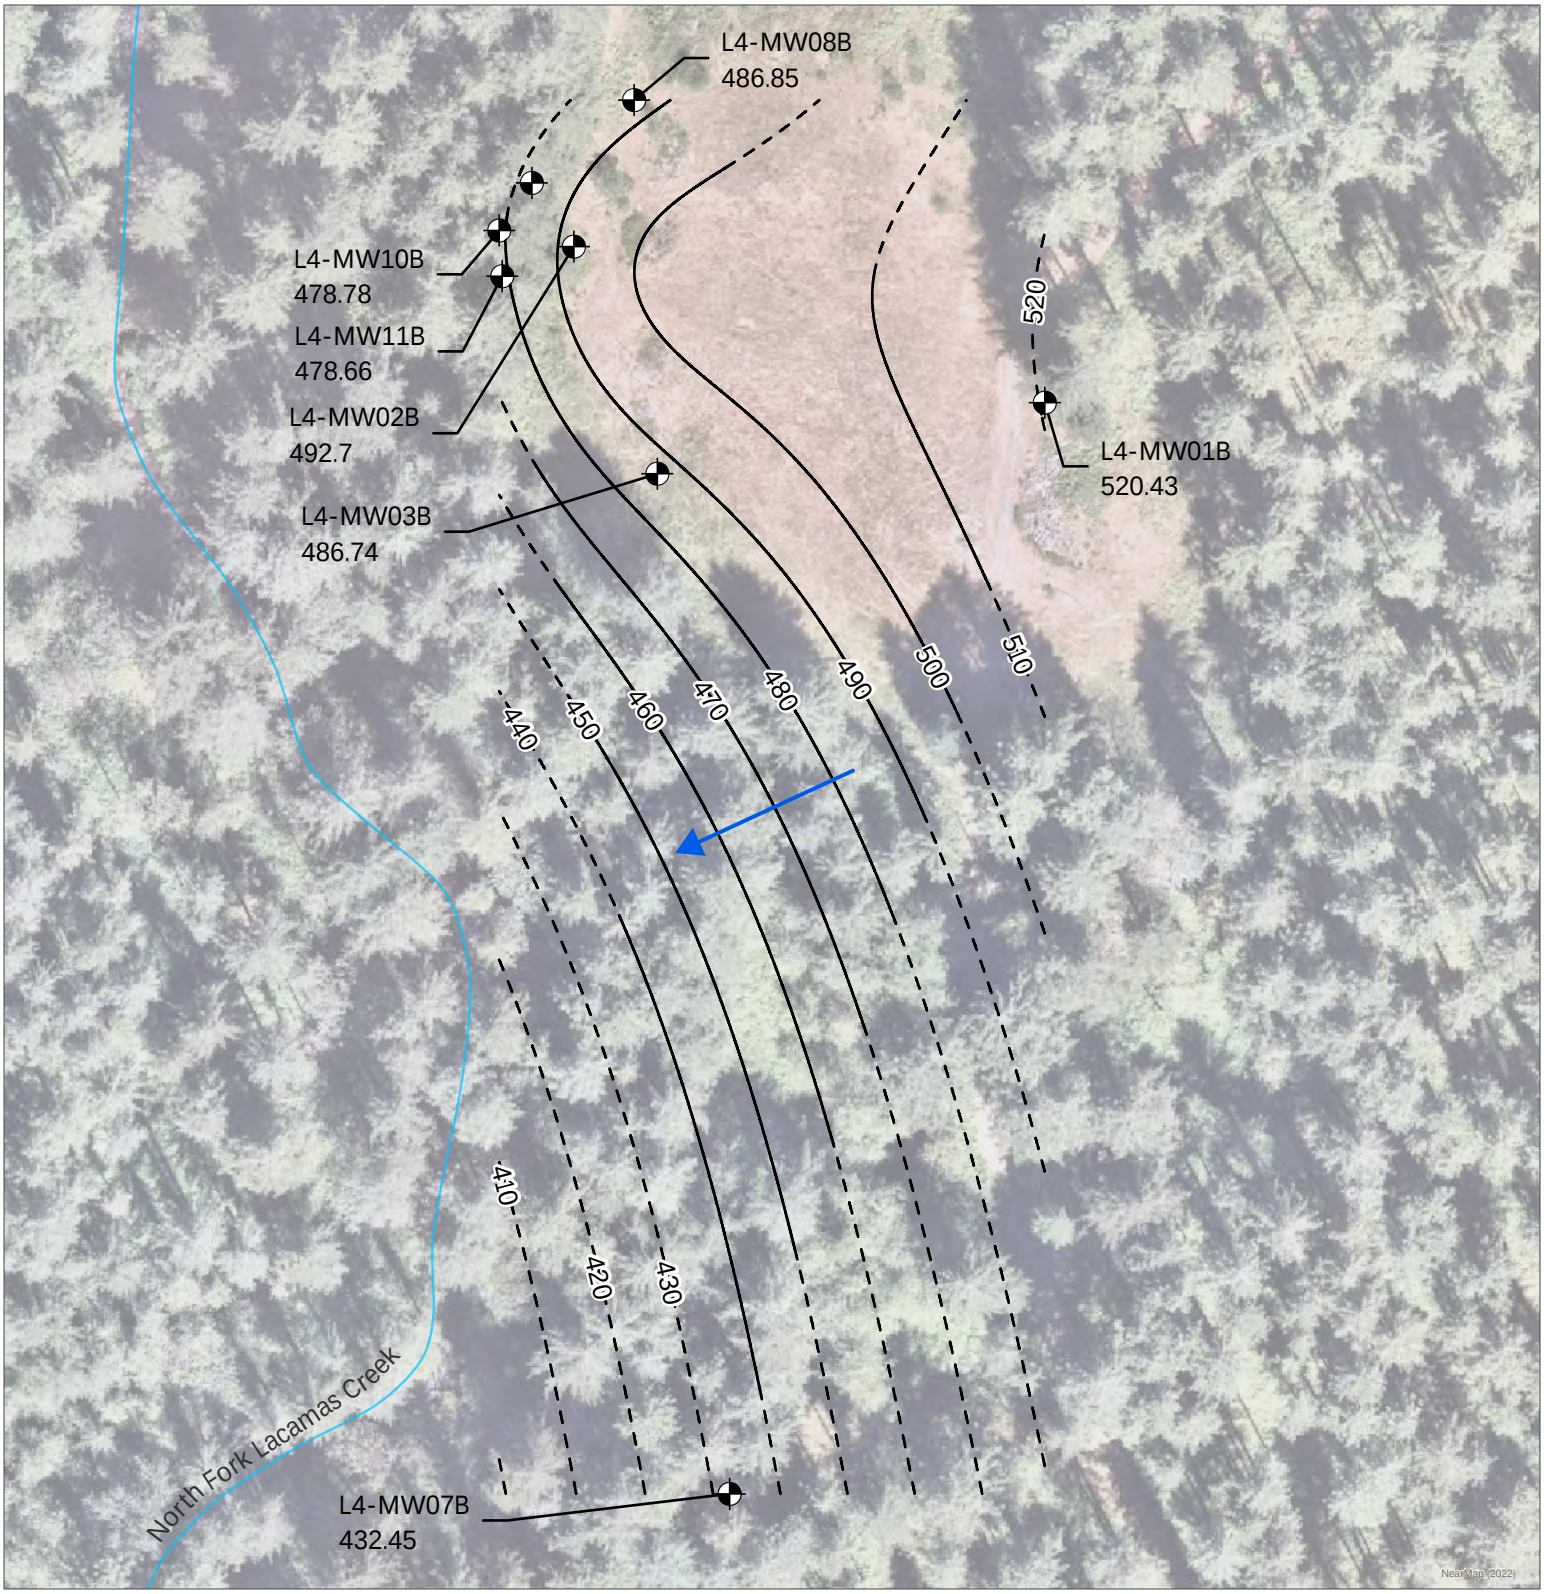
Deep Landfill 4 Monitoring Wells: Groundwater Elevation

Groundwater elevations are provided in Table 2 for the first quarter 2023. Wells L4-MW17 and L4-MW18 are located topographically downgradient from the Landfill 4 area and are not included in groundwater flow discussion. Well L4-MW07B is screened in the same area of the aquifer as the other deep wells at the Landfill 4 area (above bedrock) and is included in the deep groundwater flow discussion. Figure 6A illustrates groundwater contours and flow direction for the Landfill 4 shallow wells, and Figure 6B for the Landfill 4 deep wells.

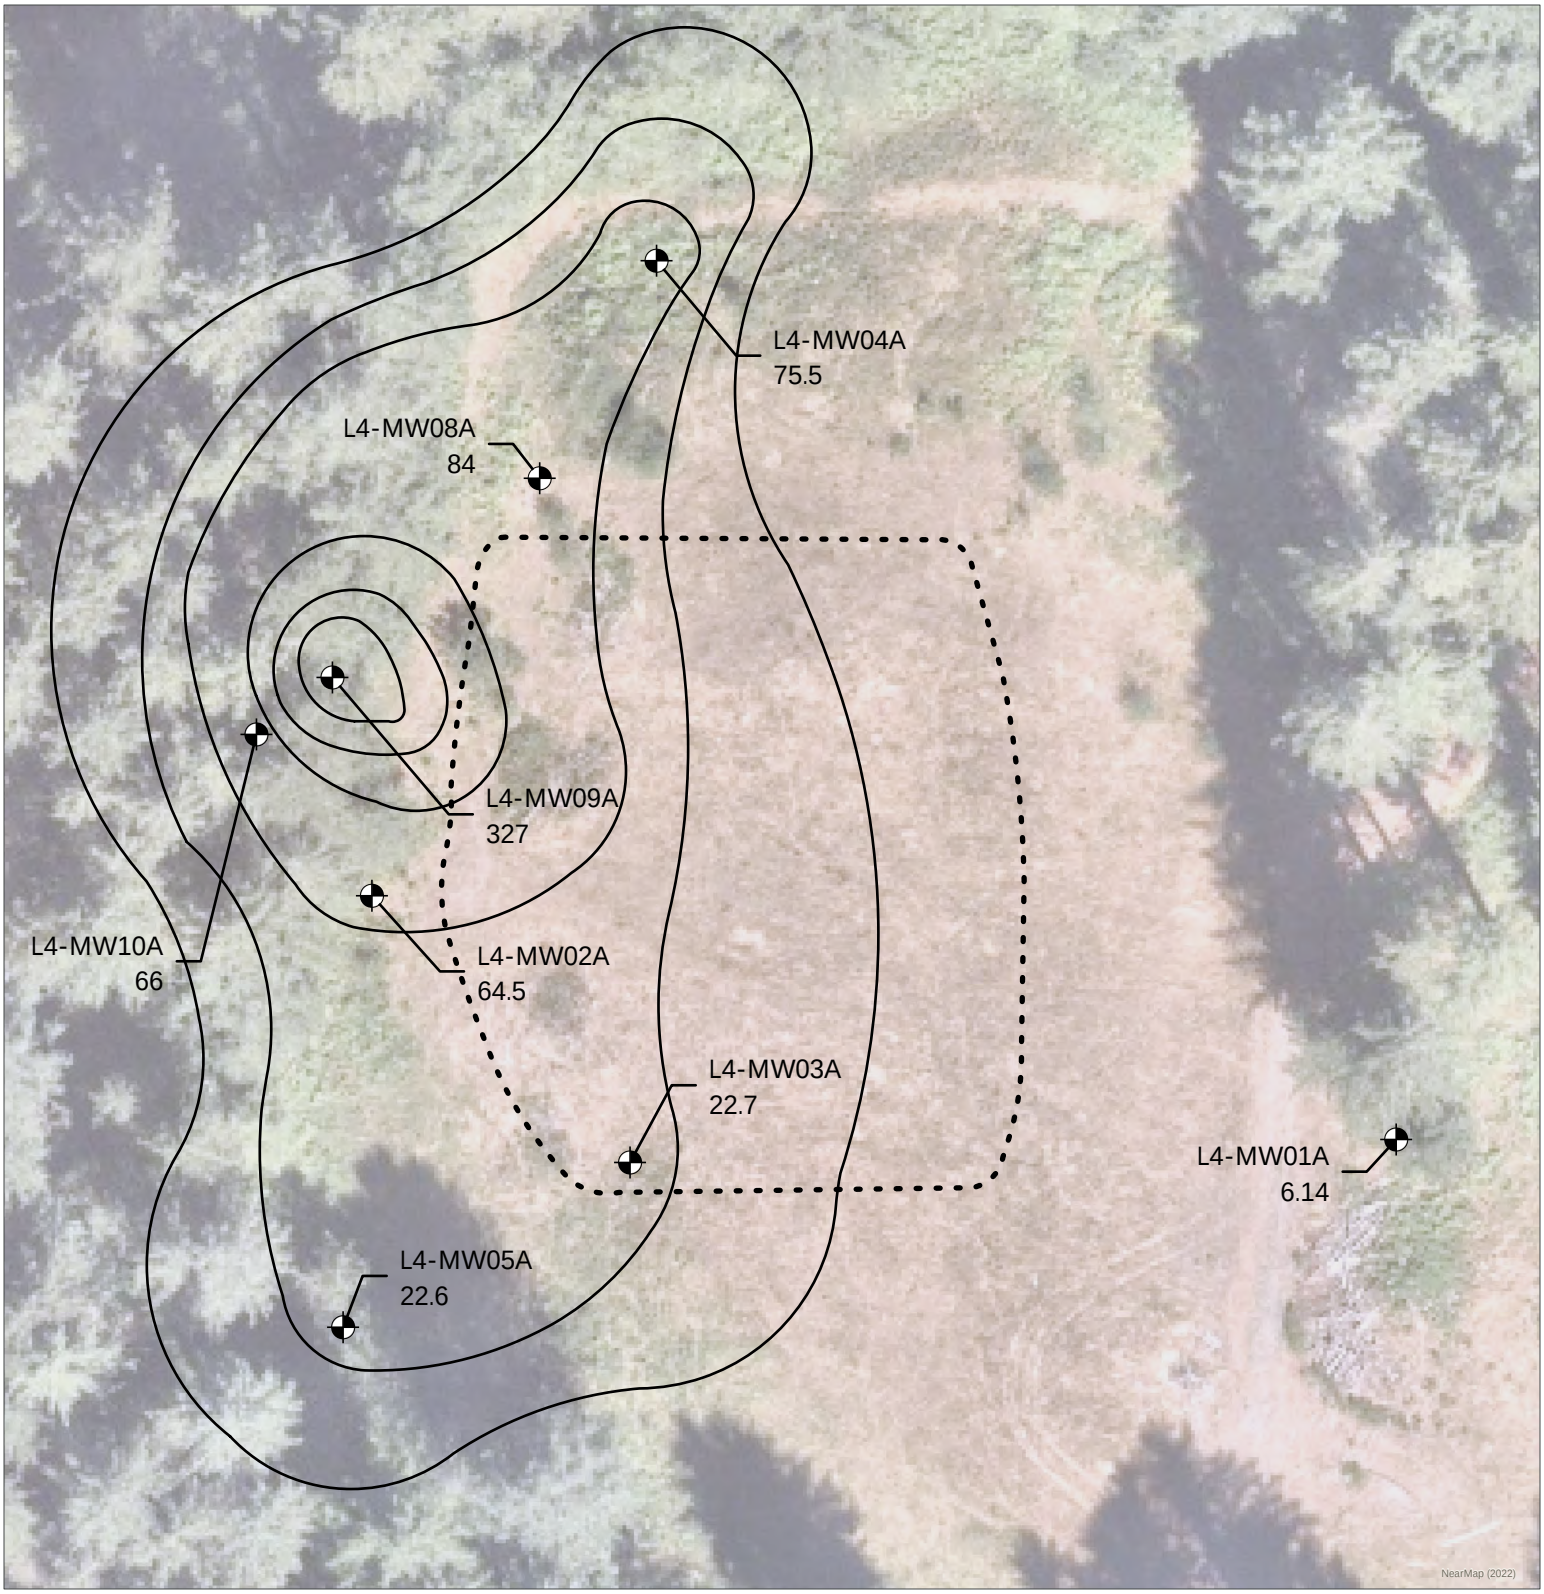
Shallow Landfill 4 Monitoring Wells: Perchlorate Concentrations

Table 3 provides detected concentrations or MRLs of non-detections for the contaminants of concern. Figures 7A and 7B show perchlorate isocontours at shallow and deep wells, respectively. Figures 8A and 8B show RDX isocontours at shallow and deep wells, respectively.

Of the 18 wells in the Landfill 4/Demolition Area 1 area, 13 had one or more detections of perchlorate, RDX, 2,4-dinitrotoluene, or 1,1,2,2-tetrachloroethane that exceeded MTCA Method B cleanup levels (see Table 3). Four wells had VOC detections; only L4-MW09B had an exceedance (1,1,2,2-tetrachloroethane) above MTCA Method B cleanup levels.

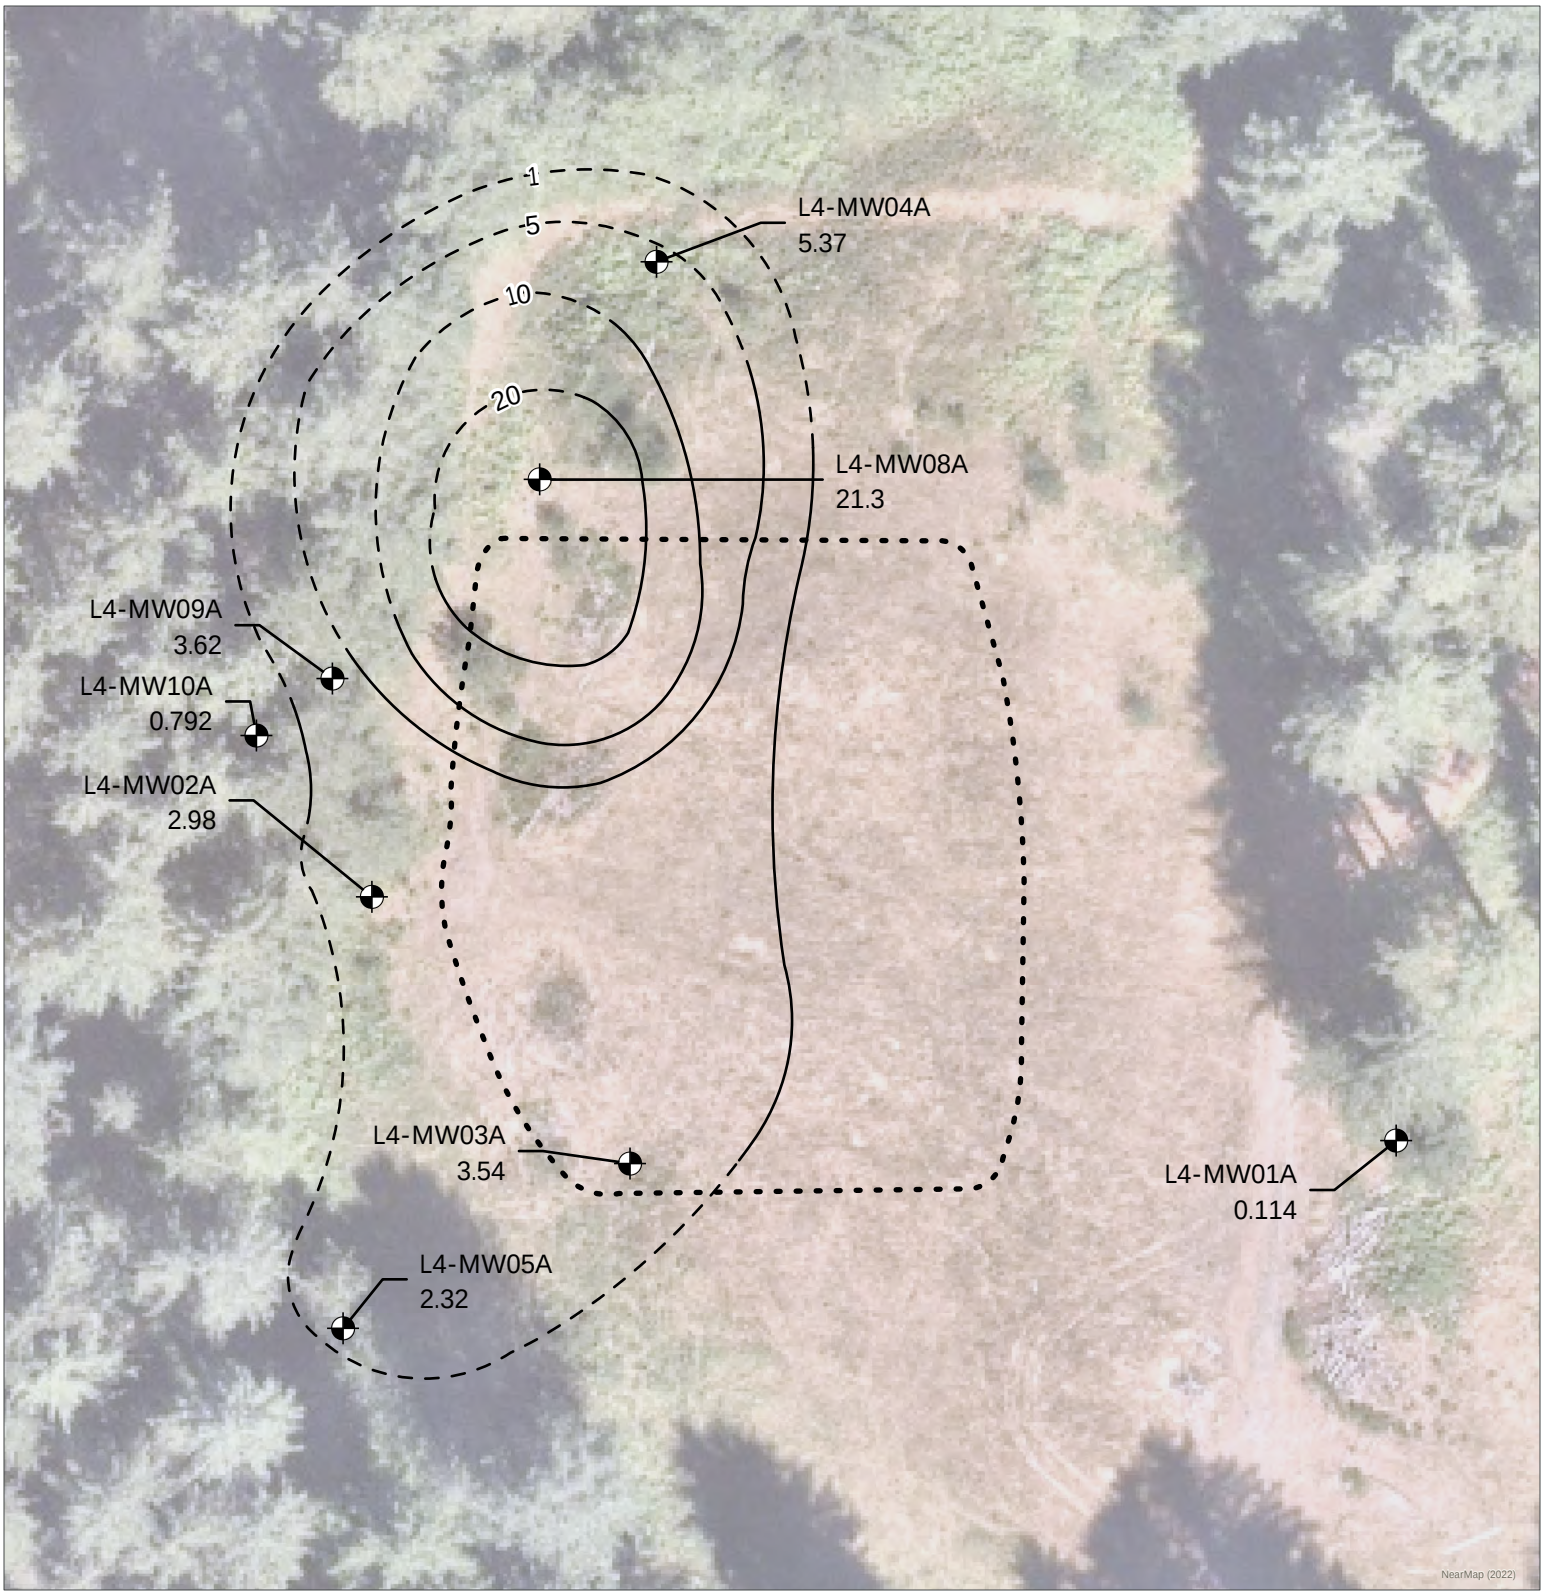
Shallow Landfill 4 Monitoring Wells: RDX Concentrations

1.1 µg/L = RDX Cleanup Level in Groundwater
