Quarterly Groundwater Compliance Monitoring
First Quarter 2023

Ultra Custom Cleaners
2222 NW Bucklin Hill Road
Silverdale, Washington

CSID 14334
FSID 18955

for
Bucklin Place LLC

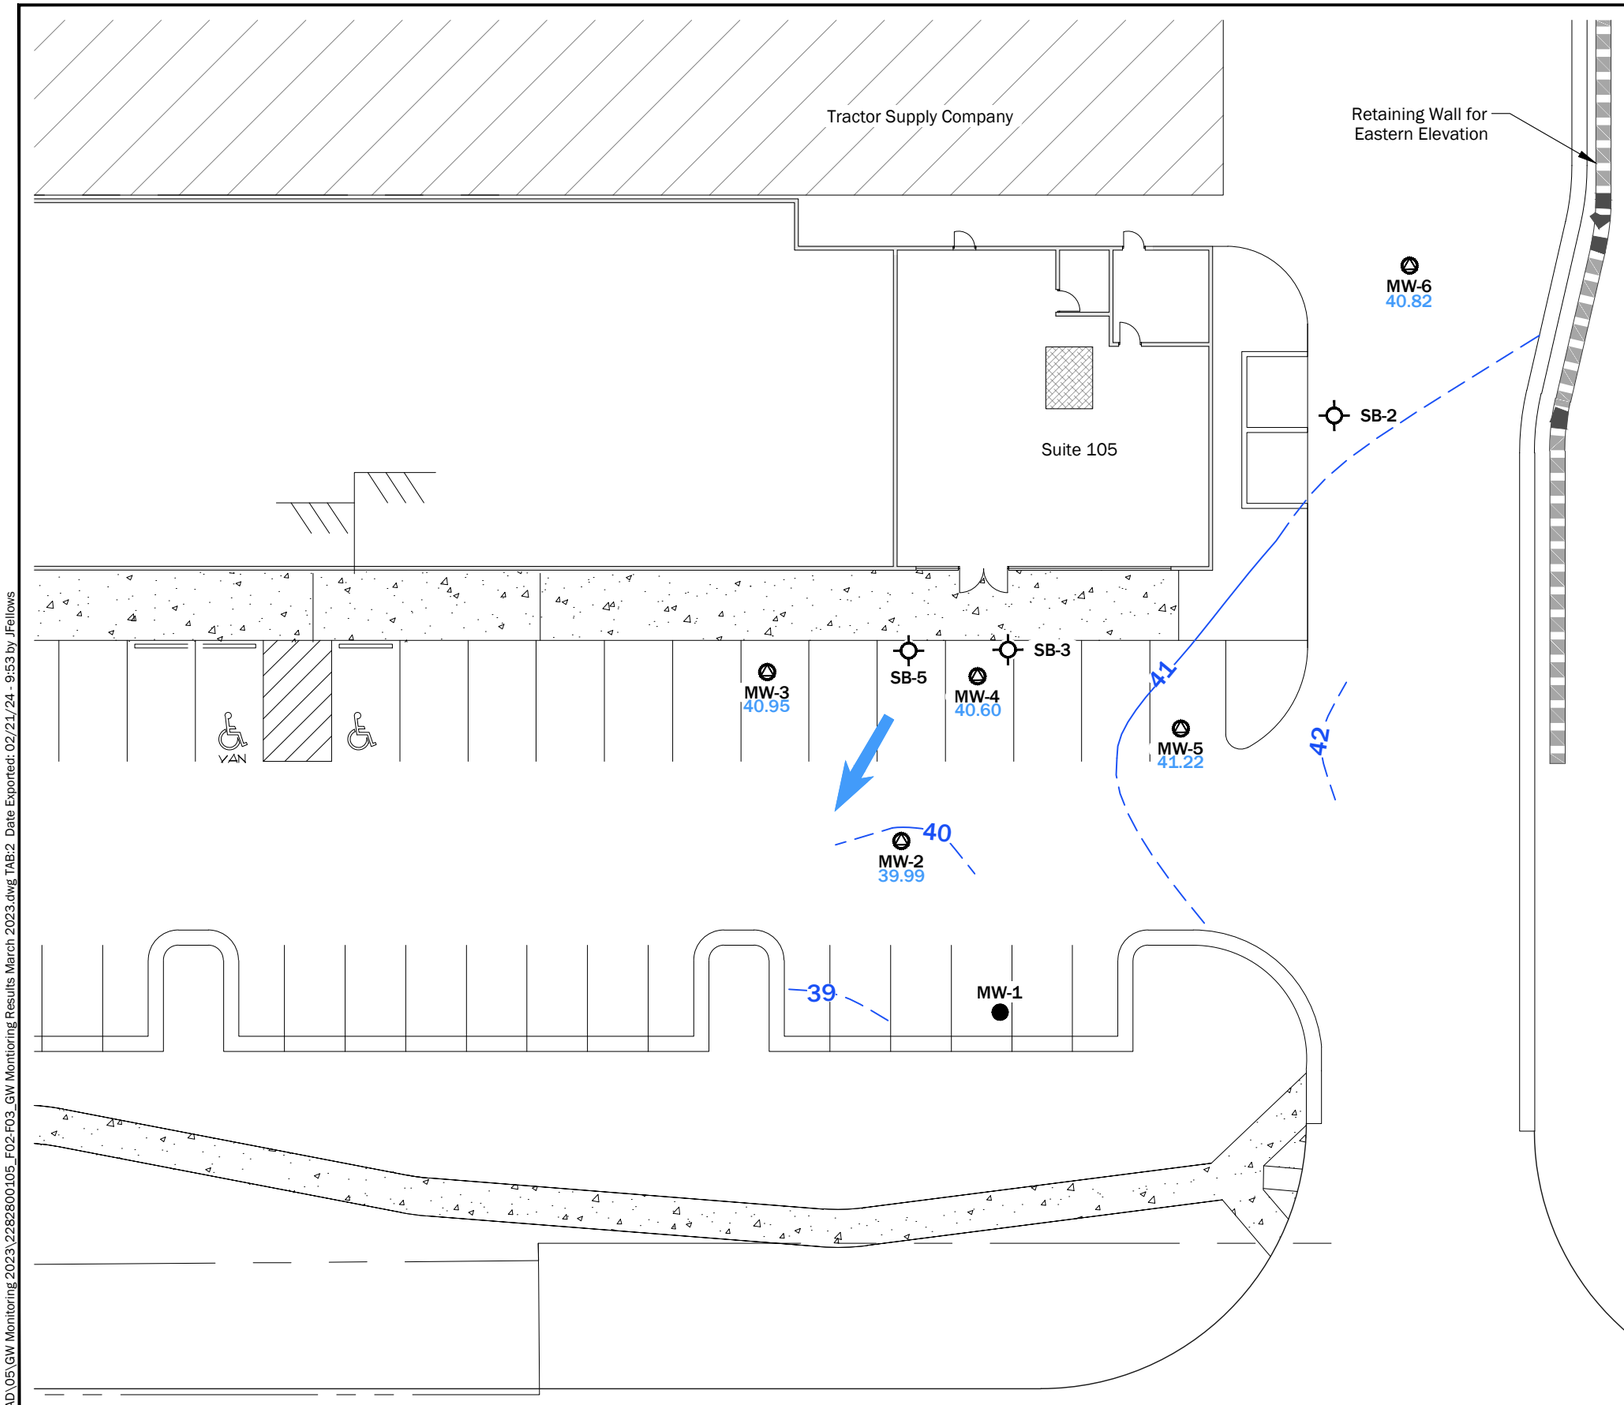
Figure 2

Depths to groundwater were measured on March 28, 2023. Depths to groundwater ranged between 5.28 feet below ground surface (bgs) (MW-6) and 6.68 feet bgs (MW-2); MW-1 produced groundwater under artesian pressure. Groundwater elevations ranged from 39.99 feet (MW-2) to 41.22 feet (MW-5) (North American Vertical Datum of 1988 [NAVD88]) and reflect seasonal changes. The groundwater flow direction is generally toward the southwest with a prominent influx coming from the abutment to the east. Depths to groundwater and groundwater elevations are summarized in Table 1. The groundwater elevations and groundwater elevation contours are shown in Figure 2.

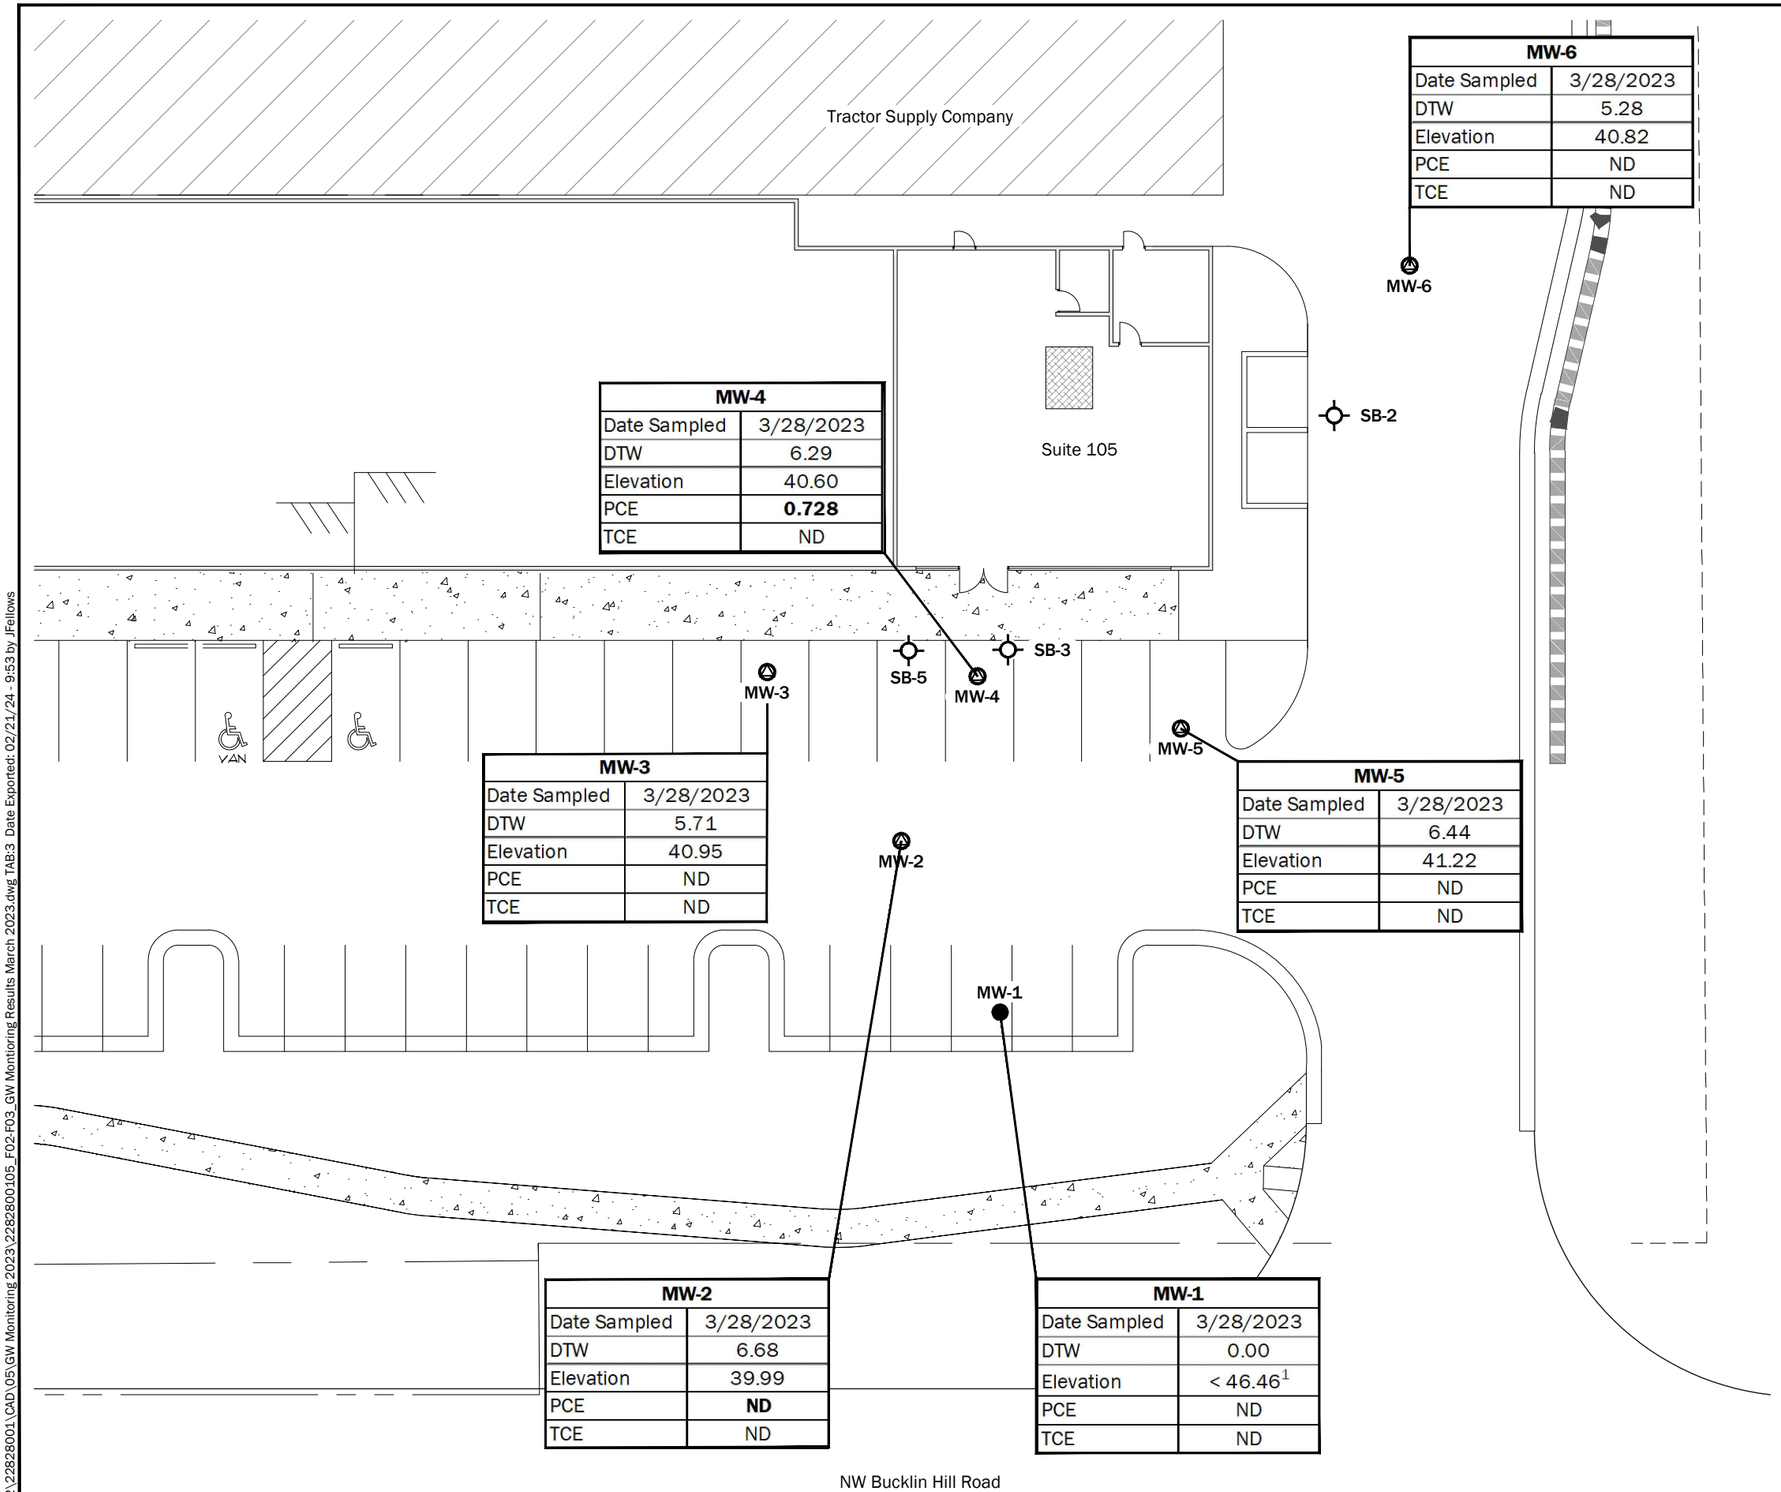
Figure 3

PCE was detected at a concentration less than the MTCA Method A cleanup level (5 micrograms per liter [µg/L]) at MW-4 (0.728 µg/L). PCE was not detected at a concentration greater than the laboratory reporting limit at any of the remaining wells. There were no detections of TCE, cis-1,2-DCE, trans-1,2-DCE, 1,1-DCE and vinyl chloride greater than the laboratory reporting limit for MW-1 through MW-6. These analytical results are depicted on Figure 3.

MW-4	
Date Sampled	3/28/2023
DTW	6.29
Elevation	40.60
PCE	**0.728**
TCE	ND

MW-2	
Date Sampled	3/28/2023
DTW	6.68
Elevation	39.99
PCE	**ND**
TCE	ND
