Quarterly Groundwater Compliance Monitoring
Second Quarter 2023

Ultra Custom Cleaners
2222 NW Bucklin Hill Road
Silverdale, Washington

CSID 14334
FSID 18955

March 1, 2024

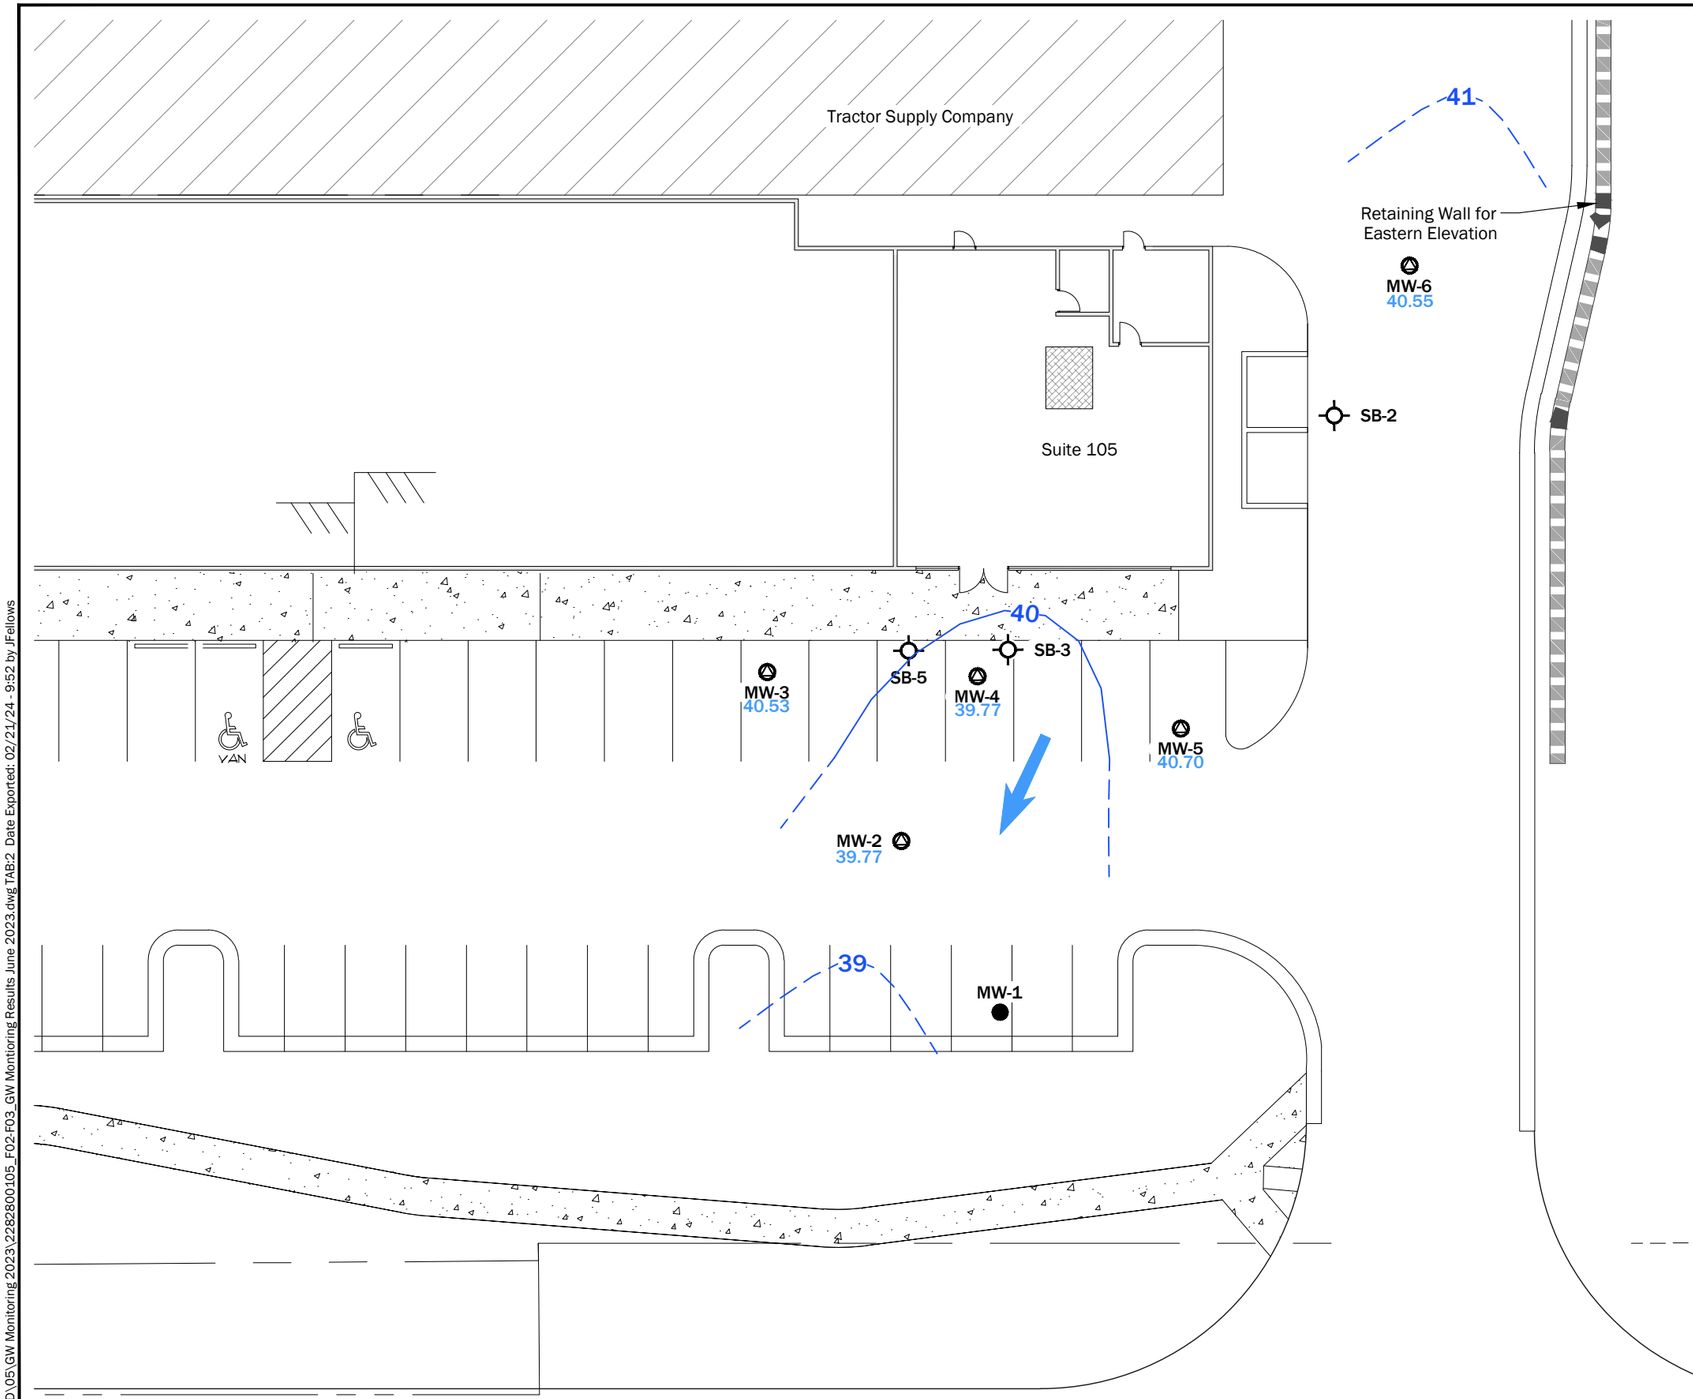
Figure 2

Depths to groundwater were measured on June 20, 2023. Depths to groundwater ranged between 5.55 feet below ground surface (bgs) (MW-6) and 7.12 feet bgs (MW-4); MW-1 produced groundwater under artesian pressure. Groundwater elevations ranged from 39.77 feet (MW-2 and MW-4) to 40.70 feet (MW-5) (North American Vertical Datum of 1988 [NAVD88]) and reflect seasonal changes. The groundwater flow direction is generally toward the south-southwest. Depths to groundwater and groundwater elevations are summarized in Table 1. The groundwater elevations and groundwater elevation contours are shown in Figure 2.

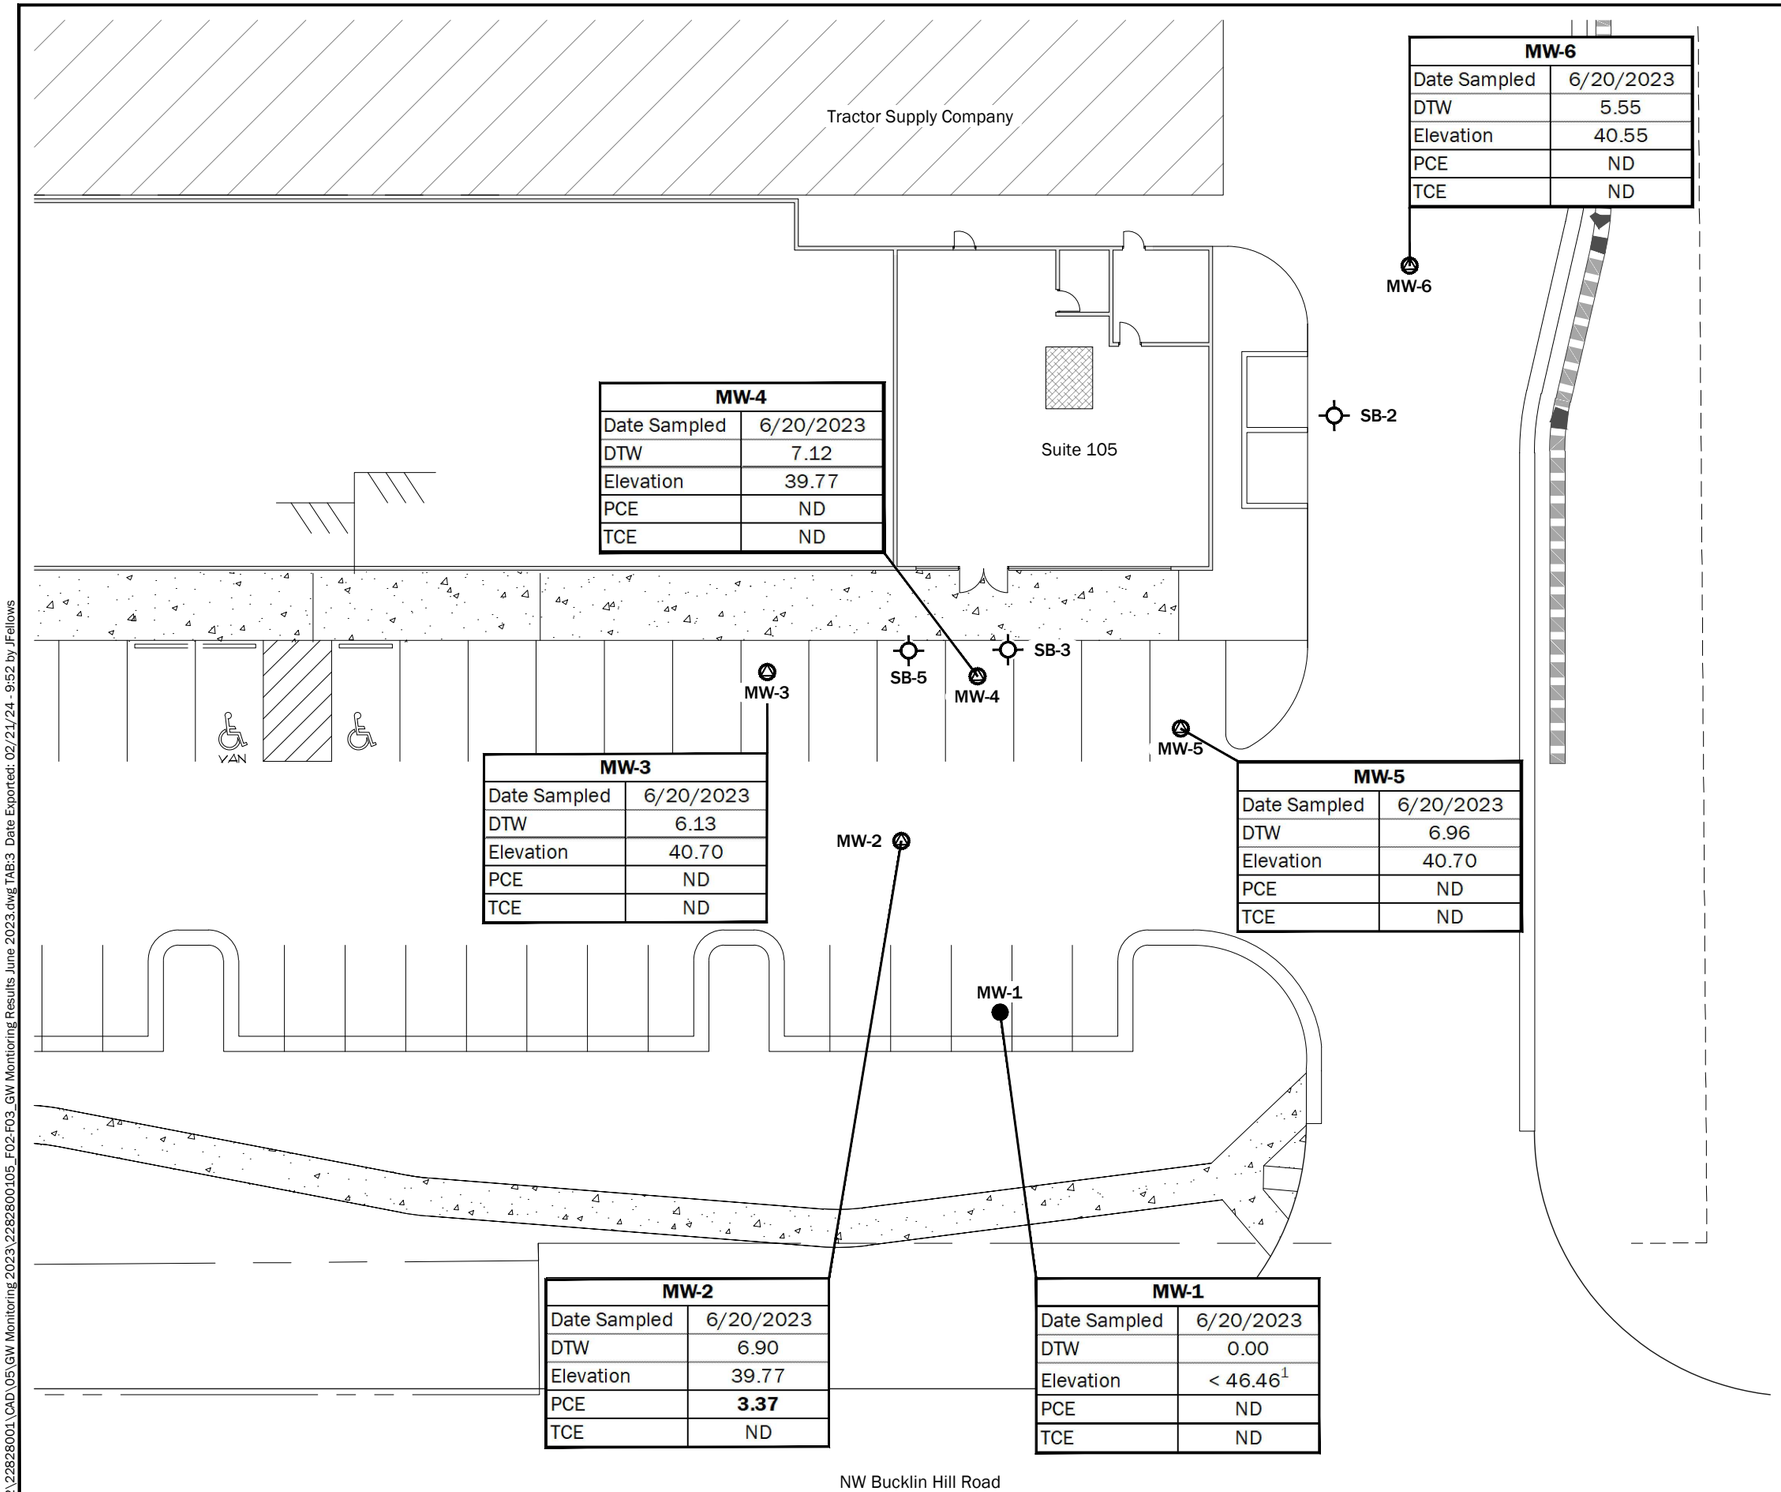
Figure 3

There were no detections of PCE, TCE, cis-1,2-DCE, trans-1,2-DCE, 1,1-DCE or vinyl chloride at concentrations greater than the laboratory reporting limit for MW-1 through MW-6. These analytical results are depicted on Figure 3.

The results of the 2Q2023 groundwater monitoring marked the fourth consecutive quarter during which all chemical analytes, including PCE, were either detected at concentrations less than the MTCA Method A cleanup level of 5 micrograms per liter (µg/L) or were not at concentrations greater than the laboratory reporting limit.

MW-6	
Date Sampled	6/20/2023
DTW	5.55
Elevation	40.55
PCE	ND
TCE	ND

MW-4	
Date Sampled	6/20/2023
DTW	7.12
Elevation	39.77
PCE	ND
TCE	ND

MW-3	
Date Sampled	6/20/2023
DTW	6.13
Elevation	40.70
PCE	ND
TCE	ND

MW-5	
Date Sampled	6/20/2023
DTW	6.96
Elevation	40.70
PCE	ND
TCE	ND

MW-2	
Date Sampled	6/20/2023
DTW	6.90
Elevation	39.77
PCE	**3.37**
TCE	ND

MW-1	
Date Sampled	6/20/2023
DTW	0.00
Elevation	< 46.46[1]
PCE	ND
TCE	ND
